# An evaluation of selected California Coastal Commission wetland projects

Teri Uyeda Zenk  
*San Jose State University*

**AN EVALUATION OF  
SELECTED CALIFORNIA COASTAL COMMISSION WETLAND PROJECTS**

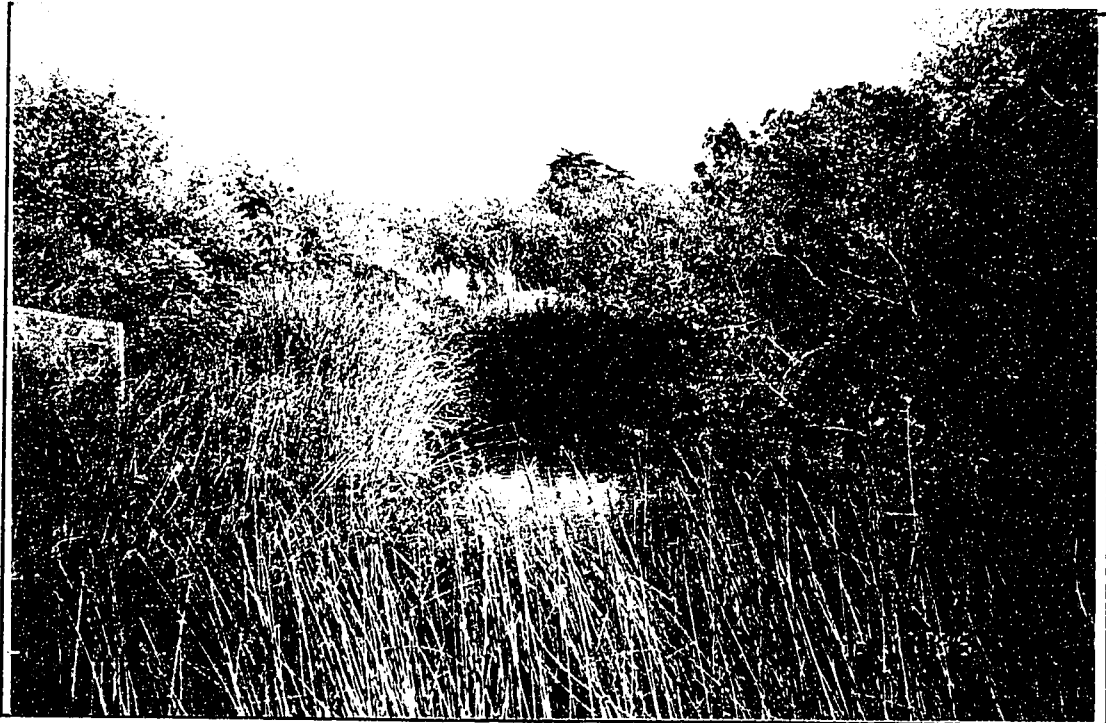
Figure 3.--Neary Lagoon Mitigation Site

The mitigation site (See Figure 3) was located to the left of the pedestrian path, before crossing the neck of the lagoon. The site was covered with dense vegetation which served as both wildlife habitat and as a screen from the railroad tracks which run adjacent to Neary Lagoon. Although fenced, the site could be accessed through a large hole in the fence near the railroad tracks. It was obvious that the site was used as a campsite by people in the area. During the field evaluation, four separate areas were observed in which the vegetation had been cleared or flattened, and items such as clothing, blankets, cookware, and garbage had been left behind. Also, six distinct paths through the revegetated area were observed. The use of the site by humans was considered to be the primary problem for both this mitigation site and Neary Lagoon in general.

In summary, the vegetation at both sites looked healthy and seemed to be thriving except where it had been altered by humans. Several non-native pampas grass tufts were observed within the fenced mitigation site, as well as along the pedestrian trail. Wildlife observations were limited to sightings of mallard ducks by the researcher.

- Field evaluations should be taken once a year to observe any corrections which may become necessary such as regrowth of invasive species, repair of floating walkways, etc.
- Remove non-native species along the path and throughout Neary Lagoon on a regular basis to reduce new growth
- Repair the hole in the fence to keep humans out of the mitigation area. This criteria is considered to be fully met since the fence was originally established at the mitigation site

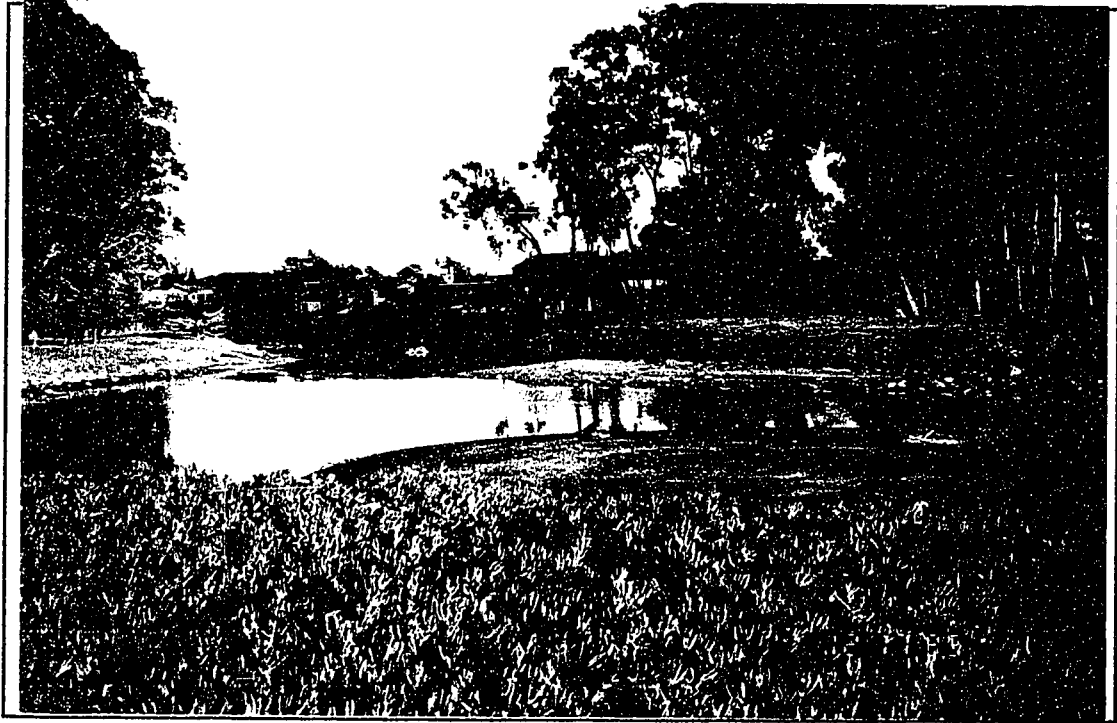
Figure 5.--Moran Lake Overview

with additional financial assistance from the Land and Water Conservation Fund. The restoration plan was to enhance the degraded lagoon by: 1) removing polluted sediment, 2) restoring tidal action, 3) creating a salt marsh, 4) revegetating barren land, and 5) providing public access and recreational facilities (See Figure 5).

There was a complete lack of marsh vegetation, or any vegetation for that matter, at the water's edge of Moran Lake. The only species found were groves of eucalyptus, a stand of Monterey Cypress, grasses, and ice plant. A large, bare mudflat area was observed at the culvert side of the lagoon, which was the site of the restoration work. Wildlife was absent as well, although gulls and a mallard were observed. In addition, the homes surrounding Moran Lake were encroaching into the lake area. In three cases, there were 15 feet or less between the homeowner's fence and the lagoon's high water mark. The park was observed to be used extensively by people and domestic animals, primarily dogs, for passive recreation. In summary, Moran Lake remains a highly degraded non-tidal lagoon. The lack of salt marsh vegetation and wildlife was an obvious

- Replace existing culvert with one at the proper elevation
- Maintain culvert entrance openings
- Remove ice plants and replant with native species
- Replant banks with emergent vegetation along shoreline
- Control in-flow water and water quality into Moran Lake by the addition of a sedimentation catch basin

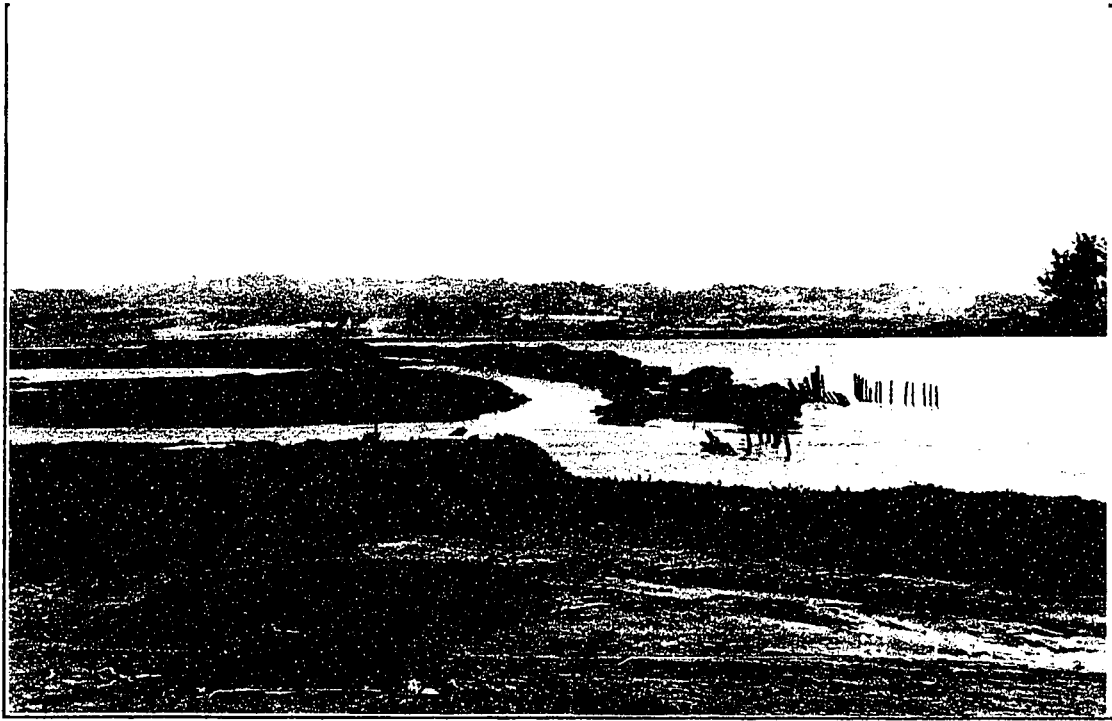
Figure 7.--Breached Levee at Moss Landing Wildlife Area

The evaporation ponds were separated from Elkhorn Slough by a levee approximately one mile long and three-quarters of a mile wide. Constant tidal movement had caused breaching (See Figure 7) in three spots along the main levee and had destroyed the inner levee system that use to support seventeen individual salt ponds, which were

now exposed tidal mudflats. The continued expansion of the mudflats would have destroyed the existing saltpond ecosystem, which relies upon the varied levels of salinity contained in the various saltponds. A uniform salinity, brought about by the mudflats, would have decreased the habitat value and in turn decreased the wildlife species found in the area.

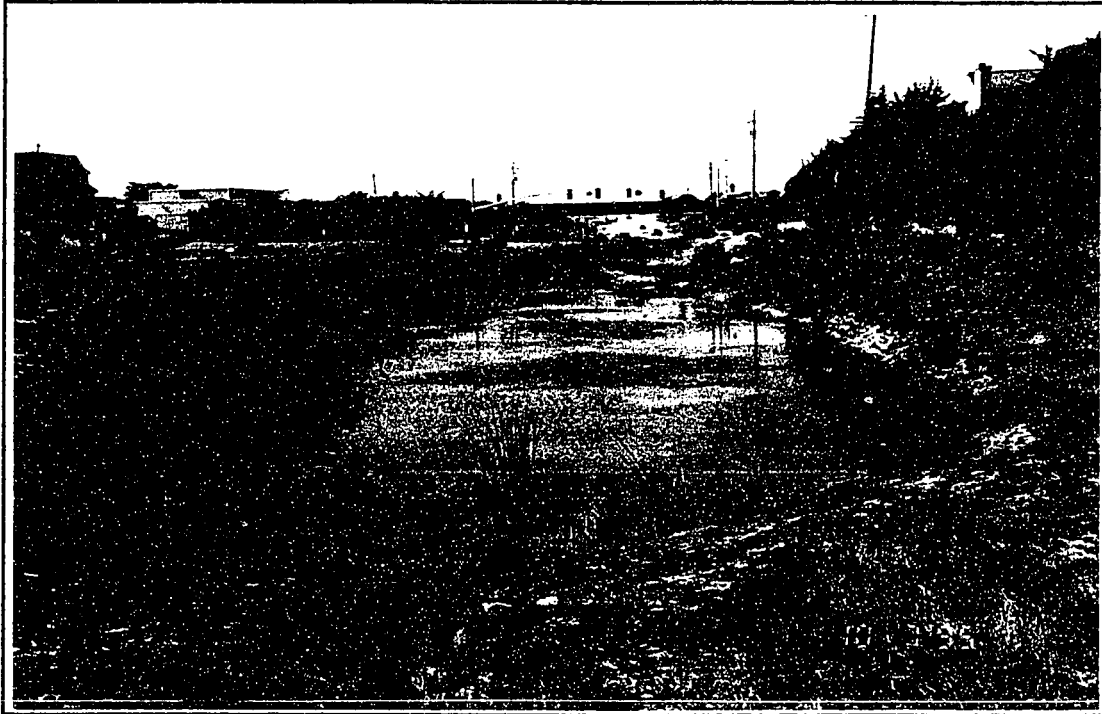
Figure 10.--Marina Landing Pond #3 North/South Site Overview

larger pond (See Figure 10), and enhanced the area for wildlife by providing a vegetative screen and establishing native vegetation at the site.

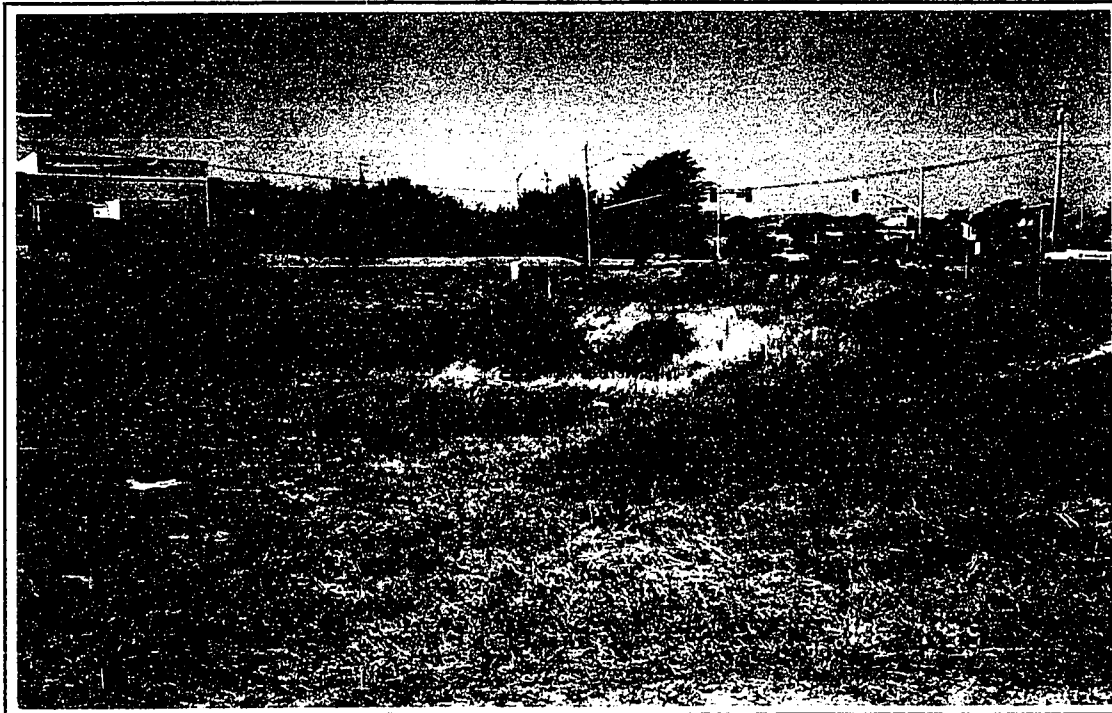
Figure 11.--Marina Landing Pond #3 West Pond Overview

The west pond of Marina Landing was one of the original three vernal ponds which comprised the Marina Landing Pond #3 site. The project background information (See Table 9) as well as the aerial photograph (See Figure 9) is the same for Marina Landing Pond #3 North/South pond. Although the north and south ponds were combined to form one larger pond, the west pond was left unaltered (See Figure 11) by the construction of the Marina Landing Shopping Center. The west pond was considered to be the overflow basin for the north/south combined pond, and remained connected to the north/south pond via a culvert that runs under Beach Road.

Under the mitigation proposal, the west pond remained at its present location and required minimal work. There was no mention of controlling the surface water runoff from the shopping center, no grading, and well water would not be provided to maintain water levels. The area, being a seasonal wetland, was not a managed site and did not require observation platforms, fencing, or wildlife habitat enhancement. The only requirements stated were that the pond was to be left at its present location and that a willow buffer was to be established along the northern edge of Beach Road.

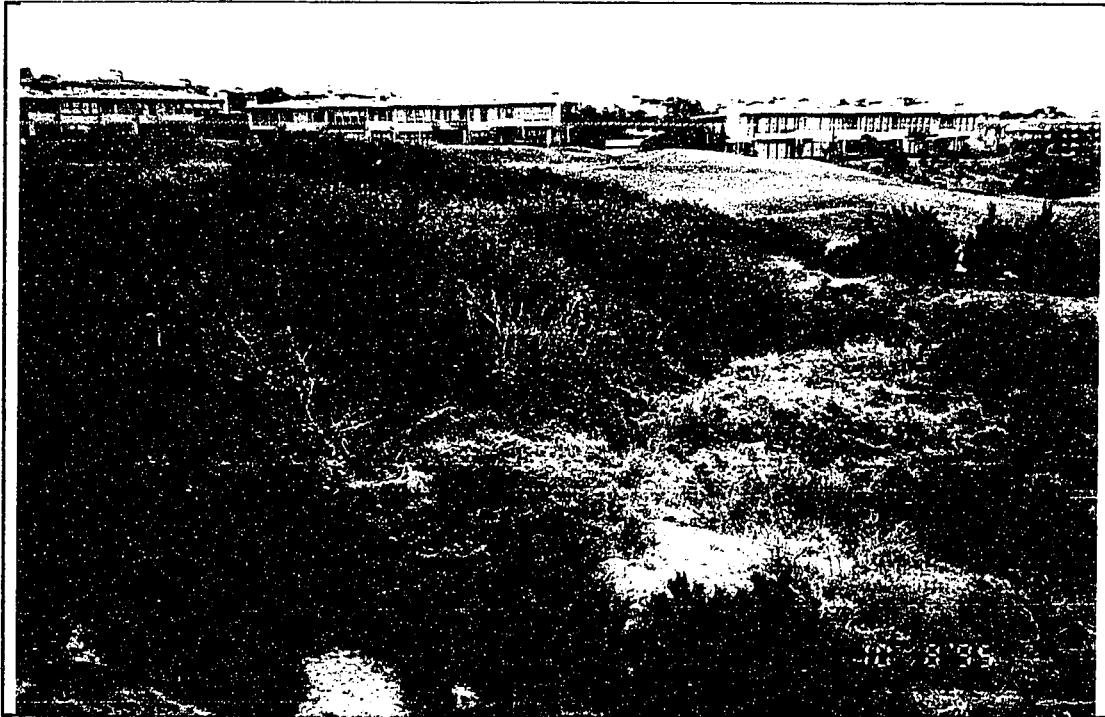
Figure 23.--Spanish Bay Northern Riparian Site

The northern riparian area (See Figure 23), located between Sunset Drive and the 14th fairway, was left largely unaltered, except where inlet aprons were installed to reduce siltation and erosion, and the addition of a pond, which was necessary to meet the storm drainage requirements of the project. The original vegetation was limited to thickets of arroyo willow, fringed by ice plant and pampas grass. Replacement vegetation emphasized native species and included wax myrtle, coyote bush, mock heather, sea rocket, and yellow bush lupine (LSA 1987, VII-4). In the past, the northern area was an illegal dumping ground for garbage. With the restoration efforts, the garbage was removed, a stormwater detention pond was excavated, and a weir was installed to allow a constant water level to be maintained. In addition to detaining storm water, the pond increased the wildlife habitat diversity. According to LSA (1987, VII-5), "song sparrow, yellowthroat, marsh wren, pied-billed grebe, moorhen, green heron, Virginia and sora rail, raccoon, opossum, tree frog, western toad, and garter snakes" benefited from the presence of the pond.

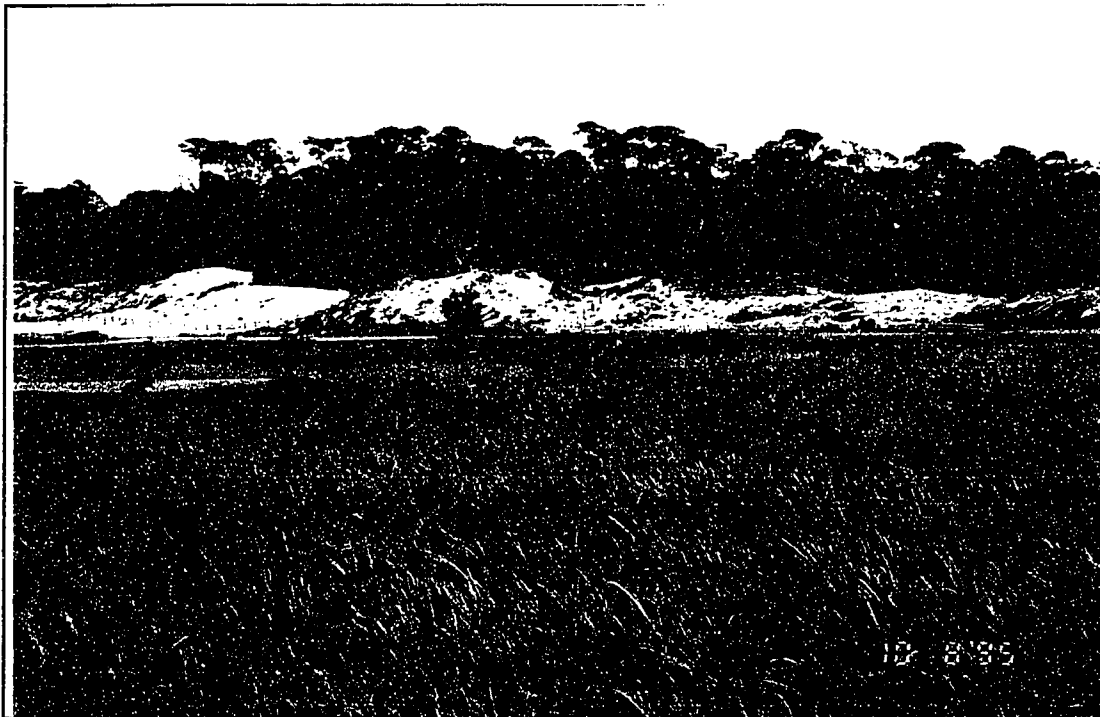
Figure 24.--Spanish Bay Southern Riparian Site

The southern site was located off Spanish Bay Road, at the edge of the Spanish Bay property. The 7th and 9th fairways were located within and adjacent to the site (See Figure 24). Prior to construction, the site was characterized by LSA in 1987 as having three different conditions: 1) defined channels, 2) broad wetland areas, and 3) hummocky low-dune terrain. The defined channels supported riparian vegetation of cattails, rushes, sedges, silverweed, willow, wax myrtle, yellow bush, lupine, blackberry, french broom, acacia, and invasive ice plant. The wetland area supported sedges, rushes, silverweed, ice plant, willow, blackberry, pampas grass, acacia, and french broom. The wetland area was terraced and provided habitats with different moisture requirements. Heavy weed cover was observed in this area after it had been mined and filled. The dune hummock area supported "almost pure ice plant mixed with stands of yellow bush lupine, sagewort, purple beach pea," (LSA 1987, VII-6) and other native vegetation.

Required mitigation included the expansion of the riparian habitat from 3.0 to 4.1 acres (See Table 16), removal of non-native species, and revegetating with native plants.
