FTIR, A POWERFUL TECHNIQUE IN ORGANIC COATINGS FAILURE DIAGNOSIS*

MARIA ROSARIO COSTA ⁽¹⁾(**), MARIA TERESA SANTOS ⁽¹⁾ and TERESA CUNHA DIAMANTINO ⁽¹⁾

Keywords: FTIR, Organic Coatings, Failure Diagnosis

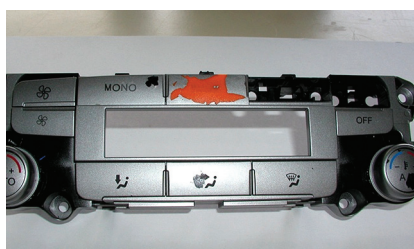
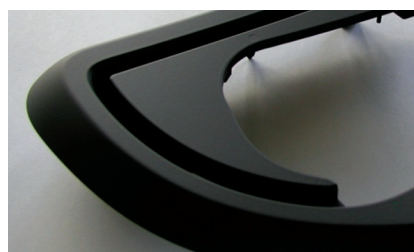
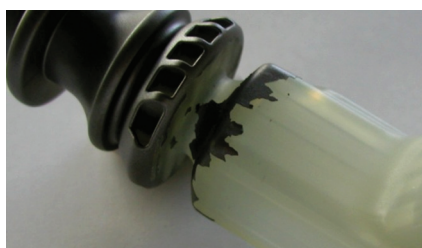
Fig. 1 - Samples with adhesion problems.

Three samples, from automotive industry, with organic coatings adhesion problems are show in Figure 1.

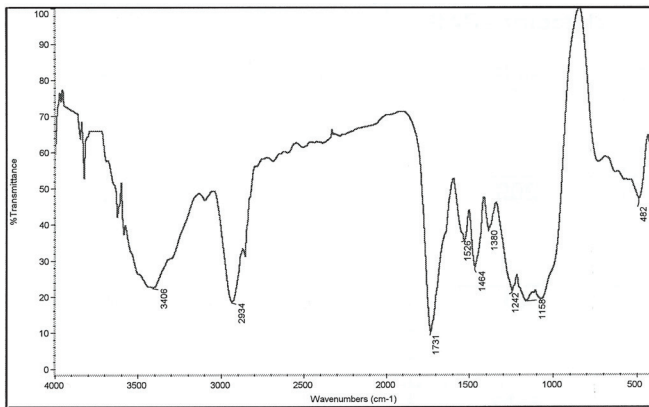
Fig. 2- FTIR spectrum of delaminated coating, as it is (sample A).

sample with coating adhesion problems is shown in **Figure 2**. Main absorption bands are found at $\approx 3406\text{ cm}^{-1}$; $\approx 1731\text{ cm}^{-1}$; $\approx 1526\text{ cm}^{-1}$; $\approx 1464\text{ cm}^{-1}$; $\approx 1380\text{ cm}^{-1}$ and $\approx 1242\text{ cm}^{-1}$, which can be assigned to the vibration of groups N-H, C=O (ester), C=O (amide), CH₂ and CH₃. In this case we can say that the organic coating contains ester and amide groups. The spectrum of extracted delaminated coating with CCl₄ is shown in **Figure 3**. This is similar to **Figure 2**, which means

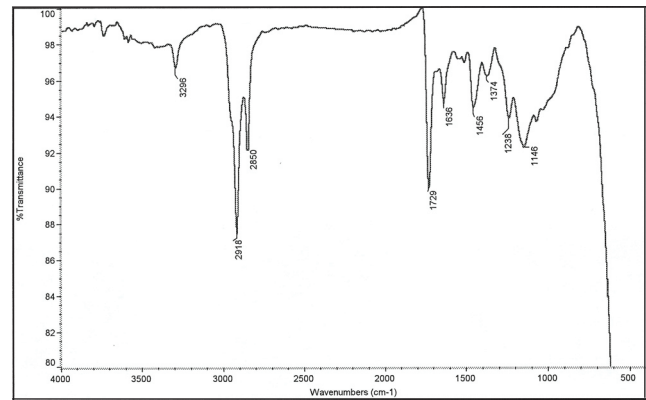
Fig. 3 - Extract in CCl₄ of delaminated coating (sample A).

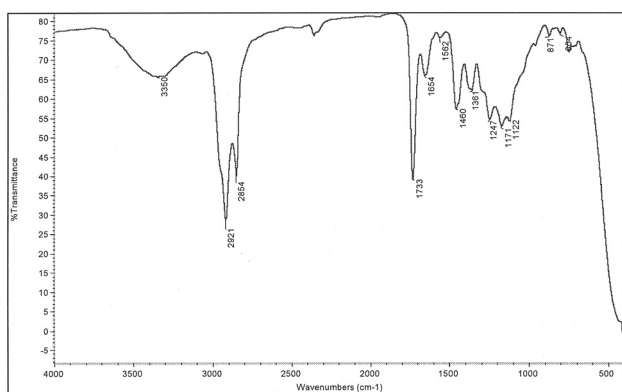
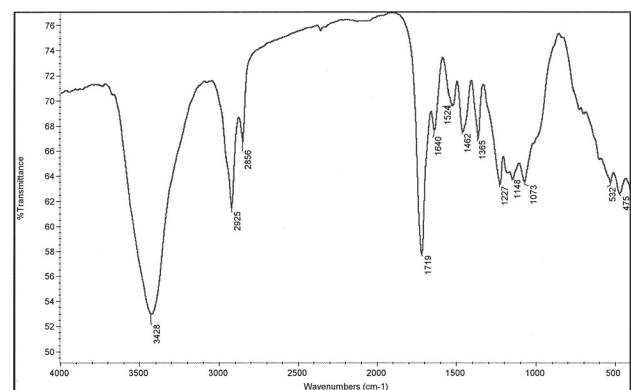
Fig. 4 - Extract in ethyl ether of the coating (sample A).

Fig. 5 - Coating after extraction with ethyl ether (sample A).

that the coating was dissolved in the solvent used in the extraction (CCl₄). The organic coating was also extracted with ethyl ether, trying to isolate a possible contaminant. **Figures 4** and **5** show the FTIR spectra of the extract and of the coating after extraction, respectively. They are similar and present absorption bands characteristic of a polyamide. Nevertheless can be seen a decrease in the absorption bands at $\approx 3350\text{ cm}^{-1}$ and $\approx 1562\text{ cm}^{-1}$ regarding

the vibration of N-H (amide), as well as the appearing of absorption bands at $\approx 1122\text{ cm}^{-1}$; $\approx 871\text{ cm}^{-1}$ and $\approx 800\text{ cm}^{-1}$, which may be assigned to the vibration of [CO₃]²⁻ and Si-O groups. This means that the coating was partially dissolved in ether, also entraining compounds like carbonates and silicates.

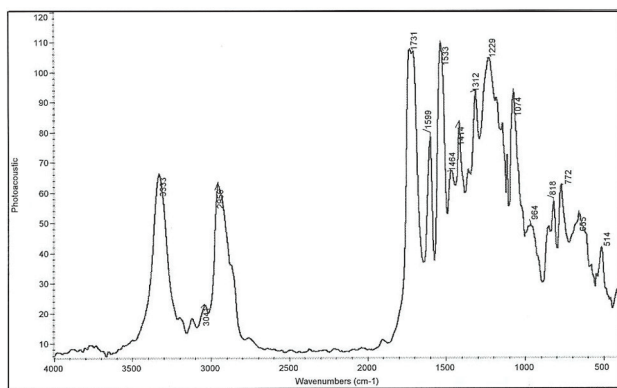
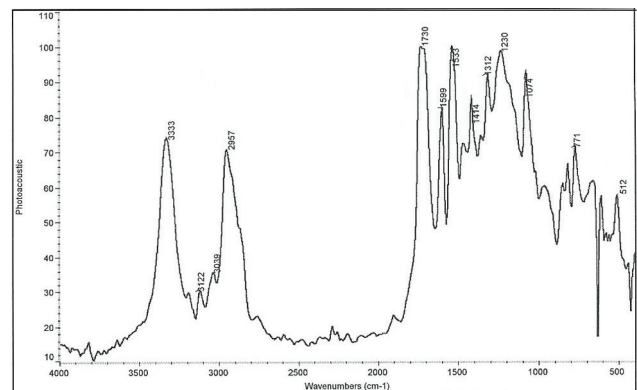
Fig. 6 - Substrate without coating (substrate) (sample A).

Fig. 7 - Surface after coating removal (sample A).

Spectra of PAS/FTIR of uncoated surface (substrate) (Figure 6), as well as the surface after coating removal (Figure 7) show that absorption bands present in substrate are characteristic of a polyurethane. The surface of sample was contacted with carbon tetrachloride with the aim of extracting the contaminant that caused the lack of adhesion. The spectrum of Figure 8 is similar to the previous ones, which means the presence of a polyamide. Nevertheless there are absorption bands at $\approx 1256 \text{ cm}^{-1}$; $\approx 1093 \text{ cm}^{-1}$ (double band) and $\approx 800 \text{ cm}^{-1}$, which can be assigned to the vibration of Si-O group. The presence in the extract of an organic compound with silicon, meaning a silicone may be assumed.

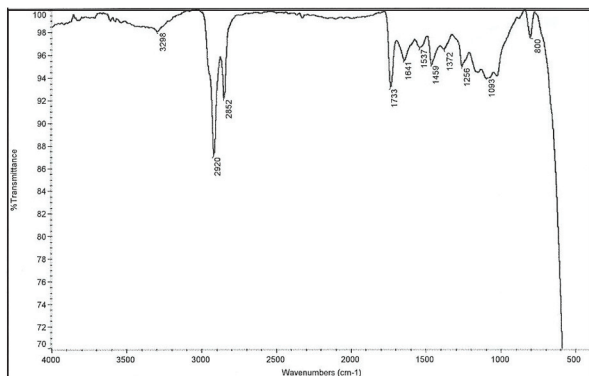
Fig. 8 - FTIR spectrum of the extract in CCl_4 after coating removal (sample A).

The contaminant present on the surface of sample A that may have caused the lack of adhesion, is probably a

silicon containing organic compound: a silicone.

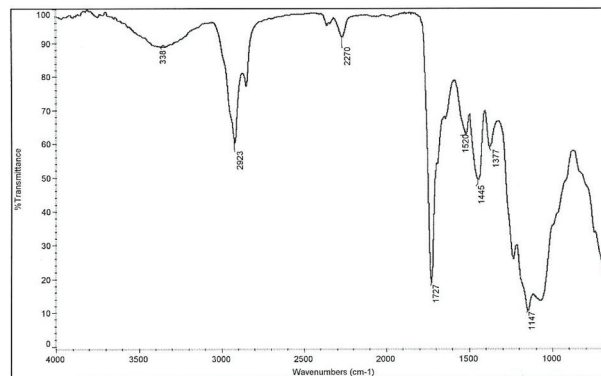
Fig. 9 - FTIR/MCT spectrum of the organic coating of sample B without defect – front side.

MCT/FTIR spectra from the coated sample surface were collected (Figure 9), showing absorption bands at $\approx 3380 \text{ cm}^{-1}$; $\approx 2270 \text{ cm}^{-1}$; $\approx 1727 \text{ cm}^{-1}$; $\approx 1520 \text{ cm}^{-1}$; $\approx 1445 \text{ cm}^{-1}$; $\approx 1377 \text{ cm}^{-1}$ and $\approx 1250 \text{ cm}^{-1}$, which can be assigned to the vibration of groups OH or NH, N=C=O (isocyanate), NH, CH_2 and CH_3 , and C=O (urethane). Comparing the spectrum with the bibliography it can be concluded that it is similar to a polyurethane. The MCT/FTIR spectrum of the back side of the uncoated sample was

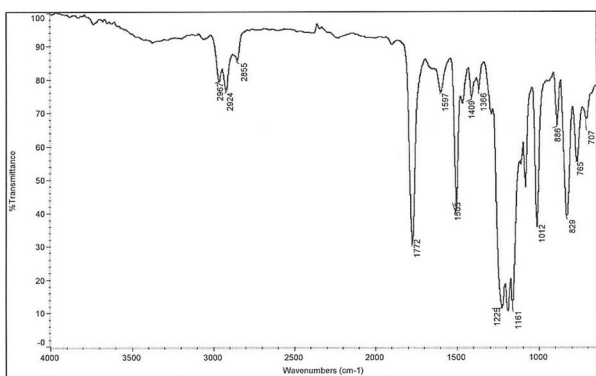
Fig. 10 - FTIR/MCT spectrum of the surface of sample B without defect – back side.

also collected (Figure 10), which shows as main absorption bands those verified at $\approx 1772 \text{ cm}^{-1}$; $\approx 1597 \text{ cm}^{-1}$; $\approx 1503 \text{ cm}^{-1}$; $\approx 1225 \text{ cm}^{-1}$; $\approx 829 \text{ cm}^{-1}$ and $\approx 765 \text{ cm}^{-1}$, possibly assigned to the vibration of C=O (ester) and all the other bands assigned to aromatic ring vibration. This analysis shows the possibility of a polycarbonate polystyrene as a substrate.

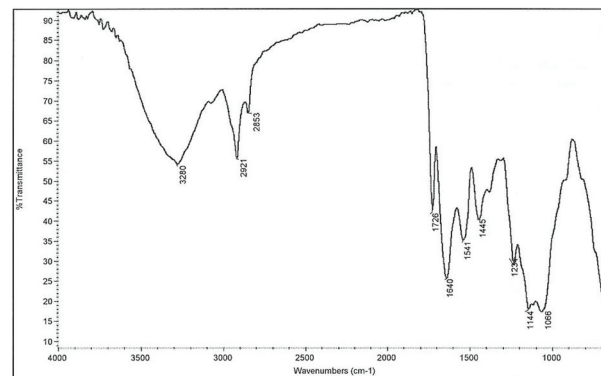
Fig. 11 - FTIR/MCT of the organic coating of sample B with defect – front side.

MCT/FTIR spectrum of the surface of the sample with lack of adhesion is shown in Figure 11, showing absorption bands at $\approx 3380 \text{ cm}^{-1}$; $\approx 1726 \text{ cm}^{-1}$; $\approx 1640 \text{ cm}^{-1}$; $\approx 1541 \text{ cm}^{-1}$; $\approx 1445 \text{ cm}^{-1}$ and $\approx 1234 \text{ cm}^{-1}$, which can be assigned to the vibration of OH or NH, CH_2 , CH_3 , and C-O (urethane). This spectrum is similar to a polyurethane. MCT/FTIR spectrum was also collected for the back side of the sample

(uncoated). It shows the same main absorption bands found in Figure 10, at $\approx 1772\text{ cm}^{-1}$; $\approx 1640\text{ cm}^{-1}$; $\approx 1543\text{ cm}^{-1}$; $\approx 1226\text{ cm}^{-1}$; $\approx 826\text{ cm}^{-1}$ and $\approx 762\text{ cm}^{-1}$ which can be assigned to the vibration of C=O (ester) and all other bands to the vibration of the aromatic ring, pointing out to a polycarbonate polystyrene. The FTIR spectrum of the front side of the coated surface shows an absorption band at $\approx 1640\text{ cm}^{-1}$ as an inflection, while for the sample surface with lack of adhesion it is more intense. The same also happens to the absorption band at $\approx 3280\text{ cm}^{-1}$, both assigned to different vibration modes of NH group. In the sample with lack of adhesion some part of the substrate could be seen together with the coating as a white film, leading to a FTIR spectrum similar to the backside of the sample (polycarbonate substrate). The bands at 3288 , 1644 and 1543 cm^{-1} have higher intensity and can be assigned to the NH vibration, probably an amide.

The contamination present on the surface of sample B, which caused lack of adhesion may be an organic compound containing nitrogen, such as an amide.

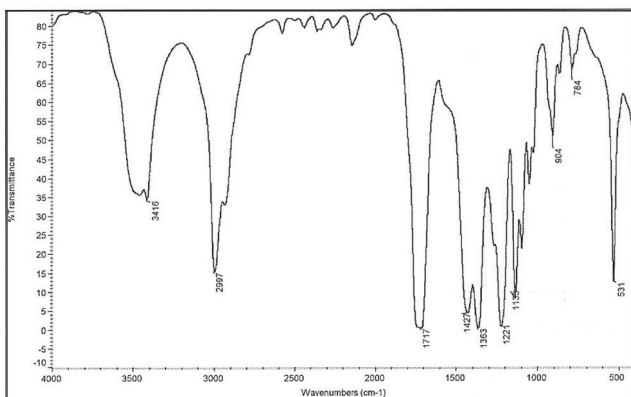
FTIR spectrum of the thinner as it is, is shown in Figure 12. Main absorption bands could be found at $\approx 1717\text{ cm}^{-1}$; $\approx 1427\text{ cm}^{-1}$; $\approx 1363\text{ cm}^{-1}$ and $\approx 1221\text{ cm}^{-1}$, and can be assigned to the vibration of functional groups C=O (ketone), CH_3 , CH_2 and C-O-C, exactly to 2-propanone.

Fig. 12 - FTIR spectrum of the thinner.

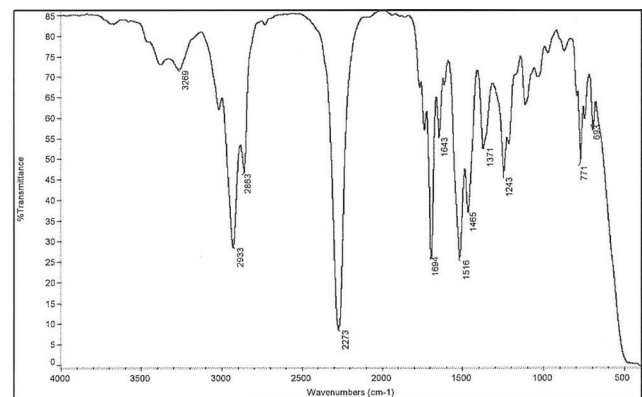
FTIR spectrum of the hardener, as it is, is shown in Figure 13, where absorption bands at $\approx 2273\text{ cm}^{-1}$; $\approx 1694\text{ cm}^{-1}$; $\approx 1643\text{ cm}^{-1}$; $\approx 1516\text{ cm}^{-1}$; $\approx 864\text{ cm}^{-1}$ and $\approx 771\text{ cm}^{-1}$, may be assigned to the vibration of N=C=O (isocyanate), C=C, N-H and absorption bands of aromatic ring substitution, corresponding to an isocyanate. This kind of isocyanate seems to be based in hexamethylene diisocyanate.

Fig. 13 - FTIR spectrum of the component A (hardener).

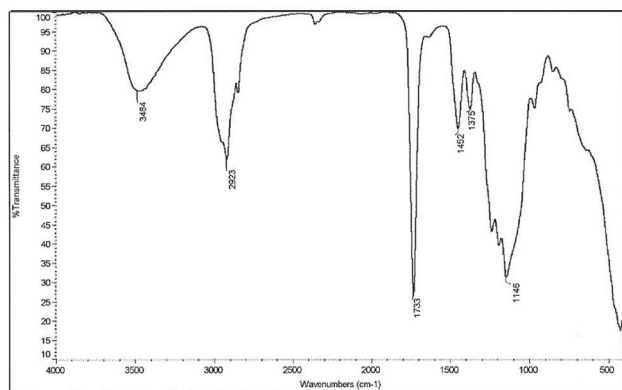
FTIR spectrum of the paint, as it is, was registered for a NaCl plate. The spectrum is shown in Figure 14, where the most relevant band is found at $\approx 1733\text{ cm}^{-1}$ and may be assigned to the vibration of C=O of an ester.

Fig. 14 - FTIR spectrum of the component B.

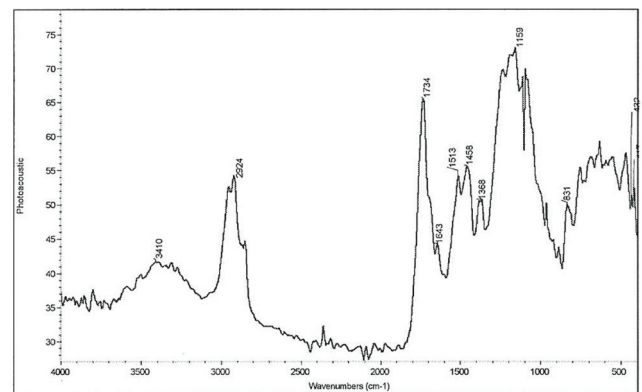
Fig. 15 - PAS/FTIR spectrum of the organic coating of sample C1 (without defect) – front side.

PAS/FTIR spectrum of sample C1 coated surface is shown in Figure 15. Absorption bands found at ≈ 3410 cm^{-1} ; ≈ 1734 cm^{-1} ; ≈ 1643 cm^{-1} ; ≈ 1513 cm^{-1} ; ≈ 1458 cm^{-1} ; ≈ 1368 cm^{-1} and ≈ 1250 cm^{-1} , may be assigned to the vibration of OH or NH, NH, CH₂, CH₃ and C-O (urethane) groups, indicating a polyurethane coating. PAS/FTIR spectrum of the uncoated backside of sample C1 is shown in Figure 16. Main absorption bands were found at ≈ 1778 cm^{-1} ; ≈ 1598 cm^{-1} ; ≈ 1505 cm^{-1} ; ≈ 1247 cm^{-1} ; ≈ 832 cm^{-1} and ≈ 768 cm^{-1} may be assigned to the vibration of C=O (ester) and of aromatic ring, suggesting a polycarbonate polystyrene substrate. These two PAS/FTIR spectra have an acceptable definition, but also present some noise which may hide some bands or lead to misunderstanding.

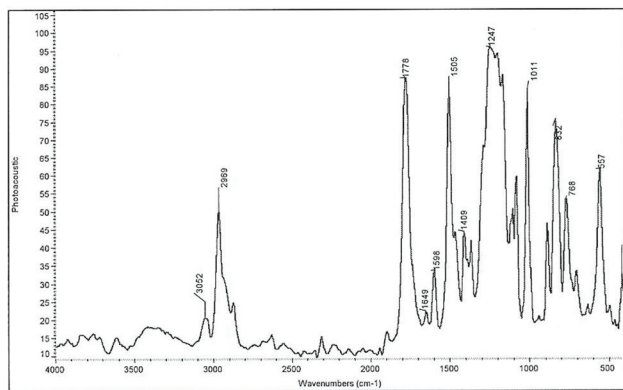
Fig. 16 - PAS/FTIR spectrum of the surface of sample C1 (without defect) – back side.

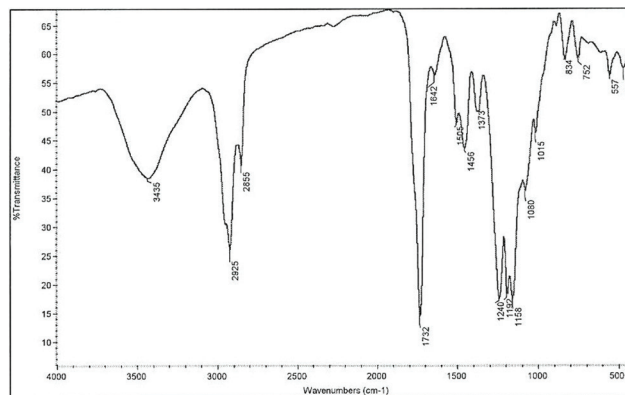
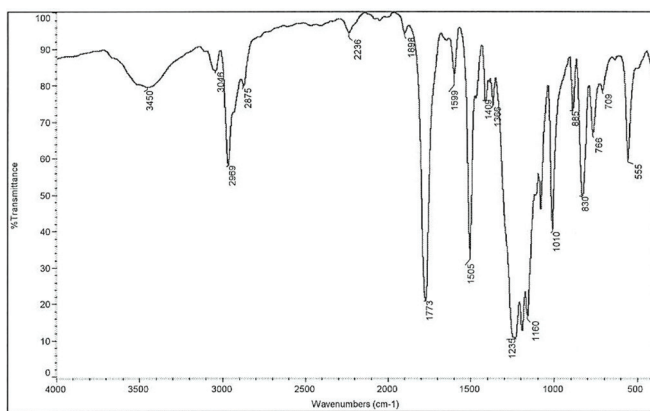
Fig. 17 - FTIR spectrum of the organic coating of sample C1 – front side.

Fig. 18 - FTIR of sample C1- backside.

That is why KBr plates were done after coating removal by scraping. FTIR spectra of the coated surface as well as of the backside of sample C1 are shown in Figures 17 and 18, corresponding to a polyurethane and to a polycarbonate polystyrene.

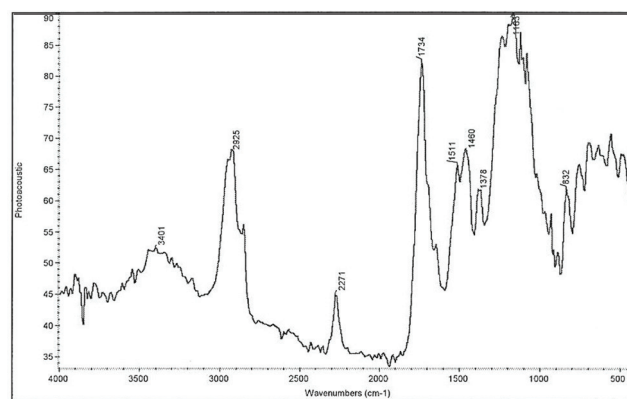
Fig. 19 - PAS/FTIR spectrum of the organic coating of sample C2 – front side.

PAS/FTIR spectrum of the coated surface of sample C2 is shown in Figure 19, where absorption bands at ≈ 3401 cm^{-1} ; ≈ 2925 cm^{-1} ; ≈ 2271 cm^{-1} ; ≈ 1734 cm^{-1} ; ≈ 1640 cm^{-1} ; ≈ 1511 cm^{-1} ; ≈ 1460 cm^{-1} and ≈ 1234 cm^{-1} may be assigned to the vibration of OH or NH, CH₂, CH₃, N=C=O and C-O (urethane) groups. This spectrum is similar to the one of a polyurethane containing some residual isocyanate (absorption band at 2271 cm^{-1}). PAS/FTIR was also collected for the backside of sample C2 (Figure 20 -

The lack of adhesion may be assigned to a different coating cure degree,

which is indicated by the presence of the unreacted functional group $N=C=O$ (isocyanate).

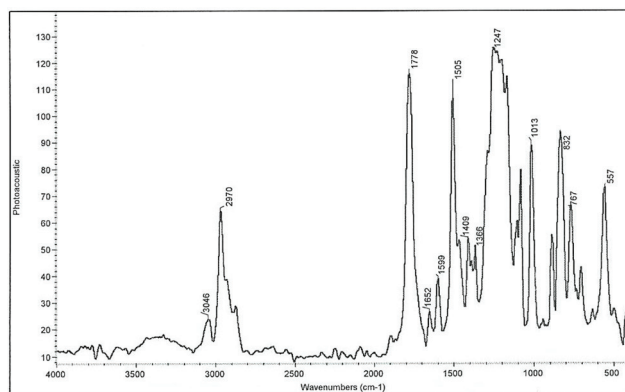
uncoated). The spectrum is similar to that presented in Figure 16, showing as main absorption bands those found at ≈ 1778 cm^{-1} ; ≈ 1652 cm^{-1} ; ≈ 1505 cm^{-1} ; ≈ 1247 cm^{-1} ; ≈ 832 cm^{-1} and ≈ 767 cm^{-1} which may be assigned to C=O (ester) and the other bands assigned to aromatic ring vibration, indicating the same substrate, a polycarbonate polystyrene.

Fig. 20 - PAS/FTIR spectrum of the surface of sample C2 - backside.
