# Stains in Pavement Applications of a Portuguese Limestone

The recent application of an ornamental Portuguese limestone widely used in the market resulted in the appearance of reddish brown spots on the stone surface applied in a building floor.

This effect, aesthetically undesirable, brought troubles both to the supplier and the customer. As an attempt to detect the origin of the spots experiments were performed in the laboratory isolating each of the constituents of the system: base mortar, epoxy mortar and stone.

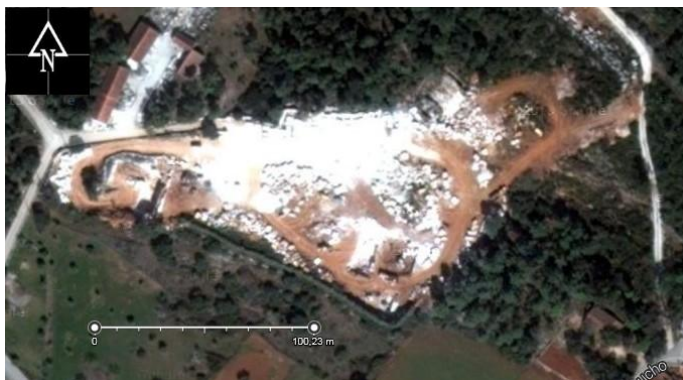
The quarry where the studied limestone is explored is located in the Place of Maxieira, which belongs to Fátima Parish, Ourém Municipality, Santarém District (Portugal). It has 210m long and 90m wide (Figure 2).

Figure 2 - Aerial view of Maxieira quarry, where the limestone of this case study is explored.
