**NBS MONOGRAPH 128**

**Corrosion Rates  
On Underground  
Steel Test Piles  
At Turcot Yard,  
Montreal,  
Canada — Part 1**

**W. J. Schwerdtfeger and Melvin Romanoff**

**Issued July 1972**

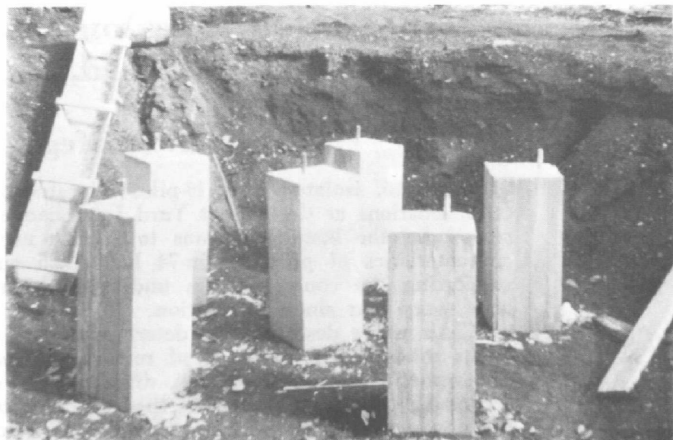
FIGURE 1. Site C—View (before backfilling) showing the 6 driven piles encased by concrete at the upper ends. Reinforcing rods shown protruding above the concrete are for the electrical connection.

The piles at the three sites were arranged in the same way with the following exceptions. At site C, concrete encasements were poured over the upper 7 ft (2.1 m) of the six driven piles and over one end of the horizontal pile, again for a distance of about 7 ft (2.1 m). The concrete encasement was rectangular in cross section with at least 6 in (15.2 cm) of concrete covering the steel at all points. All piles at site A were exposed entirely bare. At site B, an organic coating was used on the upper ends of the piles to cover about the same area of steel encased by concrete at site C. Before applying the coating, the area to be coated was cleaned with a motor-driven rotary steel wire brush. The brushing operation was immediately followed by applying a hand-brushed coat of epoxy primer. The next day, a brush coat of C-200 coal-tar epoxy coating was applied over the primer coat. After driving the piles and before the concreting and coating operations just described, the driven piles were cutoff at the top ends 2 ft (0.61 m) below the ground line. Identification numbers were welded on each pile about 12 in (0.3 m) below the top. Prior to driving, identification numbers were also welded about 24 in (0.6 m) from the bottom ends. A 1.375 in (3.5 cm) steel reinforcing rod was welded to the top of each driven pile and terminated about 12 in (0.3 m) below the ground line. On the horizontal piles, reinforcing rods were also positioned vertically and welded to the center of the pile. The rods served as points of electrical contact for carrying out the polarization

measurements. To keep the soil out of direct contact with the rods when not in use, the rods were covered with removable molded concrete caps which protruded above the ground line. Figure 1 shows the concrete encased piles (upper ends) at site C before back-filling and figures 2 and 3 are views after back-filling.

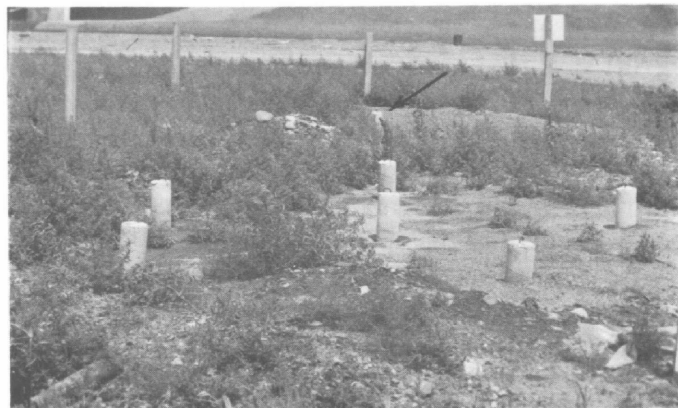
FIGURE 2. Site C—View (after backfilling) showing concrete caps covering the reinforcing rods. Location of the horizontal pile is indicated by arrow in the background.

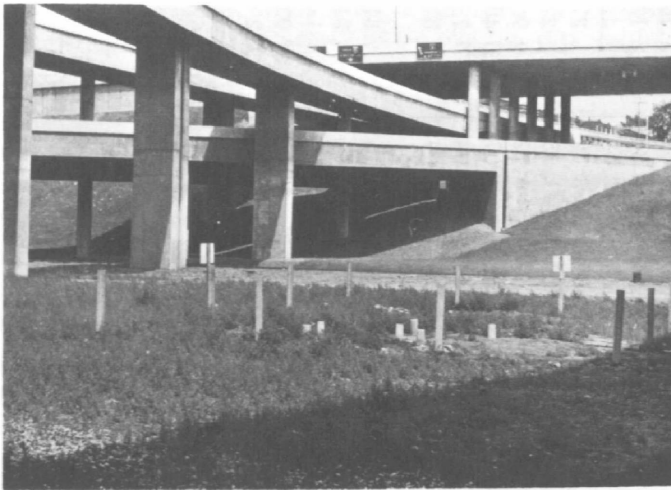
FIGURE 3. Site C—Showing surrounding highway structures.

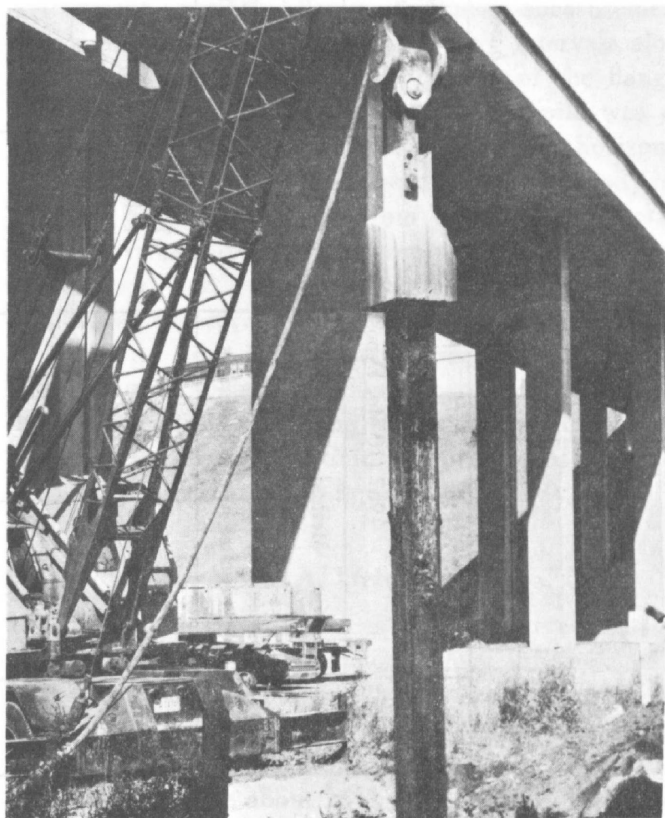
FIGURE 8. Site C—pile C1 in the process of being extracted.

Before exposing test piles to the underground environment, random flange thickness measurements were made at about 12 in (30.5 cm) intervals along the entire length of each pile on two of the flanges. After 3 years of exposure, one driven pile was extracted from each of the 3 sites and the horizontal pile (buried in a backfilled trench) was removed from site B. Soil was scraped from the piles and rotary motor-driven wire brushes were used to remove loose mill scale and corrosion products. Random flange thickness measurements were repeated on the same flanges as done before exposure. In addition, pit depths were measured where corrosion was significant. Photographs showing mechanical equipment and the driven pile at site C in the process of being extracted are illustrated in figures 7, 8, and 9.
