Journal section: *Biomaterials and Bioengineering in Dentistry*
Publication Types: *Research*

Fractographic study of the behavior of different ceramic veneers on full coverage crowns in relation to supporting core materials

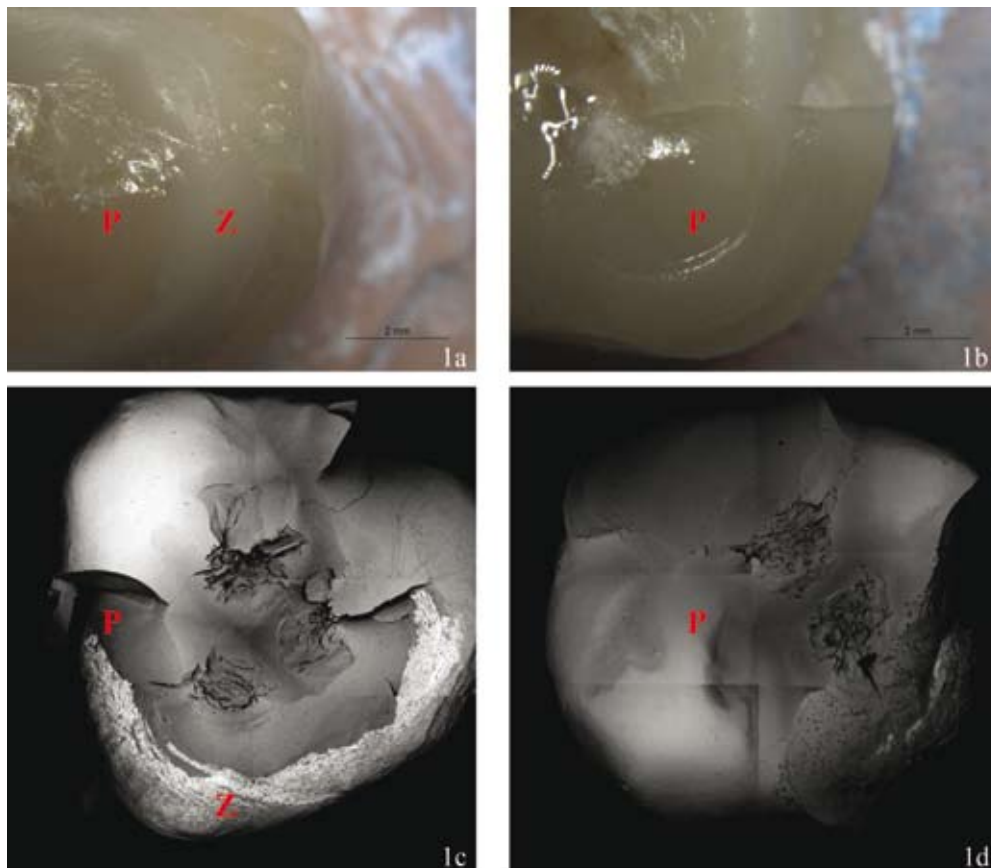
Fig. 1. A.-Adhesive fracture of Specimen 8, Group 1 observed under the Stereo Microscope 8x. B.-Cohesive fracture of Specimen 18, Group 2 observed under the Stereo Microscope 8x. C.-Adhesive fracture of Specimen 8, Group 1 observed using SEM BSE x25. D.- Cohesive fracture of Specimen 18, Group 2 observed using SEM BSE x25. P = Porcelain Veneer. Z = Zirconia.

Of the 120 crowns studied, 58.3% suffered adhesive fracture, 40% cohesive fracture, and 1.7% complete crown fracture. In Group 1, 60% of crowns underwent cohesive fracture, 30% adhesive fracture, and 10% complete crown fracture (Fig. 1). In Group 2, 85% of crowns suffered cohesive fracture while 15% suffered adhesive fracture (Fig. 1). In Group 3, 70% of crowns underwent cohesive fracture, while 30% suffered adhesive fracture. In Group 4, all fractures were adhesive, exposing the metal core. In Group 5, 10% of crowns underwent cohesive fracture, while 90% suffered adhesive fracture. In Group 6, 15% of crowns underwent cohesive fracture, whereas 85% were adhesive fractures. Table 1 shows the fracture types obtained in each group and their relation

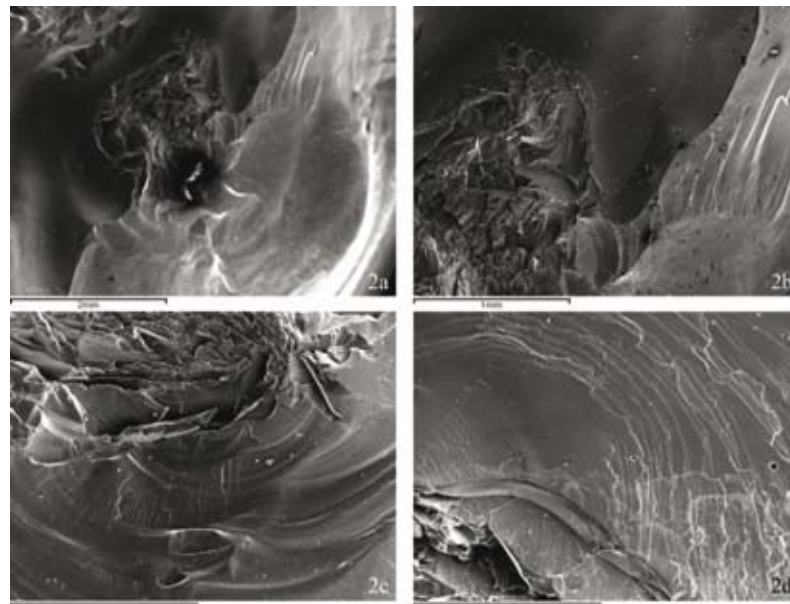
Fig. 2. A.- Peripheral or radial surface fracture propagation adjacent to the area of contact with the antagonist (Specimen number 18, Group 1 SEM SE x25. B.- Same Specimen SEM SE x50. C.-The same fracture propagation pattern is seen in Specimen 8, Group 2, SEM SE x100. D.-The same fracture propagation pattern in Specimen 6, Group 2, SEM SE x100.

Surface fracture patterns for all the crowns analyzed at the point of occlusion with the antagonist were radial or peripheral, in other words, the deformation of the veneer material was produced in the occlusal zone, with the fracture projected from the central point of load application towards the periphery where porcelain delamination occurred (Fig. 2).

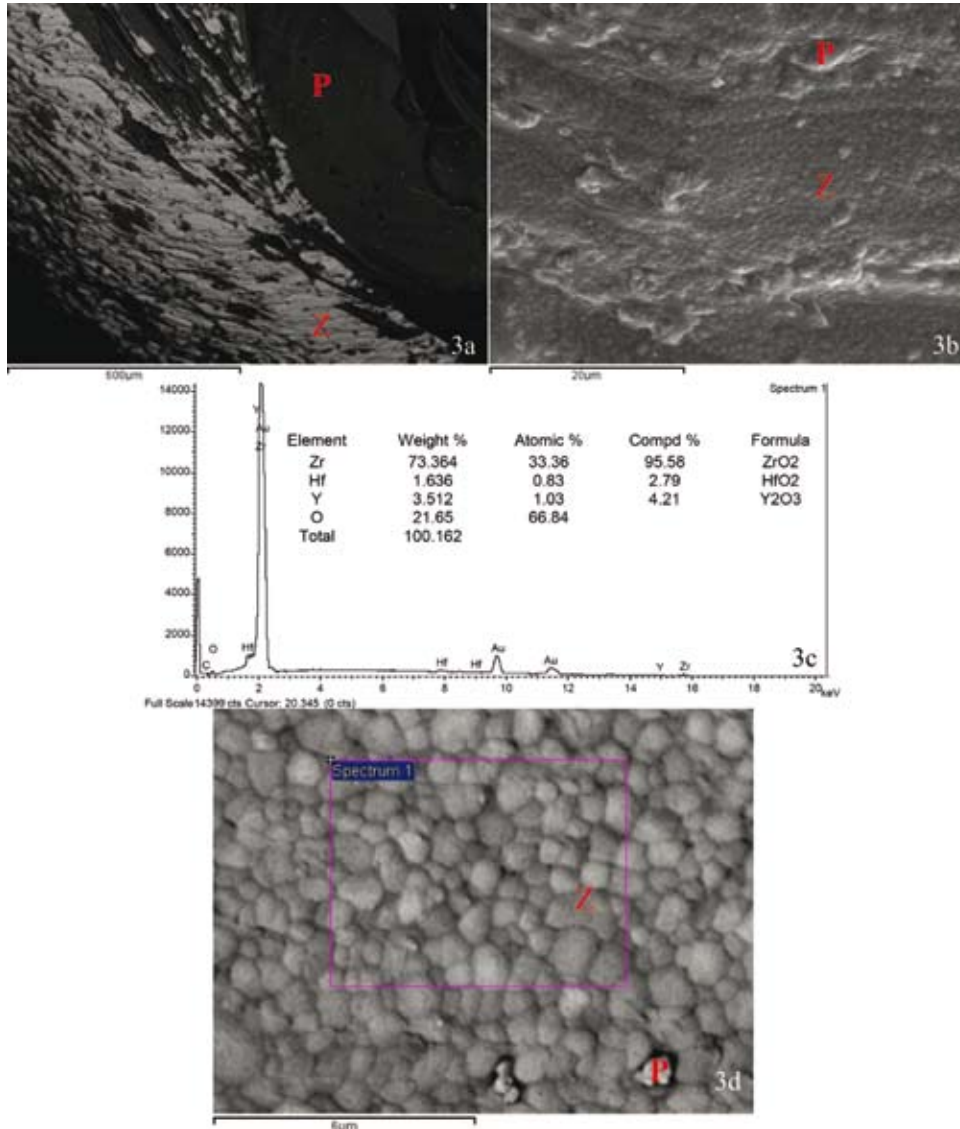
Fig 3. A.-Specimen 1, Group III 100x BSE. B.-Same Specimen x2500 SE. C.-Composition analysis from Spectrum 1 x10000 BSE. D.-Same Specimen x10000 BSE.
P = Porcelain Veneer. **Z** = Zirconia

Composition analysis of selected specimens by SEM helped make a clear distinction between cohesive fractures and adhesive fractures (those that exposed the internal core) (Fig. 3).
