Journal section: Prosthetic Dentistry

Publication Types: Research

Influence of surface preparation on fracture load of resin composite-based repairs

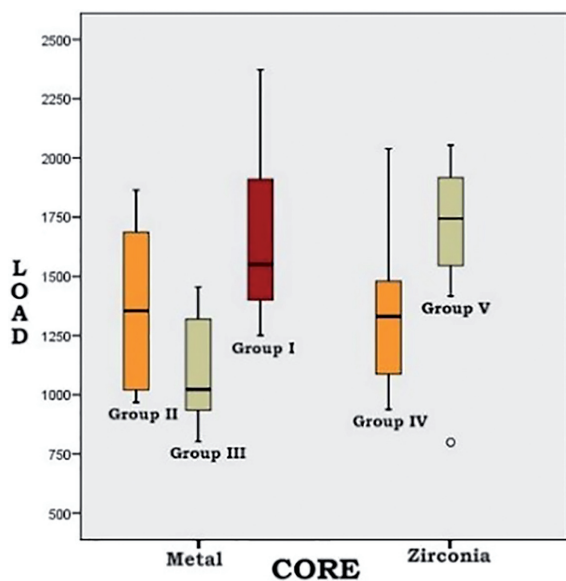
**Fig. 1.** Box plot shows the distribution of fracture resistance values in relation to crown core material and surface preparation.

Repaired ceramic-fused-to-metal crowns obtained mean final fracture values of 1372.4N, Group I (diamond bur + HF) obtaining the highest value (1667.2±394.3N). Bonferroni bivariate contrast analysis revealed that mean fracture resistance was significantly higher for Group I than for Group III (silica-coated) (1094.3±212.6N) ($p=0.001$). However, no evidence was found of higher fracture resistance in Group I than Group II (air-particle abrasion) (1355.6±333.8N) ($p=0.137$). No statistically significant differences were found between Group II (air-particle abrasion) and Group III (silica-coated) ($p=0.275$) (Fig. 1).

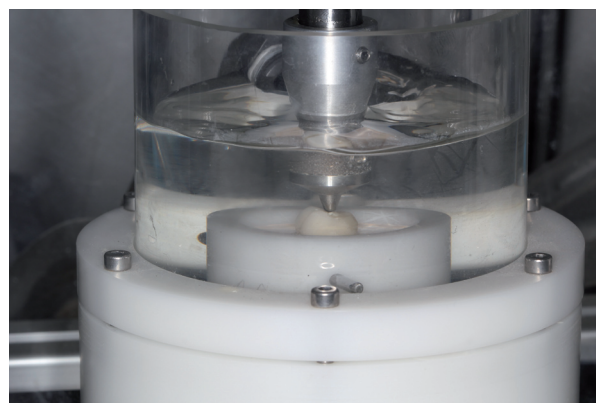
**Fig. 3.** Sample undergoing dynamic loading and thermocycling.

When the samples had been repaired, they were subjected to dynamic loading in a chewing simulator (SD Mechatronik, Chewing Simulator CS-4. Mechatronik GmbH, Feldkirchen, Germany); they received 120,000 cycles with loads of 80N and 2Hz frequency with a vertical displacement of 2mm. They then underwent thermocycling (Thermocycler 2000, Heto-Holten A/S, Allerød, Denmark) for 6000 cycles with temperature changes between 5°C and 55°C every 30 seconds. When the samples had been fatigued, they were subjected to load testing (Shimadzu model AG-X plus) until the point of fracture, registering the final fracture values in Newtons (N), as well as the type of fracture produced.

Although crowns with zirconia cores showed a tendency for samples repaired with silica-coating to obtain higher final fracture values (1660.2±361.6N, compared with an overall mean fracture resistance of 1517.8N), no significant differences were found between these samples (Group V) and samples treated with air-particle abrasion (Group IV: 1375±362.9N) ($p=0.067$) (Table 1) (Fig. 2). Observing the type of fracture produced, all in vitro mechanical failures were found to be adhesive fractures (Fig. 3).

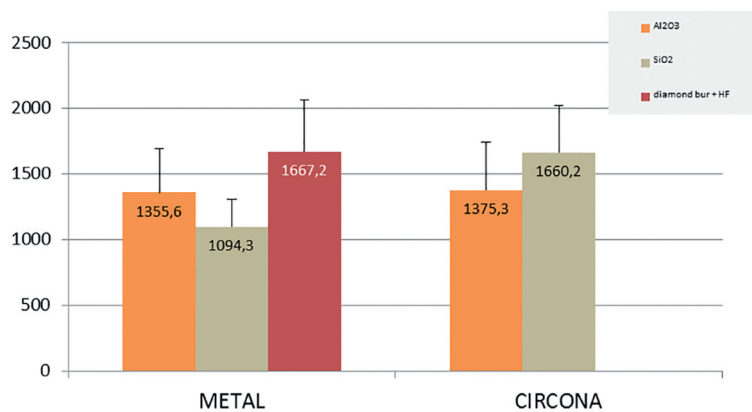
**Fig. 2.** Mean fracture resistance (N) in relation to crown core material and surface preparation.
