# SPERT III PRESSURIZER VESSEL FAILURE

IDO-16743  
AEC Research and Development Report  
Reactor Technology  
TID-4500 (16th Ed.)  
Issued: January 29, 1962

SPECIAL POWER EXCURSION REACTOR TESTS

On October 26, 1961, at approximately 8:00 p.m. a failure occurred in the Spert III pressurizer vessel, an integral component of the primary coolant system of the Spert III reactor facility. At the time of failure, the reactor contained a subcritical array of fuel, and non-nuclear tests were being conducted to evaluate experimental procedures and the performance of plant equipment in preparation for a series of cold water accident studies scheduled to follow. Subsequent investigations have led to the conclusion that because of error in the indication of the existing level-control instrumentation on the vessel, it was possible for one or more of the electric heaters to operate above the steam-water interface thus causing superheating of the steam and producing overtemperature in the upper half of the vessel. The failure mechanism was third-stage creep at elevated temperatures.

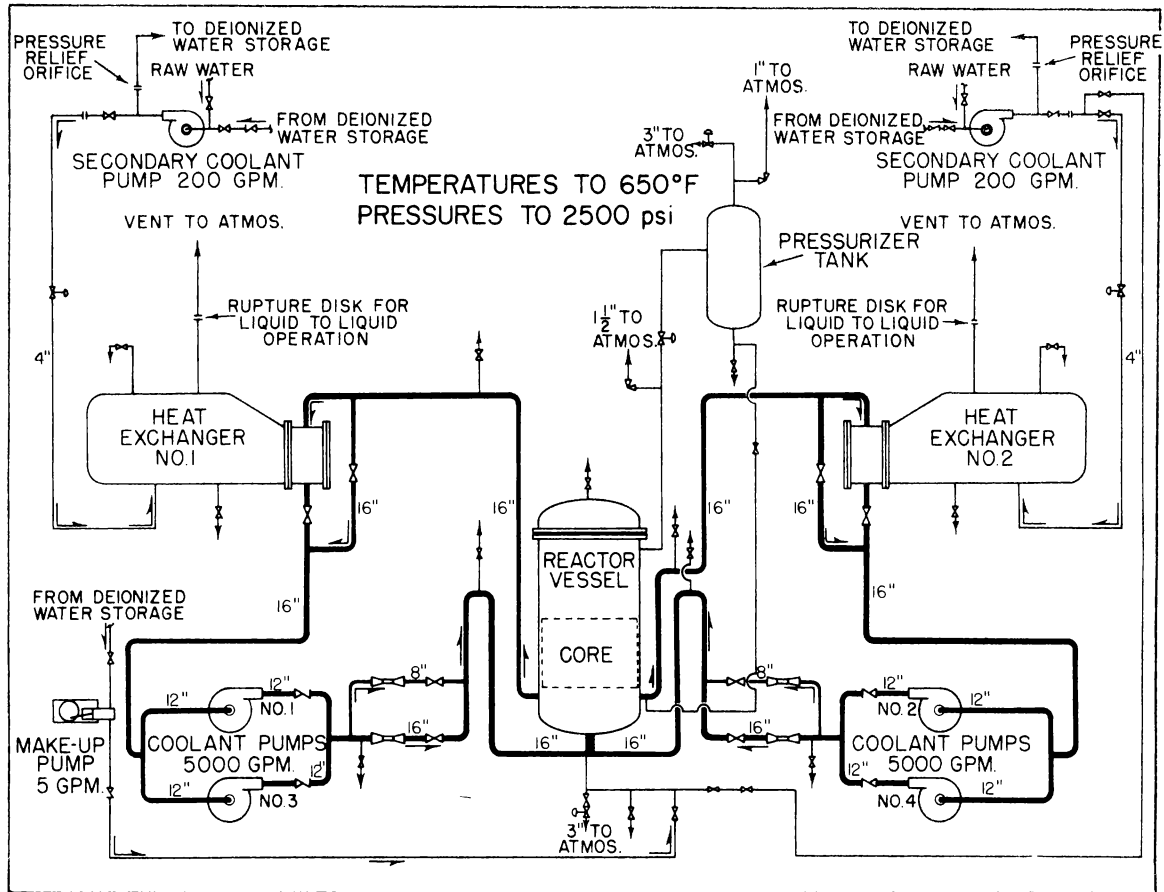
Fig. 3 Spert III piping schematic.

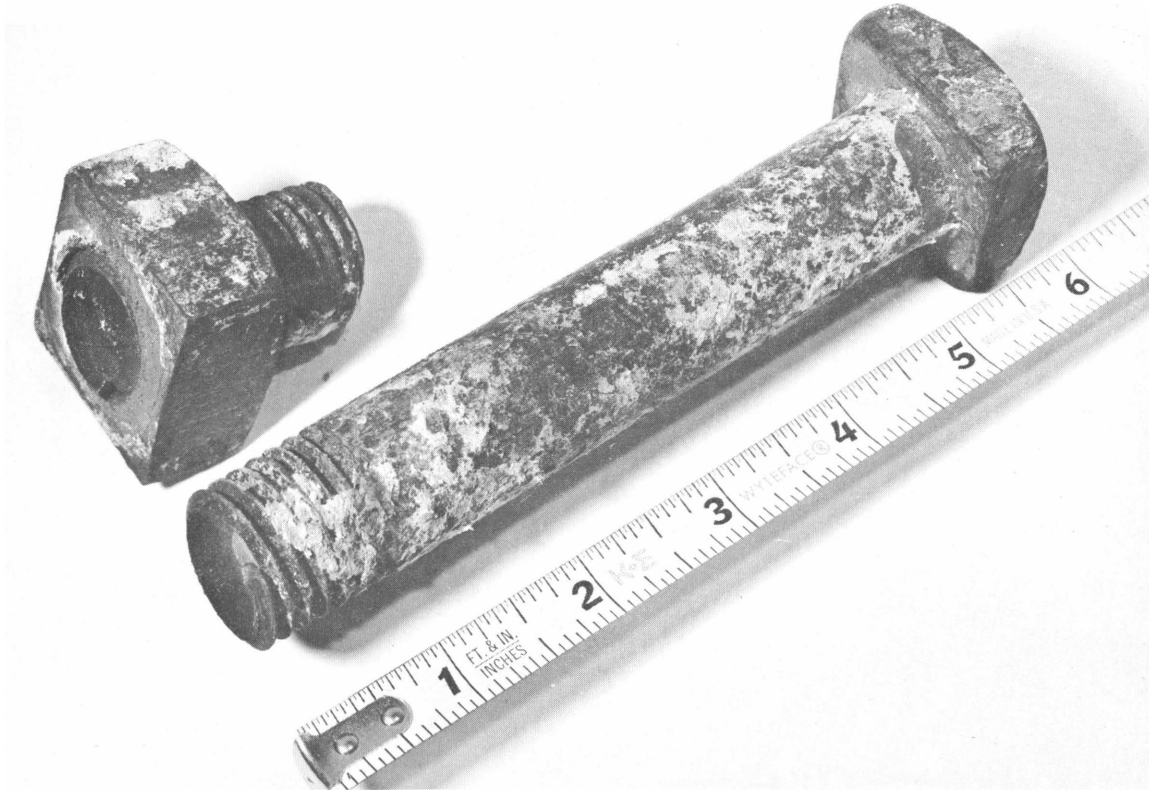
Fig. 22 Photograph of broken stabilizing-band bolt.

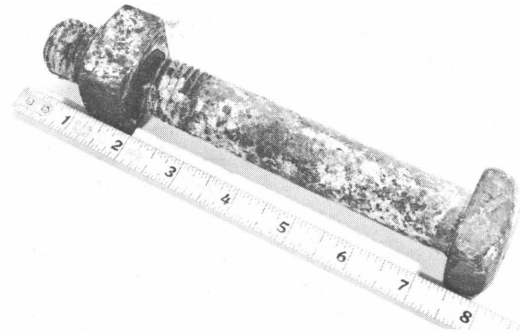
Fig. 24 Photograph of broken bolt on stabilizing band.

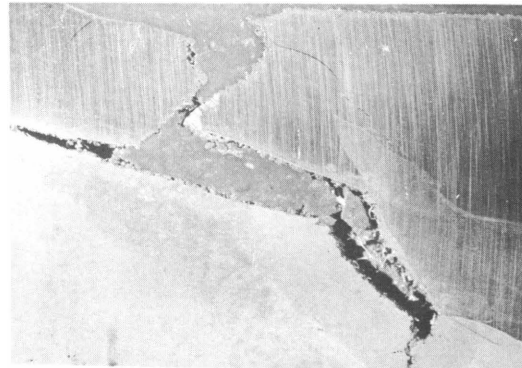
Fig. 52 304L cladding crack at the edge of the weld, 14X, electrolytic etch. The weld is the thicker material.

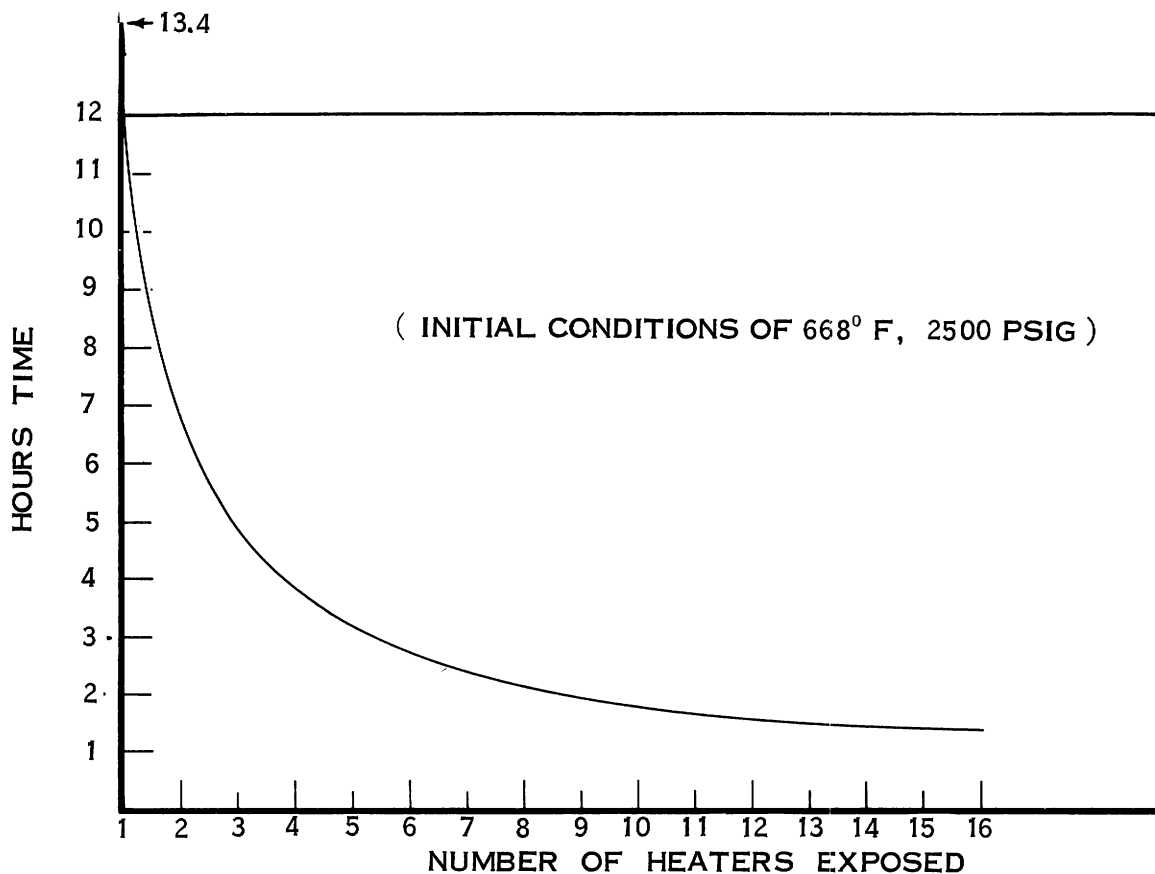
If the steam is at 1000°F, it has been calculated that the heater surface would be approximately 1400°F. The manufacturer's recommended maximum operating temperature for the heaters is 1500°F. Therefore, it is possible to superheat the steam to 1000°F without burning out the heaters.

Fig. 1 Pressurizer heat-up time as a function of number of heaters exposed.
