INEL-95/0517
November 1995

**Idaho
National
Engineering
Laboratory**

**Alternatives to Reduce Corrosion
of Carbon Steel Storage Drums**

**Larry R. Zirker
George A. Beitel**

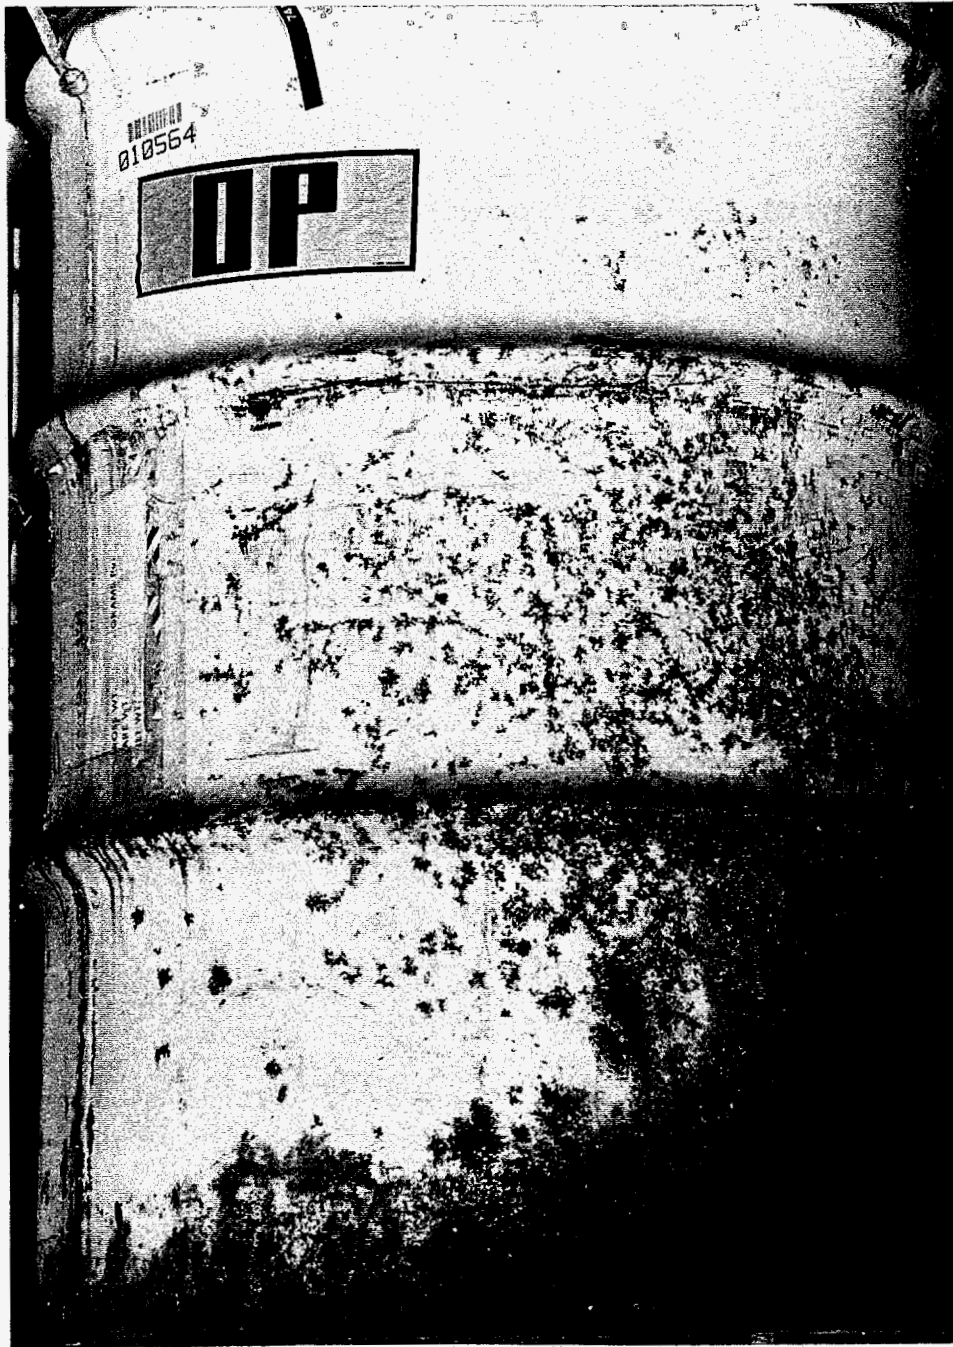
Figure 2. Photograph of OP drum.

Figure 2 shows an at-risk drum of radioactive waste stored at the RWMC. It has failed the inspection criteria for excessive rust and it has been set aside as a drum "to be overpacked" (note: the "OP" label in the figure). It has been estimated that there will be 12,000 of these "OP" drums identified over the next 6 years as the drums at the RWMC are moved from the covered and protected storage areas into the new RCRA Type II storage modules.²

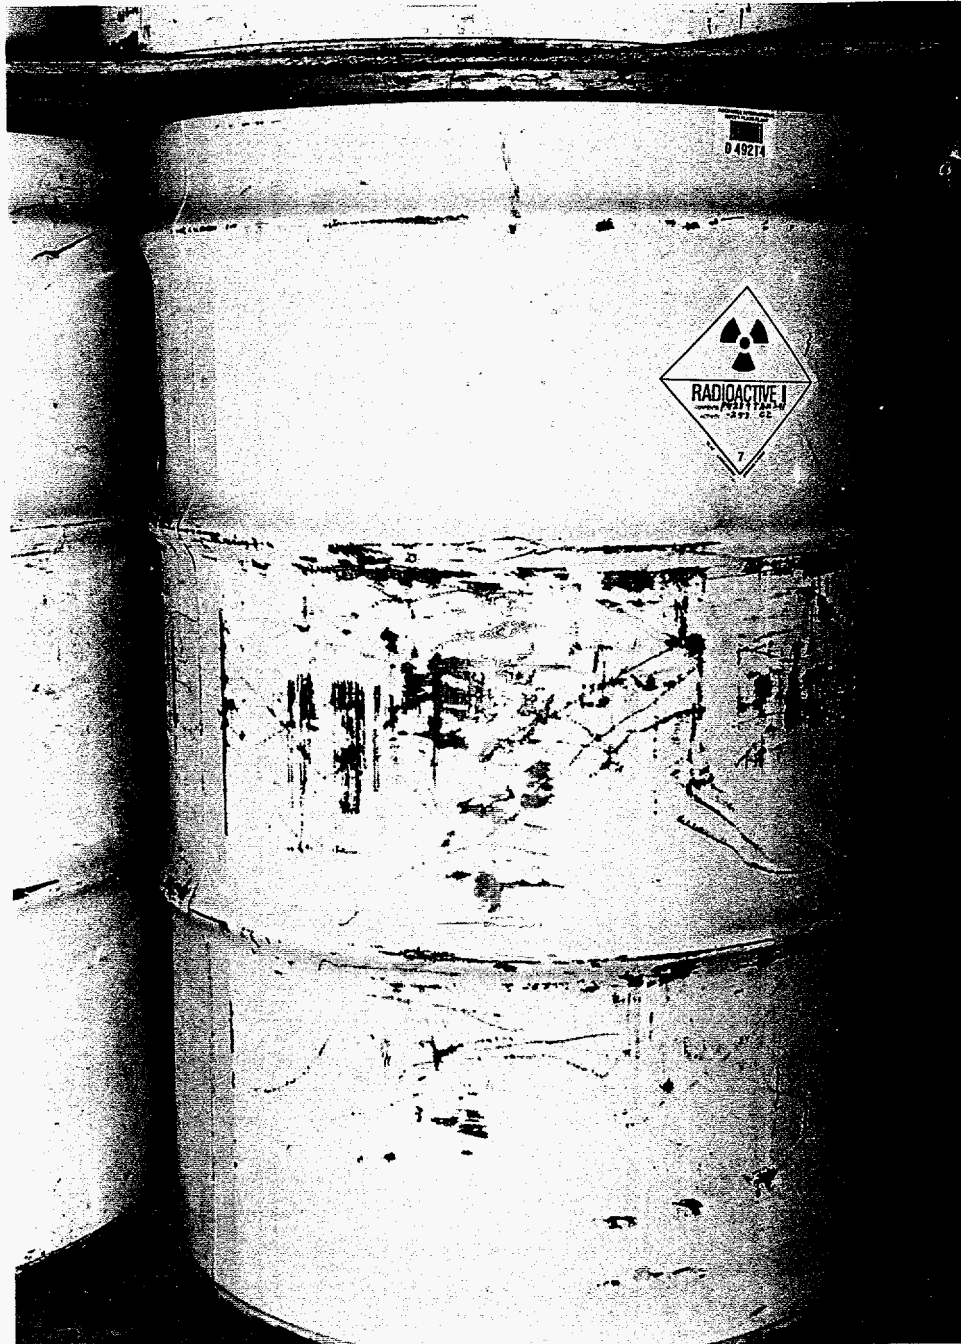
Figure 10. Drum handling abrasion.

The second visit was very enlightening. The week of the second visit the weather was colder than the week before and the snow was not melting and leaking into the building. As the assessment team entered Building 628, multiple water deposits on both the floor and the plastic spacers were observed. Water was on the pallets of every drum stack and on the floor in between most of the stacks.

- Consider padding or coating the drum handling arms to reduce drum paint abrasion.
- Monitor future drum movement to assess damage with coated drum handler.
- It would be prudent to have an on going corrosion study program at the facility since actual transfer of drums to disposal may not occur for some time.
- Characterize rust from an empty drum one returned from Argonne-West, for example.
- Place corrosion coupons in Building 628 to develop qualitative corrosion data.
- Develop a drum stack monitoring system to quantify environmental conditions to which the drums are exposed.

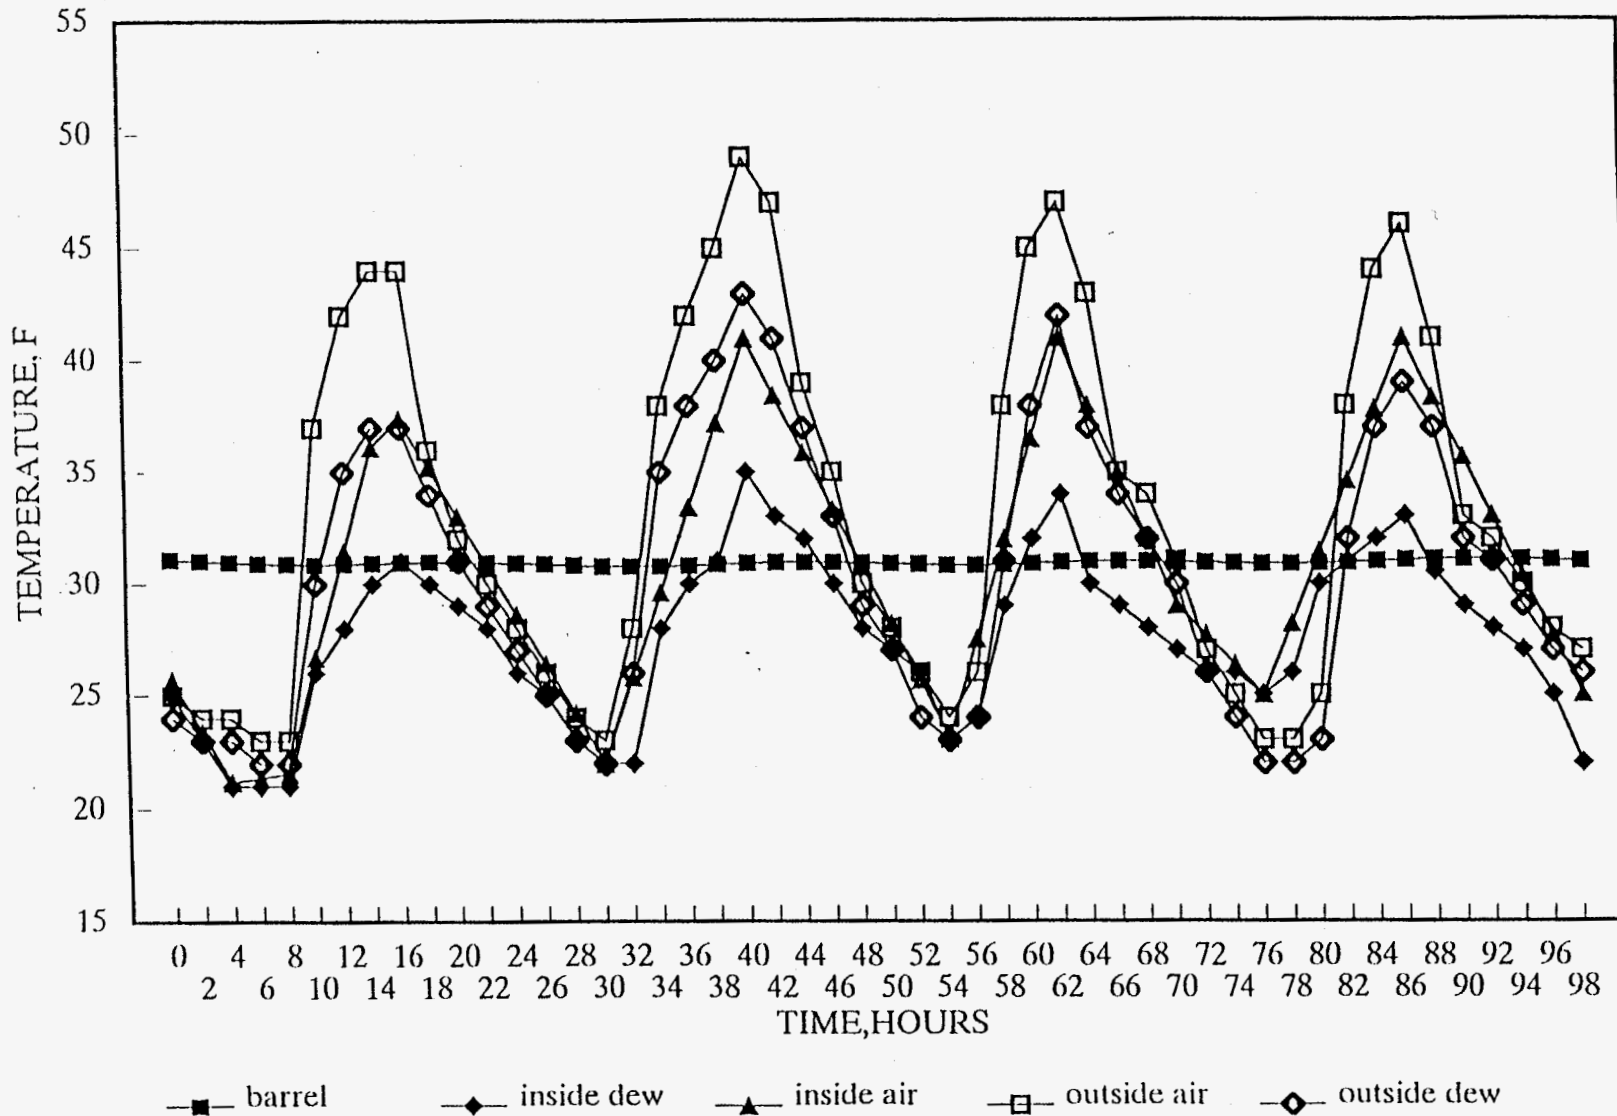
Figure 11. Temperature/dew point plots.

BARREL SURFACE-AIR-DEW POINT
