OBIC Analysis of Stressed, Thermally-Isolated Polysilicon Resistors

Electronics Quality/Reliability Center
Sandia National Laboratories, MS 1081
Albuquerque, New Mexico 87185-1081

Abstract: High gain Optical Beam Induced Current (OBIC) imaging has been used for the first time to examine the internal structural effects of electrical stress on thermally-isolated polysilicon resistors. The resistors are examined over a wide range of current densities, producing Joule heating up to ~ 1200 °C. Throughout this current density range, the OBIC images indicate a clustering of dopant under dc stress and a more uniform distribution under ac conditions. The OBIC images also reveal areas that are precursors to catastrophic resistor failure. In addition to OBIC imaging, conventional electrical measurements were performed, examining the polysilicon resistance degradation and time-to-failure as a function of electrical stress. The electrical measurements show a monotonic increase in polysilicon resistor lifetime with frequency (up to 2 kHz) when subjected to a bipolar ac stress. The enhanced lifetime was observed even under high temperature (from Joule heating) stress conditions previously repor

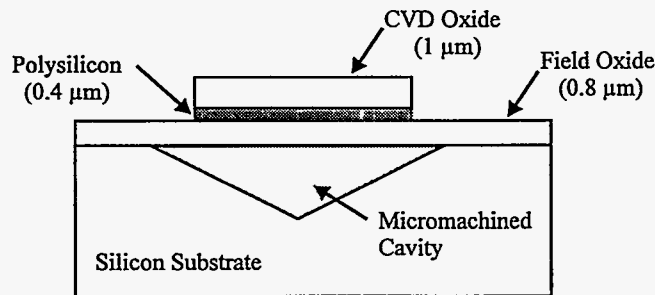
Fig. 1. Schematic cross section of a thermally-isolated polysilicon resistor.

The polysilicon resistors were fabricated in a MOSIS foundry service using a 2.0 μm double metal, double polysilicon, *n*-well CMOS process [8]. A post-process etch step was used to remove the exposed silicon substrate material to create the suspended resistor structure [4]. Fig. 1 shows a schematic cross section of a resistor. The resistor structure is a sandwich of field and CVD oxides that encapsulate a polysilicon resistor. The 4000 Å thick, 4 μm wide, CVD polysilicon film is doped in-situ with phosphorous, resulting in a sheet resistance of 21 Ω/sq . A scanning electron micrograph of a thermally-isolated polysilicon resistor is shown in Fig. 2.

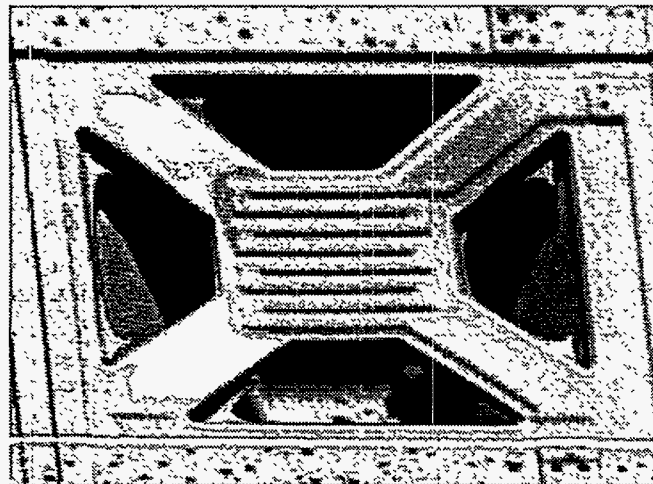
Fig. 2. SEM micrograph of a polysilicon resistor.

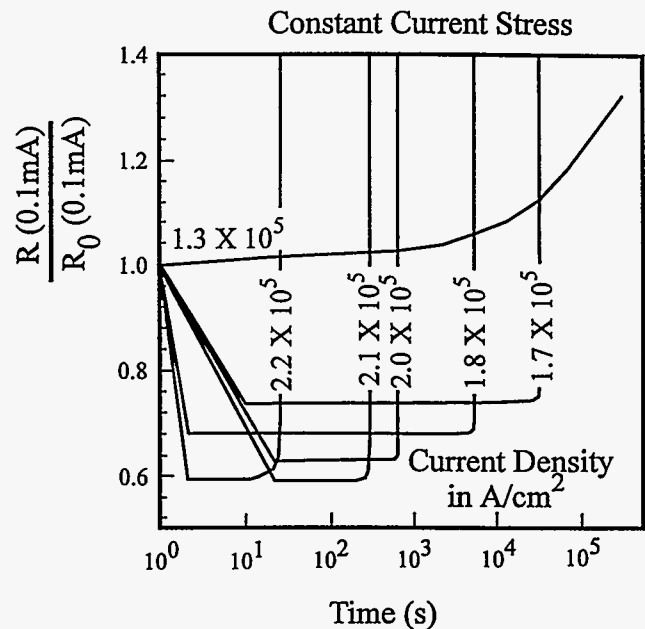
Fig. 3. Variation in relative resistance resulting from dc stressing.

Fig. 3 displays the variation in resistance resulting from constant current dc stressing. To determine the resistance, the voltage was measured with 0.1 mA applied current. Two features stand out in Fig. 3. First, there is an initial drop in resistance that occurs for high stress current density. The initial drop in resistance is proportional to the stress current density, but does appear to saturate at high current densities (2.2×10^5 and 2.1×10^5 A/cm² have similar resistance drops). One mechanism proposed for the reduction in resistance is polysilicon recrystallization and subsequent grain growth when the Joule heating is in excess of 800 °C [9]. For a given dopant concentration, it has been shown that the polysilicon resistivity decreases with increasing grain size [10]. A second possible mechanism for the reduced resistance is dopant segregation from the grain boundary into the polysilicon grains at high temperature [5]. The resistance reduction phenomenon is repeatable and has been proposed as a polysilicon resistor trimming procedure [11].

The second feature seen in Fig. 3 is the change in resistance with time. There is an abrupt increase in resistance with continued stressing at $1.7 \times 10^5 \text{ A/cm}^2$ ($\sim 750 \text{ }^\circ\text{C}$) and above and a gradual increase with a $1.3 \times 10^5 \text{ A/cm}^2$ ($\sim 475 \text{ }^\circ\text{C}$) stress. The abrupt resistance increase occurs sooner for higher stress current densities. The abrupt increase represents catastrophic failure. The gradual increase is believed to be due to thermomigration [2] and electromigration [3] of dopants. Thermomigration of the dopants occurs when there are thermal gradients along the polysilicon resistor. The dopants diffuse from the hotter regions and cluster in the cooler areas [2]. The incandescent image shown in Fig. 4 illustrates areas of varying photon emission intensity and therefore, varying temperature (brightest = hottest). The image was acquired using a standard video camera on an optical microscope. Thermomigration will tend to drive the dopant to the periphery of the resistor, away from hotter central region. Dopant electromigration in polysilicon, as in metals, is manifested by movement of dopant atoms via momentum transfer from the "electron wind" of current stressing [3]. In either the thermomigration or electromigration case, a small change in dopant distribution can greatly affect the overall resistance of a polysilicon resistor [11]. Although too small to be seen in Fig. 3, there is a gradual resistance increase under stress conditions $\geq 1.7 \times 10^5 \text{ A/cm}^2$ after the initial resistance drop. This slight increase may be the result of electromigration with continued stress.

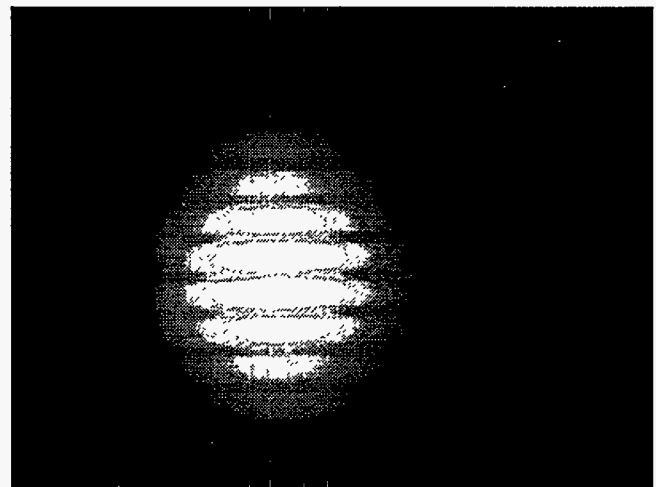
Fig. 4. Incandescent image of a polysilicon heater dc stressed at a 2.1×10^5 A/cm² current density. The field of view is similar to Fig. 2.

At current densities above 2.0×10^5 A/cm², the resistors are visibly incandescent, making thermal gradients easily observable. Fig. 4 is an incandescent image using a 2.1×10^5 A/cm² current density. As the shape of the incandescence in Fig. 4 illustrates, the four field oxide "arms" supporting the resistor structure (Fig. 2) provide some "heat sinking" at the corners of the resistor.

An incandescent image of the polysilicon resistor in Fig. 9 is shown in Fig. 4. Note that the transition regions of bright to dark in the incandescent image align well with the OBIC contrast variations. This is consistent with the dopant thermomigration described above. The dopants are believed to diffuse from warmer areas, abruptly slowing their motion when coming in contact with a cooler region. Electromigration would also follow the thermal profile, with faster dopant motion in the hotter regions of the resistor. The diffusion (depletion) and subsequent clustering (accumulation) of dopant yield a varying Fermi level along

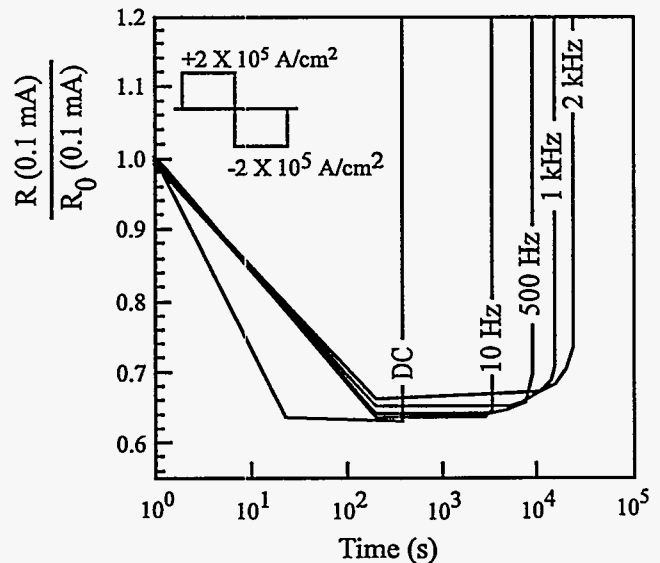
Fig. 5. Relative resistance variation resulting from ac stressing.

Fig. 5 displays the resistance variation resulting from constant current density, bipolar ac stressing. Three features are evident in Fig. 5. First, as with the dc stressing shown in Fig. 3, there is an initial drop in the polysilicon resistance.

The second feature seen in Fig. 5 is an abrupt increase in resistance with continued ac stressing (following a period of slowly increasing resistance). The time to the abrupt change increases with increasing frequency. The increased time to failure with ac stressing demonstrates an

The third feature seen in Fig. 5 is a slight decrease in the initial resistance drop with increasing frequency. The decrease has been observed before, but was considered insignificant and possibly due to intrinsic differences in the pre-stress resistance and subsequent self-heating [1]. The frequency dependence of the initial resistance drop seen in Fig. 5 suggests a more fundamental mechanism than sample variation, possibly related to the effects of momentum transfer or a change in the resistor's Joule heating response for ac versus dc stress. The temperatures we report in this paper are based on the assumption that ac

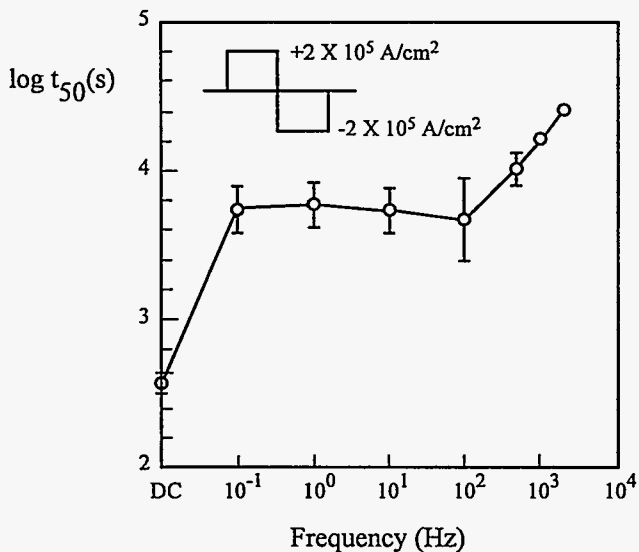
Fig. 6. Relationship between the time-to-failure and bipolar, ac stressing frequency with a $\pm 2.0 \times 10^5$ A/cm² applied current density.

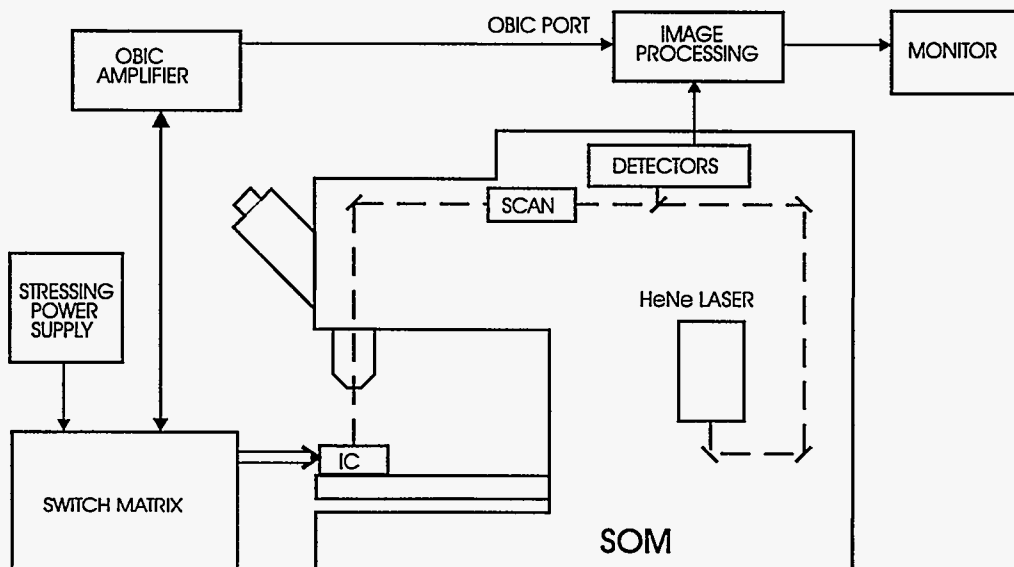
Fig. 7. Block diagram of the OBIC system.

A block diagram of the OBIC system is shown in Fig. 7. The scanning optical microscope (SOM) is a Zeiss Laser Scan Microscope. A 5 mW, 633 nm, HeNe laser is used. A pair of galvanometer-driven mirrors move the laser spot across the field of view in a 512 x 512 pixel raster. A photomultiplier detector is used to produce reflected light images.

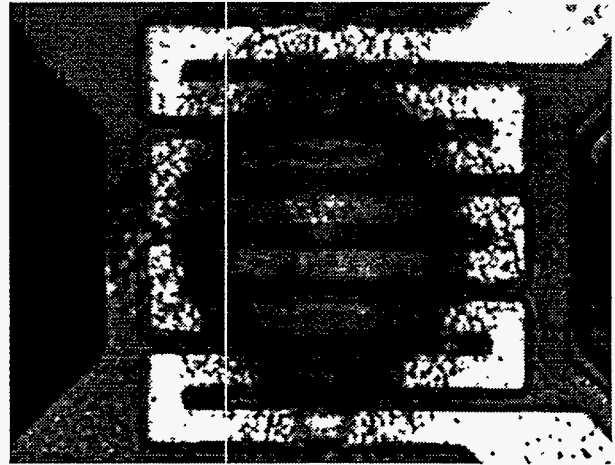
Fig. 8. Non-uniform oxide reflow produced by thermal shock. Note the similarity in shape to Fig. 4.

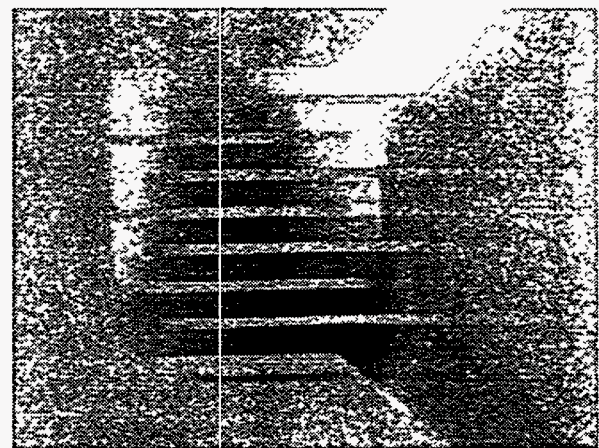
Fig. 9. OBIC image of a polysilicon resistor dc stressed at high temperature (~1100 °C) for 100 seconds.

DC Stressed Polysilicon Resistors: An example of OBIC analysis applied to a dc stressed, thermally-isolated polysilicon resistor is shown in Fig. 9. The resistor shown had been dc stressed at $2.1 \times 10^5 \text{ A/cm}^2$ for 100 seconds after the current ramp. From power calculations, the temperature of the resistor is ~1100 °C under these stress conditions. The resistance value before stress is 2.2 k Ω . After 100 seconds of stress the resistance value is 1.4 k Ω . It is noted that the resistance drop actually occurs in less than 10 seconds. The resistance increases slowly during the subsequent stressing prior to failure. There is an overall bright to dark shading from top to bottom in the OBIC image of the resistor in Fig. 9. The shading is produced by the difference in resistance path from current generating areas on the resistor to the OBIC amplifier.

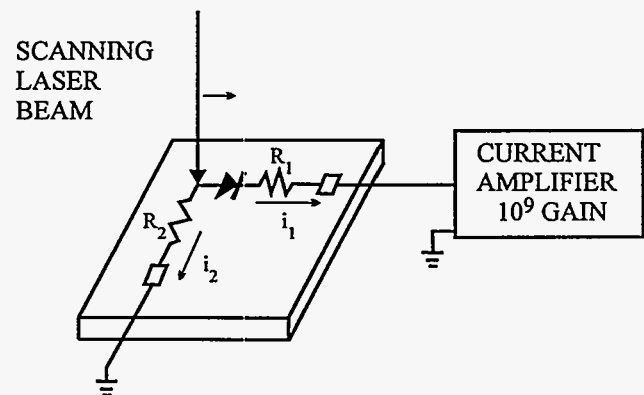
Fig. 10. Schematic of OBIC signal generation from a stressed polysilicon resistor. The diode represents a local Fermi level gradient.

A schematic of OBIC signal generation is shown in Fig. 10. The top of the resistor is connected to the input of the OBIC amplifier. Currents produced in this area have a lower ohmic path to the amplifier and produce a brighter signal. The bottom of the resistor is connected to ground. Currents produced towards the bottom of the resistor have a lower ohmic path to ground and appear dark. At several locations along the length of the polysilicon resistor there are abrupt bright to dark contrast changes. The signals in these locations result from local gradients in the Fermi level.

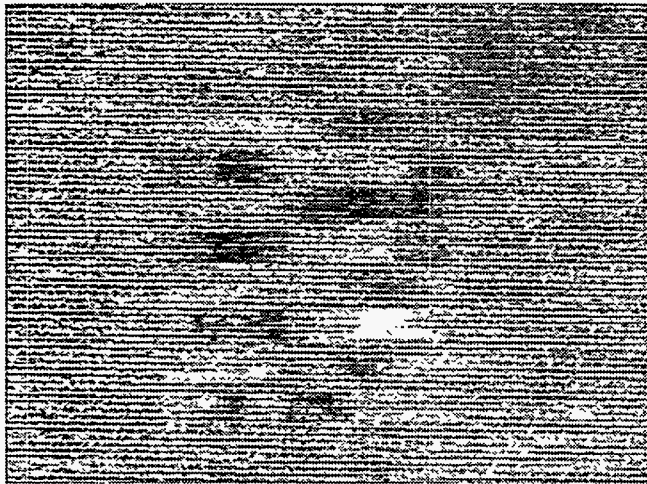
Fig. 11. OBIC image of a polysilicon resistor dc stressed at low temperature ($\sim 170^\circ \text{C}$) for 48 hours.

DC stress at lower current densities did not produce the initial drop in resistance, but did yield increased resistance for longer stress times. Fig. 11 is an OBIC image of a resistor dc stressed at $1.1 \times 10^5 \text{ A/cm}^2$ for 48 hours. The resistance increases by 6% over this period (2.08 k Ω to 2.20 k Ω). The calculated temperature of the resistor is $\sim 170^\circ \text{C}$ under these conditions. The OBIC contrast in Fig. 11 is reduced and is distributed differently as compared to Fig. 9. The areas of contrast change (accumulation-depletion regions) occur along the left-to-right lengths of the polysilicon resistors, similar to electromigration effects observed at 180° turns in metal test structures.

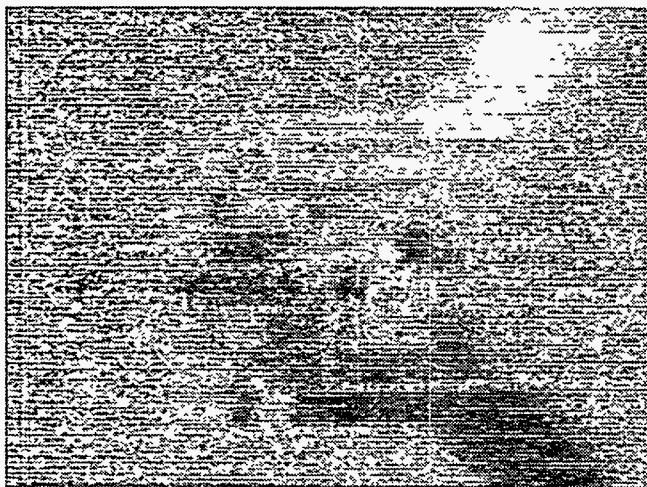
Fig. 12. An OBIC image of the resistor shown in Fig. 11 before any stressing.

Fig. 12 is an OBIC image of the resistor in Fig. 11 before stressing. There are some subtle contrast variations along the unstressed resistor, indicating the presence of Fermi level gradients, but the OBIC signals are weaker (and therefore a noisier image is produced) than those observed for stressed resistors.

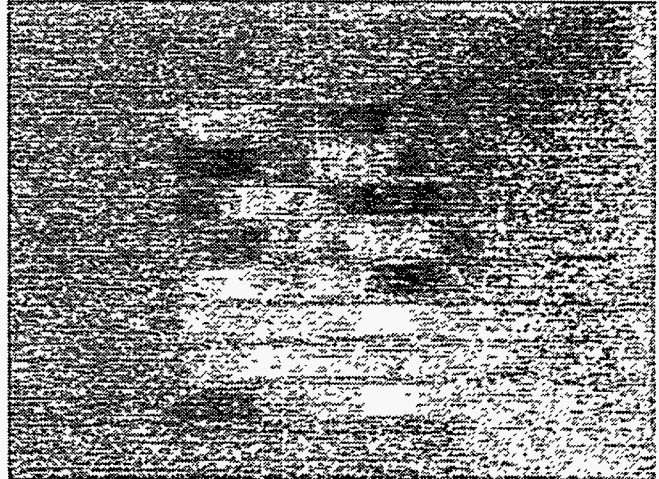
Fig. 13. OBIC image of a polysilicon resistor stressed similarly to the resistor shown in Fig. 11, but with the current direction reversed.

Fig. 13 shows an OBIC image of a resistor dc stressed similarly to the resistor in Fig. 11, but the current direction is reversed. Note that the bright to dark contrast variations occur in the same locations as in Fig. 11 and are not reversed as might be expected. The implications of this are addressed in the Discussion.

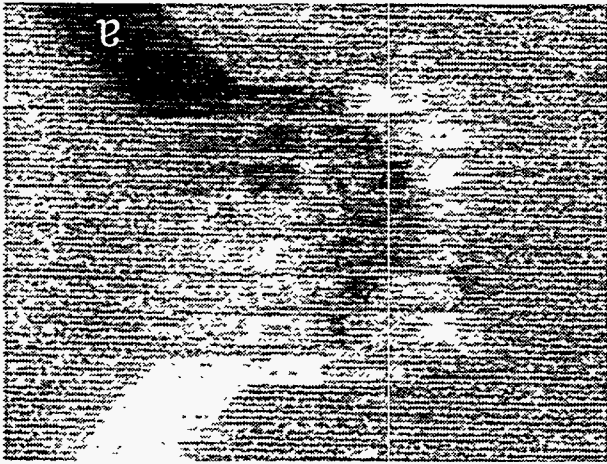
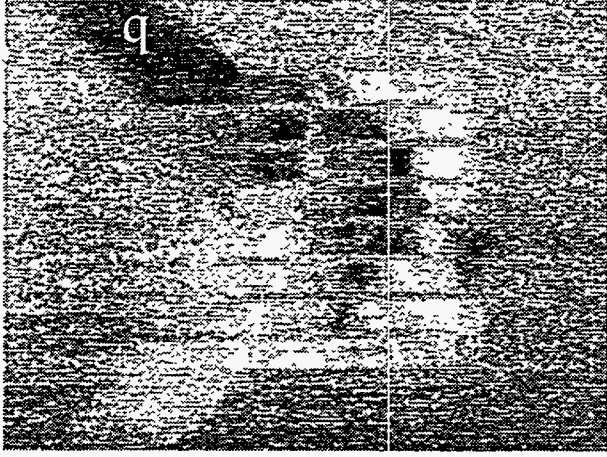
Fig. 17. OBIC images of a polysilicon resistor (a) before and (b) after a 48 hour, 1 kHz, $\pm 1.1 \times 10^5 \text{ A/cm}^2$ stress.

can be seen. AC stressing at low power levels produces no change in the OBIC image. Fig. 17(a) is an OBIC image of a resistor before stressing and Fig. 17(b) is an OBIC image of the

same resistor after a 1 kHz ac stress of $\pm 1.1 \times 10^5 \text{ A/cm}^2$ for 48 hours. As in the dc case, the temperature is $\sim 170^\circ\text{C}$ under these conditions. The resistance was 2.1 k Ω before and after the stressing. Note that there is essentially no difference between the OBIC images.

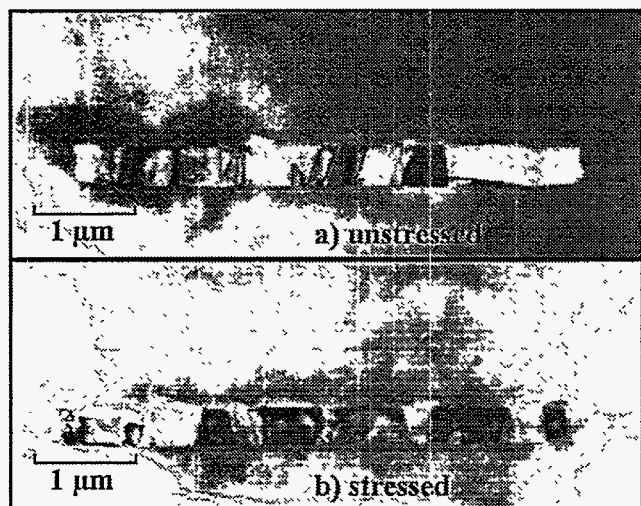
Fig. 18. TEM cross sections of an (a) unstressed and (b) stressed polysilicon resistor. The stress condition was $2.0 \times 10^5 \text{ A/cm}^2$ ($\sim 1100 \text{ }^\circ\text{C}$) for ~ 100 seconds.

The microstructure of the polysilicon resistors was investigated with transmission electron microscopy (TEM). Cross-sectional samples were prepared of both a stressed ($2.0 \times 10^5 \text{ A/cm}^2$ dc current for approximately 100 seconds) and an unstressed resistor. The sections of the two samples were oriented to slice through all the fingers of each resistor. Fig. 18(a) is representative of the microstructure of the unstressed sample, and Fig. 18(b) shows the microstructure of one of the center fingers (which experienced the greatest amount of heating) of the stressed resistor. Both the stressed and unstressed polysilicon exhibit columnar grains with the grain size on the order of the layer thickness, $0.4 \mu\text{m}$. Comparison of the TEM images from all the fingers of the two resistors shows no appreciable difference in microstructure between the unstressed polysilicon resistor and a resistor stressed at $2.0 \times 10^5 \text{ A/cm}^2$ ($\sim 1100 \text{ }^\circ\text{C}$).

A previous study [1] attributed the abrupt drop in polysilicon resistance at high temperatures to recrystallization of the polysilicon, but did not include a microstructural examination. The TEM results obtained in this study show that appreciable grain growth does not occur during stressing, and thus another mechanism is responsible for the drop in resistance. The roles of both carrier trapping and dopant trapping at the grain boundaries have been examined for electrical conduction in polysilicon [5]. Both phosphorous and boron segregate to polysilicon grain boundaries at relatively lower temperatures. The reduction in carrier concentration (and hence increased resistivity) at lower temperatures is due to this segregation effect. When the dopant segregates to the grain boundary it becomes electrically inactive and the resistivity increases. Conversely, at higher temperatures the segregation is less and the carrier concentration rises. This result is consistent with our finding that the polysilicon resistance drops upon heating above $\sim 800 \text{ }^\circ\text{C}$ and that the resistance drop is greater the higher the stress temperature. The saturation observed above $2.1 \times 10^5 \text{ A/cm}^2$ in Fig. 3 is also consistent with reference [5], which shows that the increase in carrier concentration as a function of temperature saturates around $1000 \text{ }^\circ\text{C}$.
