FIELD PERFORMANCE OF EROSION RESISTANT MATERIALS ON BOILER INDUCED DRAFT FAN BLADES

TENNESSEE VALLEY AUTHORITY KINGSTON FOSSIL PLANT

May 1993

FIELD PERFORMANCE OF EROSION RESISTANT MATERIALS ON BOILER INDUCED DRAFT FAN BLADES TENNESSEE VALLEY AUTHORITY KINGSTON FOSSIL PLANT MAY 1993

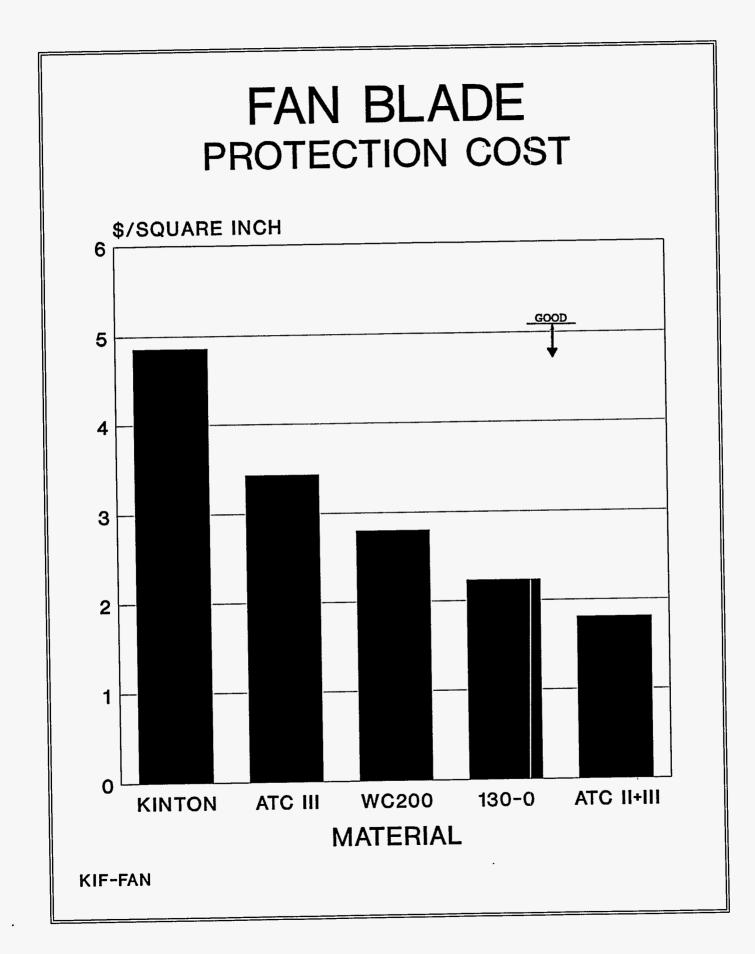
UNIT-5 "B" INDUCED DRAFT FAN BLADES Test period: June 24, 1990 to February 15, 1992

Condition of the Conforma Clad WC200 Tungsten Carbide coating after operating about 20 months. The coating protected the fan blades from erosion except for a small area at the edge of the blade where the coating is starting to come off. There is also an unprotected area at the side of the blade that eroded and was weld repaired. The cost of this coating was \$12,000 for 120 Kingston fan blades (\$100 per blade).

In April 1992 the blades with the WC200 Conforma Clad were inspected after being in operation for 20 months (see photographs on page 5). Inspections of these blades indicated a need for cladding a greater area of the blade than was cladded. The area near the blade ear was eroded severely and was weld repaired with weld overlay. This fan was then placed in operation for about 10 more months before the blades were replaced. At the end of this operating period the blades were eroded so severely that two blades failed and were thrown from the fan rotor (see photographs on page 6). It appeared that during this 10 month operating period there was two or three times as much fly ash erosion of the blades as there was during the preceding 20 month operating period. This higher rate of erosion (4 to 6 times higher than normal) was caused by a decrease in the performance of the fly ash collectors preceding the induced draft fans.

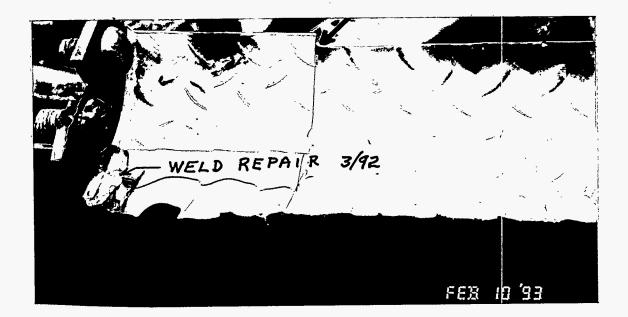
UNIT-5 "B" INDUCED DRAFT FAN BLADES Test period: June 24, 1990 to February 8, 1993

Condition of the Conforma Clad WC200 Tungsten Carbide coating and fan blade base metal after operating about 30 months. The coating protected the fan blades from erosion in the area it is installed except for an area of severe erosion near the inlet edge. The coating cost: \$12,000 for 120 blades (\$100 per blade).

The Kinton Carbide and Conforma Clad WC200 cladding caused an accelerated rate of erosion in the base metal near the edges of the cladding (see the photographs on pages 6 and 7). This was probably due to the cladding thickness being a step change from the base metal which caused the fly ash to cut a path (channel) down the edge of the cladding. The Metadur coating thickness tapered off at its edges and did not cause this channeling effect (see the photographs on page 8).

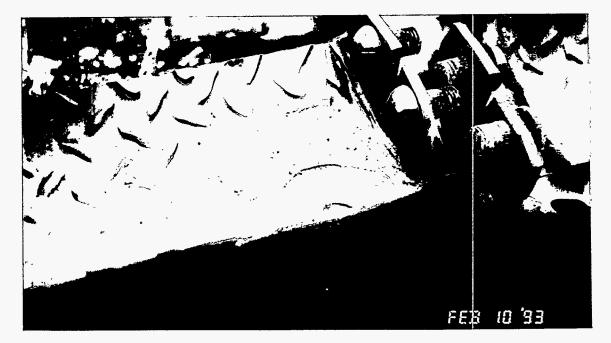
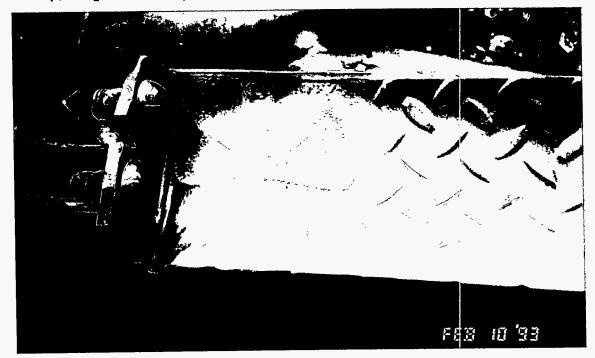
UNIT-5 "A" INDUCED DRAFT FAN BLADES Test period: April 12, 1992 to February 8, 1993

Condition of the ATC Metadur III 80% Tungsten Carbide coating and fan blade base metal after operating about 10 months at 4 to 6 times the normal erosion rate. The coating reduced solid particle erosion and made the blade last about twice as long as it would have lasted without the coating. The coating cost: \$11,400 for 120 blades (\$95 per blade).

On February 8, 1993, after unit 5 at the Kingston Plant had been in operation for about 10 months, it was taken out of service. The test blades in the "A" induced draft fan with the ATC Metadur III coatings were replaced with blades made of conventional material. The test blades were severely eroded in the area near the blade ears where there was no coating (see photographs on page 8). It appeared the ATC Metadur III coating may have doubled the life of these blades. It may possibly tripled the life of the blades if more area of the blade is covered with this coating.

It is recommended that the ATC Metadur II (50% tungsten carbide) coating (0.040" thick) be installed over the area of the blades that experience severe erosion (about 20% of the blade's concave surface) and the Metadur III (80% tungsten carbide) coating (0.020" thick) be installed over the Metadur II coating in the area experiencing maximum erosion (about 6% of the blade's concave surface). This coating arrangement is shown on page 10 and cost about \$12,000 to install on 120 blades of a Kingston fan (\$100 per blade).

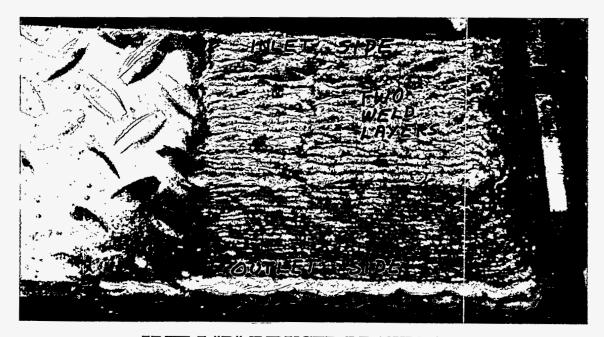
UNIT-7 "B" INDUCED DRAFT FAN FAN BLADE EROSION PROBLEM

A fan blade before it was placed in service with a 60% Tungsten Carbide weld overlay on the area that experiences fly ash erosion. Two layers of weld overlay are installed on the area that experiences severe erosion. The weld overlay is made from 1/16 inch diameter Stoody 130-0 mig welding wire. The contractor was Consolidated Metal Services, Inc. The cost was \$13,024 for 120 blades (\$109 per blade) for a Kingston fan and \$17,572 for 128 blades (\$137 per blade) for a Widows Creek unit-7 fan.

If the Stoody 130-0 weld overlay proves to be satisfactory it may be considered an alternate method of protecting the fan blades from fly ash erosion. At the time of this report, the test blades with the Stoody 130-0 weld overlay had not been inspected. The cost for installing the Stoody 130-0 on 120 blades of a Kingston fan was \$13,024 (\$108.53 per blade). It is expected that this price could be reduced in the future with lower cost MIG welding wire.
