## X-ray K-edge Analysis of Drain Lines in Wilhelm Hall, Ames Laboratory

Terry Jensen and Craig Whitmore

Ames Laboratory and Center for NDE  
Iowa State University  
Ames, IA 50011

January 5, 1999

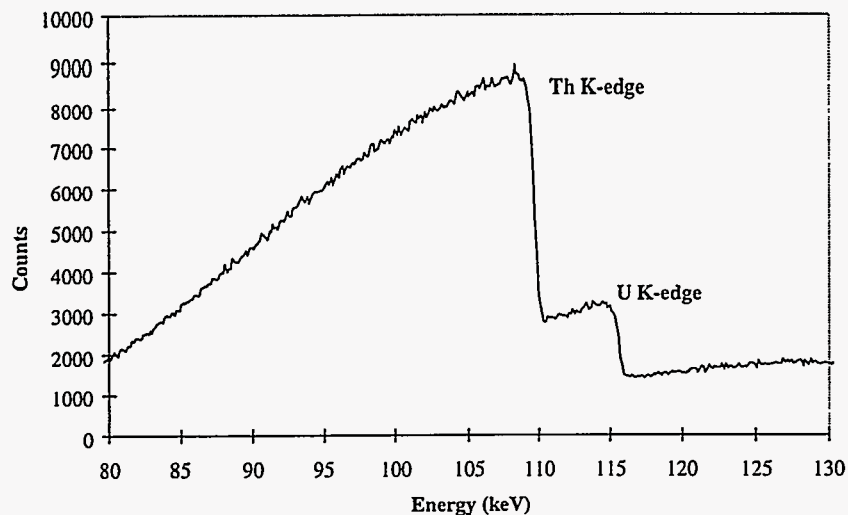
Figure 1. Example spectrum from K-edge inspection of thorium and uranium calibration foils through 1/8 inch of steel.

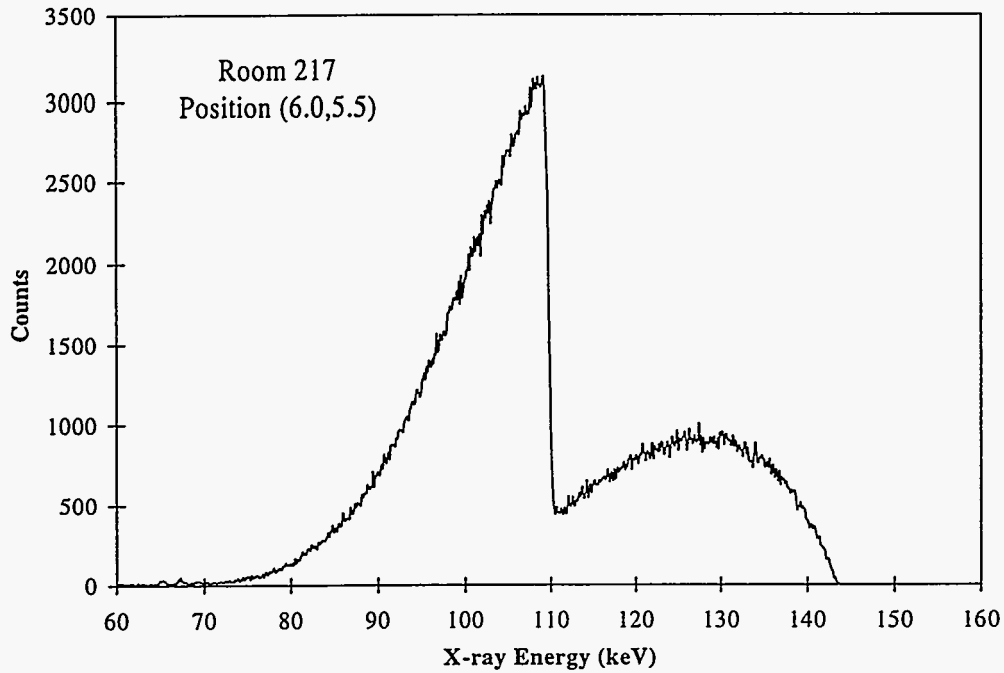
Figure 3. Spectrum showing the highest concentration of thorium found ( $\sim 0.5 \text{ g/cm}^2$ ) in the drain trap in room 217.

K-edge measurements indicate substantial thorium deposits in this drain trap (as high as 0.5  $\text{g/cm}^2$ ), and moderate thorium contamination in the joint region downstream of the trap. The joints also contained substantial amounts of lead (likely from soldering) which made it quite difficult to obtain adequate statistics in these regions. It was not possible to position the K-edge system on the straight section of the pipe.

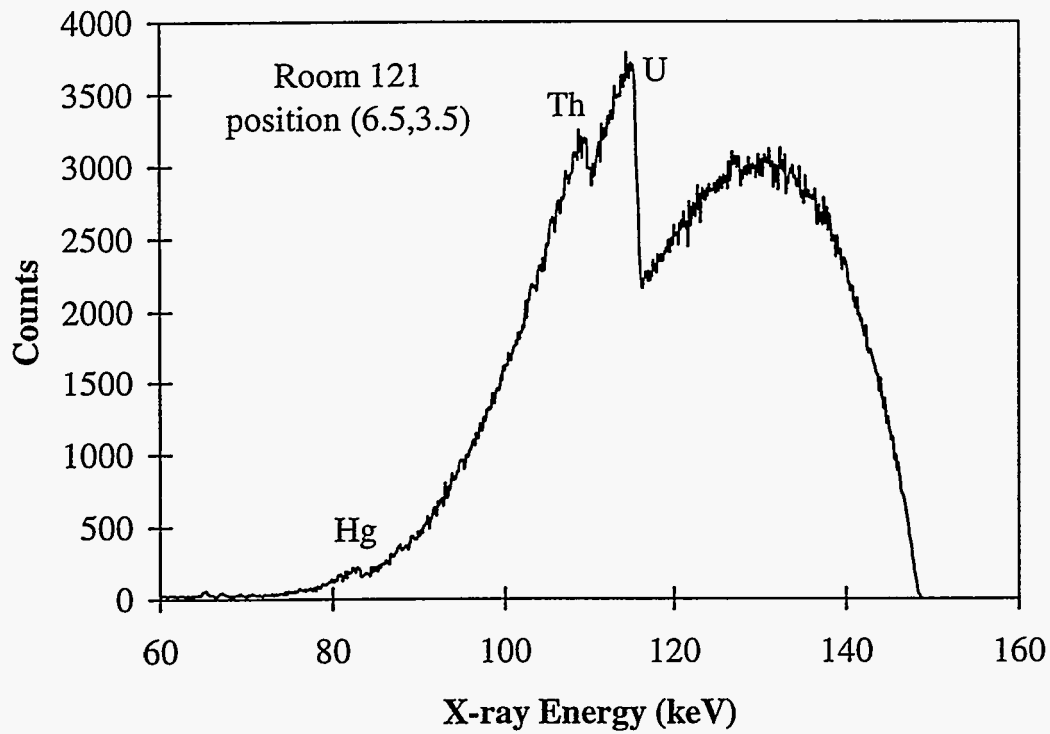
Figure 4. Spectrum from a region of the drain trap in room 121 showing signals for uranium, thorium and mercury.

K-edge measurements indicate significant deposits of mercury, thorium and uranium in this trap. Mercury and uranium are found throughout the trap, whereas thorium appears to be concentrated in a small region. Several measurements were also made on the straight section of pipe just downstream from this trap. No significant contamination was found in this region, with limits of  $<11 \text{ mg/cm}^2 \text{ Hg}$ ,  $<4 \text{ mg/cm}^2 \text{ Th}$ , and  $<7 \text{ mg/cm}^2 \text{ U}$ .

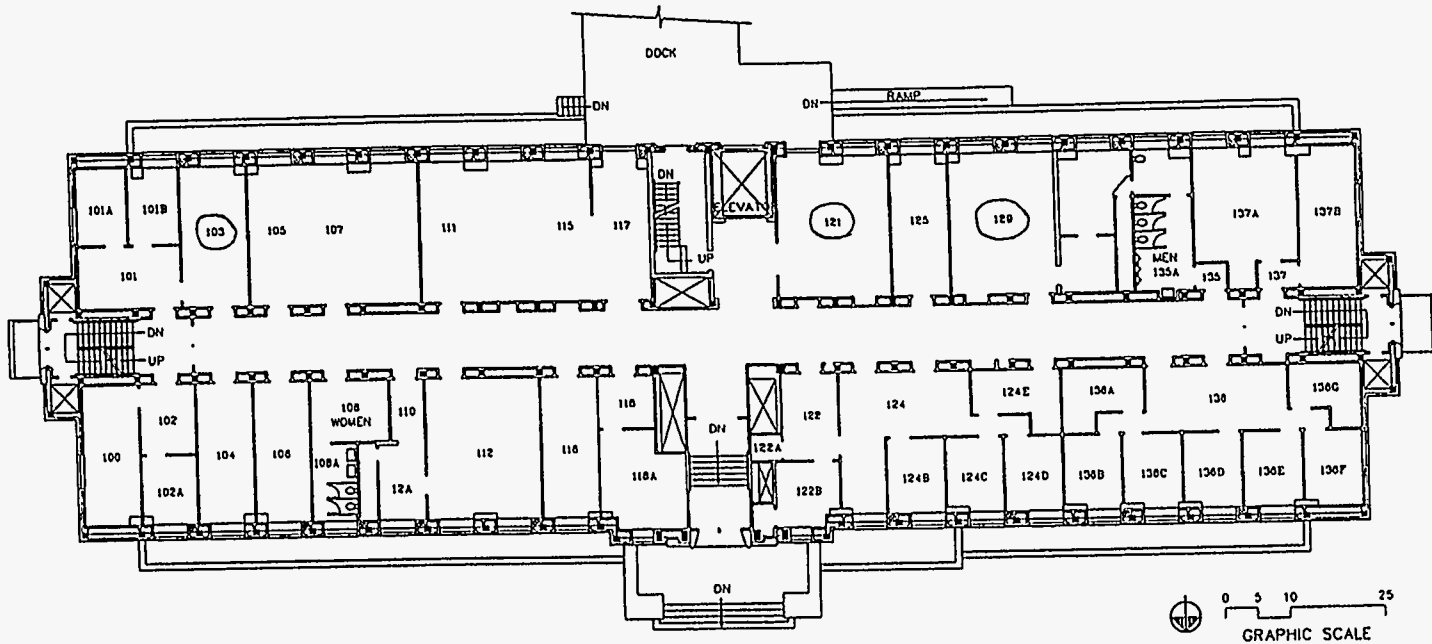
WILHELM HALL  
FIRST FLOOR PLAN

Wilhelm Hall First Floor layout with rooms targeted for K-edge inspection circled.

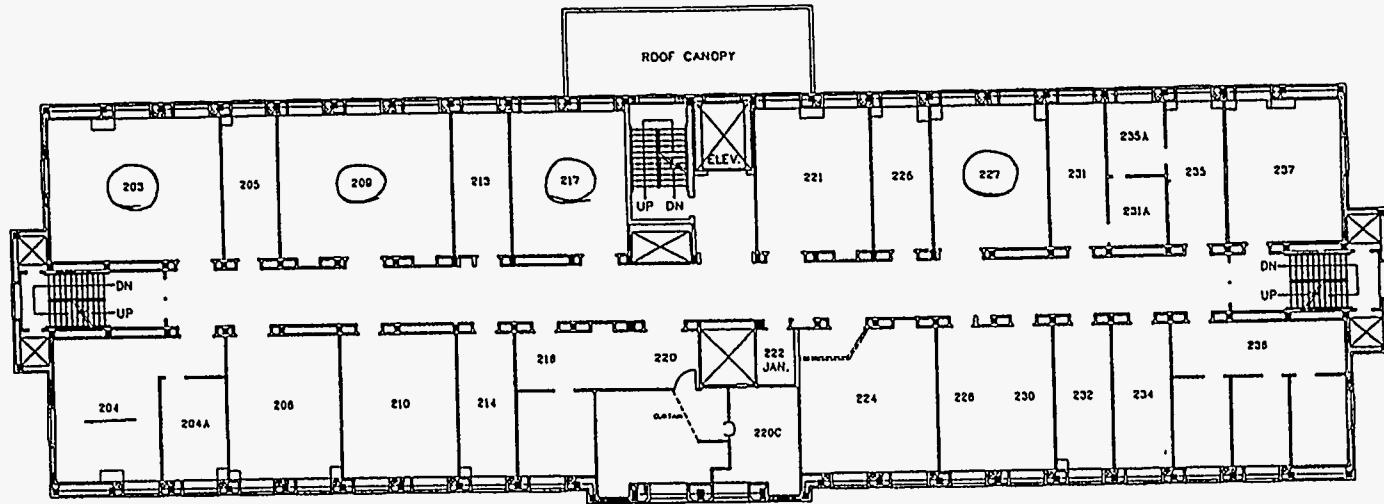
WILHELM HALL  
SECOND FLOOR PLAN

Wilhelm Hall Second Floor layout with rooms targeted for K-edge inspection circled.
