Lance Water Injection Tests Adjacent to the 281-3H Retention Basin at the Savannah River Site, Aiken, South Carolina

B. Freifeld, L. Myer, G. Moridis, P. Cook,
A. James, L. Pellerin, and K. Pruess
Earth Sciences Division

September 1996

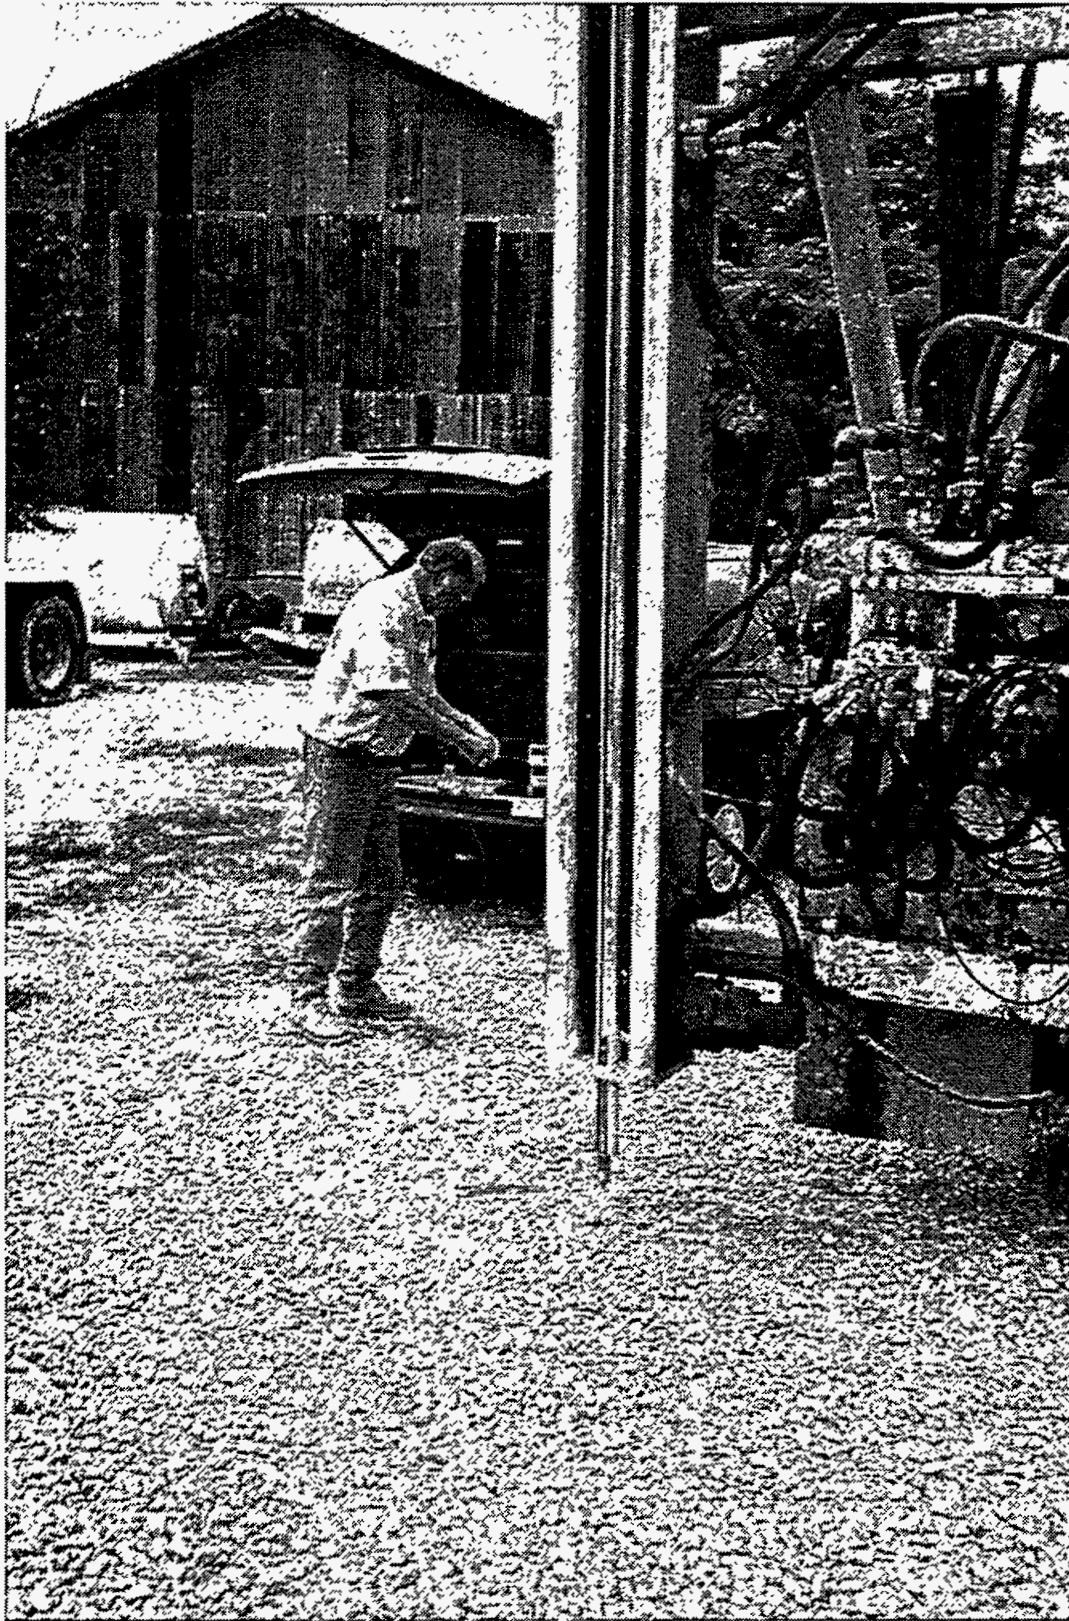
Figure 3. Lance injection truck with instrumented injection tip installed. Masthead is locked in the vertical position.
