SANDIA REPORT

SAND97-0507 • UC-213

Degradation of the Materials of Construction in Li-Ion Batteries

Abstract

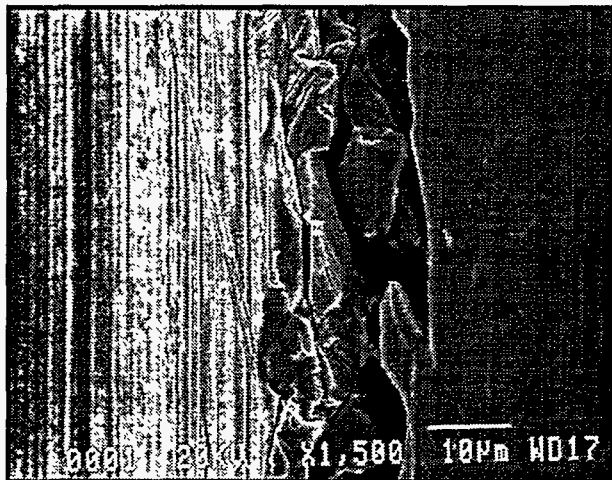
Figure 1. SEM photograph of the brittle fracture observed in a Ni test coupon aged in a Li/SOCl₂ cell environment.

Potentially serious corrosion problems have been observed in primary lithium batteries. For example, environmentally assisted cracking (EAC) can occur at highly stressed portions of the nickel anode current collector grid in Li/SOCl₂ cells, an effect related to alkali-metal embrittlement [1,2]. An example of a cracked grid section is shown in Figure 1. In Li/SO₂ cells, EAC of the nickel-plated carbon steel container has reduced service life [3]. Additionally, unacceptable chemical degradation of the glass/metal seal occurred in both of these primary cell technologies [2].

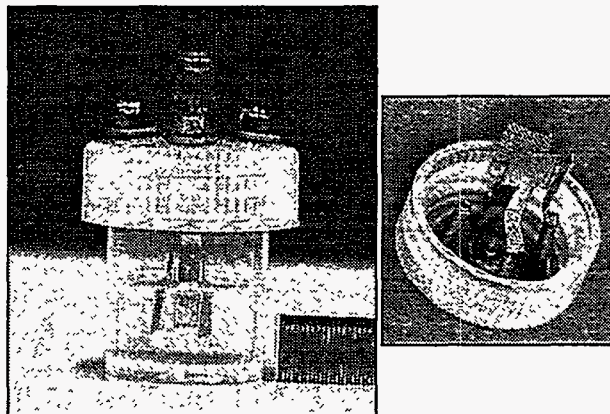
Figure 2. Photographs of the experimental flooded half-cell configuration

The corrosion characteristics of aluminum alloys 1100 (99.0% min and 0.12% Cu) and 1145 (99.45% min) and copper alloy 110 (99.9% min) were studied in flooded half-cells that had a standard 3-electrode configuration (Figure 2). These cells contained a relatively large excess of electrolyte compared to actual cells to help ensure constant conditions over the extended period of the experiments. The cell container was a 10-ml Nalgene bottle with three metal feed-through seals placed in the lid that also functioned as points of attachment for the electrodes. The cell containers were vacuum leak checked prior to assembly to ensure hermeticity (maximum leak rate of 4×10^{-5} cc/sec). A platinum counter and the aluminum or copper working electrode were each spot-welded to a small strip of nickel, which was then subsequently spot welded to the tip of

one of the feed-throughs. Similarly, a lithium reference electrode was cold welded to a strip of nickel that was also spot welded to a feed-through. The platinum and working electrodes were approximately 1 cm x 1 cm (1 cm² area) and were positioned facing each other with a separation of approximately 0.5 cm. The lithium electrode was positioned perpendicular to and along side the other two electrodes, close to their edges. The 100- μ m thick working electrodes were coated with polyvinylidene fluoride (PVDF) following spot-welding but prior to cell assembly on the side facing away from the counter electrode.

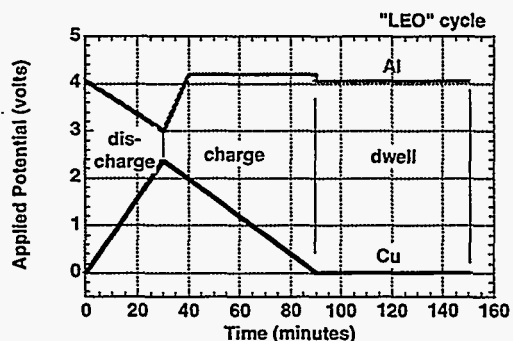
Figure 3. Simulated low-earth-orbit (LEO) electrical cycle regime

Individual cells were aged using a simulated low-earth-orbit (LEO) cycle. Each 150-minute LEO cycle regime consisted of four phases: discharge, constant current charge to voltage cutoff, potentiostatic charge at the voltage cutoff, and dwell (Figure 3). This type of aging simulated the electrical conditions the respective current collectors in an aerospace application might undergo. The relatively high top-of-charge voltage (4.2 V) for the aluminum electrodes was selected as a slight overtest condition (i.e. top-of-charge voltage for a Sony cell is nominally 4.1 V). Electrical cycling was performed by connecting all cells on test in parallel and controlling the voltage on the assemblage with a programmable potentiostat (Figure 4).

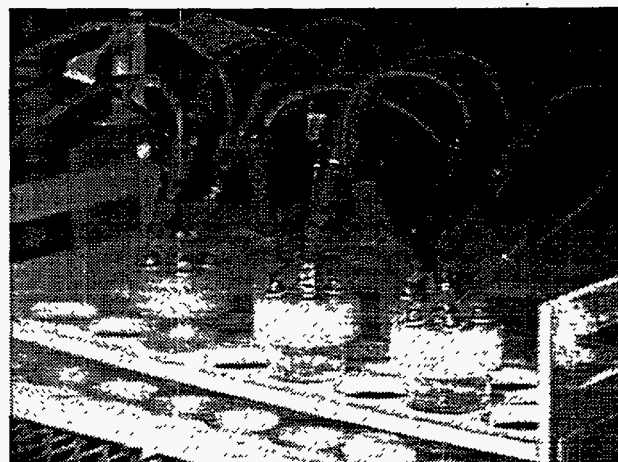
Figure 4. Photograph of the Al half cells undergoing LEO cycling

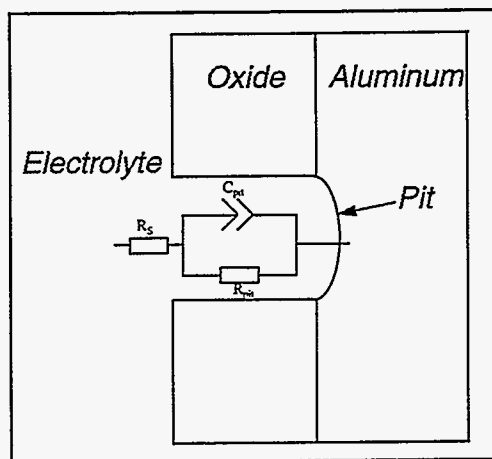
Figure 6. Simplified equivalent electrical circuit representation of the electrochemical processes occurring at the surface of an uncoated aluminum electrode

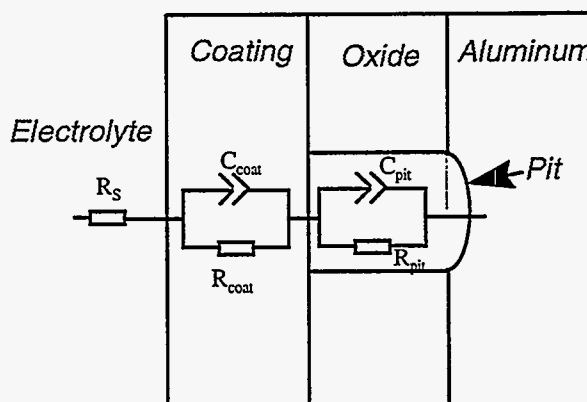
Figure 7. Simplified equivalent electrical circuit representation of the electrochemical processes occurring at the surface of a coated aluminum electrode

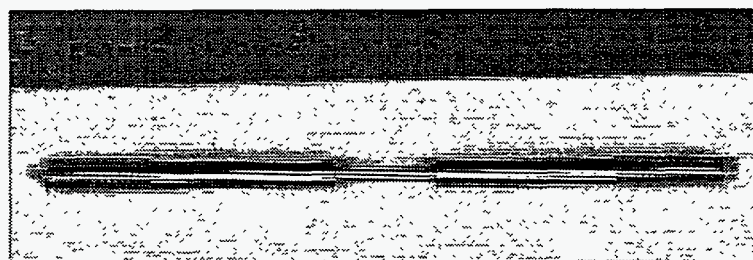
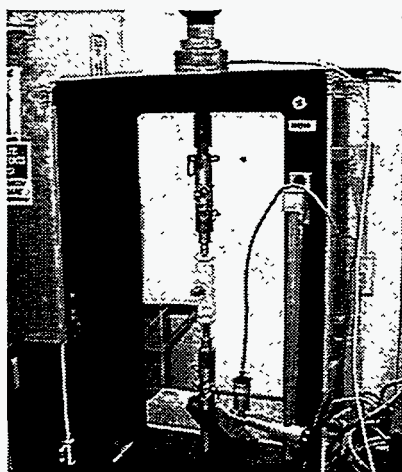
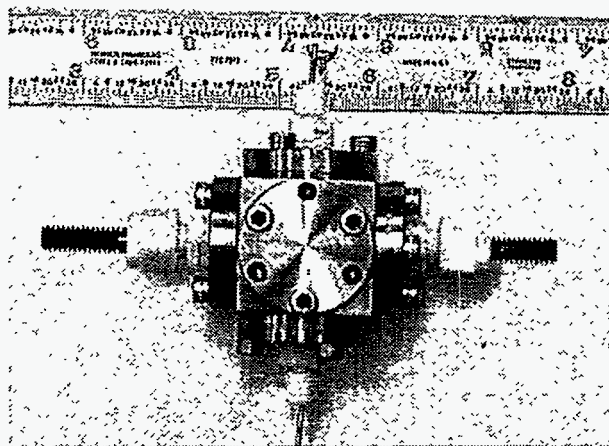
Figure 8. Photographs of the equipment used to determine susceptibility of copper to EAC: (a) copper tensile bar (alloy 110; diameter = 6.3 mm), (b) the constant extension rate test (CERT) apparatus, (c) stainless steel cell used to conduct constant potential CERT experiments.

The susceptibility of copper to EAC was assessed using constant extension rate testing (CERT) and exposure of U-bend samples (with actual foil stock) in flooded cells. Photographs of the CERT test apparatus are shown in Figure 8. The strain rates used varied from 10^{-6} to 10^{-7} cm/sec. The CERT experiments were performed on 6.3 mm round copper tensile bar samples (Figure 8a) either at open circuit or near the lithium potential. This latter condition was achieved by either (1) cold welding a strip of lithium onto the copper rod (cell configuration shown in Figure 8b), or (2) by using a Aardvark V-2LR potentiostat, a concentric platinum mesh counter electrode, and a lithium reference electrode in the stainless steel cell shown in Figure 8c. To determine if EAC might occur under more realistic conditions, a number of half cells were constructed and cycled with copper foil electrodes bent into a "U-shaped" configuration. This shape was maintained by spot welding the foil end back onto the body. The radius of curvature was relatively tight at about 0.08 cm to ensure significant plastic deformation.

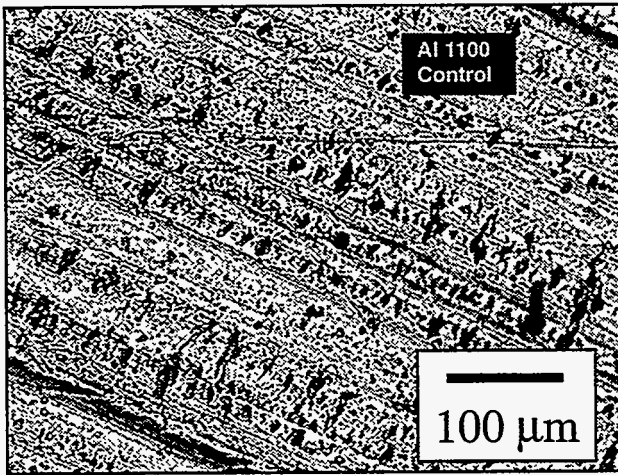
Figure 9. Photograph of the bare Al surface prior to LEO cycling

During electrical cycling, the aluminum current collector undergoes a form of pitting corrosion. After several days of cycling and 40 LEO cycles, some general attack of the aluminum surface was visible in that an almost electropolished appearance existed, but more importantly, some scattered pitting had initiated (compare Figures 9-10). With continued cycling, the pit density increased, as shown in Figure 11 for 690 LEO cycles in the PC:DEC electrolyte. Cycling in the EC:DMC electrolyte resulted in a higher pit density, as shown in Figure 12, even at 150 LEO cycles. Curiously, what optically appeared to be pits after extended cycling in both electrolytes are actually mounds. Based on cross-sectional SEM examination of the foil (Figures 13-14), these mounds must be filled in pits. Surface analyses using XPS and Auger analyses were performed to help understand this phenomenon (detailed results presented below). Initial results indicate that the mounds contain both Al^0 and Al_2O_3 . Because of the primarily anodic conditions during LEO cycling, the existence of metallic aluminum implies that the mounds are electrically isolated from the foil. Two possible explanations are that 1) corrosion and its associated reaction products undermined the surface of a developed pit and caused the overlying metal to bulge and break away, or 2) metal was redeposited on poorly conductive corrosion products during the discharge portion of the LEO cycle during which cathodic conditions actually exist (open circuit voltage for Al is between 3.2 and 3.6 V).

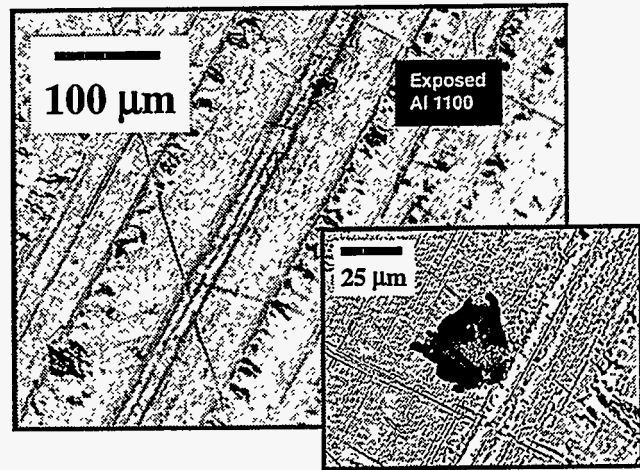
Figure 10. Photographs of the Al surface after 40 LEO cycles in PC:DEC electrolyte

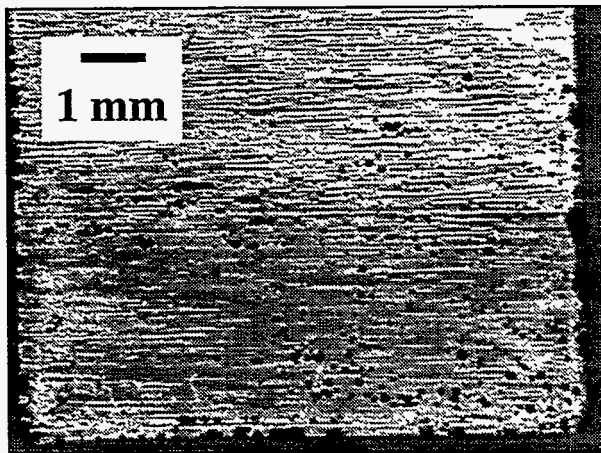
Figure 11. Photograph of an Al surface after 690 LEO cycles in PC:DEC electrolyte

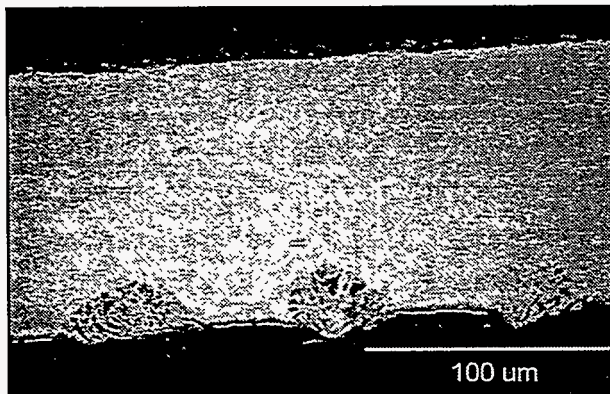
Figure 13. SEM cross-section of Al foil after 150 cycles in EC:DMC electrolyte

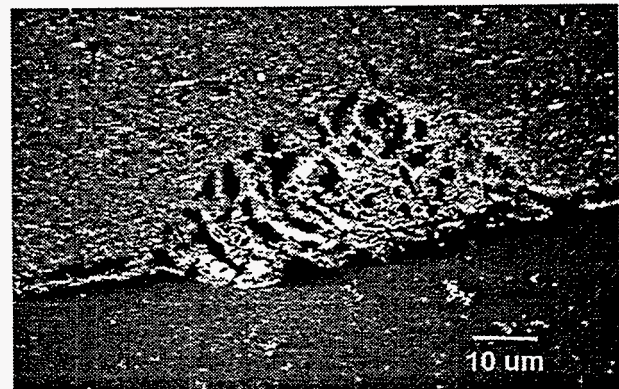
Figure 14. SEM cross-section of Al foil after 150 cycles in EC:DMC electrolyte (expanded view of one mound from Figure 13)

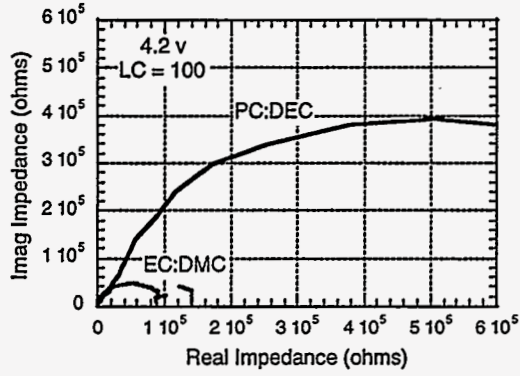
Figure 15. Nyquist plot for Al alloy 1100 in PC:DEC and EC:DMC electrolytes

The results from the electrochemical impedance spectroscopy measurements provide insight and understanding into the Al corrosion processes. First, as discussed above, pit density is higher in the EC:DMC electrolyte. The EIS results (Figures 15-16) confirm that the EC:DMC electrolyte is more corrosive (lower R_{pit}) than the PC:DEC electrolyte over the majority of the tested cycle life. At cycle 100, the diameter of the semicircular component in Figure 15 that corresponds to R_{pit} is much smaller and, as shown in Figure 16, a distinct separation in the explicitly calculated R_{pit} values from the model exists over the first several hundred cycles. The increased corrosion

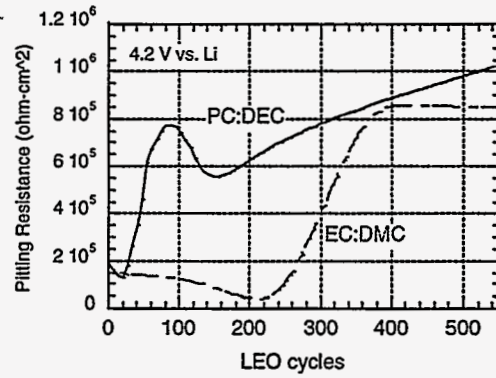
Figure 16. Effect of cycling on the calculated R_{pit} parameter for both electrolytes (Al 1100)

current observed initially during DC measurements also support this conclusion (Figure 17). Second, and importantly, the pitting resistance appears to improve with cycling in both electrolytes, but especially in the EC:DMC solvent (Figure 16). However, as discussed below, this does not mean that the pitting process is self-limiting over time and stops in either electrolyte. Also note that no attempt was made to analyze impurities and then monitor changes during cycling in either electrolyte. As such, these differences may not be an intrinsic property and could be due to an associated impurity effect. Preliminary surface spectroscopy results (again see Surface Analysis section) indicate that the EC:DMC electrolyte used in this study may have had a higher chloride concentration, which is known to cause pitting corrosion in organic electrolytes [9].

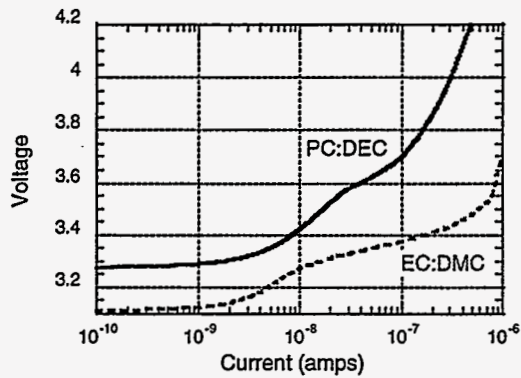
Figure 17. Comparison of anodic DC polarization response for Al alloy 1100 in PC:DEC and EC:DMC electrolytes prior to cycling

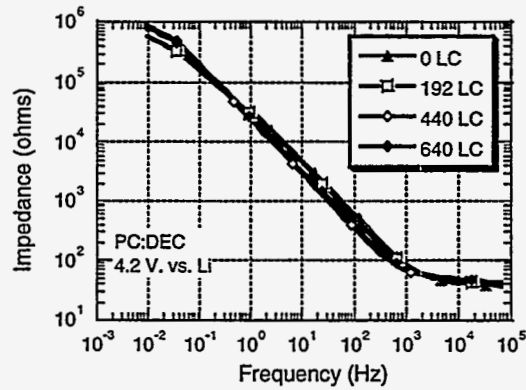
Figure 18. Bode magnitude plot for aluminum alloy 1100 in PC:DEC electrolyte

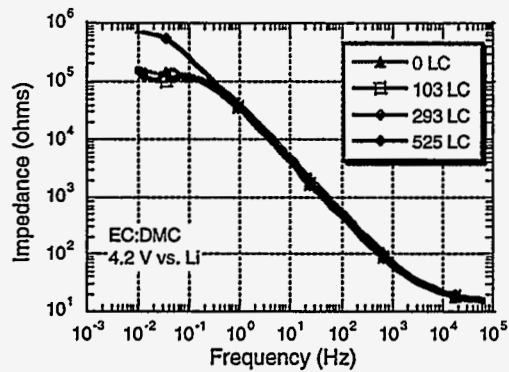
Figure 19. Bode magnitude plot for aluminum alloy 1100 in EC:DMC electrolyte

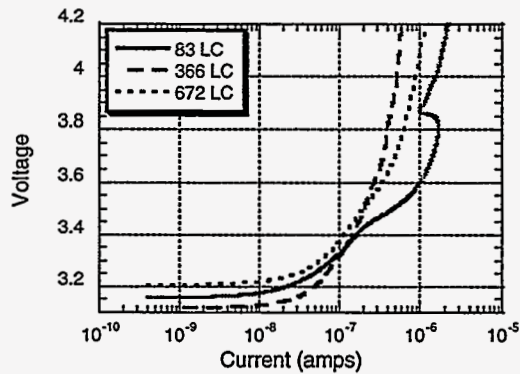
Figure 20. Anodic DC polarization response for Al alloy 1100 in PC:DEC electrolyte as function of cycling

- The greater the applied anodic voltage the greater the anodic corrosion current (Figure 20), a result consistent with a lower R_{pit} value (smaller semi-circle diameter in the Nyquist plot shown in Figure 21).

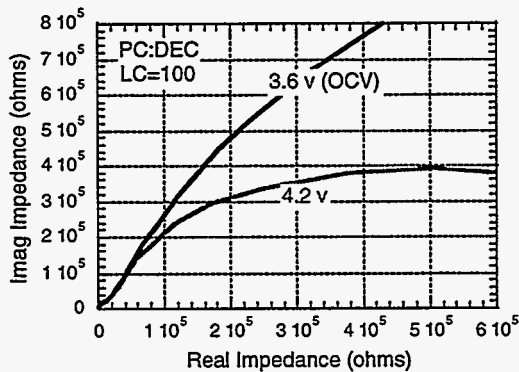
Figure 21. Nyquist plot for aluminum alloy 1100 in PC:DEC electrolyte (at 2 voltages)

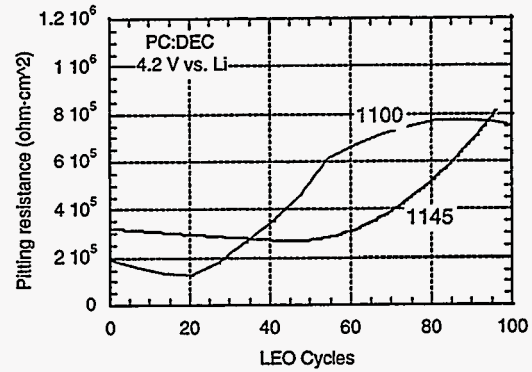
Figure 22. Effect of alloy composition on the calculated R_{pit} parameter in PC:DEC electrolyte

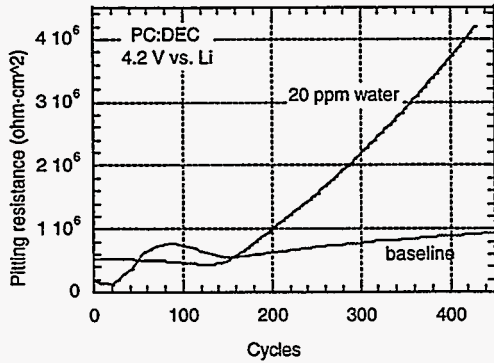
Figure 23. Effect of an initial water addition on the calculated R_{pit} parameter for Al alloy 1100 in PC:DEC electrolyte.

- The addition of 20 ppm water to the PC:DEC electrolyte appears to substantially improve corrosion resistance after 100+ cycles (Figure 23). A similar beneficial effect due to water (although at much higher levels) has been observed in a related work that involved a PC-based electrolyte and stainless steel couple. The effect was attributed to a stabilizing effect on the passive layer [10]. However, a more detailed analysis is needed with this system before a definitive conclusion can be reached. Of possible relevance to this understanding and confirmed by the DC response obtained during LEO cycling, the water appears to be effectively electrolyzed out during the first few LEO cycles (Figure 24). Possibly, a chemical radical product during the electrolysis is an effective passive-layer stabilizer.

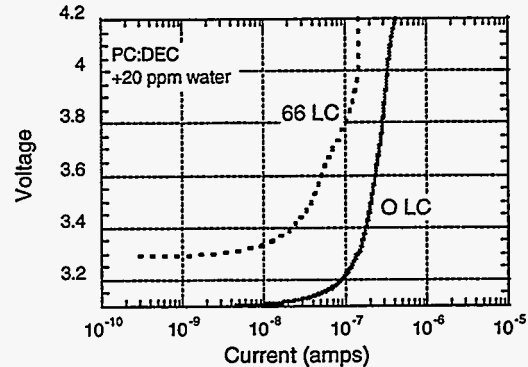
Figure 24. Anodic DC polarization response for Al alloy 1100 in PC:DEC electrolyte into which 20 ppm H_2O was initially added

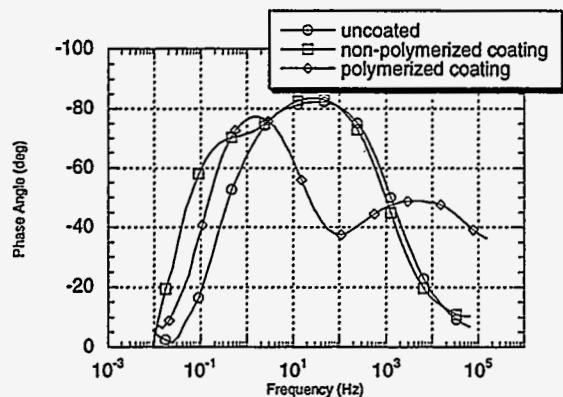
Figure 25. Bode phase plot for uncoated and coated aluminum electrodes

The effect of the two carbon-based coatings on the general electrochemical behavior of Al is depicted in the Bode phase plot shown in Figure 25. The uncoated electrode has a single dominant process (represented with a single capacitive/resistive combination and thus one pseudo-time constant), whereas the two coated electrodes show two processes: the non-polymerized with two overlapping time constants, and the polymerized with two distinct time constants. Modeling results for EIS data taken around LEO cycle 100 are shown separately in Figures 26-28 for a bare electrode and the two coated electrodes. The two lines in each plot demonstrate the favorable comparison between the modeling predictions and the actual data. The low frequency limit results indicate that pitting resistance can increase by close to one order of magnitude for coated electrodes. The higher resistivities for the coated electrodes implies that less corrosion should be present. This prediction is confirmed by the photograph presented in Figure 29 (compare with Figure 11 for uncoated Al). As shown in Figure 30, some interaction (swelling and delamination) did occur between the electrolyte and both coatings, yet protection

was still provided. As such, the ability to provide long-term protection is unknown. Although not confirmed with surface analysis, a possible reason that these coatings improve the corrosion resistance of aluminum is that much of the active pit area becomes sealed.

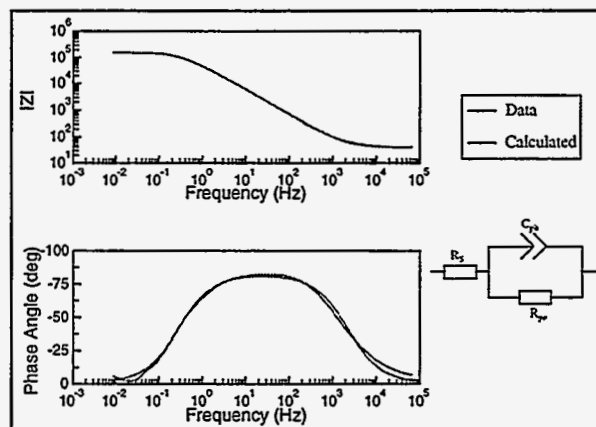
Figure 26. Bode plots for the uncoated aluminum electrode in the PC:DEC electrolyte.

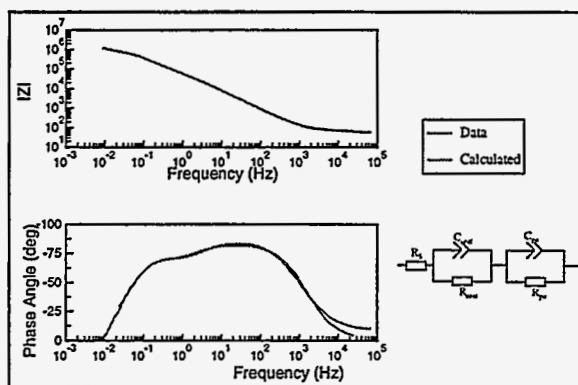
Figure 27. Bode plots for non-polymerized C-coated Al in PC:DEC electrolyte

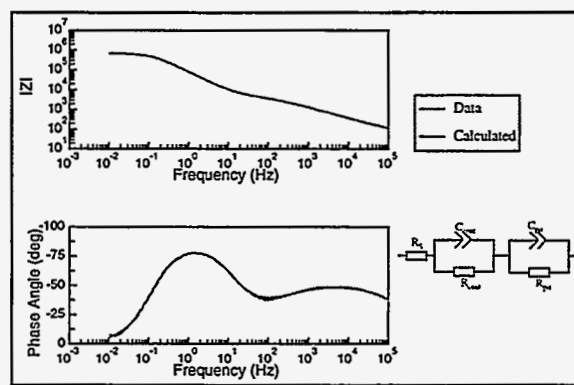
Figure 28. Bode plots for polymerized C-coated Al in the PC:DEC electrolyte

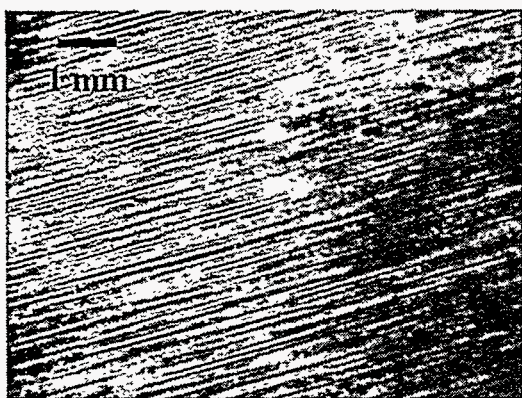
Figure 29. Al substrate after polymerized C coating removed after 445 cycles

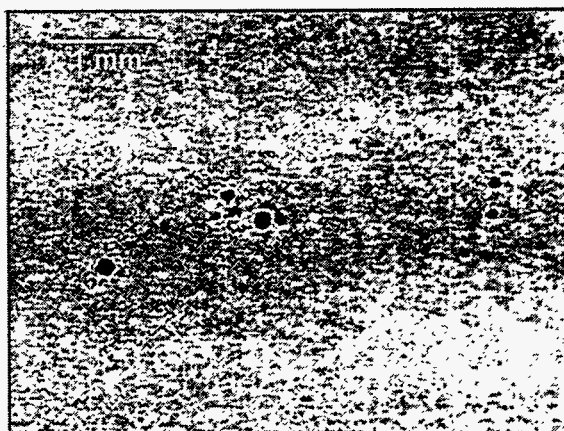
Figure 32. More detail of current collector shown in Figure 31

A practical validation of these results comes from a section of a positive electrode taken from a commercial Sony Li-Ion cell (1991 vintage) that had been subjected to about 4000 LEO cycles. Two representative photographs are shown in Figures 31 and 32. Significant localized pitting corrosion of the aluminum occurred to the point that the foil had a large number of visible perforations. Whether or not the holes were at some time mounds is presently unknown because of the difficult nature of removing the active materials without physical disruption of the surface. However, this does prove that the pitting process is not self-limiting. An assessment of the final resistivity of the foil has not been made to determine if the limited general corrosion had a significant effect on cell resistance. However, such a measurement would be meaningless without the corrosion products in place, a situation that cannot be ensured with extracted electrodes such as these.

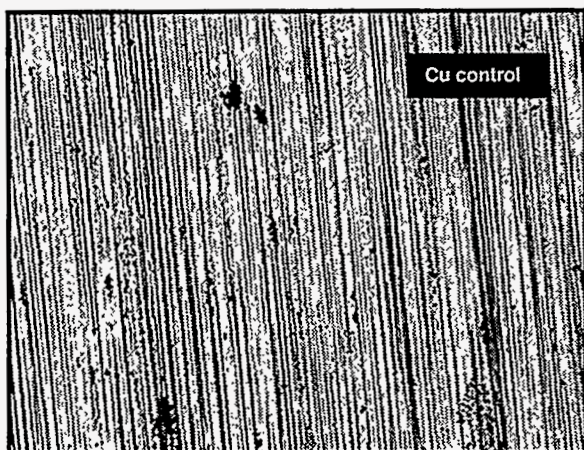
Figure 33. Photograph of the bare copper surface prior to LEO cycling

As expected and shown in Figures 33 and 34, copper is not attacked at the cathodic potentials associated with actual cells. That is, copper has an open circuit voltage in these electrolytes that is > 3 V vs. Li and the “applied” potential on the electrode ranges from about 0 V to ~ 1.5 V vs. Li. The conditions studied were similar to those described above for aluminum: baseline, initial water addition of 20 ppm, two carbon coatings, and temperature. As with aluminum, elevated temperature led to premature breakdown of the electrolyte. However, and probably due to the lower applied voltage, the onset of degradation was much longer (> 100 LEO cycles). Although not tested with aluminum, the EC:DMC formulation showed better high temperature longevity. Typical EIS results are shown in Figures 35 and 36. In general, no conditions were found that resulted in either uniform or localized attack of the copper. The presence of the two carbon coatings also had no effect.

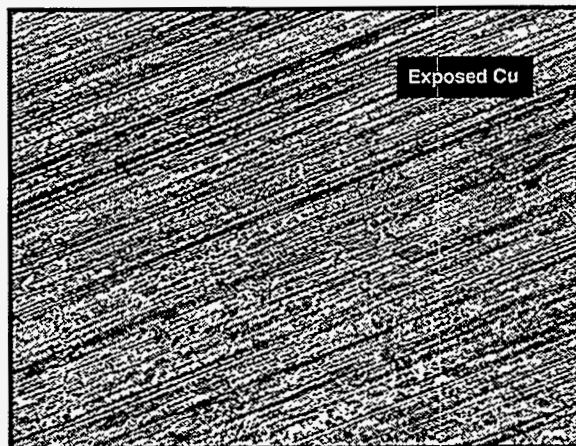
Figure 34. Photographs of the copper surface after 40 LEO cycles in PC:DEC electrolyte

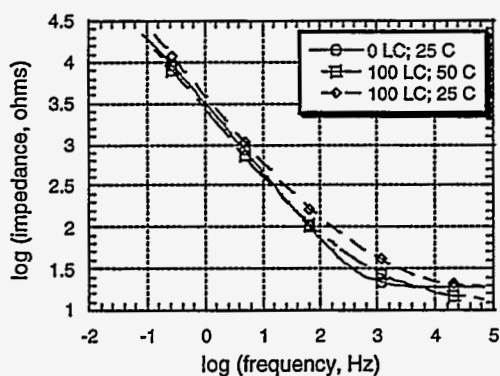
Figure 35. Effect of cycling on the Bode magnitude response for Cu alloy 110 cycled in PC:DEC electrolyte (cycling at 50 C; measurement temperature indicated)

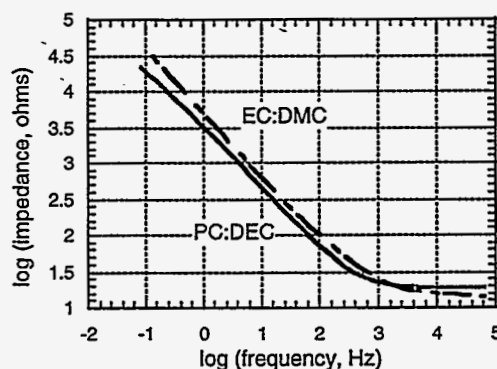
Figure 36. Comparison of Bode magnitude response for Cu alloy 110 in PC:DEC and EC:DMC electrolytes prior to LEO cycling

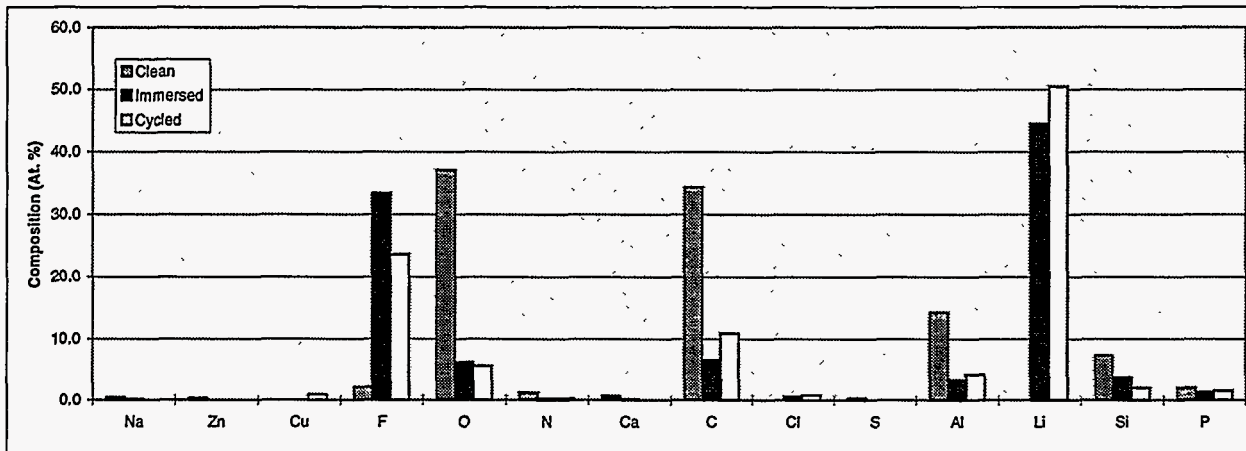
Figure 37. XPS results from analysis of uncoated aluminum exposed to the PC:DEC electrolyte. Composition is in atomic %. The cycled electrode experienced 212 LEO cycles.

Figure 37 (Al 1100) and Figure 38 (Cu 110) show the comparison of surface compositions for samples after initial electrode preparation and cleaning, after immersion in the PC:DEC formula electrolyte for 64 hours, and after completing LEO cycling (212 cycles for Al, 100 for Cu) in cells containing the PC:DEC formula electrolyte. There is very little difference observed for immersion in the electrolyte versus actually cycling the cell for either electrode material. Cycling the cell produces more Li and less F on the surface, relative to immersion in the electrolyte, while the surface concentrations of other species are essentially unchanged. For every copper sample, including those from cycled cells, the surface layers remain quite thin - well below the 150 Å maximum sampling depth of XPS (as evidenced by the presence of the underlying electrode metal). The situation regarding the thickness of the aluminum is not clear at this point. More aluminum exists in the air-formed oxide layer than in the samples exposed to the electrolytes. But, because the composition of Al is not affected by aging in these cell environments, either the thickness does not change or the composition of the layer is constant. More detailed sputter depth profiling must be performed to clarify this situation. Also, spurious contaminants can be observed after cell cycling, including Cu, Ni and Mn. Many of the differences observed for the samples after initial electrode preparation and cleaning may be attributed to the fact that these samples were not transferred into the XPS system through the glove bag, but were exposed to laboratory air prior to analysis. Very few differences are observed between the Al 1100 and Cu 110 electrode surfaces. Prior to placement in the cells, after initial electrode preparation and cleaning, the Al surface shows higher O and lower C, relative to the Cu surface. Immersion in the electrolyte produces much greater surface concentrations of Li and slightly lower concentrations of F, O, C and P for the Al surface, relative to the Cu surface. Cycling the cell removes most of the observed differences between the Al and Cu surface compositions.

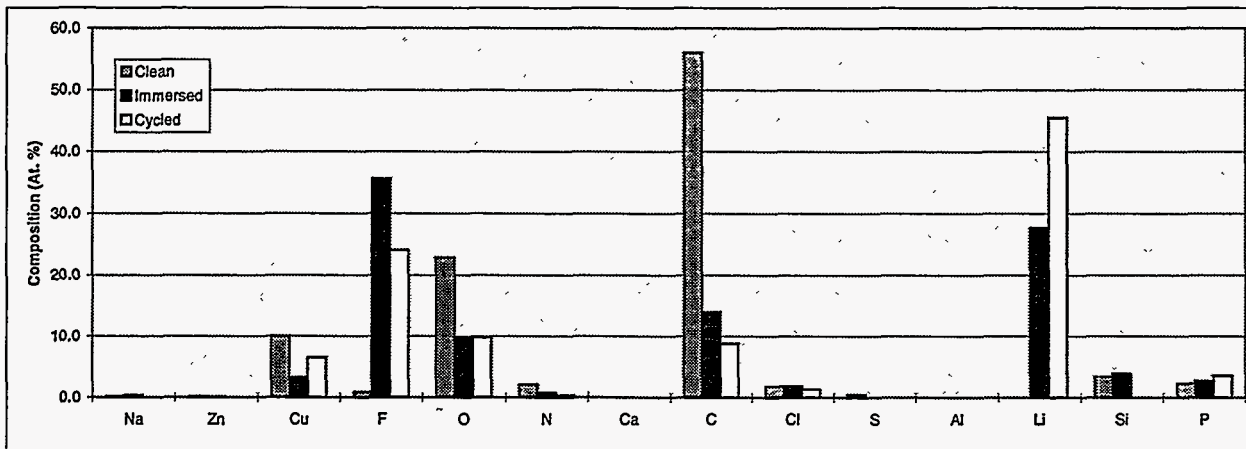
Figure 38. XPS results from analysis of uncoated copper exposed to the PC:DEC electrolyte. Composition is in atomic %. The cycled electrode experienced 100 LEO cycles.

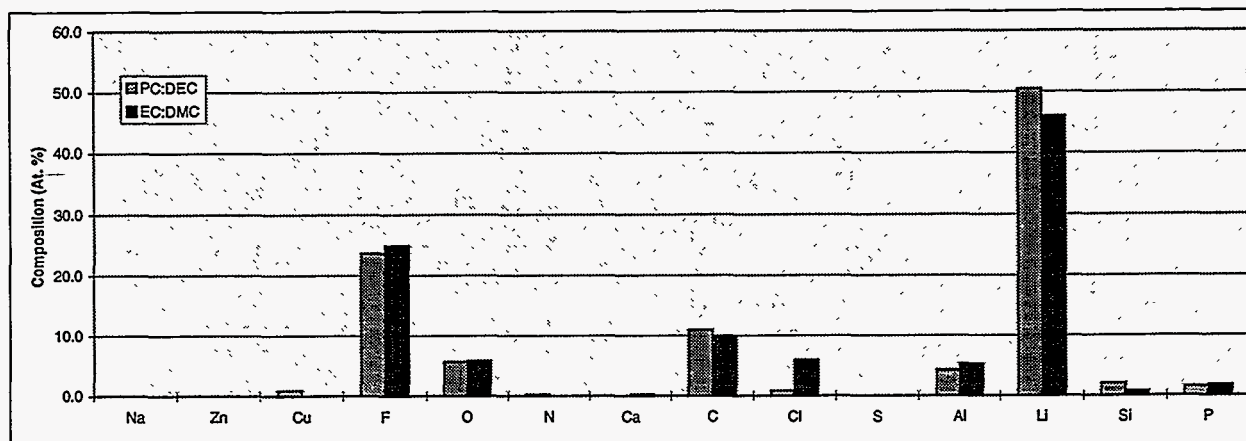
Figure 39. XPS results comparing the surface composition of aluminum after cycling in the PC:DEC electrolyte (212 cycles) and the EC:DMC electrolyte (150 cycles). Composition is in atomic %.

A comparison of surface compositions for Al 1100 electrodes after completion of a limited number of LEO cycles in cells containing the PC:DEC (212 cycles) versus the EC:DMC (150 cycles) electrolyte is shown in Figure 39. The surface of the Al electrodes are very similar when cycled in a cell containing either PC:DEC or EC:DMC formula electrolytes, suggesting that the common LiPF₆ electrolyte salt has the dominant effect. The primary difference observed is an increase in Cl (possibly B) in the EC:DMC formula electrolyte relative to the PC:DEC formula electrolyte.

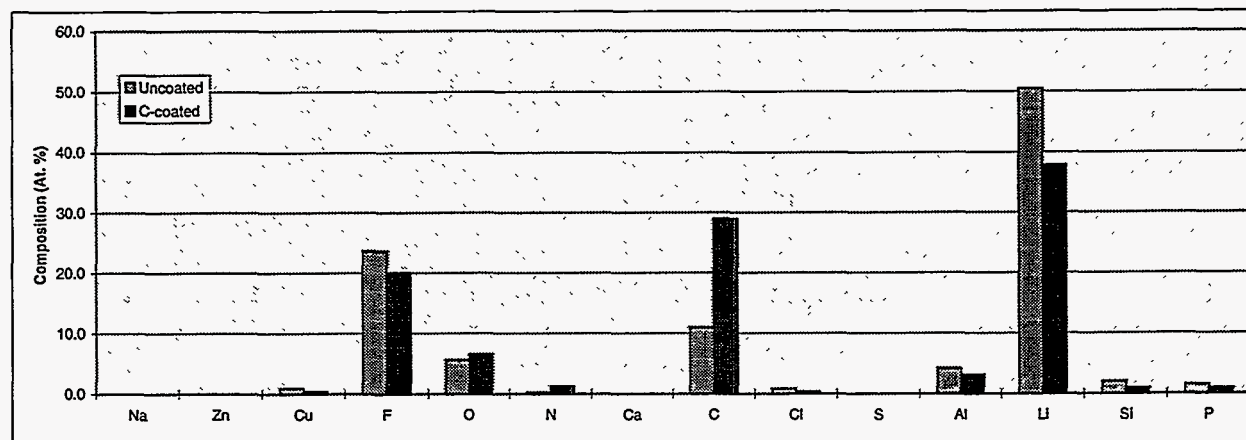
Figure 40. XPS results comparing the surface composition after cycling in the PC:DEC electrolyte of uncoated (212 cycles) and carbon-coated (115 cycles) aluminum. Composition in atomic %.

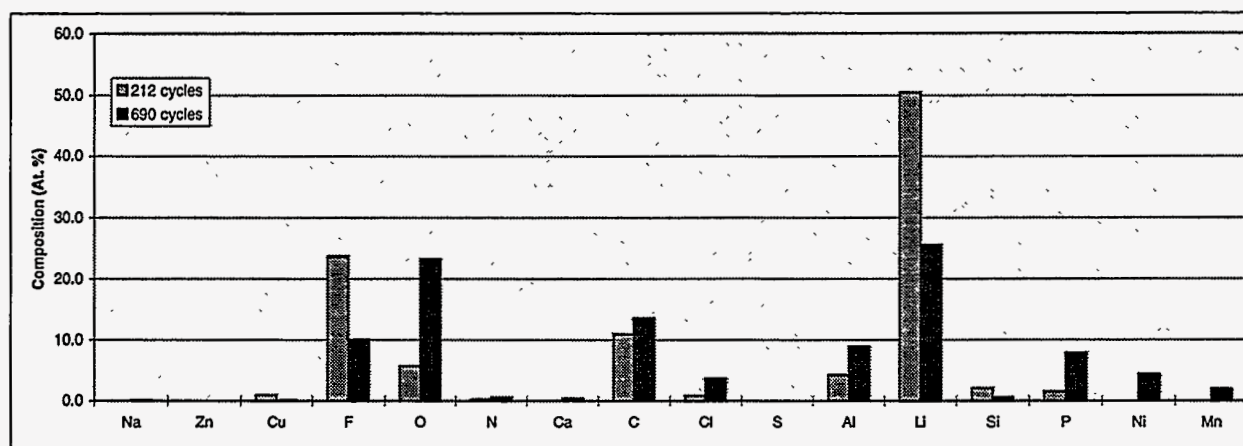
Figure 41. XPS results comparing the aluminum surface composition from short-term cycling (212 cycles) and long-term cycling (pitted - 690 cycles) in the PC:DEC electrolyte. Composition in atomic %.

Figure 41 shows the comparison of surface compositions for Al 1100 electrodes after completion of 212 and 690 LEO cycles in cells containing the PC:DEC formula electrolyte. The heavily pitted electrode (690 cycles) shows considerably less F and Li and considerably more O, Cl (B?), P and contaminants (Ni, Mn), relative to the unpitted electrode (212 cycles). The source of the contaminants is presently unclear.

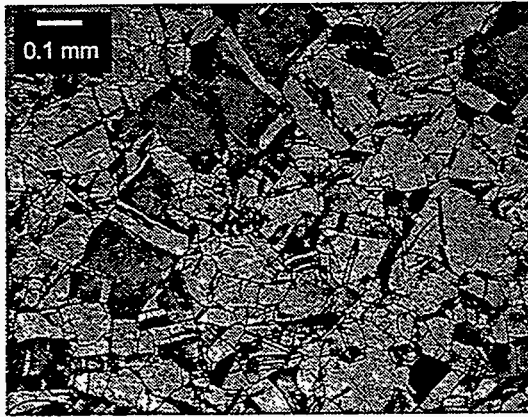
Figure 44. Optical photograph of transverse cross-sectioned copper tensile bar that did exhibit brittle behavior

specimens is shown in Figures 44-47 and the respective SEM fracture surfaces are shown in Figures 48 and 49. Interestingly, intergranular cracking occurred in the large grained material despite an unfavorable orientation of the grains (longitudinally elongation). This occurrence is probably possible because of the severe CERT conditions. Relative to internal stress, the degree of work hardening was similar: large-grained susceptible sample: 116 VHN; small-grained sample: 119 VHN. The conditions under which a susceptibility is evident are consistent with those observed for Ni in Li/SOCl₂ cells [1], implying that the Cu EAC phenomenon is mechanistically similar, that is, Li-induced EAC.

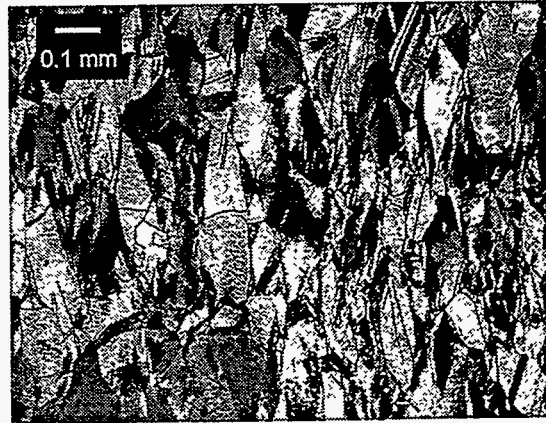
Figure 45. Optical photograph of longitudinal cross-sectioned copper tensile bar that did exhibit brittle behavior

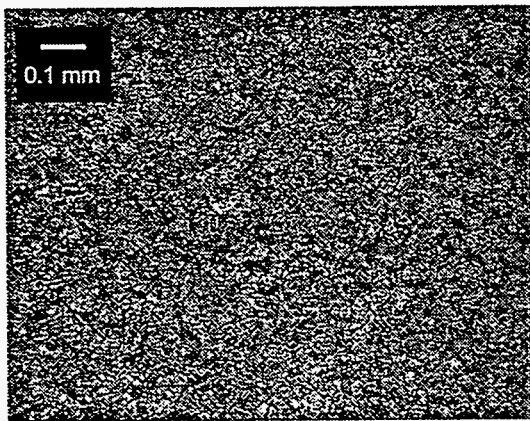
Figure 46. Optical photograph of transverse cross-sectioned copper tensile bar that did not exhibit brittle behavior

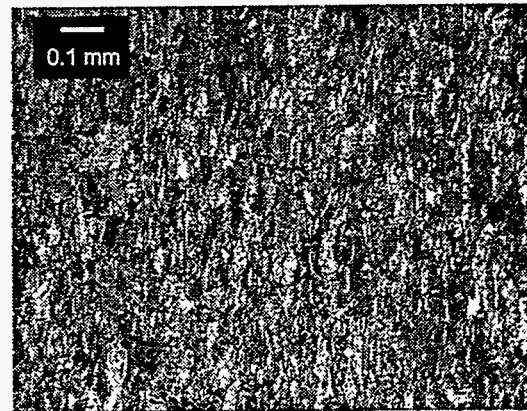
Figure 47. Optical photograph of longitudinal cross-sectioned copper tensile bar that did not exhibit brittle behavior

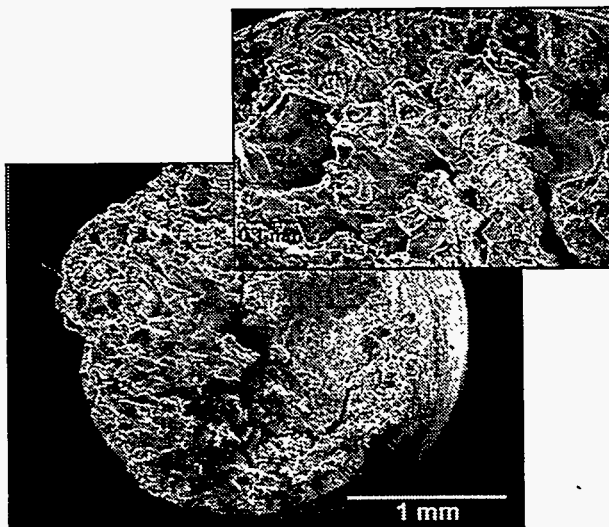
Figure 48. SEM photograph of the brittle fracture surface of coarse-grained, work-hardened copper

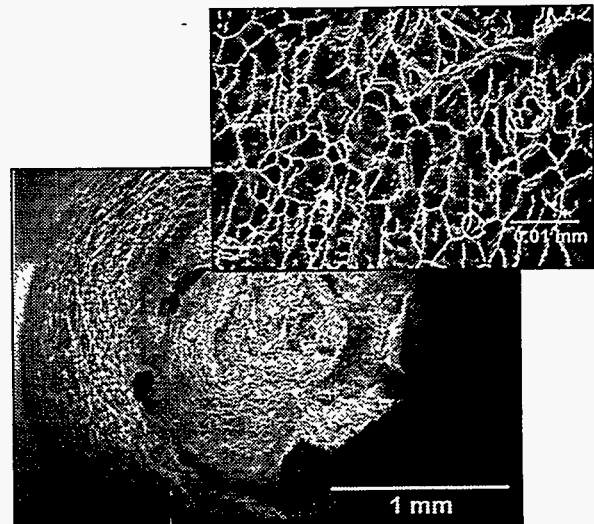
Figure 49. SEM photograph of the ductile fracture surface of fine-grained, work-hardened copper
