**TRANSIENT-OVERPOWER TEST E8 ON FFTF-TYPE
LOW-POWER-IRRADIATED FUEL**

**R. Simms, R. K. Lo, W. F. Murphy,
G. S. Stanford, and A. B. Rothman**

ARGONNE NATIONAL LABORATORY, ARGONNE, ILLINOIS

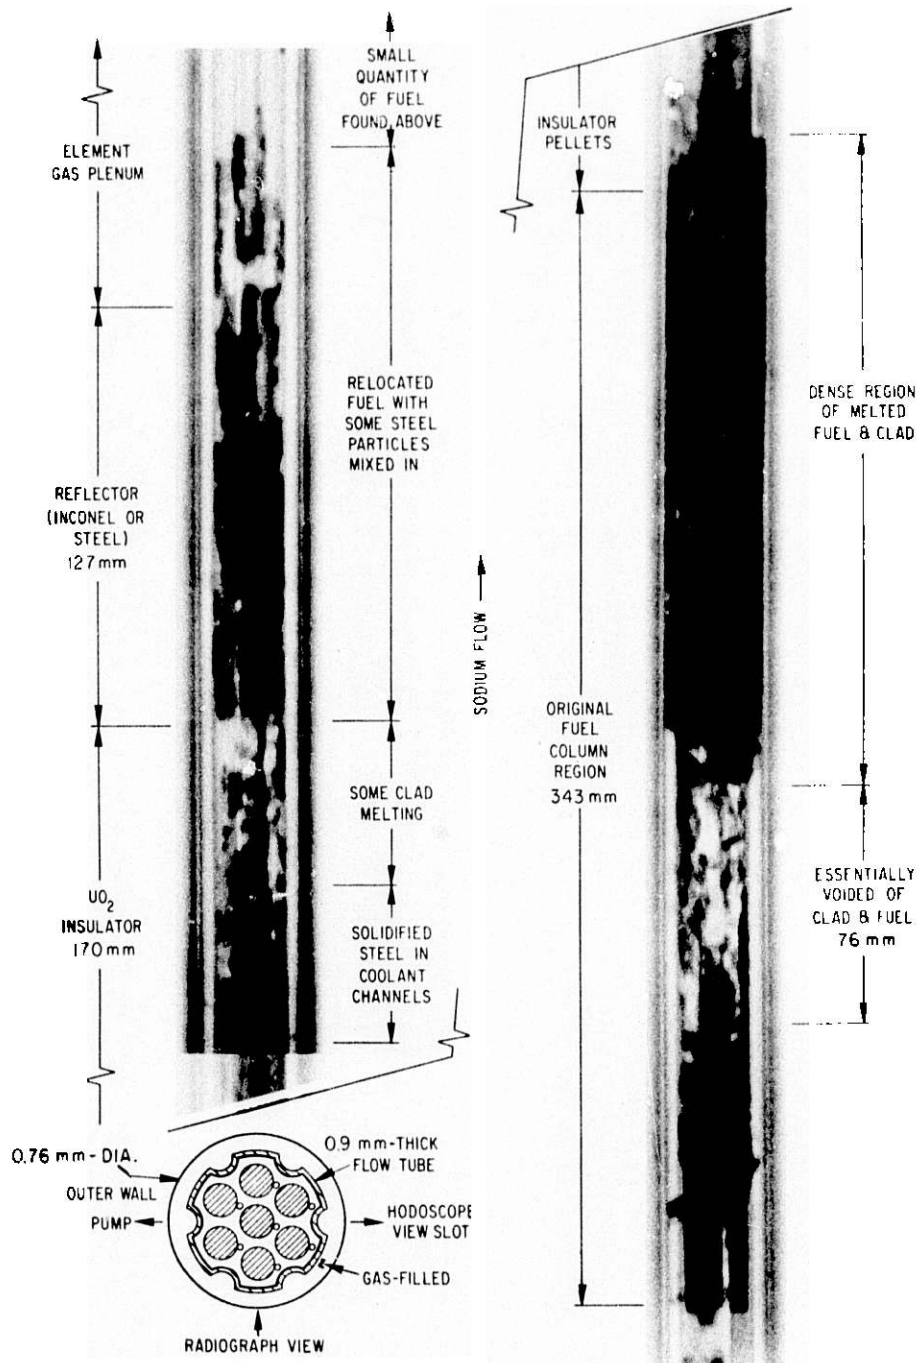
Fig. 2. Posttest Neutron Radiograph of Fuel-column Region of E8 Test Section. ANL Neg. No. 900-77-114.

From these examinations, the following observations can be drawn by reference to Fig. 2. The region from the midplane to 76 mm below was essentially free of either fuel or steel. The region from the midplane to the top of the original fuel column contained a mixture of failed fuel and steel. A steel barrier formed in some of the cooling channels just above the top of the fuel column. Fuel, with a little steel entrained, also solidified above this blockage in the region containing the fuel-element reflector pieces. The latter showed that the fuel did move above the top of the original fuel column, but that the reflector pieces and flow tube acted as a heat sink. Molten fuel had apparently entered the coolant channel before very much cladding had melted, consistent with the pressure-transducer signals indicating that the element failures had been abrupt. The results substantiate that a small degree of fuel sweepout is possible for an LMFBR, even at the reduced test flow velocities. The fuel-sweepout mechanism and resultant decrease in reactivity has been postulated⁴ as the means to terminate hypothetical overpower LMFBR accidents. Tests with higher coolant flow rates are currently being planned.

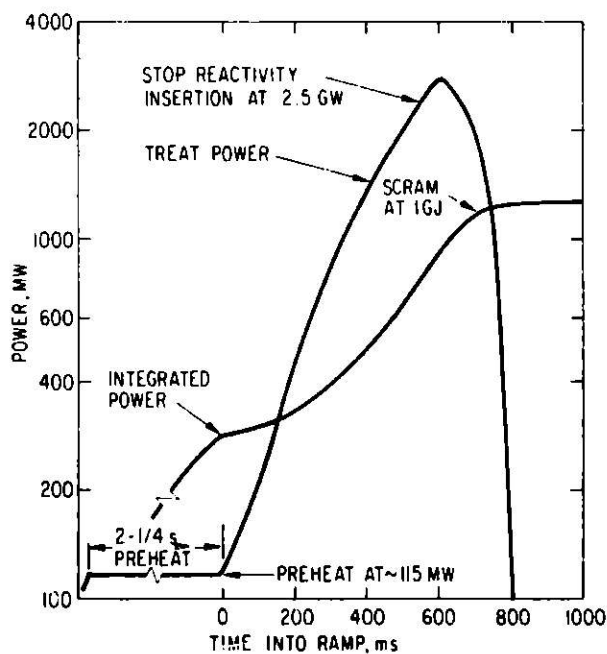
Fig. 6. Desired E8 Transient. ANL
Neg. No. 900-77-17.

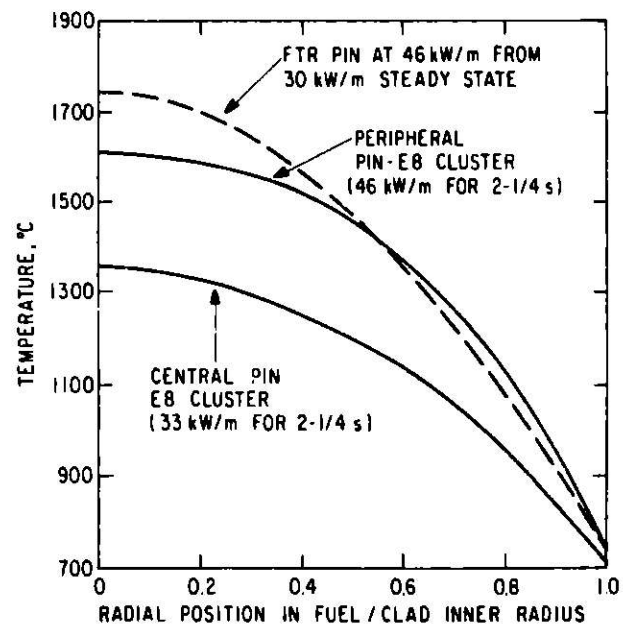
Fig. 7. Radial Temperature Profile Calculated for E8 Cluster Relative to FTR at Start of TREAT Ramp. ANL Neg. No. 900-77-46 Rev. 1.

point, COBRA calculations indicated that the stored enthalpy for the FTR at 46 kW/m (on a ramp from steady-state operation at 30 kW/m*) will equal the energy stored in the E8 element with the highest calibration factor. In other words, the TREAT transient catches up to the FTR ramp at 46 kW/m, the level of loading for the test element during the TREAT preheat. A further refinement in the modeling for simulating the accident conditions at the end of a preheat within the test region is probably not warranted when all the experimental uncertainties are considered.

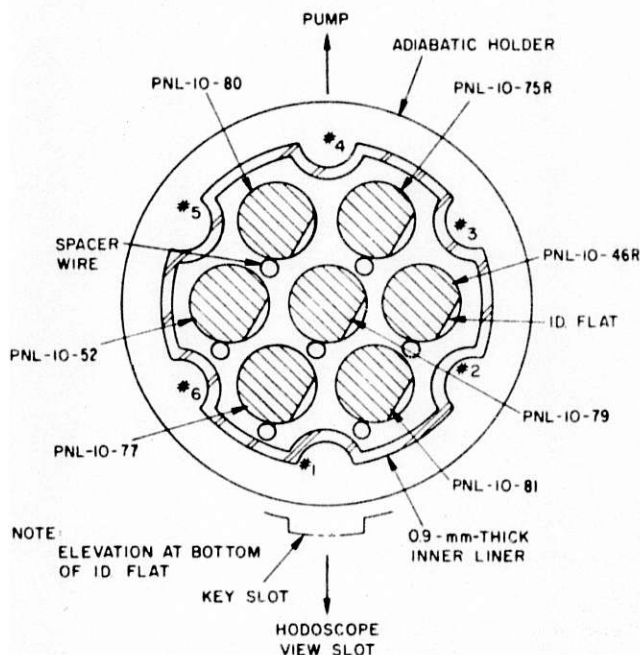
Fig. 9. Fuel-element Arrangement for E8 Calibration Test Showing Cross-sectional View at Elevation of Identification Flat (Looking down). ANL Neg. No. 900-3425 Rev. 3.

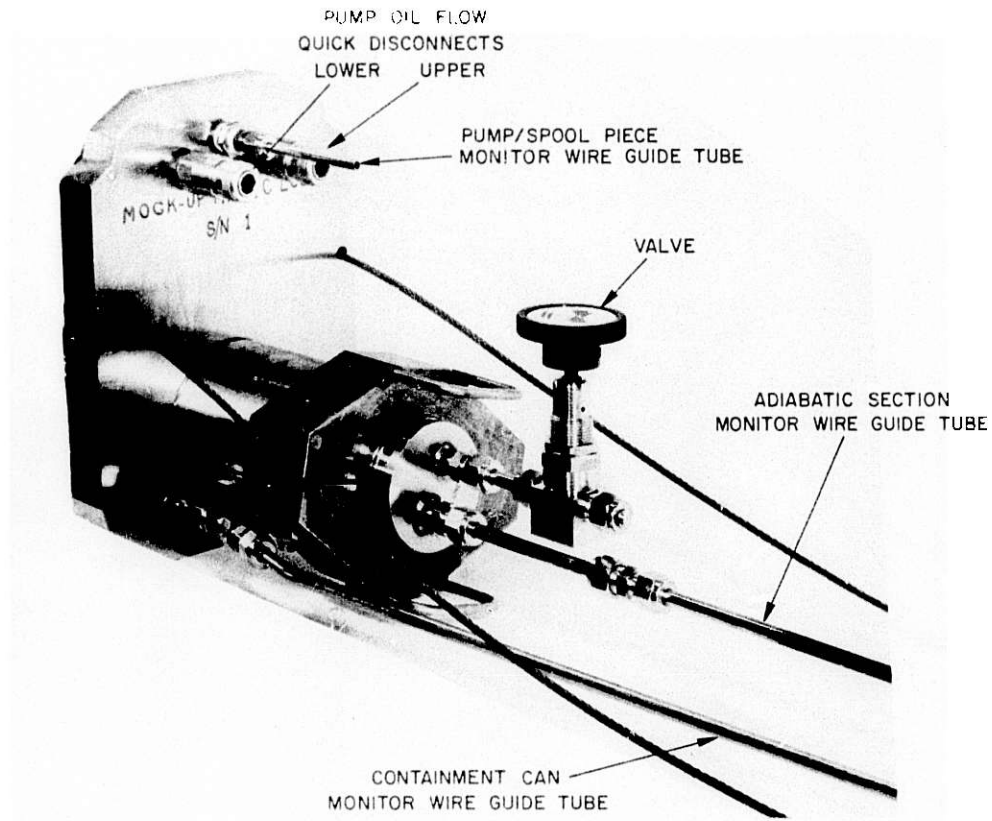
Fig. 10. Identification of Equipment Penetrating Upper Plate of E8 Mockup Loop and Test Train. ANL Neg. No. 900-3374.

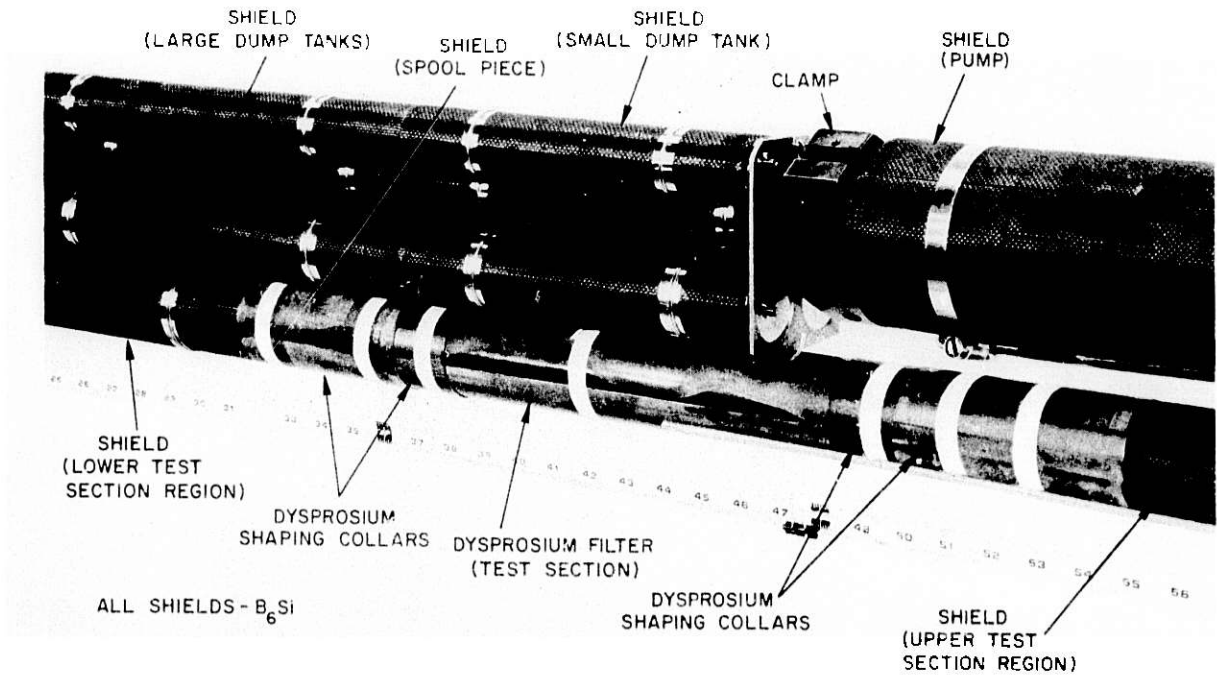
Fig. 11. Location of Filters, Shields, and Shaping Collars on E8 Calibration Loop. ANL Neg. No. 900-3375A.

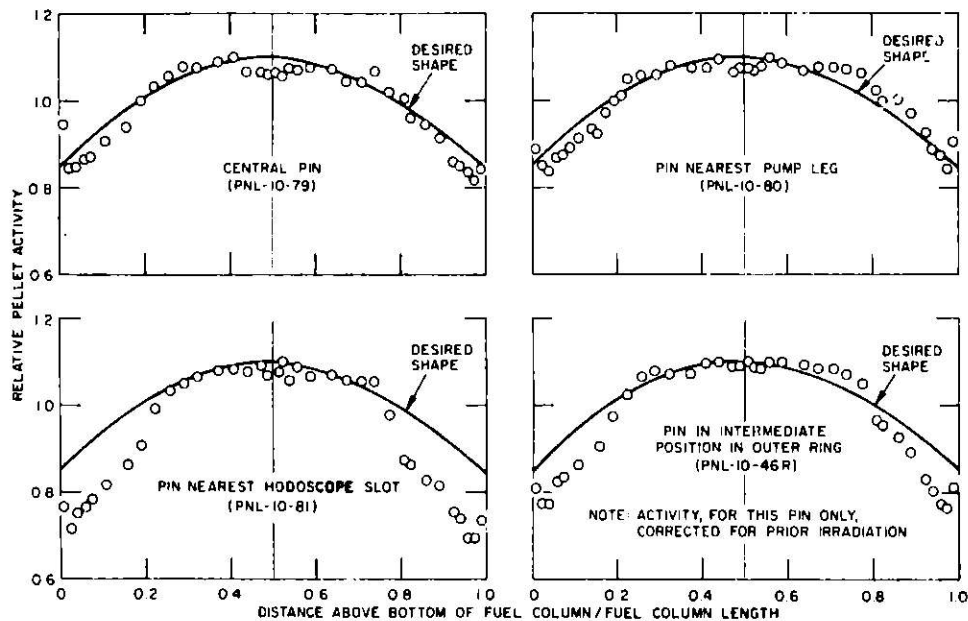
Fig. 12. Axial Power Profiles for Elements in E8 Calibration Test, ANL Neg. No. 900-3942 Rev. 1.

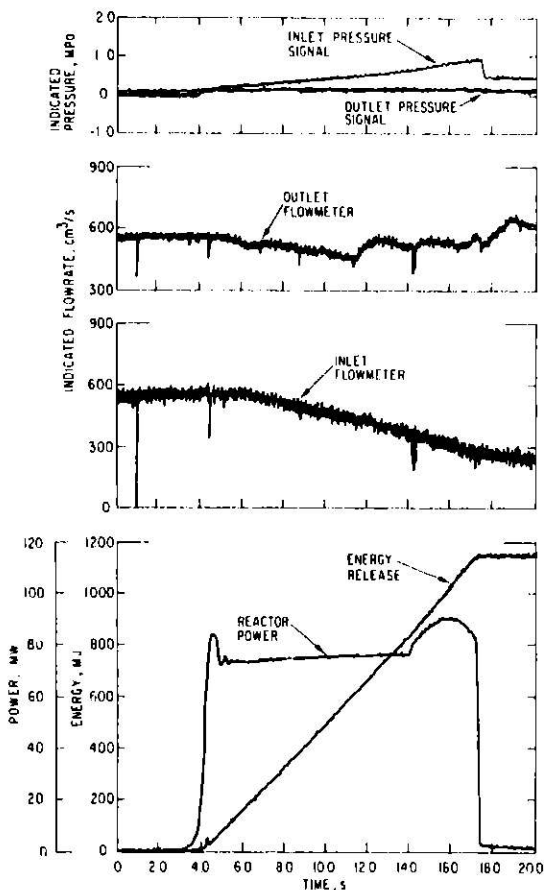
Fig. 13. Reactor Power, Test-region Flow, and Pressure Signals for Heat-balance Test E8-1. ANL Neg. No. 900-77-36.

(that at the inlet) responded significantly to the radiation and thermal environment at its location, since no pressure changes in the loop should have occurred. Similar observations were made in other Mark-II loop tests. Subsequent study of this phenomenon has identified the problem as the radiation response of the cables with the electronic circuitry used. The output signal from the lower transducer failed to return to its initial value of zero during the data-recording period of 2 min (120 s). The outlet (upper) transducer was nearly unaffected by the transient.

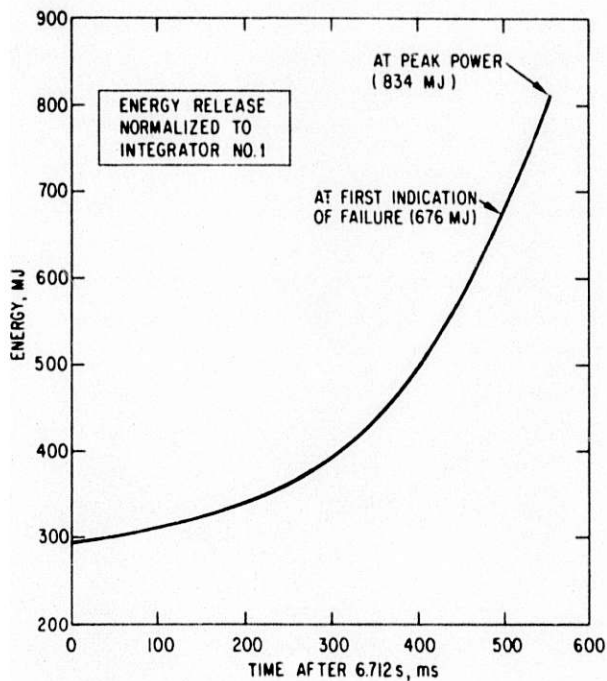
Fig. 15. TREAT Energy Release as a Function of Time into Burst. ANL Neg. No. 900-77-19 Rev. 1.

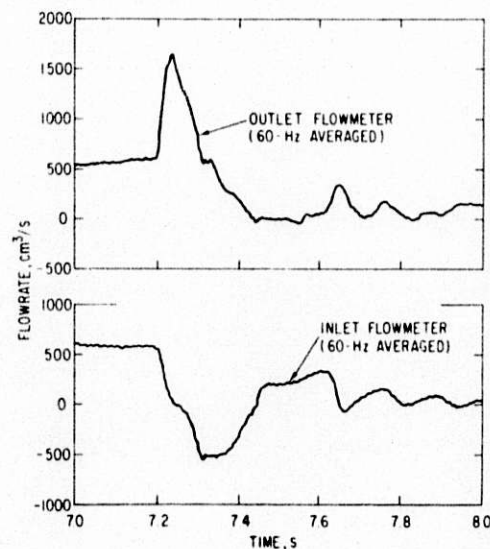
Fig. 17. Flowmeter Signals for E8-2. ANL Neg. No. 900-77-28.

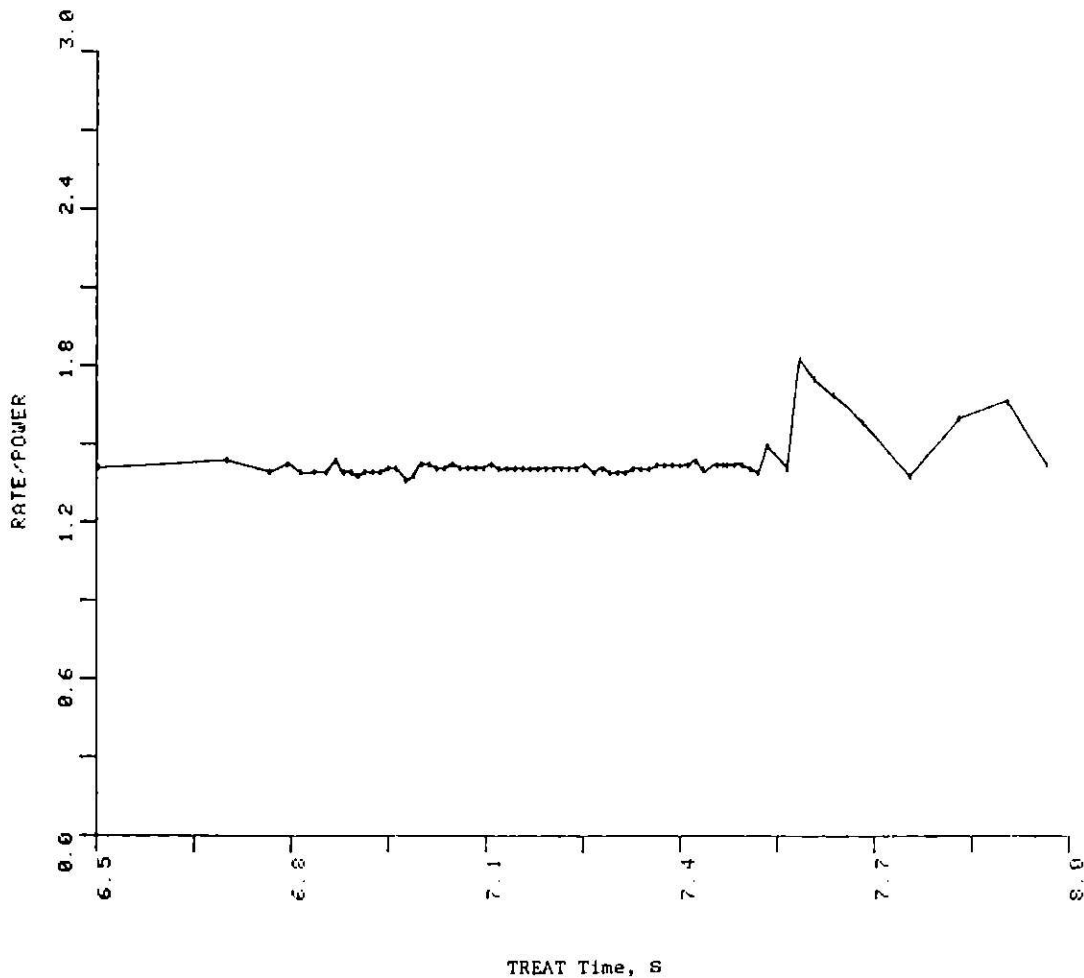
Fig. 19. Ratio of Array Average to Power Monitor for Test E5 Hodoscope Data

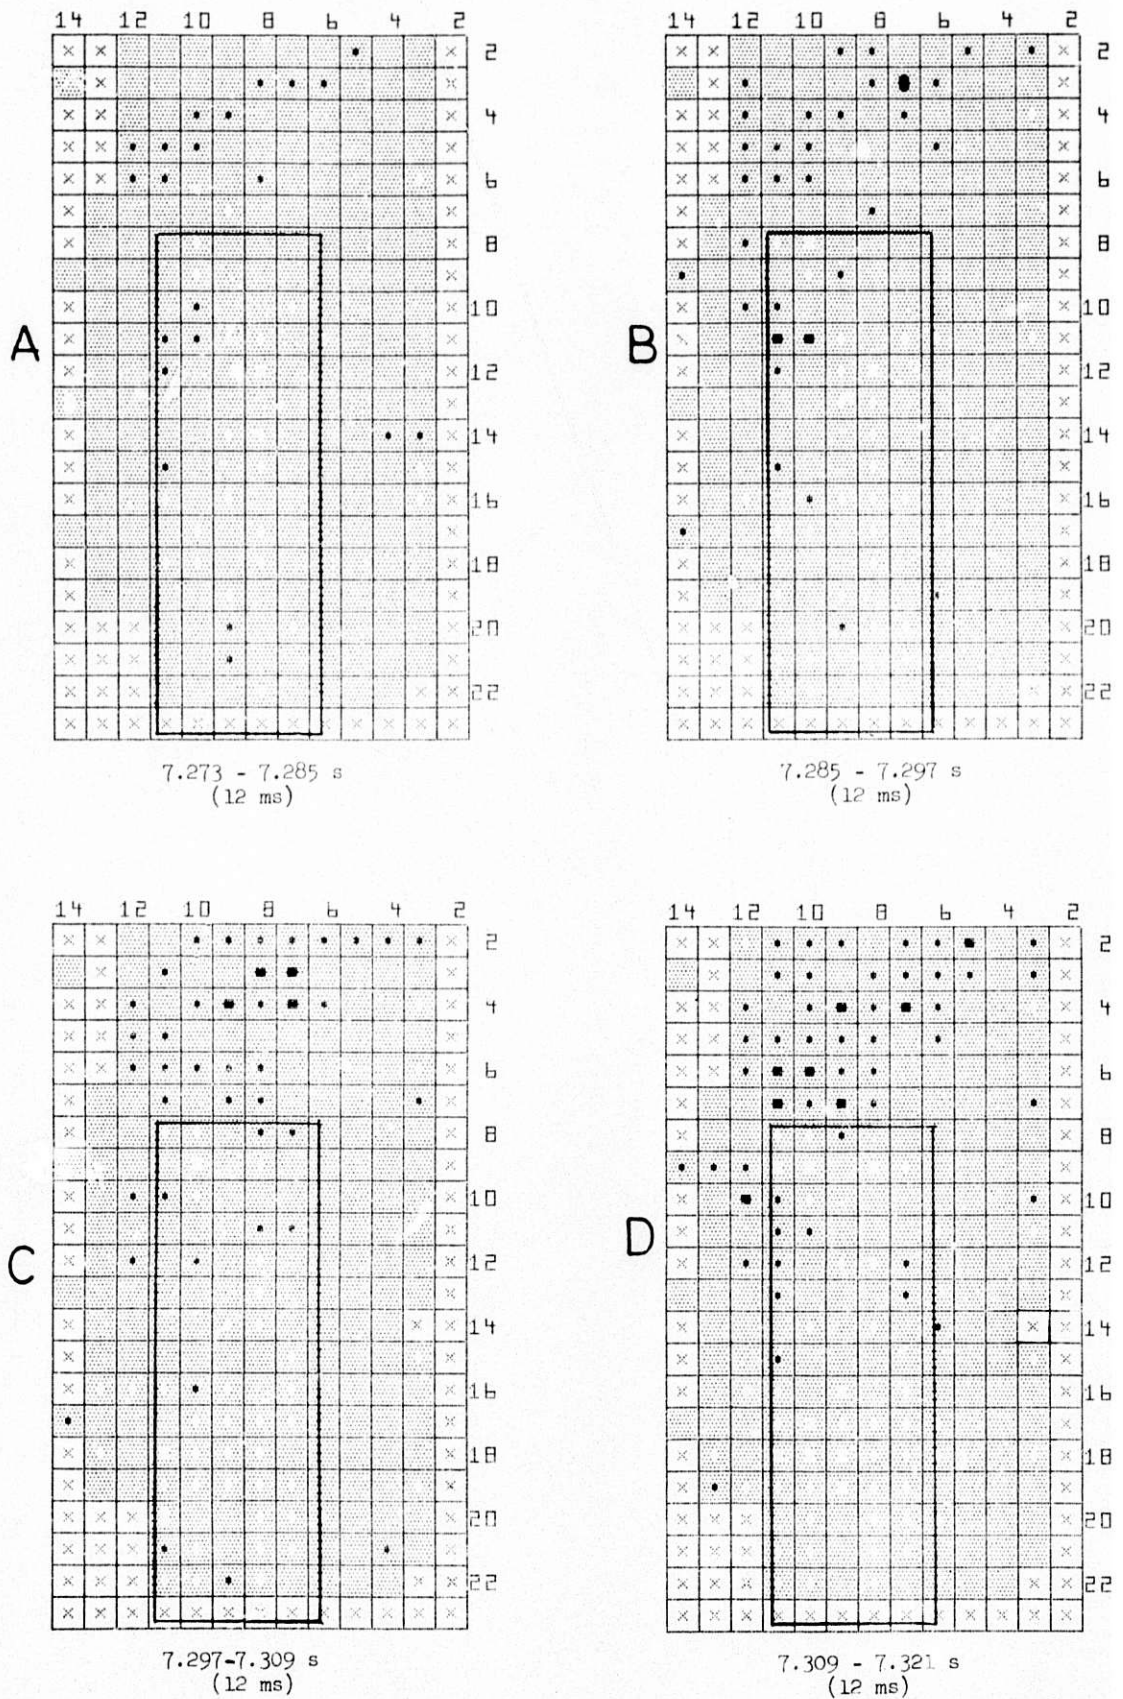
Fig. 25. Differential Hodographs for E8 in Time Interval 7.273-7.321 s, Referenced to Interval 7.261-7.273 s (12 ms). Scale maximum, 4.5 g fuel. See Fig. 20 for key.

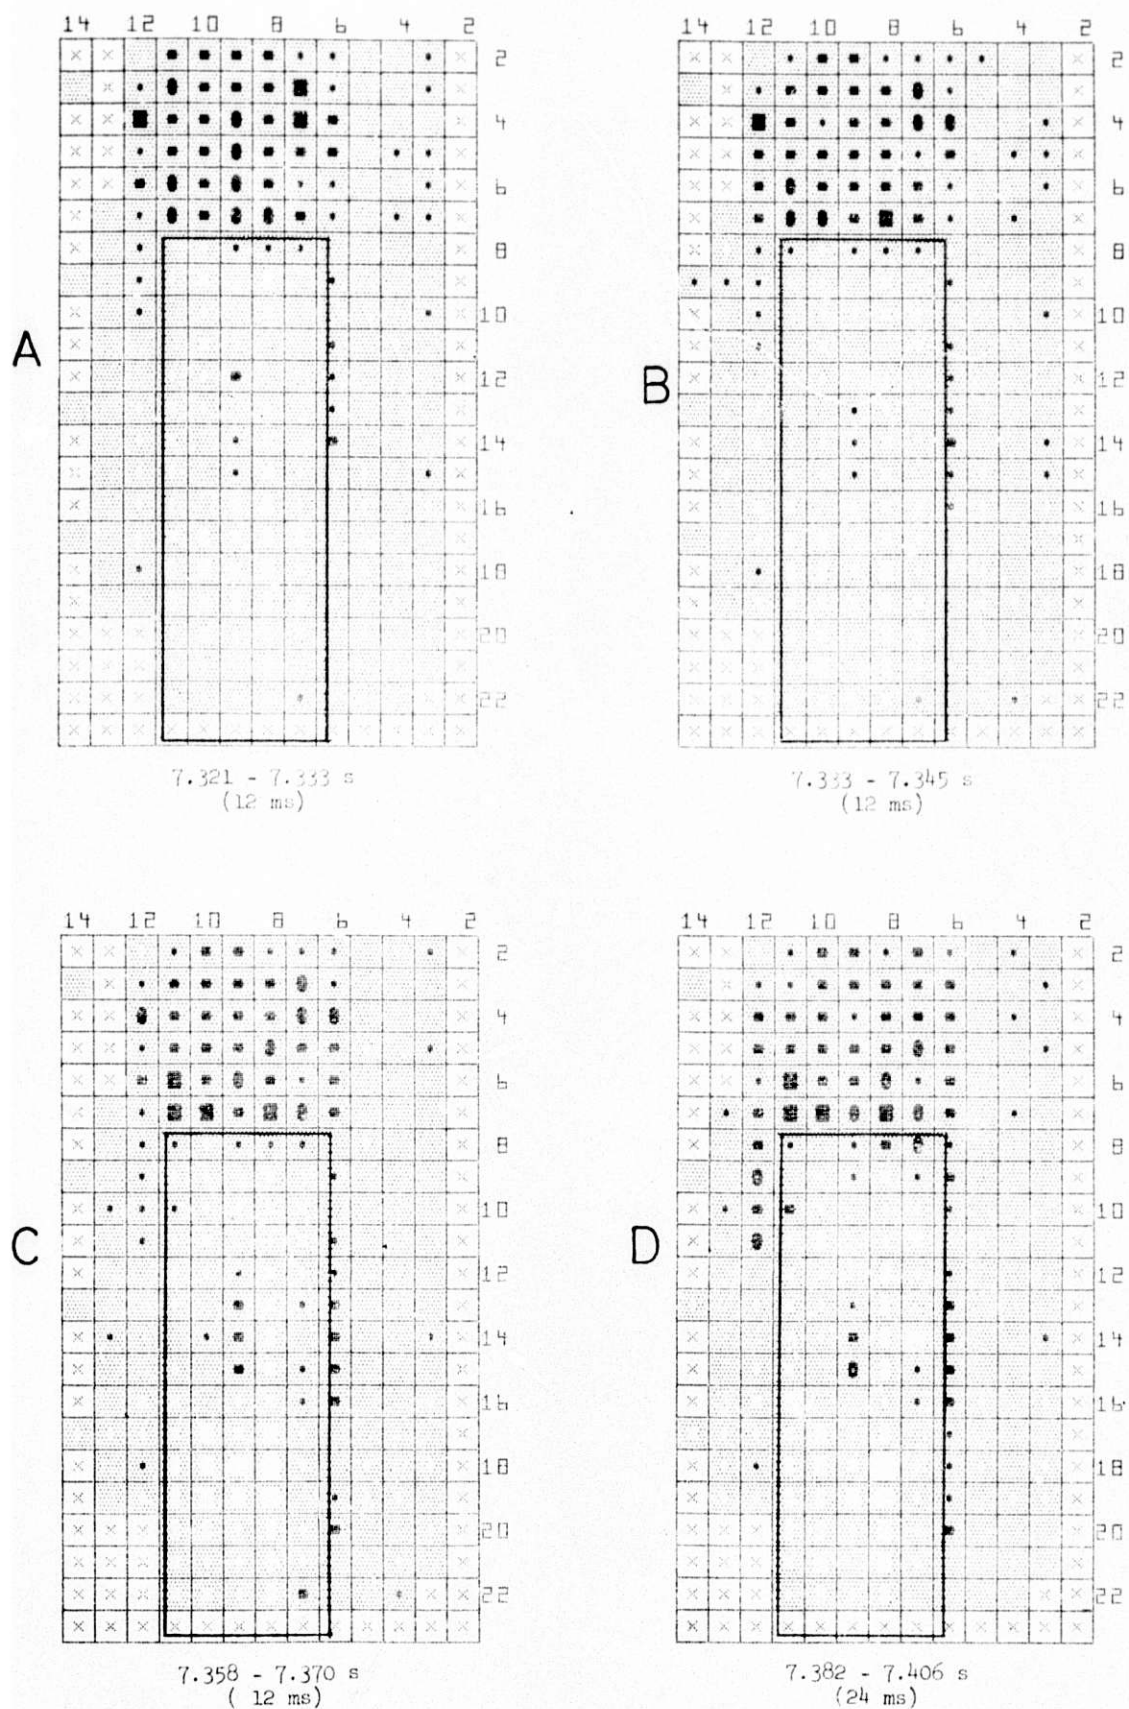
Fig. 26. Differential Hodographs for E8 in Time Interval 7.321-7.406 s, Referenced to Preheat Plateau (4.53-6.65 s). Scale maximum, 4.5 g fuel. See Fig. 20 for key.

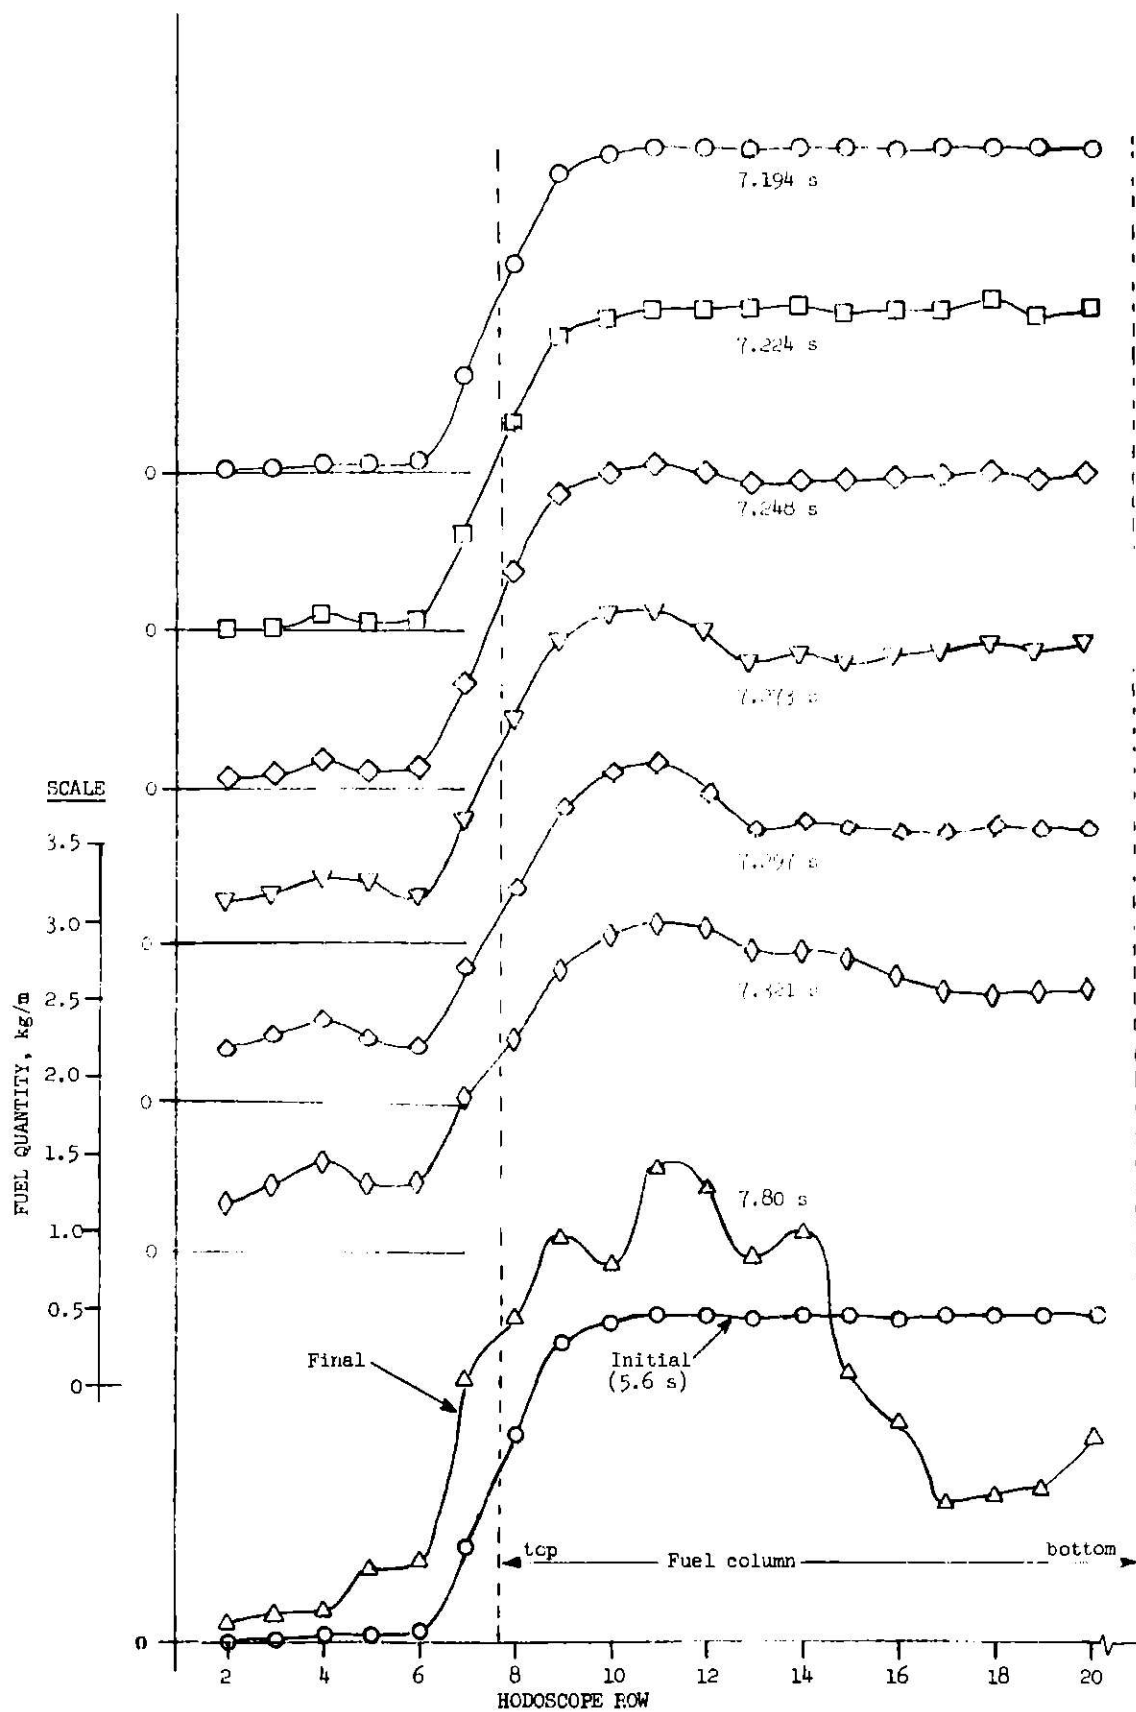
Fig. 28. Selected Axial Profiles of Fuel Distribution in Transient E8

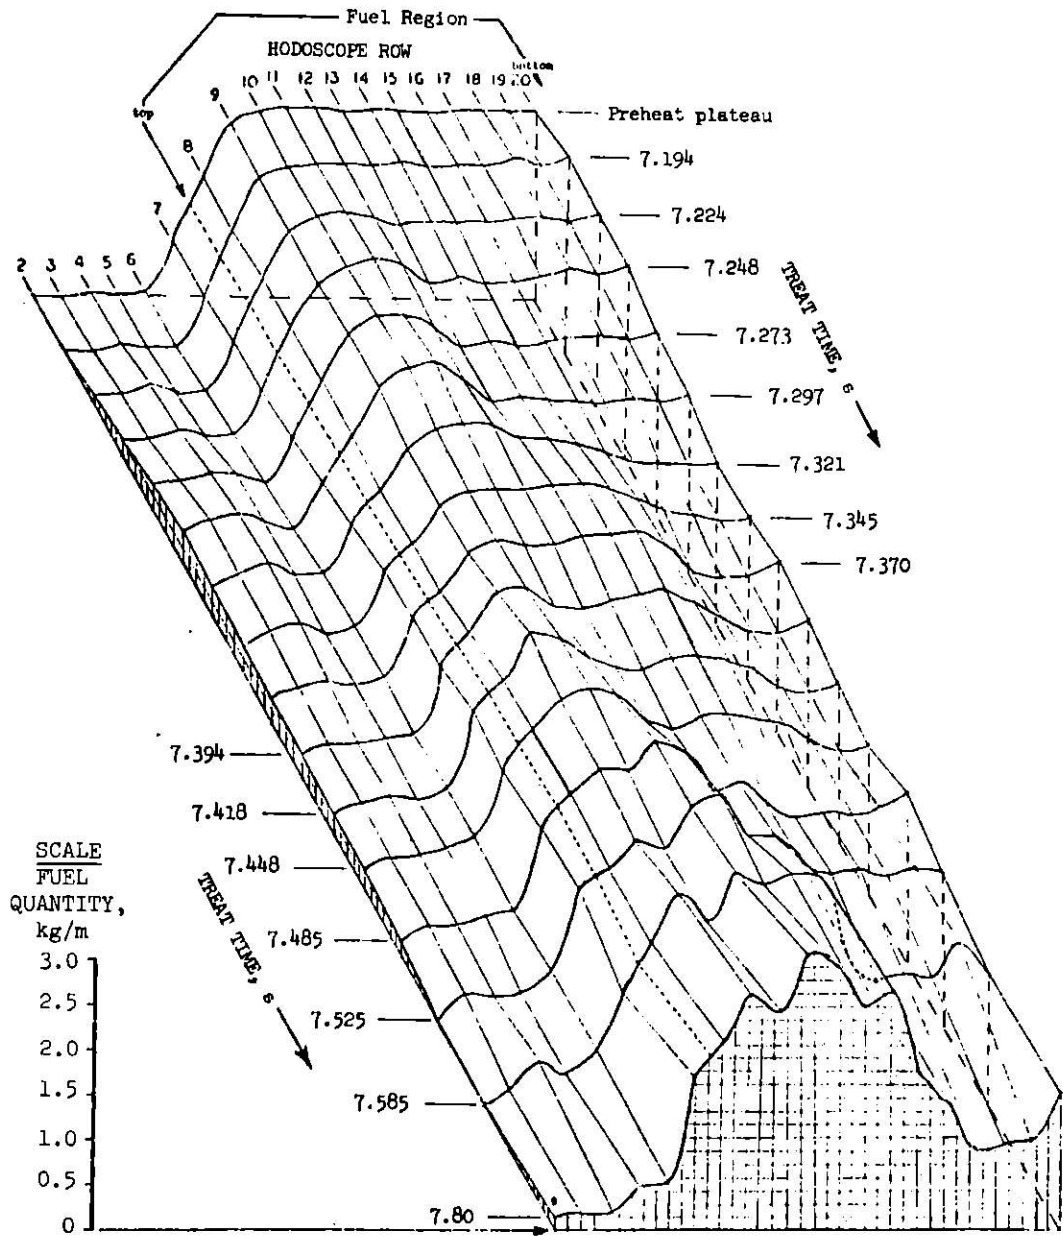
Fig. 29. Axial Fuel-quantity Profiles in Transient E8

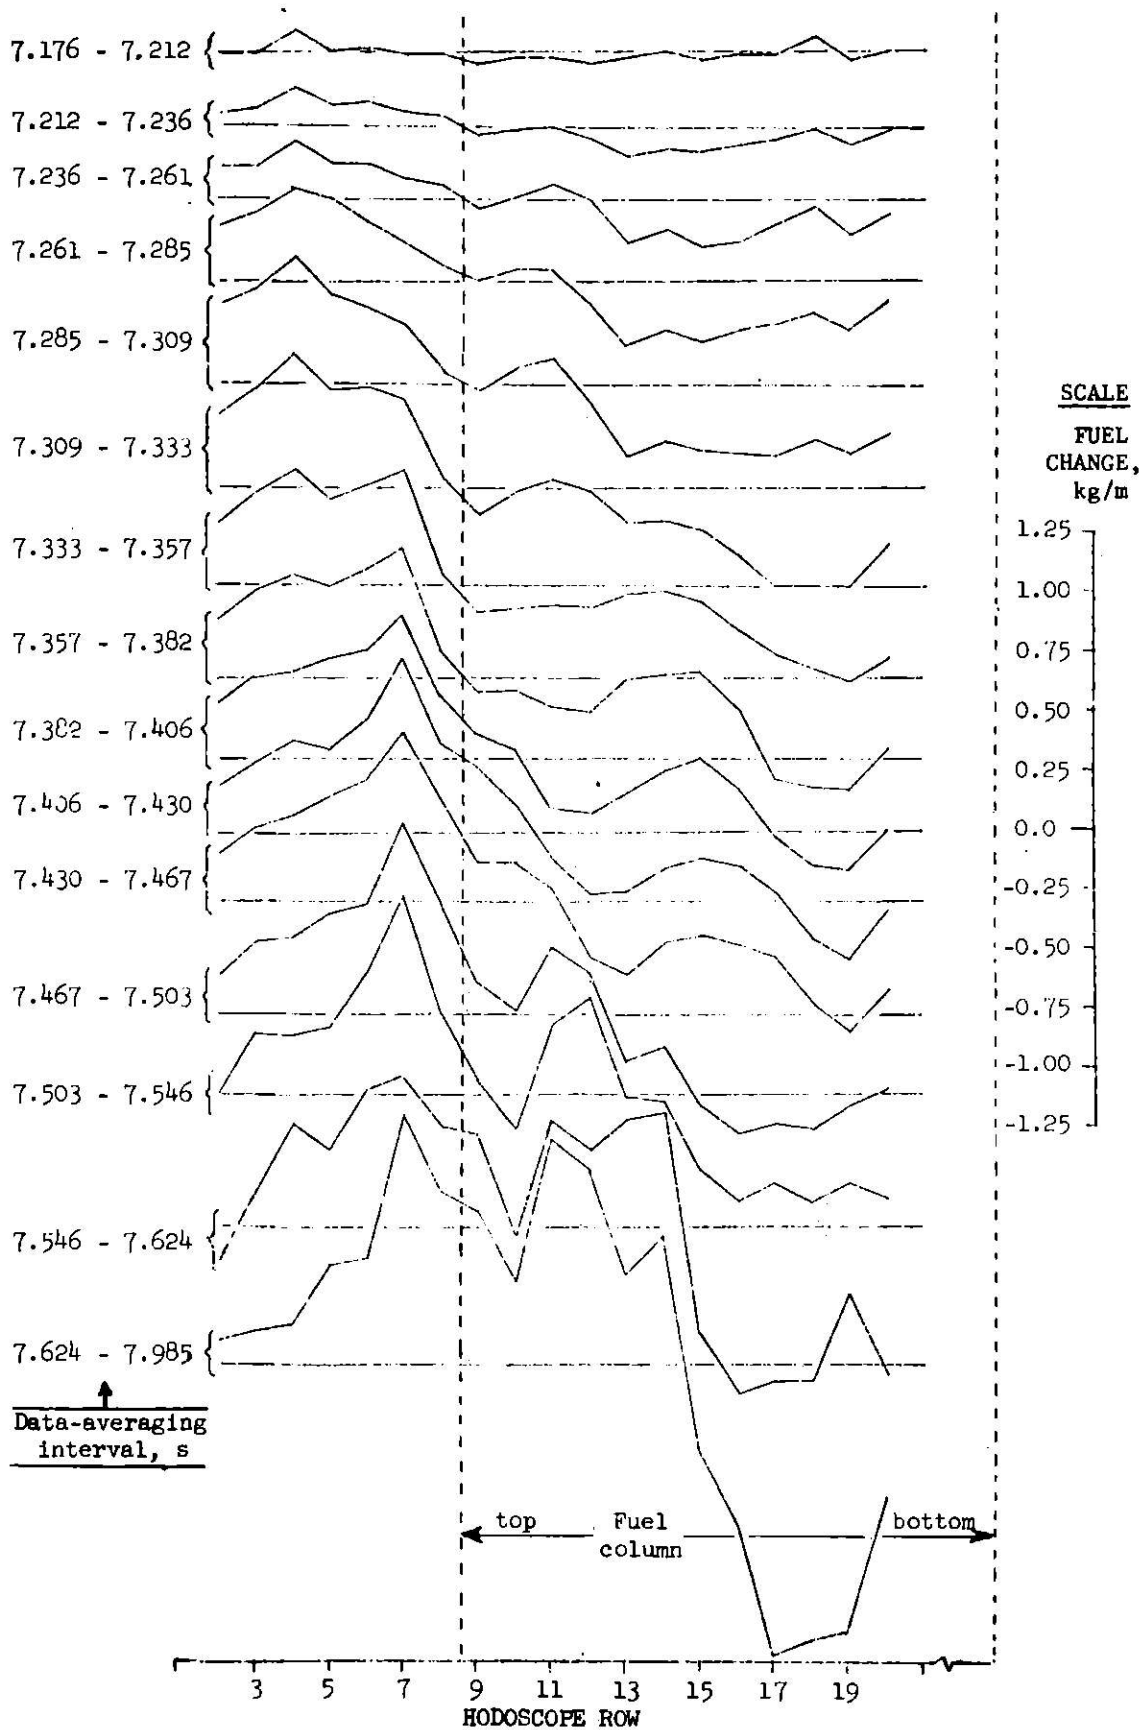
Fig. 30. Axial Profiles of Fuel-quantity Changes in Transient E8

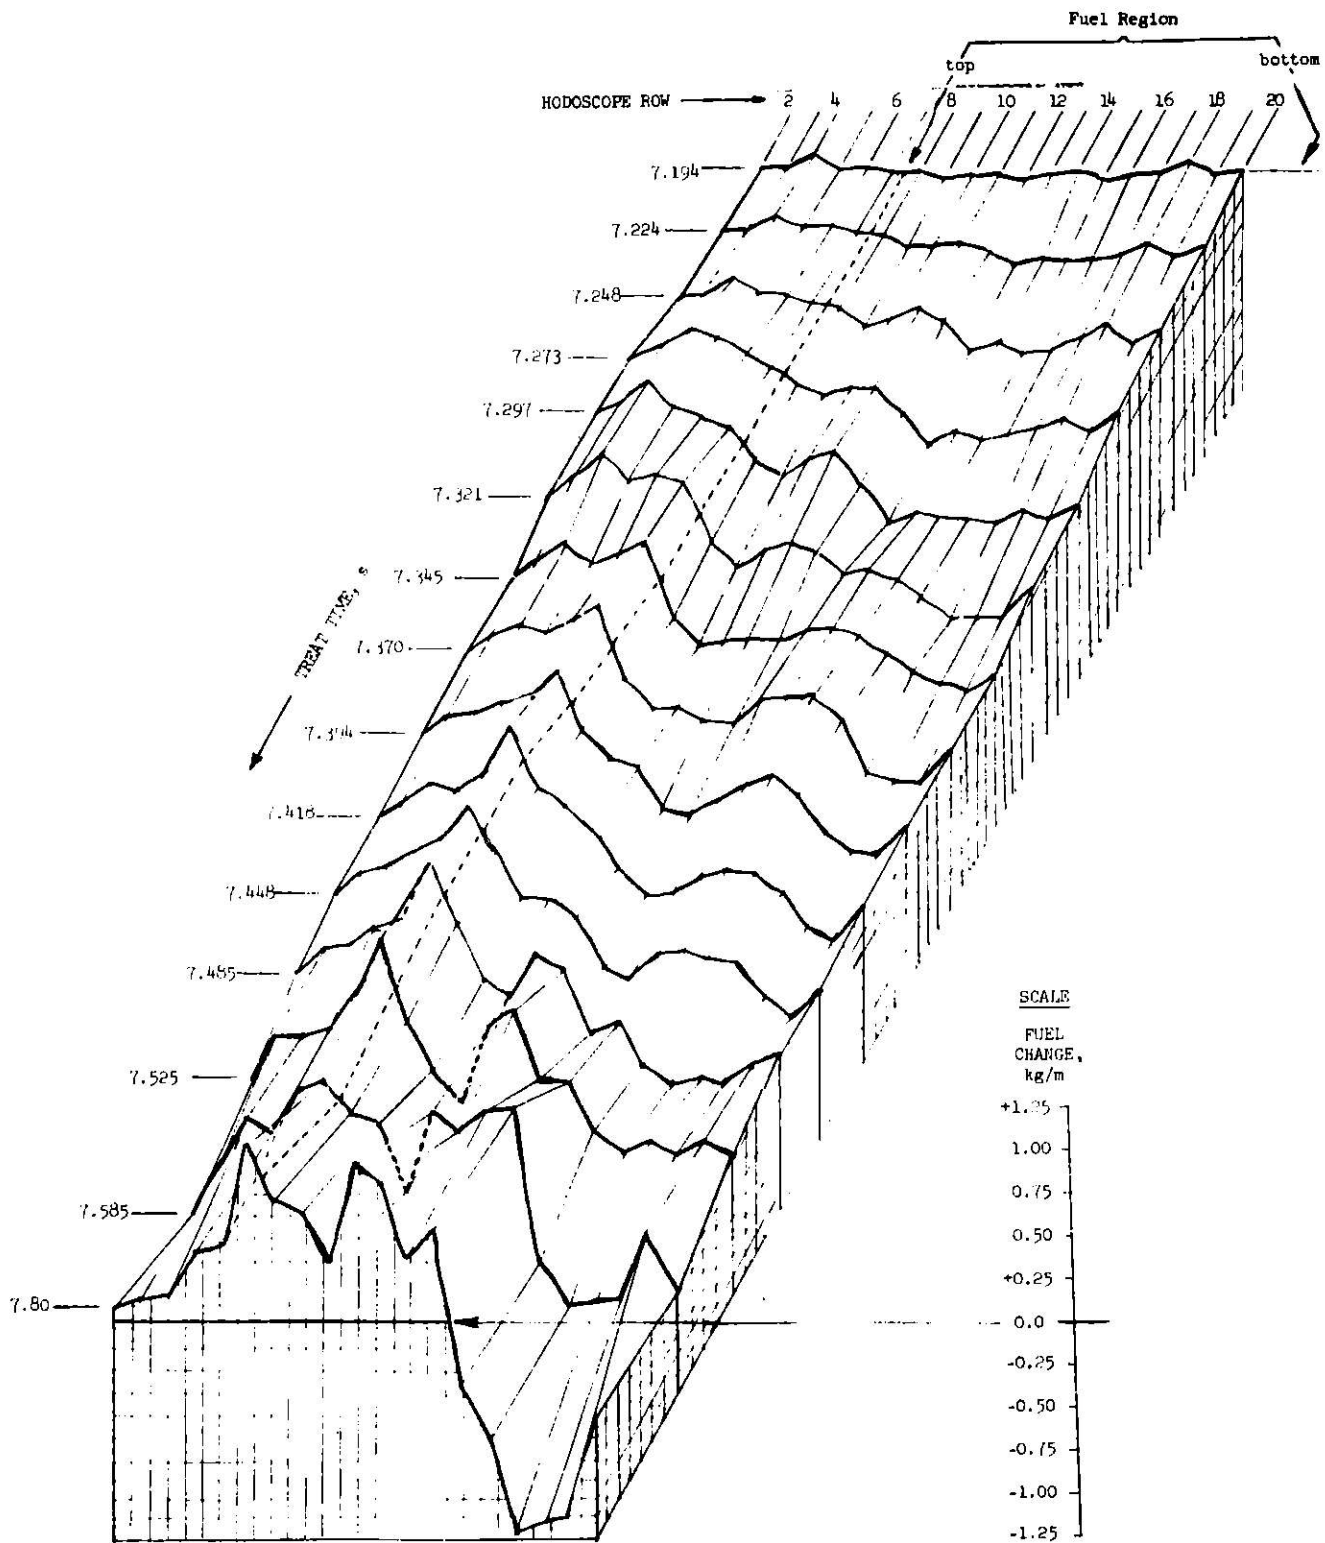
Fig. 31. Changes in Axial Distribution of Test Fuel in Transient E8

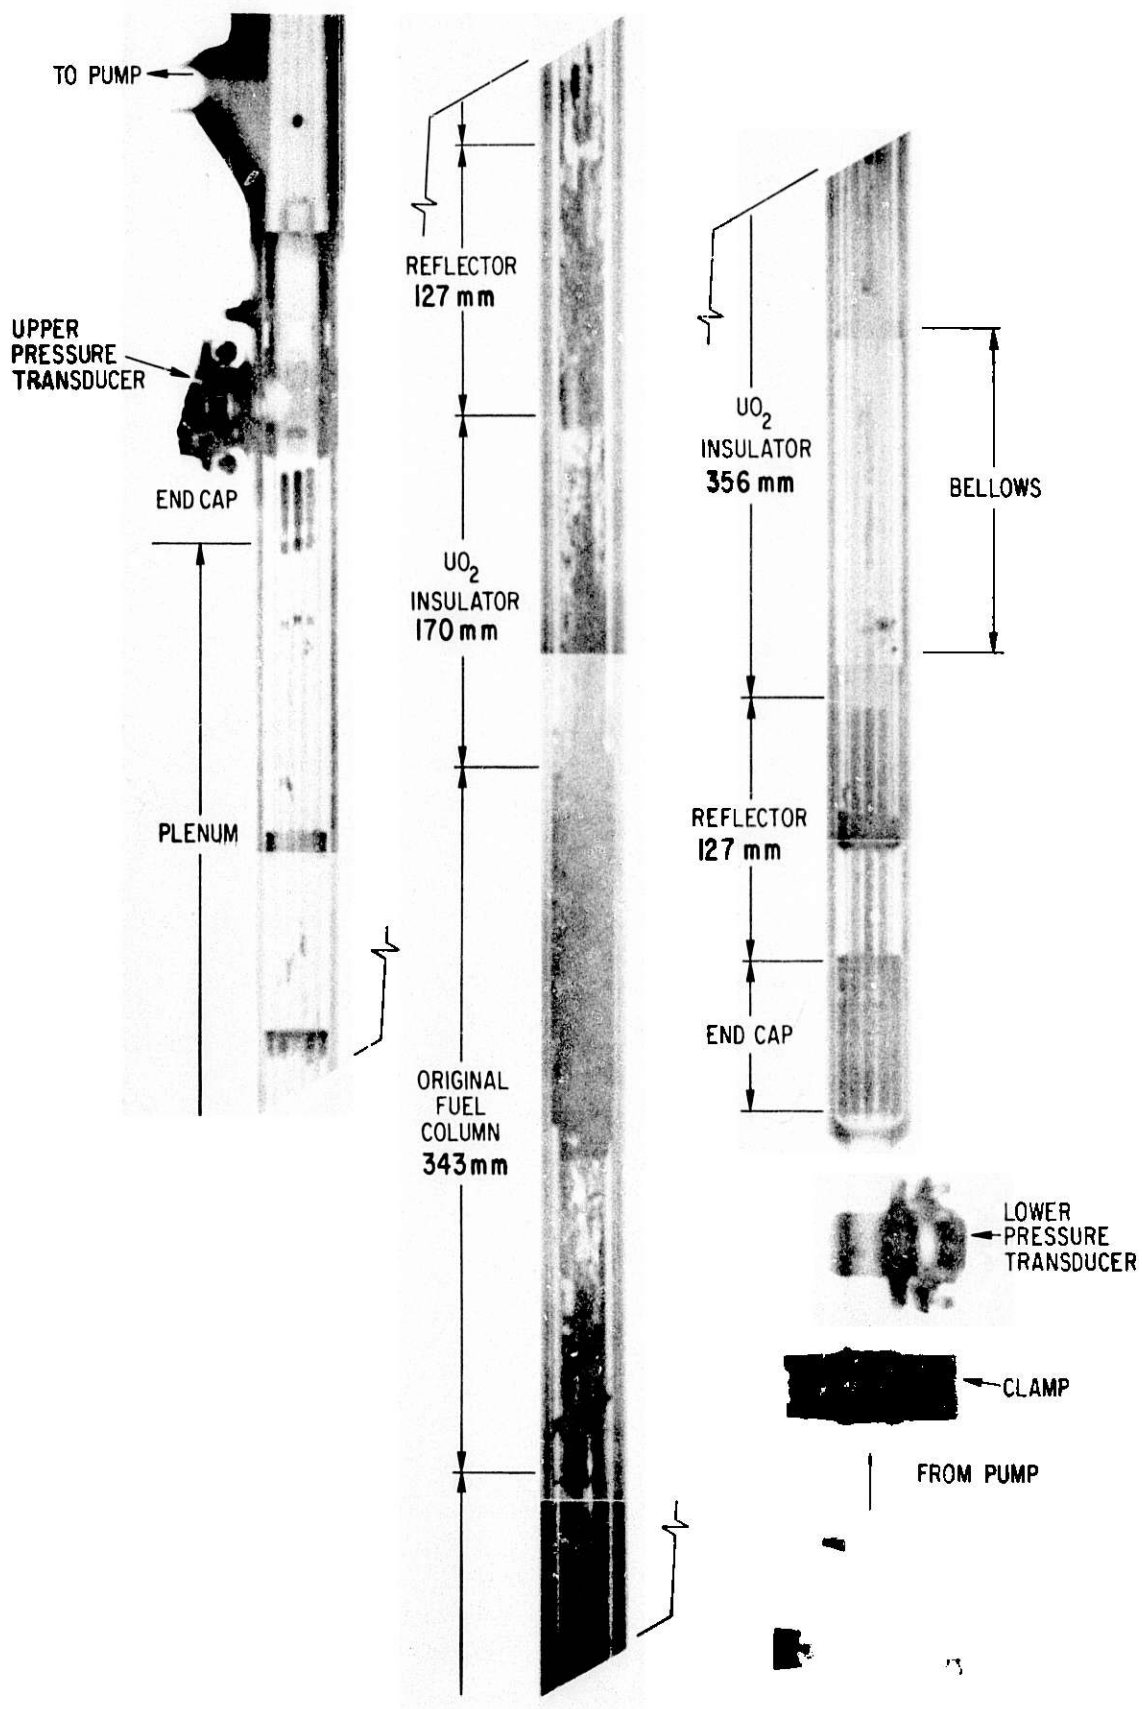
Fig. 32. Posttest Neutron Radiograph of ES Test Section. ANL Neg. No. 900-77-1444.

The adiabatic tube appeared to be intact on the neutron radiograph, although two tube penetrations were subsequently found during disassembly. The fluted (flow) tube appeared to have melted completely over the top half (165 mm) of the fuel column, with evidence for partial or local melting for some distance above and below.

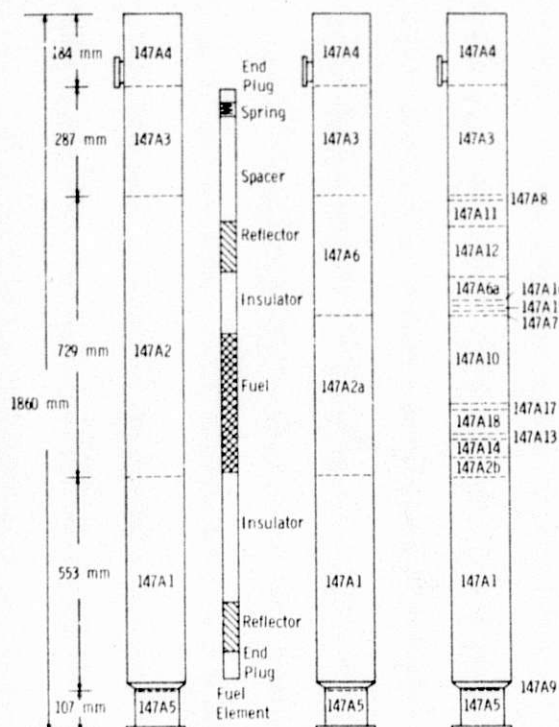
Fig. 33. Sectioning Schematic of Test-train Leg of E8 Loop

Section 147A1 in Fig. 33 contained the bottoms of the fuel elements, including reflector rods, and almost all the stacks of insulator pellets. This piece was 553 mm long. Section 147A2, 729 mm long, contained the full length of fuel columns, the upper insulator pellets and reflector rods, and part of the spacer tubes. Section 147A3, 287 mm long, contained the tops of the elements, including the spring and more than half of the spacer tube. Section 147A4 was set aside, since it appeared to be of little interest.

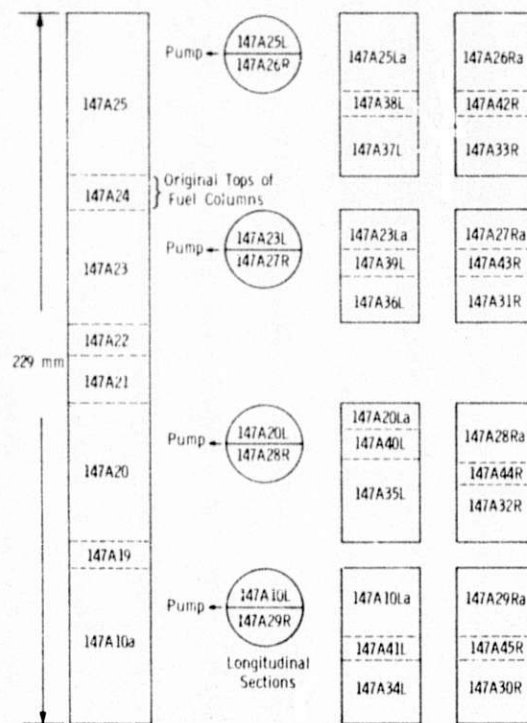
Fig. 34. Sectioning Schematic of Piece 147A10
