**TRANSIENT-OVERPOWER TEST E8 ON FFTF-TYPE
LOW-POWER-IRRADIATED FUEL**

**R. Simms, R. K. Lo, W. F. Murphy,
G. S. Stanford, and A. B. Rothman**

ARGONNE NATIONAL LABORATORY, ARGONNE, ILLINOIS

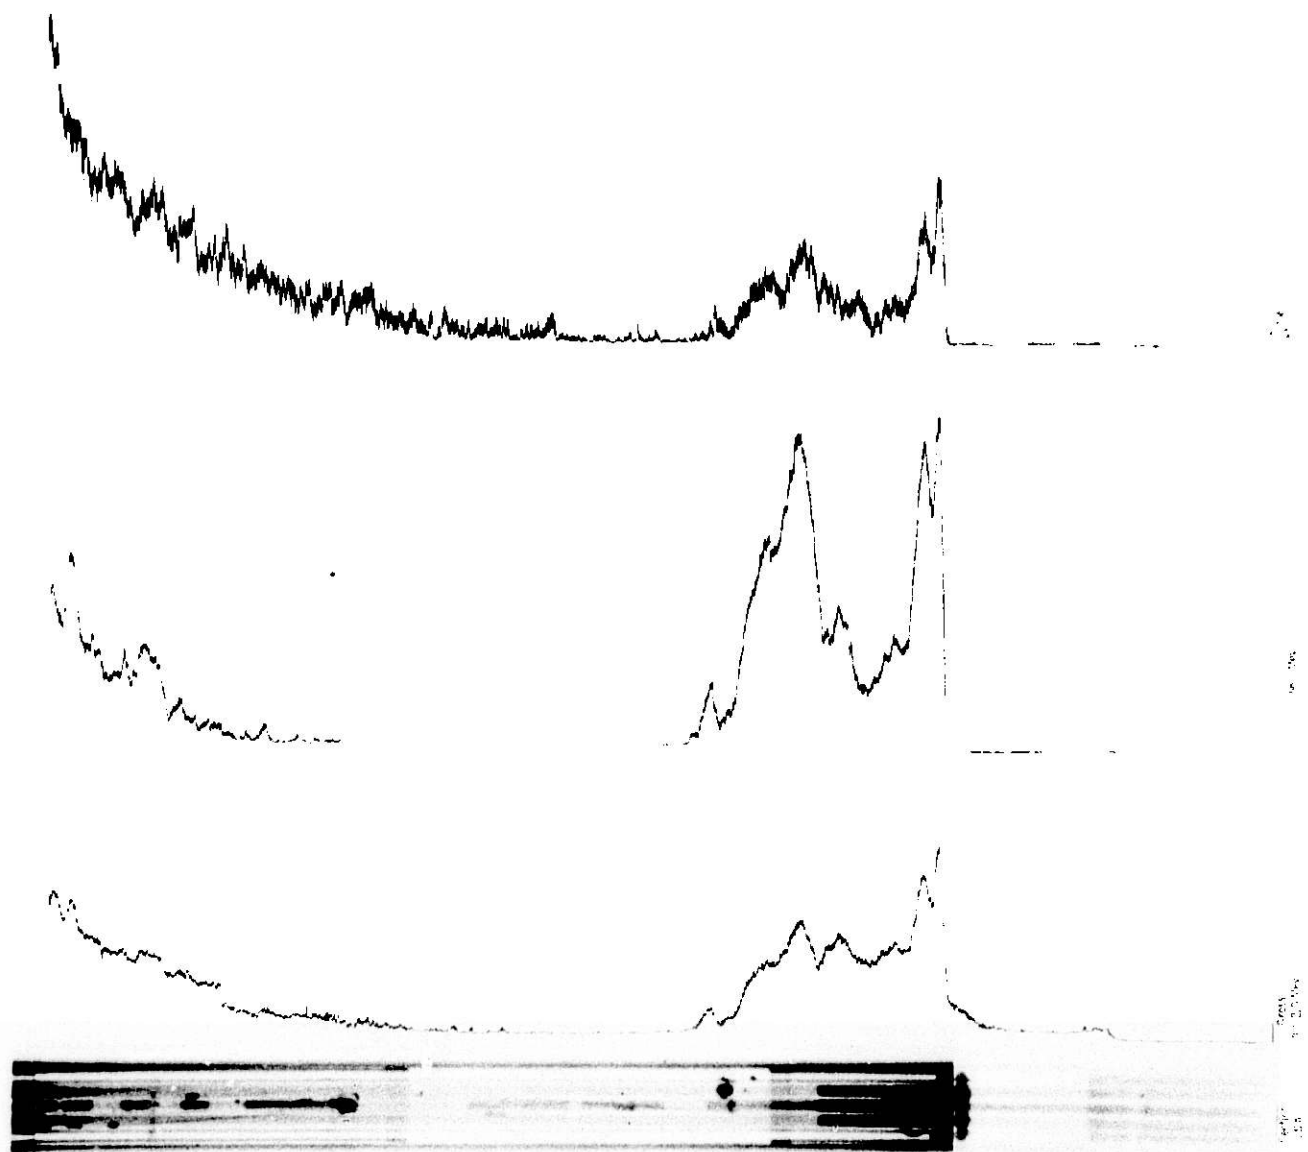
Fig. 35. Gamma Spectrometry of Section 147A1. Neg. No. MSD-188532.

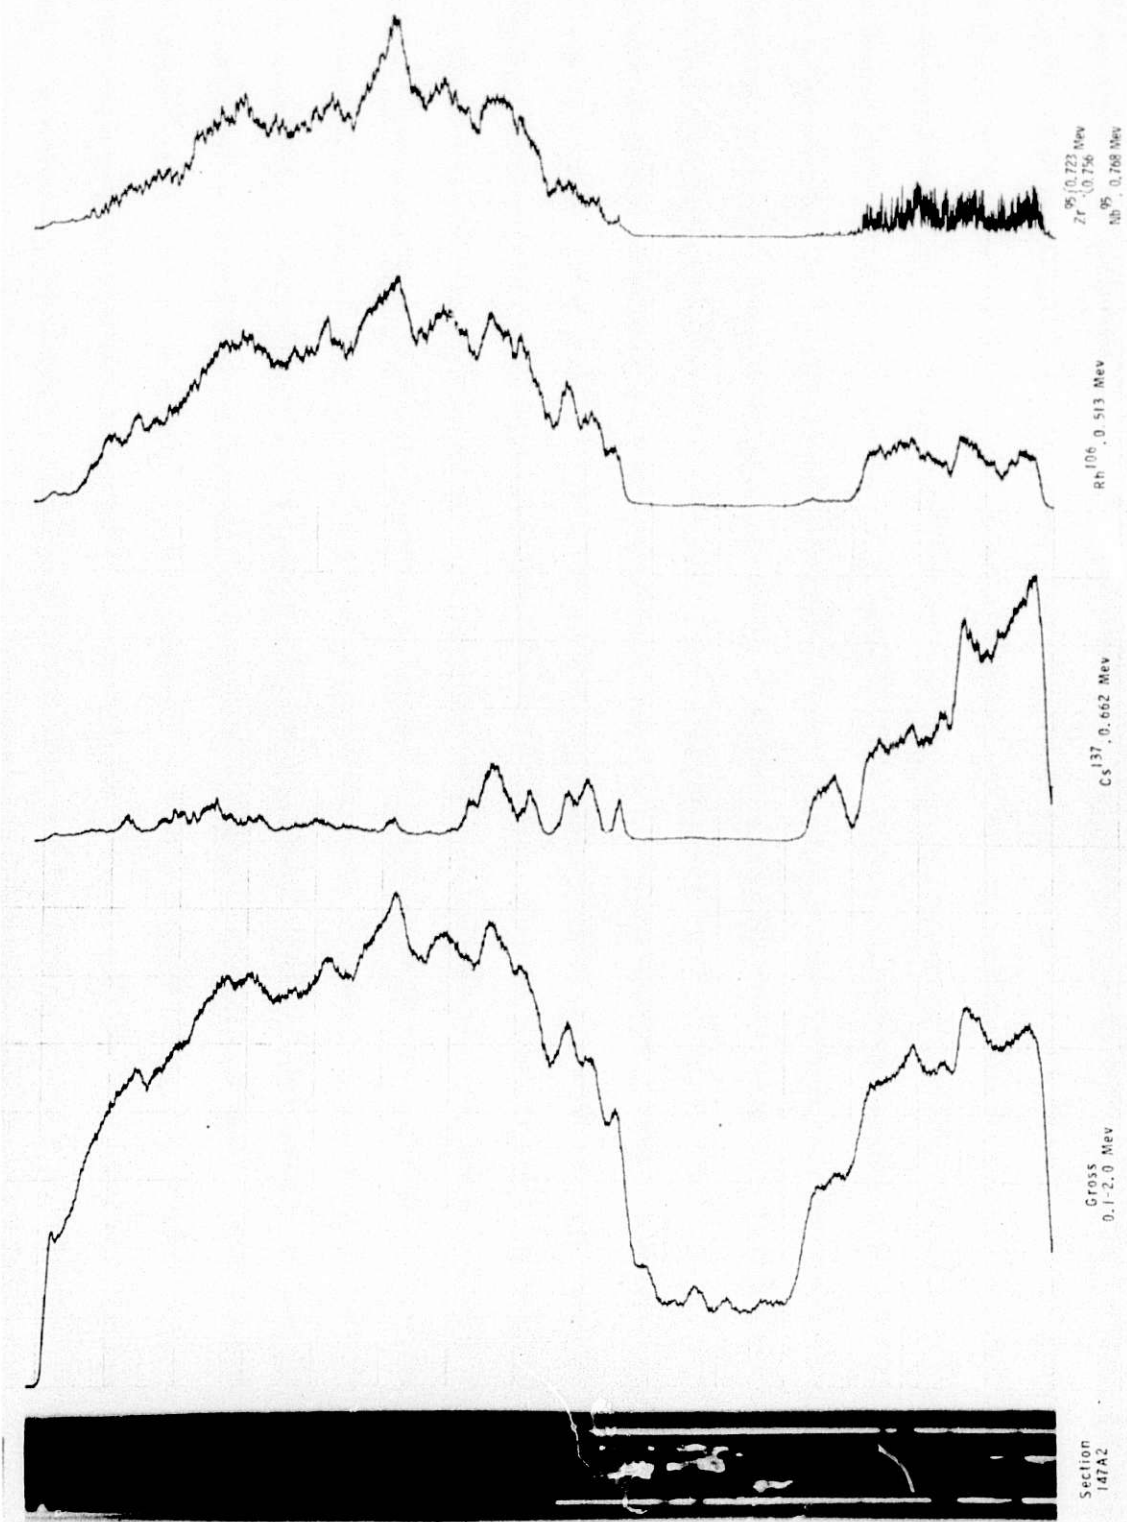
Fig. 36. Gamma Spectrometry of Section 147A2a. Neg. No. MSD-188534.

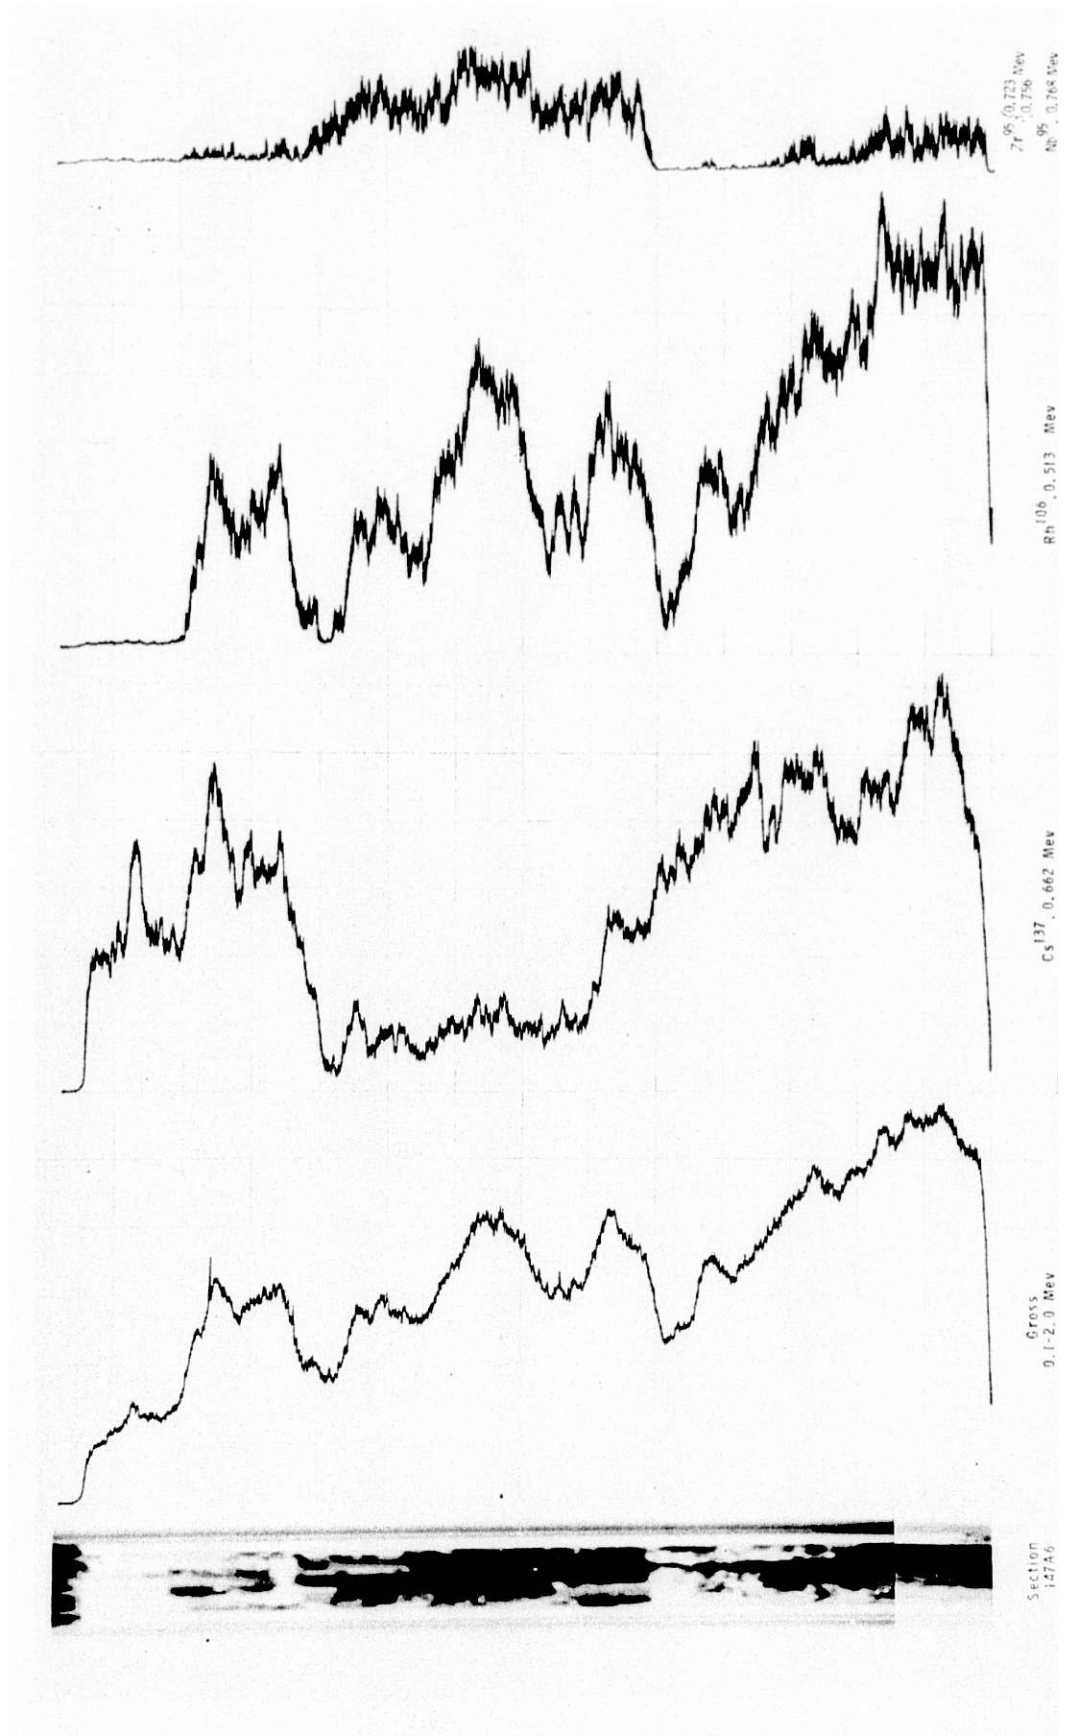
Fig. 37. Gamma Spectrometry of Section 147A6. Neg. No. MSD-188535.

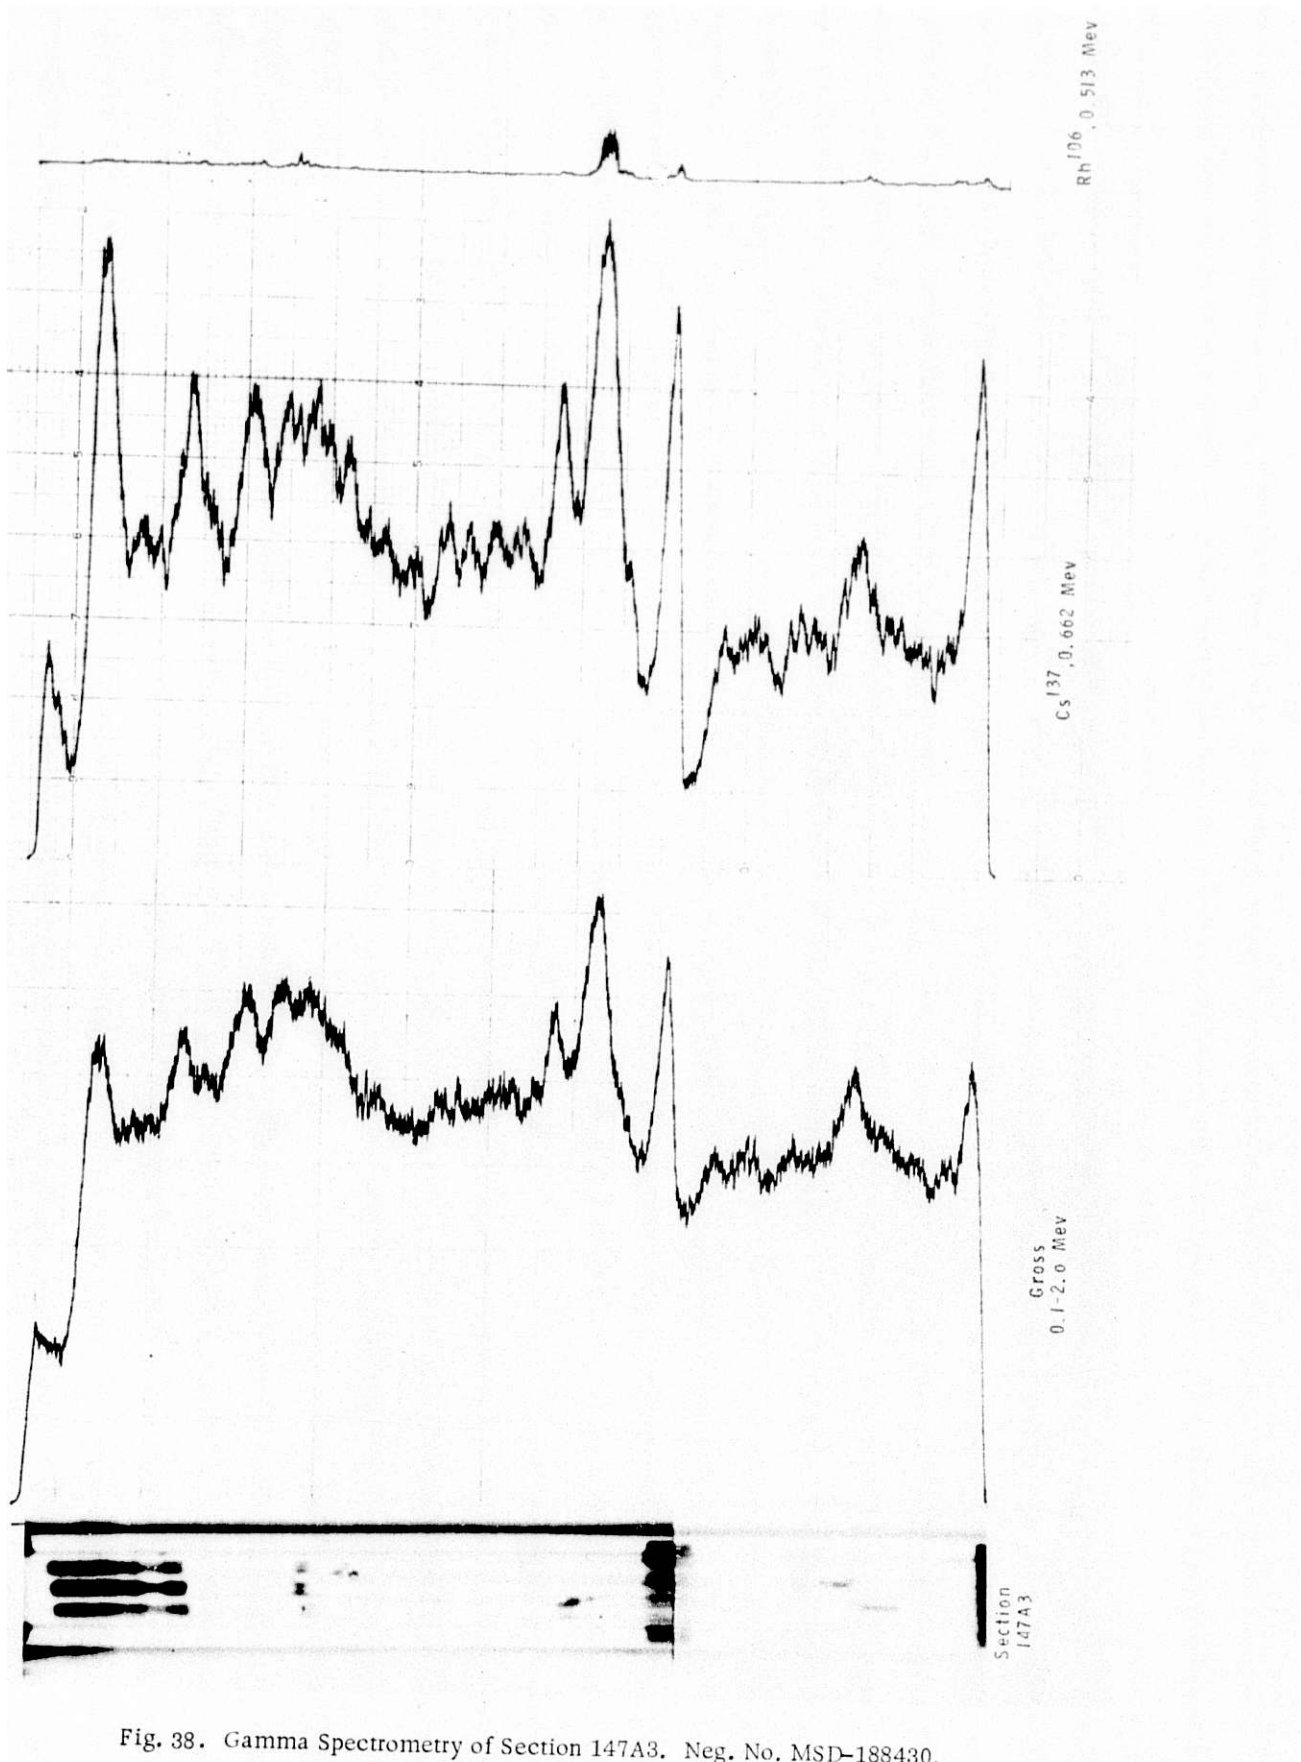
Fig. 38. Gamma Spectrometry of Section 147A3. Neg. No. MSD-188430.

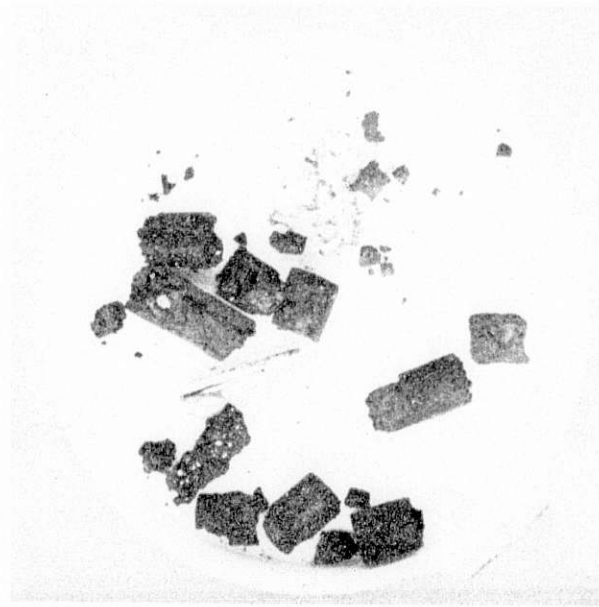
Fig. 34. Fuel section from 147A13, 147A14, and 147A15. Fuel is 70% UO₂, 20% Na₂CO₃, and 10% Na₂O.

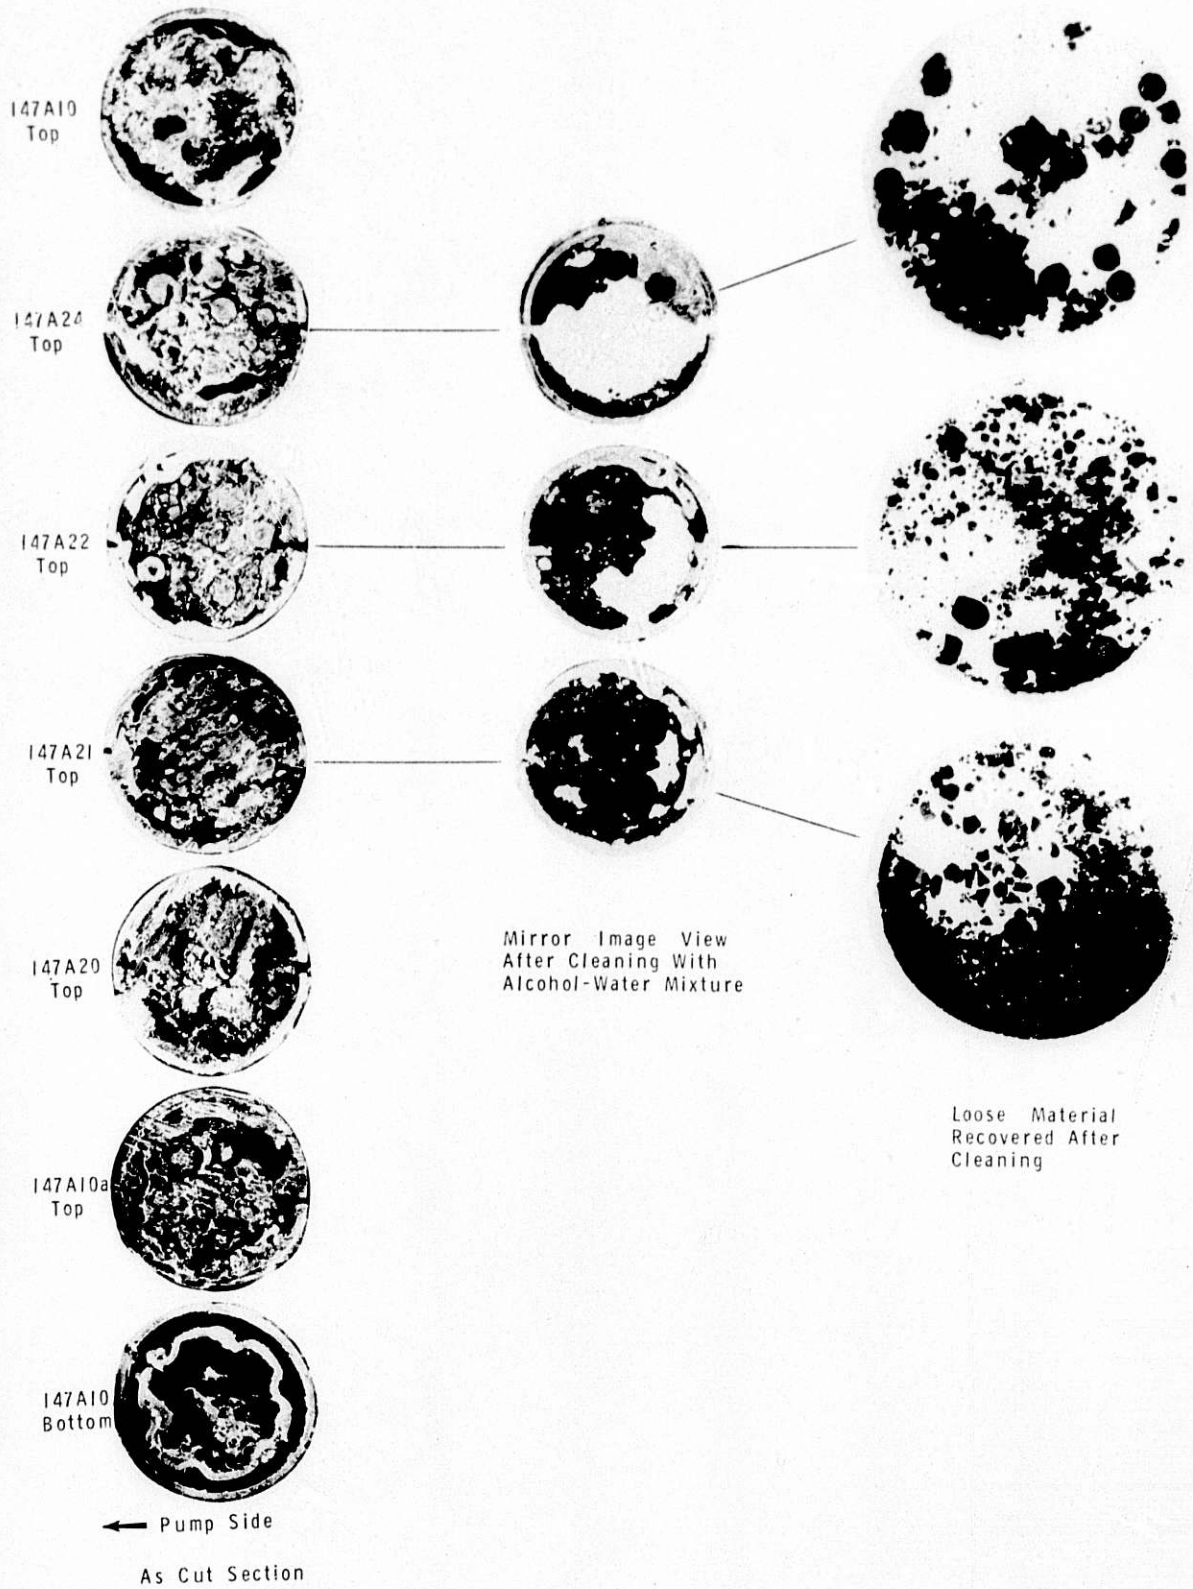
Fig. 48. Transverse Sections and Some Debris from Segment 147A10. Mag. 0.9X. Neg. No. MSD-188431.

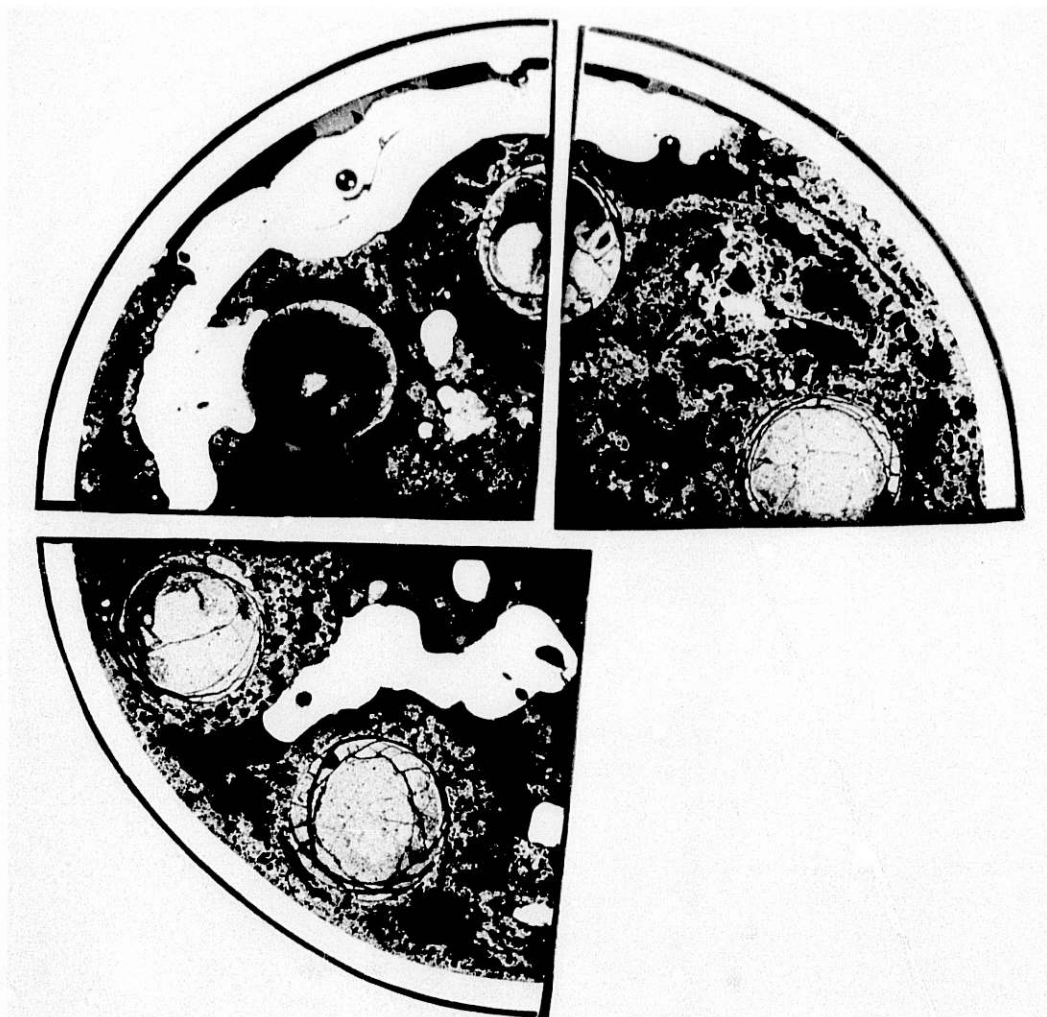
Fig. 49. Transverse Section through Fuel Region about 1.6 cm below Original Top of Fuel Columns. Sections 147A39L and 147A46R. Neg. No. MSD-185659.

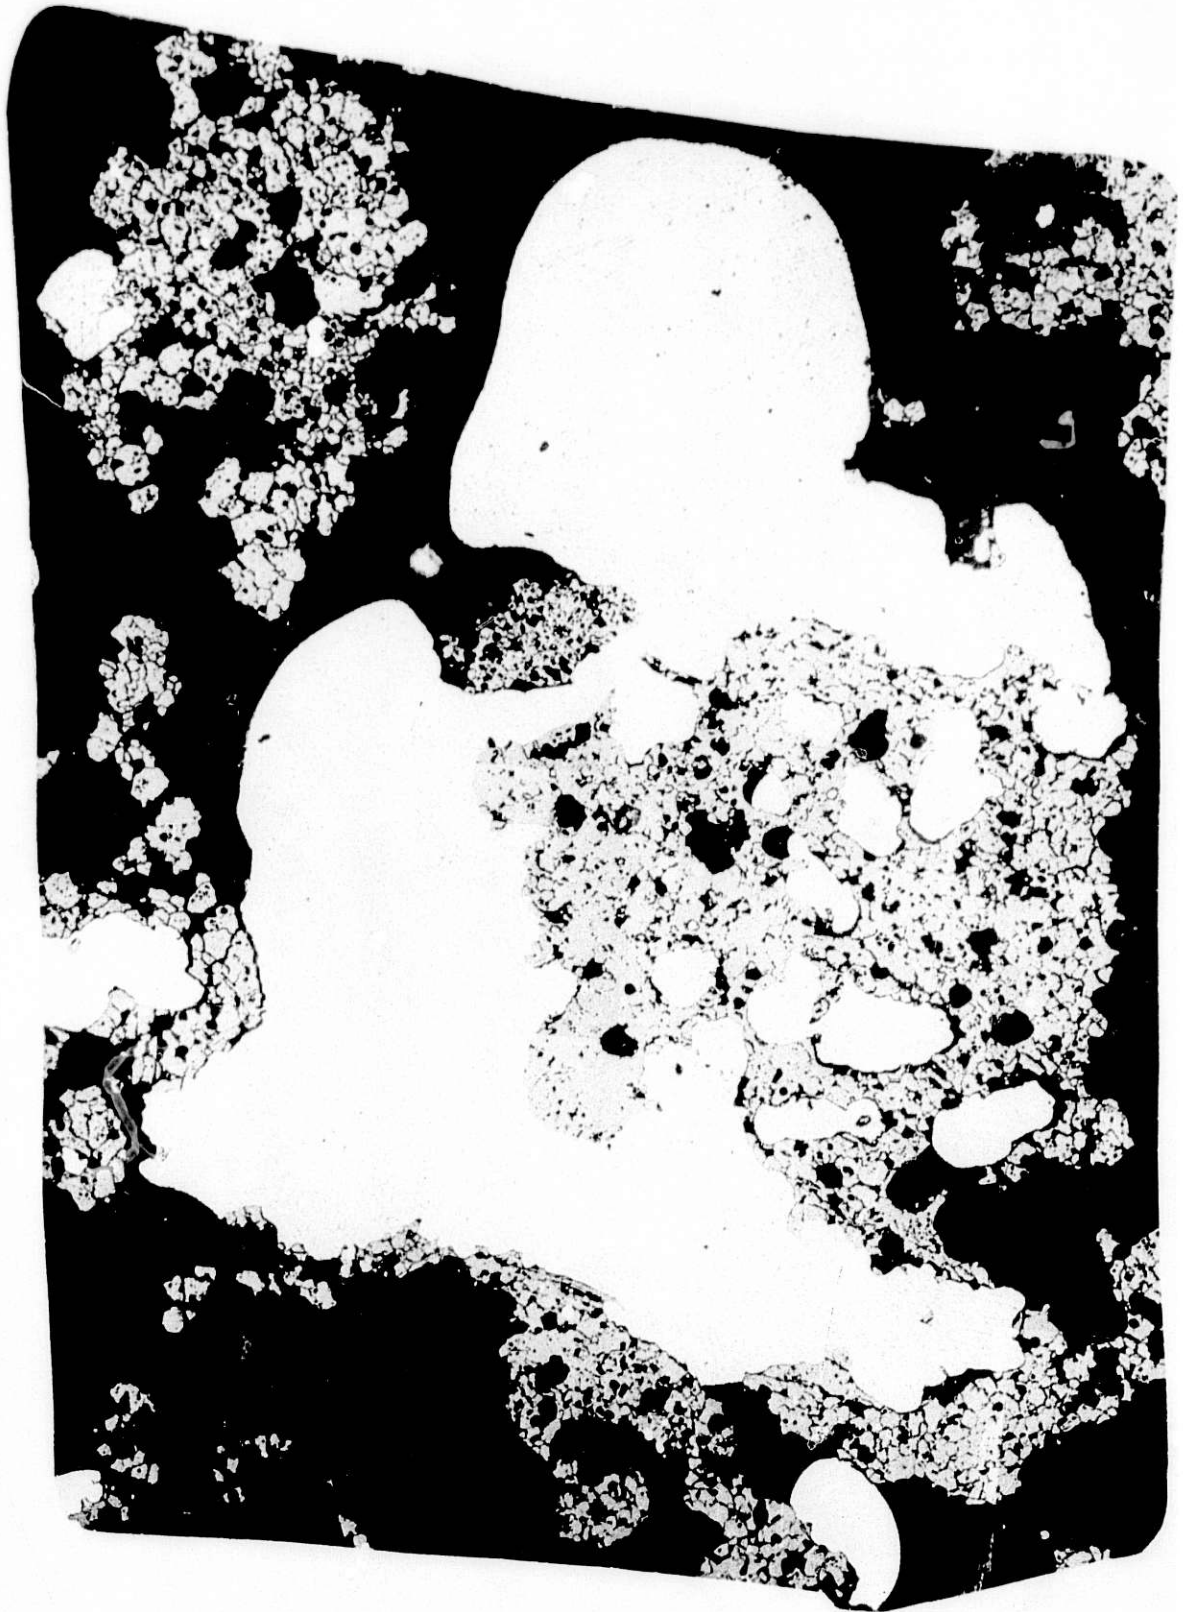
Fig. 50. Melted Steel in Melted Fuel. Section 147A39L. Mag. 85X. Neg. No. MSD-158400.

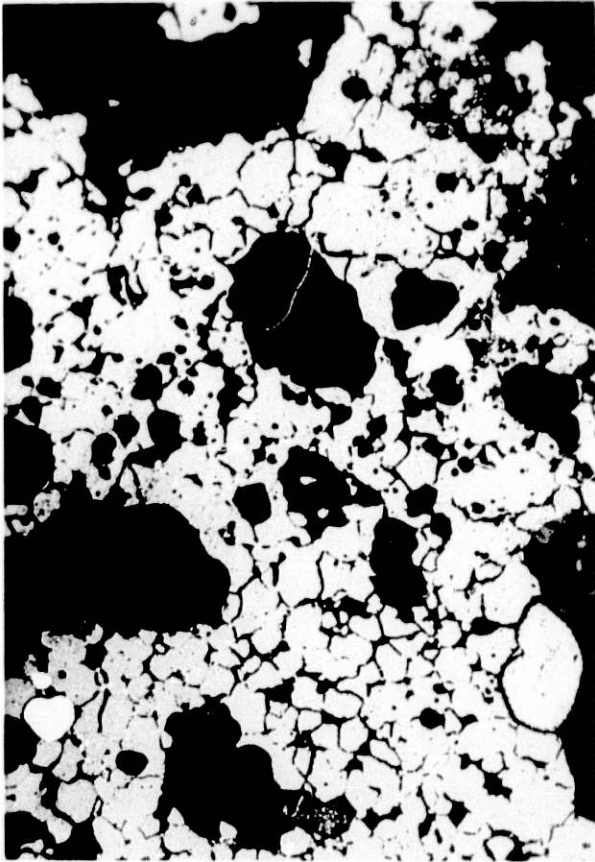
Fig. 51. Typical Melted Fuel Section with Lobes of Stainless Steel. Mag. 100X. Neg. No. MSU-187137.

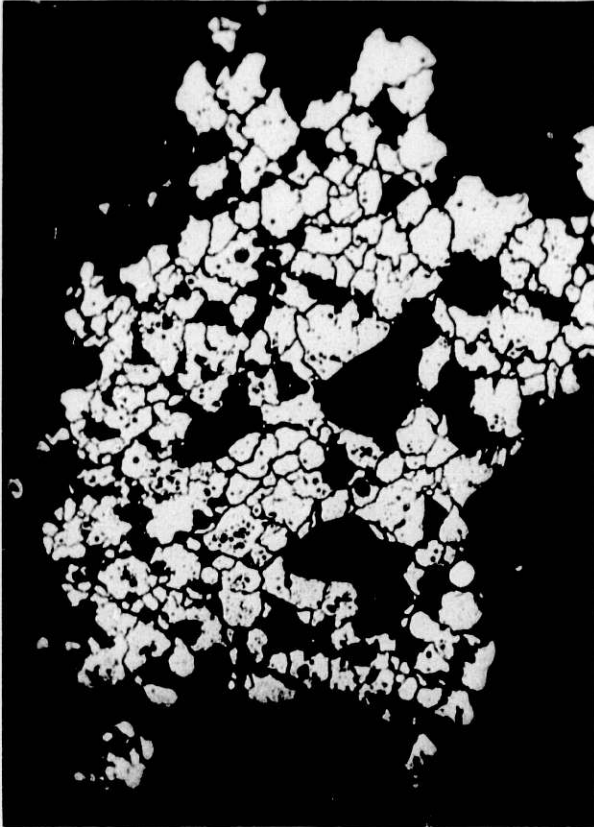
Fig. 53. Steel Globules in Melted Fuel from Upper Reflector-rod Region. Mag. 173X. Neg. No. MSD-137878.

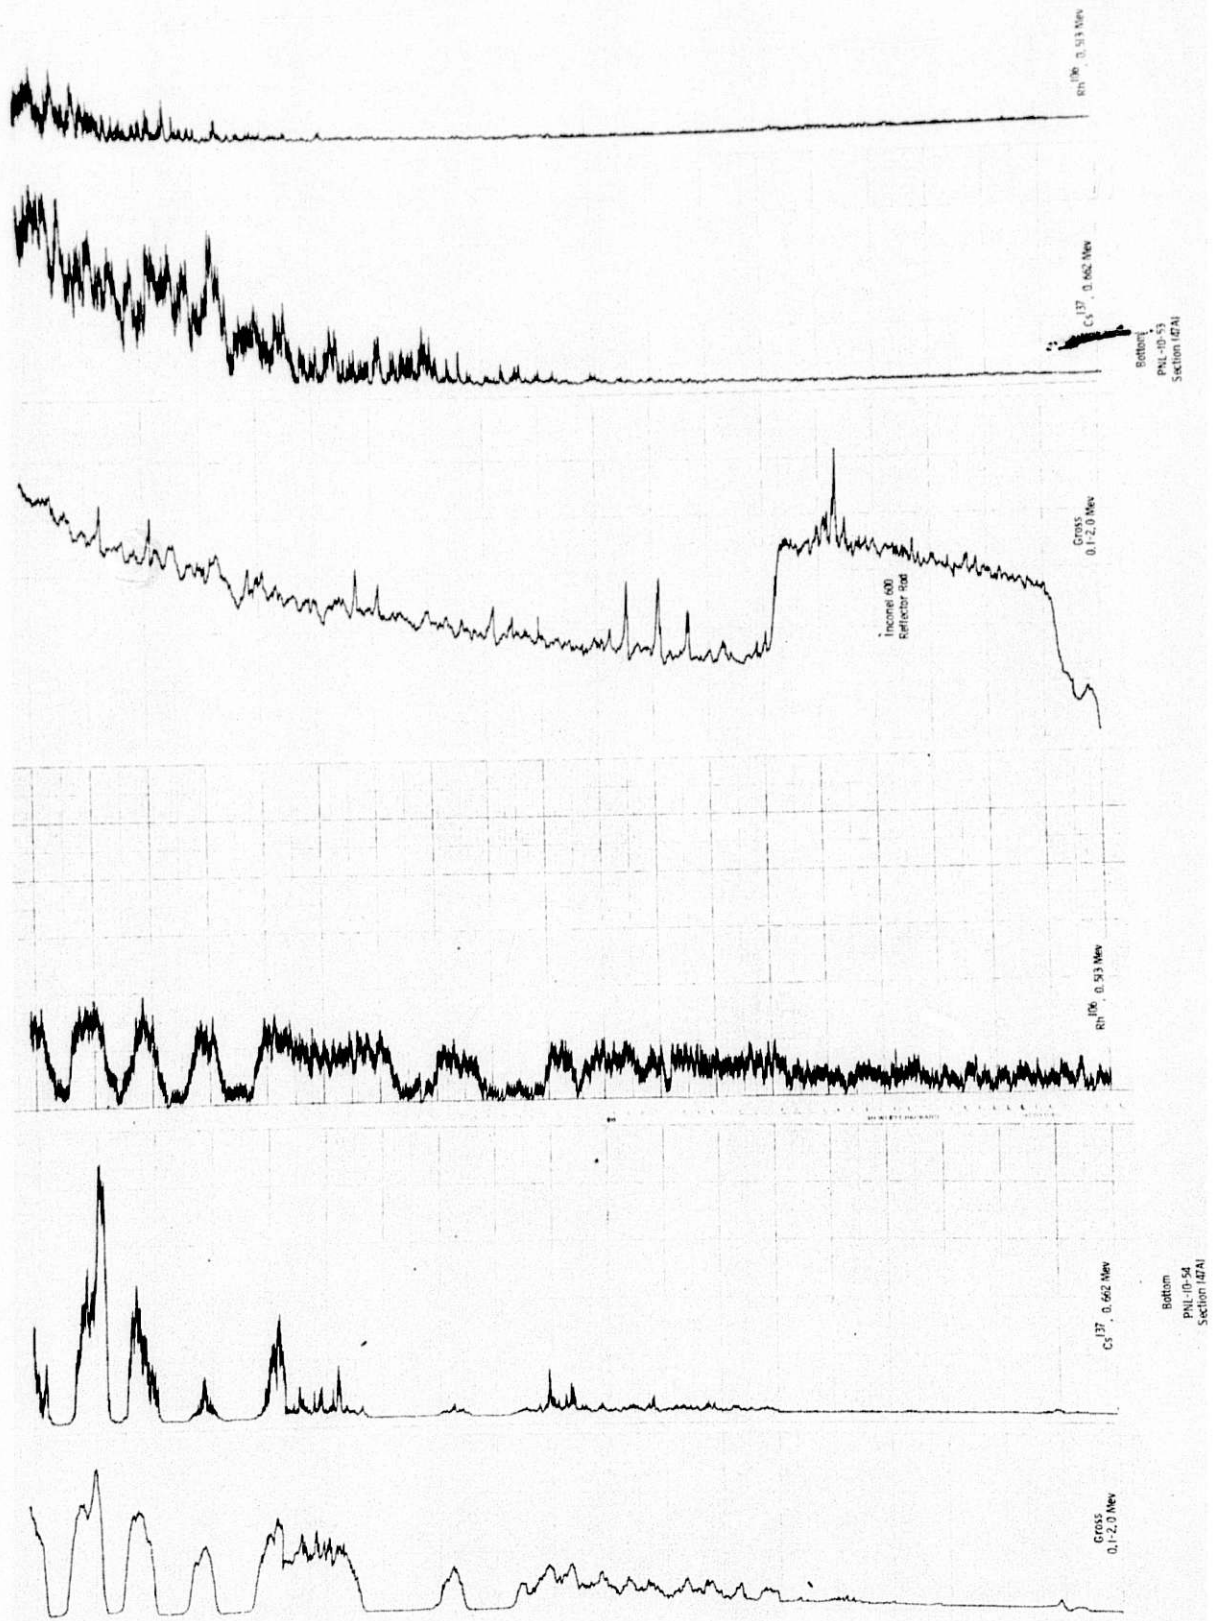
Fig. 54. Gamma Spectrometry of Bottom Sections of Elements PNL-10-53 and -44, Showing Gaps in Stack of Insulator Pellets in Latter. Neg. No. MSD-188533.

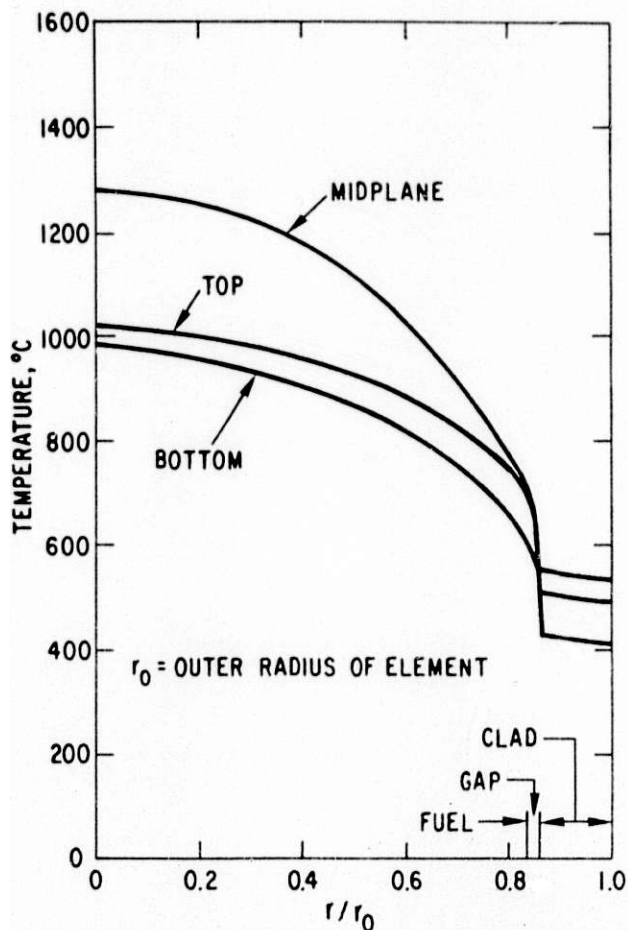
Fig. 56. Radial Temperature Distribution of Central Fuel Element at TREAT Clock Time 6.712 s (Beginning of power burst). ANL Neg. No. 900-77-82 Rev. 1.

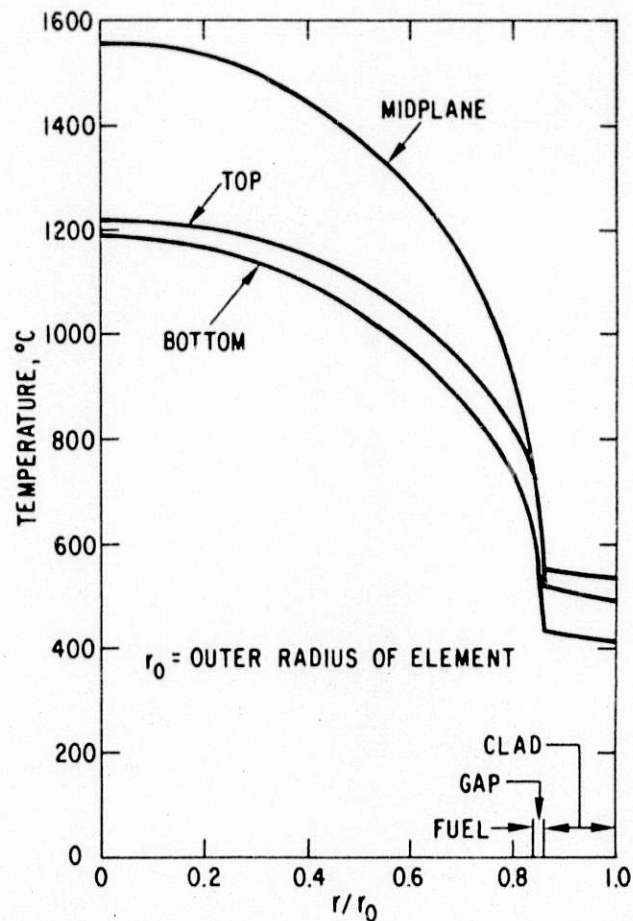
Fig. 57. Radial Temperature Distribution of Peripheral Fuel Element at TREAT Clock Time 6.712 s (Beginning of power burst). ANL Neg. No. 900-77-79 Rev. 2.

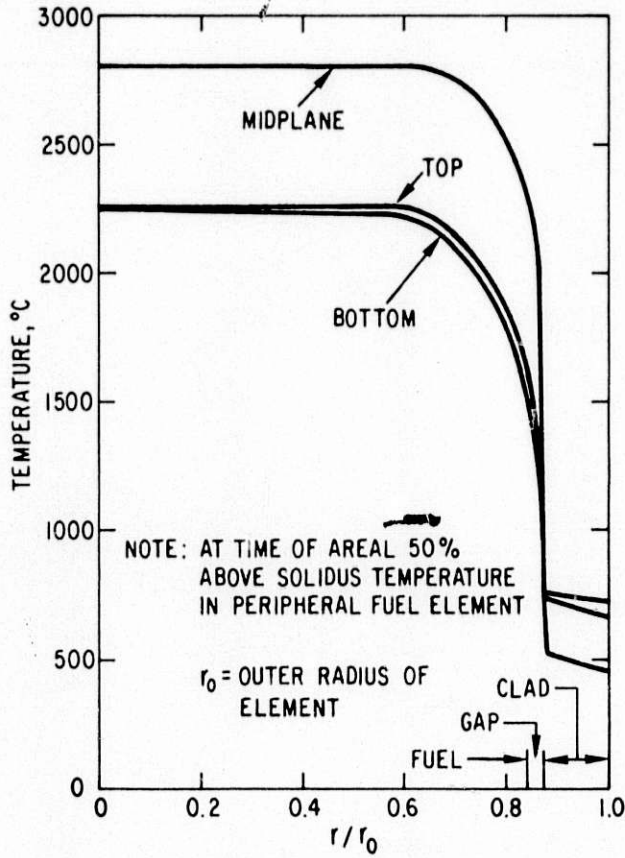
Fig. 59. Radial Temperature Distribution of Peripheral Fuel Column at TREAT Clock Time 7.212 s. ANL Neg. No. 900-77-80 Rev. 1.

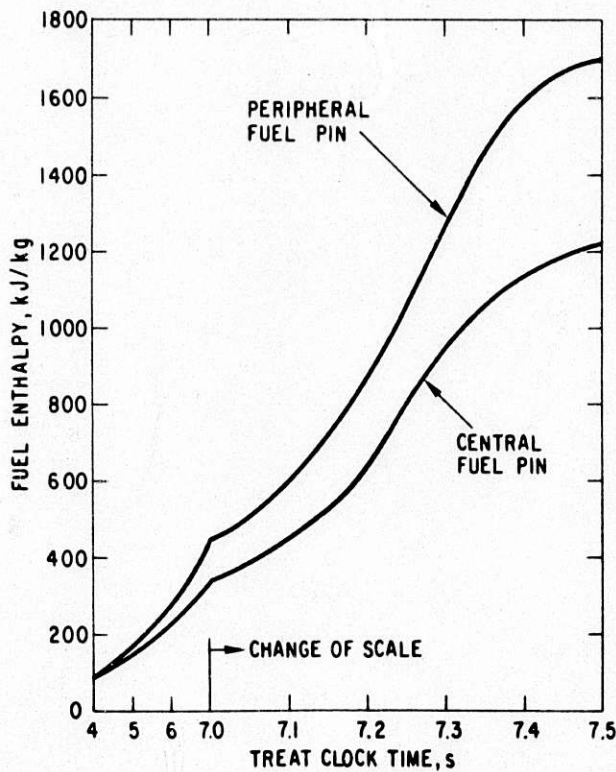
Fig. 61
Change of Fuel Enthalpy at Midplane during Transient. ANL Neg. No. 900-77-84.

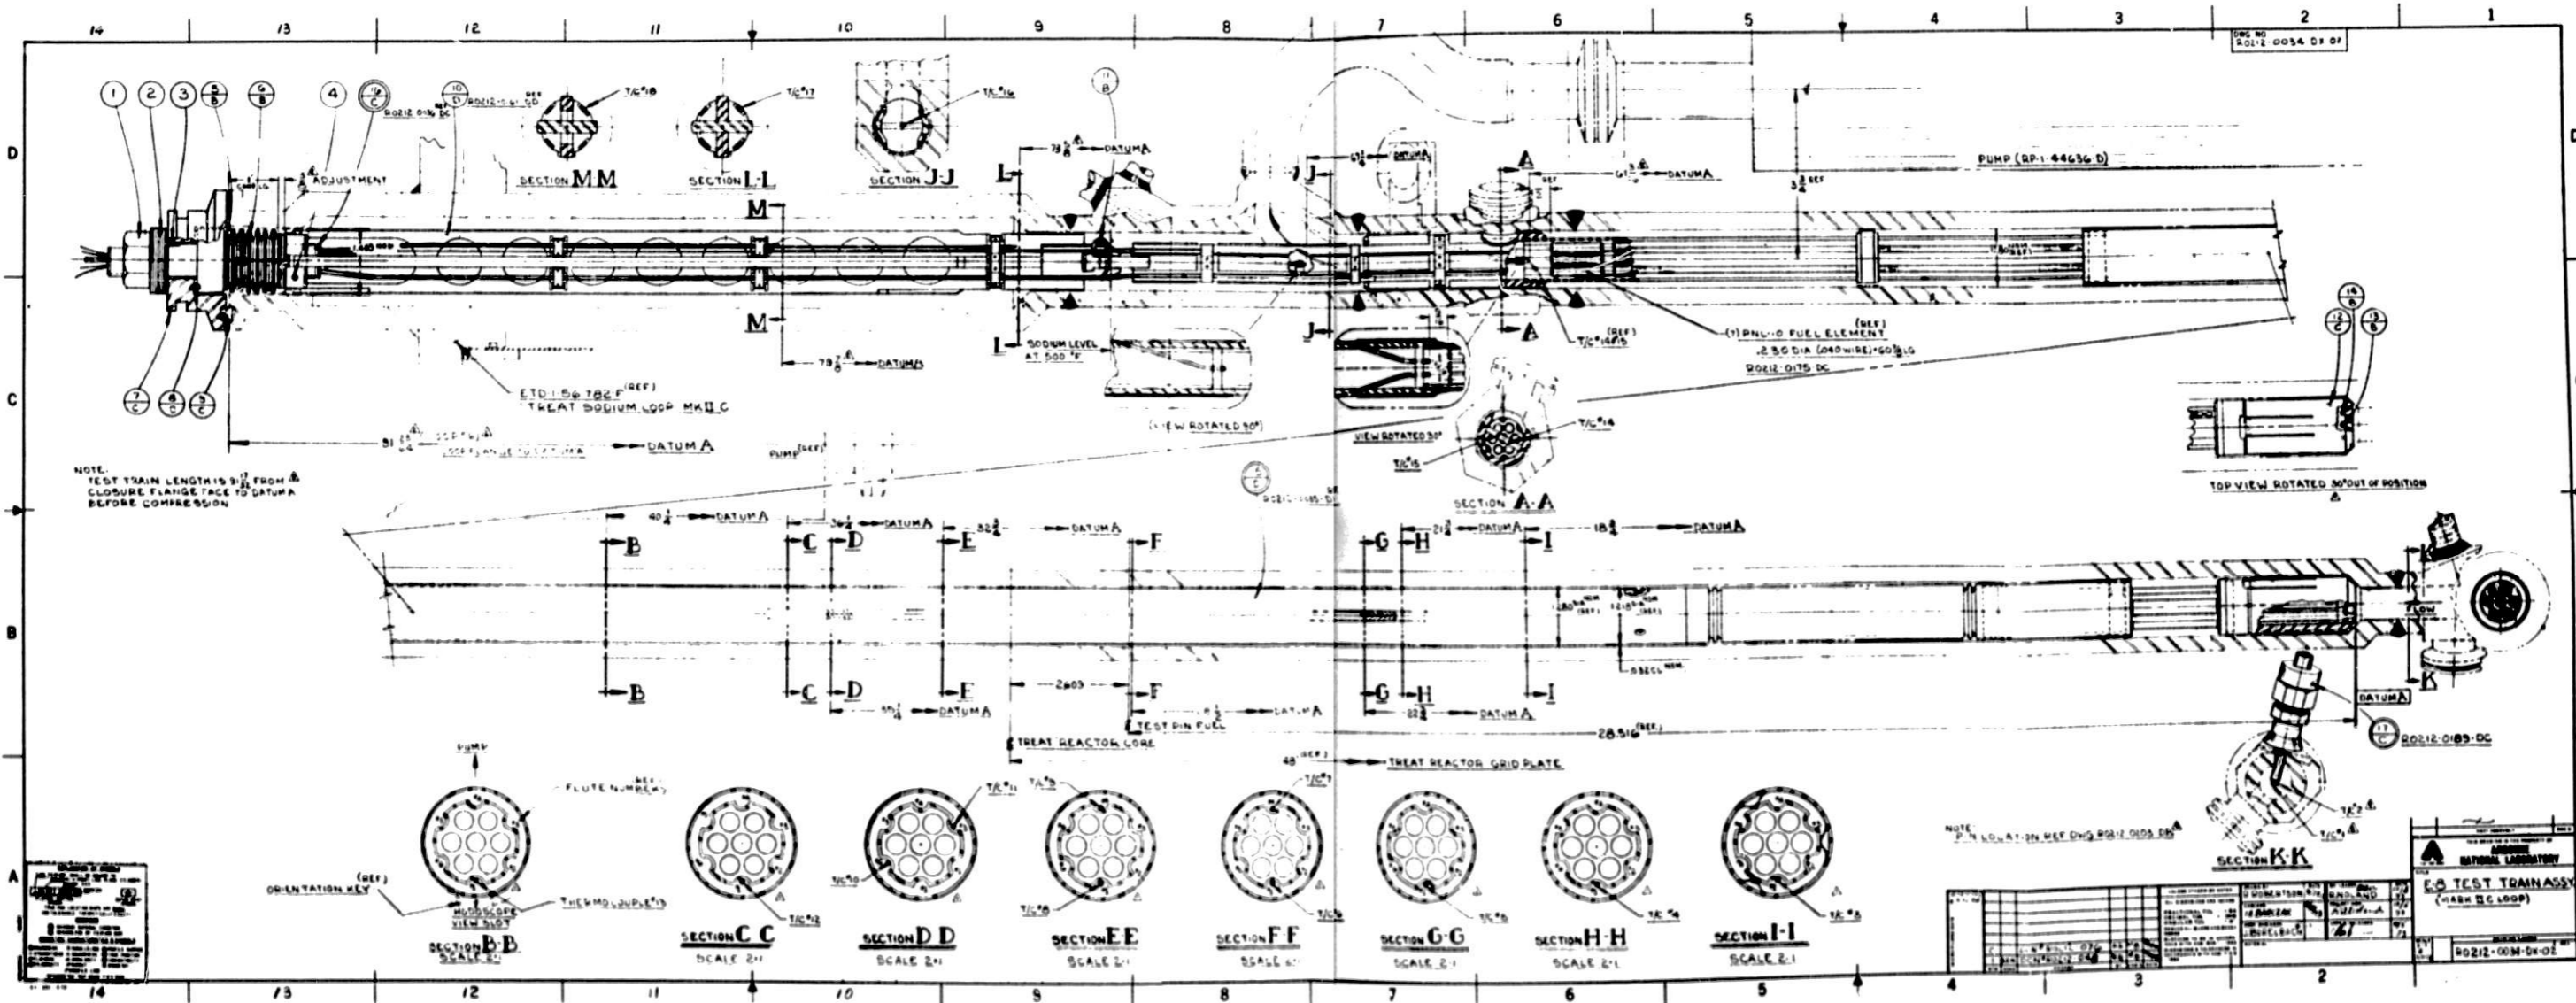
Fig. A.1. ES Test-train Assembly

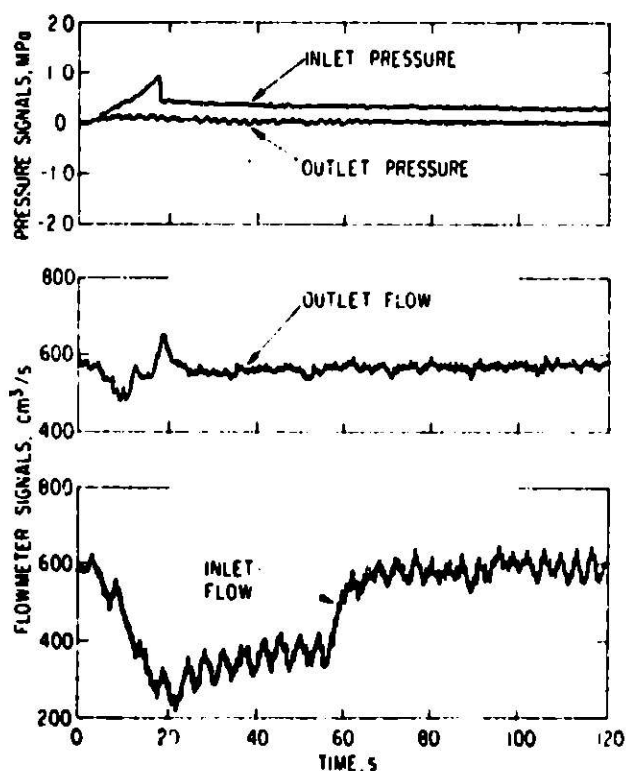
Fig. C.1. Flow and Pressure Signals in Heat-balance Test E8-1 (0-120 s). ANL Neg. No. 990-77-23.

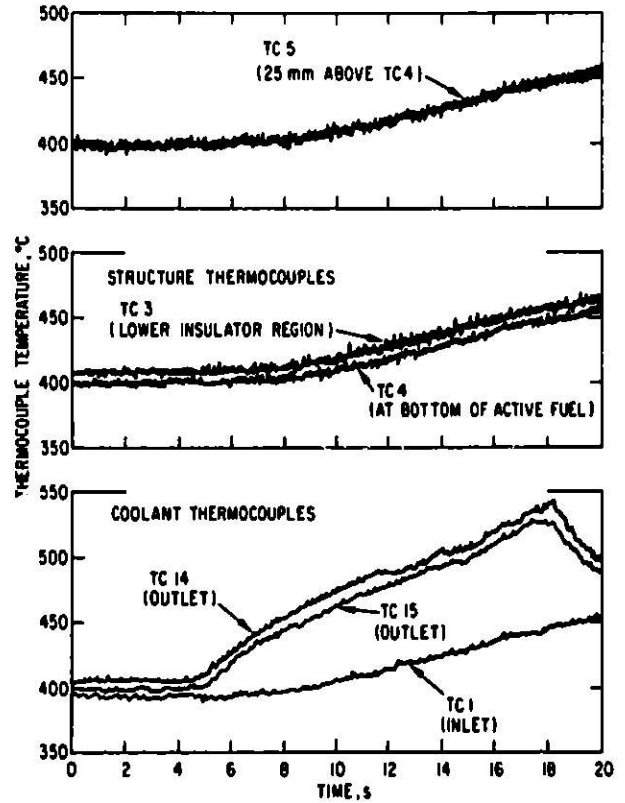
Fig. C.4. Temperatures of Coolant and Structure Thermocouples in Test E8-1 (0-20 s). ANL Neg. No. 900-77-16.

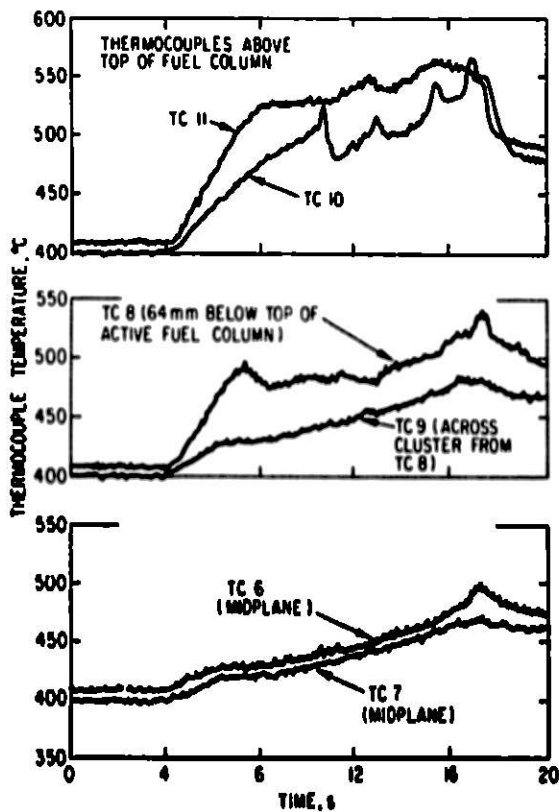
Fig. C.5
Temperatures of Structure Thermocouples in Test E8-1. ANL Neg. No. 900-77-20.

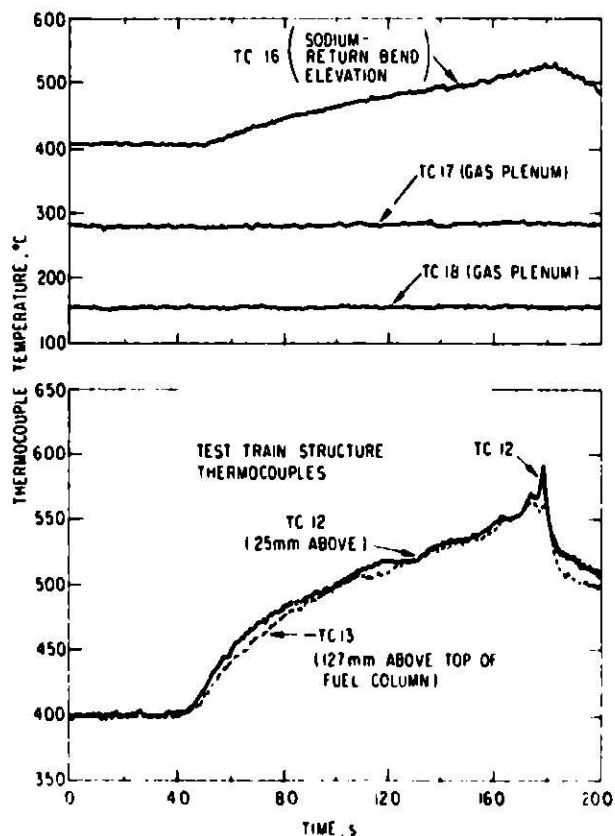
Fig. C.6. Temperatures of Test-train Thermocouples above Active Fuel Column.
ANL Neg. No. 900-77-22.

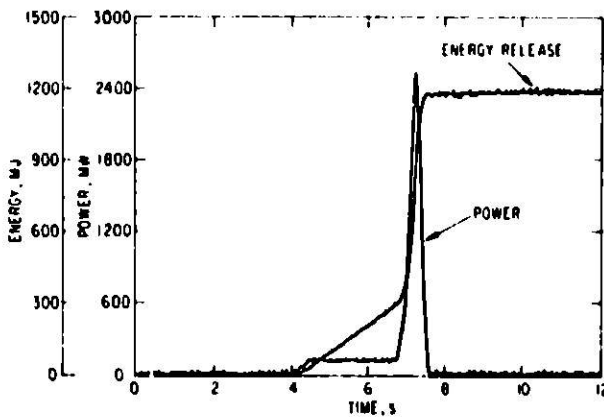
Fig. D.1. Power and Energy Release in Test E8-2 (TREAT Transient 1588). ANL Neg. No. 900-77-41.
