**TRANSIENT-OVERPOWER TEST E8 ON FFTF-TYPE
LOW-POWER-IRRADIATED FUEL**

**R. Simms, R. K. Lo, W. F. Murphy,
G. S. Stanford, and A. B. Rothman**

ARGONNE NATIONAL LABORATORY, ARGONNE, ILLINOIS

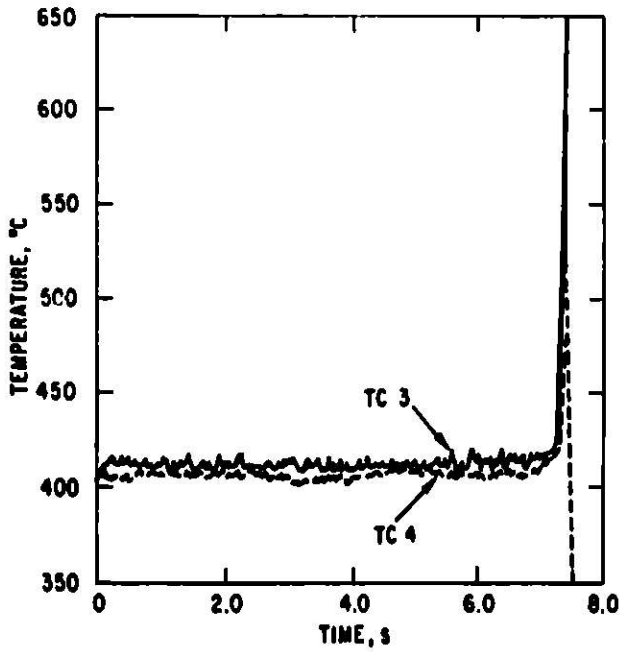
Fig. D.7. Temperatures from Structure Thermocouples at Elevations below Bottom of Active Fuel-column Region in Test E8-2 (0-8 s). ANL Neg. No. 900-77-14.

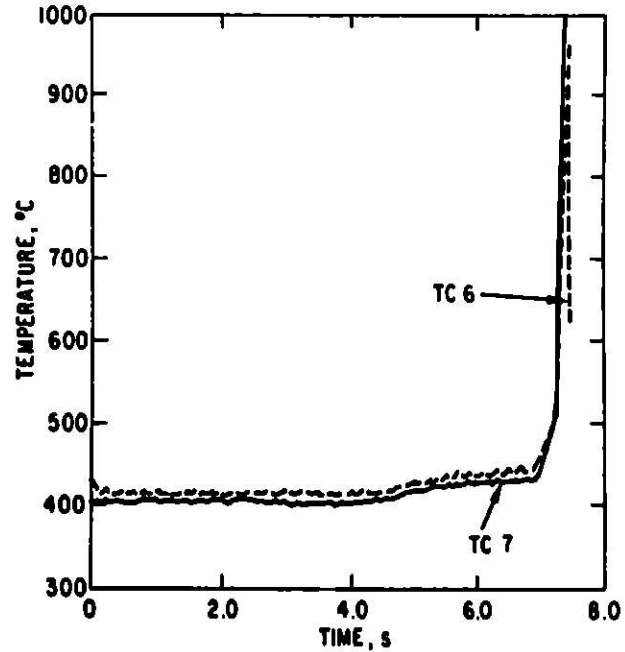
Fig. D.8. Temperatures from Structure Thermocouples at Fuel-column Midplane in Test E8-2 (0-8 s). ANL Neg. No. 900-77-45.

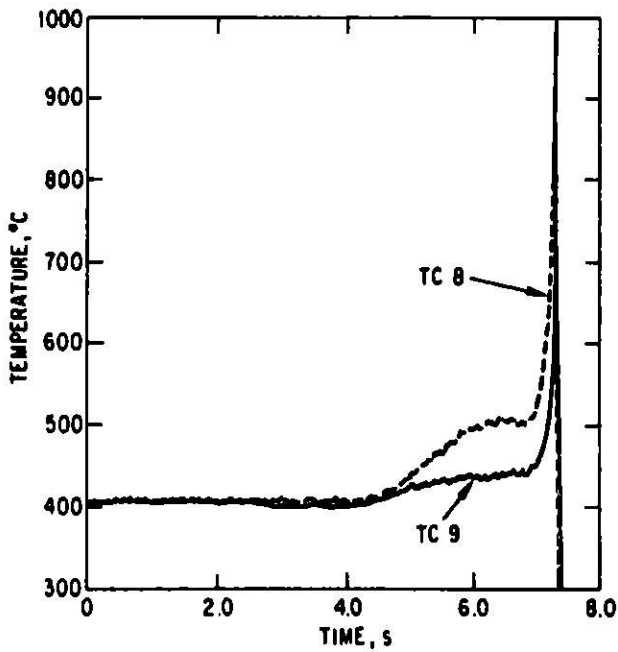
Fig. D.9. Temperatures from Structure Thermocouples 64 mm below Top of Active Fuel Column in Test EB-2 (0-8 s). ANL Neg. No. 900-77-44.

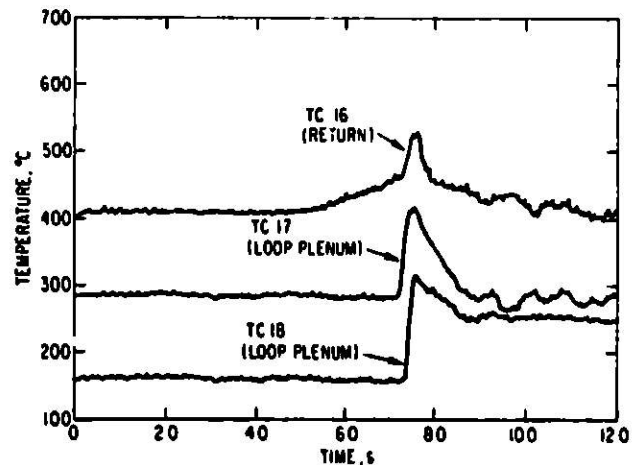
Fig. D.12. Temperatures from Thermocouples in Upper Loop Region in Test EB-2 (0-12 s). ANL Neg. No. 900-77-39.

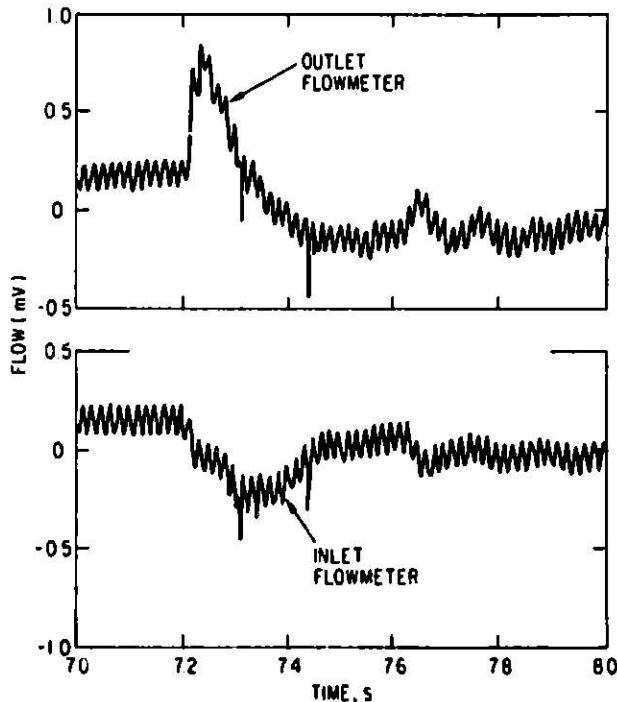
Fig. E.1. Signal Output from Inlet and Outlet Flowmeters from Test E8-2. ANL Neg. No. 900-77-40.

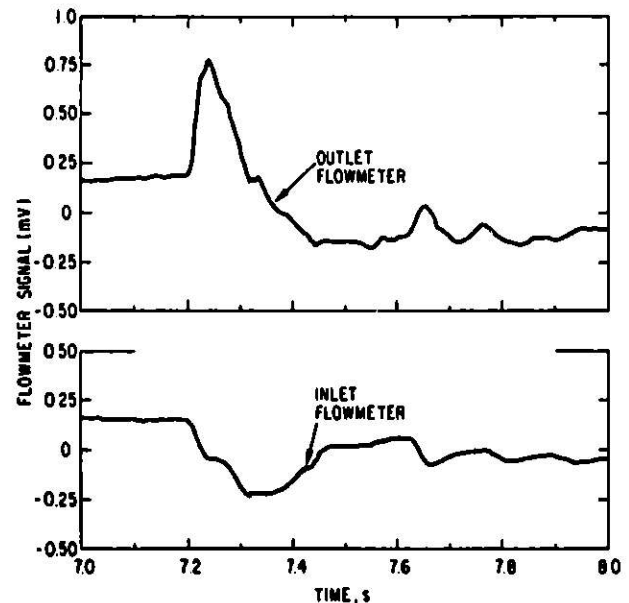
Fig. E.2. Signal Output from Flowmeter after Removal of 60-Hz Component for Test E8-2. ANL Neg. No. 900-77-31.
