Investigation of High-Energy-Proton Effects in Aluminum*

Carl J. Czajkowski, C. Lewis Snead, Jr., and Michael Todosow

Brookhaven National Laboratory

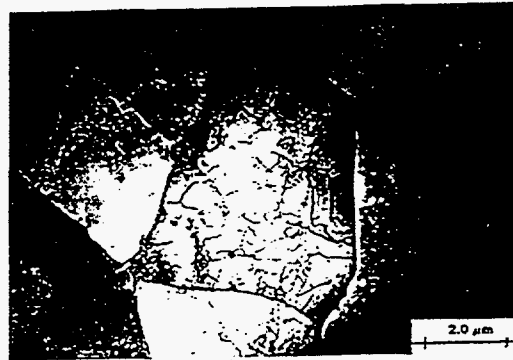
Figure 3. TEM photo showing a subcell dislocation network in 1100 Al.

The 1100 aluminum material was examined by electron microscopy. The 1100 alloy, which is 99.2% pure aluminum, had dislocations present. The 1100 material (Figure 3) had sub-cell dislocation networks associated with the grains. The major impurities identified were Si and Fe.

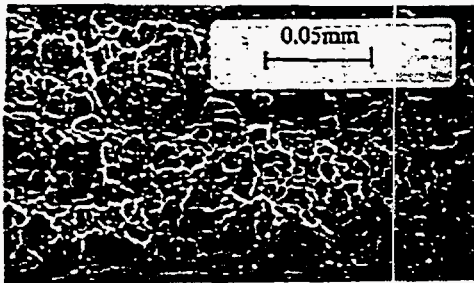
Figure 6. Low-magnification fractograph showing ductile fracture face after tensile test (typical).

The smaller (circular) specimens were cut to provide: 1 microhardness specimen; 1 TEM specimen, and 2 archive specimens. The large "dog bone" style specimen was the tensile specimen. Figure 6 is a fractograph of a typical tensile test specimen tested (3 total), which showed a desirable "dimpled rupture" (ductile) fracture. Table 3 lists the results of the tensile and microhardness measurements taken.
