Metallurgical Analysis
of a 304L Stainless Steel Canister
from the Spent Fuel Test--Climax

H. Weiss
R. A. Van Konynenburg
R. D. McCright

April 1985

Nuclear Waste
Management
Projects

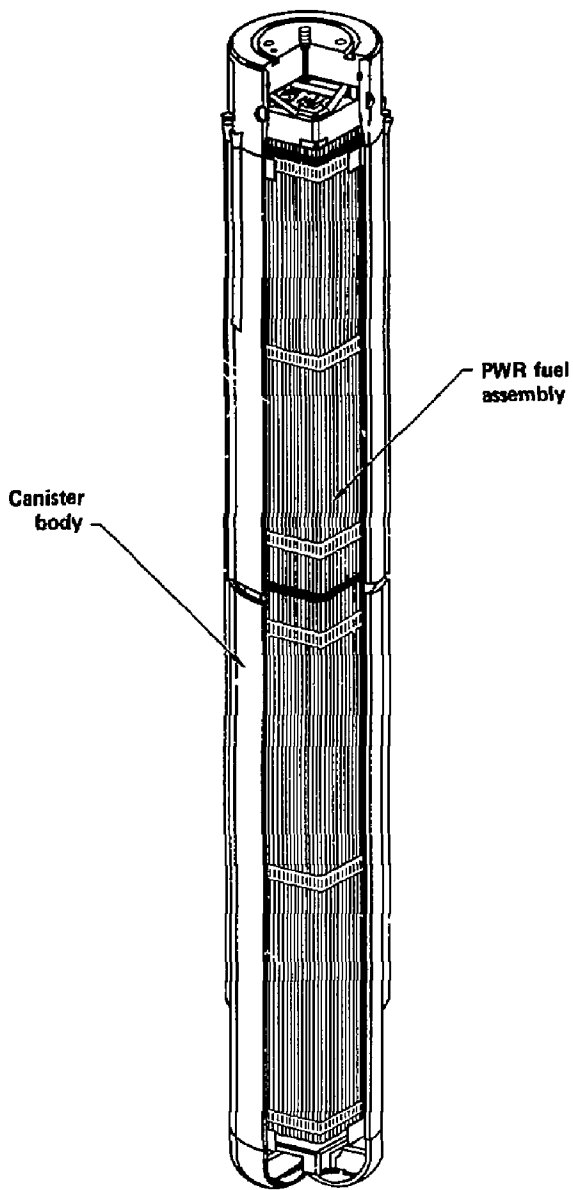
Fig. 1 Spent fuel canister assembly

Each spent fuel assembly was inserted into a stainless steel canister, as shown in Fig. 1. The canister consisted of a canister body and a closure lid. The main body of the canister was a standard 356 mm OD, 9.52 mm wall, Type 304L stainless steel pipe 3.92 m long. A standard 9.52 mm wall, Type 304L stainless steel ellipsoidal end cap was welded to the bottom of this pipe. A cruciform-shaped fixture fabricated from 19 mm thick Type 304L stainless steel was welded into the end cap. This fixture supported the fuel assembly and served as a loose-clearance keyway into which the fuel assembly bottom nozzle fitted.

The upper body of the canister consisted of a section of 356 mm OD, 23.8 mm wall, Type 304L stainless steel pipe, approximately 230 mm long. This section was welded to the top of the main body and contained all the machined mating features for the closure lid. The canister body welds were made in accordance with Section IX of the ASME Boiler and Pressure Vessel Code and were inspected by dye penetrant. All external canister welds were made using Type 308L stainless steel weld wire.

Welded to the inside of the canister body was a Type 304 stainless steel support cage to hold the fuel assembly, formed from standard angles tied together on four sides by thin plates at six elevations. This cage provided lateral support over the entire length of the fuel assembly, limiting its possible lateral movement to about 8 mm.

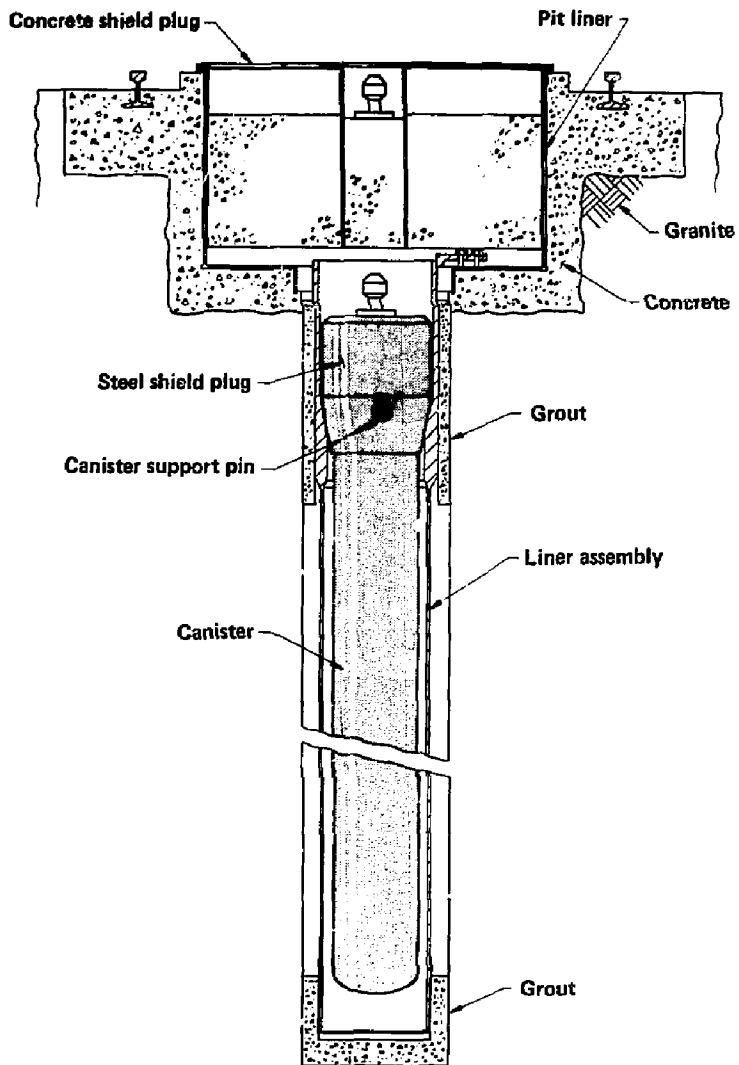
Fig. 2 Drawing of emplacement of liner and canister in repository.

The canisters were lowered into vertical holes drilled into the floor of the Climax facility, located 420 m below ground level and 1116 m above sea level. The holes had been lined with carbon steel liners prior to insertion of the canisters (see Fig. 2). These liners had been grouted in position at top and bottom. The liners had an OD of 457 mm and a wall thickness of 6.35 mm. The liners were about 4.9 m long, and were fabricated from two sections of carbon steel pipe. Six thermocouples were placed at various locations along both the liner wall and the outside surface of the canister.

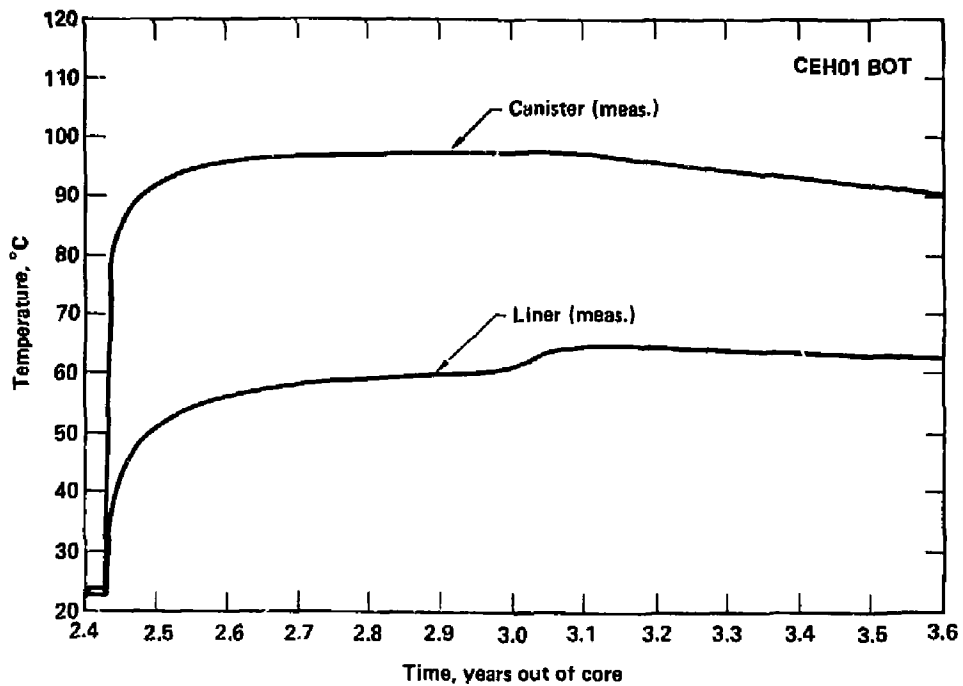
Fig. 3 Temperature histories of the canister and borehole liner located in CEH01. Note the break in the trends of the curves at about 3.0 YOC which result from water being boiled out of the Canister-liner annulus.

Thermocouple data from the canister midheight indicate a maximum temperature of between 135 and 140°C for a period of approximately two months. Of more significance, Fig. 3⁽³⁾ shows the thermocouple data from near the bottom of the canister. It can be seen that the canister temperature rose to a level near the boiling point of water for this elevation (about 96.5°C) and remained there until a time corresponding to about 3.1 years out of the reactor core. At about 3.0 years out of core the thermocouple on the liner recorded an abrupt rise in temperature. It was noted that water was present outside the liner when the liner was emplaced. It is surmised that water had leaked through a crack in the liner early in the test and entered the annular region between the canister and liner as well as the region outside the liner. The rise in the liner temperature occurred when the water between the liner and the rock had completely departed, either by evaporation or percolation through the rock. This produced a poorer thermal conductance between them, because of the change in the primary thermal transport mechanism from conduction-convection to radiation, and allowed the decay heat from the

canister to raise the liner temperature. The canister temperature did not rise when this occurred because water remained in the canister-liner annulus. This was possible because the crack in the liner weld had sealed, probably due to precipitation of solute minerals. The boiling and refluxing of this water held the canister temperature nearly constant. The gradual rise in canister temperature was probably due to concentration of solute species by distillation, which raised the boiling point of the solution. The thermal output decreased with time by nuclear decay until boiling ceased at about 3.1 years out-of-core. The water in the canister-liner annulus slowly evaporated through the gap around the shield plug (see Fig. 2). In support of this suggestion, it should be noted that water was observed on the ledge under the concrete shield plug when it was lifted.

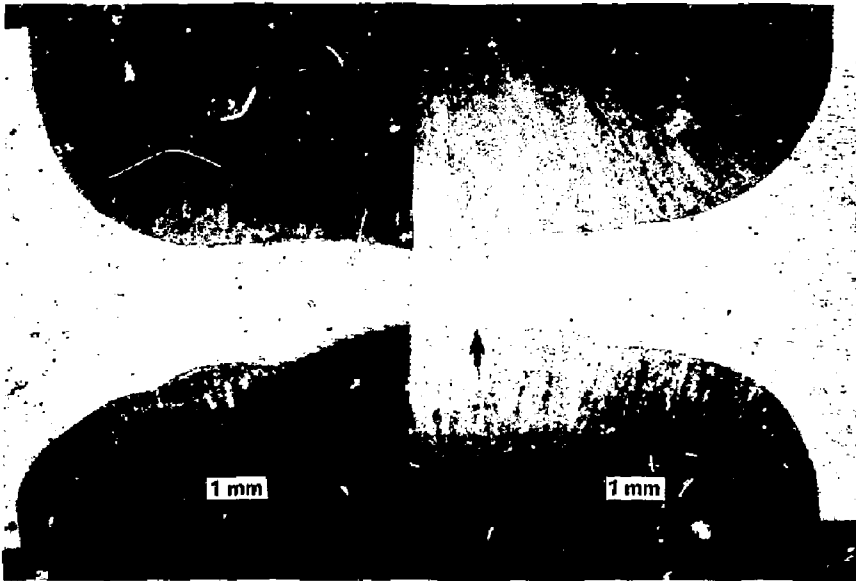
It was determined that the canister was fabricated from longitudinally welded pipe, with both inside and outside welds, as shown in Fig. 5. This weld appears to have been produced by an autogenous resistance-type process, based upon the large width of the fusion zone and the amount of upset in the center, unwelded region. The weld is sound with no fissures; however, one can find fault with the lack of penetration through the wall.

Fig. 5 Autogenous assembly longitudinal weld on canister body, showing incomplete weld penetration and high deformation area (at arrow).

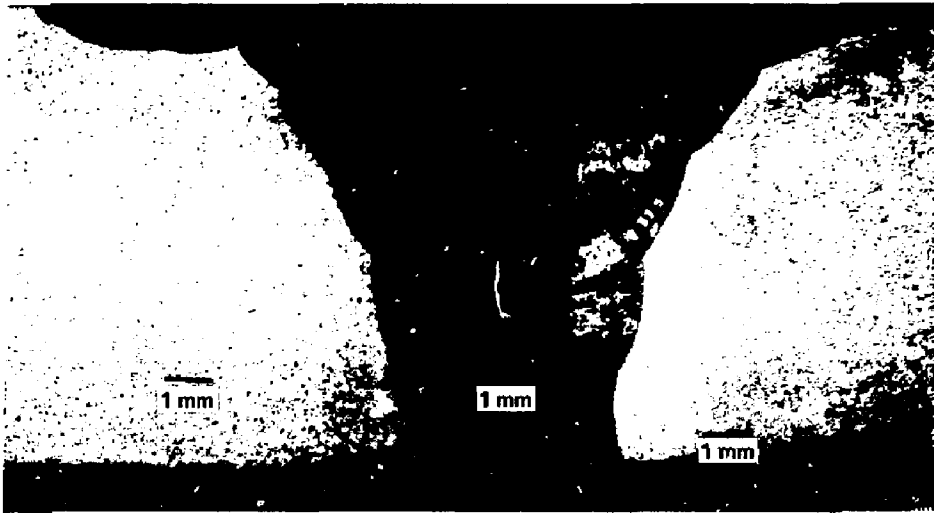
The end cap, Fig. 6, was attached using a multipass, filler weld process. A chemical analysis of the weld material suggests that it was probably AISI 308-type material. The weld appears to be sound and functional. The base material was also analyzed and all the analytical results are shown in Table II.

Fig. 6 Bottom circumferential weld section showing multipass filler wire process.
