**Decommissioning the Brookhaven National Laboratory
Building 830 Gamma Irradiation Facility**

Biays S. Bowerman
Environmental Research and Technology Division
Environmental Sciences Department

**Brookhaven National Laboratory
Brookhaven Science Associates
Upton, Long Island New York 11973**

The Building 830 Gamma Irradiation Facility (GIF) at Brookhaven National Laboratory (BNL) was decommissioned because its design was not in compliance with current hazardous tank standards and its cobalt-60 sources were approaching the end of their useful life. The facility contained 354 stainless steel encapsulated cobalt-60 sources in a pool, which provided shielding. Total cobalt-60 inventory amounted to 24,000 Curies when the sources were shipped for disposal.

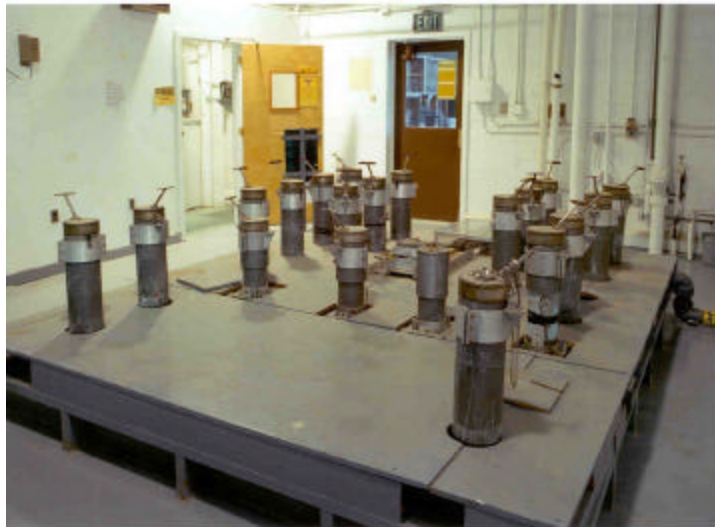
Figure 1 View of the GIF room in 1994, with shielded air tubes and cover in place.

The GIF was built in the late 1960's as an addition to Building 830, then known as the High Intensity Radiation Development Laboratory (HIRDL). Completed and commissioned in 1969, it consisted of a pool, 10 ft. by 8 ft. by 13 ft. deep, with sealed cobalt-60 gamma sources located at the bottom of the pool. The water depth provided shielding. Access to the sources for irradiation studies was through stainless steel air tubes 16 ft. x 4 in. OD x 16 gauge wall thickness. One-inch lead jackets around the air tubes above the water level counter weighed the tube buoyancy and provided shielding to personnel. Pool water was circulated through a chiller/filter system, maintaining pool temperature at 7EC to prevent algae growth. The pool was kept covered (see Figure 1) so that equipment, tools, and personnel would not fall in.

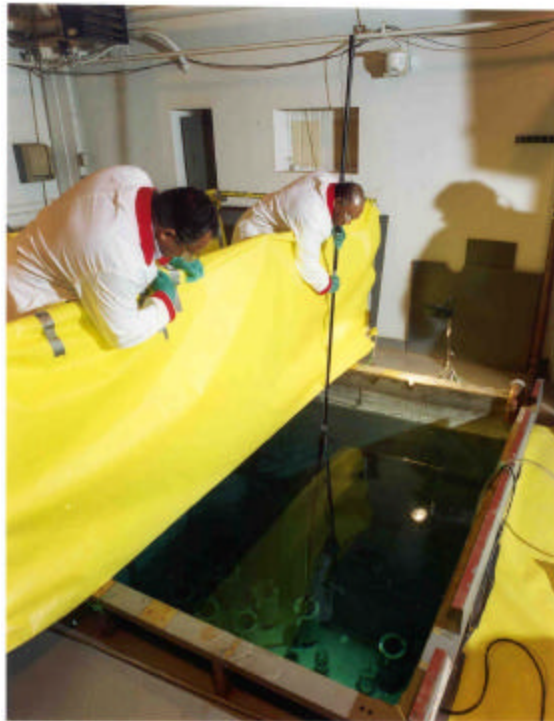
Figure 6 Operators used remote manipulators to move ^{60}Co Sources from racks to basket.

The source transfer or packaging step was accomplished using 20-foot poles equipped with pneumatic pliers at one end. Operators handled these manipulators from a scaffolding and railing placed over the pool to allow more convenient vertical access. (See Figure 6. The operators, from Master-Lee, Inc., were experienced with spent-fuel pools and other remote manipulation work in water.) Worker exposures were minimal and the process took about three days to complete. After the racks (and lead casks) were empty of sources (Figure 7), they were brought out of the pool and surveyed (Figure 8). A few of the racks had fixed contamination and had to be disposed of as radioactive waste. The rest of the racks and the lead casks were free of contamination or had loose contamination that was removed. All these free-release items were eventually sent to an off-site metal recycling company.

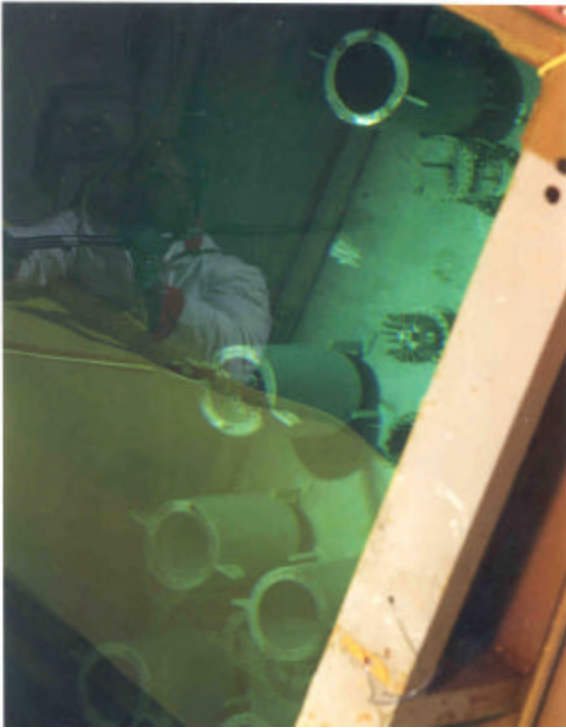
Figure 7 A view of the empty lead casks. Some sources remain in the center rack.

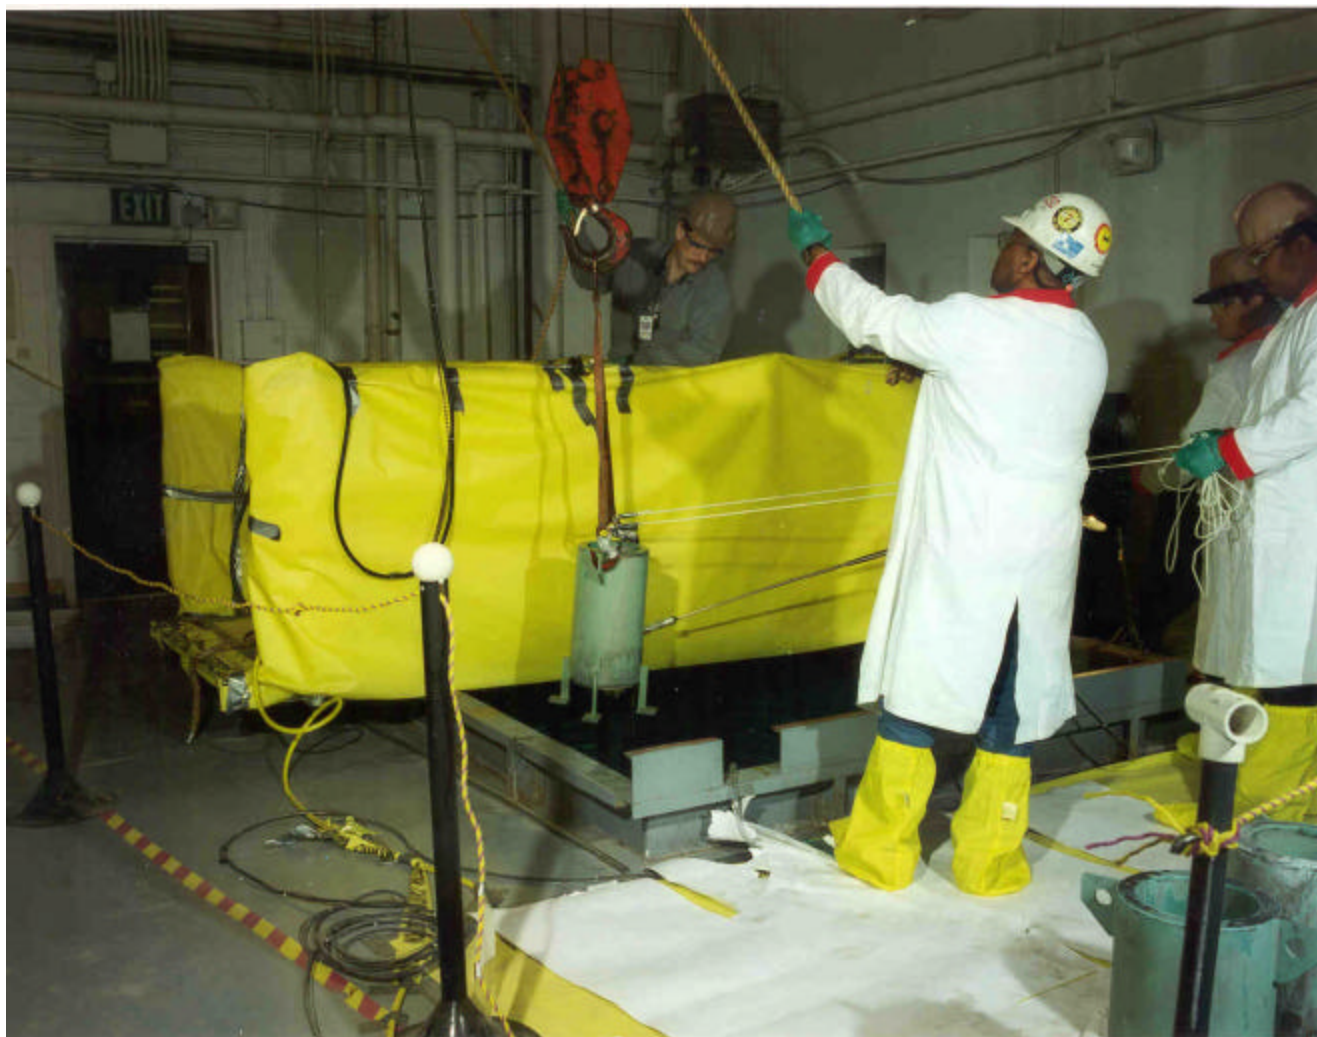
Figure 8 Operator removes lead cask from the pool.

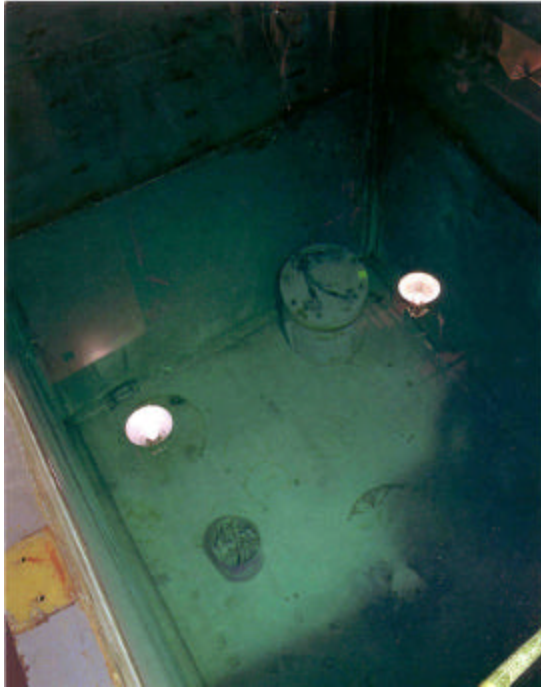
Figure 9 The sources have been packaged, and all racks and lead casks removed.

to model) if the sources were confined to one or two containers, rather than spread over 21 source racks in arrays ranging from 4 to 36 sources. Figure 9 shows the pool after all racks and lead casks were removed, with one of the loaded baskets and a loaded, sealed liner, prior to the inventory verification measurements. Figure 10 is a view of the basket with the room lights out.

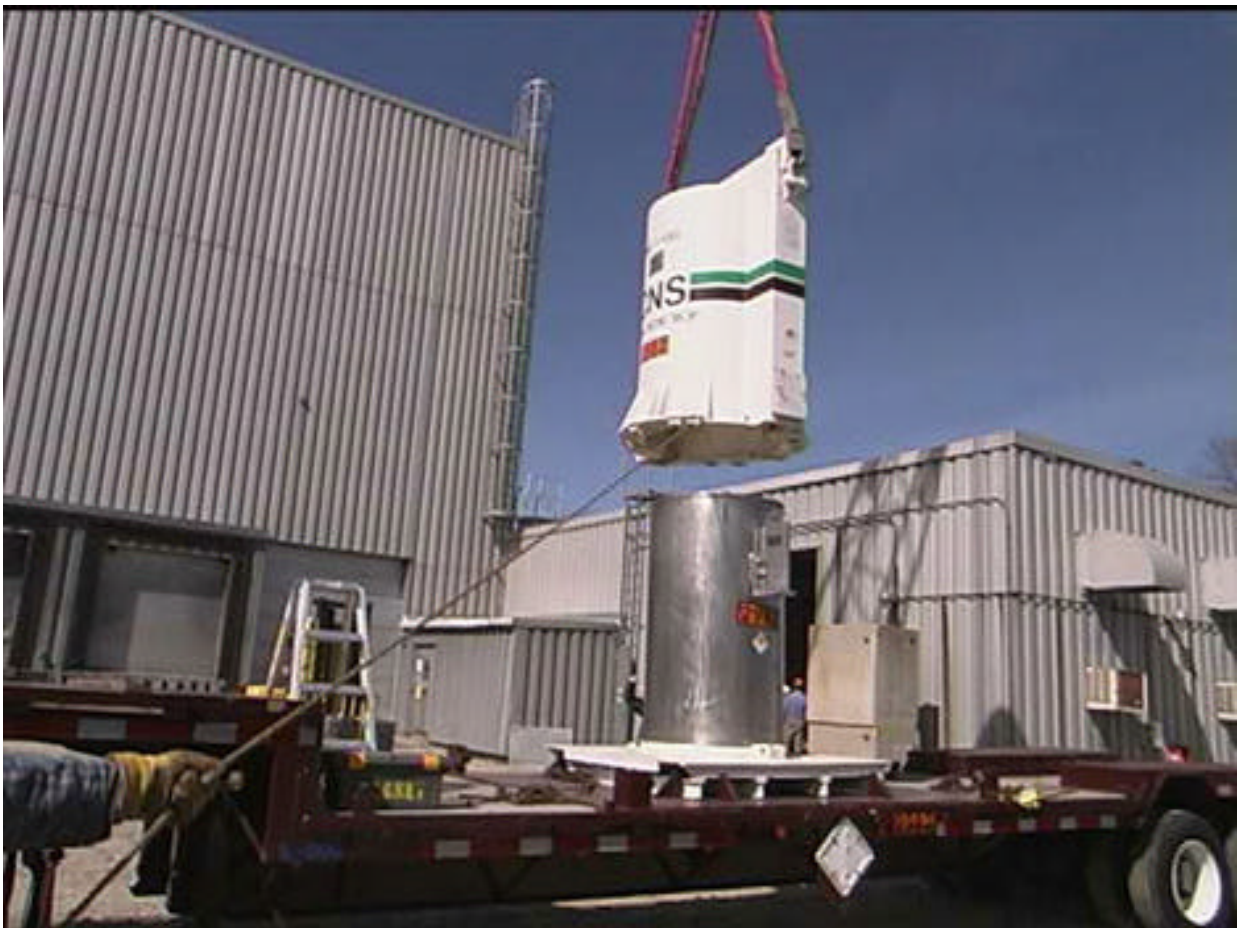
Figure 12 Shipping cask preparation – Removing the impact cover.

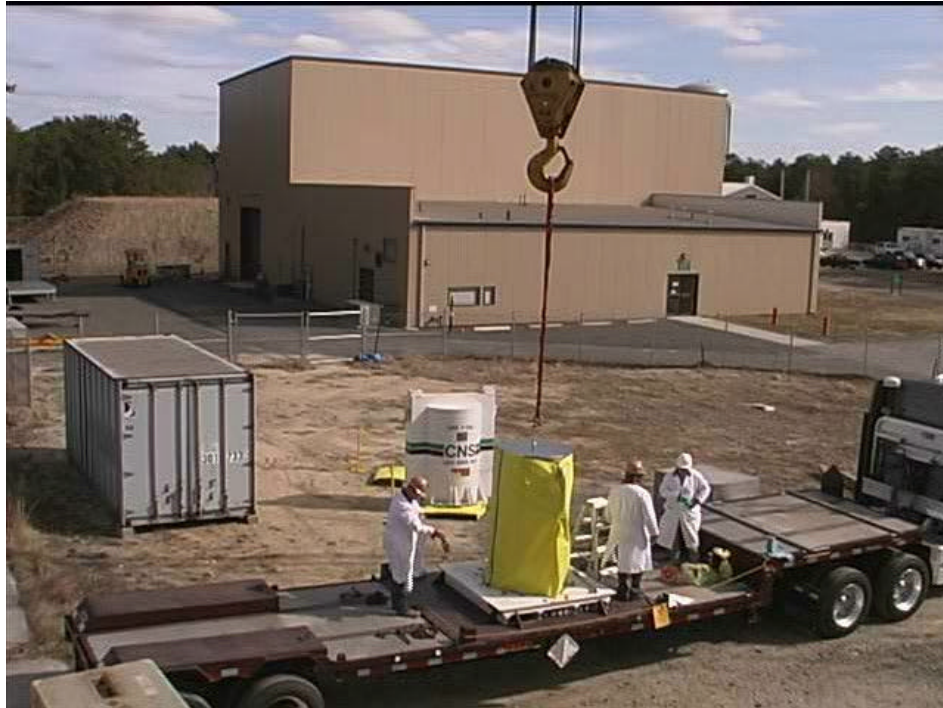
Figure 13 Shipping cask preparation – Removing the contamination seal cover. (Cask was wrapped because low levels of contamination were found under impact cover.)

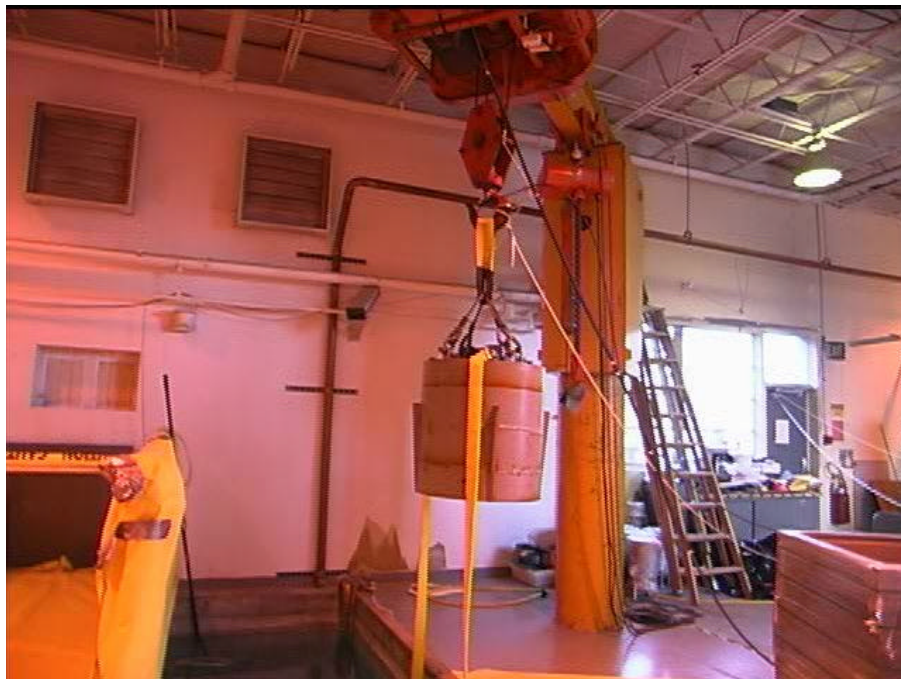
Figure 14 Lifting liner from pool. (Rigging straps were placed remotely while liner was underwater.)

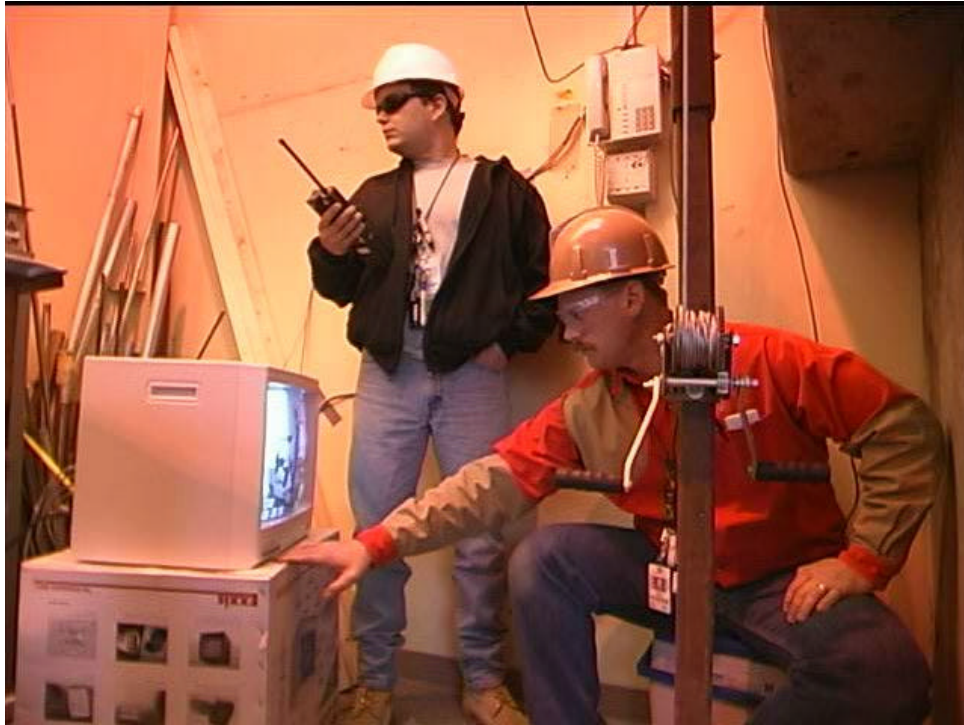
Figure 15 Operating GIF crane from behind temporary shield wall. (HP staff communicates with Control by radio. Crank used to swing crane jib. TV monitor shows position of liner.)

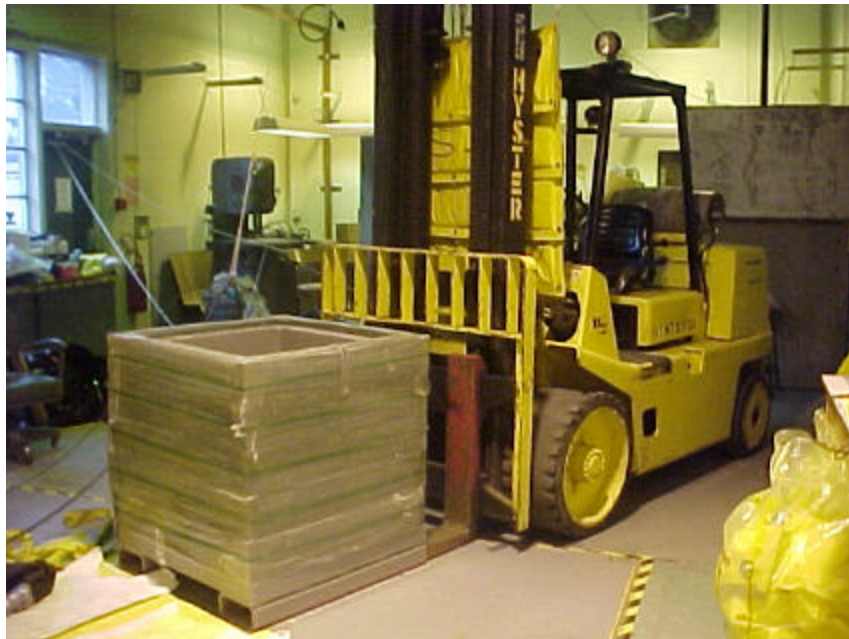
Figure 16 Forklift with shielded transfer box in position next to pool. (Shield wall for crane operator is visible in background to right. The roll-up door was closed for this photo.)

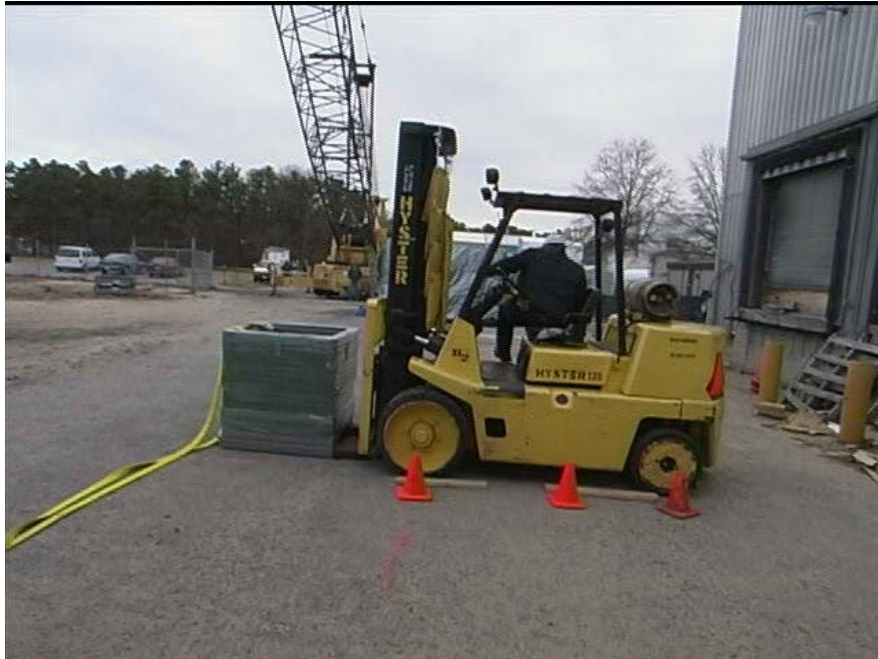
Figure 17 Loaded forklift in parked position outside. (Operator is leaving to go behind shield wall next to Grove crane. Note rigging straps attached to liner in shield box.)

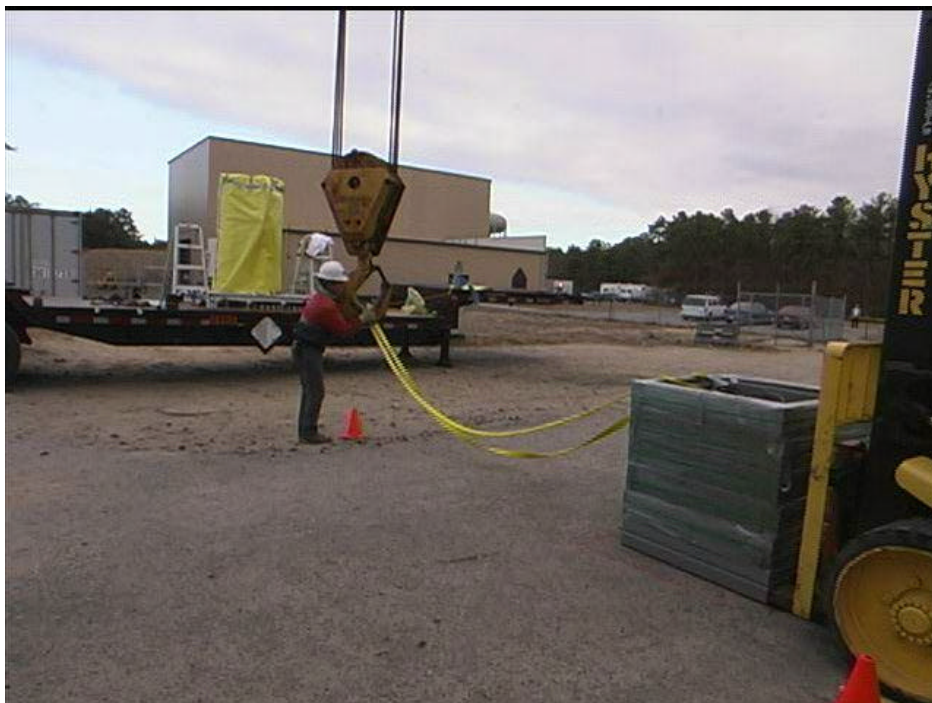
Figure 18 Rigger attaches rigging straps to Grove crane hook before exiting the high radiation area.

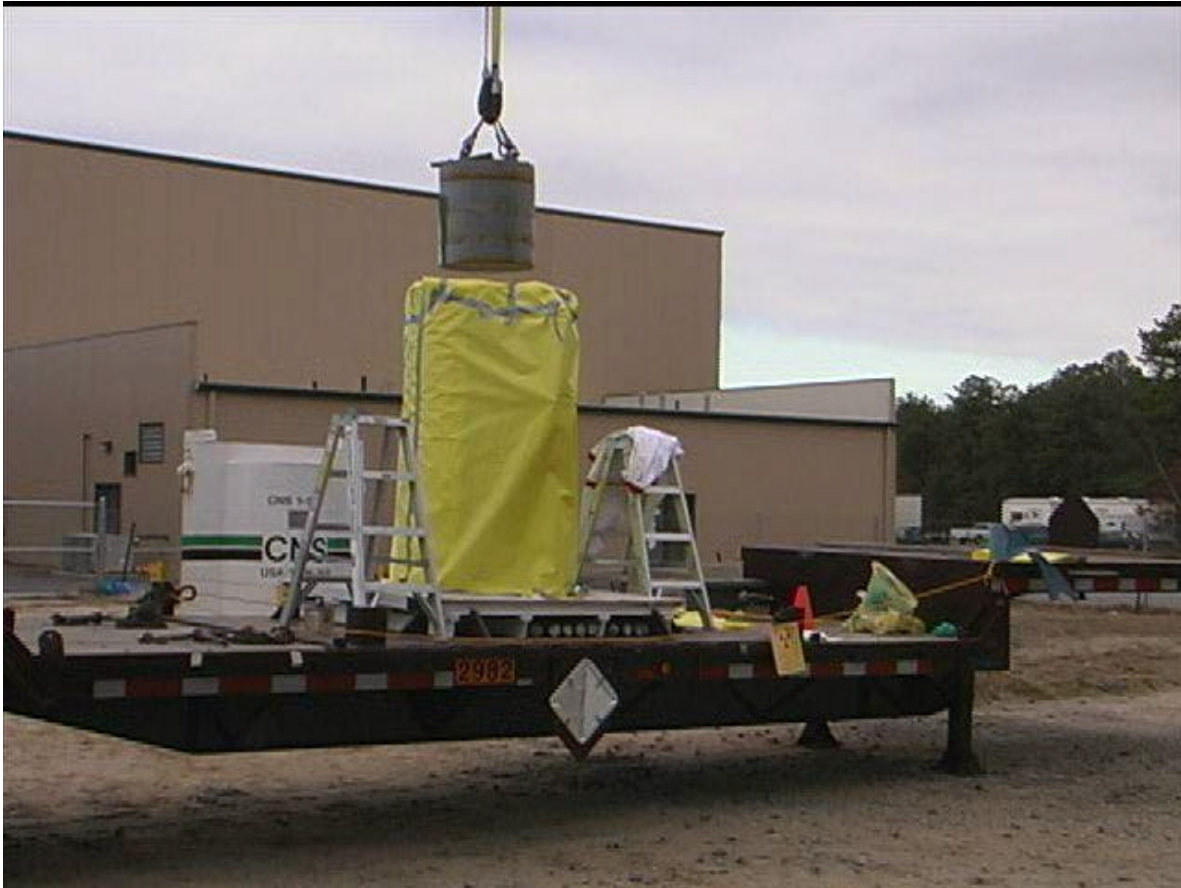
Figure 19 Liner being lowered into shipping cask.

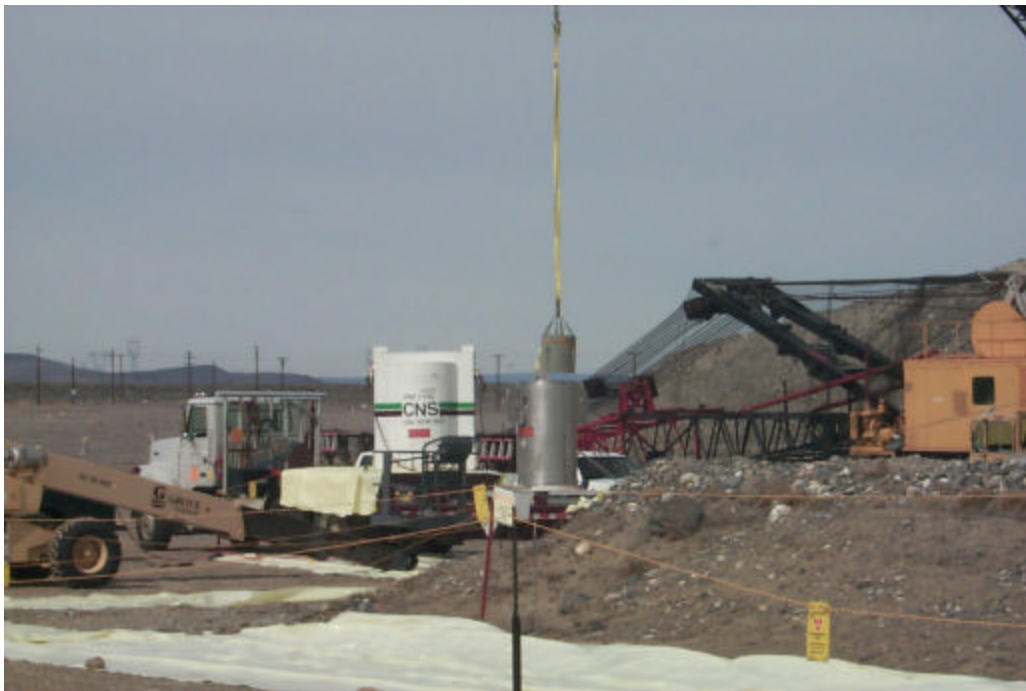
Figure 20 Liner being unloaded at the Hanford DOE disposal facility.

The liners containing the sources were finally disposed of eight days after being removed from the GIF, on Monday, March 20, 2000. Figure 20 shows one of the liners being unloaded at the DOE Hanford facility.

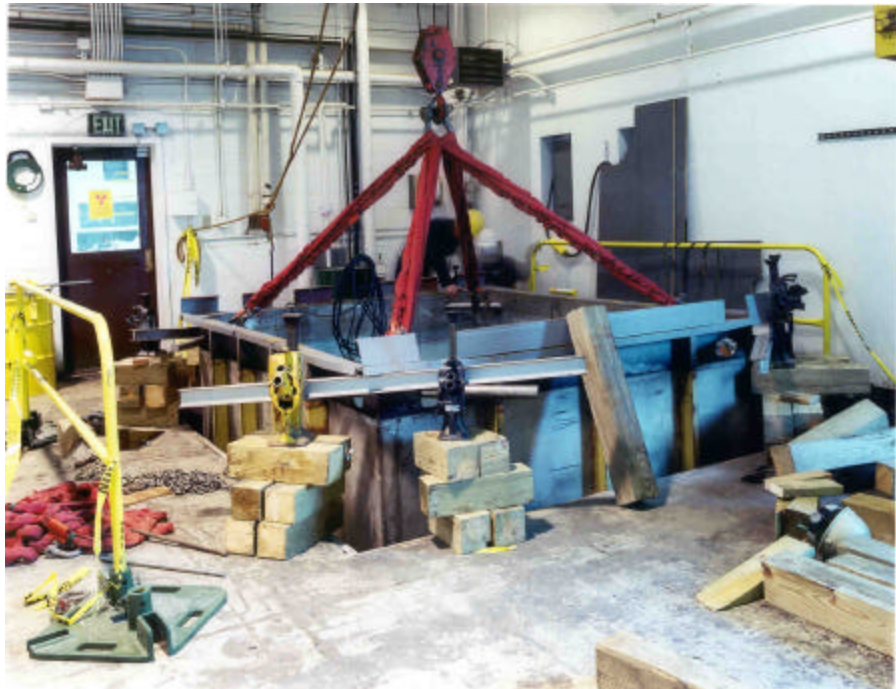
Figure 21 The liner lifted slowly from its installed position.

After the pool was empty and dry, the stainless steel pool liner was surveyed and found to be releasable per DOE/BNL limits ($<1,000$ dpm/100 cm²). Tank removal proved to be a challenge because of its size and configuration. Two scenarios for removal were considered: 1) extensive cutting and removal of small pieces of tank, or 2) removal of the tank in two large pieces. The second scenario was chosen to eliminate Confined Space considerations for welders working inside of the tank. There was some difficulty lifting the tank because the space between the tank wall and concrete-lined pit had been backfilled with sand at the time of construction. Holes were cut at the tank corners for struts to rig to the crane. Initial lifting was measured in inches, using jacks in conjunction with the crane (Figure 21). When the tank was about four feet above its original position in the pit, the sand loosened up so the crane was all that was needed to lift (Figure 22). Here the welders cut more holes for struts to allow the use of the crane to lift further, at which point the tank was cut in half, at the original welded seam (Figure 23). The top half was removed and placed outside (Figures 24 and 25). The lower half was subsequently removed in similar fashion (Figures 26, 27). Both halves of the stainless steel tank, having been surveyed and found free-releasable, were sent off-site for recycling.

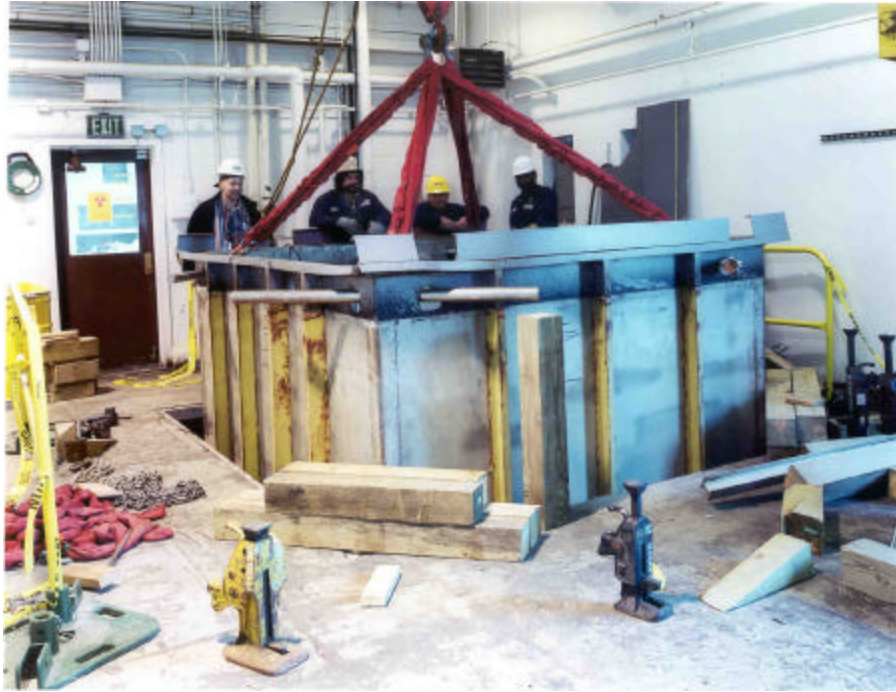
Figure 22 The jib crane was able to lift the tank after the backfill sand loosened up.

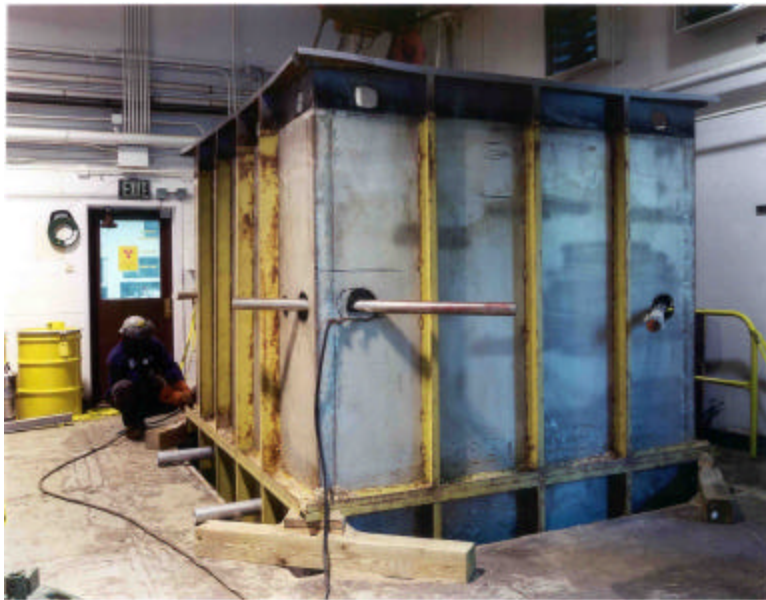
Figure 23 Plasma torch cutting along the original weld seam.

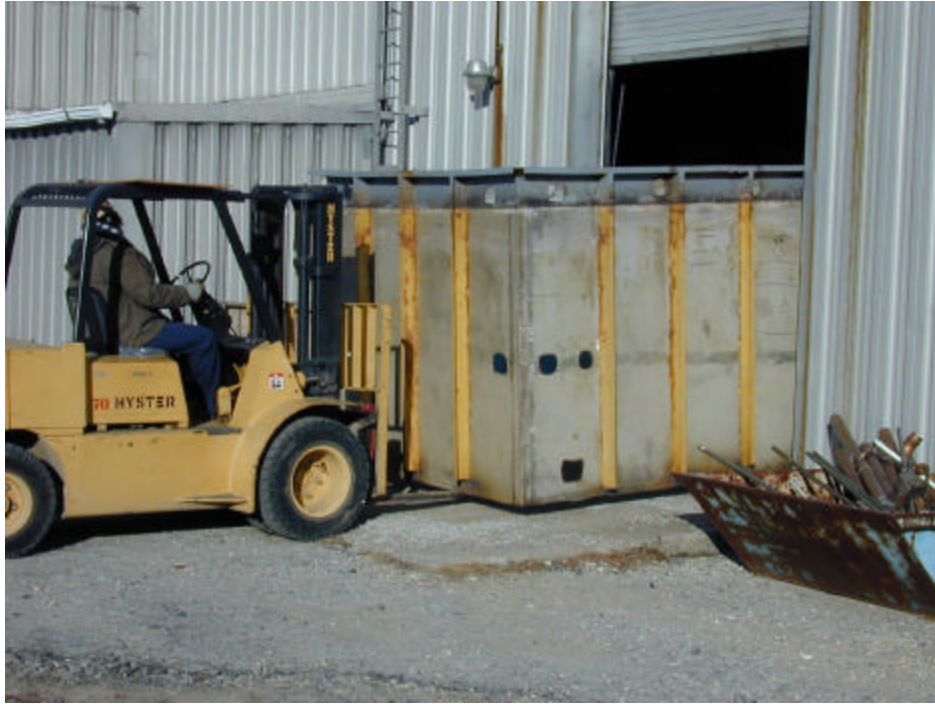
Figure 24 Moving the tank's top half out the roll-up door.

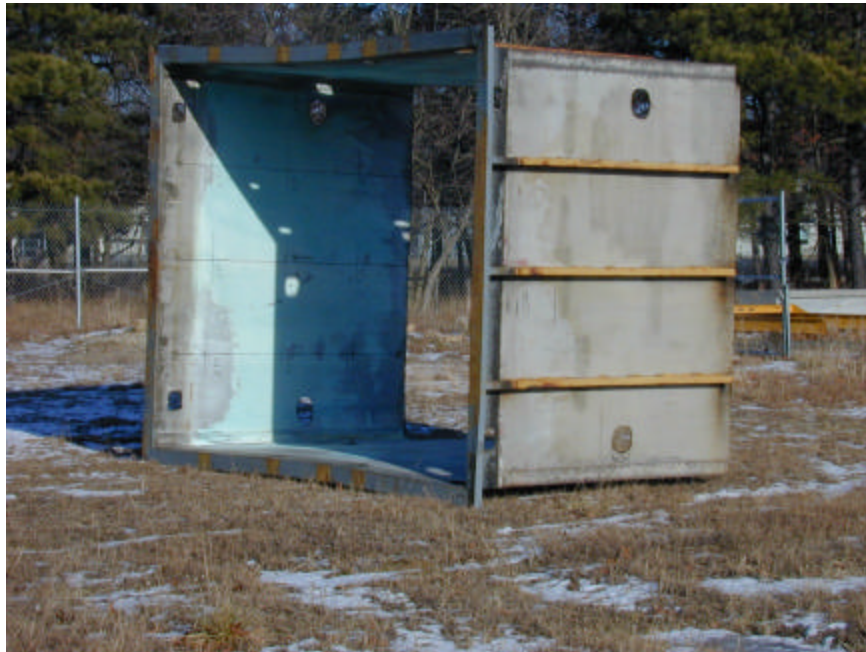
Figure 25 The top half of the tank outside.

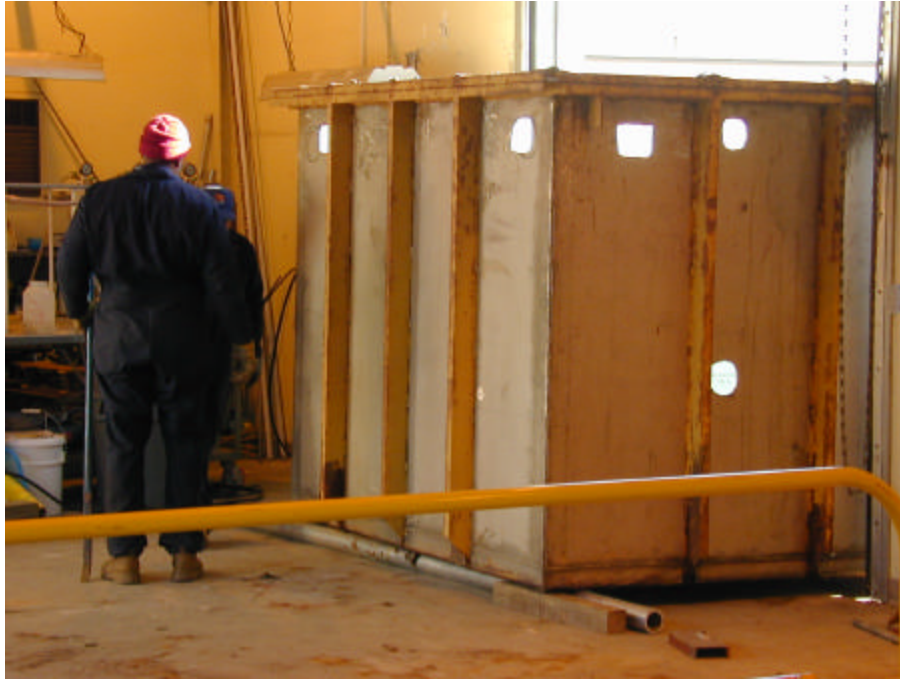
Figure 26 Moving the lower half of the tank out the door.

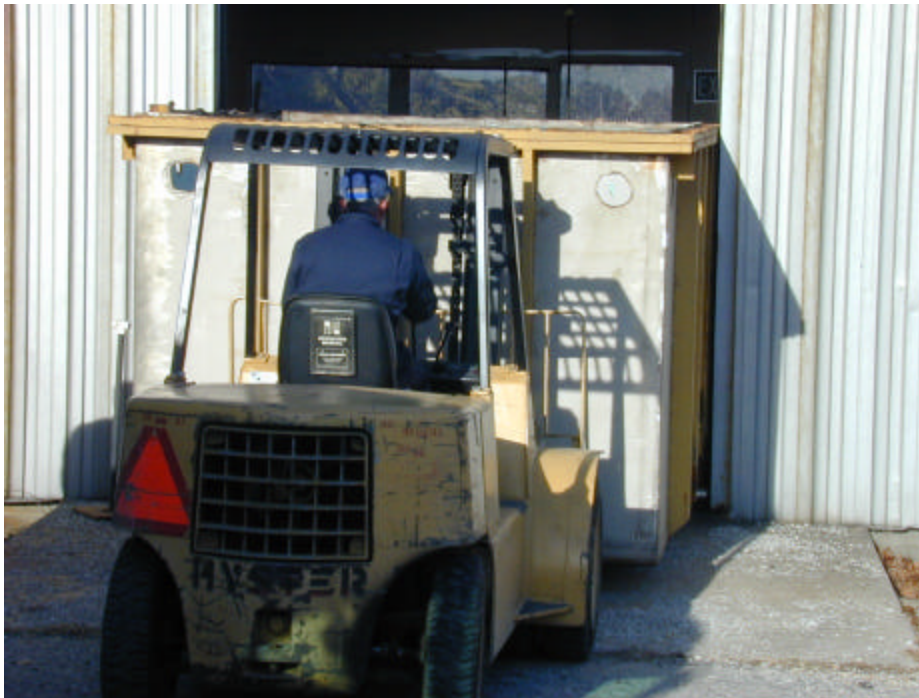
Figure 27 A tight squeeze again, and the lower half is out.

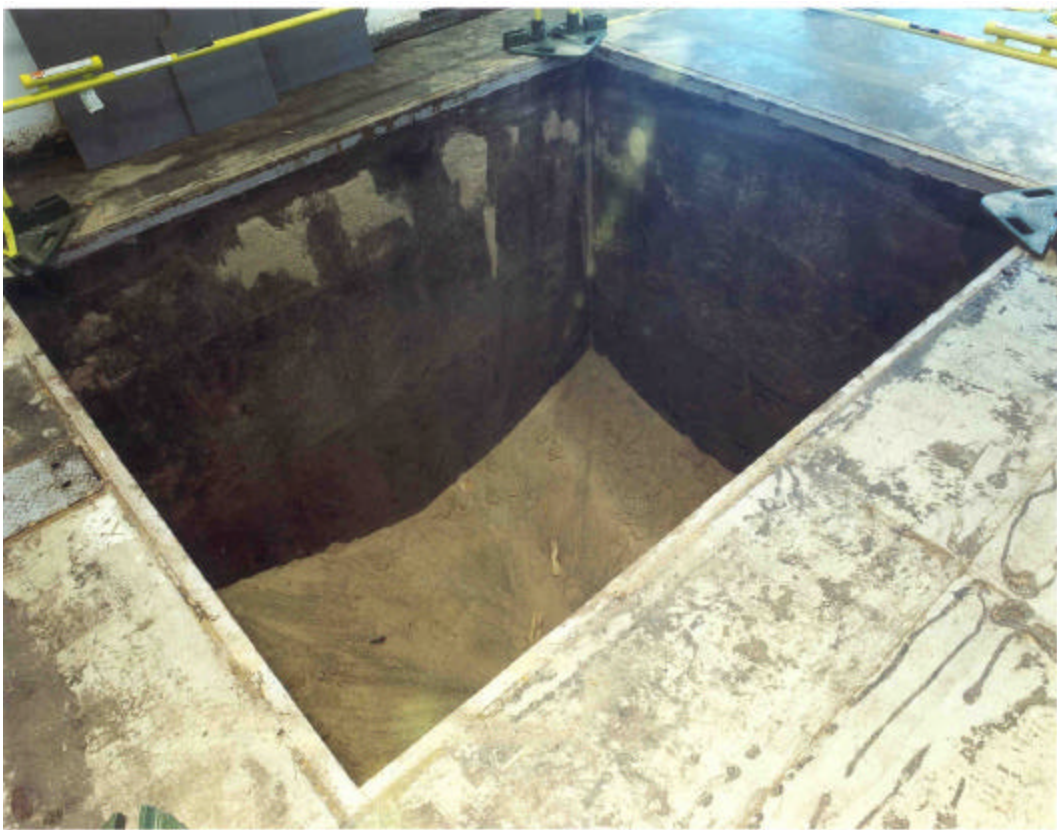
Figure 28 The empty pool pit, with original tank backfill sand.

After the tank removal, the backfill sand (between the tank and pit wall) was left in the pit (Figure 28). The Suffolk County Department of Health Services indicated that sampling and analysis of the sand was necessary to verify that the tank had not leaked and that no residual contamination remained. Samples of the sand at the pit bottom were taken and tested by gamma spectroscopy (COC# 21012209). No radioactive contamination was detected, and backfilling the pit began.

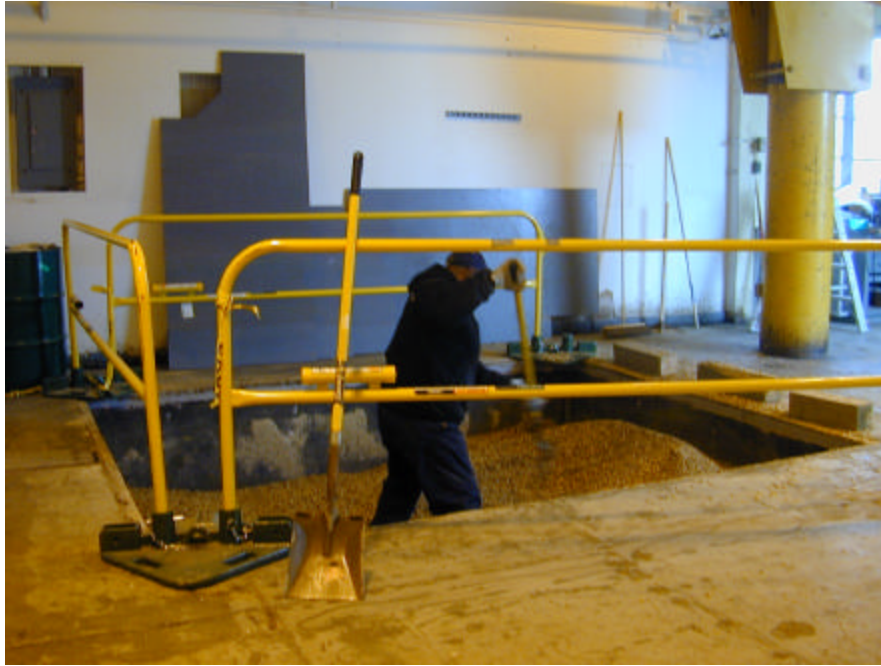
Figure 29 Spreading and tamping the gravel backfill.

The pit was filled with gravel, rather than sand, to provide a cost saving in reduced labor and risk. Sand would have required workers operating a motor-driven tamper in the pit to compact the sand. This would have meant confined space restrictions because of the emissions from the tamper. Gravel required minimal manual tamping (Figure 29). The last two feet of the pit were capped with reinforced concrete (Figure 30). Following this, the floor was painted to match the rest of the room. The only remaining evidence that the GIF was in the room is the 5-ton jib crane (Figure 31).

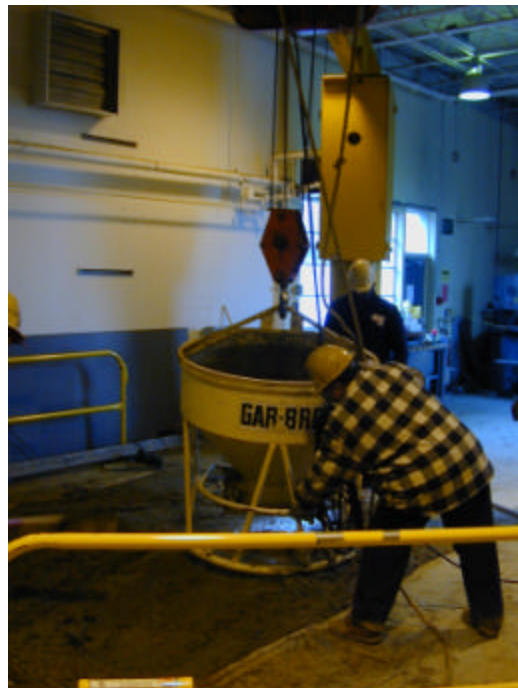
Figure 30 Installing the concrete cap.

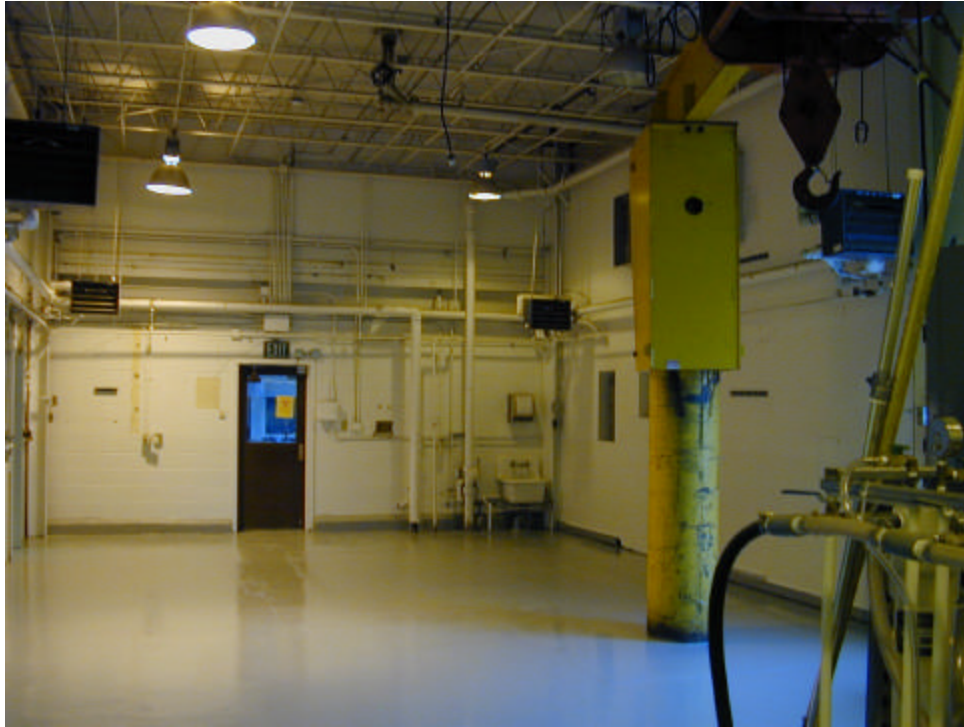
Figure 31 The finished product, an empty room with a crane.
