**Characterization of Leak Pathways in the Below Grade
Ducts of the Brookhaven Graphite Research Reactor
Using Perfluorocarbon Tracers**

Environmental Sciences Department

April 2001

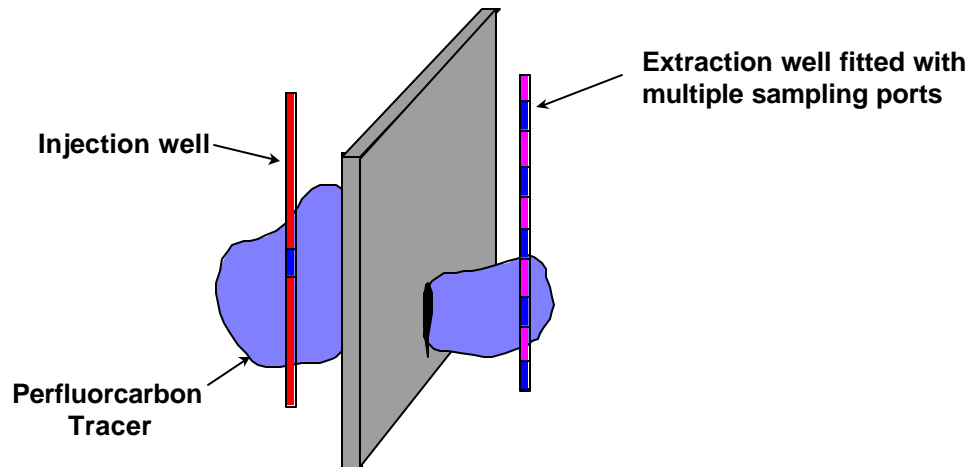
Figure 2. Schematic of leak detection using perfluorocarbon tracer technology

Very small leaks are easily identified because PFTs can be detected at extremely low levels. Leaks in the BGRR Below Grade duct were located by injecting the PFT(s) inside of the duct and monitoring for that tracer(s) outside of the duct (see Figure 2). Where and how much of the tracer was detected on the monitoring side of the duct helped estimate the location and size of any leaks. Larger openings in the duct mean that greater concentrations of tracer are transported out more rapidly. The injection and monitoring of the tracers were accomplished using conventional low-cost monitoring methods, such as multilevel sampling ports, placed using cone penetrometer (Geoprobe®) techniques.

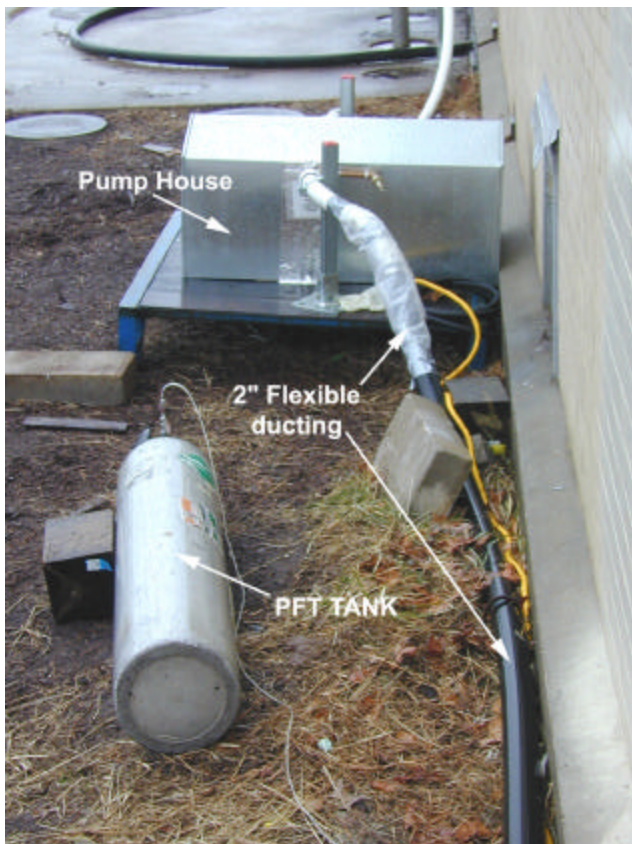
Figure 3. Injection loop at the pump for south duct

plenum, and 12 volume exchanges per day in the smaller north secondary plenum. The tracer gas cylinders were connected to the circuits to allow injection of the PFTs.

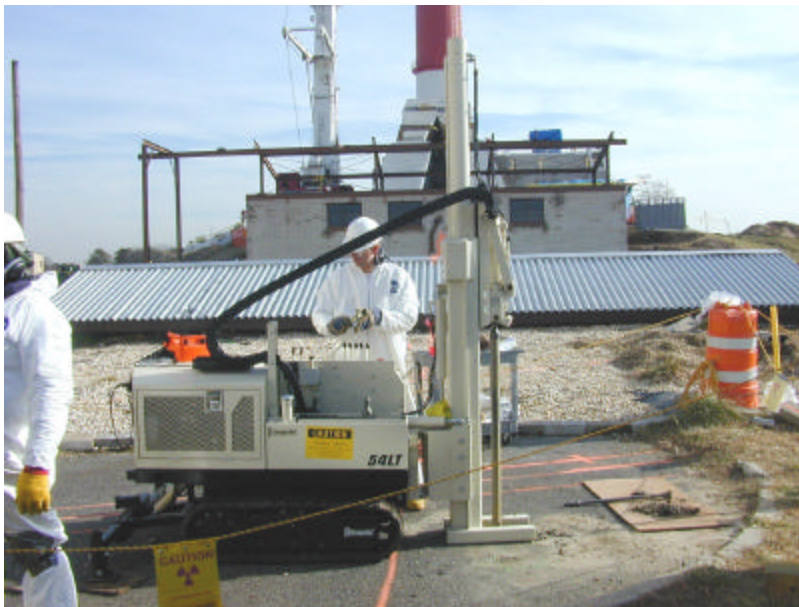
Figure 5. Geoprobe® Model 54 LT continuous push soil-probing unit used to install monitoring ports in soil adjacent to the BGRR Below Grade Ducts

The boreholes were placed using a Geoprobe® Model 54 LT continuous push soil-probing unit (Figure 5). This unit is basically a hydraulically-driven penetrometer that was used to push a 2.125-inch outer diameter steel rod into the subsurface at each monitoring well location. The rod was then withdrawn and the resulting hole used for installation of the monitoring ports. The ports themselves are of simple design (see Figure 6): a sintered glass filter, to prevent plugging, was attached to a length of 0.125 in polypropylene tubing. Several ports are bundled together, each having a different length of tubing. The bundle of ports was then lowered into the borehole until the first port reached the desired depth. Once the filter was in place, the hole was backfilled with a blended-sand mix. The sand was used to prevent vertical cross-talk from port to port and to prevent advective currents in the borehole. Backfilling was completed by slowly pouring sand down the 2.125-inch hole. The sand firmly held all the ports in place and kept them at the desired depths.

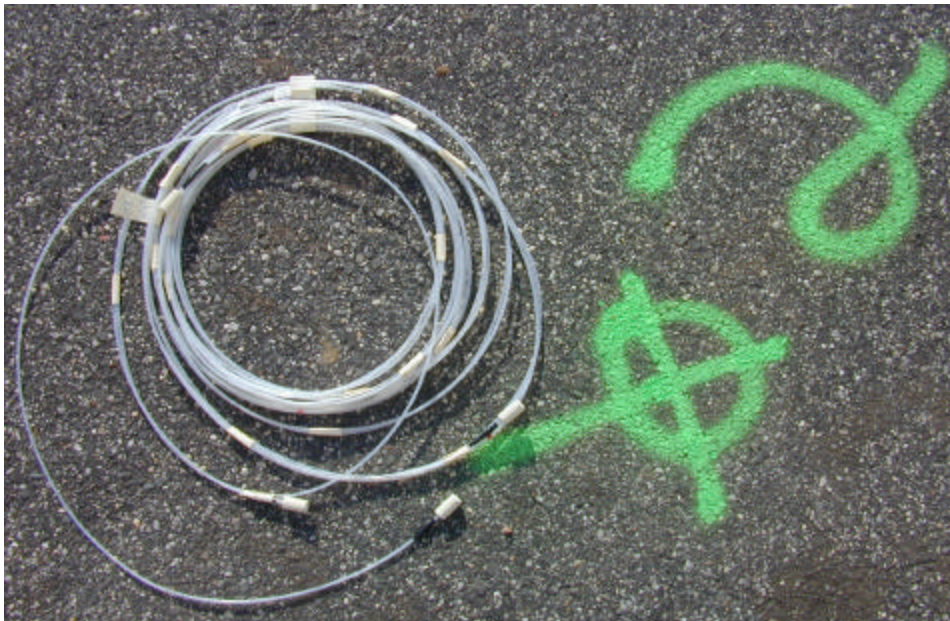
Figure 6. Bundle of sample ports showing the sintered glass filters attached to polypropylene tubing

The ends of the monitoring port access tubes (attached to the filters) extend to the surface to allow sampling of the soil gases. The polypropylene tubing was protected using short lengths of two-inch polyvinyl chloride (PVC) pipe. The pipe was placed over the tubing and into the top of the borehole as the last foot of borehole was being backfilled.

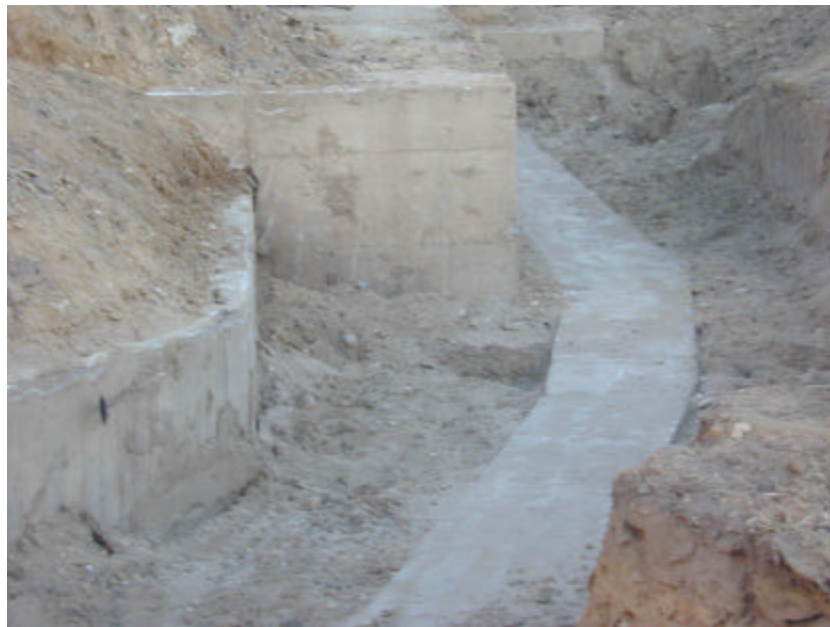
Figure 7. The underground electrical duct running along side the south cooling duct

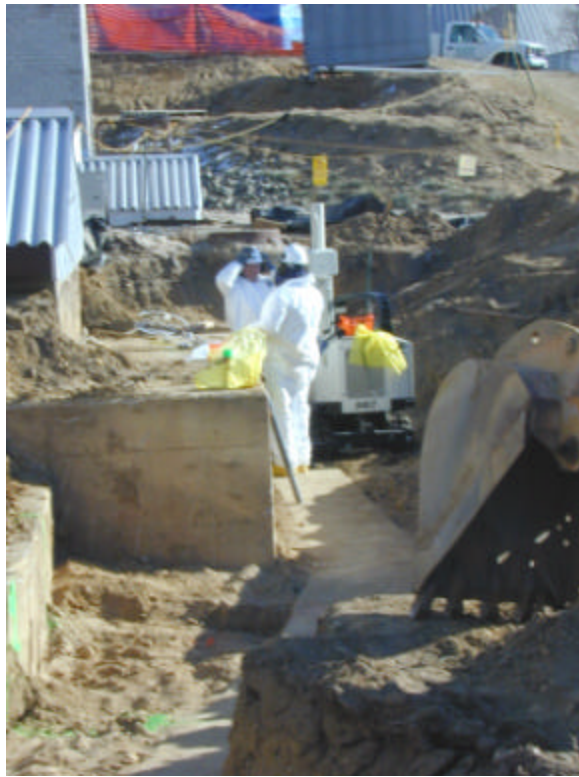
Figure 8. Geoprobe® installing ports along the south duct, between the electrical duct and main duct

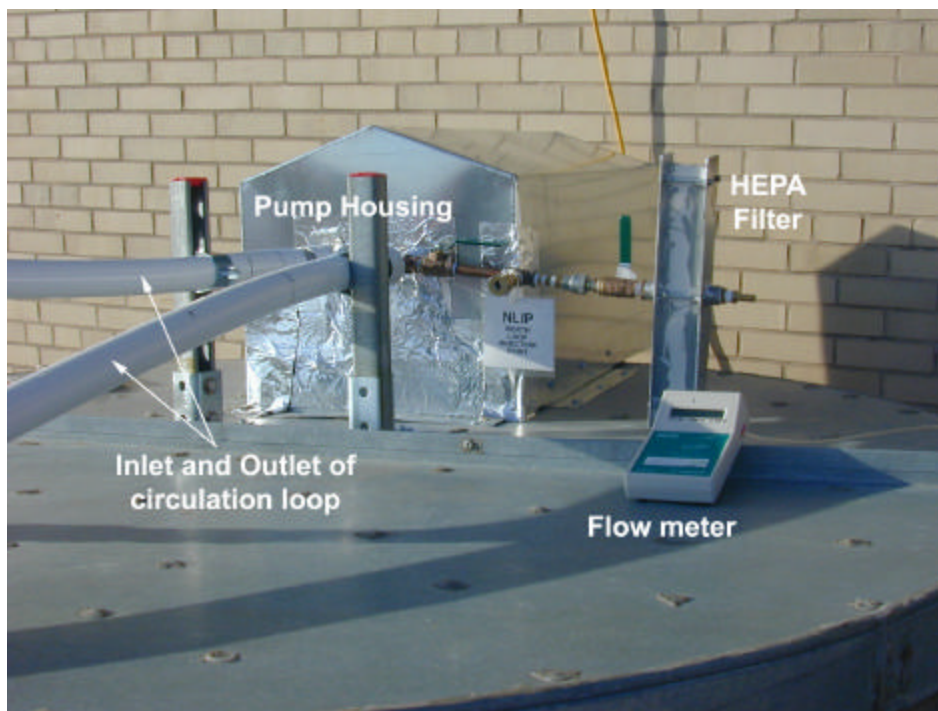
Figure 9. Flow meter connected to tracer inlet of the north air circulation loop

The rate of gas injection was determined based on the volume of the cooling channel, the source concentration of the tracer (100 to 1000 parts per million [ppm]), expected diffusion rates and engineering assumptions about the cross-talk between the primary duct and reactor pile volumes with the secondary cooling ducts. The north and the south ducts are isolated from each other, therefore a different tracer was used in each cooling duct. This yielded data that is specific for each duct and helps to more accurately define transport pathways. PDCB tracer was injected into the north secondary-duct at an average injection rate of 19.1 milliliters per minute (ml/min). PMCH was injected at a rate of 9.1 ml/min into the south secondary duct. The injection of tracers began on January 30, 2001 and ended February 6, 2001. The flow rates of the tracers were monitored daily during injection of tracers. Figure 9 shows the flow rate being measured at the north injection loop using a hand-held electronic flow-meter.

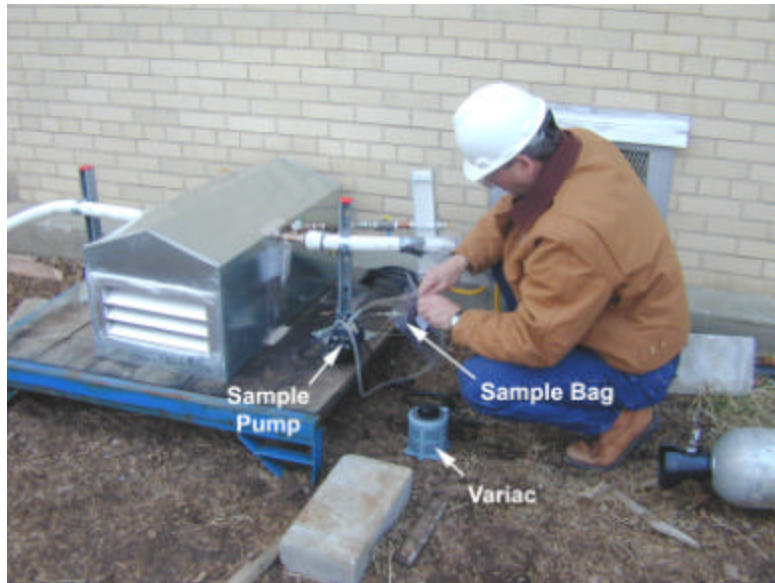
Figure 10. Air sample being collected at the south circulation loop

minute to a volume of 500 to 1000 ml. The typical chemical analysis used one ml, and prior field experience had determined that a maximum of 50 ml would be required for analysis. The pump was controlled by a Variac variable voltage controller to allow throttling the pump and provided an adjustable flow rate. The valve to the bag was shut when an appropriate volume was obtained, then the pump was turned off and the valve to the HEPA closed. The sample bags were then sent to an on-site analytical laboratory for chemical analysis (described later). Figure 10 shows a sample being taken at the south injection loop. Figure 11 shows a close-up of the sampling pump and the sample collection bag.

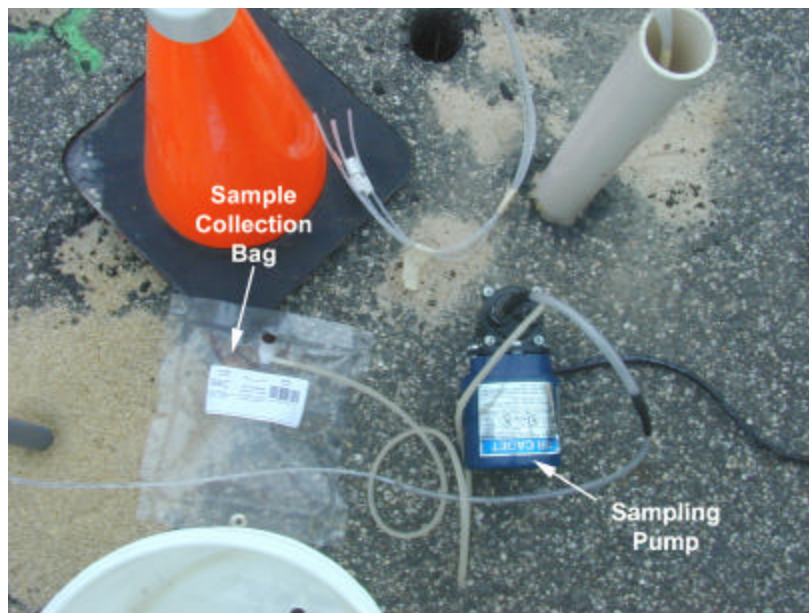
Figure 11. Gas sample bag and pump used to collect air samples

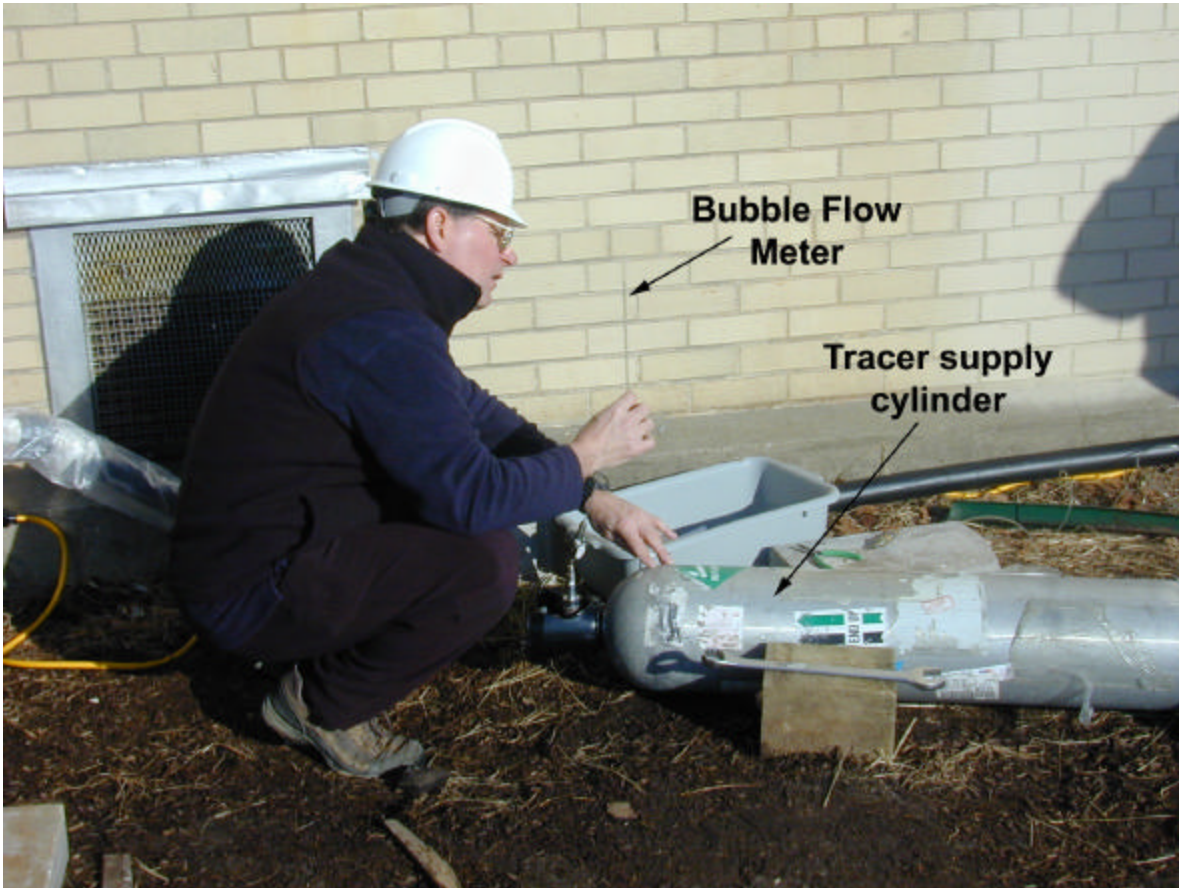
Figure 12. Measurement of tracer flow rate using a bubble meter

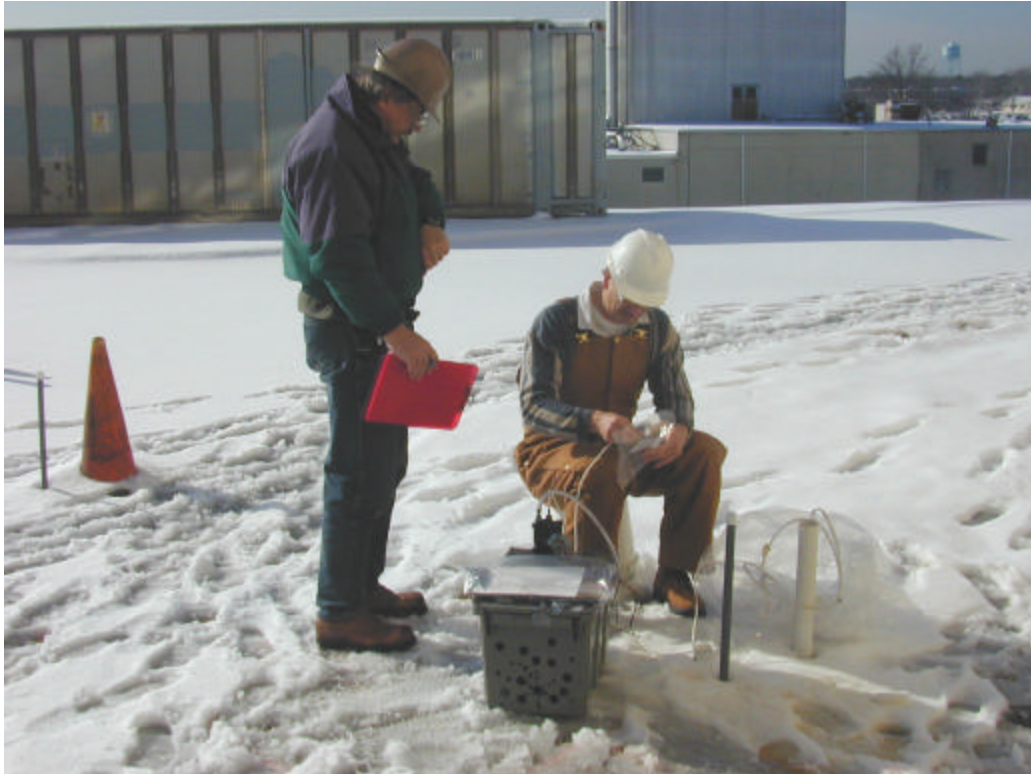
Figure 13. Collecting air samples from an external port

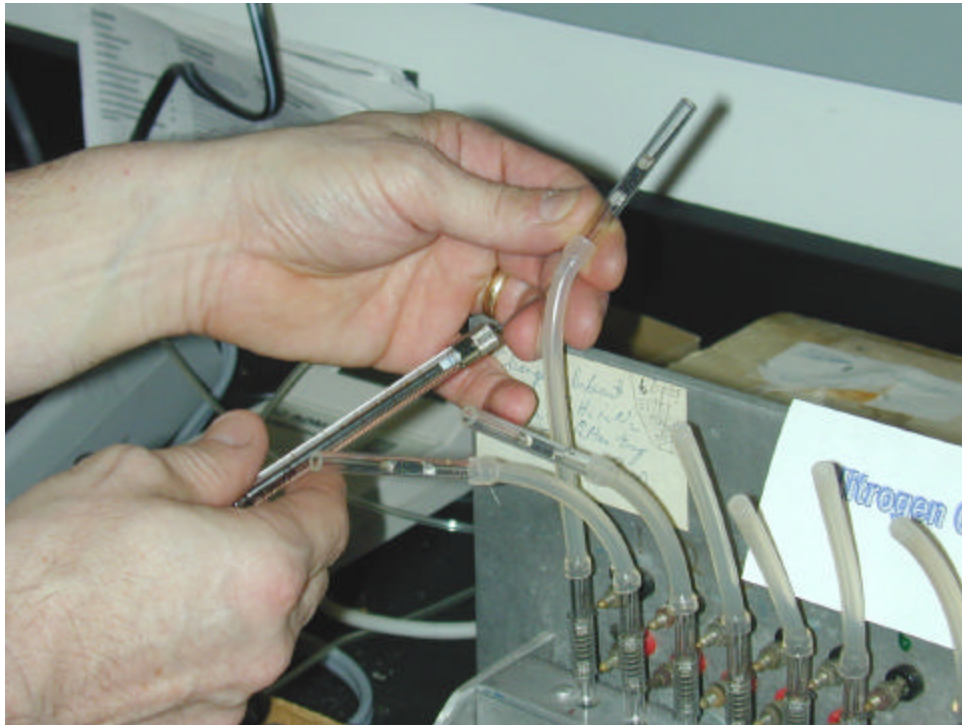
Figure 14. Injection of sample onto a Capillary Adsorbent Tracer Sampler (CATS)

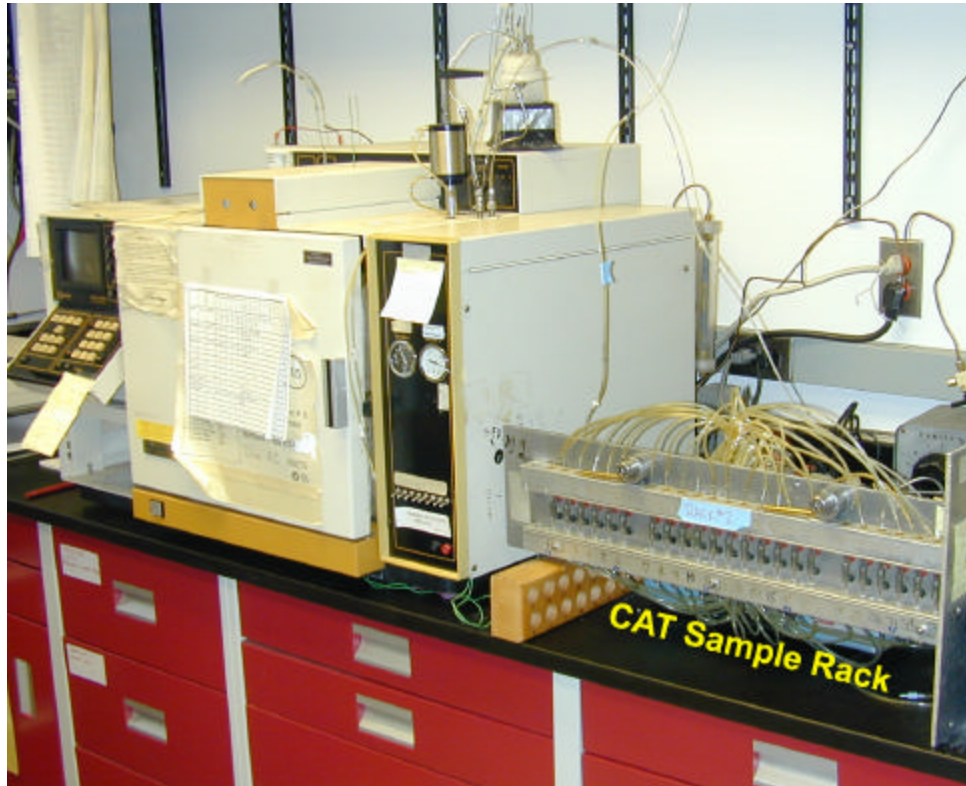
Figure 15. Gas chromatograph and CATS sample rack used to analyze samples for PFTs

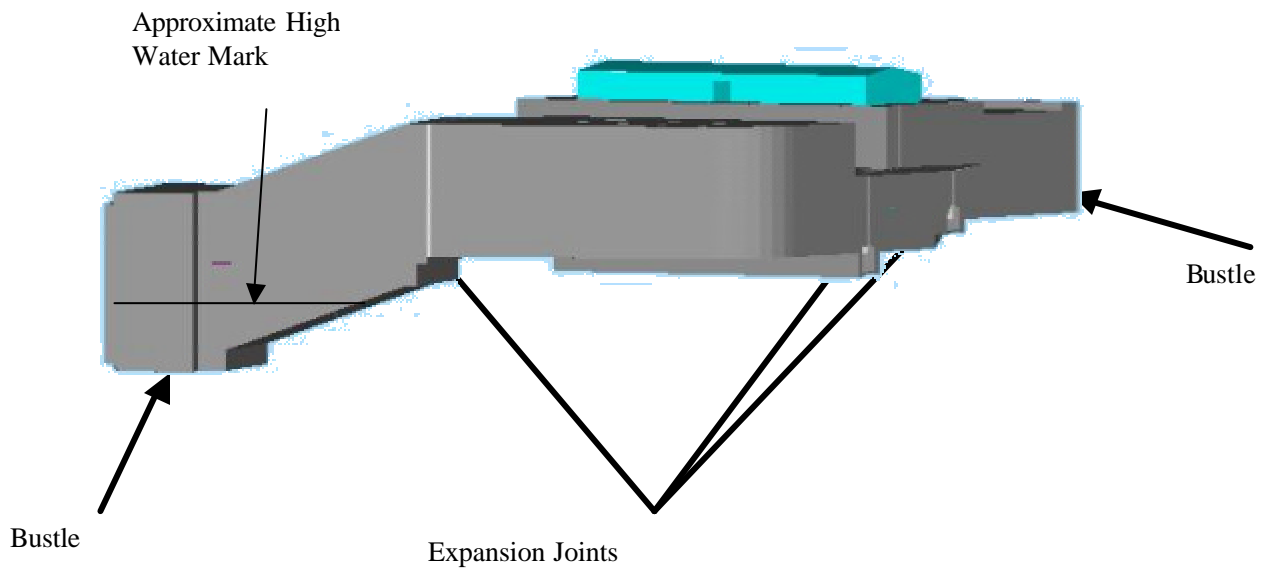
Figure 16. South duct features

The BGRR below grade ducts were constructed with five major expansion joints. Figure 16, South duct features, and 17, North duct features, are side view representations of the ducts indicating the location of the expansion joints in these ducts. Additionally, each bustle area labeled on the figures has an expansion joint. It was expected that the expansion joints would be susceptible to gas leakage due to corrosion from water accumulated in the ducts in the years since the BGRR was shut down. The accumulated water was pumped out in 1998, and the area has been monitored for water intrusion since. These figures also include the approximate location of the high water marks found inside the duct. At the lowest elevation, near Building 701, the water mark was approximately 66 inches above the bottom of the primary duct. Therefore, gas leak pathways below the high water level required increased attention as they may be indicative of water leak pathways.

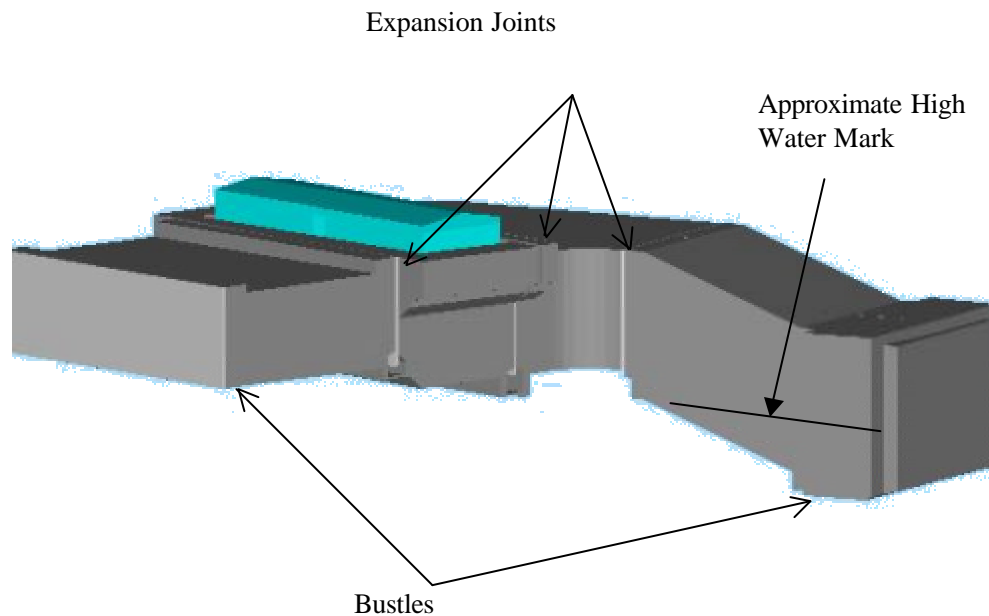
Figure 17. North duct features

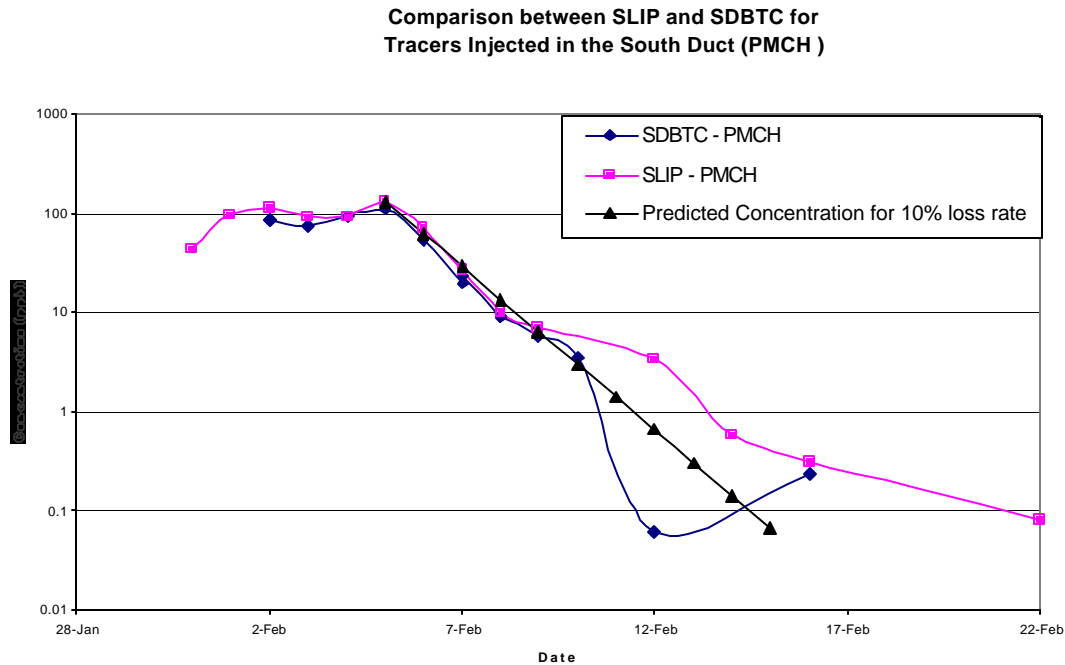
Figure 18 presents the concentrations at the two monitoring locations (SLIP – South Loop Injection Point and SDBTC – South Duct Bottom Tracer Concentration) in the secondary plenum during the entire testing period (interior sampling locations are provided in Figure 1). Figure 18 demonstrates the excellent agreement between the two locations indicating that the tracer was well mixed in the plenum.

Figure 18. PMCH Concentration in the south duct secondary plenum

An equilibrium concentration of approximately 100 ppb was maintained during the injection period. Once the injection was stopped on February 6th, the concentrations both decreased at a steady rate. By performing a simple mass balance model, it was estimated that approximately 10 percent of the tracer was lost for each complete volume circulation for the south duct secondary plenum. In this duct, the flow rate of ten cubic feet per minute led to a complete exchange of the air volume of the secondary plenum in approximately 3.3 hours. The model, assuming a 10 percent loss rate per complete air exchange, predicted an equilibrium concentration of approximately 100 ppb for the injection concentration and flow rate used in the test.

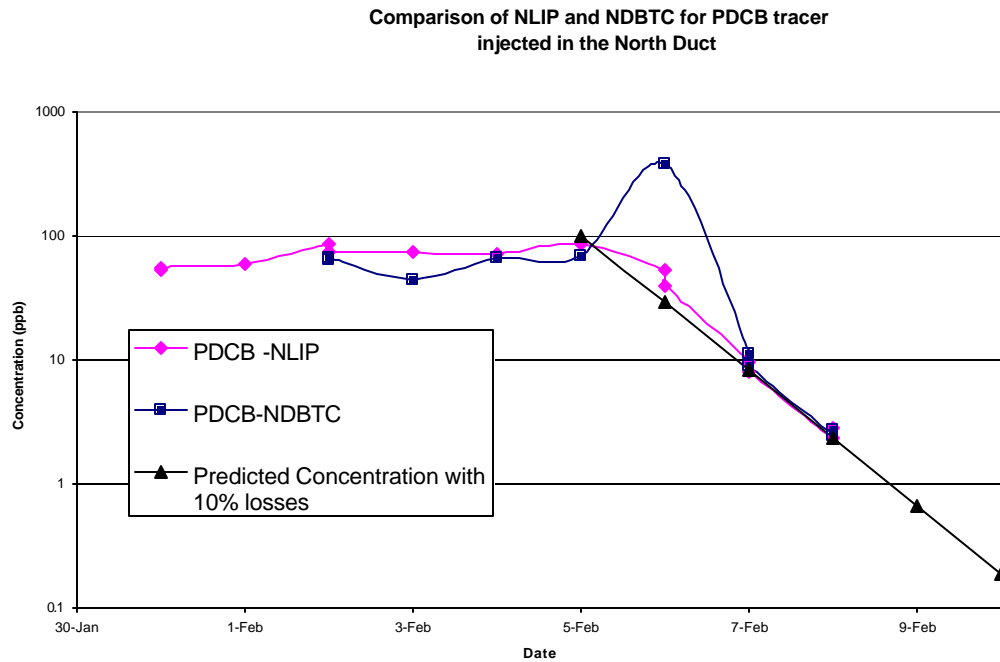
Figure 19. PDCB Concentration in the north duct secondary plenum

Figure 19 displays the PDCB concentrations in the north duct. Again, an equilibrium concentration near 70 ppb was attained during the injection period. The peak in concentration was observed on February 6th at the end of the injection period. This is believed to be due to experimental error due to insufficient purging of the sample lines. However, this cannot be unequivocally demonstrated. Figure 19 contains the concentrations at NLIP (North Loop Injection Point), NDBTC (North Duct Bottom Tracer Concentration), and the predicted concentration after the source was turned off, assuming ten percent loss for each time the volume of flow induced by the fan equaled the volume of the secondary plenum. The north duct is approximately 40 percent smaller than the south duct in volume and, a complete exchange of air through the plenum required only 2 hours. Therefore, the decay in concentration was expected to occur much faster than in the south duct. This was the case, and the predicted curve matched the data well for the first three days after the source was terminated. After February 9th, the measured value of PDCB in the two sampling locations was less than 0.001 ppb. The cause for the rapid decrease in PDCB concentration after this time is not known.

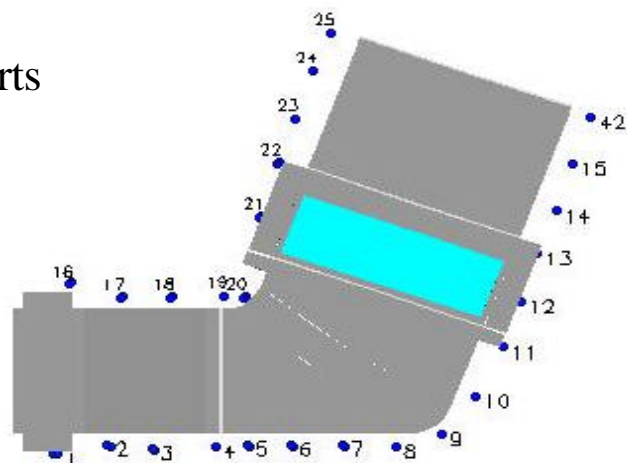
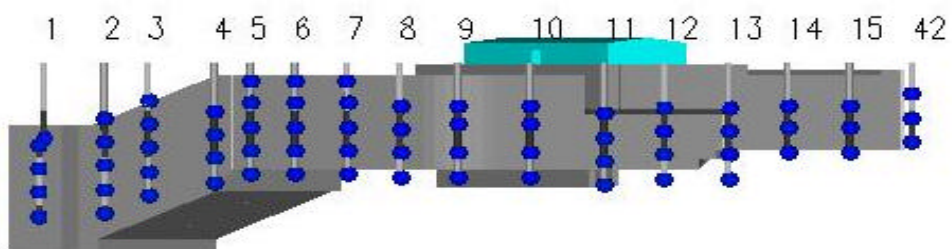
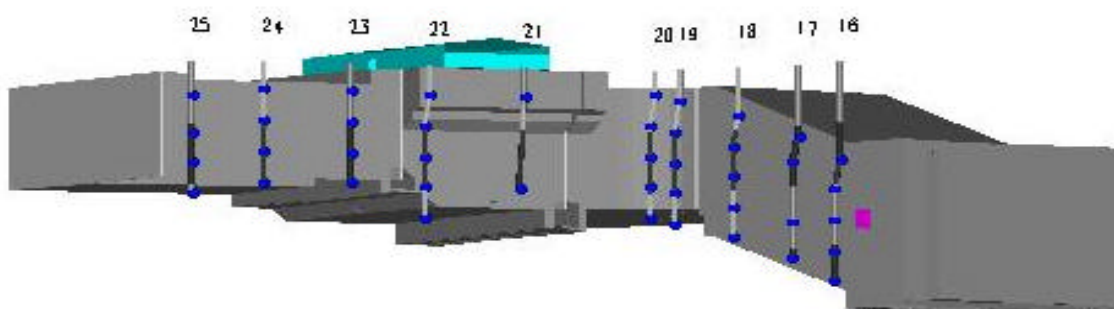
Figure 20. Top and side view of sample locations

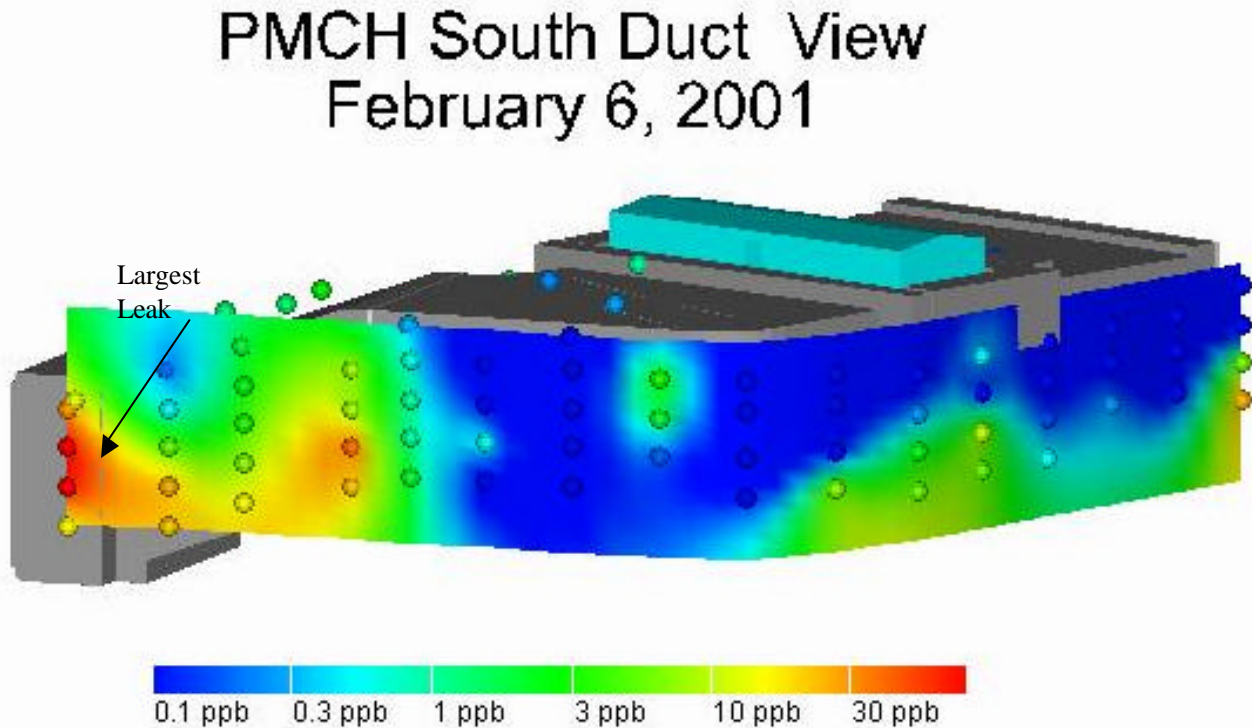
PMCH was injected into the south duct from January 30th, through February 6th. A complete set of exterior samples was collected on February 6th. Figure 21 displays the concentration profile for PMCH along the south duct on February 6th. The figure contains all measured sampling ports (small colored circles) and provides a concentration contour along the duct. This profile is a fully developed profile as it represents the concentrations at the end of the injection period. Sampling ports above the duct are visible and color-coded to the same scale. Viewing Figure 21, it is clear that the greatest leaks all occur along the expansion joints. The largest leak occurred at the first bustle (see Figure 16 for bustle and expansion joint locations and Figure 20 for port locations) and the peak measured value was 82 ppb. Considering that the concentrations PMCH in the south secondary plenum were approximately 100 ppb, further supports the notion that there is a large leak at this location. The second largest leak occurs at the second expansion joint (4th set of sampling ports, port 4-3). It has a concentration approximately half the value of the largest leak. Smaller potential leaks are found at the locations of the other expansion joints. These leaks are one-tenth to 1/100 of the size of the largest leak. Large areas of this duct are not leaking gas as evidenced by the blue regions.

Figure 21. PMCH concentration contours the day after completion of the seven-day injection period

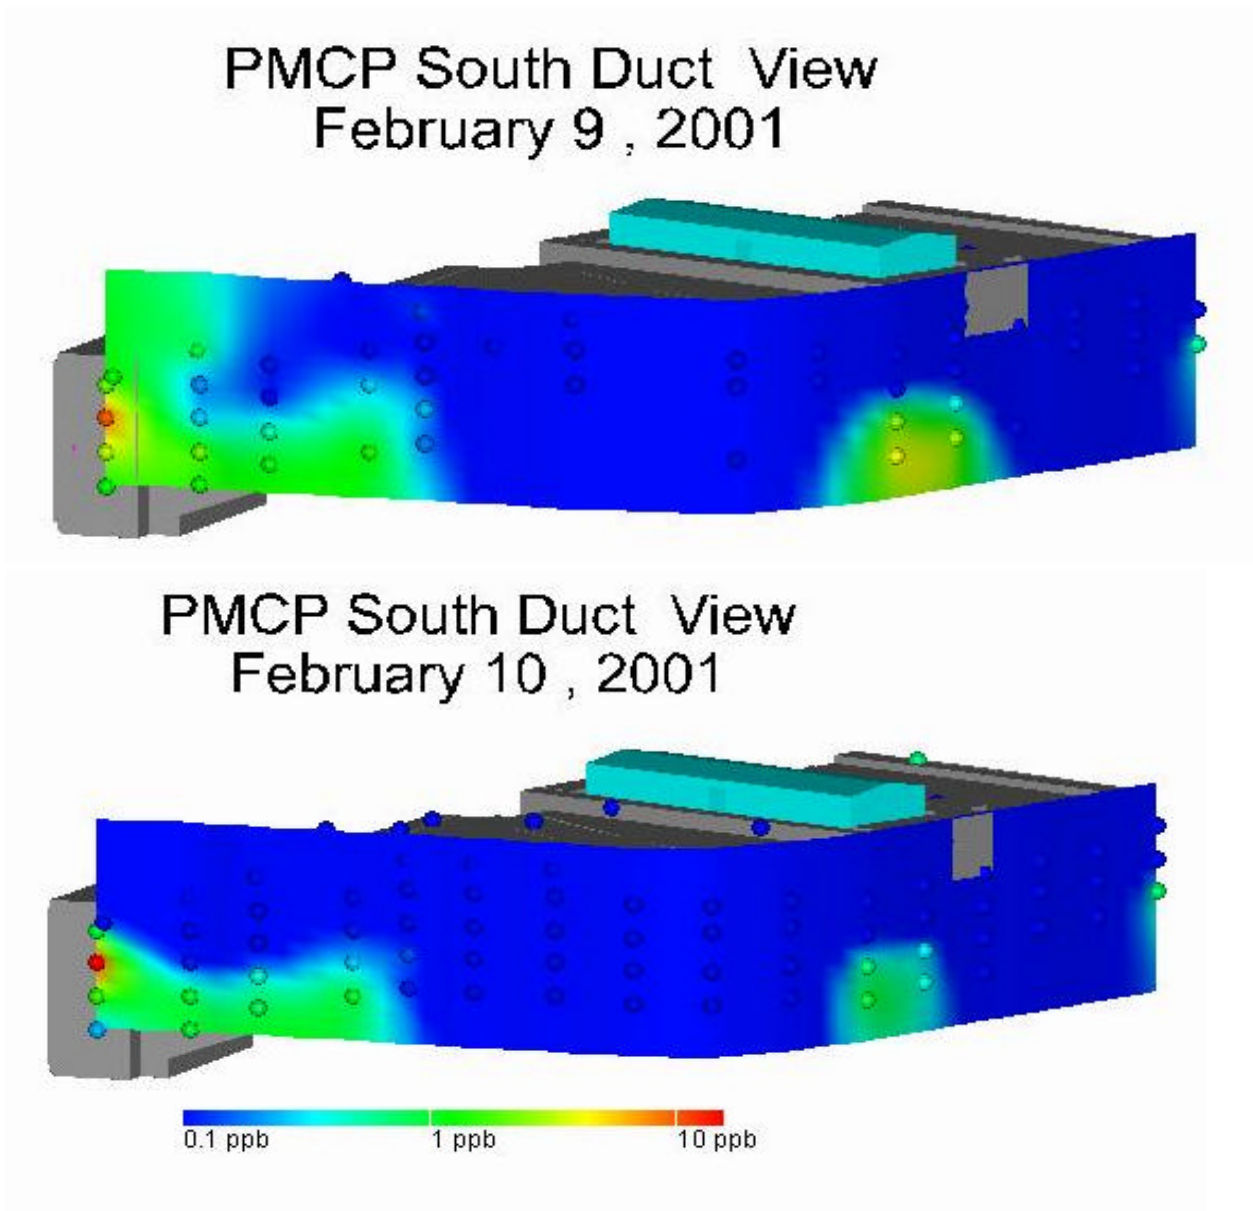
Figure 22. PMCP concentrations on the second and third day after the leak test injections were started

In the leak test, PMCP was injected in the south duct from February 7th through the 16th. Figures 22, 23, and 24 show the buildup and decline of PMCP along the south wall from February 9th through February 22nd.

The leak at the first bustle is seen to appear on February 9th, the first sampling date after the injection was started. The concentration of PMCP at this location (1-2) continues to increase until February 12th, after which time it remains stable at around 15 ppb. This is the largest leak on this side. The sampling port immediately beneath this port (1-3) also has high measured PMCP concentrations. This indicates the leak is between the two sampling ports. The fact that the concentration in the lower port was slightly less than port 1-2 on the 9th and 10th indicates that the leak is probably closer to port 1-2. It is interesting to note that the observed high water line in the primary plenum is located between ports 1-2 and 1-3. The second biggest leak was found at the first expansion joint (4th set of sampling ports). Potential leaks were also found near the expansion joint at the filter bed area. (11-4). A possible leak in the bottom of the duct can be seen at the bustle area near the instrument house (42-4, far edge of the figure). At this location, PMCH did not arrive until February 14th indicating that potential leak was along the bottom of the south duct several feet away from the sampling port (i.e. near the middle of the plenum). The possibility of bottom leaks will be discussed later in this report.

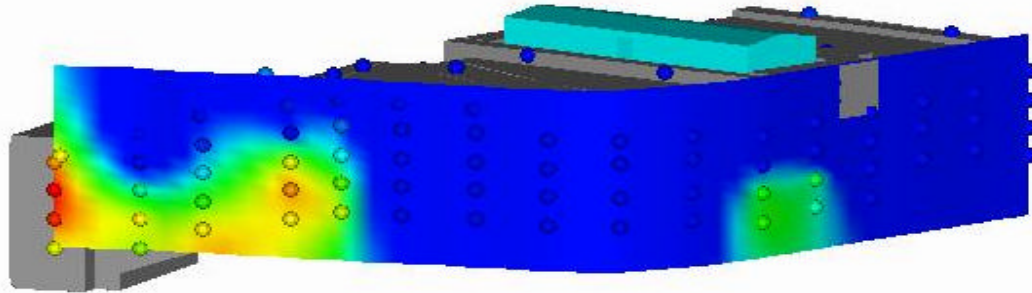
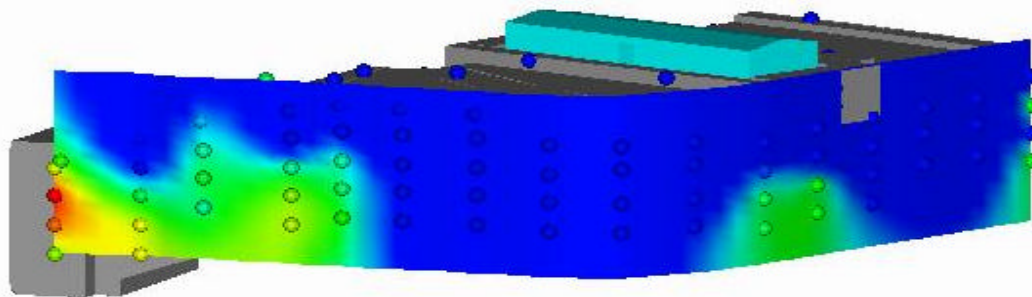
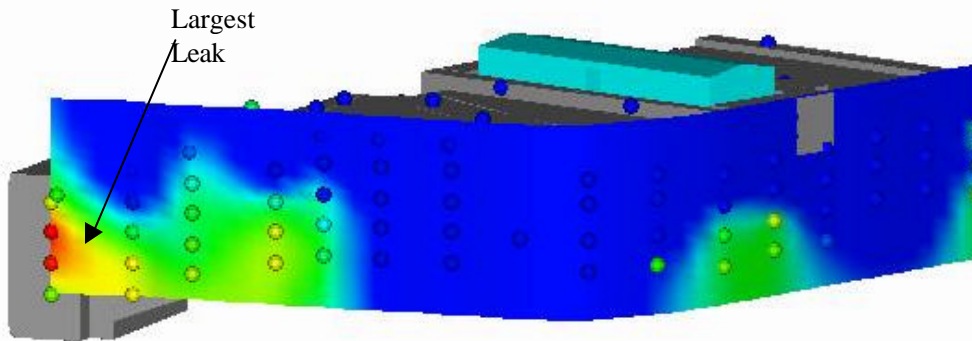
Figure 23. PMCP concentration on the fifth, seventh, and ninth day after the leak test was started

The leak profile is remarkably stable during the injection test providing confidence that the information provided by the test is reliable. In addition, the leak profile of PMCP (second test) is similar to that found by PMCH (first test). This provides further confidence that all leak pathways from the south plenum to the surrounding soils have been defined. Similar graphical visualizations were generated for all tracers on all sampling dates. Examination of the concentration profiles for all tracers including those injected into the north duct (PDCB and o-PDCH) all showed the same leak locations. The appearance of tracers injected in the north duct outside the south duct will be discussed later in this report.

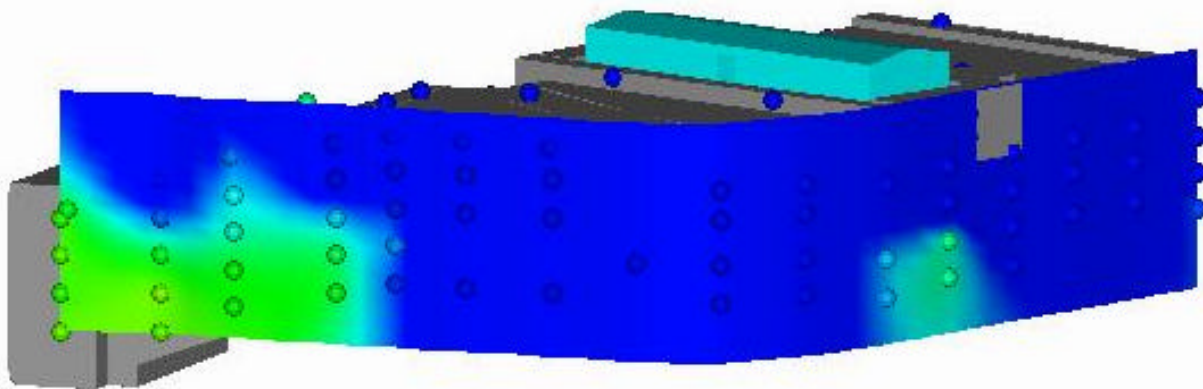
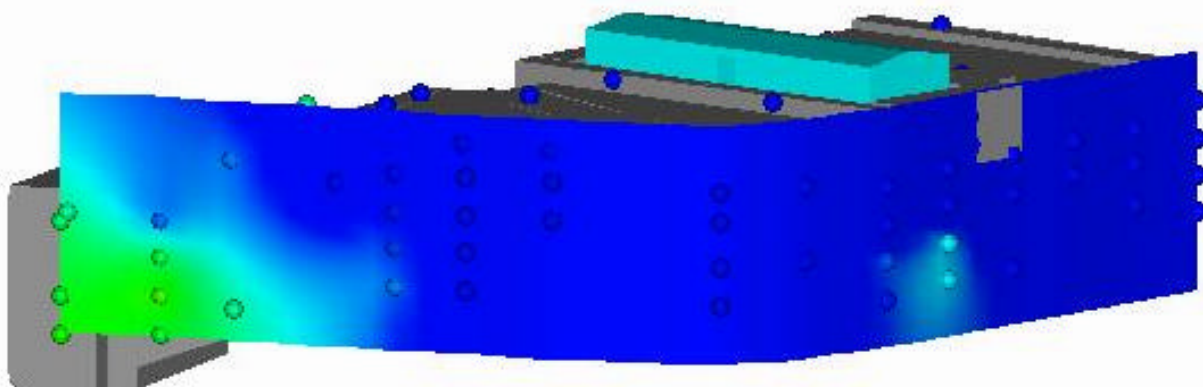
Figure 24. PMCP concentrations on the fourth and sixth days after injection was completed

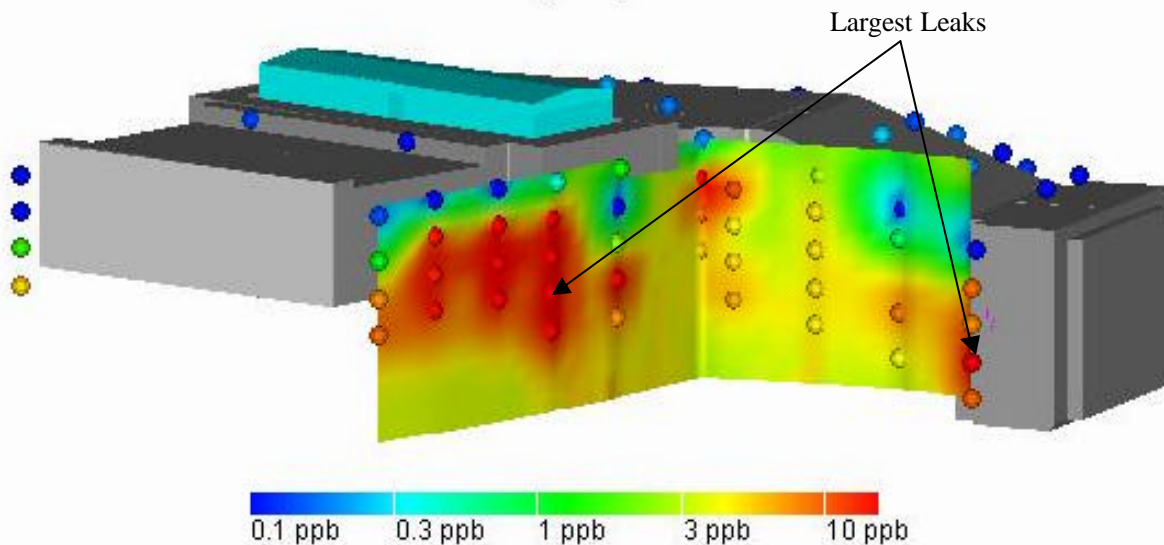
Figure 25. PDCB concentration contour at the end of the eight-day injection period, February 6th

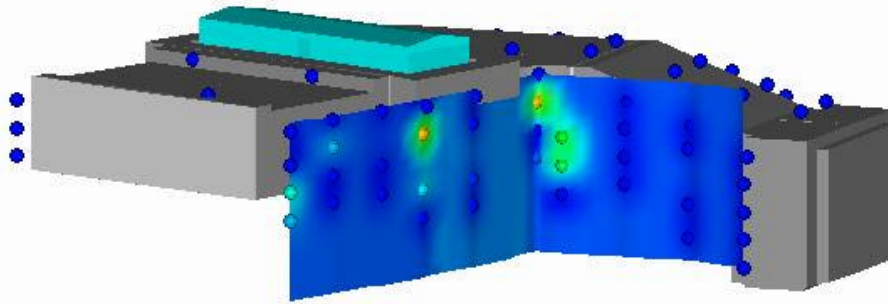
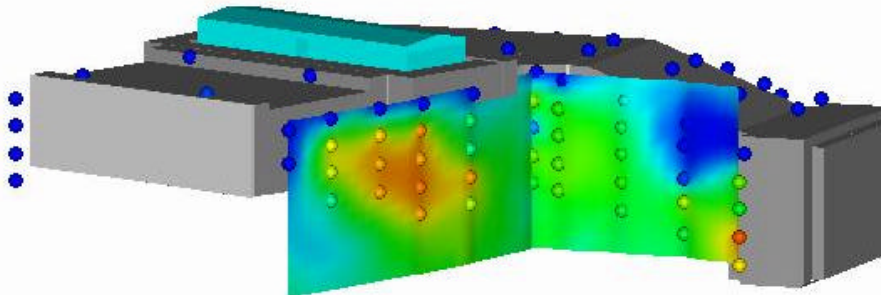
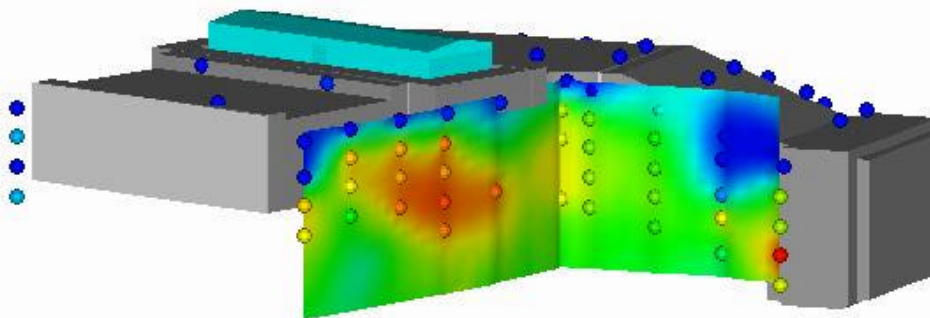
Figure 26. o-PDCH Concentrations on the first, third, and fifth day after the start of injection

During the leak test, o-PDCH was injected into the north duct secondary plenum from February 9 to February 16th. Figures 26 and 27 present the time evolution of o-PDCH concentration along the north Duct. From this time evolution further refinement in detecting the leaking areas can be obtained. The data from February 10th were collected in the morning, approximately 16 hours after the start of injection. There is some evidence of leaking at two expansion joints, however substantial amounts of the tracer have not reached the sampling ports. On the 3rd day after injection, February 12th, two leak areas are observed. One, at the first bustle (port 16-3) and the other is centered around the expansion joint (sampling location 22, Figure 4) but is spread along a 20 to 25 foot section (sample locations 21, 22, and 23). This figure illustrates that there is substantial leakage along the entire length of the expansion joint on the northernmost side of the filter beds (sample location 22) as all four sampling ports indicate substantial o-PDCH concentration. On February 14th, the contamination continues to spread around this region. The sampling port along the bustle (port 16-3) still remains high.

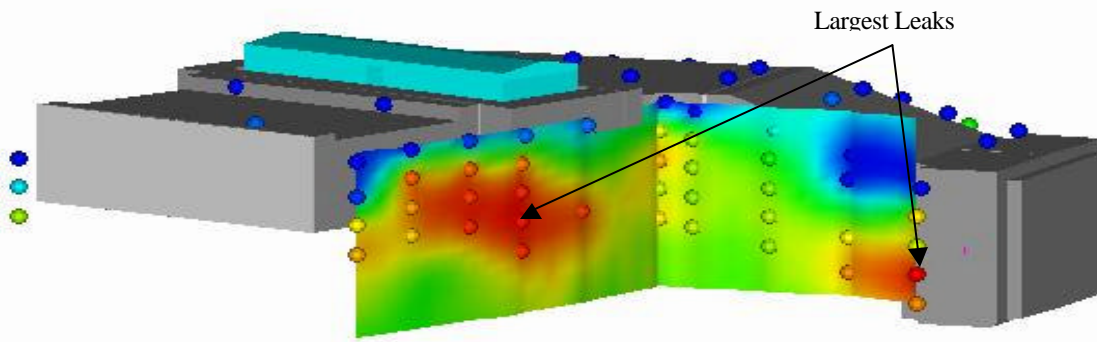
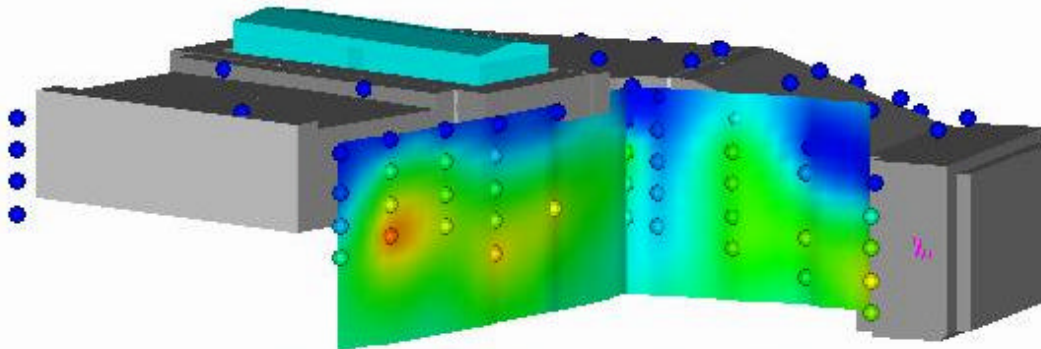
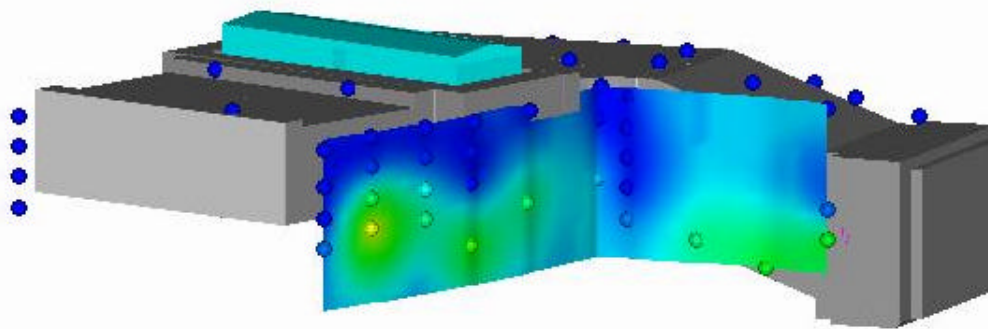
Figure 27 displays the o-PDCH concentration contours on the final day of the injection (February 16th), and at four days (February 20th) and six days (February 22nd) after the injection was stopped. On, February 16th, the tracer has spread further around the northernmost expansion joint near the filter bed. Spreading was also observed to the second sampling location (port 17-3) from the leak detected at 16-3. The profile appears similar to the profile found at the end of the preliminary tests using PDCB, Figure 24. As with PDCB, approximately 25 percent (11 of 43 ports) were within a factor of 2 of the peak measured value 1.8 ppb and 50 percent (21 of 43 ports) were within a factor of 4 of the peak.

Figure 27. o-PDCH concentrations at the end of the injection (February 16th), fourth (February 20th), and sixth (February 22nd) days after the injection was stopped

The data from February 20th and 22nd show a shift in the distribution of o-PDCH outside the north duct occurred after the injection was stopped. In general, the concentrations decreased, however, the peak concentration measured on the 20th and 22nd occurred at the bottom of sampling location 24 which is the first set of sampling ports from the bustle (and expansion joint) at the Instrument House. This indicates that there may be a leak at the bottom of the duct near this region. The potential for bottom leaks will be discussed later in the report.
