**Characterization of Leak Pathways in the Below Grade
Ducts of the Brookhaven Graphite Research Reactor
Using Perfluorocarbon Tracers**

Environmental Sciences Department

April 2001

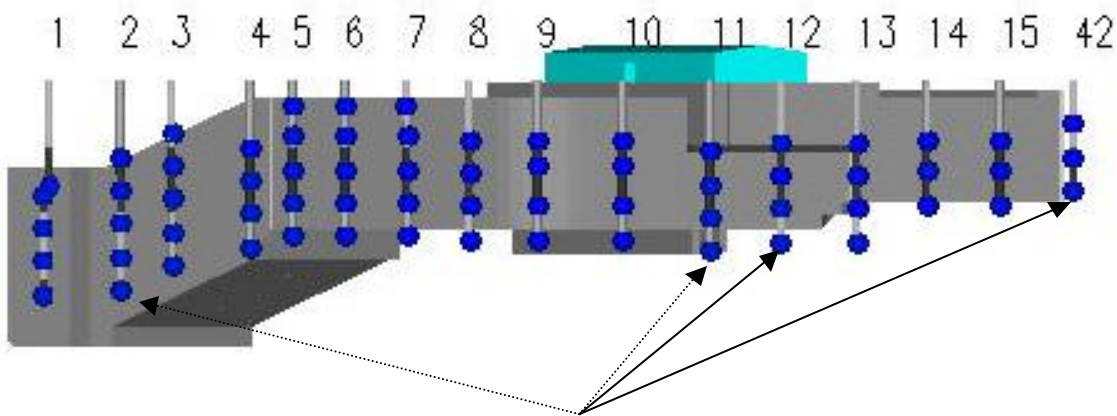
Figure 30 presents a side view of the south duct. Arrows point to the sampling ports with the most evidence for a bottom leak. Solid lines indicate strong evidence of a leak (for example, several tracers indicate a bottom leak) while dotted lines indicate some evidence of a leak (one or two of the four tracers indicate a bottom leak). Sample locations 12 and 42 provide strong evidence of a bottom leak. In some cases, if a large leak was present on the side of the duct, it is difficult to determine if a bottom leak exists. This is due to the dilution that occurs traveling from the leak to the sampling point. The further the travel distance, the greater the dilution. This occurred at sampling locations 2 and 11 and is reflected by the dotted line indicating a potential bottom leak.

Figure 30. Sample locations with evidence of a leak along the bottom of the duct

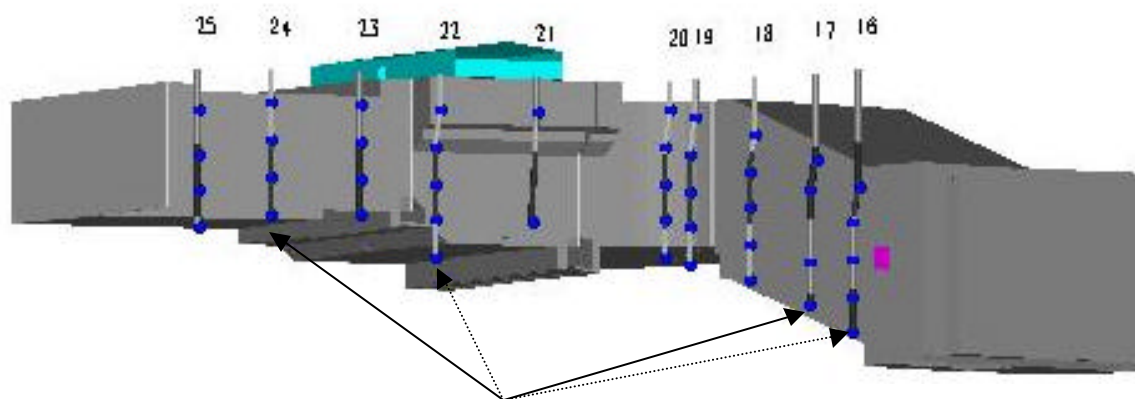
Figure 31. North duct potential bottom leak locations

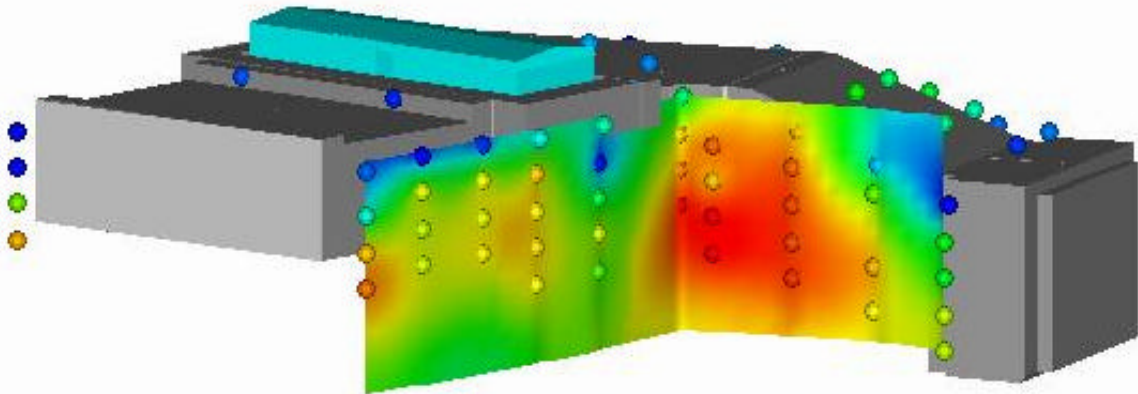
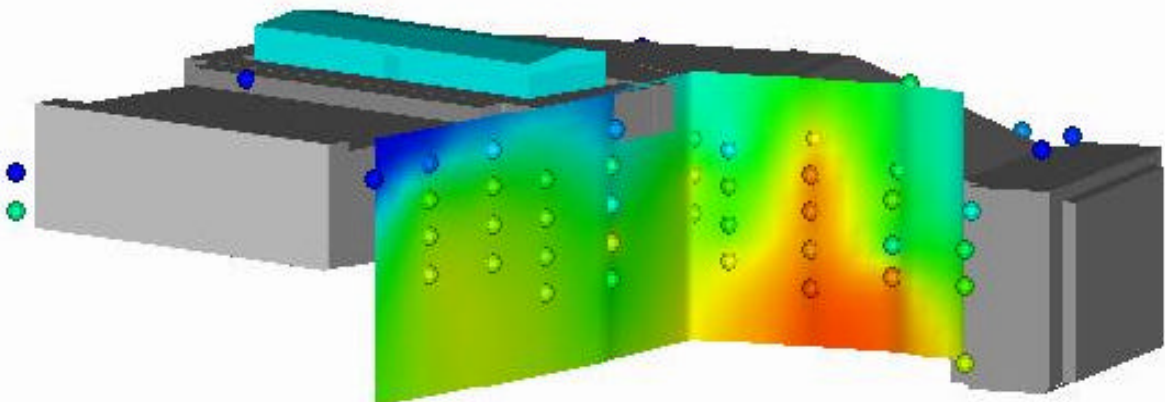
Figure 33. PMCH concentrations along the north duct one and four days after the injection was stopped
