Hydrate Core Drilling Tests

Topical Report

MAURER TECHNOLOGY INC.

ANADARKO PETROLEUM CORP.

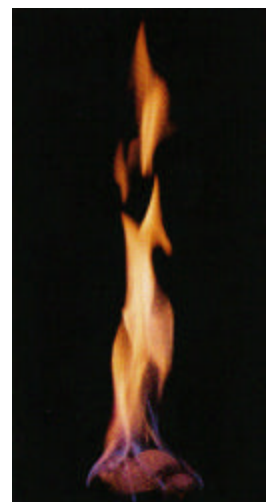
Figure 1.
Methane Hydrate

Natural-gas hydrates (**Figure 1**) beneath the permafrost have been encountered by the oil and gas industry for years. Numerous drilling problems, including gas kicks and uncontrolled gas releases, have been well documented in the arctic regions by Russian, USA and Canadian engineers. Substantial reserves of natural gas are present around the world in the form of frozen hydrates. Hydrates are natural gas trapped in a frozen mixture of water and earth. Conditions required for hydrates to form include cold temperatures, such as at the bottom of the sea floor and in arctic areas where permafrost exists. One such area is under the tundra of Alaska.

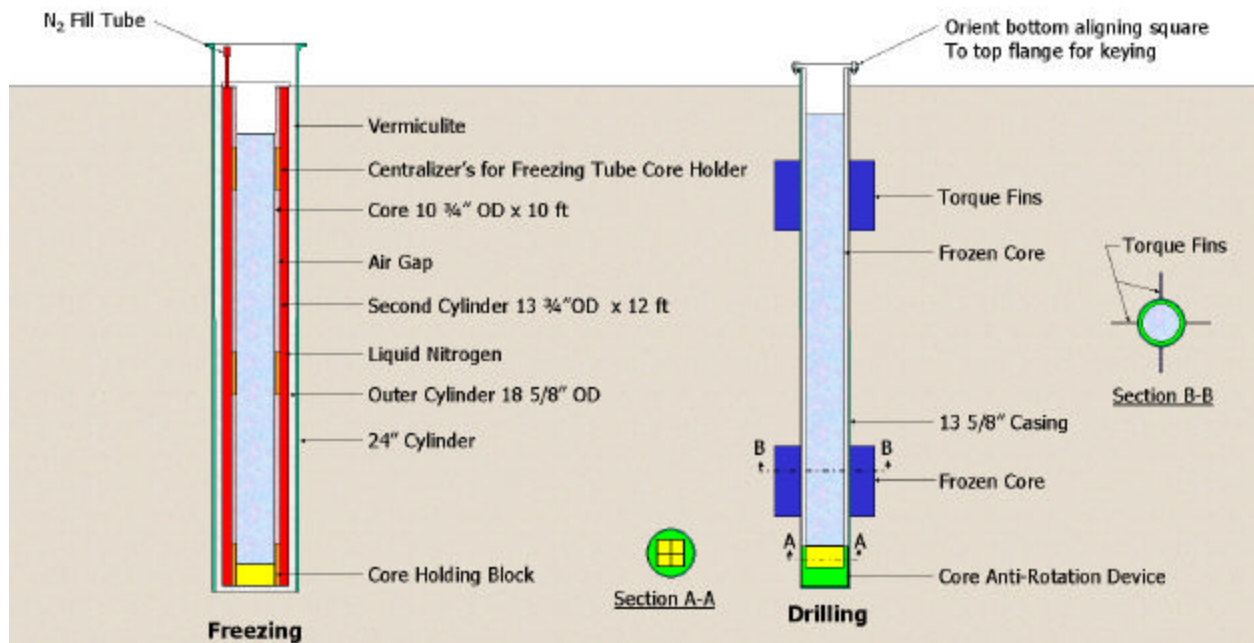
Figure 2. Core Drilling/Freezing Facility Schematic

A core drilling and freezing facility was installed at the DRC. This facility consisted of two pieces of casing (approximately 15 ft in length) placed in the ground (**Figure 2**). The tube on the left is the freezing chamber, and is used with equipment built by OU to freeze simulated hydrate cylinders. The tube on the right is the drilling chamber. Samples frozen in the freezing chamber are transferred to the drilling chamber where they are cored.

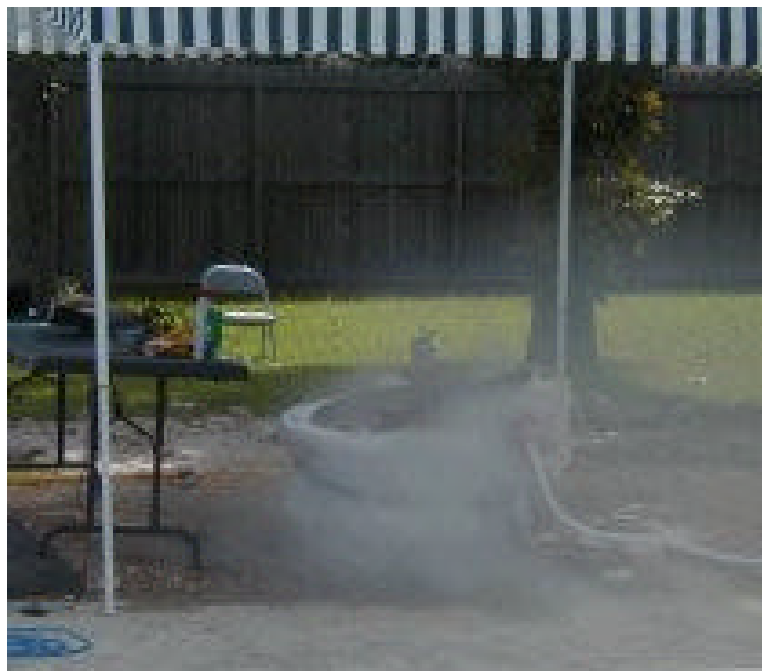
Figure 3. Freezing Chamber

Figures 3 and 4 show the freezing and drilling/coring chambers, respectively. The fog in front of the freezing chamber is caused by vaporization of liquid nitrogen.

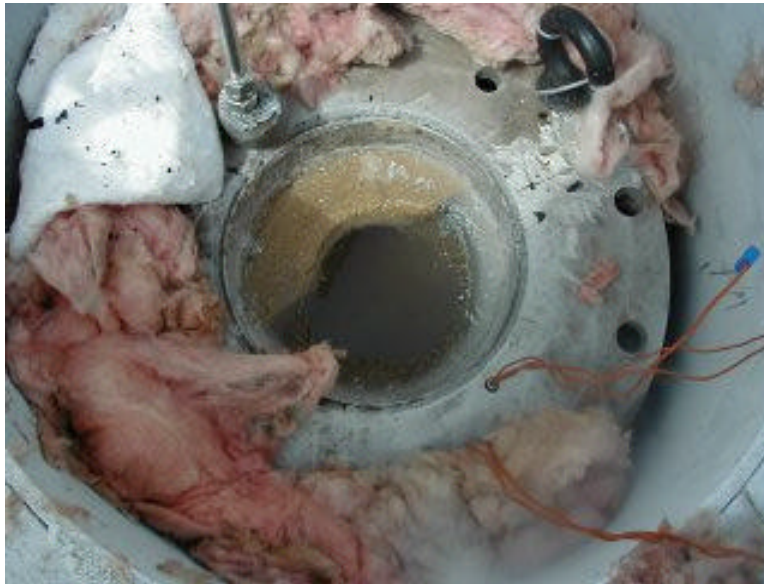
Figure 5. Partially Frozen Simulated Hydrate Cylinder

As the freezing chamber cools, it begins to fill with liquid nitrogen (that is, the nitrogen no longer evaporates). Noting when the temperature recorded by each thermocouple drops to levels close to -300°F is an indication of the liquid nitrogen level. The top center of the sample is the last area to freeze due to the insulating effect of the ice that is formed at the outside edge of the tube. **Figure 5** shows a cylinder that has not completely frozen.

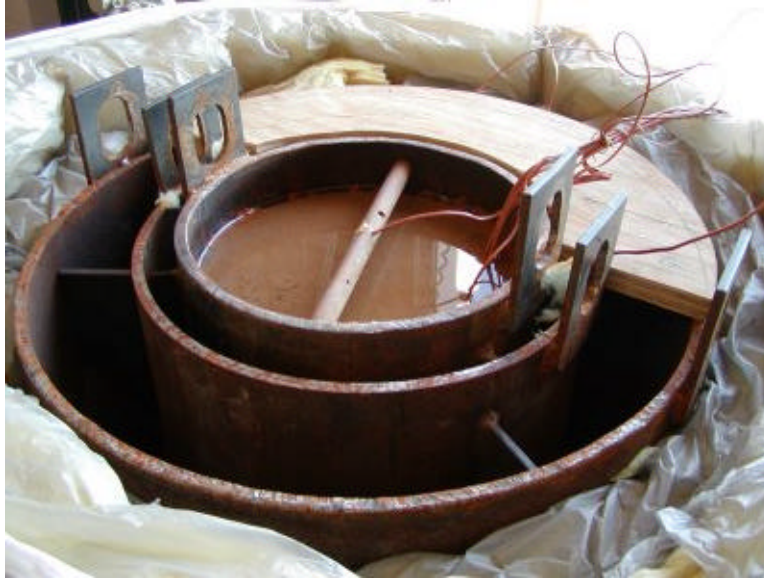
Figure 6. OU Prototype Freezing Apparatus

The prototype apparatus developed by OU **Figure 6**) consists of three nested tubes, with the inner tube forming a chamber for the simulated hydrate sample, and the outer two the freezing and nitrogen chambers. The original design placed the liquid nitrogen in the outer annulus and left an air gap between the nitrogen and core chamber. This was done to slow the freezing process and increase temperature uniformity of the frozen cylinder. This approach was based on the assumption that the cylinder would be moved directly from the freezing chamber to the drilling chamber. However, during the coring tests, the simulated hydrate cylinders were stored in a freezer truck overnight so that they could finish freezing and achieve uniform temperature.

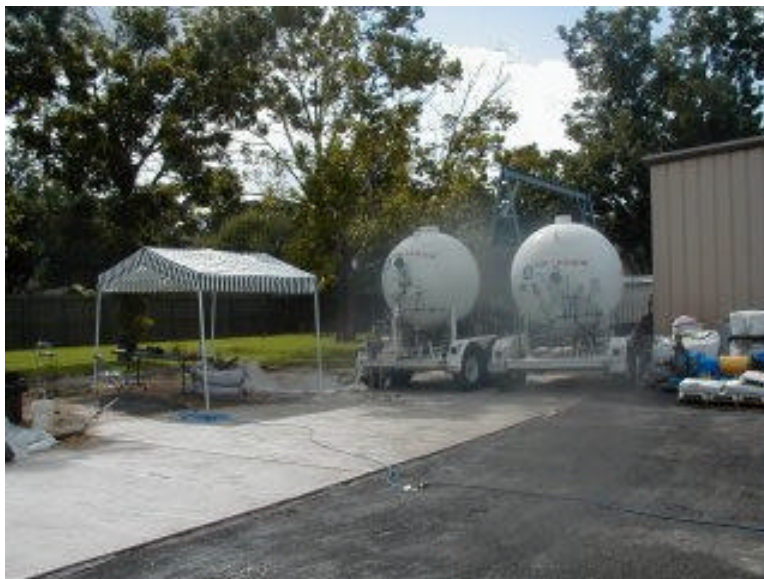
Figure 7. Liquid Nitrogen Tanks

To speed the freezing process at the DRC tests, liquid nitrogen was introduced into the chamber in direct contact with the simulated hydrate cylinder chamber. This reduced freezing time considerably. **Figure 7** shows two nitrogen tanks feeding the freezing chamber during preparation of one of the frozen simulated hydrate cylinders.

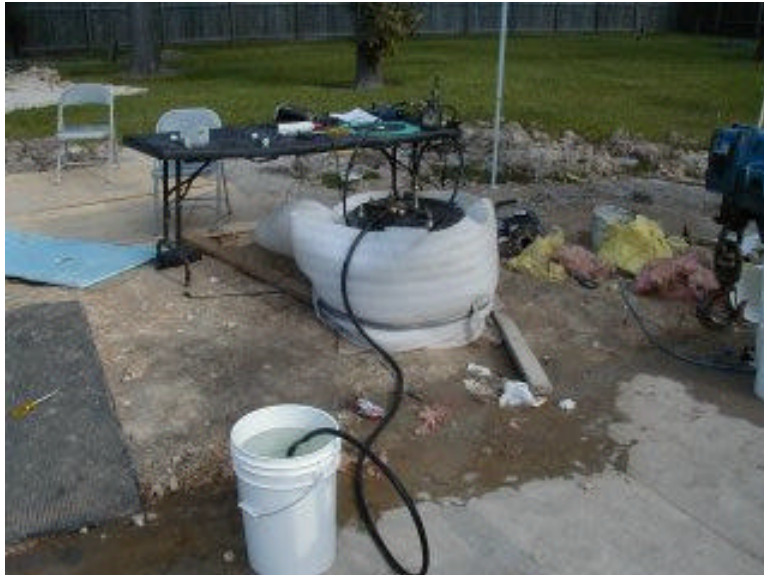
Figure 8. Vacuum Filling Freezing Chamber

with water only. For solid ice cylinders, the freezing chamber was evacuated before being filled with water so that the ice would be homogeneous with no entrapped air. **Figure 8** shows the vacuum pump on the table and the bucket in front from which water was drawn during the filling process.

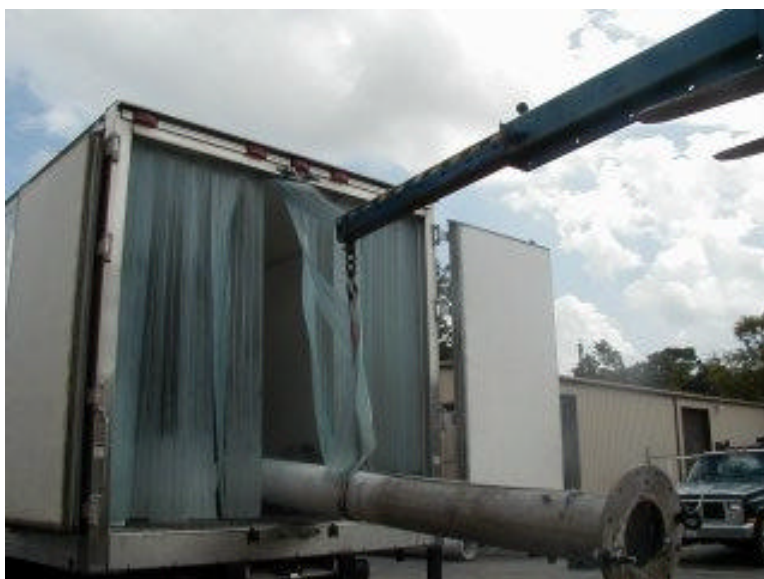
Figure 9. Storing Simulated Hydrate Cylinder in Freezer Truck

After freezing, the cylinders were removed from the freezing chamber and stored in a freezer truck (**Figure 9**). This allowed each cylinder to achieve a uniform temperature before it was moved to the drilling chamber.

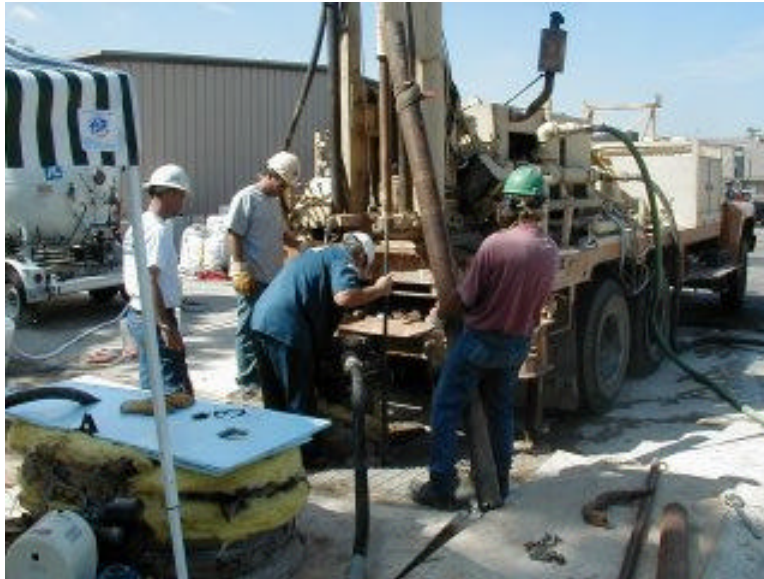
Figure 10. Environmental Coring Rig

A small environmental monitoring rig provided by Fugro Geosciences Inc. was used for the coring tests (**Figure 10**). A mining core barrel was used to core the simulated hydrate cylinders.

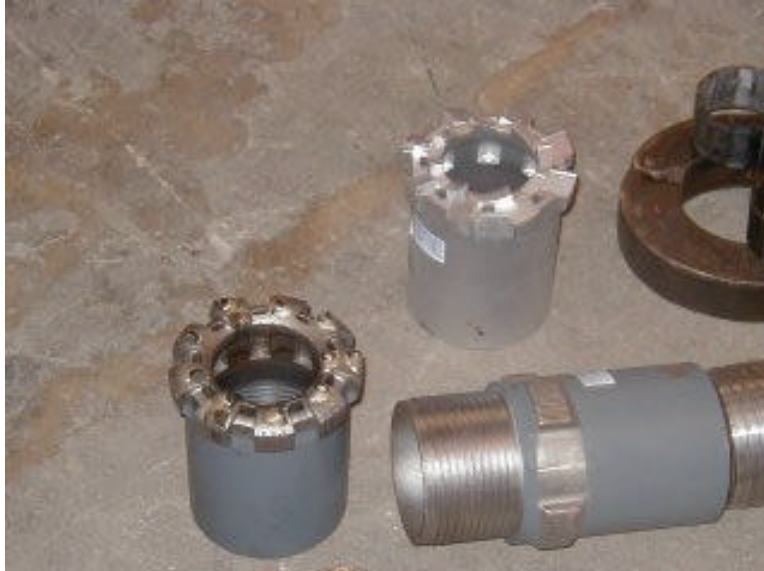
Figure 11. Core Bits

Figure 11 shows two core bits: a PDC bit (lower left) and a carbide bit (upper right). Only the PDC bit was used on these tests. Cores were captured in both stainless steel and Lexan core sleeves. Both types of sleeves worked well. The Lexan holders, when removed with the frozen core, allowed the core to be easily cut into pieces. The purpose of cutting the core into sections for these tests was for ease of shipping. In the field, the core would need to be divided to allow a range of tests to be performed.

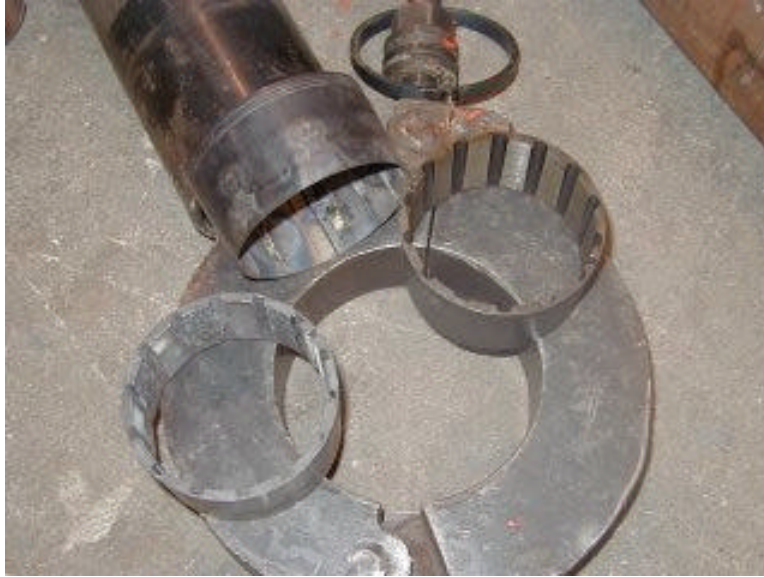
Figure 12. Core Catchers

Several core catchers were provided by the service companies to determine which would work best with frozen core. **Figure 12** shows three core catchers that were provided. None of the catchers worked well when the core eroded and became under sized. The simple serrated catcher did not catch the core. The core catcher with spring fingers and some rough hardmetal applied to the inner surface worked well when the last portion of the core was drilled dry, which allowed maintaining full core diameter. (This catcher is shown standing on its side at the end of the core barrel in Figure 12.)

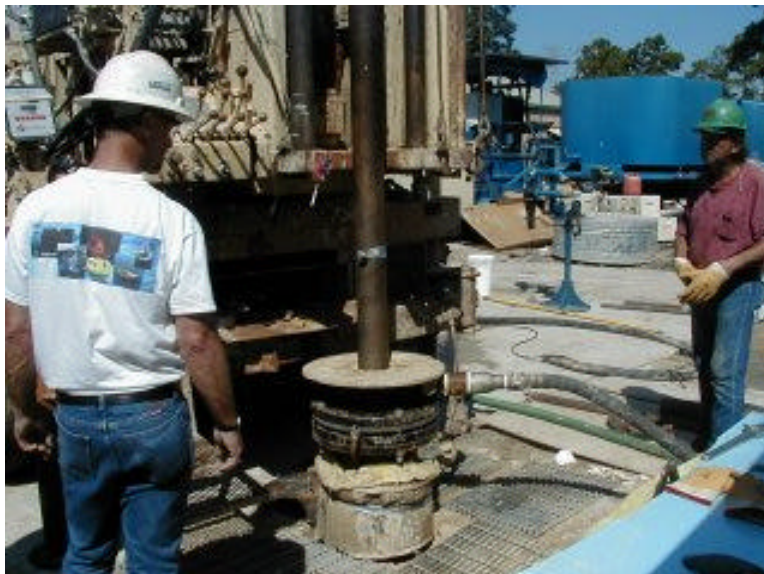
Figure 13. Drilling/Coring Operation

Figure 13 shows the core barrel during the drilling operation. Two 5-ft cores were taken from each of the cylinders. This procedure was adopted (as opposed to a single long core) to increase the experience handling the cores and because a larger rig with enough space to clear a 10 ft barrel below the mast was too costly for the test budget. The increased core-handling experience proved to be very valuable since it allowed us to determine the difficulties keeping the core the correct size during drilling and what drilling techniques would yield the best core. Discovering that core could not be successfully recovered except by drilling without circulation would have been a very costly lesson if learned on site in Alaska.

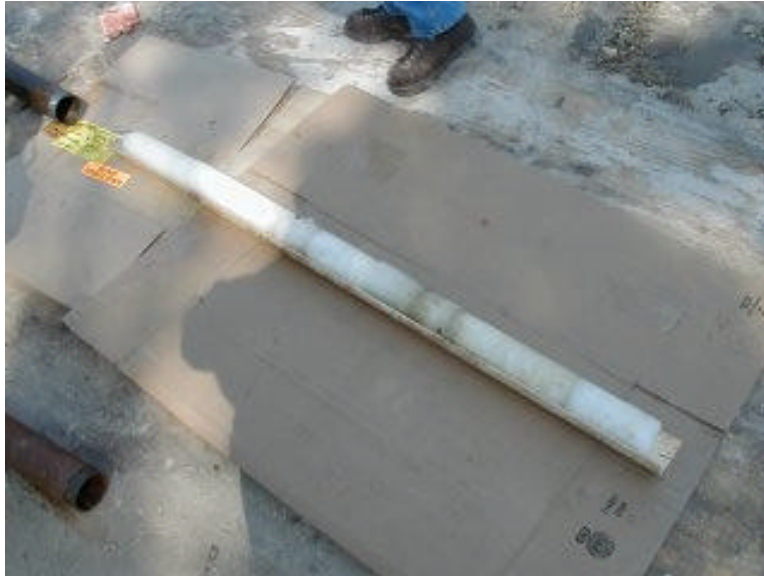
Figure 14. Ice Core

Figure 14 shows one of the recovered pure ice cores (that is, no sand). The difference in recovery of the pure ice core versus the lack of success with cores containing fine sand showed that sand allowed the drilling fluid to easily erode the core.

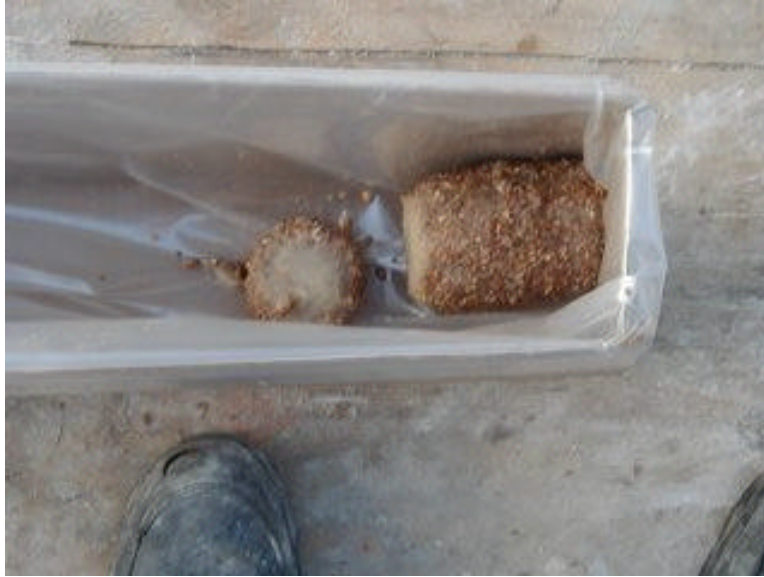
Figure 15. Core from Sample with Coarse Number 1 Sand

It is believed that hydrate formations in Alaska have more coarse materials mixed with the hydrate and permafrost. To test what effect coarse rock this would have on coring, a simulated hydrate cylinder was made with very coarse (number 1) sand. A sample of core from this cylinder is shown in **Figure 15**. The coarse sand jammed the core barrel during the drilling process. This occurred because the drilling fluid did not have sufficient viscosity to carry the larger sand cuttings out of the hole. These tests showed that a proper viscosity mud will be important to the coring operation and that dry coring should be pursued with care and only after cleaning the hole.

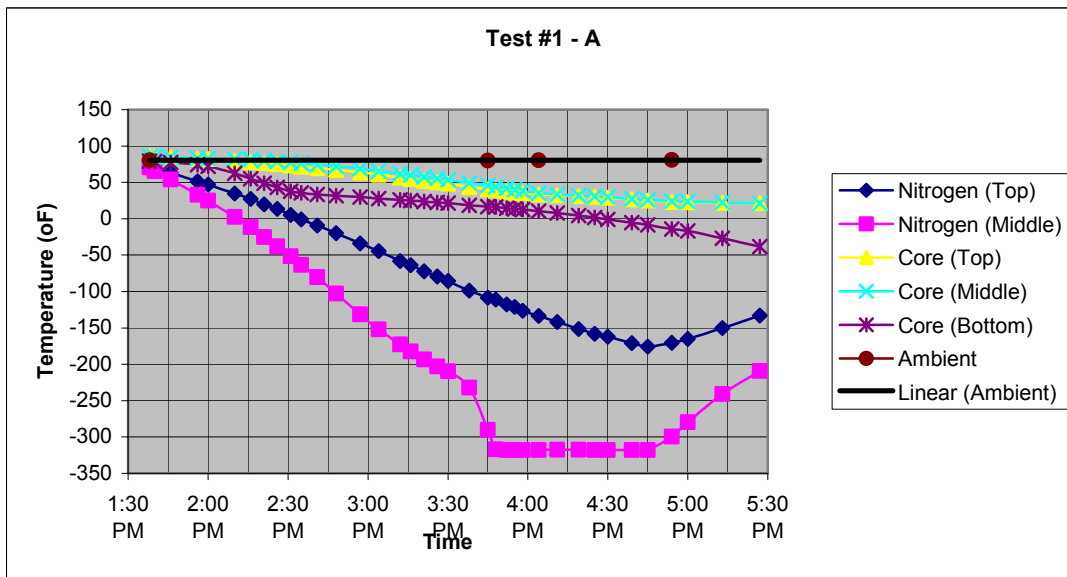
Figure 1: Results of Test #1 – A

Before starting the test, the Nitrogen tank was vented to reduce the pressure to 22 psi. Nitrogen was injected in the annulus space formed by the 18'' and 14'' casings. The injection was at a low rate by keeping the injection valve $\frac{1}{4}$ open. Nitrogen injection was stopped at 4:46 pm, but temperature measurements were taken until 5:27 pm. The core was left in the freezing cased well until next morning. All test temperatures are shown in Figure 1.

Comments on the test results: Figure 1 clearly shows that the annulus where Nitrogen was injected was half-filled with liquid Nitrogen from 3:45 pm to 4:46 pm (Nitrogen (middle) = -318 °F). As soon as the Nitrogen injection was ceased at 4:46 pm, the Nitrogen (top) and Nitrogen (middle) temperatures increased dramatically, which can be explained by a rapid transformation of liquid Nitrogen into gas due to the lack of insulation of the apparatus. At 5:30 pm, when the test was concluded, only the lower-mid part of the core was properly frozen. In the upper-mid part, the core center was still unfrozen. The core was left in place until next morning. The next test is a sequence of this test.

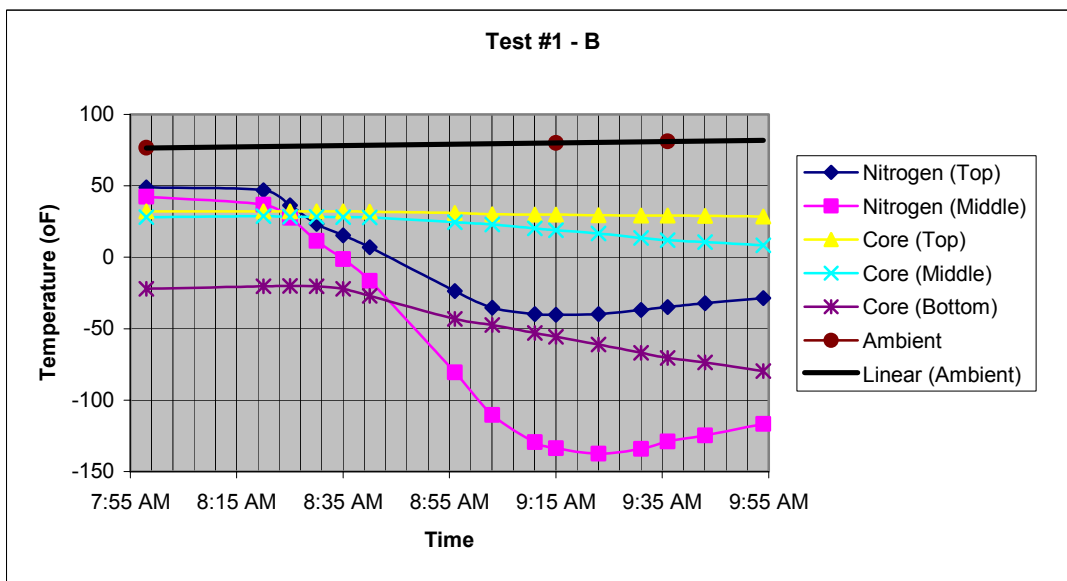
Figure 2: Results of Test #1 – B

This test was run on Tuesday, September 17, 2002, from 8:20 am to 9:54 am. The ambient temperature was in the range of 76.6 °F to 80.6 °F. This test is a continuation of Test #1 – A. With the core holder in place, and as the core temperature increased over night due to the lack of insulation, Nitrogen was injected in the same way previously described to reduce the core temperature. At 9:54 am, when the temperatures of the Nitrogen (top), Nitrogen (middle), core (top), core (middle), and core (bottom) dropped to -28.5 °F, -116.6 °F, 28.6 °F, 8.3 °F, -79.6 °F, respectively, the Nitrogen injection was ceased. At about 11:00 pm, the core holder was removed from the apparatus and placed in the freezing truck (Figures 16 – 19). The freezing truck temperature was set to 25 °F. All test temperatures are shown in Figure 2.

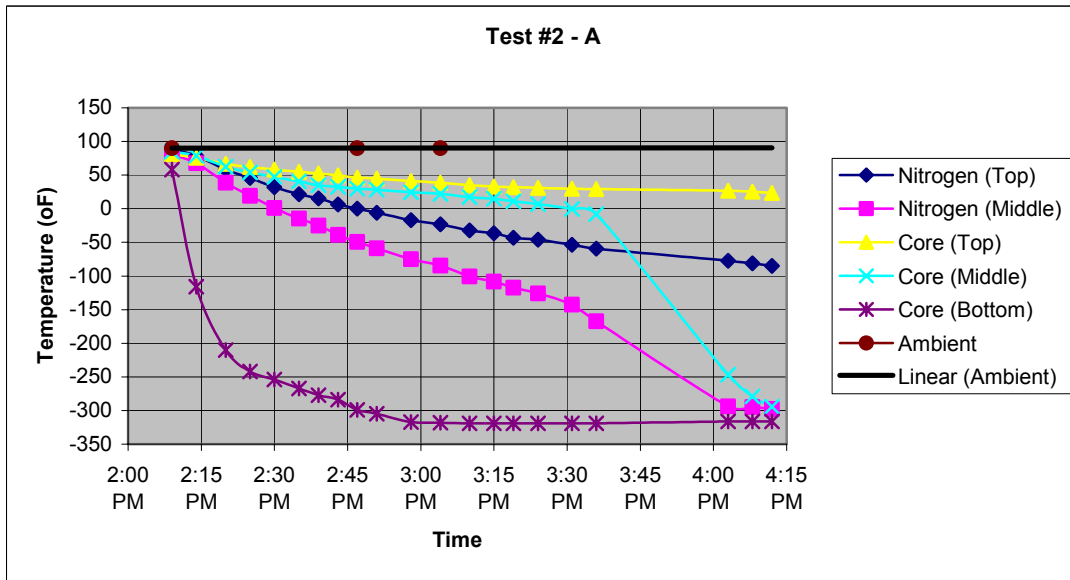
Figure 3: Results of Test #2 – A

At 4:13 pm, when the Nitrogen (top), Nitrogen (middle), core (top), core (middle), and core (bottom) temperatures were -84.9 °F, -297.5 °F, 23.6 °F, -294.3 °F, -316 °F, respectively, the test was terminated and the core stored in the freezing truck. Although the core top was not completely frozen, the test had to be stopped because no personnel would be available on site for assistance afterward. The test temperatures are shown in Figure 3.

Comments on the test results: Figure 3 shows that although the quality of the insulation material used was not ideal, it was acceptable since very cold core temperatures were

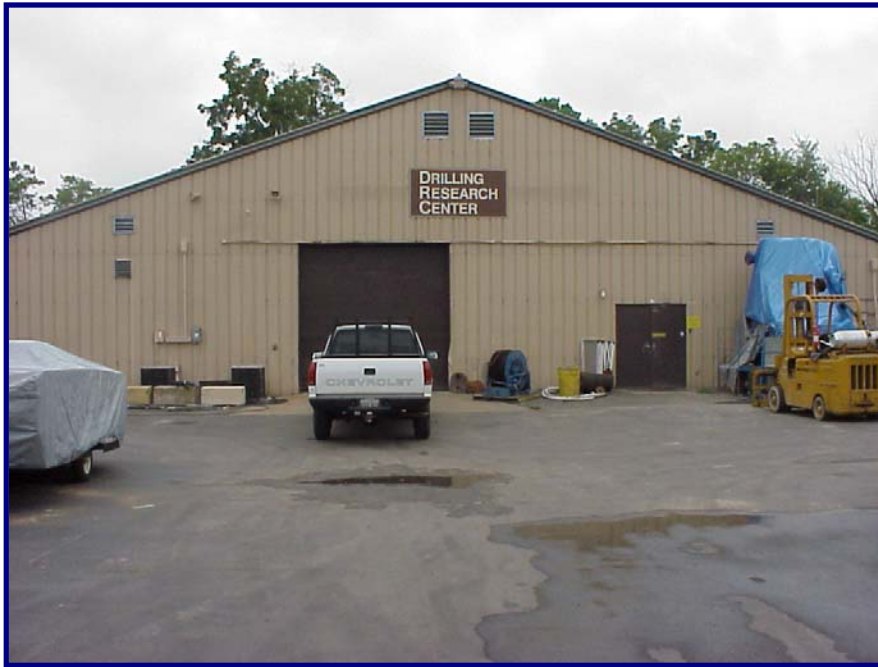
Figure 6: Maurer's Drilling Research Center

Five tests were performed at the Maurer’s Drilling Research Center (Fig. 6). Table 1 shows a list of the tests conducted as well as dates. Differently from the lab tests performed at the Well Construction Technology Center, in Norman, the present tests were conducted with the apparatus placed in a 24” cased well, specially drilled and cased for this purpose. The major reason for placing the 12-ft long apparatus in a cased well was to facilitate the process of pulling the core holder in and out of the apparatus (Figures 7 and 8). However, both the high humidity inside the well and the high temperature of the surrounding formation would be expected to be very detrimental to an optimum freezing of the sand/water mixture. Thus, it would be necessary the use of an efficient insulation of the core apparatus. This will be evident in the first two tests conducted.

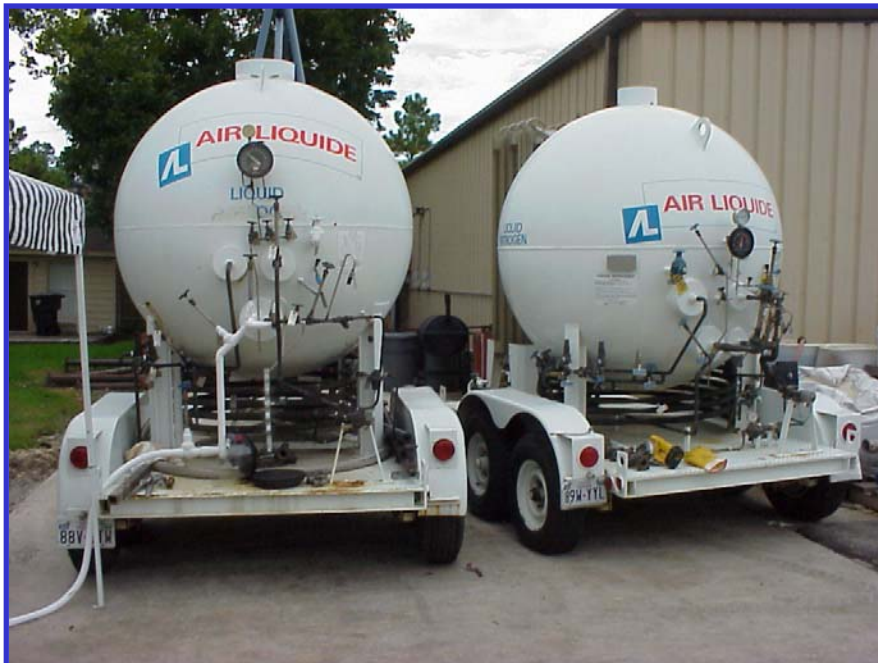
Figure 9: Nitrogen Reservoirs

All tests were performed with a 20/40 sand mesh and tap water. Two tests were performed by injecting Nitrogen in the lower part of the annulus space formed by the 18” and 14” casings. The remaining tests were performed by injecting Nitrogen in the annulus space formed by the 14” and 10” casings. Liquid Nitrogen was stored on site in two spherical tanks (Figure 9). These were 320 and 400 gallons tanks.

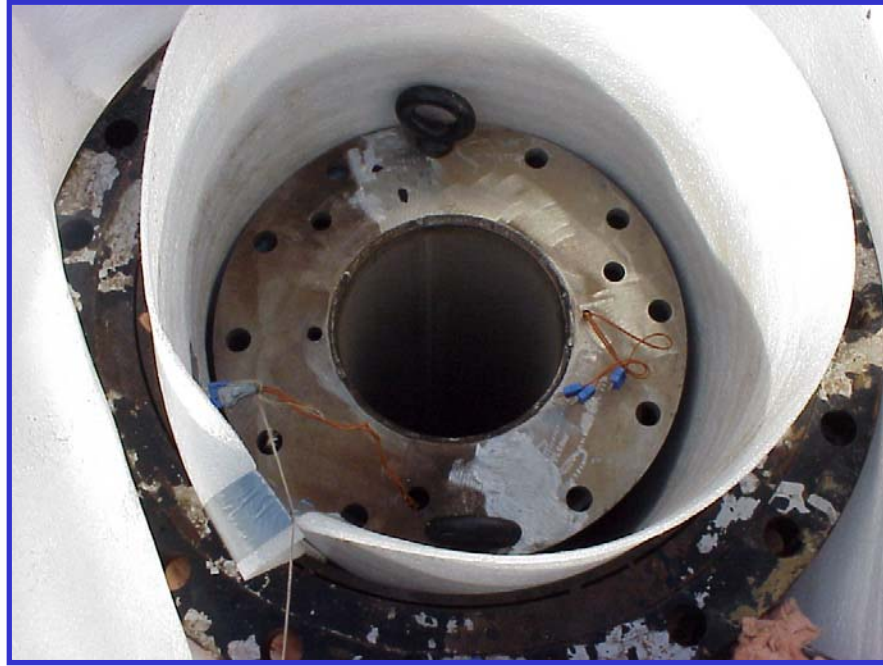
Figure 10: Core Preparation before Freezing

The hydrate core apparatus was placed in the cased freezing well ($\phi = 24''$) without any load of sand or water (Figure 10). With the core holder in place (10'' casing), it was then filled with sand and finally water was added (Figure 11). Because of the water expansion at low temperatures, the sand and water mixture level was kept one foot below the top of the core holder. The top of the sand/water mixture was covered with a metallic lid to improve heat transfer (Figure 12).

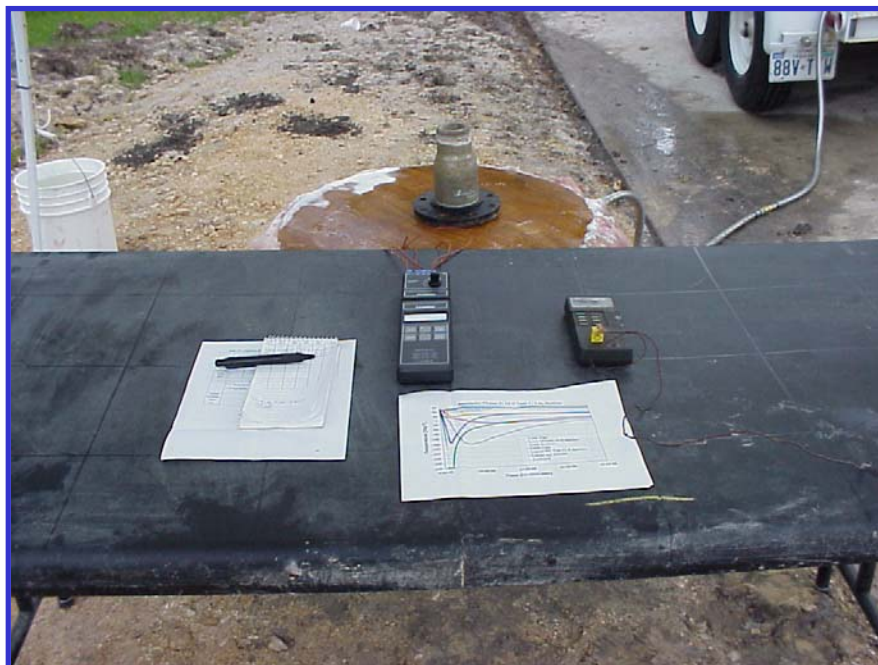
Figure 13: Thermocouple Readers

In the first three tests, the apparatus was equipped with five thermocouples. Two of these were used to measure temperatures in the annulus space formed by the 18'' and 14'' casings. They were placed at 10'' and 6'' from the bottom of the apparatus. Because these thermocouples were placed in the annulus originally designed to inject Nitrogen, they were labeled Nitrogen (top) and Nitrogen (middle), respectively. Three other thermocouples were placed in the 10'' casing to measure the peripheral temperature of the core. These thermocouples were placed at 1 ft, 6 ft, and 11 feet from the bottom of the apparatus. They were labeled core (bottom), core (middle), and core (top), respectively. In tests four and five, a sixth thermocouple was placed in the very center of the core, at about 1.5 ft from the top. This thermocouple was labeled core (top/center). In addition, the ambient temperature was also measured in all tests. Thermocouple readers were used to exhibit the temperatures during the tests. These temperature measurements were recorded by hand on a report notebook (Figure 13).

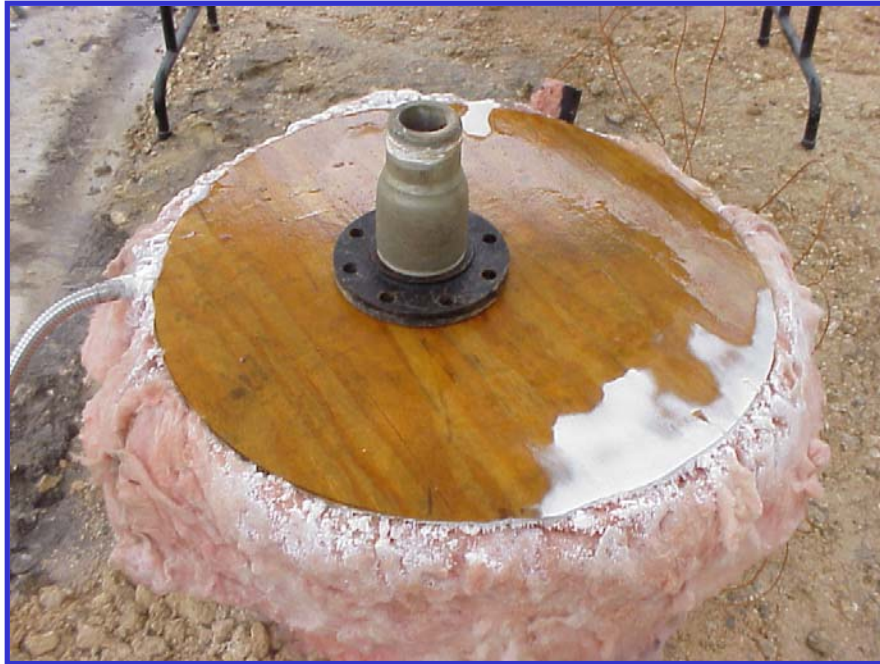
Figure 14: Details of the Insulation of the Top of the Apparatus

This test was conducted on Monday, September 16, 2002, from 1:37 pm to 5:27 pm. The ambient temperature was in the range of 79.8 °F to 80.6 °F. For this test, the core apparatus was not insulated from the freezing cased well, except for the top that was exposed to the ambient. Improvised pieces of fiberglass insulation material were used (Figure 14). A canopy was used to prevent direct incidence of sunlight on the top of the apparatus (Figure 15).

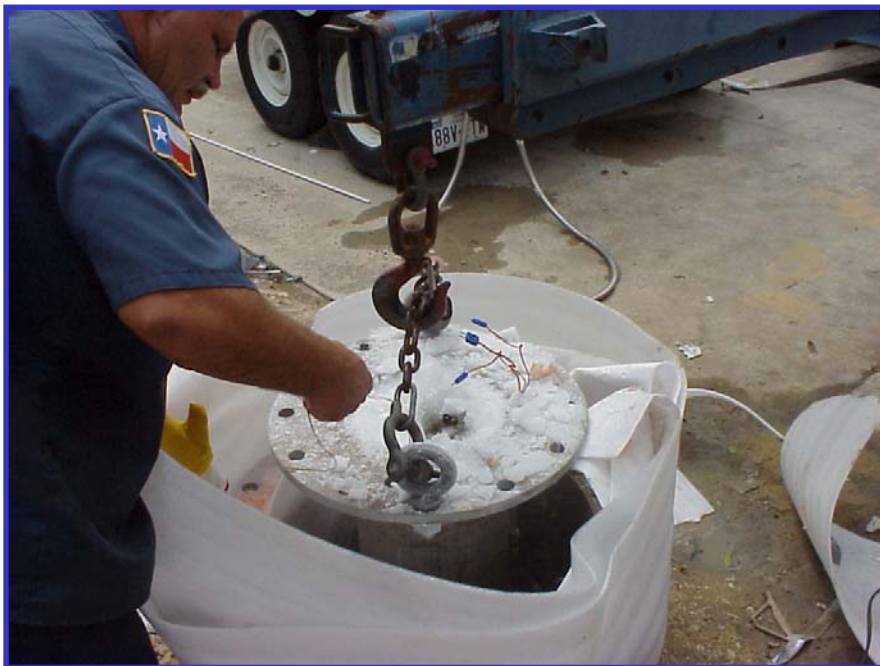
Figure 21: Details of Removing Frozen Core #3 from the Apparatus (Cont'd)

After the successful conclusion of this test, at 1:33 pm, the core holder was removed from the apparatus and stored in the freezing truck (Figures 20 to 24).

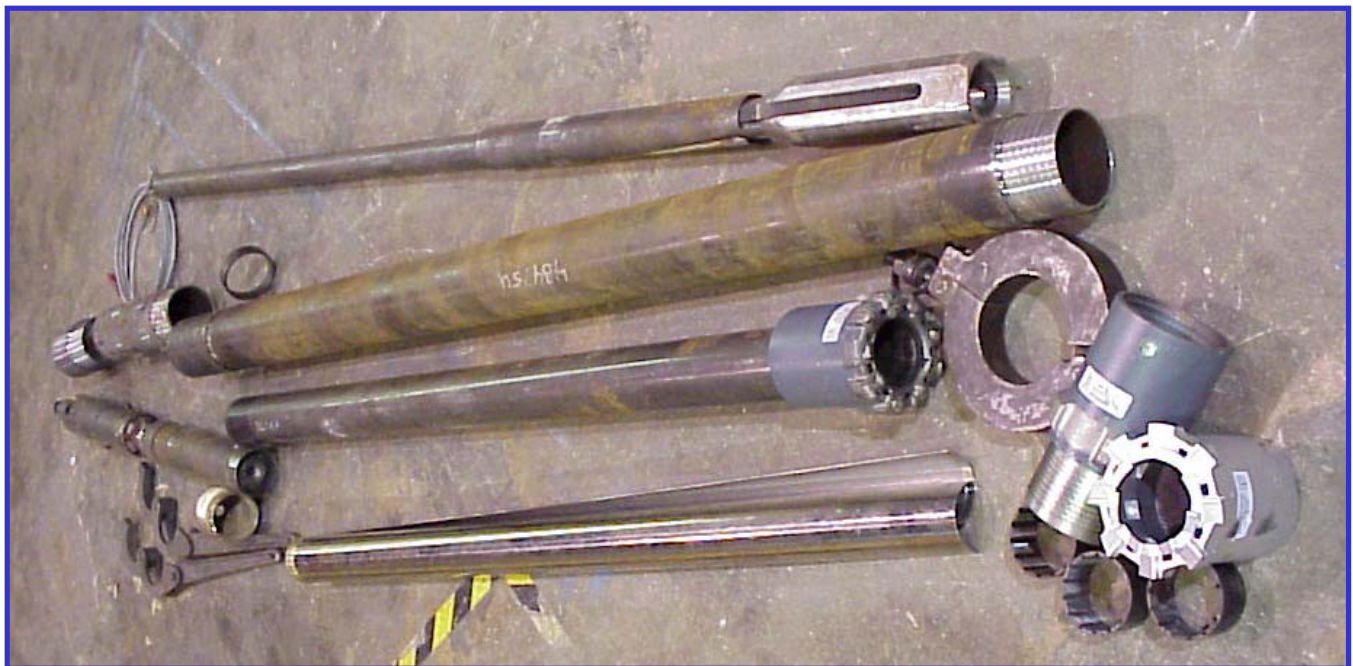
Figure 25: Coring Tools

Figures 25 to 37 show details of the frozen rock preparation and the coring operation. Figure 25 shows the coring tools. Figure 26 depicts the drilling rig. Figures 27 to 29 show the core preparation. Figures 30 and 31 depict the frozen rock placement in the well to be cored. Figure 32 and 33 show the wellhead and the coring tools preparation, respectively. Figure 34 and 35 show the coring operation. Figure 36 and 37 show details of the recovered frozen core.

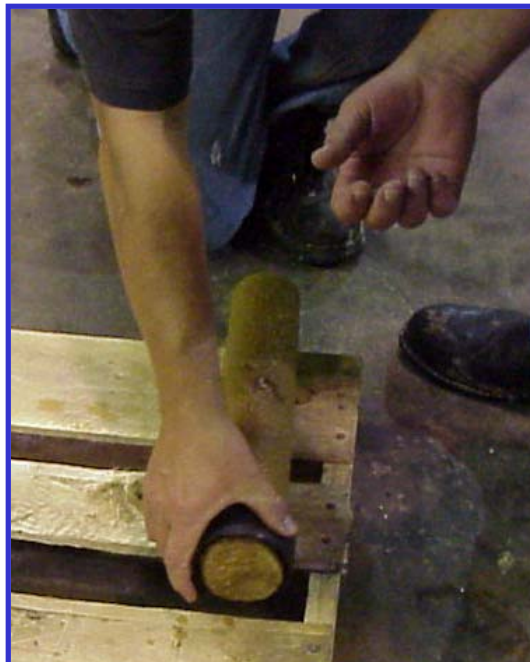
Figure 37: Details of the Recovered Frozen Core (Cont'd)

Improvements in the core procedures will be required since the first recovered core had a diameter significantly smaller than the core barrel (Figure 37). These improvements include mud composition and coring tools. Mud with KCl was used. The presence of KCl in the mud might have accelerated the unfreezing rate of the frozen rock. The reduction in the recovered diameter might also be a result of the friction between the sand and the bit/core barrel.
