# Detection of Subsurface Defects Using X-Ray Lateral Migration Radiography – A New Backscatter Imaging Technique

Final Report  
U.S. Department of Energy  
Idaho Operations Office  
Grant Number  
DE-FG07-00ID13922

NUCLEAR AND RADIOLOGICAL ENGINEERING DEPARTMENT  
UNIVERSITY OF FLORIDA  
Gainesville, FL 32611  
February, 2003

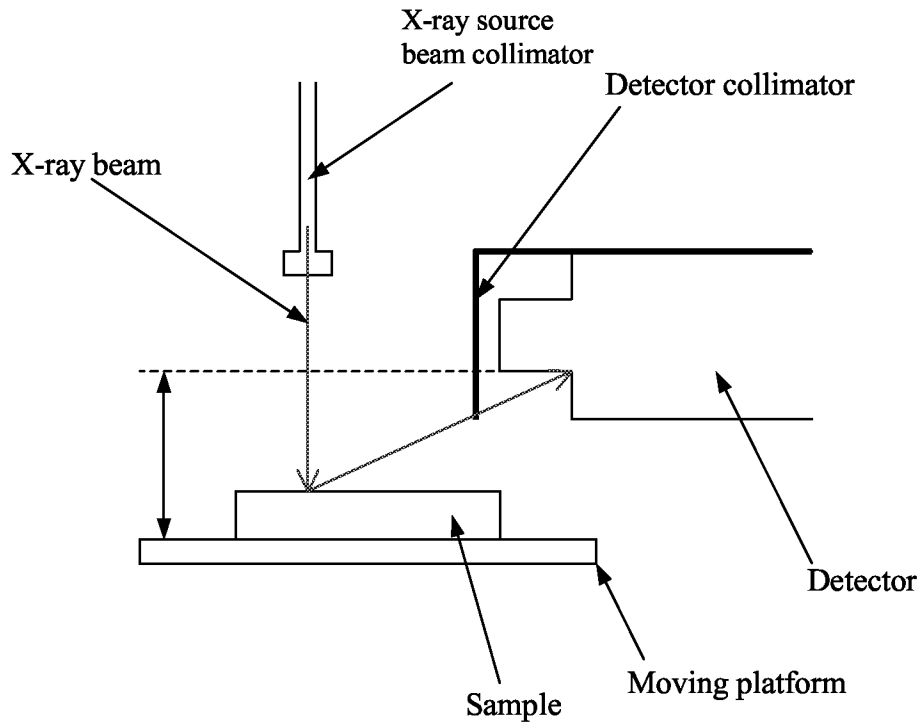
Figure 1. Simplified schematic of LMR flaw detection experimental setup.

Figure 1 is a simplified schematic illustrating the LMR flaw detection experimental setup. The X-ray source collimator tube is used to define the size or diameter of the probe beam and to a degree, the resolution of the scan. The sample to be examined rests on the sample table of the moving platform assembly. The scan pattern and irradiation time per pixel are computer-controlled. Two types of detectors can be employed. Uncollimated detectors respond primarily to single-scatter photons and provide surface or near-surface information. These signals are easily corrupted by surface clutter or surface inhomogeneities sometimes making it very difficult to detect sub-surface defects. Collimated detectors respond primarily to multiple collision photons. These signals, although much less intense than those reaching the collimated detector, are less easily corrupted by surface clutter and generally provide a much higher signal-to-noise ratio than uncollimated detectors. Figure 1 shows a collimated detector. The length of the lead collimator is sized to just clip out single-scatter photons. Important distances include the source beam-to-detector distance, the height of the detector above the sample, the collimator length and the height of the X-ray source above the sample. Also important are the beam size (diameter), the pixel irradiation time and the X-ray generator voltage and current.

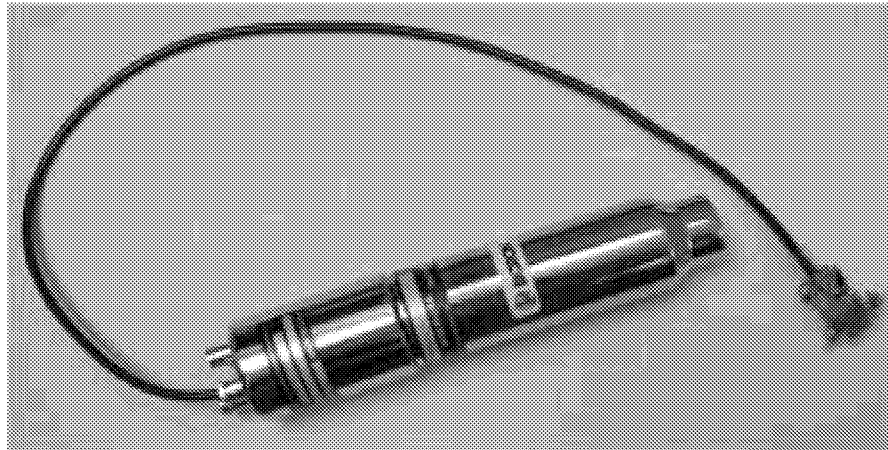
Figure 4. Bicron NaI scintillator detector.

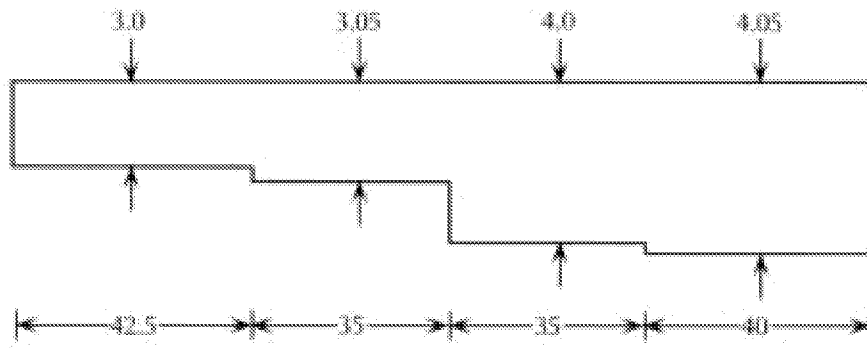
SIDE VIEW OF TOP PLATE

SIDE VIEW OF BOTTOM PLATE

Figure 17. Schematic of machined aluminum flaw plate #2.

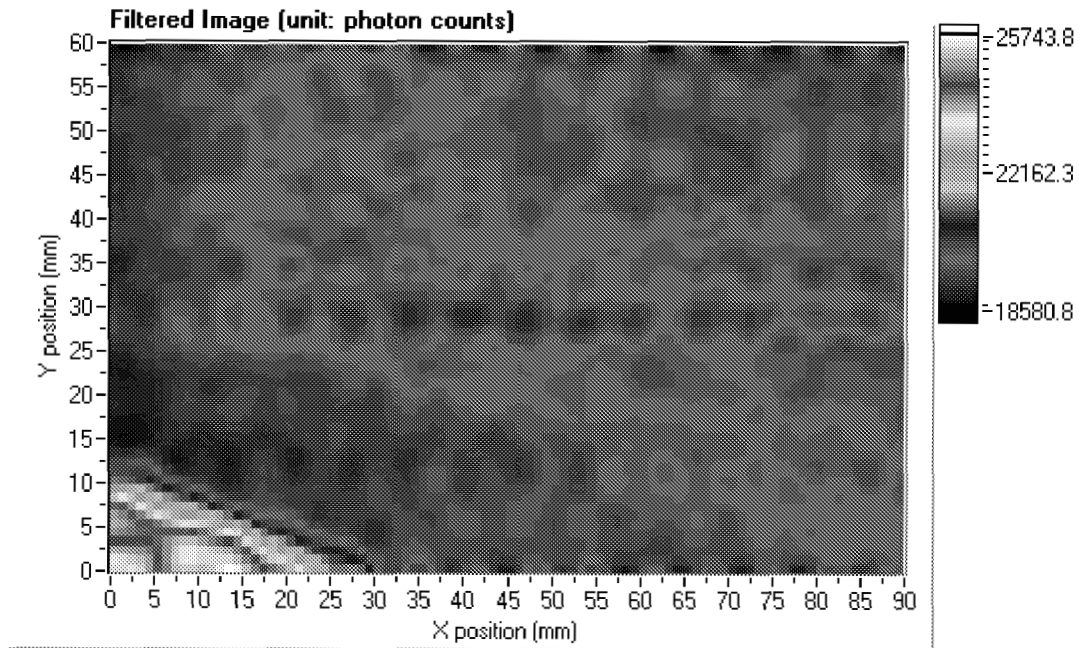
**Figure 20.** Scan of Sample #1 at Location 3 with labeled side down.  
(2 mm X-ray beam spot; 60 kVp and 5.7 mA; detector 2)

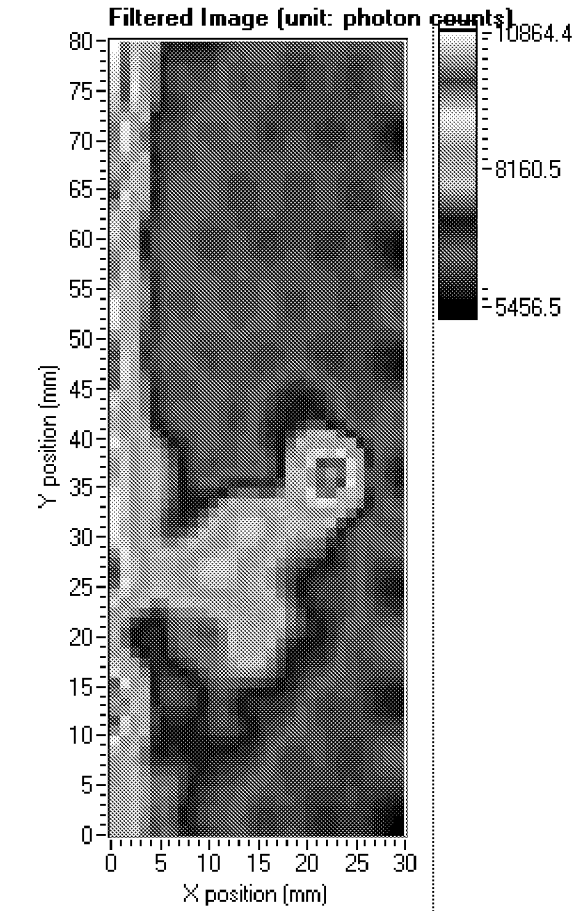
**Figure 25. Scan 3 for Sample #2 with labeled side down.**

(2 mm X-ray beam spot; 55 kVp and 5 mA; detector 1)

red vertical strip at about  $x = 0$  is corrosion

red spot centered at  $x = 22$  and  $y = 36$  is a cell with water

green area is a region of crushed core

The Scan 1 results for Sample #6 clearly demonstrate that LMR is able to detect areas of corrosion when the side containing the corrosion is face up. A more difficult, and more significant, test is to be able to detect the corrosion when the corroded side is face down and the opposite or reverse side (which is clean and un-corroded) is face-up. Figure 34 presents results for this case. The higher intensity, red and red-orange regions that include the right, top and bottom portion of the image is the good or un-corroded area of the frame member scan. Because the scanning was from the reverse side, the right side of the image corresponds to the left side of the delineated scan zone in the frame member photograph. The lower intensity, yellow region in the center left side of the image is the corroded area. The intensity difference between the corroded and uncorroded regions is 15 to 20 %. The corroded area is seen clearly even when this 2 mm thick frame member is scanned with the opposite (or good) side facing up. This result demonstrates that LMR is capable of picking up composition changes on the inside of shell-like components with only outside surface area access. This capability is also seen in the scan results for Sample #2 (Figures 24 and 25).

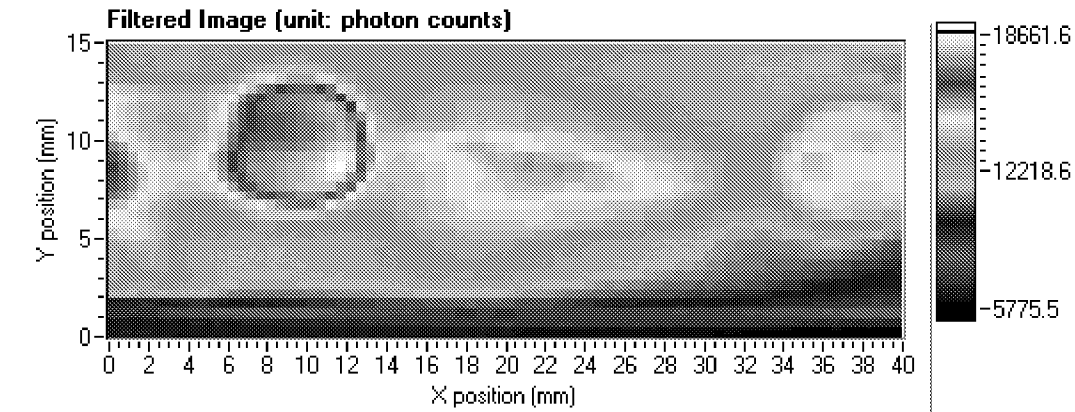
**Figure 28. Scan of Sample #3 – processed image with the sample covered by aluminum skin; scanned area marked by the blue lines in Figure 8.**

(1 mm X-ray beam spot; 75 kVp and 8 mA; detector 3)

[Relative to the previous image, which was taken without an aluminum skin covering, the number of counts (image intensity) is lower.]

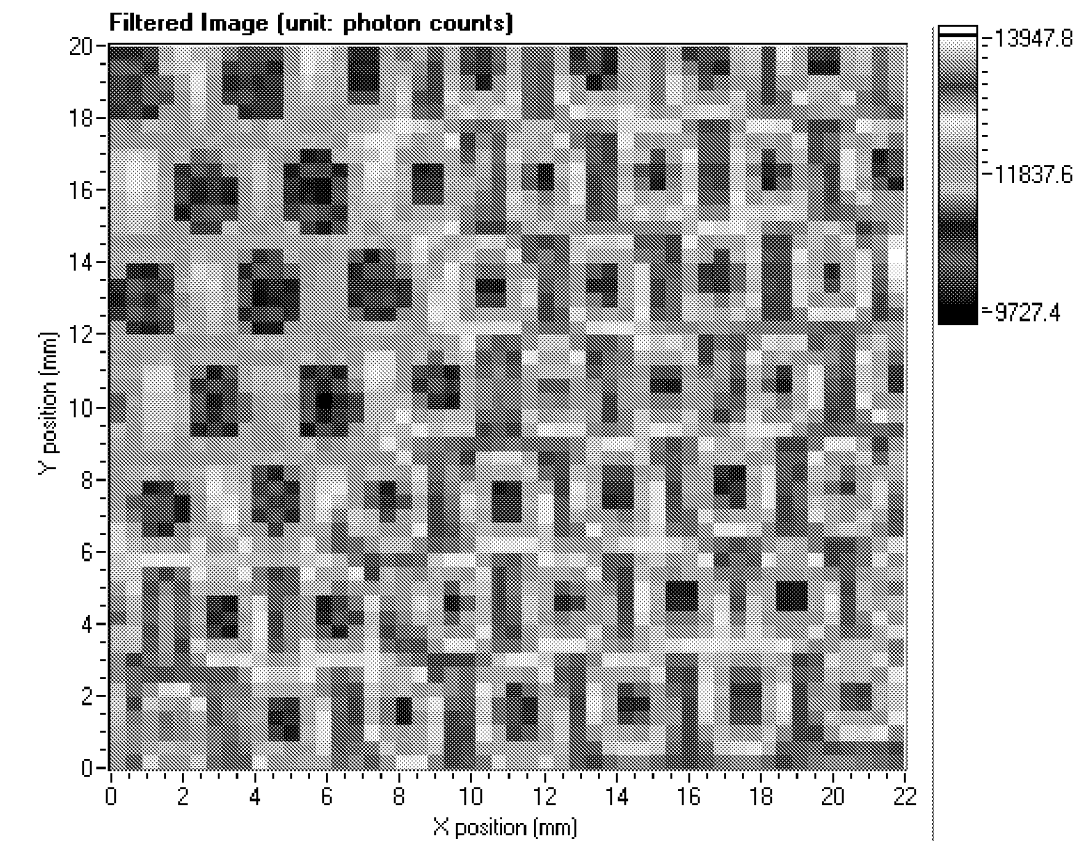
**Figure 40. Scan of the 0.5 inch diameter debonding region of Sample #8 - labeled side facing up.**

(2 mm X-ray beam spot; 75 kVp and 9 mA; detector 1)

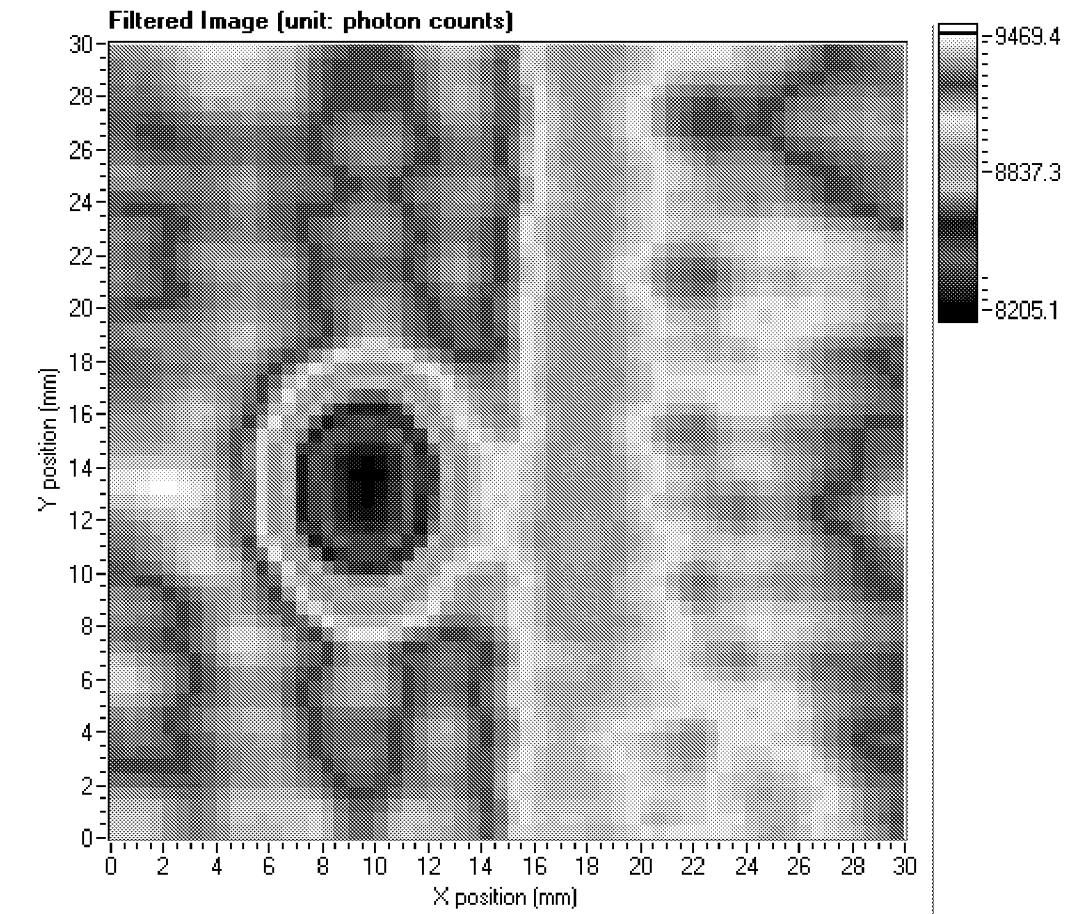
**Figure 44. Processed image of the 0.25 inch diameter debonding region of Sample #8 - labeled side facing up.**

(2 mm X-ray beam spot; 70 kVp and 8 mA; detector 1)

Figures 43 and 44 give images of the 0.25 inch (~ 6 mm) diameter debonding region. Figure 43 shows the unprocessed image and Figure 44 presents the processed image. The debonding area is clearly visible in both images. In Figure 44 it shows as the low intensity region centered at  $x = 10$  and  $y = 13$ . The low intensity vertical line at about  $y = 18$  clearly indicates the presence of some additional, but unknown, internal defect in this aluminum honeycomb panel. Finally, Figure 45 gives a scan of the “film region” of Sample #8. A small piece of film was located inside the honeycomb panel and the LMR scan clearly shows the location of this piece of film. For the images in Figures 43, 44 and 45 the X-ray generator beam spot was 2 mm and the X-ray generator was operated at 75 kVp and 9 mA. All of the scans of Sample #8 with the three detector system and the new image acquisition process used 1 mm x 1 mm pixels.

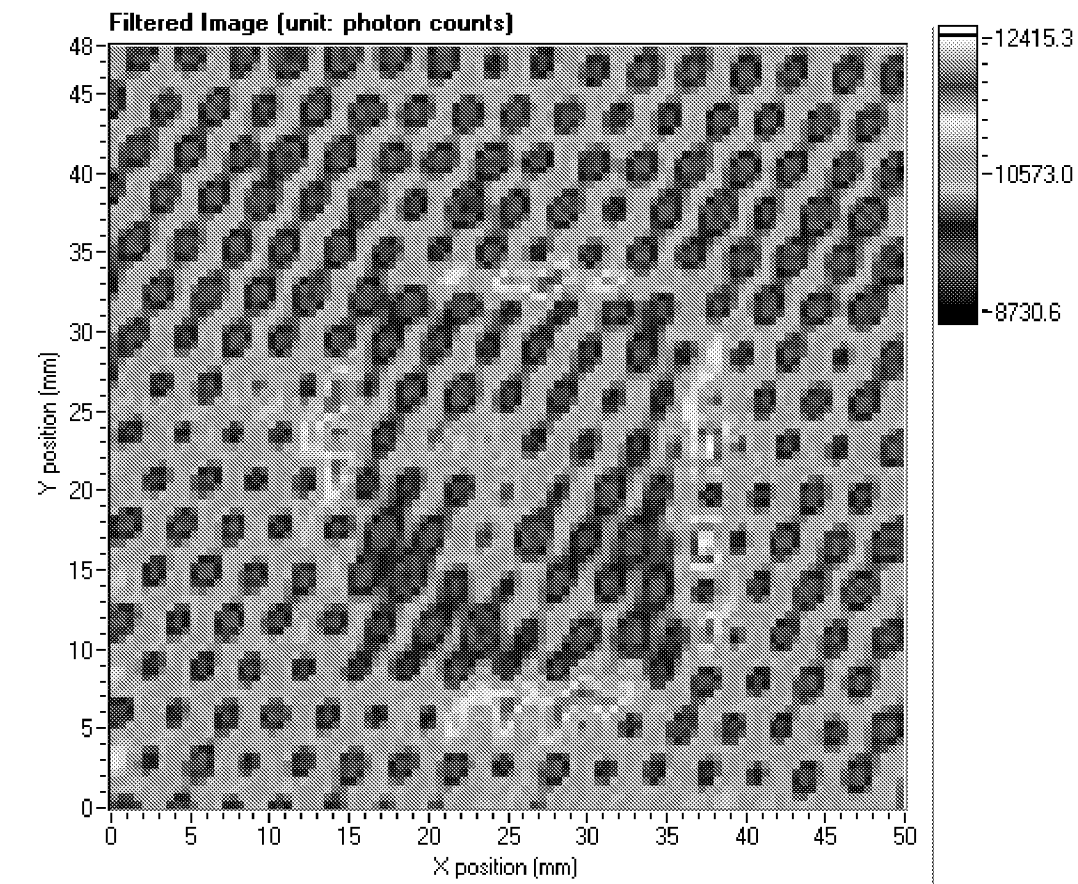
**Figure 45. Scan of the film region of Sample #8 - labeled side facing down.**

(2 mm X-ray beam spot; 75 kVp and 9 mA; detector 1)
