**FIXED-PRICE SUBCONTRACTING FOR
DECONTAMINATION AND DECOMMISSIONING
OF SMALL FACILITIES
AT OAK RIDGE NATIONAL LABORATORY***

M.A. Harper
Bechtel Jacobs Company LLC
P.O. Box 4699, Building 7078D, Oak Ridge, TN 37831-6402

Abandoned facilities were decontaminated and decommissioned in preparation for final remediation of Solid Waste Storage Area (SWSA) 4 at Oak Ridge National Laboratory. The facilities varied in age from approximately 5 years to more than 40 years, with radiological conditions ranging from clean to highly contaminated with fission products.

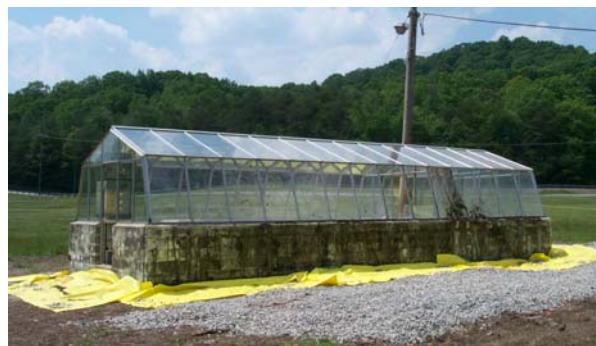
Fig. 1. Alpha Greenhouse.

Constructed in the mid-1970s, the facility was a 14 by 37-ft aluminum frame and glass greenhouse structure erected on a 4-ft concrete block wall on slab. No utilities beyond electrical service existed at the building.

Pre-demolition radiological surveys revealed no removable contamination or fixed radioactivity above DOE release limits (5). Asbestos-containing materials in the form of piping insulation and stored transite panels were present within the building, as was a small heating, ventilating, and air-conditioning unit. These items were removed from the building, leaving a virtually clean structure for conventional demolition.

A Caterpillar 325 excavator outfitted with a concrete pulverizing tool was used to demolish and size-reduce the structure. Frame sections were placed in a roll-off waste container as they were sectioned and removed. Under a continuous water mist, the masonry sidewalls were demolished, size-reduced, and left adjacent to the building slab to ultimately be covered by an engineered cap (6).

All non-masonry demolition debris was determined to meet the waste acceptance criteria for disposal at the clean construction and demolition landfill located at the Y-12 National Security Complex in Oak Ridge. One 20-ft roll-off waste container was generated as a result of Building 7833 demolition.

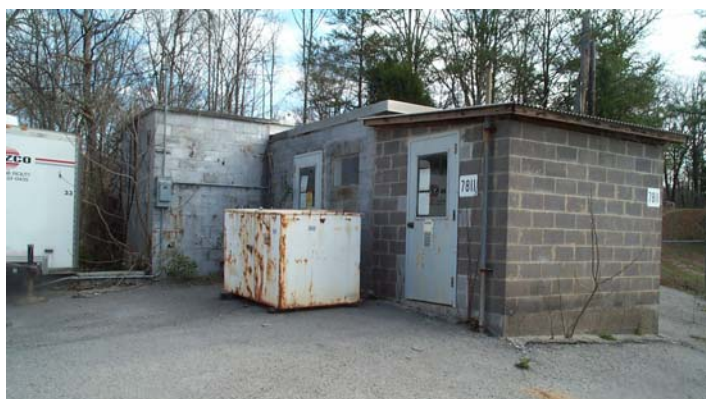
Fig. 2. Pilot Pit Facility.

The key feature of the Pilot Pit Facility was a shielded below-grade containment vessel containing a sintering furnace and mixing assembly. The vessel was covered by a 5-ft-thick concrete shield plug with access hatch, and surrounded by a mound of asphalt-covered soil. The asphalt/soil mound was maintained on three sides with concrete walls. Adjacent to one wall was Building 7811, a concrete block building on slab with a maximum footprint of 16 by 21 ft, designed as the control house for the pit experiment. A below-grade off-gas cleaning system was housed in concrete culverts placed vertically in the ground

about 50 ft away from the sintering pit. Co-located at the Pilot Pit Facility site were four 12-ft tall vertical concrete lysimeters on concrete bases. These structures were used in 1984 for municipal waste leaching studies.

Radiological surveys were conducted on miscellaneous items stored inside Building 7811, as well as the building structure itself. Visual indications of a legacy spill on the building floor were confirmed when contact dose rates up to 210 mrad/h beta and 3 mR/h gamma on contact with floor slab were discovered. This area of the floor also contained low levels of removable contamination. Surveys of the lysimeters, off-gas system, and sintering pit revealed no additional radiological conditions. Non-friable asbestos-containing material was detected in the built-up roofing system of Building 7811.

The four concrete lysimeters were the first structures to be demolished at the Pilot Pit Facility using a Caterpillar 325 track hoe with concrete pulverizer. The lysimeters were pushed over and the waste from the 1984 experiment was separated out and placed in an open-top roll-off waste container pending disposal at the nearby Y-12 Sanitary Landfill. The remaining concrete lysimeter structures were crushed and left on-site.

Building 7811 was demolished to slab using the trackhoe in conjunction with a Bobcat-mounted hoe-ram attachment. All non-masonry debris was managed as clean construction and demolition (C&D) waste. Masonry debris was size-reduced and spread on-site with the exception of a number of concrete blocks found to contain radiologically contaminated mud dauber nests. These blocks were handled as low-level (radioactive) waste (LLW). The portion of the building slab having elevated levels of radiological activity was cleaned of transferable contamination and covered with several inches of new concrete.

Below-grade structures at the facility (off-gas cleaning system and sintering pit) were exposed by removing the concrete covers. Equipment from these structures was removed and the pits were filled with the size-reduced clean masonry rubble generated from demolition of the above-grade structures.

Three waste streams were generated during demolition of the Pilot Pit Facility: sanitary waste (one roll-off container), clean C&D debris (one roll-off container), and LLW (less than one intermodal container).

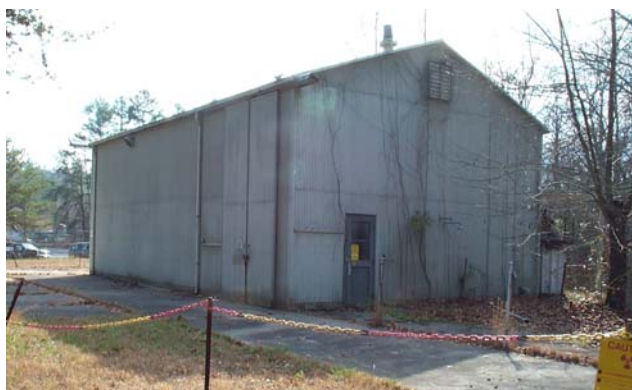
Fig. 3. Decontamination Facility.

The building consisted of a steel frame with insulated, corrugated metal roof and side panels on a 48 by 33-ft concrete floor slab. A 6-ft-deep decontamination pit was constructed below the slab. The building contained a small change room/office area constructed of concrete block walls. Floor gravity drains conveyed liquid rad waste to an adjacent waste disposal pit (Pit 1). Equipment remaining in the building included an overhead monorail hoist, decontamination vessel, welding hood, and milling machine. The facility had no process ventilation system. Exterior to the building were a number miscellaneous concrete pads and tank support structures.

Due to the nature of processes conducted in the building, a variety of radiological contaminants were present in different configurations. Pre-demolition characterization data indicated that the building was grossly contaminated with beta and gamma emitters (primarily Sr-90, Cs-137, and Co-60), with localized spots of high contamination. Some alpha contamination was also present. The entire building was posted as an airborne contamination zone, radiation zone, and contamination area. General area dose rates within the building ranged up to 10 mR/h. Contact dose rates, particularly on equipment in the building, were

substantially higher. In addition to radiological constituents, asbestos pipe insulation was present in the building (8).

The first D&D task at the Decontamination Facility was abatement of radiologically contaminated asbestos pipe insulation. The entire interior of the building and its contents were coated with a spray-applied fixative to lock-down transferable surface contamination. No attempt was made to decontaminate equipment items in the building. Instead, all equipment was managed as LLW and placed in intermodal containers for shipment to an off-site, licensed disposal facility.

Demolition of the building structure was accomplished using a Caterpillar 325 track hoe with a hydraulic shear. An experienced operator carefully peeled the roof and side panels from the structural steel framework, placed the removed sections into an intermodal waste box, and size-reduced the sections as necessary using the shear. Demolition and size reduction of the framework proceeded in the same manner.

Once accessible, the concrete block room was demolished with the shear. Because the block did not exhibit elevated levels of radioactivity, it was size-reduced and placed in the building decontamination pit as a means of stabilizing the below-grade structure. The remaining slab was cleaned of all loose material and coated with fixative. All other debris generated from Building 7819 demolition was managed as LLW. Eight 20-ft intermodal waste containers from Building 7819 were packaged for transport to and disposal at Envirocare of Utah.

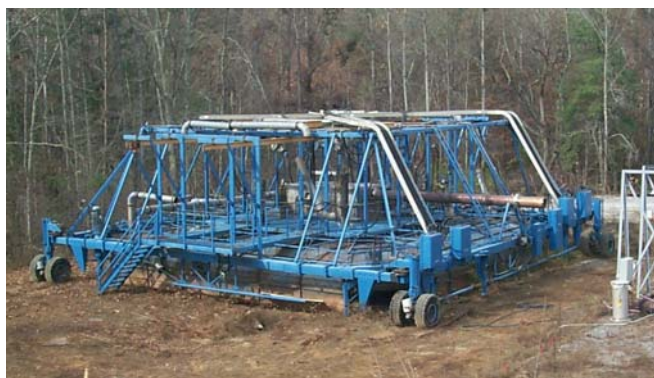
Fig. 4. In-situ Vitrification Hood System Structure.

The ISV system structure consisted of a 50 x 50 x 6-ft-high off-gas collection hood fabricated from over 200 separate stainless steel panels. The hood, which contacted the ground during operations, was suspended from a large framework structure using shackles and chain. The tubular steel framework provided support for all the components that comprised the ISV hood system. Flanged plates having either bolted fasteners or clevis ends with pin fasteners were used to join the members. Tensioning members used to truss the structure consisted

of steel cable and turnbuckles. The structure also contained a travel system that allowed it to be moved and steered by four geared wheel assemblies under its own power (10).

Surveys of the ISV system revealed few areas of slightly elevated radiological activity. Because of the benign condition of the structure, regulators agreed that in-place disassembly of the system, which was to be covered later by the SWSA 4 engineered cap, was an acceptable D&D solution. Initially, all

mechanical components that contained hydraulic fluids were removed. The ISV structure was then demolished in-place using a Caterpillar 325 with a hydraulic sheer attachment. The demolition debris was size-reduced and placed in a single layer so that the height of any single piece was not greater than 18 inches. Individual pieces of debris with enclosed void spaces greater than 8 inches were crushed. The debris was left in-place to be covered by the SWSA 4 cap.
