INVESTIGATION OF THE SUITABILITY OF PREPAKT
CONCRETE FOR MASS AND REINFORCED
CONCRETE STRUCTURES

TECHNICAL MEMORANDUM NO. 6-330

CONDUCTED FOR
OFFICE, CHIEF OF ENGINEERS
BY
WATERWAYS EXPERIMENT STATION
VICKSBURG, MISSISSIPPI

OCTOBER 1951
PRICE \$1.00

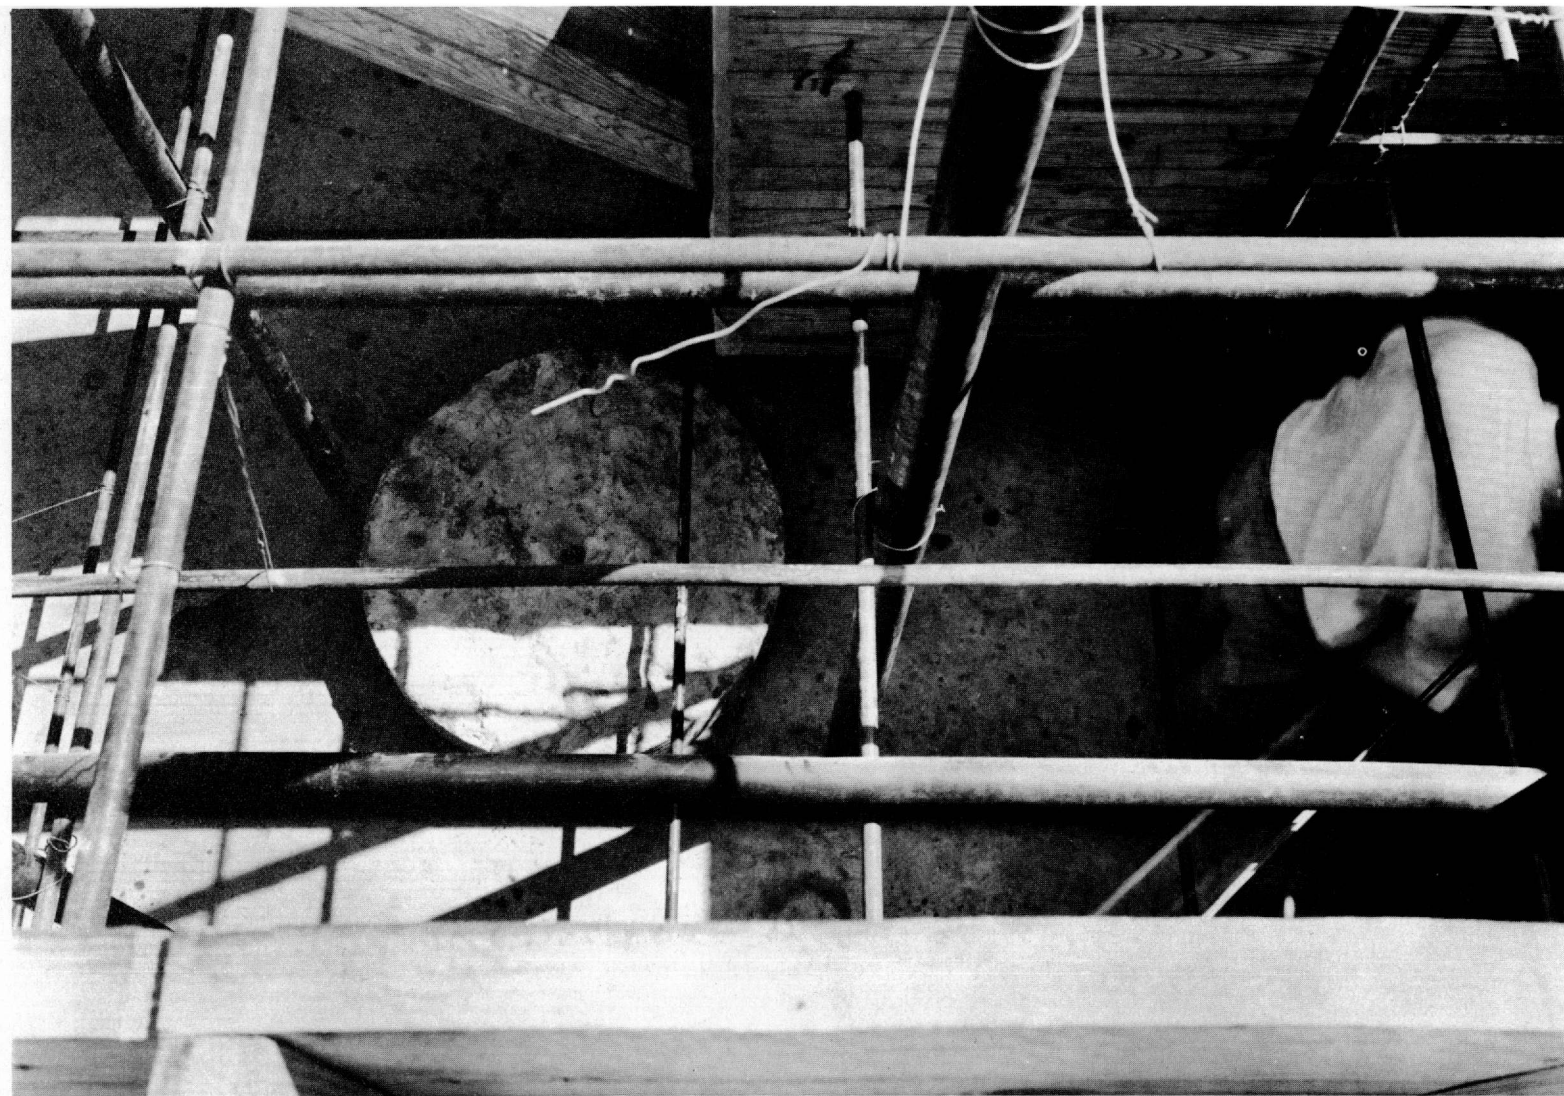
PLATE 11

Sandblasted core in place on foundation of test block

88. Bond between Prepakt and rock. The bond between a sandblasted section of limestone rock core (plate 10) placed in the bottom of the block form (plate 11) and the Prepakt grout was found to be good by examination of core 5, section E (plate 52). The contact between grout and limestone was a gently curving plane with visible differences in elevation of about 1-1/4 in. The bond was very close, and at magnifications up to 60X (see figures 18 and 19) no opening between limestone and

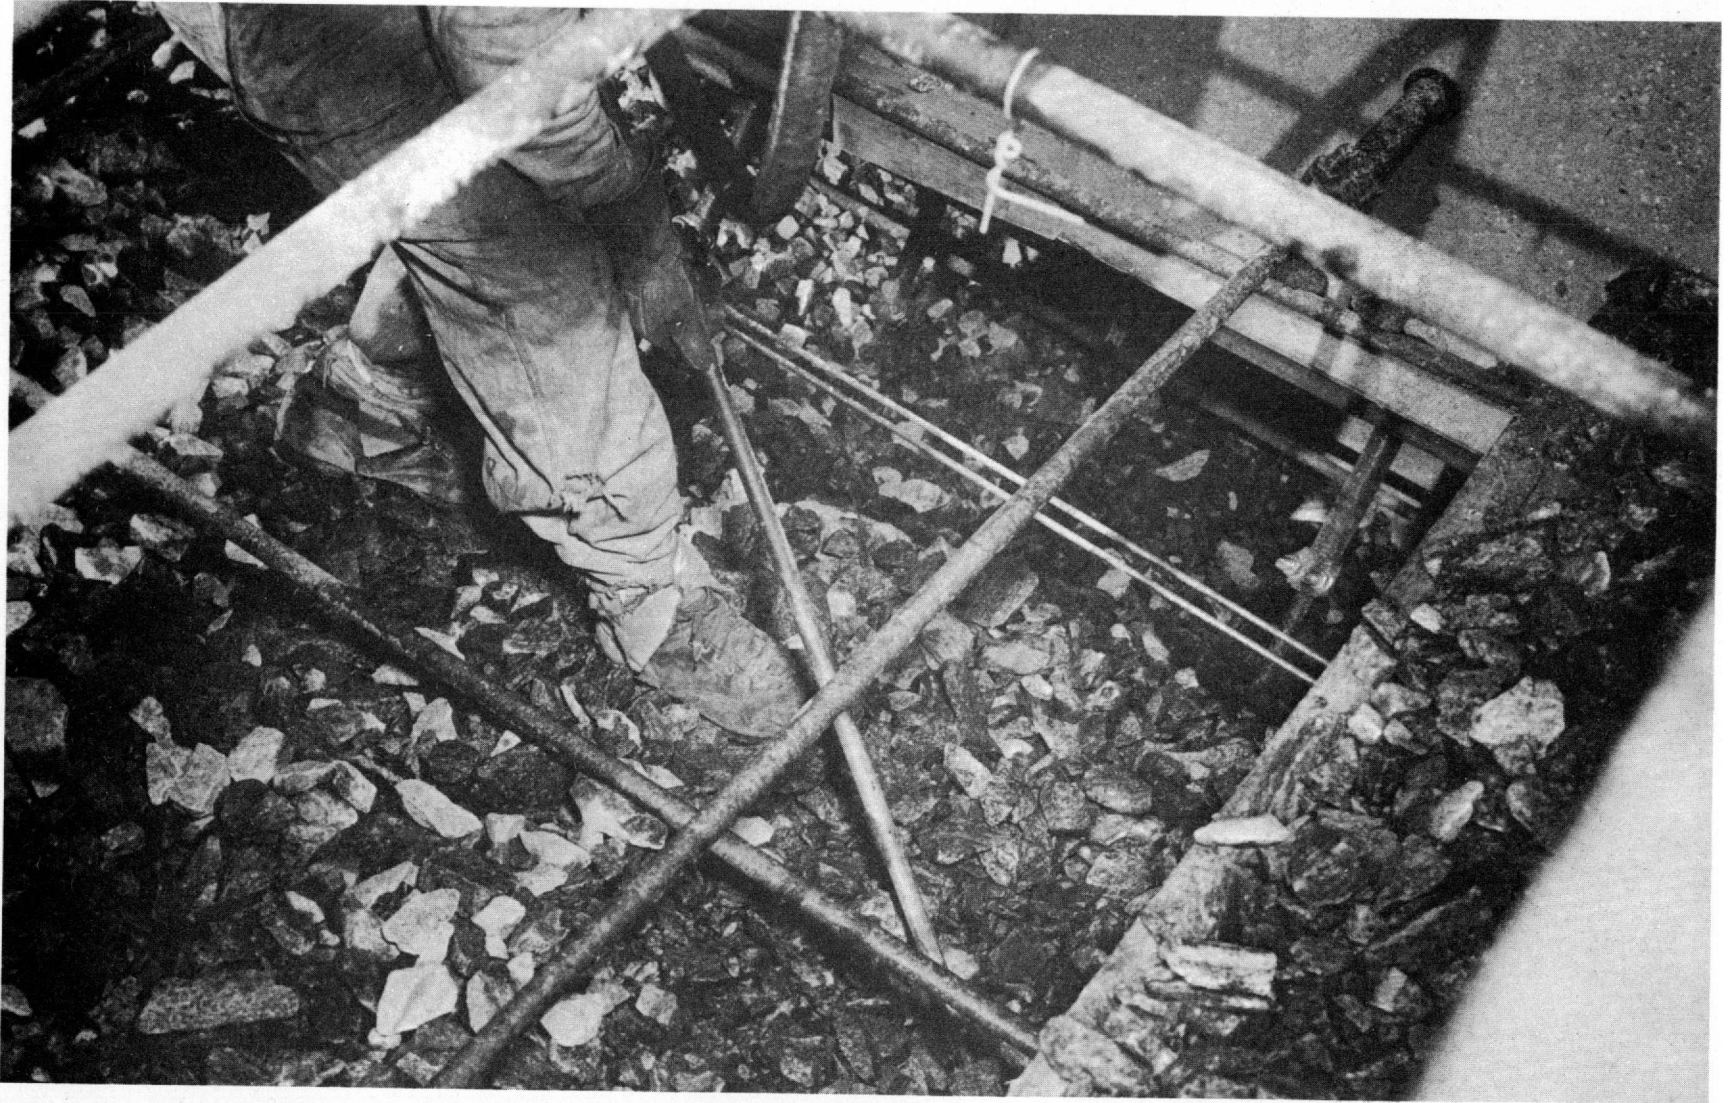
Placing coarse aggregate under blockout with compressed air jet

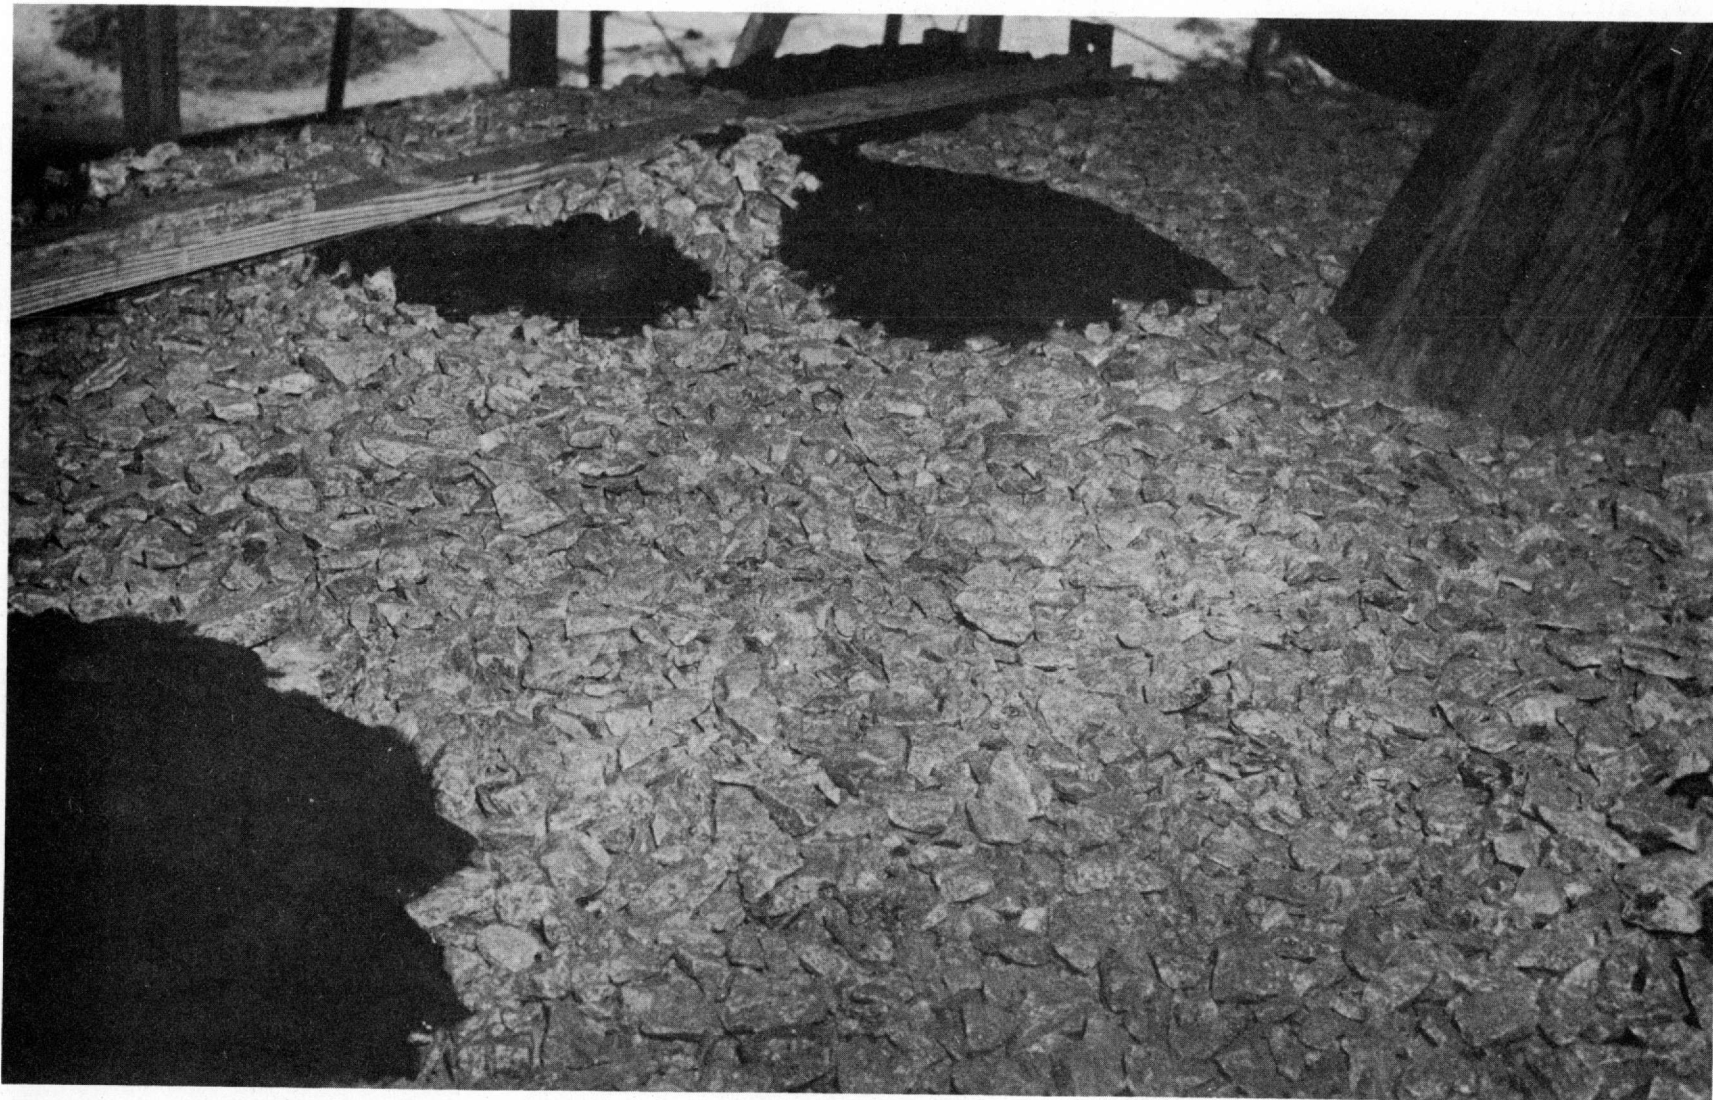
Grout eruption through coarse aggregate

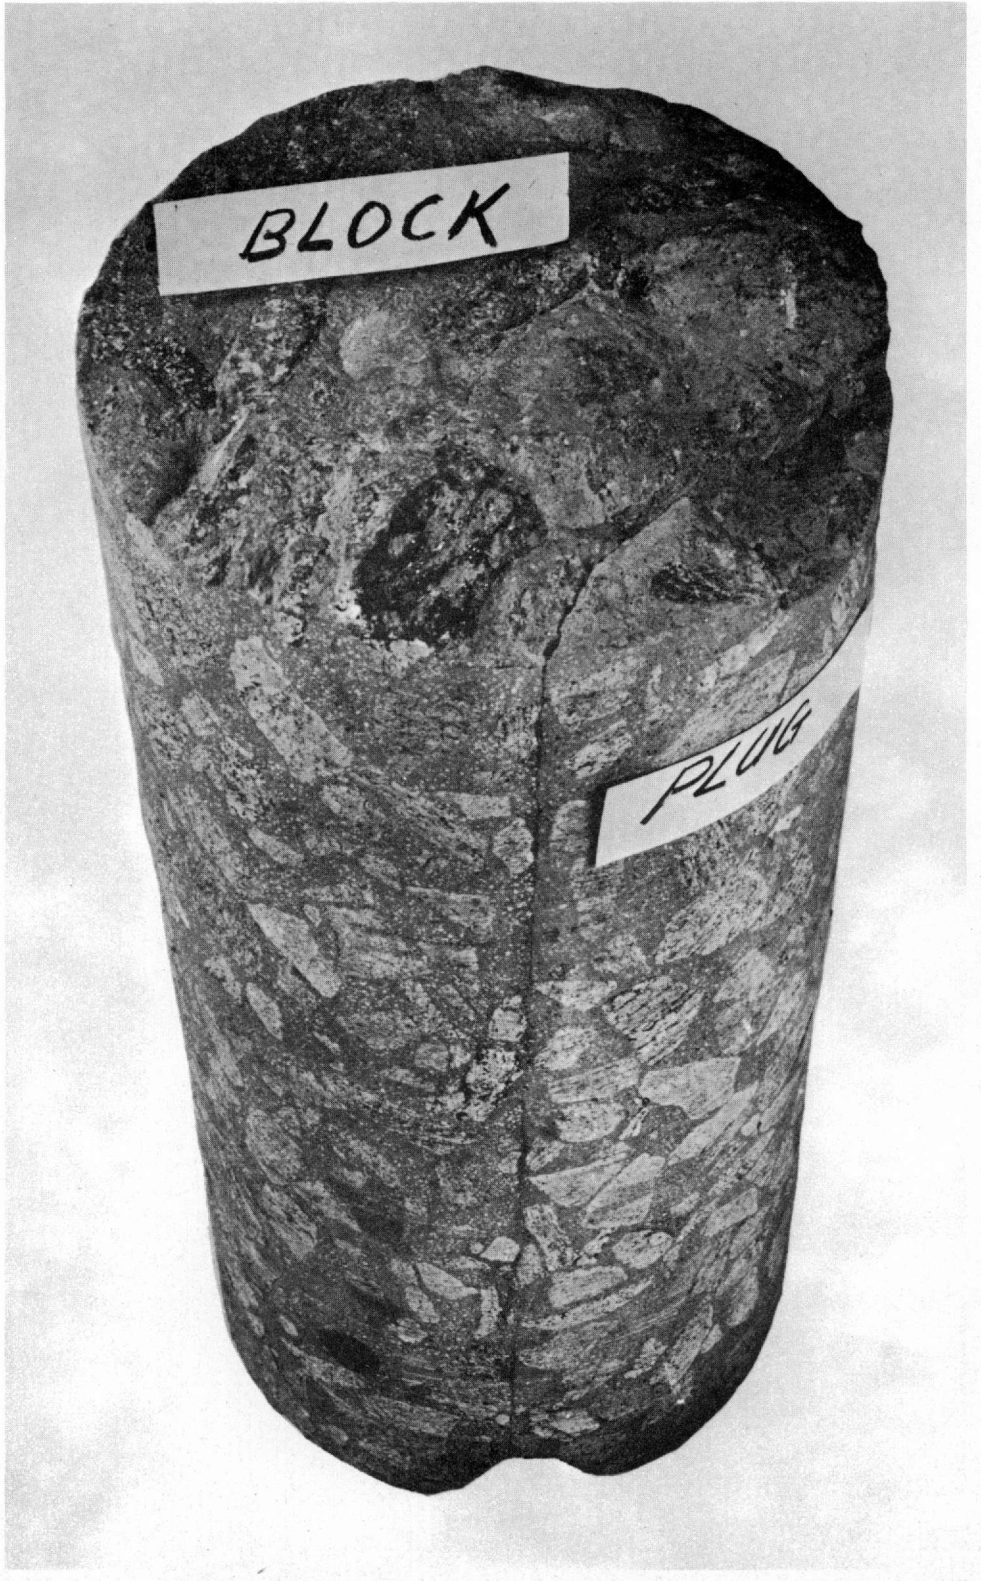
Section of core of Prepakt block to Prepakt plug at elevations 3.0 ft to 4.9 ft with 4.9-ft plane up, showing lack of bond between block and plug

87. Bond between new and old Prepakt. Plate 56 shows the core taken along the axis of the penstock and intersecting the junction of the block and plug. Lack of bond will be noted between the new and older Prepakt. No preparation of the older Prepakt surface was made prior to grouting the Prepakt plug. Such preparation should be made where it is desired to bond new to old Prepakt.

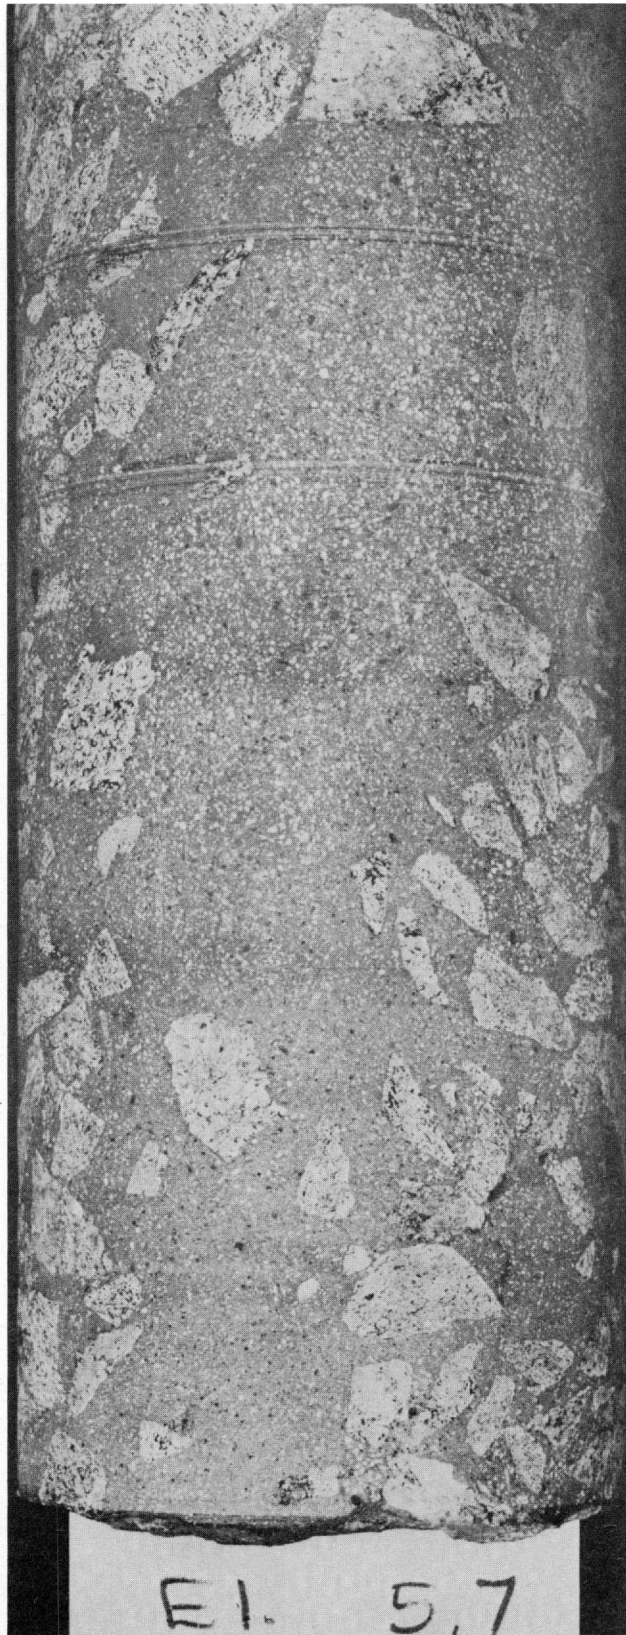
Close-up of section of core 2, near depth of 5.7 ft from top of pier,
showing void in coarse aggregate

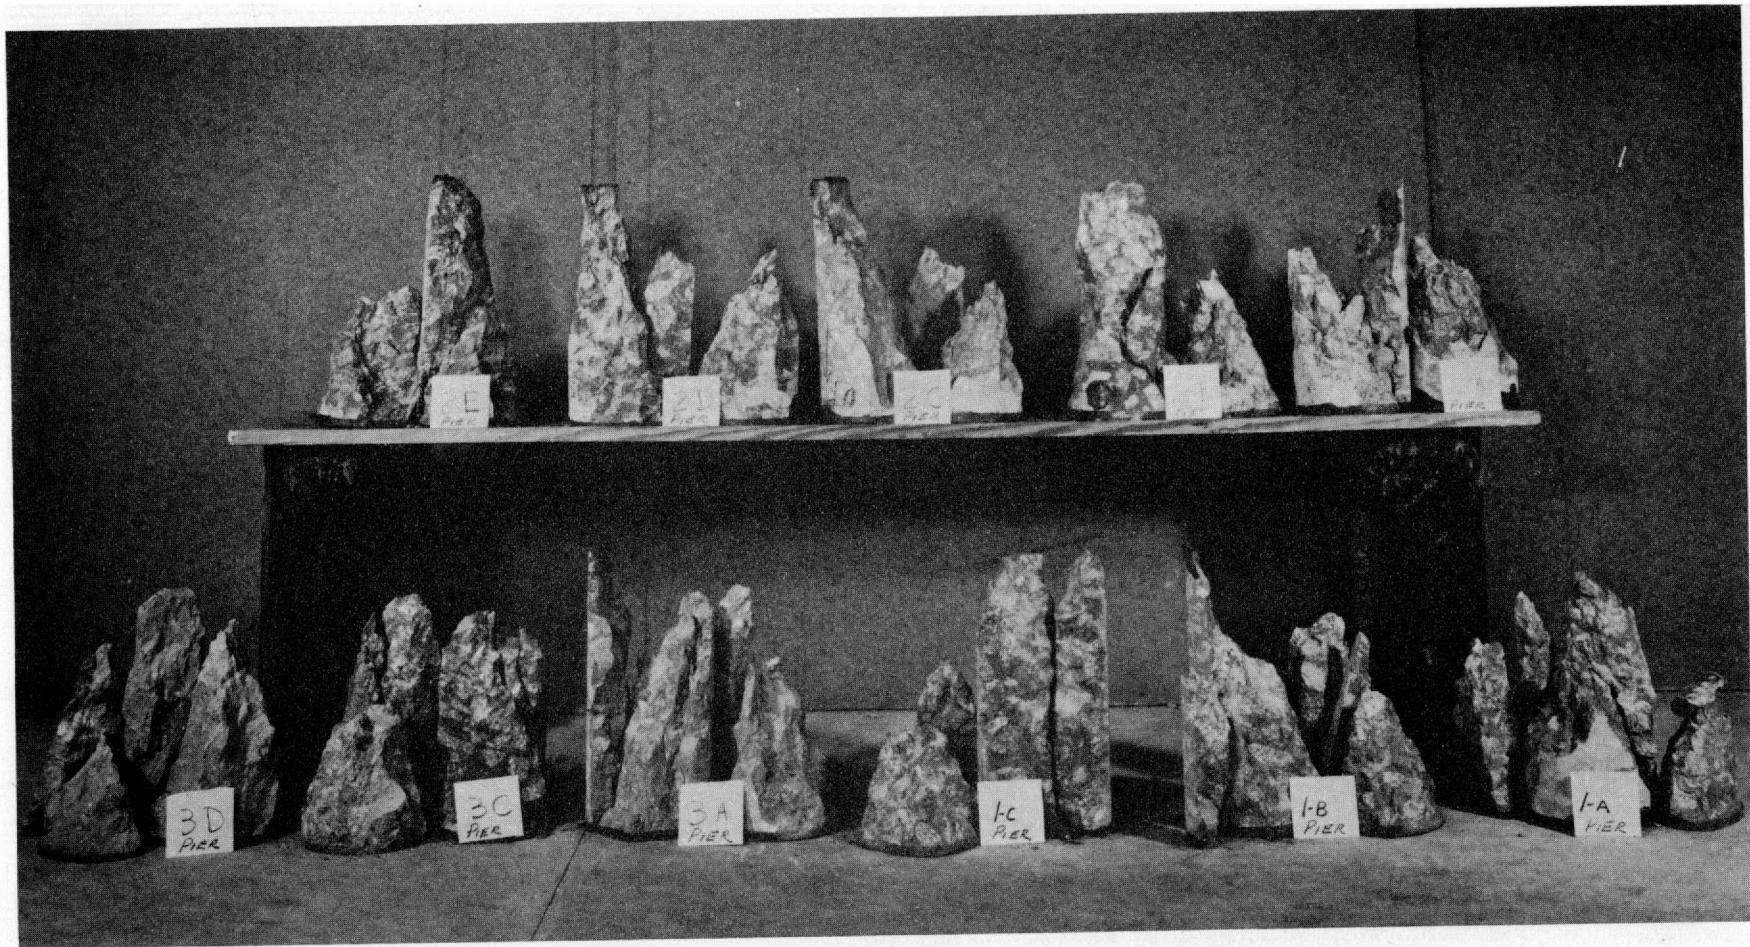
Six- by twelve-in. sections from cores 1, 2 and 3, taken from Prepakt bridge pier,
after testing in compression at 90 days

five from core 2, and three from core 3, and tested in compression at 90 days. These cores were also set aside and at an age of 182 days were broken down in the compression machine preparatory to photographing. The minimum strength obtained was 5285 psi and the maximum was 7820 with an average of 6710, all of which are extraordinarily high for concrete with a portland cement content of less than 4.5 bags per cu yd. The strengths obtained when the cores were completely broken down were, in all but one case, equal to or greater than the original values. Test results are shown in table 11. Plate 61 shows failure patterns developed by sections of cores 1, 2 and 3.
