## **Evaluation of the 183-D Water Filtration Facility for Bat Roosts and Development of a Mitigation Strategy, 100-D Area, Hanford Site**

**March 2011**

**Washington Closure Hanford**

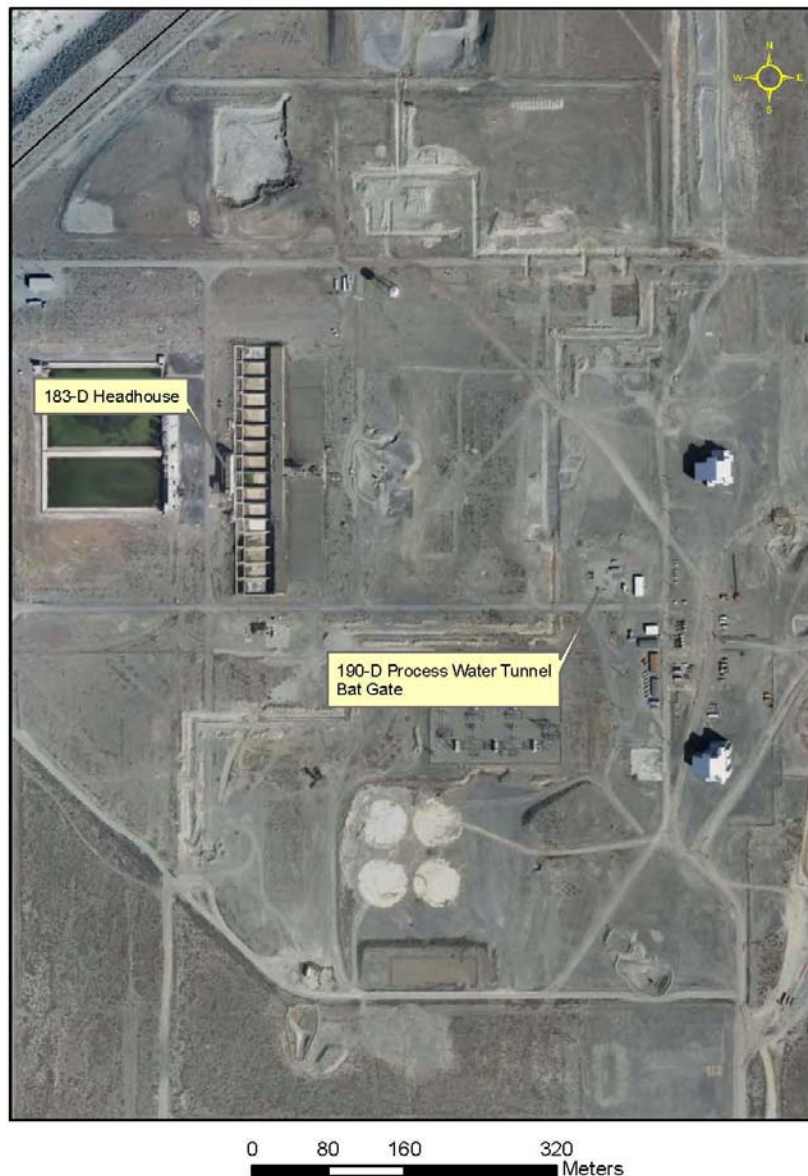
It is possible that the bats entering the 183-D Headhouse were emerging from another part of the 183-D Facility, from the 190-D/DR Process Water Tunnels (a known roost site), or from an additional unknown roost. An emergence count of Yuma bats was conducted on July 7, 2010, at the 190-D Process Water Tunnel bat gate. Approximately 340 bats were counted leaving the roost. This bat gate is approximately 400 m southeast of the 183-D Headhouse (Figure 2). As the bats emerged from the bat gate, they most often flew in the direction of the water treatment plant and the sedimentation basins. Typically, when bats first emerge from a roost, they fly to the nearest water source to get a drink and begin foraging for insects. This could explain some of the bats observed flying around and into the door on the third floor of the headhouse.

**Figure 2. 190-D Process Water Tunnel Bat Gate.**

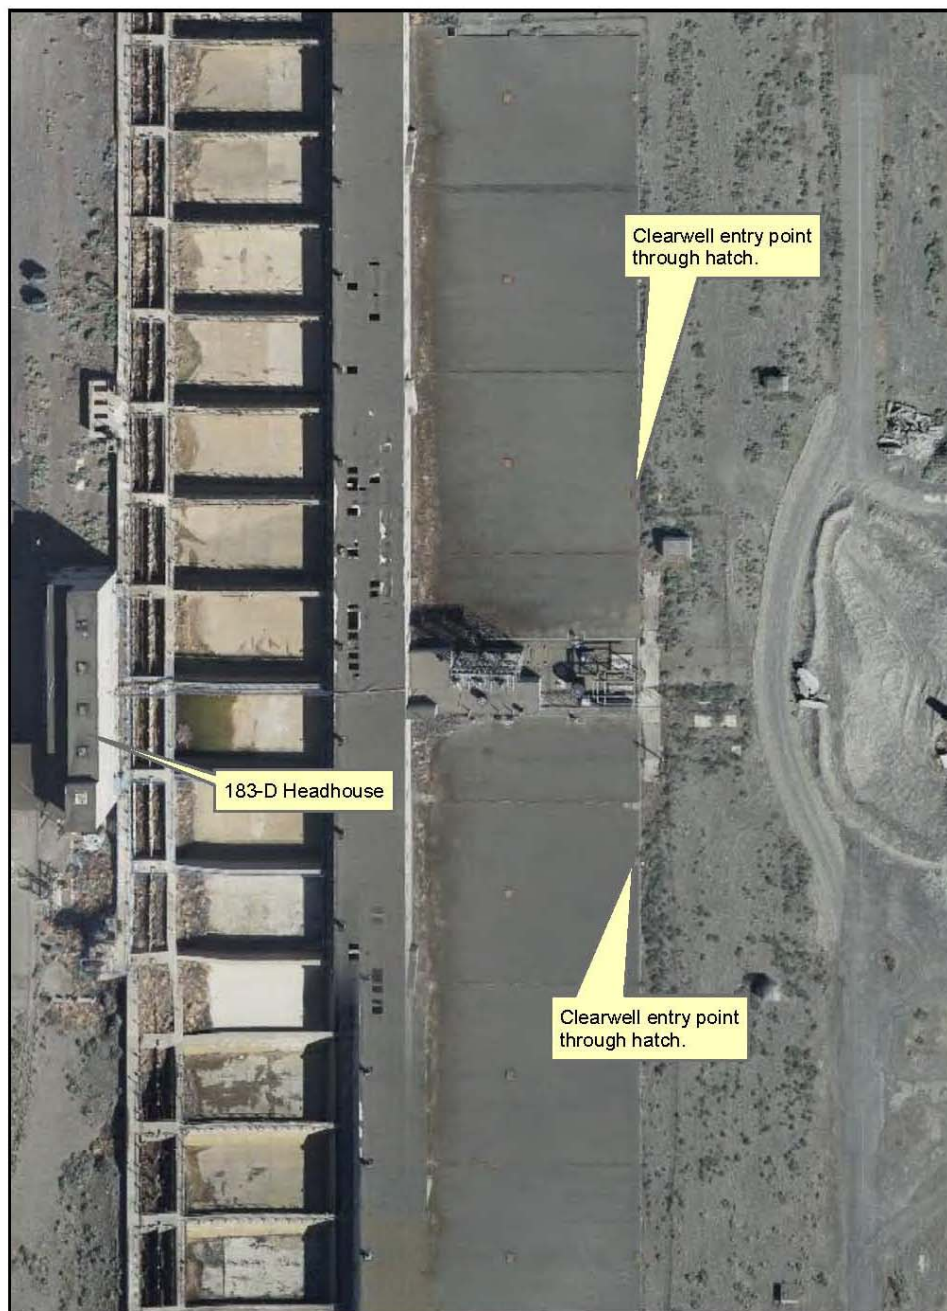
An entry into the 183-D Clearwells and connecting flumes was made on October 25, 2010, in order to assess these areas for the presence of bats. Entry was made at two locations using clearwell roof hatches (Figure 3). The interior and floor areas of both clearwells were inspected, along with associated connecting flumes. Bat guano was observed throughout the clearwells and connecting flumes, but no bats were observed during this inspection. No large localized accumulations of guano or urine staining were observed in potential bat roosting areas (under hatch covers and on roof support columns) in the clearwells that would suggest the presence of

**Figure 3. 183-D Clearwell Personnel Entry Points.**

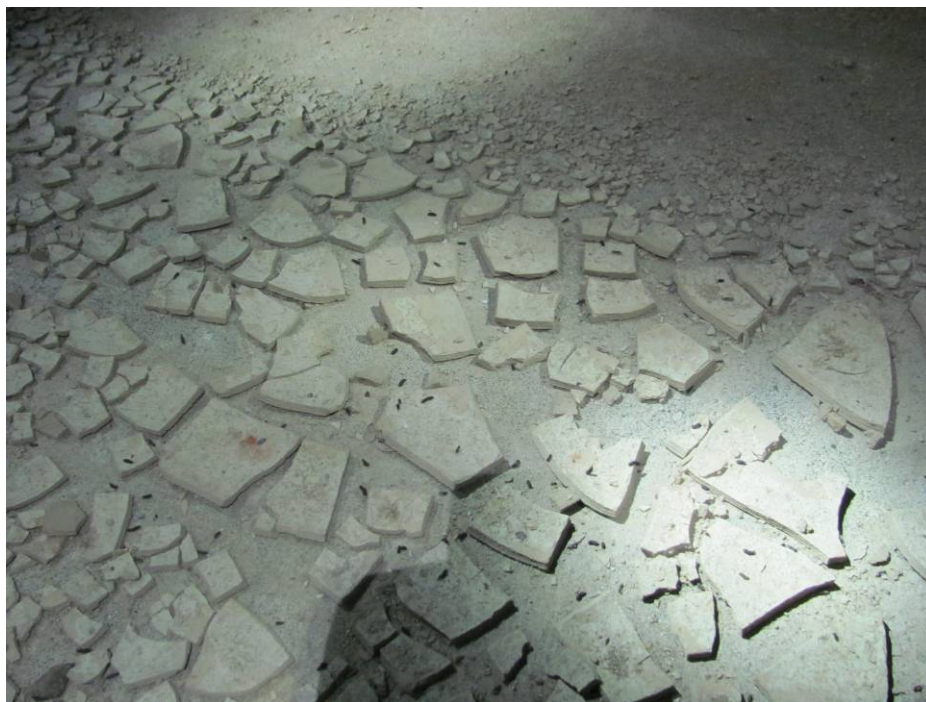
a maternity roost. The scattered guano throughout the facility does indicate that bats are using the buildings on a limited basis. The bats using the clearwells are potentially solitary individuals using the structure as a day or night roost. Figures 4 through 6 show photos of the inspection areas.

**Figure 4. Bat Guano on Clearwell Floor.**

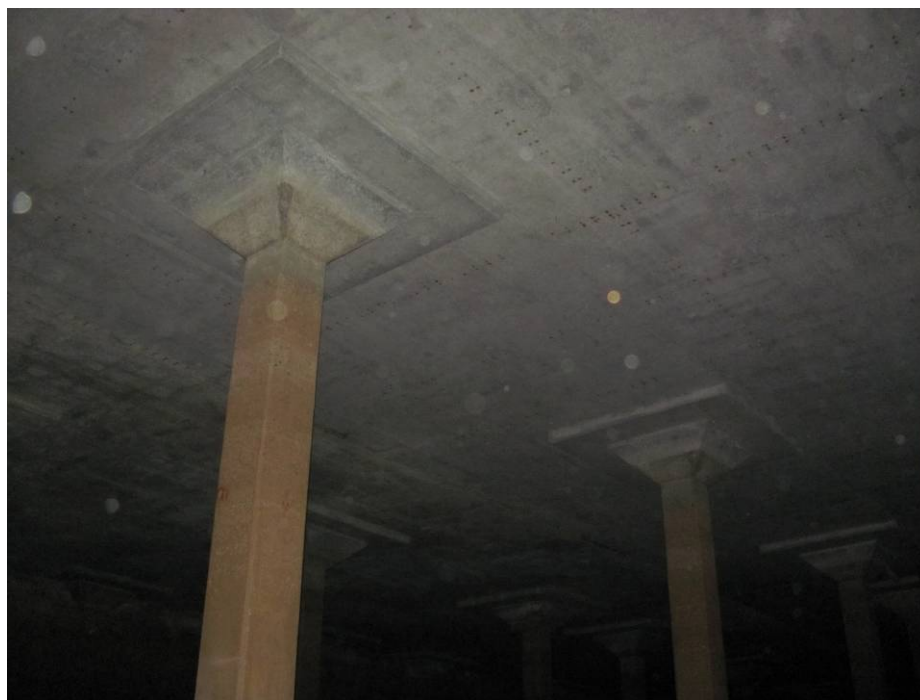
**Figure 5. Typical Clearwell Roof Support Columns (no urine staining observed to indicate roosting).**

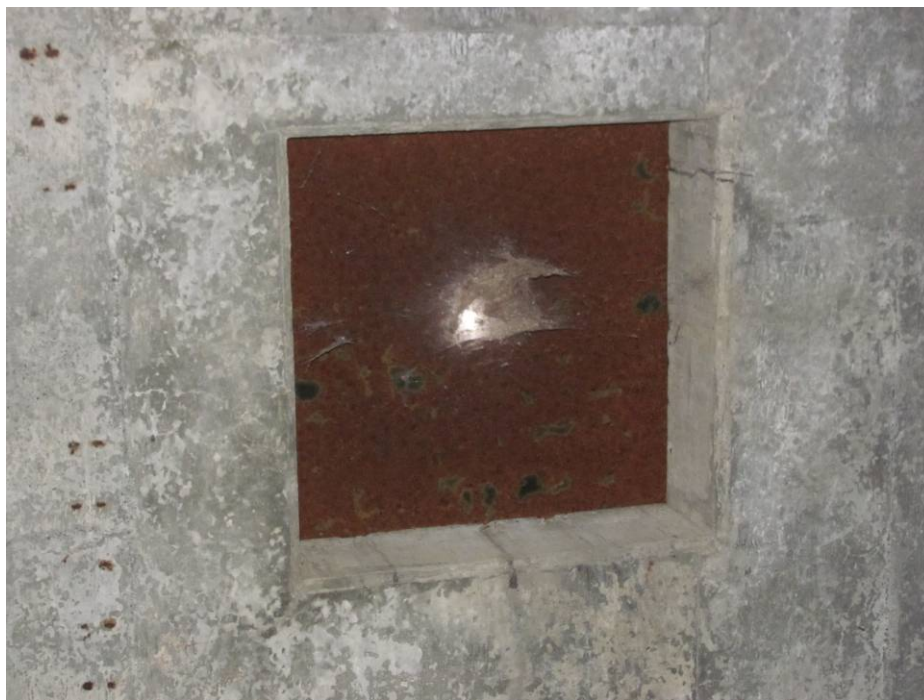
**Figure 6. Typical Clearwell Hatch Cover  
(no urine staining observed).**
