**Materials Solutions for Hydrogen Delivery in Pipelines
DE-FG36-05-GO15036**

September 2011

Secat, Inc.

Project Title: Materials Solutions for Hydrogen Delivery in Pipelines

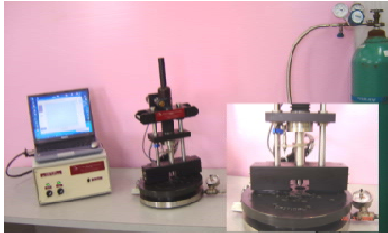
Fig. 1 – ATC SSM hydrogen testing apparatus. Picture on left shows set up, while picture on right shows details of pressurized hydrogen disk.

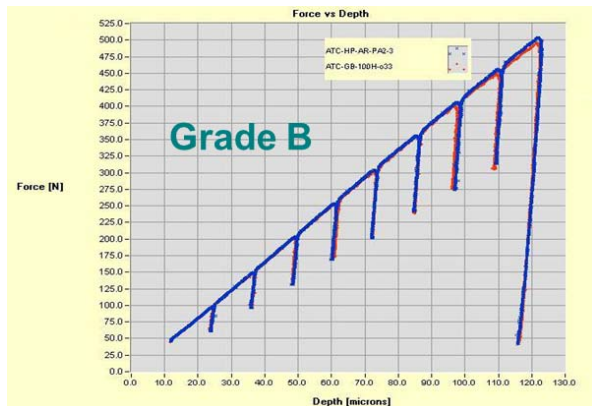
ATC SSM testing results for API Gr B ERW non-project pipeline steel. Note that both the red and blue lines are basically on top of each other signifying that the test method did not see any difference with exposure to 200 hours of 2000 psi hydrogen gas.

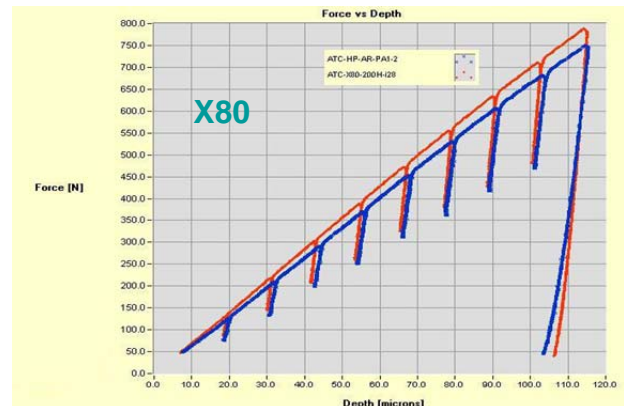
ATC SSM testing results for API X80 seamless non-project pipeline steel. Note that there is a separation between the red and blue lines signifying that the test method did see a difference with exposure to 200 hours of 2000 psi hydrogen gas.

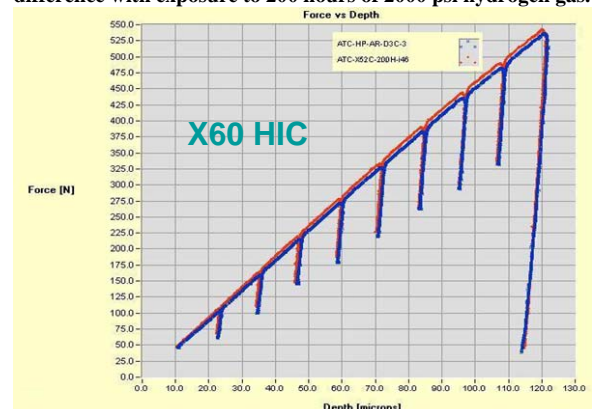
ATC SSM testing results for API X60 HIC LSAW project pipeline steel. Note that both the red and blue lines are basically on top of each other signifying that the test method did not see any difference with exposure to 200 hours of 2000 psi hydrogen gas.

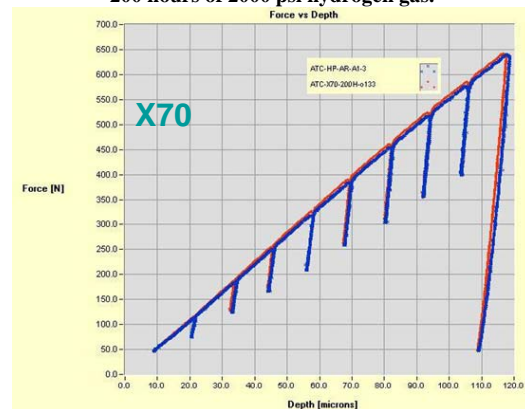
ATC SSM testing results for API X70 LSAW project pipeline steel. Note that both the red and blue lines are basically on top of each other signifying that the test method did not see any difference with exposure to 200 hours of 2000 psi hydrogen gas.

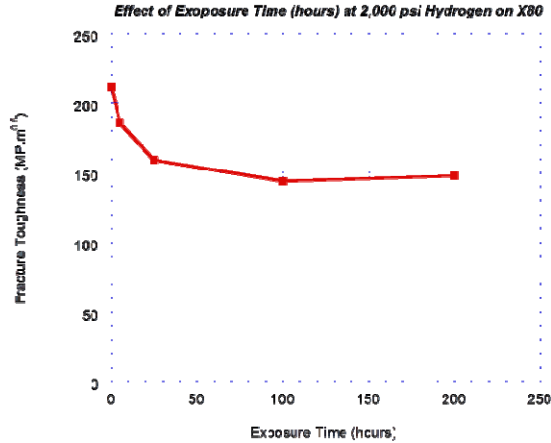
ATC SSM fracture toughness of API X80 seamless non-project pipeline steel results showing a 43% decrease in fracture toughness when exposed to hydrogen gas for 200 hours at 2000 psi hydrogen gas pressure.

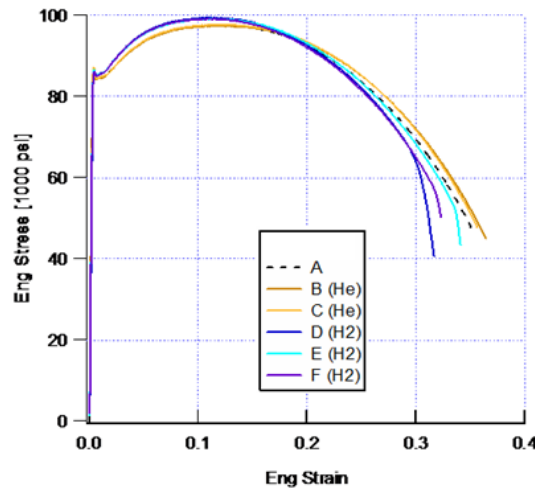
Project pipeline steel Alloy A, note the slight instability of the stress strain curve and slight degradation of strength with the exposure to hydrogen. This slight difference is most likely to the slight differences noted in microstructures between Alloy B and Alloy C.

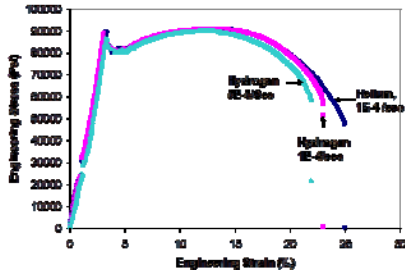
Project Alloy A API X70 pipeline steel tensile tested in hydrogen and helium at two different strain rates. Note that the presence of hydrogen decreases total strain needed for failure, regardless of strain rate.

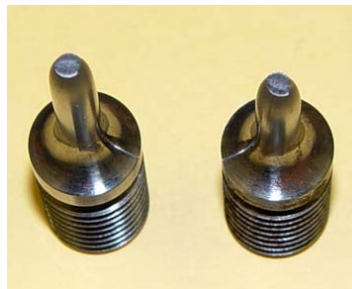
Helium Testing - Typical Ductile cup and cone fracture

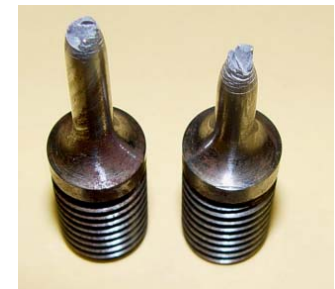
Hydrogen Testing - Faceted fracture surface with evidence for multiple secondary cracking

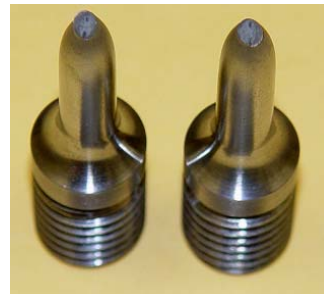
Helium Testing - Typical Ductile cup and cone fracture

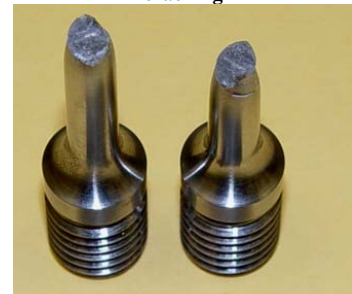
Hydrogen Testing - Faceted fracture surface with evidence for multiple secondary cracking, does not seem as severe as in Alloy A

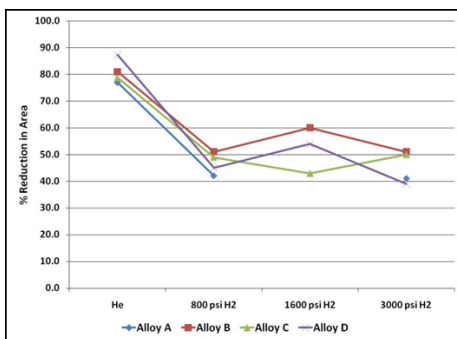
Reduction in area results four pipeline steel alloys/microstructures at 10^{-4} strain rate at various hydrogen pressures. Note the initial drop at 800 psi and then the performance with increasing pressure. Overall Alloy's B and D perform the best with increasing pressure.

Figure 6 shows the results of the reduction in area tensile testing at three different hydrogen pressures and two different strain rates performed at ORNL.

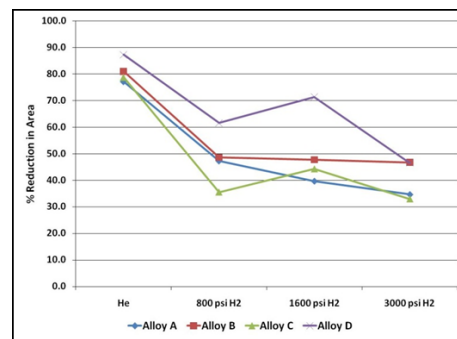
Reduction in area results four pipeline steel alloys/microstructures at 10^{-5} strain rate at various hydrogen pressures. Note the initial drop at 800 psi and then the performance with increasing pressure. Overall Alloy's B and D perform the best with increasing pressure.

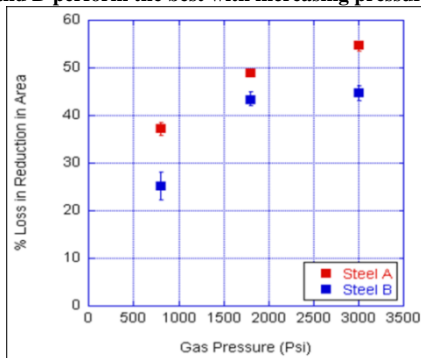
% loss in reduction in area statistics of Alloy's A and B vs. hydrogen pressure at 10^{-5} strain rate. Note the overall stability of each result at pressure

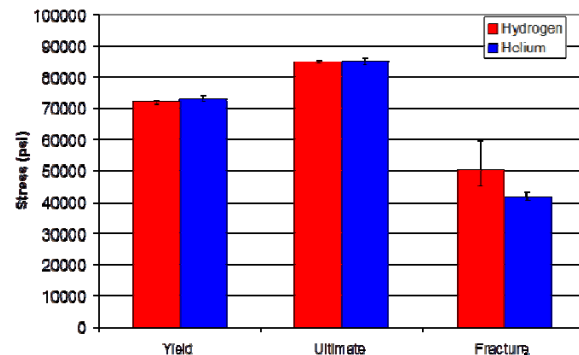
Example of strength changes for Alloy B in hydrogen vs. helium at 10^{-5} strain rate. There is no effect on yield or ultimate strength only fracture stress in the presence of hydrogen.

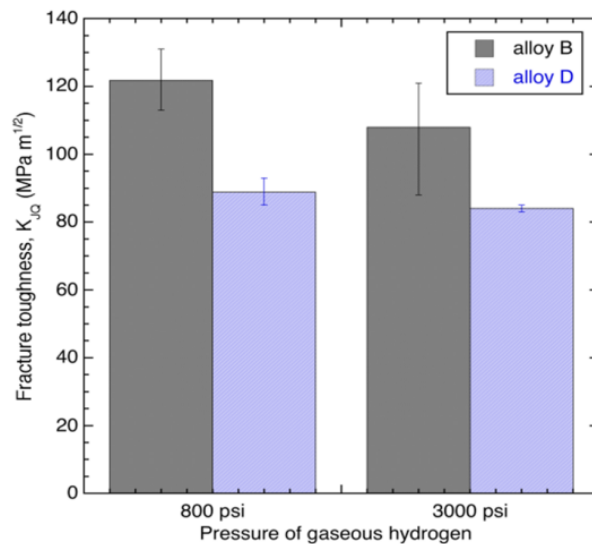
The two project alloys chosen for the further evaluation at SNLL were Alloy's B and D. Alloy B was an API X70/X80 steel grade consisting of a microstructure of 90% polygonal ferrite/10% coarse acicular ferrite. Alloy D was an API X60 HIC steel grade consisting of a microstructure of 100% polygonal ferrite. In the fracture toughness testing, both alloys performed reasonably well with $K_{I,Q}$ values of 85-90 $\text{MPa} \cdot \text{m}^{1/2}$ for Alloy D and 115-125 $\text{MPa} \cdot \text{m}^{1/2}$ for Alloy B at the two pressures, **Figure 7**.

Fig. 7 – SNLL fracture toughness results at 800 psi and 3000 psi gaseous hydrogen pressure of project Alloy's B and D

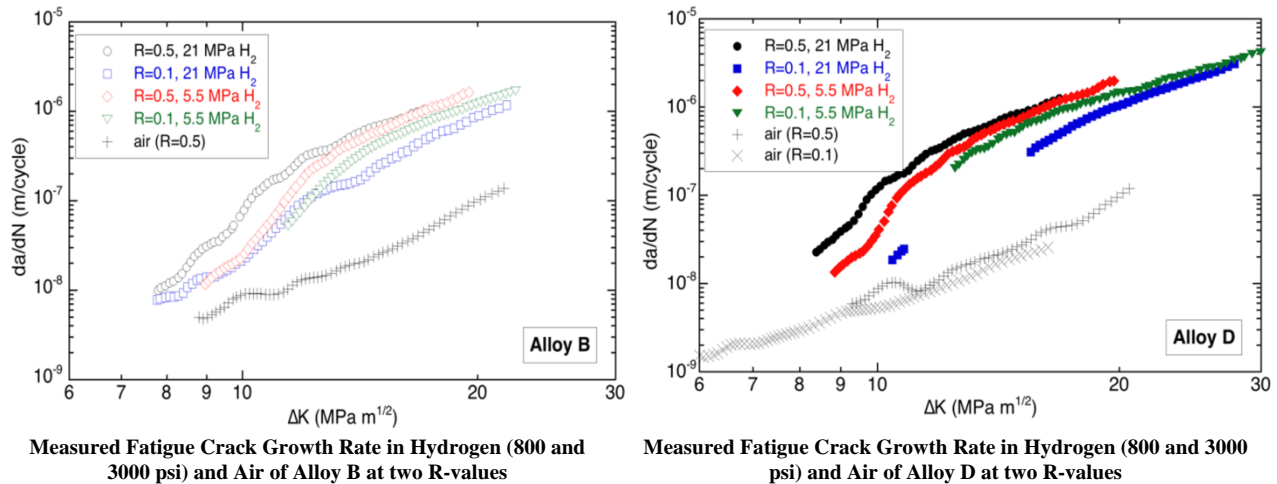
SNLL, under a work for others agreement with funding through project partner Reference Metals Company, conducted fatigue testing utilizing two R-ratio values (0.5 and 0.1, R is the ratio of the minimum to maximum load applied to the specimen) on Alloy's B and D at 800 and 3000 psi (5.5 and 21 MPa). In addition, testing was completed in air for both alloys for comparison. There was no significant difference in fatigue results by R-ratio values or microstructures. However, both microstructures showed tendencies of convergence with those values generated in air at lower ΔK values, **Figure 8**.

Fig. 8 – SNLL fatigue testing of project Alloy’s B and D

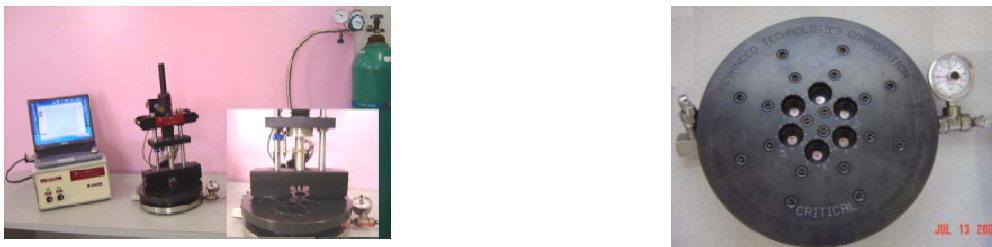
High pressure gaseous hydrogen testing capabilities were developed by ATC and ORNL. The ATC approach consisted of machining disks from steel samples and placing them in specially developed chamber that could be pressurized up to 5000 psi with gaseous hydrogen and then testing using the SSM approach over time, **Figure 10**. ATC tested project alloy ID's A and D at 2000 psi hydrogen pressure for 200 hours along with industry sample of seamless pipe API X80 and an ERW pipe API Gr B. Only the seamless API X80 showed any degradation in mechanical properties when exposed to hydrogen. The fracture toughness of the seamless API X80 fracture toughness as measured by K_{IC} decreased 43% after 200 hours exposure. Strength actually increased slightly which would not be considered normal when exposed to hydrogen. Results of the four steels from the ATC SSM testing can be seen in **Figure 11**. One item that the ATC SSM hydrogen testing showed is that the degradation of fracture toughness performance happened within the first 25 hours of exposure and then leveled off after that. Additional exposure time did not seem to affect the remaining results. After a review of the ATC SSM testing results, it was determined by the group that this method may not be valid as an evaluation technique for the project and any additional testing was abandoned.

Fig. 10 – ATC SSM hydrogen testing apparatus. Picture on left shows set up, while picture on right shows details of pressurized hydrogen disk.

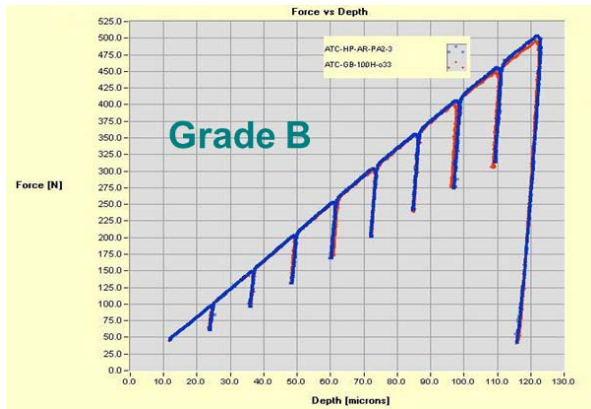
ATC SSM testing results for API Gr B ERW non-project pipeline steel. Note that both the red and blue lines are basically on top of each other either signifying that the test method did not see any difference with exposure to 200 hours of 2000 psi hydrogen gas.

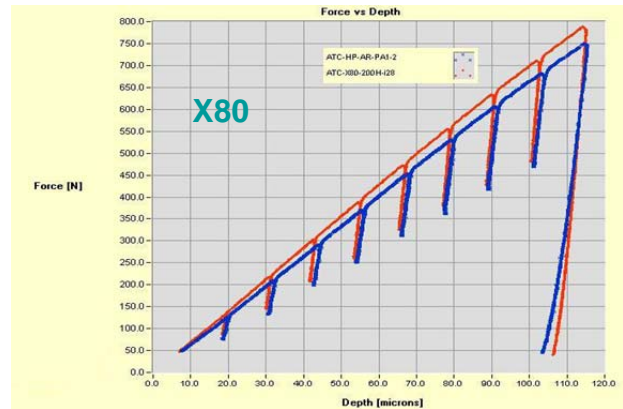
ATC SSM testing results for API X80 seamless non-project pipeline steel. Note that there is a separation between the red and blue lines signifying that the test method did see a difference with exposure to 200 hours of 2000 psi hydrogen gas.

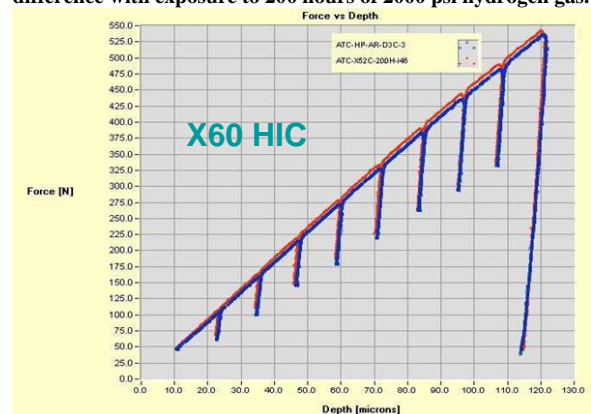
ATC SSM testing results for API X60 HIC LSAW project pipeline steel. Note that both the red and blue lines are basically on top of each other either signifying that the test method did not see any difference with exposure to 200 hours of 2000 psi hydrogen gas.

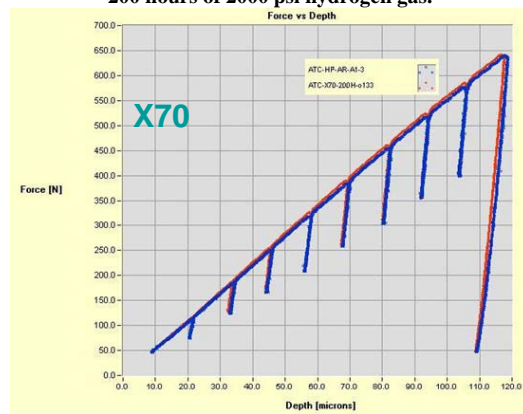
ATC SSM testing results for API X70 LSAW project pipeline steel. Note that both the red and blue lines are basically on top of each other either signifying that the test method did not see any difference with exposure to 200 hours of 2000 psi hydrogen gas.

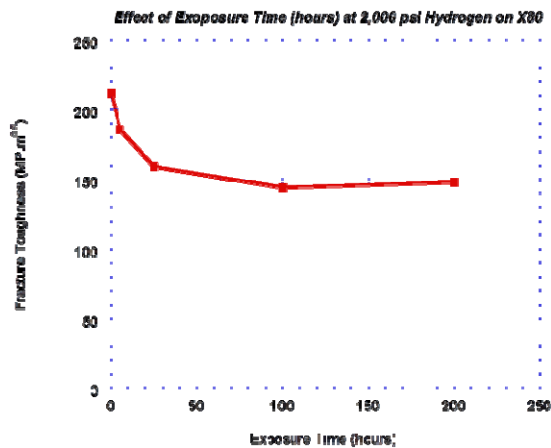
ATC SSM fracture toughness of API X80 seamless non-project pipeline steel results showing a 43% decrease in fracture toughness when exposed to hydrogen gas for 200 hours at 2000 psi hydrogen gas pressure.

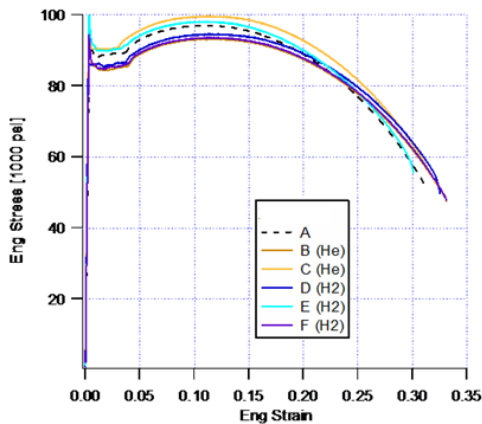
Project pipeline steel Alloy A, note the instability of the stress strain curve and degradation of strength with the exposure to hydrogen

The results showed that microstructure did indeed have an effect on performance with project Alloy A showing instability in the stress-strain curve and project Alloy’s B and C showing stable stress-strain curves, **Figure 12**.

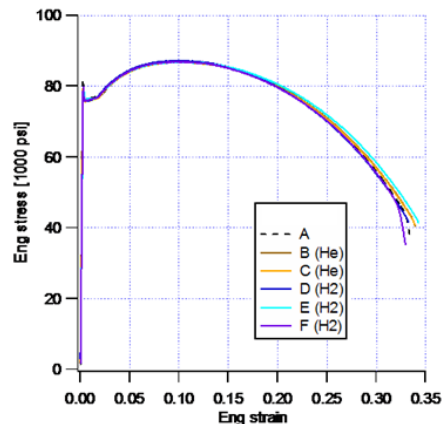
Project pipeline steel Alloy B, note the excellent stability of the stress strain curve and no degradation of strength with the exposure to hydrogen

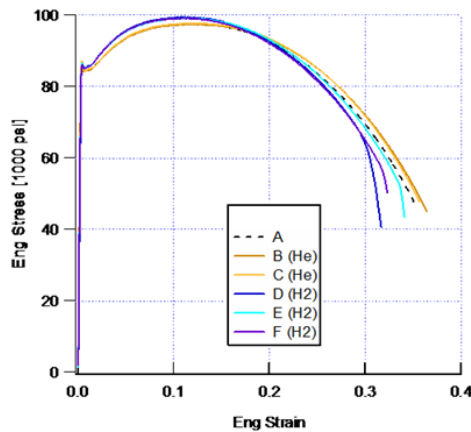
Project pipeline steel Alloy A, note the slight instability of the stress strain curve and slight degradation of strength with the exposure to hydrogen. This slight difference is most likely to the slight differences noted in microstructures between Alloy B and Alloy C.

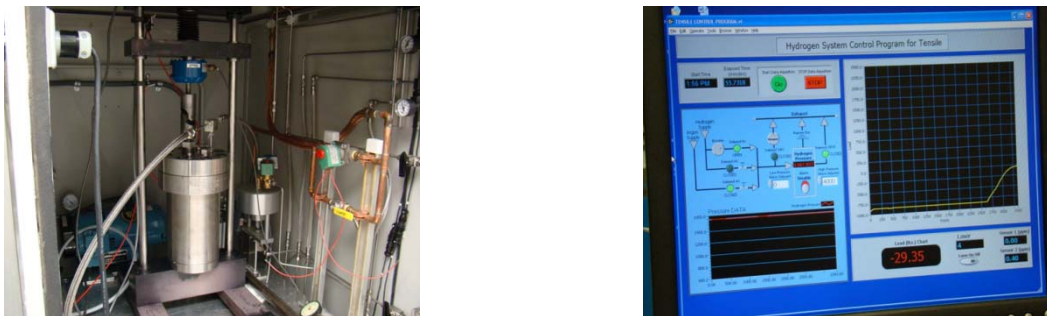
ORNL developed standard round bar tensile testing capability in an autoclave vessel capable of testing in pressurized gaseous hydrogen up to 5000 psi, **Figure 13**.

Fig. 13 – ORNL high pressure hydrogen tensile testing apparatus.

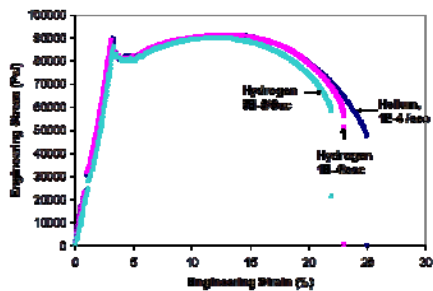
Project Alloy A API X70 pipeline steel tensile tested in hydrogen and helium at two different strain rates. Note that the presence of hydrogen decreases total strain needed for failure, regardless of strain rate.

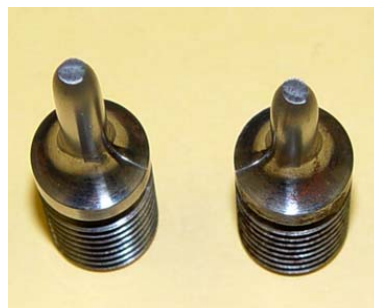
Helium Testing - Typical Ductile cup and cone fracture

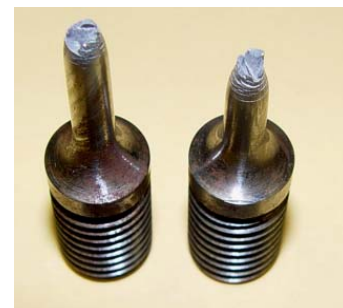
Hydrogen Testing - Faceted fracture surface with evidence for multiple secondary cracking

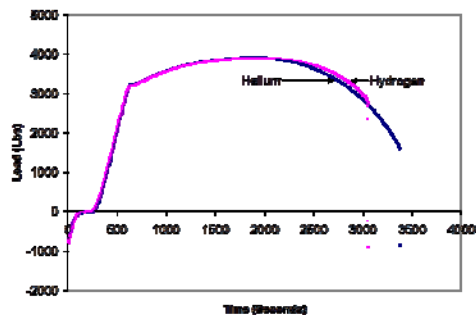
Project Alloy C at 10^{-4} strain rate. Note that presence of hydrogen decreases total strain to failure.

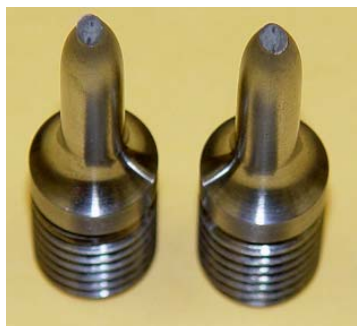
Helium Testing - Typical Ductile cup and cone fracture

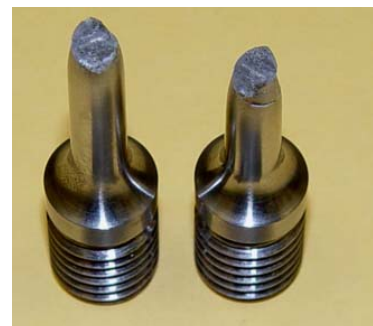
Hydrogen Testing - Faceted fracture surface with evidence for multiple secondary cracking, does not seem as severe as in Alloy A

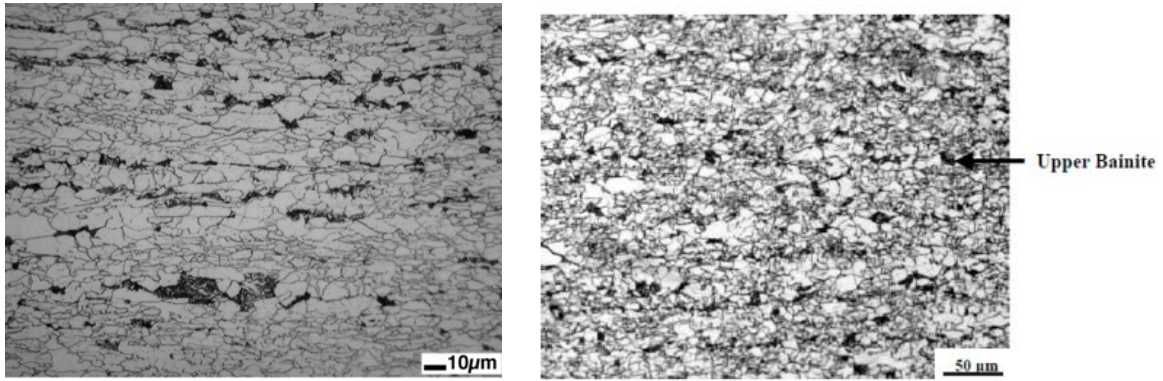
Dark Islands Identified as Upper Bainite
Fig. 15 - Optical microscopy characterization of Alloy A

Alloy A, a standard API X70, C-Mn-Si-Nb-V alloy design, was characterized as approximately 92% polygonal ferrite and 8% upper bainite¹⁰. Optical microscopy, SEM and TEM analysis can be seen in **Figures 15, 16 and 17**, respectively. Under the optical microscope, the upper bainite appears dark, as it has low reflectivity. At higher magnifications under SEM and TEM examination, upper bainite will exhibit a "feather-like" arrangement (**Figure 16 and 17**) of its ferrite laths in contrast to the sheaves of approximately parallel laths that one observes in pearlite or lath martensite.

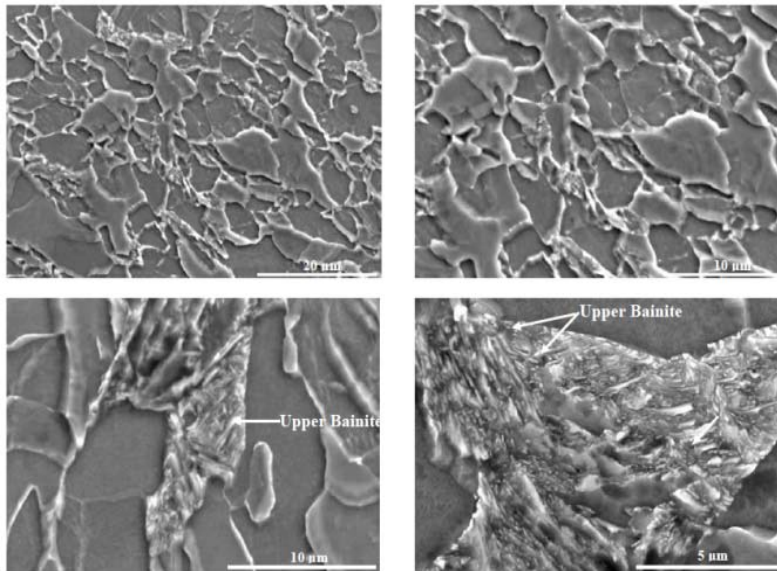
Fig. 16- SEM analysis characterization of Alloy A

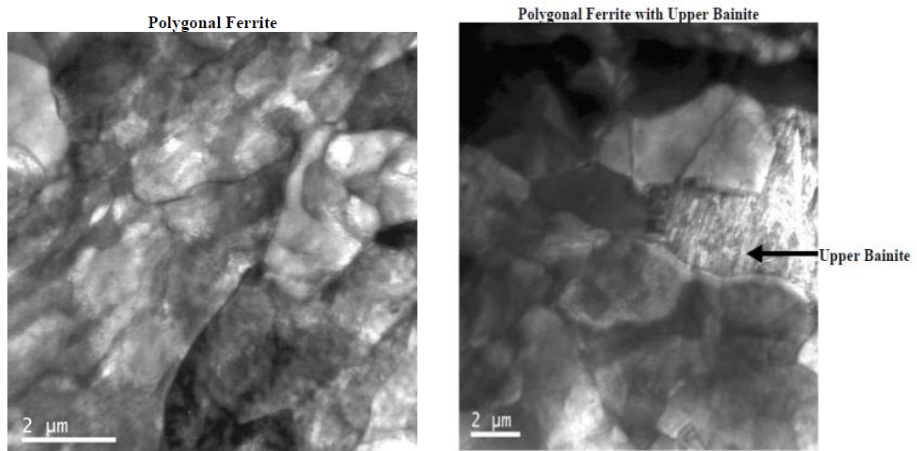
Fig. 17 - TEM analysis characterization of Alloy A

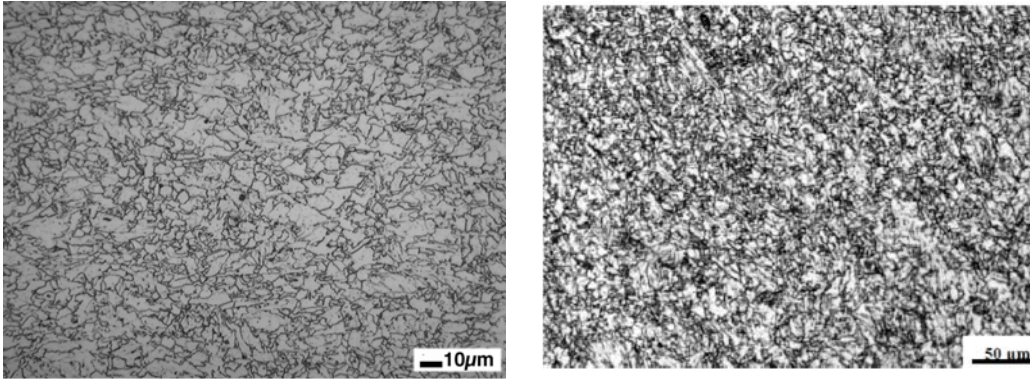
Polygonal ferrite and coarse acicular ferrite
Fig. 18 - Optical microscopy characterization of Alloy B

Alloy B, a standard API X80 (C-Mn-Si-Nb) alloy design, was characterized as approximately 90% polygonal ferrite and 10% coarse acicular ferrite. The acicular ferrite was only 10% by volume fraction and coarse, which was somewhat different than what was originally expected. Optical microscopy, SEM and TEM analysis can be seen in **Figures 18, 19 and 20** respectively.

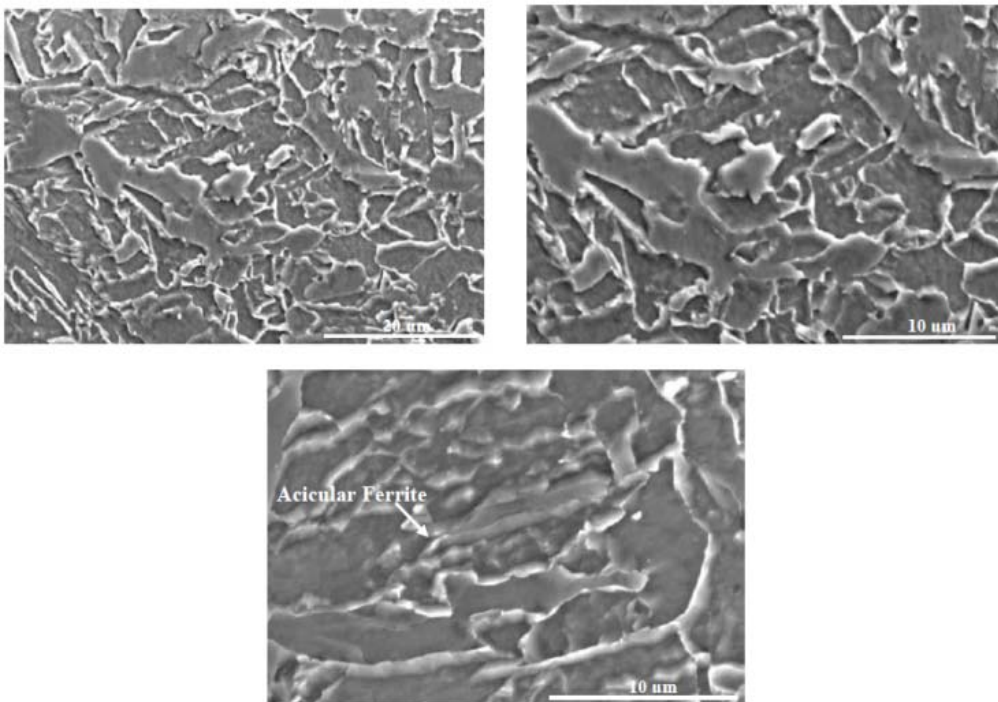
Coarse Acicular Ferrite is more apparent in TEM micrographs

Fig. 19 - SEM analysis characterization of Alloy B

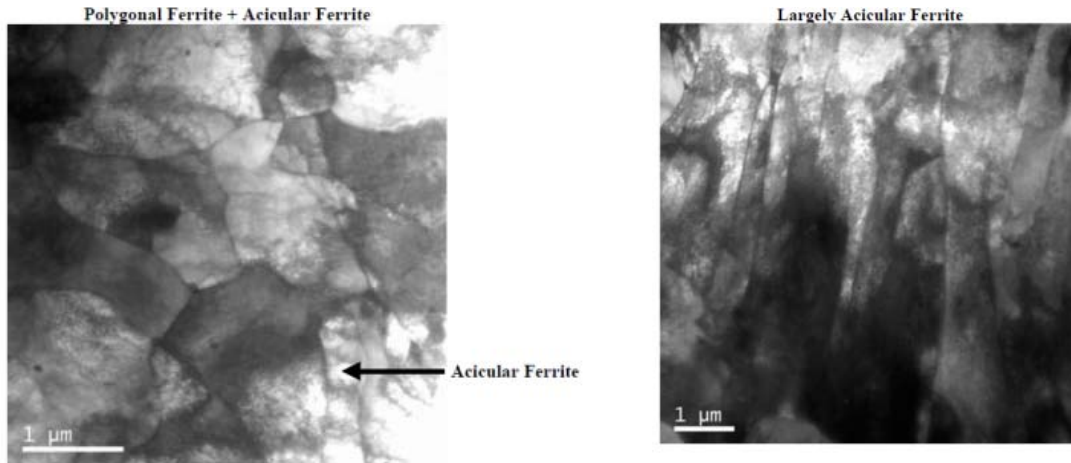
Fig. 20 - TEM analysis characterization of Alloy B

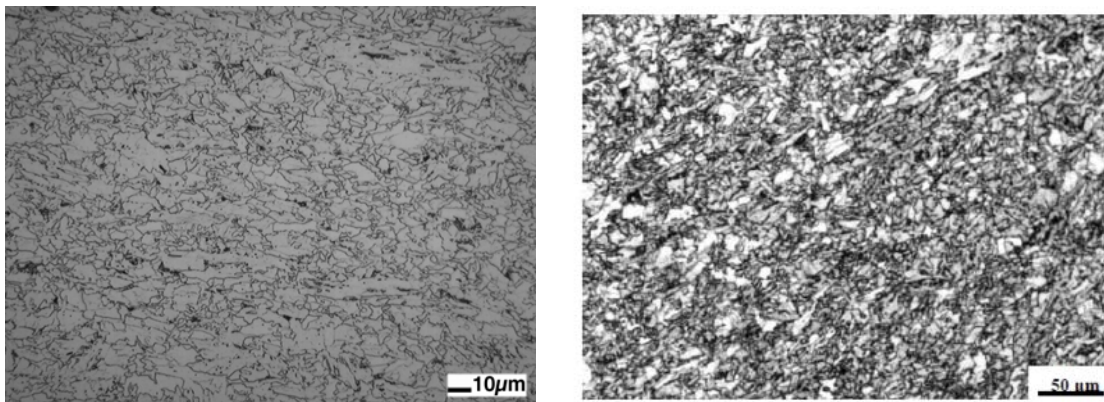
Dark Islands Identified as Upper Bainite
Fig. 21 - Optical microscopy characterization of Alloy C

Alloy C, a standard API X80 alloy design ((C-Mn-Si-Nb) with more solute elements than Alloy B) was characterized as approximately 90% polygonal ferrite and 10% predominately coarse acicular ferrite, but with very small amount of upper bainite. The acicular ferrite with a very small amount of upper bainite was only 10% by volume fraction and coarse, which again was somewhat different than what was originally expected. Optical microscopy, SEM and TEM analysis can be seen in **Figures 21, 22 and 23**, respectively. The upper bainite has been delineated in optical light, SEM and TEM microscopy. The dark appearance of upper bainite is characterized in the light microscope. Due to the low carbon level of 0.04%C in Alloy C, the upper bainite is lath ferrite with very limited carbon precipitation between the laths.

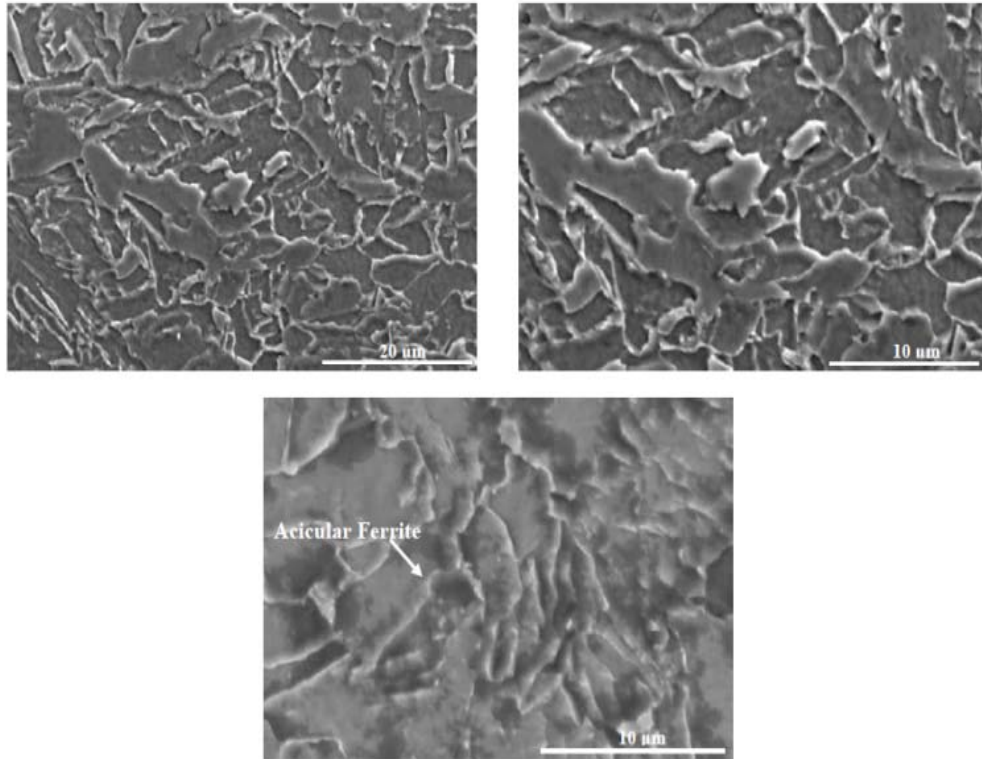
Coarse Acicular Ferrite is more apparent in TEM micrographs

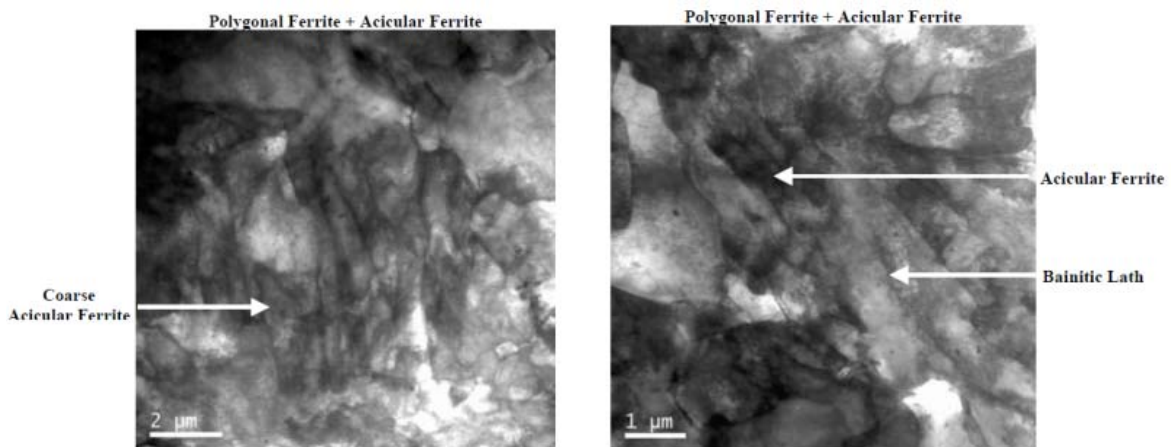
Fig. 23 - TEM analysis characterization of Alloy C

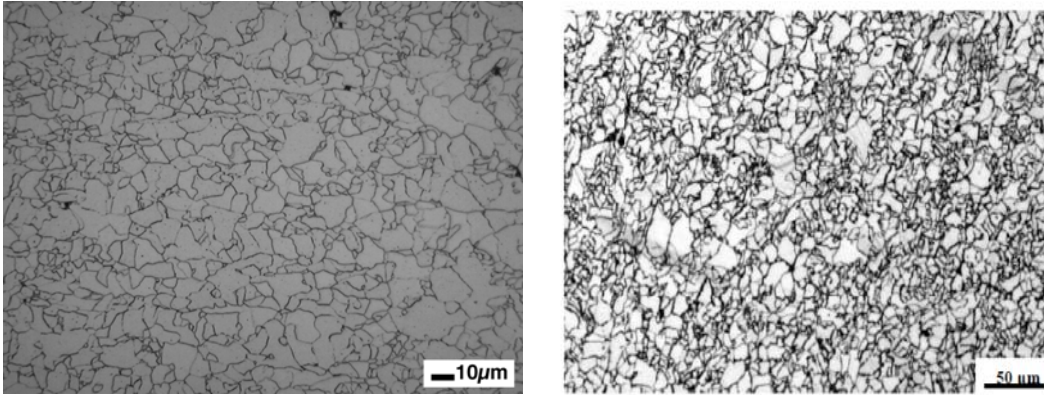
Fig. 24 - Optical microscopy characterization of Alloy D

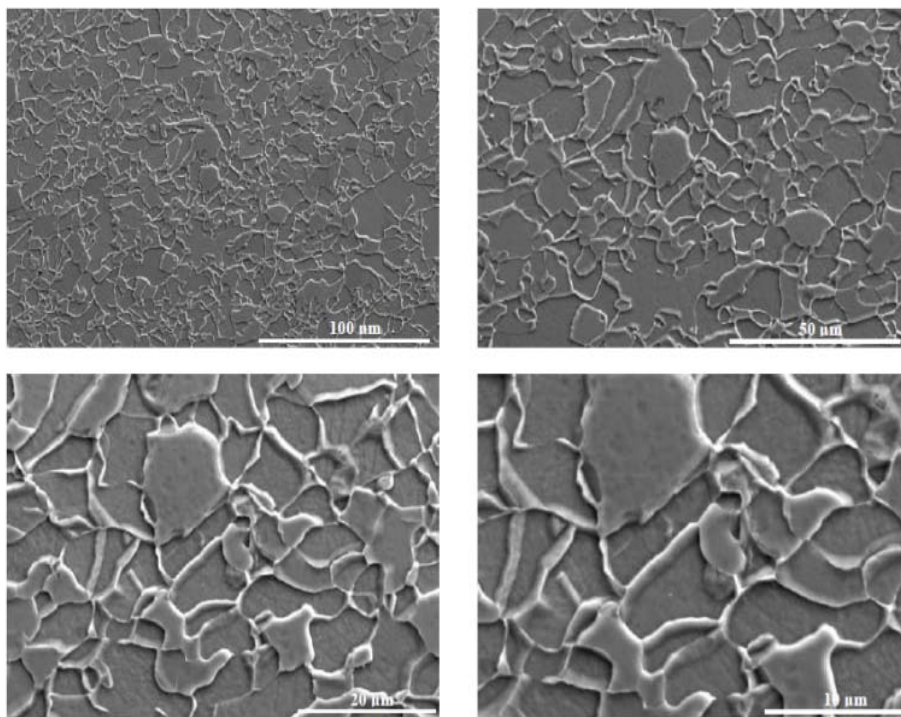
Fig. 25 - SEM analysis characterization of Alloy D

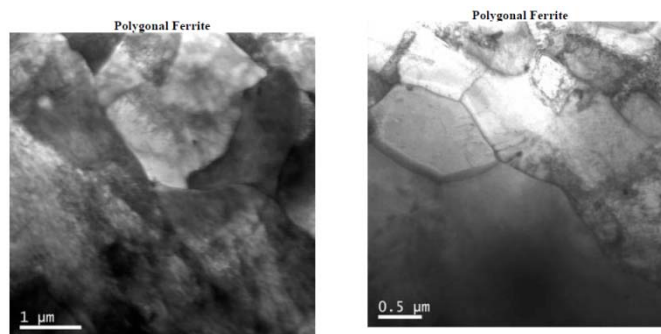
Fig. 26 - TEM analysis characterization of Alloy D

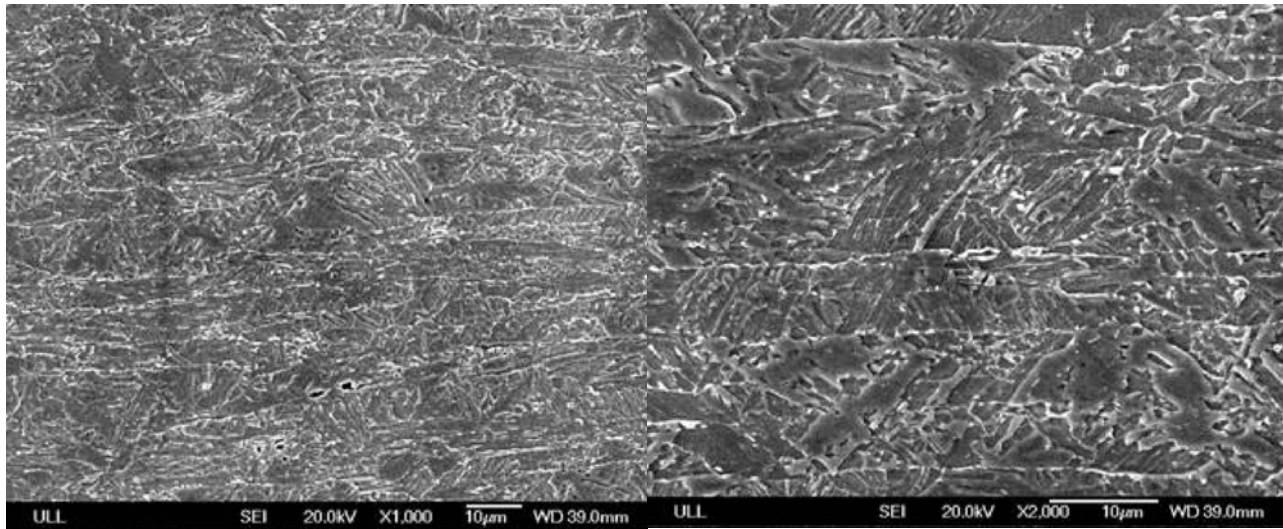
Fig. 27 – SEM analysis characterization of Alloy E

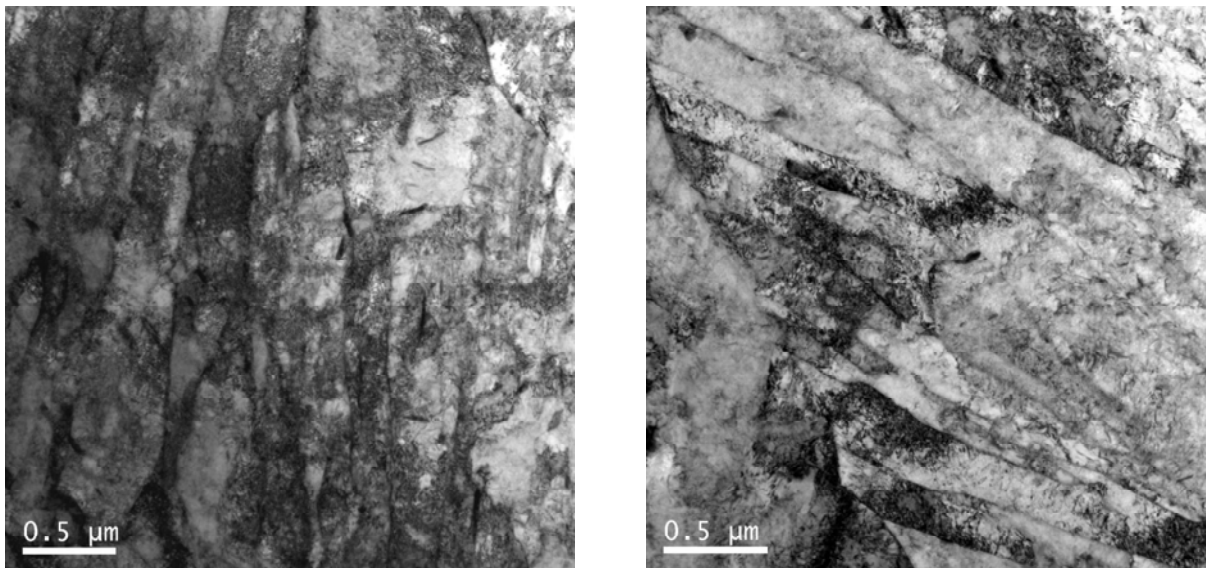
Fig. 28 – TEM analysis characterization of Alloy E

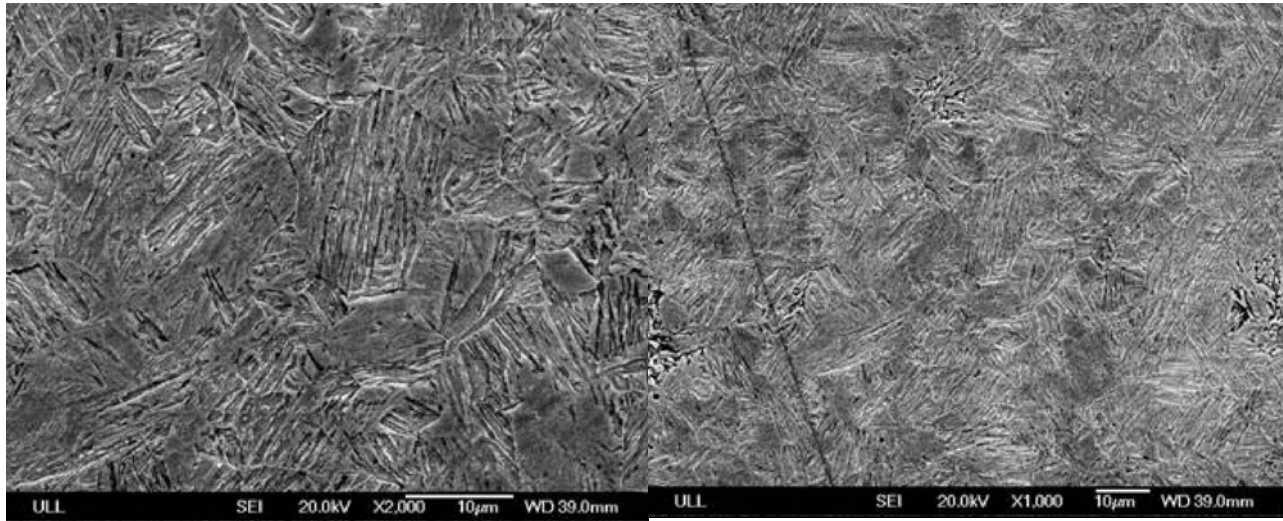
Fig. 29 – SEM analysis characterization of Alloy F

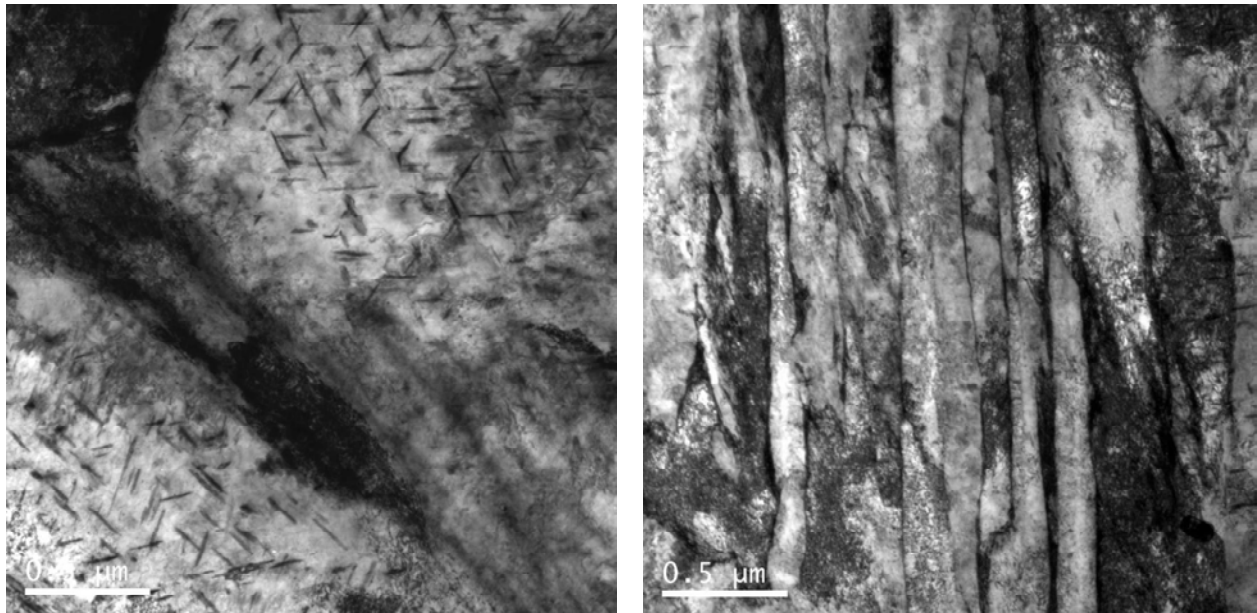
Fig. 30 – TEM analysis characterization of Alloy F

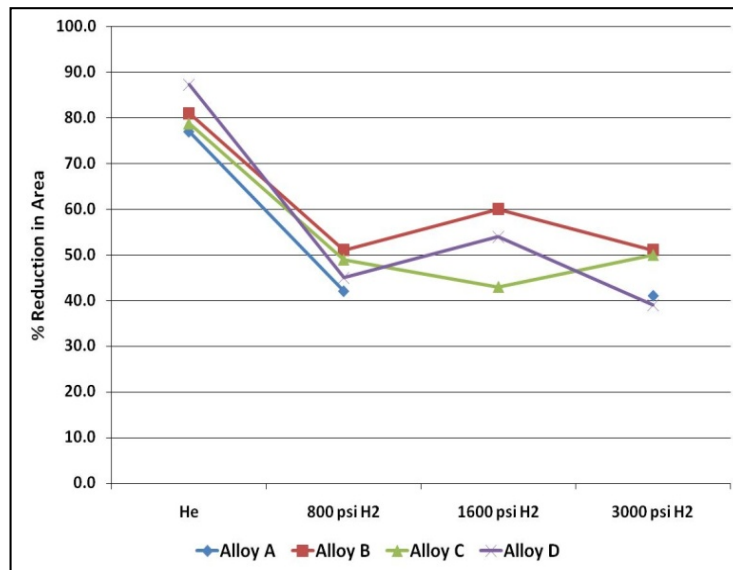
Fig. 32 - % Reduction in area comparison at strain rate of 10^{-4} for helium and hydrogen tensile testing at pressure

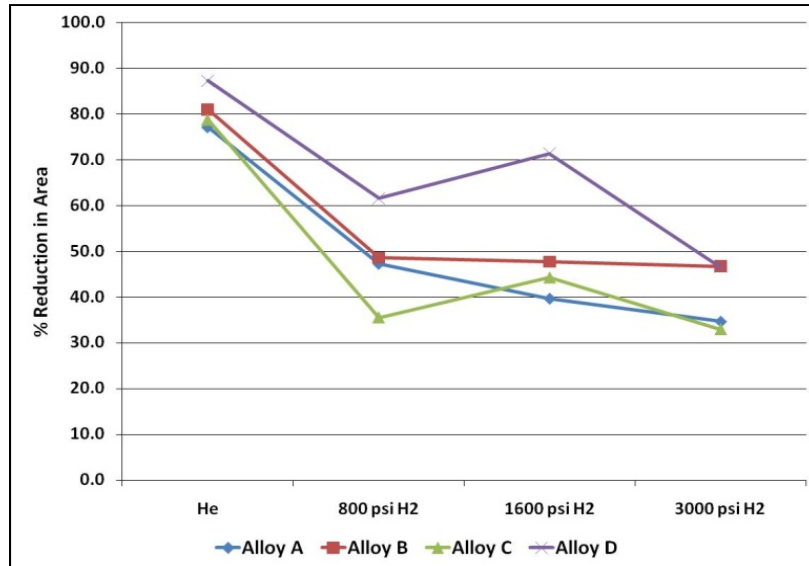
Fig. 33 - % Reduction in area comparison at strain rate of 10^{-5} for helium and hydrogen tensile testing at pressure

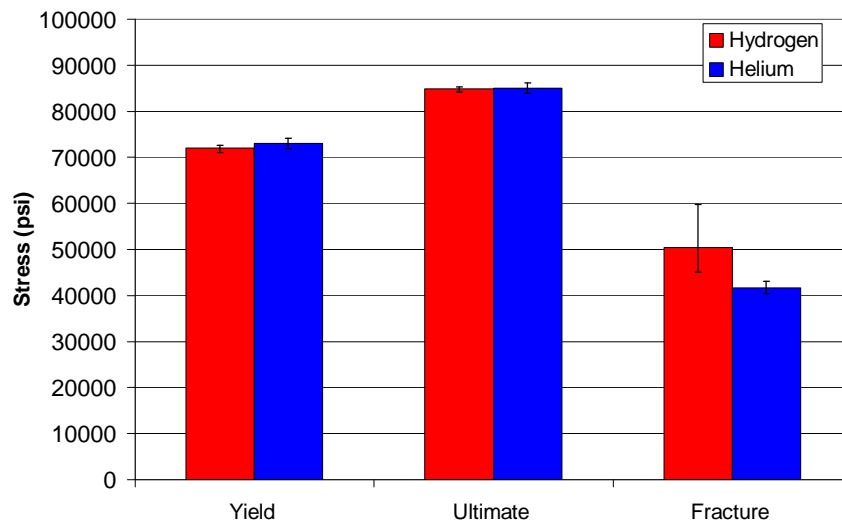
Fig. 34 - Illustration of yield strength, ultimate strength and fracture stress performance for Alloy B

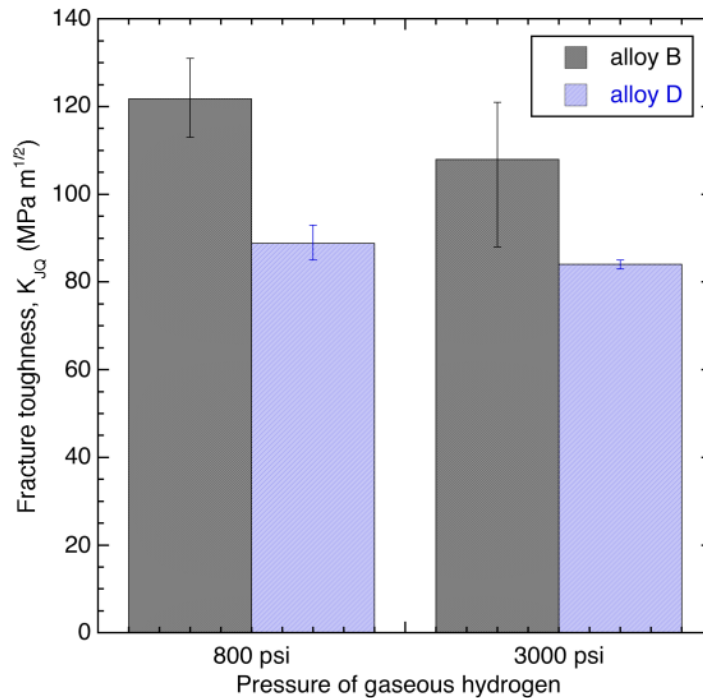
Fig. 35 - Fracture toughness measured in gaseous hydrogen. The error bars represent the minimum and maximum measured values (replicate specimens were measured for all conditions, except alloy B at pressure of 3000 psi, for which three measurements were made)

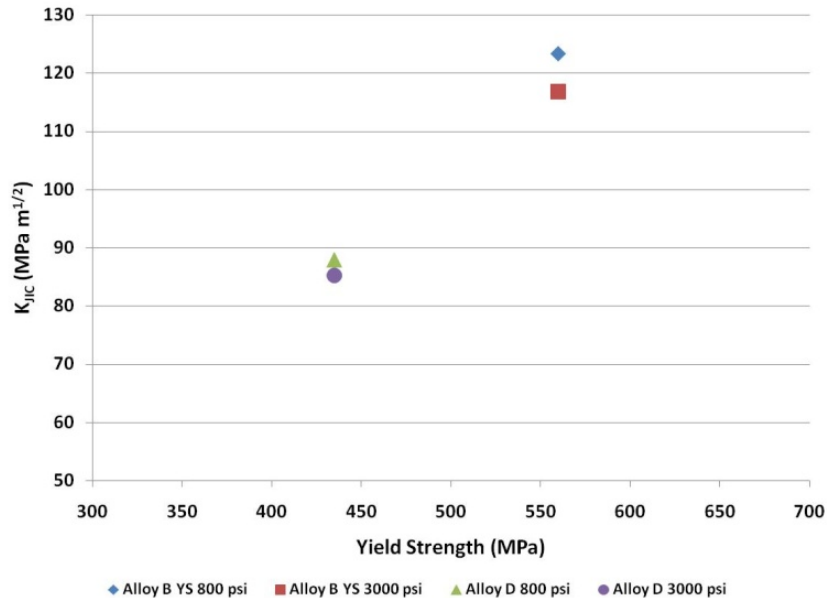
Fig. 36 - Strength vs. fracture toughness results for Alloys B and D

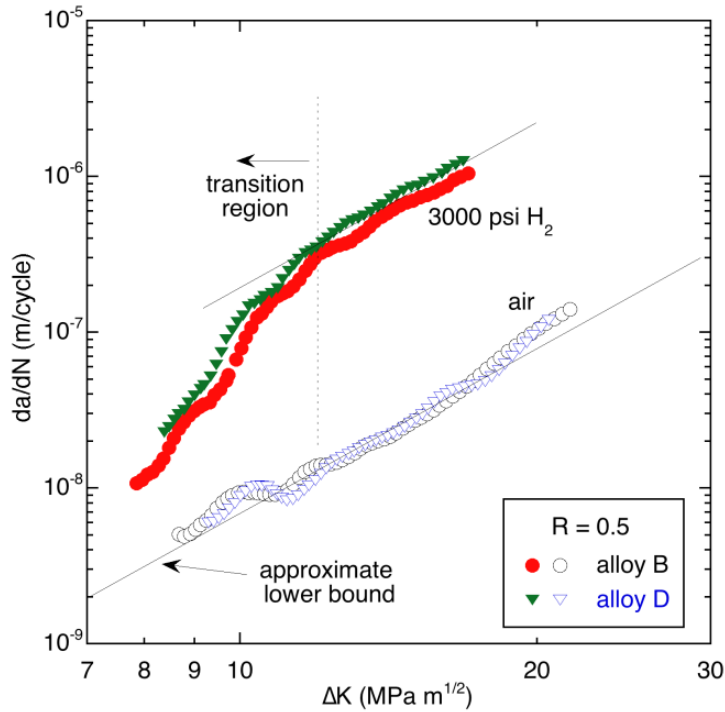
Figure 37: Fatigue crack growth of Alloy B and Alloy D in gaseous hydrogen at pressure of 3000 psi, compared to fatigue in air
