**Materials Solutions for Hydrogen Delivery in Pipelines
DE-FG36-05-GO15036**

September 2011

Secat, Inc.

Project Title: Materials Solutions for Hydrogen Delivery in Pipelines

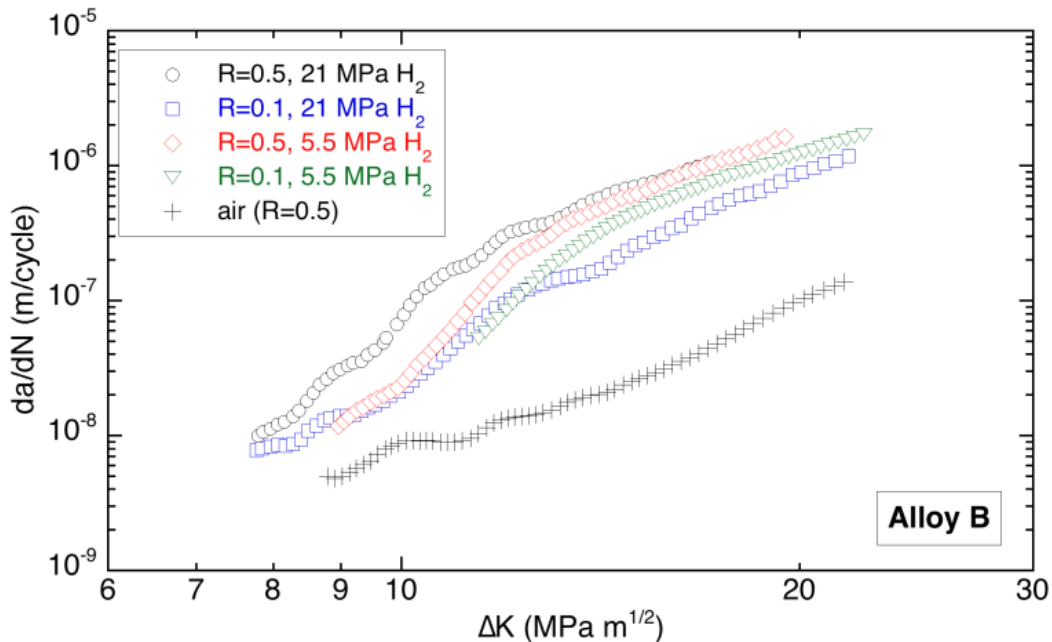
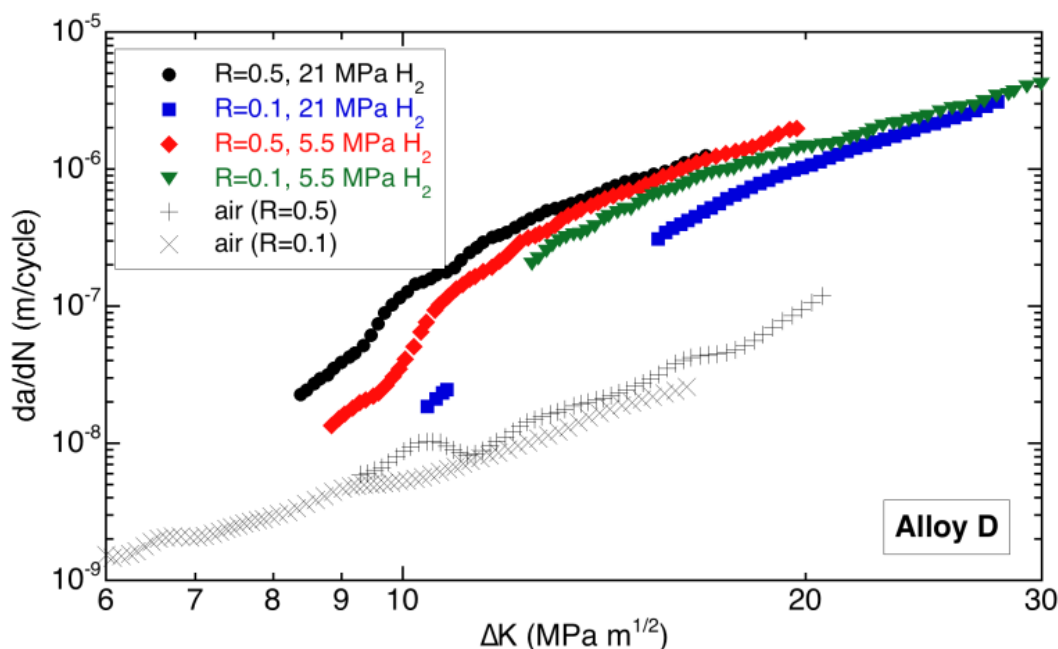
Fig. 38 - Measured fatigue crack growth rates for Alloy B and D
