Measured Cooling Performance and Potential for Buried Duct Condensation in a 1991 Central Florida Retrofit Home

D. Chasar and C. Withers
BA-PIRC

February 2013

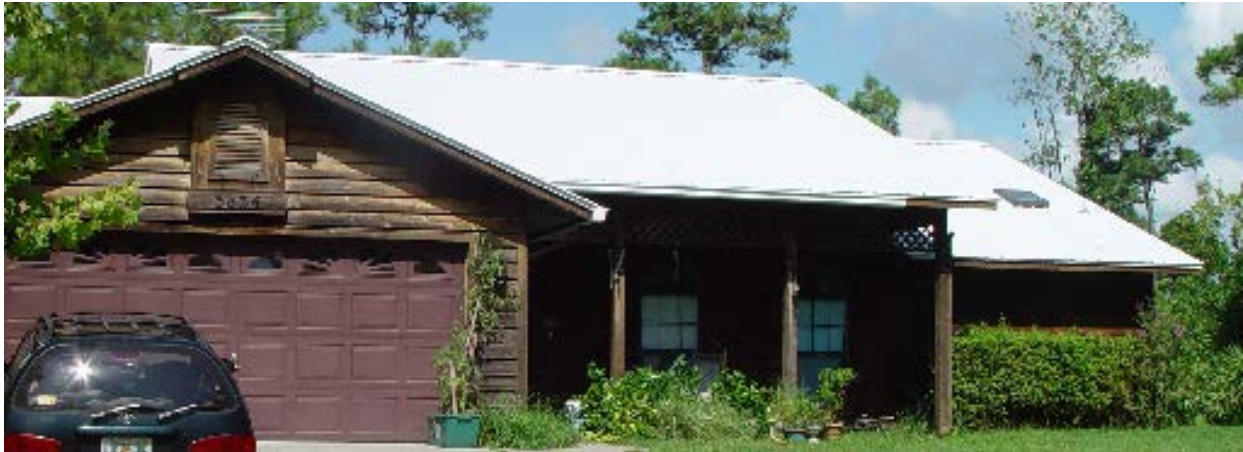
Figure 1. Wood frame retrofit home located in Cocoa, Florida

The 2,200-ft², four-bedroom wood frame home discussed in this report was built in 1991 and is located in Cocoa, Florida (Figure 1). It is occupied by a family of six. It has a 12-year-old flat plate solar water heater and a 6-year-old white metal roof but has otherwise had no energy-related improvements. During roof replacement, attic venting was eliminated. Measured cooling savings from the replacement of dark shingles with a white metal roof amounted to 19% and are documented in an FSEC report (Chasar, Moyer, and Martin 2006).

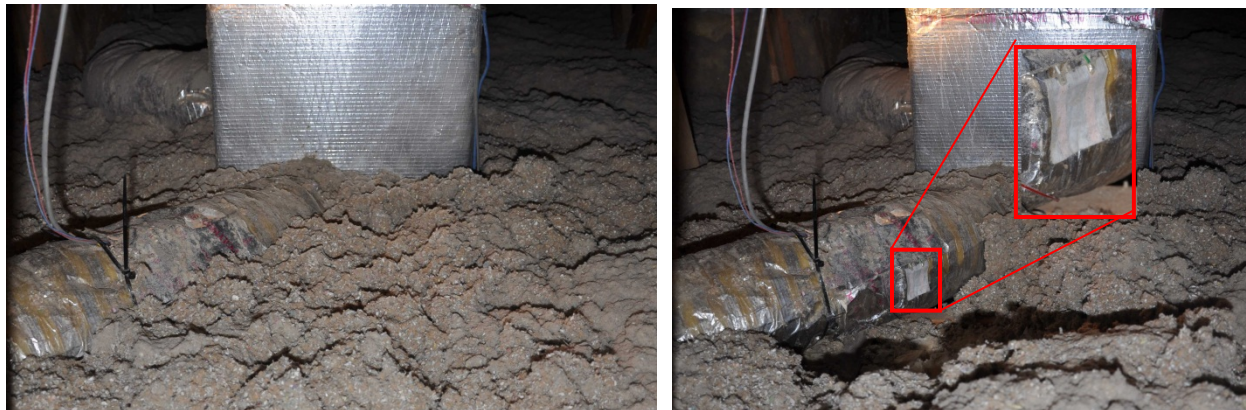
Figure 2. Photos of buried duct (left) and exposed moisture sensing strip (highlighted, right)

Various other measurements were used to examine additional impacts from the retrofit measures, including attic and interior temperatures as well as RH and supply air temperature. The ducts were fitted on the outer surface with thermocouples and condensate-sensing, resistive strips before being buried within the R-19 cellulose that was blown over the existing fiberglass batts. The photos in Figure 2 show the placement of instrumentation on the duct and the extent of duct coverage by the cellulose insulation. These readings, along with attic air conditions, were evaluated for potential and frequency of condensation. The ducts were also visually inspected for any noticeable physical effects.

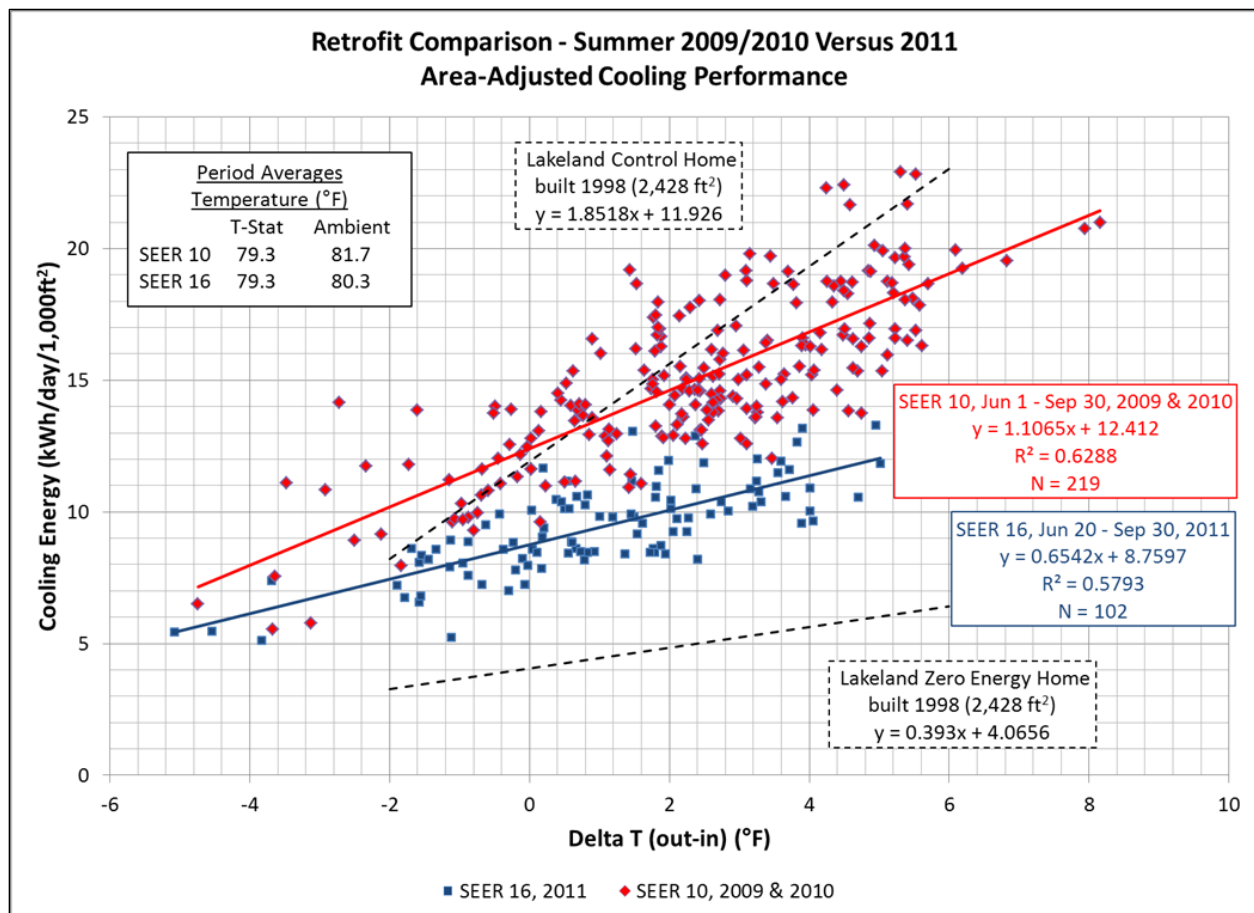
Figure 3. Pre- and post-retrofit cooling performance comparison

The pre-retrofit regression results in Figure 3 (red data) are composed of a data set from the two summers before improvements (2009 and 2010) and include a total of 219 data points. Each point represents the total cooling energy use (air handler unit [AHU] + condenser unit) for 1 day (y-axis) with respect to the outdoor minus indoor average temperature difference for the same day (x-axis). The resulting regression line has a similar y-intercept (12.4 versus 11.9) to that of the Lakeland Control Home; however, it has a noticeably lower slope (1.1 versus 1.9). This may reflect similar equipment efficiencies (both were SEER 10), but enhanced levels of building envelope performance. A similar effect was found with data taken from this residence in 2004 and 2005 that documented the impact of replacing dark shingles with a white metal roof (Chasar, Moyer, and Martin 2006).

Data from 2011, after retrofit implementation (blue data), includes 102 data points. It shows the relative performance improvements from both envelope and equipment retrofits (SEER 16, additional R-19 attic insulation and slightly tighter ducts). Twenty-six days were removed from the data sets over the three summers because of data logger downtime and known occupant influences such as vacation periods and major cooking or party events. Otherwise, all collected data were included in the analysis. An average savings of 30% was derived by applying the measured daily delta Ts for the 2011 summer period from June through September to each best-fit equation. The magnitude of this savings in the study home would amount to 1,072 kWh (or 8.9 kWh/day) for this 4-month summer period.

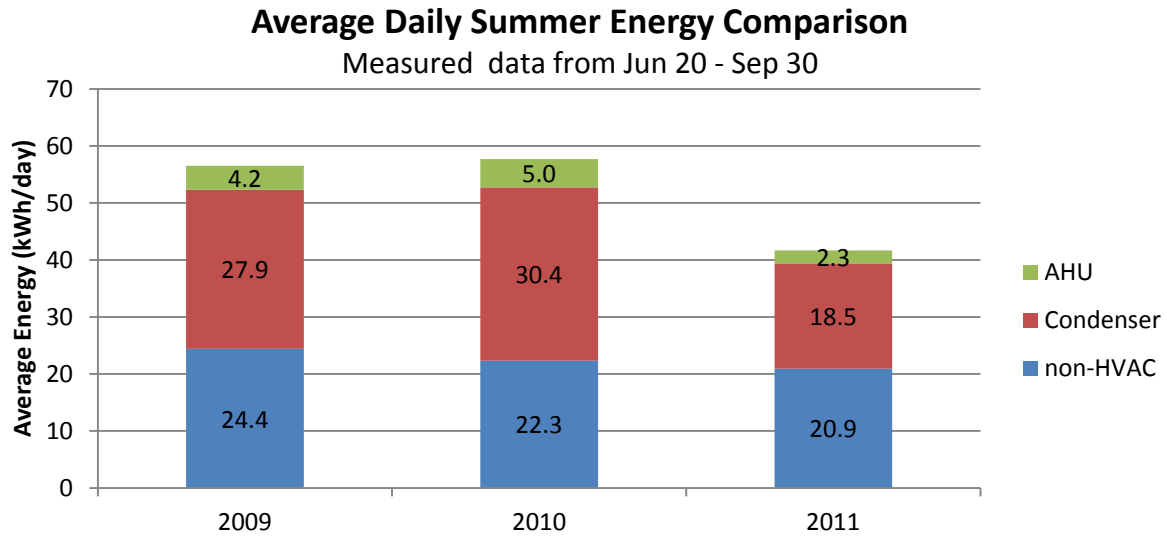
Figure 4. Unadjusted average daily cooling performance comparison

Table 3 directly compares average daily energy use and temperatures from the two pre-retrofit years (2009 and 2010) with post-retrofit data (2011). These values were unadjusted for weather differences between years but were taken from equivalent periods from June 20 to September 30. The results show a 27% total building energy reduction and 39% less cooling energy use after retrofit measures were in place. Average daily outdoor temperatures were 1°F to 2°F higher during the pre-retrofit years than during the post-retrofit period. Indoor temperatures were maintained at a stable 79.1°F to 79.5°F over the full study period with a relatively constant thermostat setting. Table 3 and Figure 4 also show how the variable-speed AHU effectively used about one-half the energy of the single-speed unit it replaced. Condenser unit energy was reduced by about one-third.

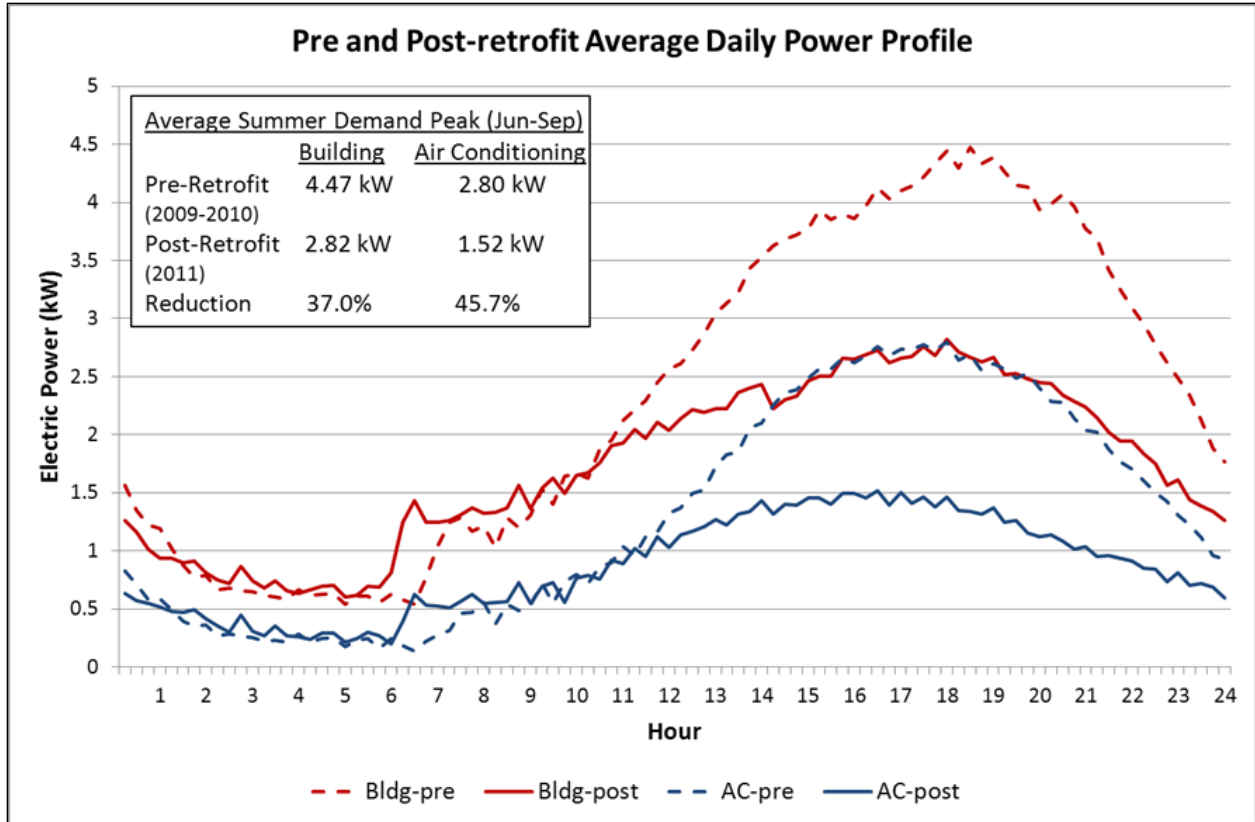
Figure 5. Pre- and post-retrofit average daily electric demand

Electric demand was also analyzed over the same summer periods. An average daily demand profile was created (Figure 5) by averaging 15-min power draws and plotting the pre- and post-retrofit values. The figure shows what an average 24-h day would look like before and after energy improvements took place. Average 15-min peak demand was reduced by 37% on a whole-building basis; submetered A/C peak demand (combined AHU and condenser unit energy) was reduced by 46%. The peak summer demand window for utilities is typically from hours 14 to 16 (2 p.m. to 4 p.m.), and reductions during this period were slightly reduced at 34% for whole-building demand and 45% for A/C peak demand.

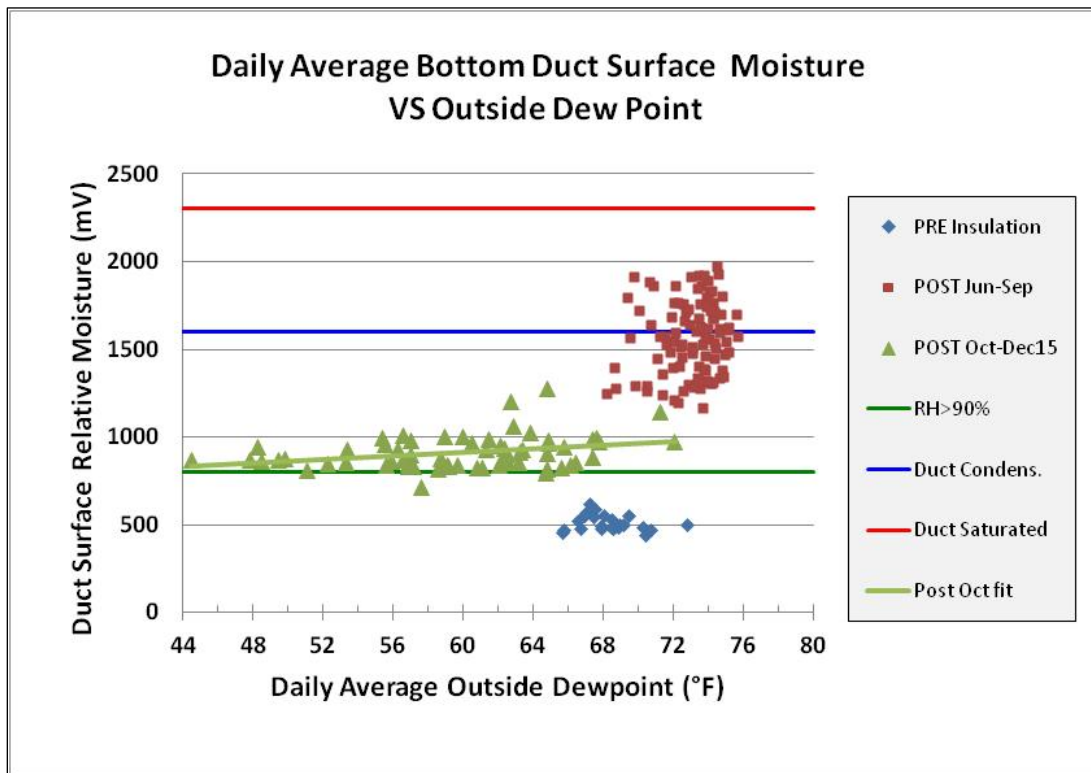
Figure 6. Relative duct moisture levels during one pre-retrofit and two post-retrofit periods

Figure 6 illustrates relative duct moisture levels using the Table 4 thresholds during pre- and post-retrofit periods. Three periods chosen from the data set (one pre-retrofit and two post-retrofit) show the impact on moisture readings under various circumstances. Data points in Figure 6 were plotted by taking the daily average duct surface moisture (mV) against daily average outdoor dew point (°F). Duct moisture data logging began in late May 2011 just 3 weeks before the blown insulation was added, as reflected in the relatively small number of blue data points clustered near the 500-mV level. Although this data set is small and was taken at moderate dew point temperatures, it illustrates the relatively low potential for condensation before burying the ducts in insulation.

A larger data set was collected after the blown attic insulation was applied. These data were separated into two groups by level of daily average outdoor dew point, which tended to be higher from June through September (red data points) than from October through December (green data points). Condensation potential is elevated during the summer months when dew points are generally 65°F or higher and reduced in the dryer fall and winter months. Interior conditions were maintained at a nearly constant 79°F during this study, suggesting that lower thermostat settings would create greater potential for duct surface condensation because the ducts would be cooled for longer periods and possibly reach lower surface temperatures.

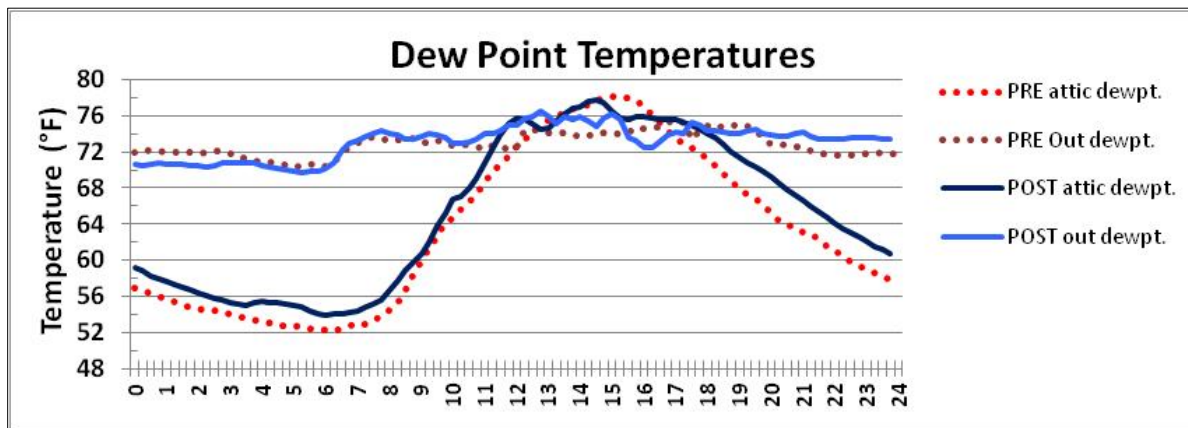
Figure 7. Outdoor and attic dew point temperatures

Data were selected for 2 days that had similar outdoor dew points representative of common summer conditions. Data for the selected days are shown in Figures 7 through 9, one before and the other after adding blown insulation to illustrate the impact of burying the ducts. Figure 7 shows the similarity of outdoor and attic dew points between periods. Pre- and post-retrofit outdoor dew points were quite similar in each case, remaining at or above 70°F during the entire period. Attic dew point temperatures were also quite similar but varied over the period, with each data set experiencing a peak between 3 p.m. and 4 p.m. before declining steadily until approximately 7 a.m. the next morning. This is a common characteristic in summertime attics where moisture desorbs from wood building materials during solar heating, adding moisture into the attic air and resulting in elevated dew points that can exceed the ambient dew point. As the attic begins cooling down overnight, the dry attic wood begins to adsorb moisture from the air, and the attic air dew point drops (Cleary 1985; Fairey, Swami, and Beal 1988).

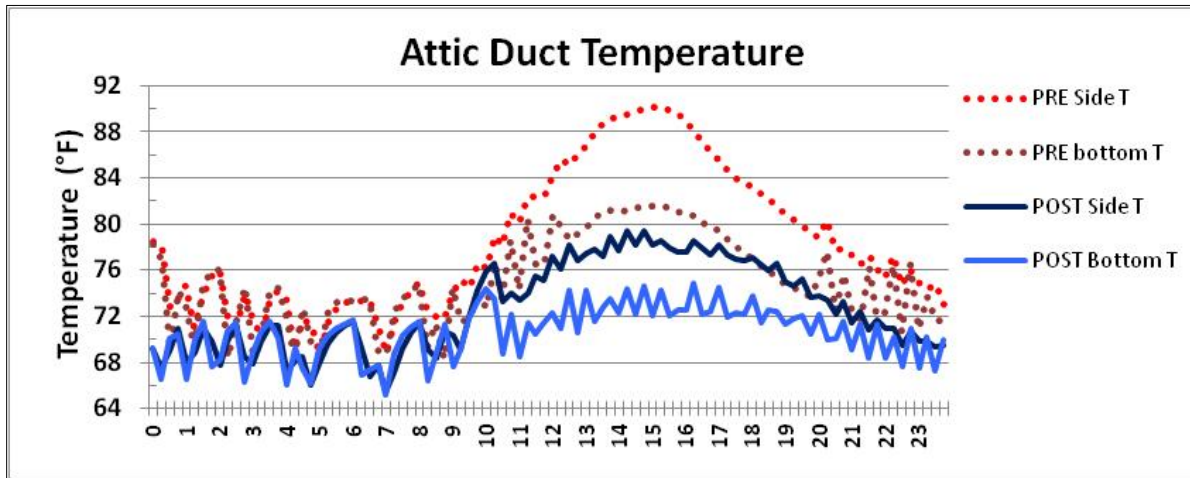
Figure 8. Pre- and post-retrofit attic duct dry bulb temperatures during similar outdoor conditions

Figure 8 compares duct surface temperatures over a daily period. This graph clearly shows how duct surface temperature is reduced after being buried in insulation. Dotted lines represent the pre-retrofit condition, which shows higher surface temperatures than the post condition, as would be expected. The bottom surface of the duct showed an 8°F drop in temperature during peak temperatures, and the side surface location showed a 12°F decrease.

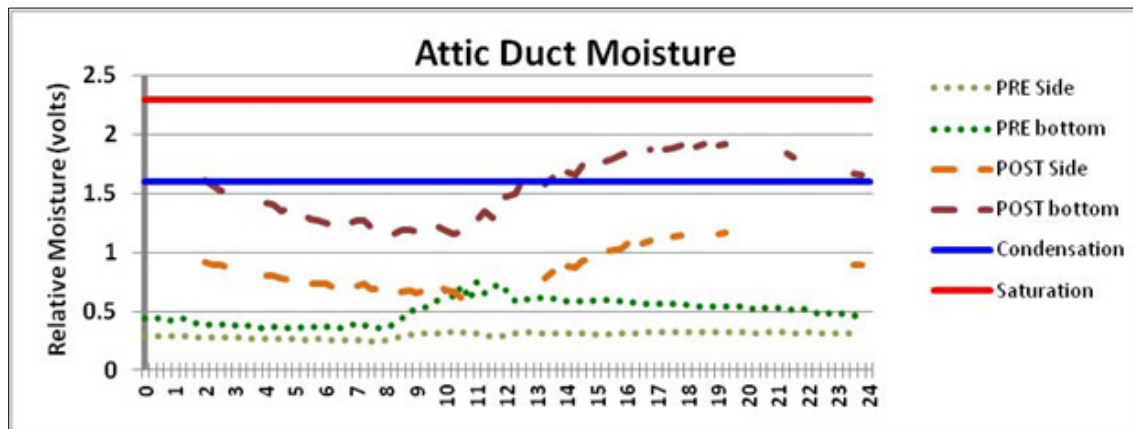
Figure 9. Pre- and post-retrofit attic duct surface moisture levels during similar outdoor conditions

Figure 9 shows duct surface moisture levels. Two solid horizontal lines are shown as a reference to the degree of wetness. The solid red line at the top indicates a saturated surface dripping with water. The solid blue line indicates a lesser degree of moisture with condensation present on the surface, but not dripping wet. A clear impact can be seen where adding insulation over the ducts results in greater surface moisture levels. The bottom area is coolest and shows the highest moisture levels. Gaps in the post-retrofit measured data (dashed lines) can be seen in the graph and are unexplained at the time this writing. These gaps occurred only during the post-retrofit period when moisture levels were elevated. Further research in the use of moisture-sensing strips will help establish the long-term reliability of moisture sensing tapes.

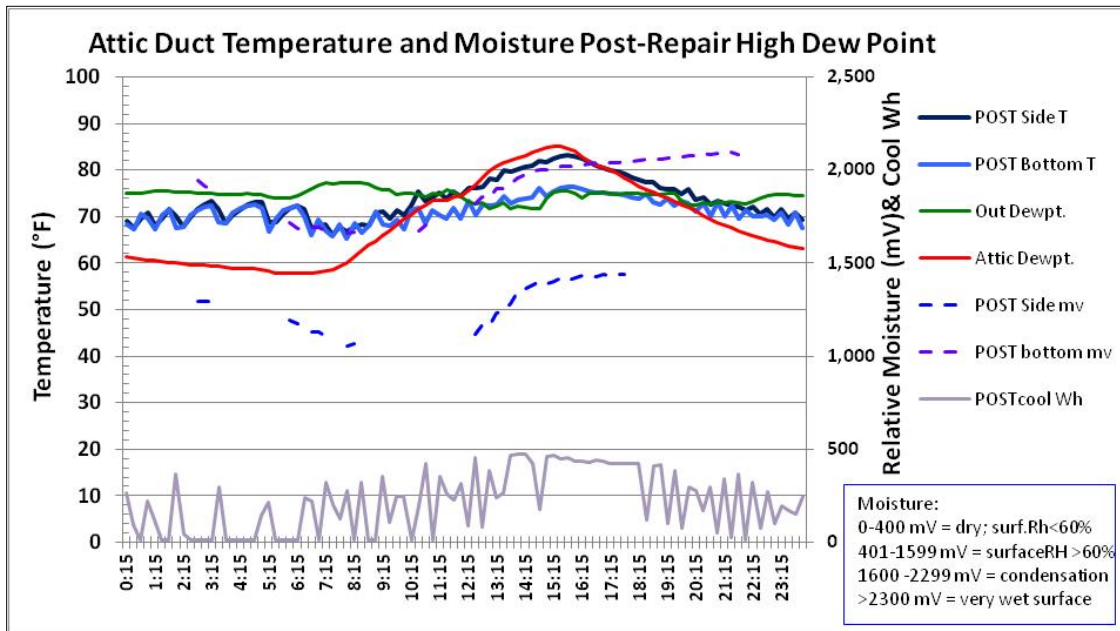
Figure 10. Post-retrofit duct conditions during worst-case dew point temperatures

Figure 10 is a 24-h plot of post-retrofit duct, attic, and outdoor conditions when dew point temperatures and A/C runtime were at their highest. This would represent a higher potential for attic duct condensation. As seen in Figure 9, the moisture sensor on the bottom duct location showed the highest potential for condensation. The daily average reading of the bottom duct location in Figure 10 is 1,929 mV. This is high enough to indicate some condensation, but not high enough to be considered saturated. A visual inspection of the ducts conducted in late fall showed no obvious signs of physical damage from accumulated moisture. Therefore, even though the moisture sensors indicate significant periods of elevated moisture during hot and humid weather, it was not enough to create any visually observable impact such as material damage or mold and mildew. As a caution, however, even though no moisture damage was observed, it might still be possible under different circumstances. As mentioned previously, a colder thermostat cooling set point will cause long runtime and colder duct surfaces. It is possible that such operation in this home could still result in enough moisture accumulation to cause moisture-related damage. Conditions will continue to be observed during the next hot and humid period.
