# **Greenbelt Homes Pilot Energy Efficiency Program Phase 1 Summary: Existing Conditions and Baseline Energy Use**

J. Wiehagen, M. Del Bianco, and A. Wood  
*NAHB Research Center*

February 2013

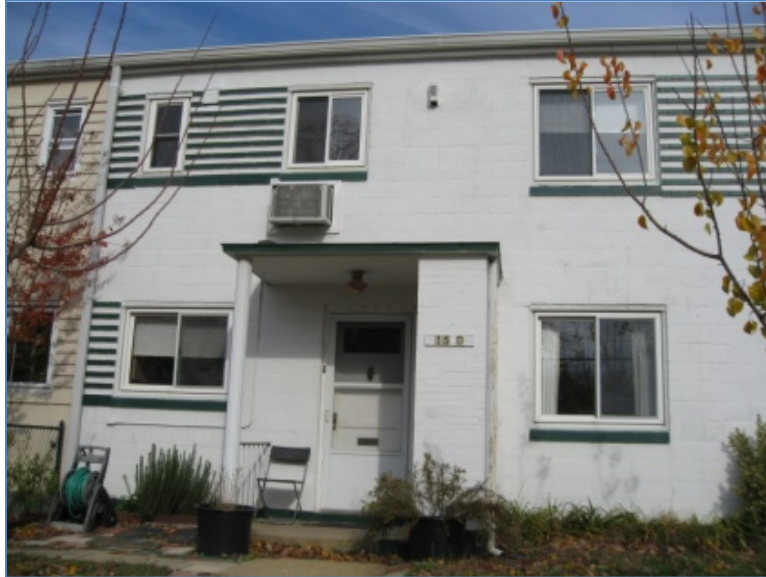
**Figure 1. Block building, one end unit, front.**

The first step of Phase 1 of the pilot program was to determine the existing condition of the 28 homes to aid in developing energy simulations and upgrade recommendations. The pre-retrofit condition of the 28 homes was established through occupant interviews, compilation of the previous years' utility bills, physical inspections, and air infiltration and water flow testing. Representative pre- and post-retrofit data for three of the seven buildings are covered in Table 2 through Table 4. Building elevations are shown in Figure 1 through Figure 6. Data for all of the buildings in the pilot program can be found in Appendix A.

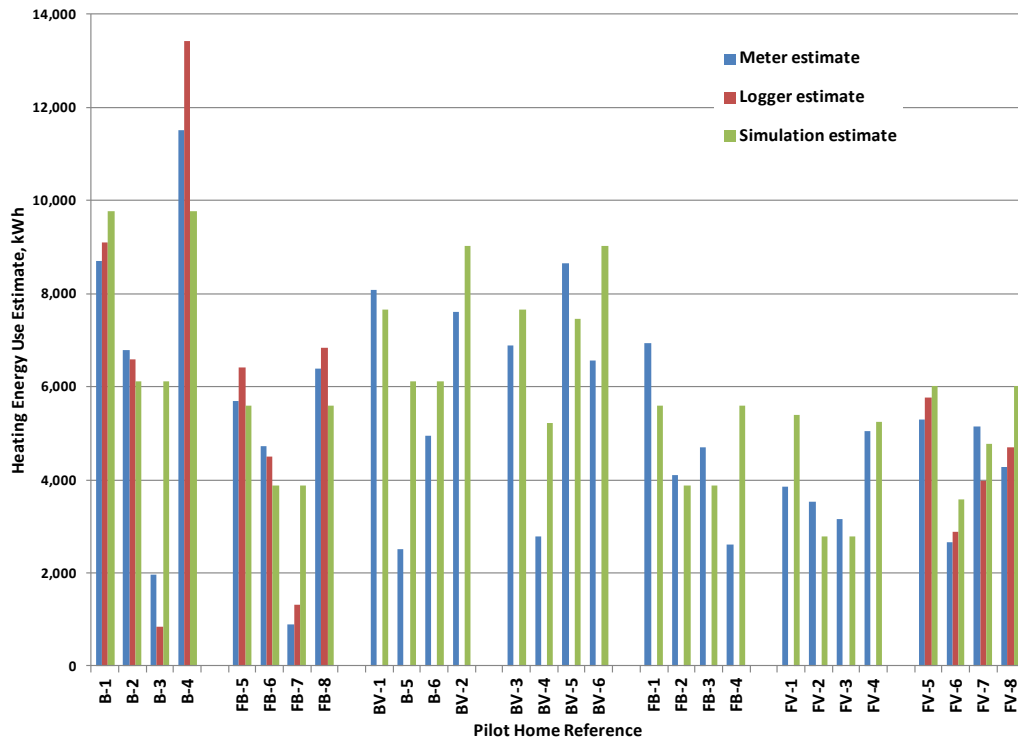
**Figure 8. Summary comparison of heating energy use estimates for the heating period November 2010 – March 2011.**

4. When comparing the simulation data estimates to the utility meter readings, the results are more varied with an average ratio of 148% for across all of the homes and a standard deviation of 109%. When removing the three outlier homes from the data set, the average ratio of simulated to meter energy use is 106% with a standard deviation of 21%, indicating a somewhat good approximation of energy use by the homes from the simulation estimates.

Figure 8 charts the data as described in the four summary points above.

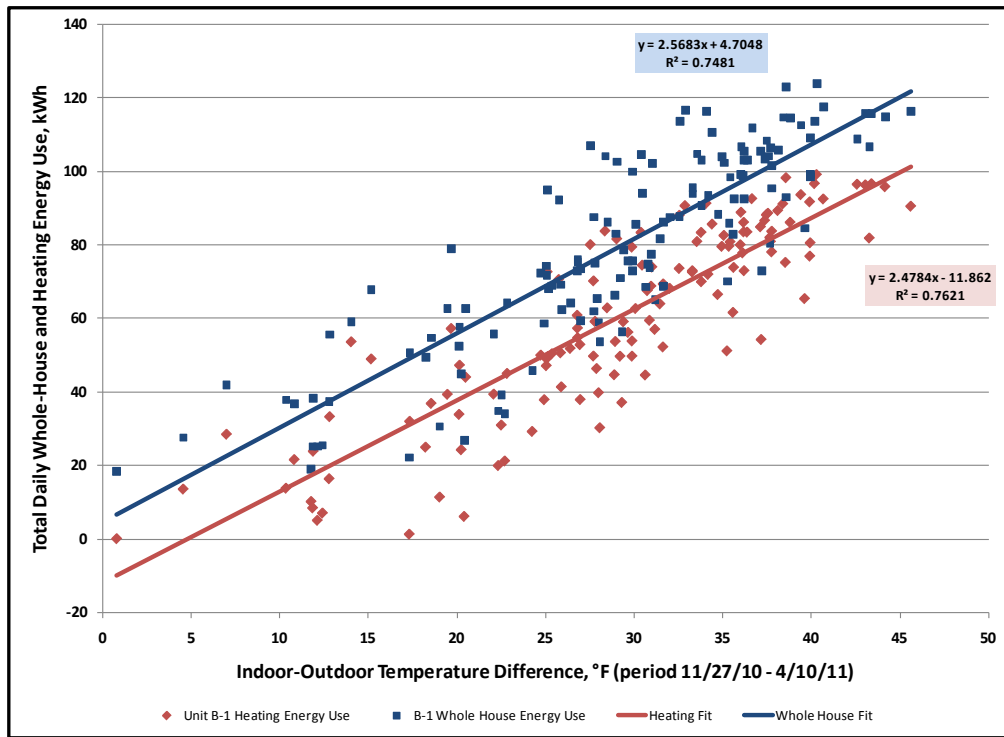
Figure 9. B-1 Whole house and heating electric use analysis.

Figure 9, Figure 10, and Figure 12 indicate similar performance because the whole house and heating energy use are consistent as evidenced by the whole house and heating energy fit lines being parallel, or having a similar slope. The area between the fit lines is generally indicative of energy use for appliances, lights, water heating and miscellaneous. When the area is consistent, as shown by these graphs, it indicates that usage is more or less routine from day to day.

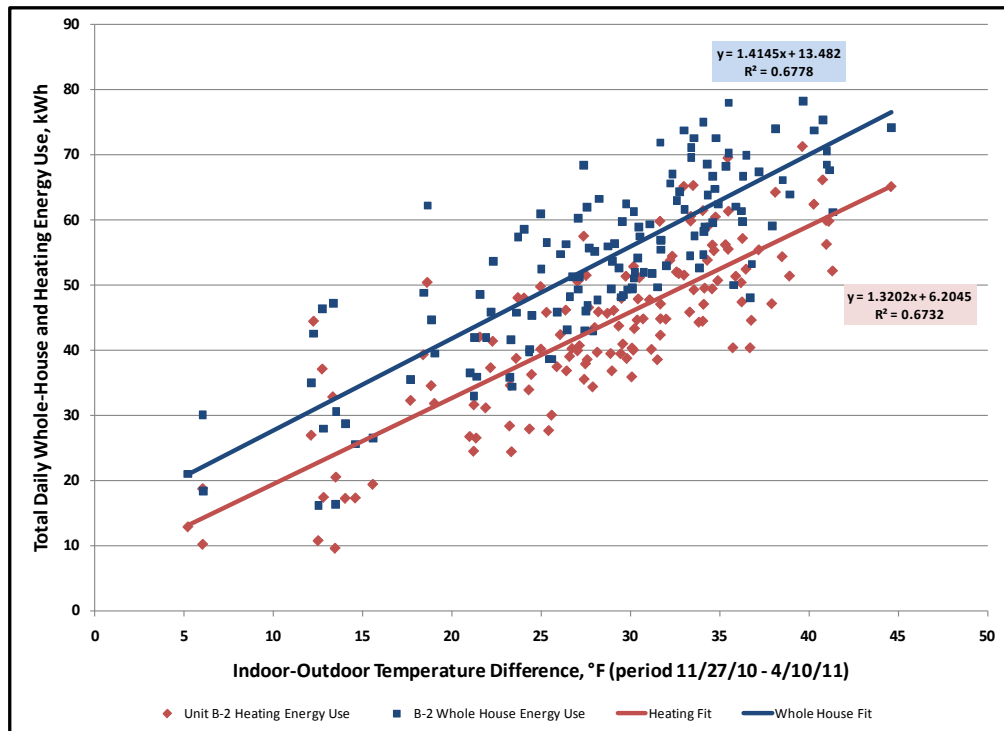
Figure 10. B-2 Whole house and heating electric use analysis.

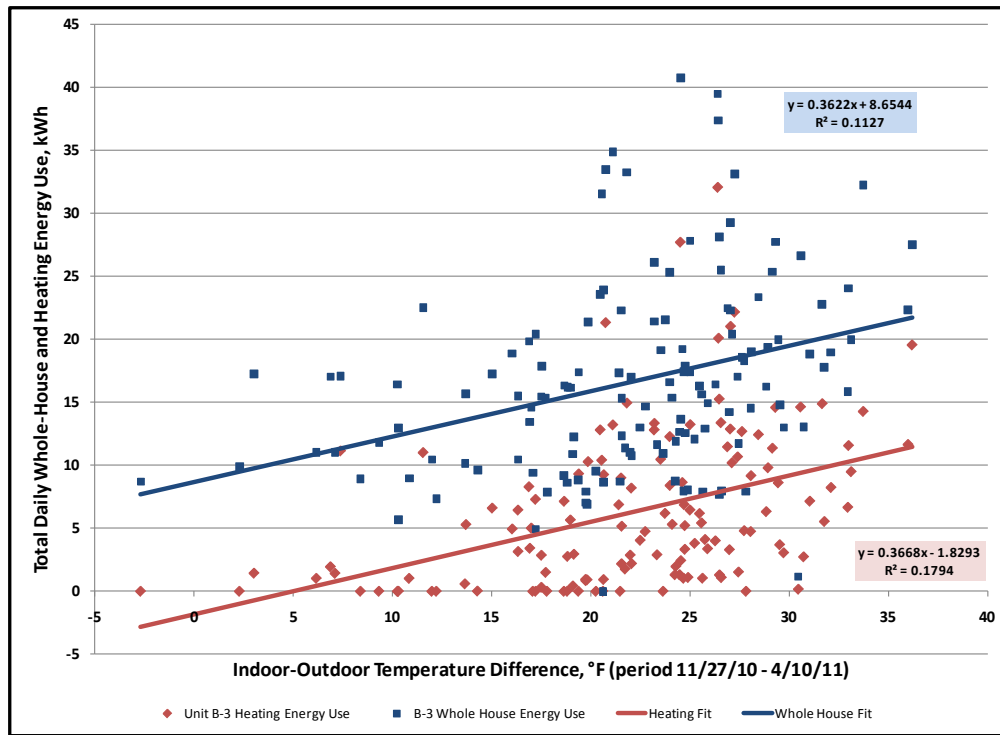
Figure 11. B-3 Whole house and heating electric use analysis.

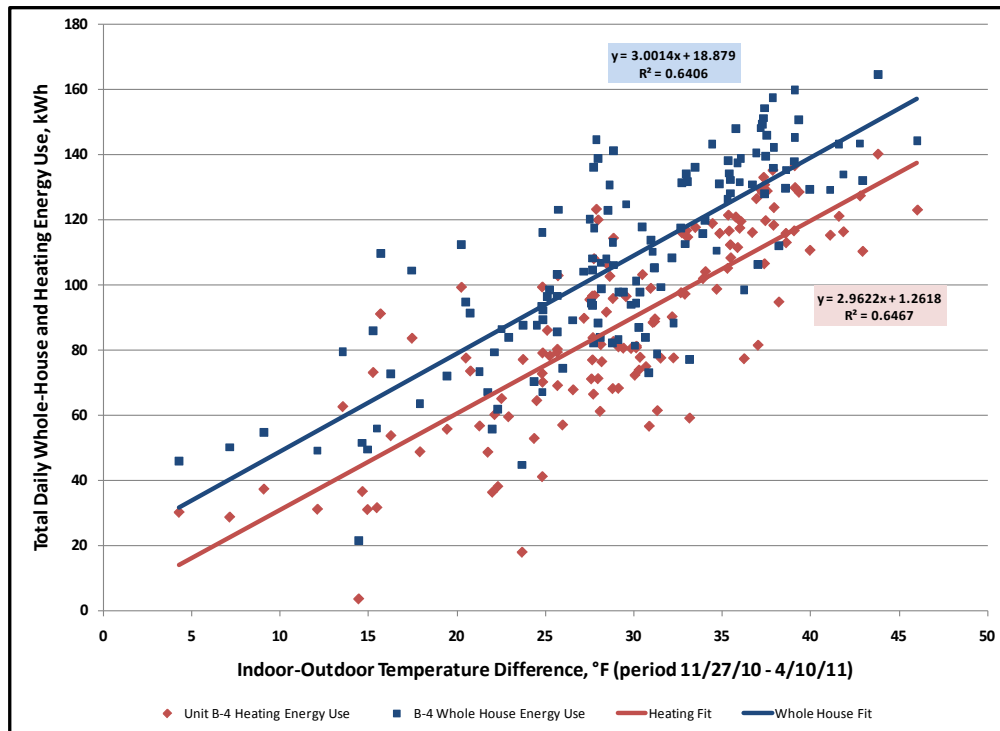
Figure 12. B-4 Whole house and heating electric use analysis.

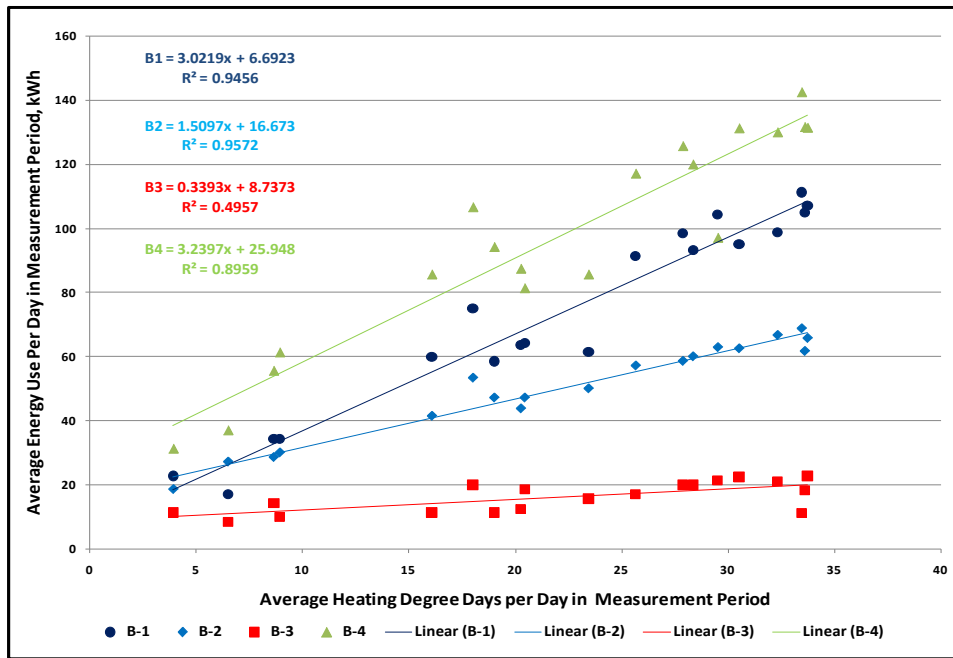
Figure 13. B-1 through B-4 average daily electricity use based on HDDs in the period.

In addition to the data measured by the transducers, the utility meter readings were logged weekly for each of the units. The utility meter data correlates well with the measured data. The utility meter data has been used to analyze the heating energy use compared to the number of HDDs in Figure 13. The use of HDD helps to compare the temperature severity (or the difference between indoor and outdoor weather) when the time period is greater than one day. HDD is the cumulative measurement (for a period) of the difference between 65°F and the average daily temperature below 65°F. Each point on the graph indicates the average daily energy usage and the average daily HDD in a period defined by meter readings. The trend line for each unit indicates the relationship between the outdoor temperature severity and the average daily electric energy consumption.

Units B-4 and B-1 demonstrate the highest daily energy usage during the heating period. These are end units with approximately 25% more exterior wall surface, nearly 50% more roof surface area, and 28% more heated area than B-2 and B-3, thus higher energy usage for space conditioning is expected.

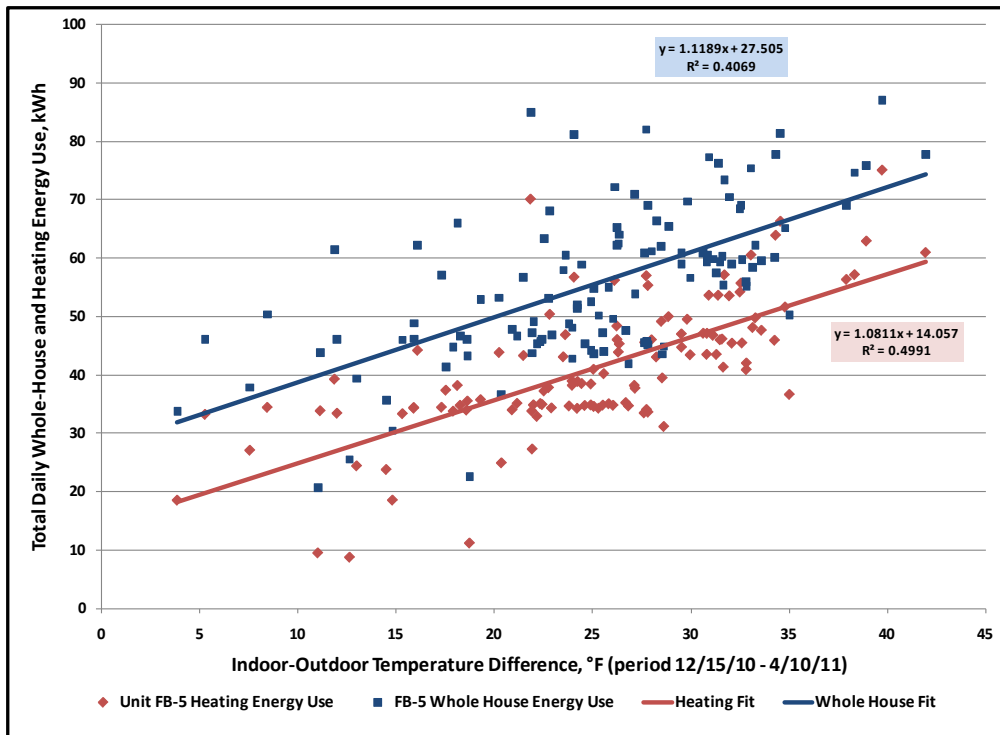
Figure 14. FB-5 Whole house and heating electric usage.

Figure 14 through Figure 17 chart the transducer data on whole house and heating energy use during the 2010/2011 heating season. Figure 18 compares the metered data and the HDD for a period.

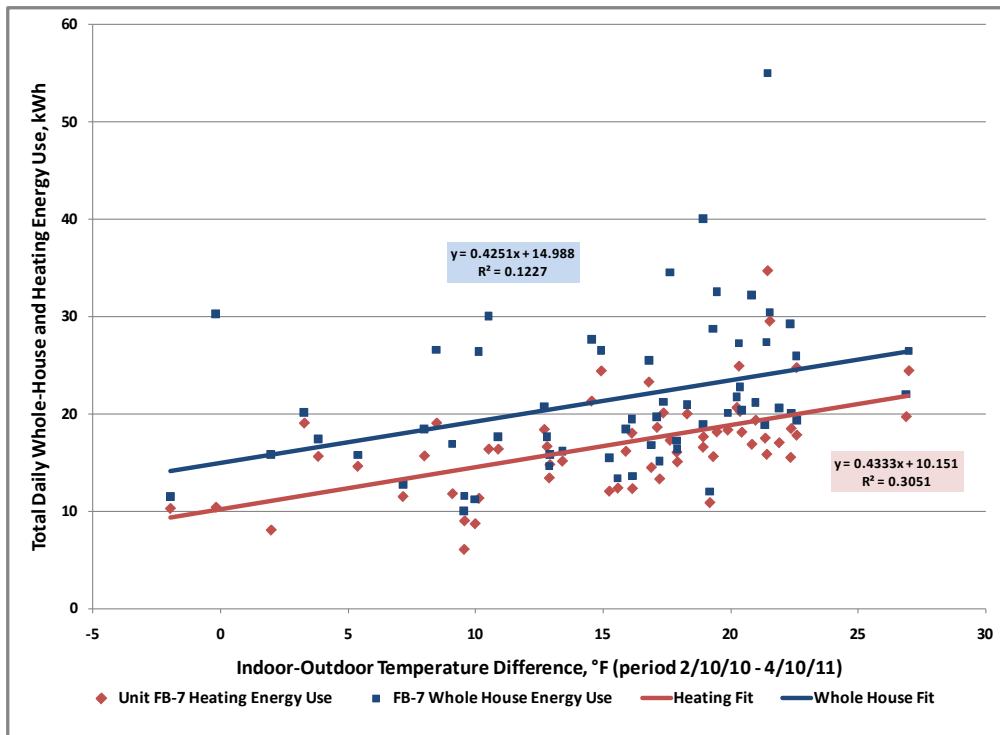
Figure 16. FB-7 Whole house and heating electric usage.

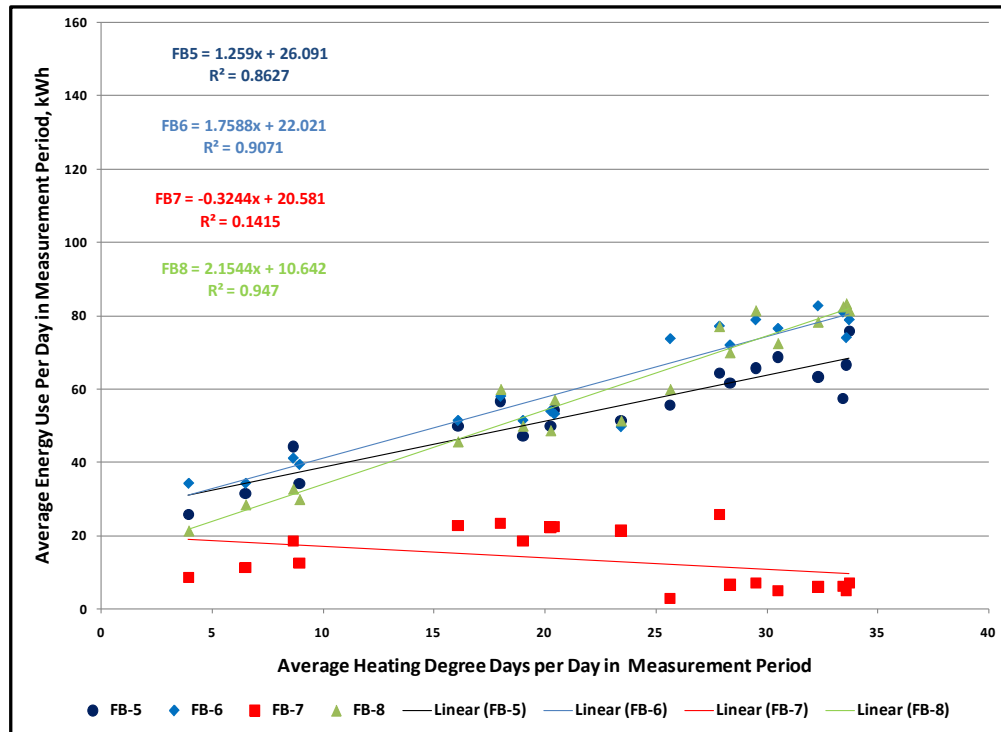
Figure 18. FB-5 through FB-8 average daily usage and HDD during the period.

Figure 18 compares the energy use recorded at the meter with the HDD for the period. The data correlates well with that presented in the previous graphs (Figure 14-Figure 17).

The energy used in these wood frame brick (FB) units is significantly lower than for the block (B) units (Figure 9 through Figure 12) due the former having wall insulation. FB-5 and FB-8 are the end units with approximately 340 more square feet of exterior wall surface than interior units; however, all of the homes in this building have similar conditioned area (Table 3).

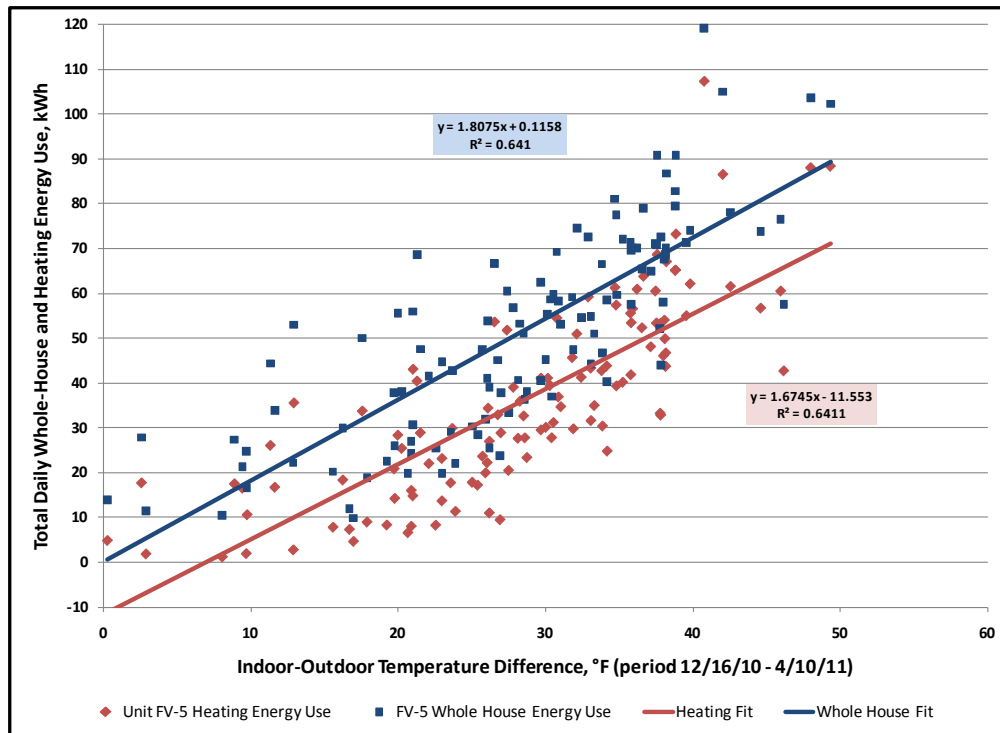
Figure 19. FV-5 Whole house and heating electric usage.

Figure 19 through Figure 22 indicate the detailed daily data for whole house and heating energy use. The maximum energy use recorded for any day is similar to that of the wood frame brick building but, the range for these wood frame vinyl homes is not as great as those of the other building types. The range of maximum daily use was 74–119 kWh per day (used in FV-6, and FV-5, respectively). The two other homes in the building recorded maximum daily energy use of 75 and 104 kWh. The maximum heating energy use, however, was as would be expected, higher for the exterior units (108 and 63 kWh), than the interior units (47 to 52 kWh). The difference in heating energy use in the end homes can be attributed to the 6°F difference in average indoor heating set point.

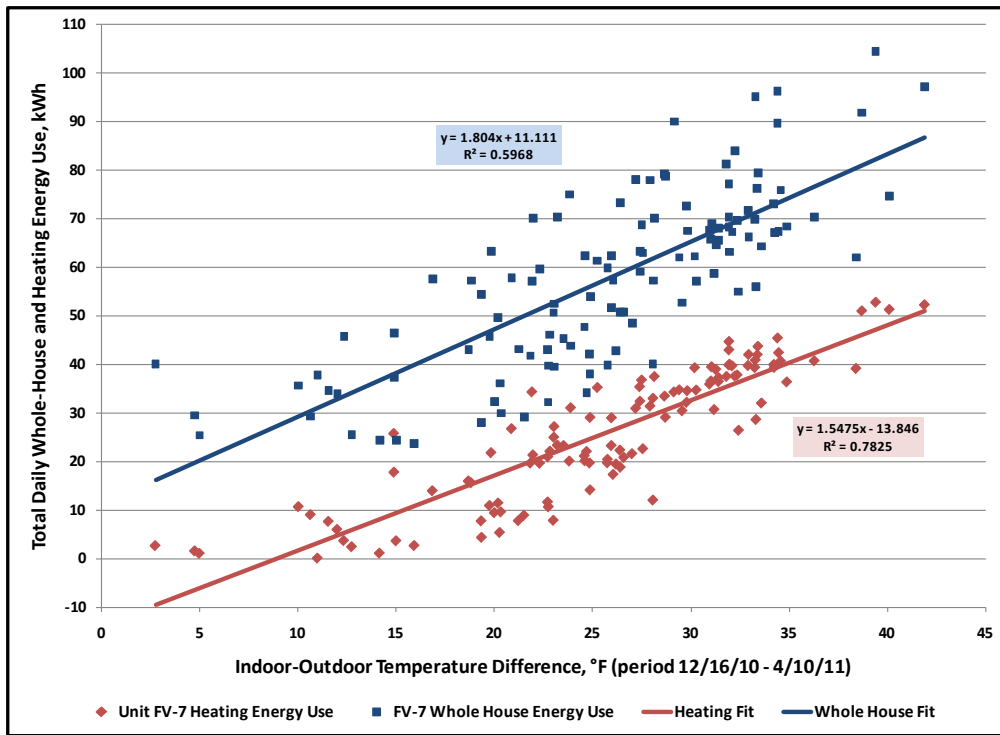
Figure 21. FV-7 Whole house and heating electric usage.

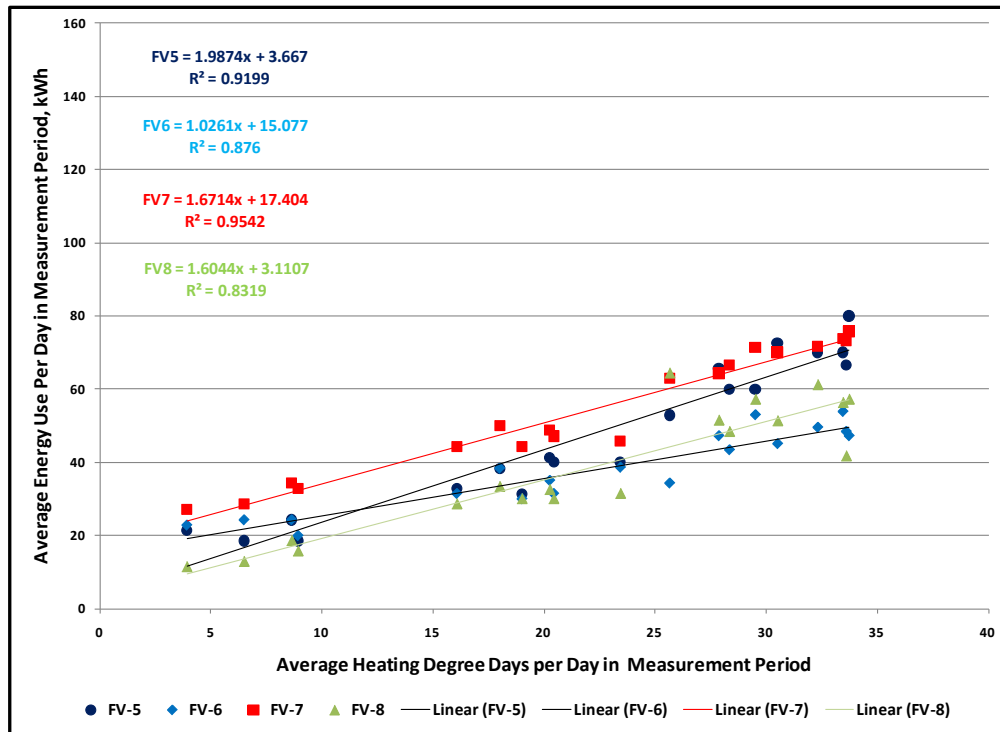
Figure 23. Average daily usage and HDD during the period; FV-5 through FV-8.

The whole house energy used in the FV and FB units is similar since these units all have similar wall and ceiling insulation. The interior unit, FV-7 shows the overall highest energy use; however, the energy use is greater for non-heating loads and is consistent for energy used for heating as with other interior units.

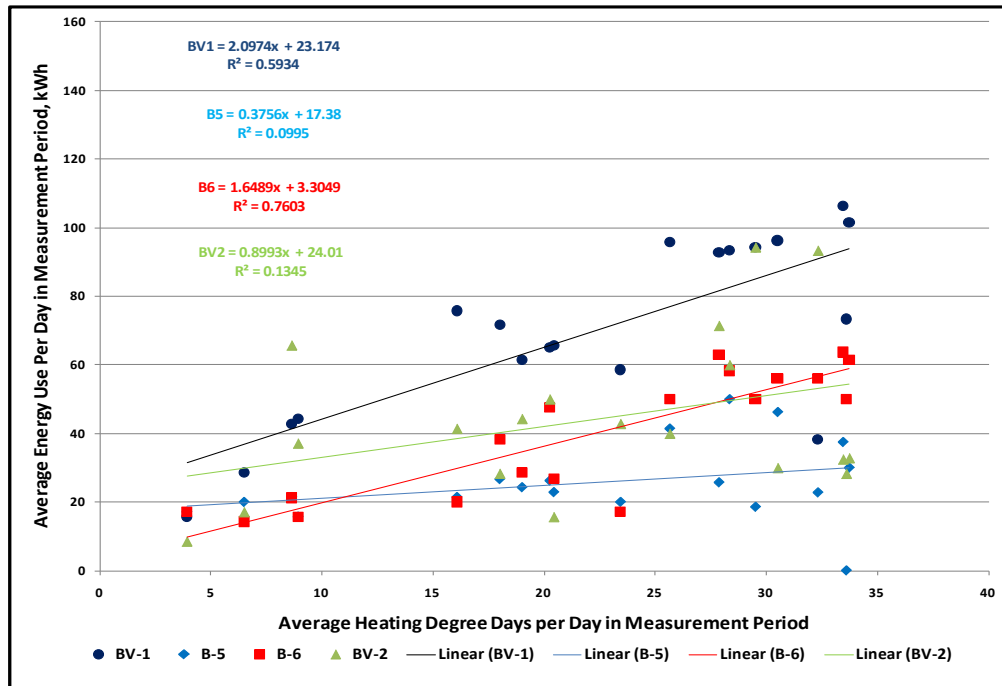
Figure 24. BV-1, B-5, B-6 and BV-2 average daily usage and HDD for the heating period.

The end units, BV-1 and BV-2, indicate the highest maximum daily energy usage during the period; however B-6, an interior unit, is a close third in energy usage. These three units have considerably different conditioned areas of 1,528, 1,245, and 921, respectively. Like the other block end units, the two in this building have more than twice as much exterior wall surface area as the interior units.

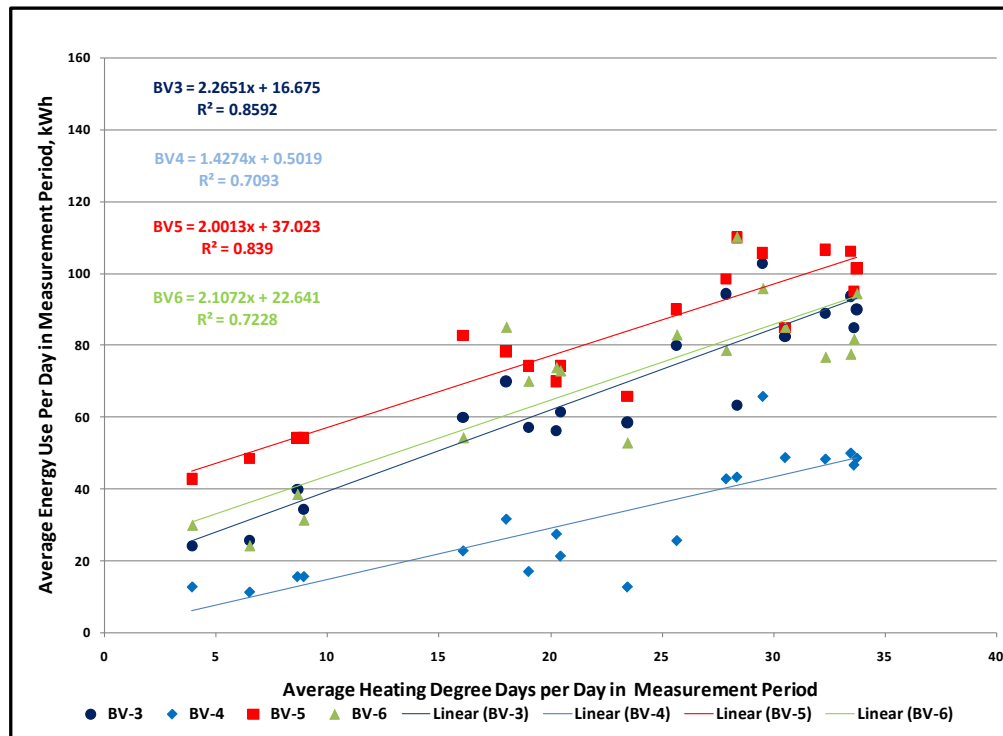
Figure 25. BV-3 through BV-6 average daily usage and HDD for the heating period.

Temperature sensors were installed in each unit of the masonry block vinyl-sided building for part of the heating season (February through April 2011). Energy use data was obtained via periodic utility meter readings, as energy transducers were installed in May 2011; after the heating season ended. The average indoor temperatures in these units were closest of any of the buildings to those used in the energy simulations—69°F, 64°F, 70°F, and 66°F. Figure 25 charts the electricity used during utility meter measurement period normalized to the number of HDDs in that period.

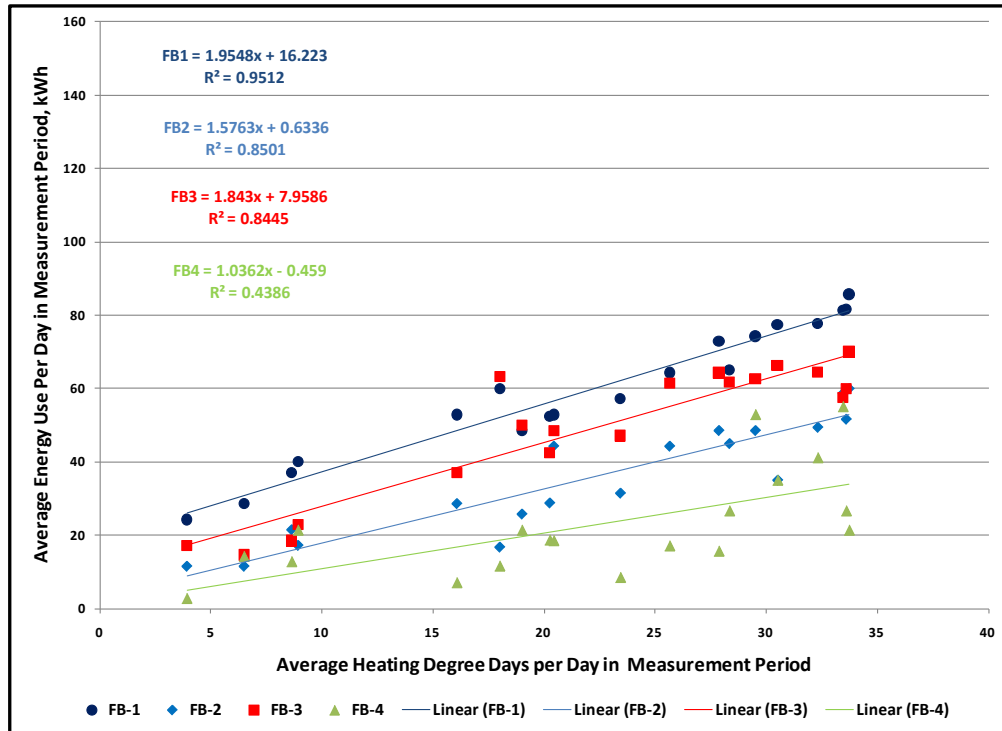
Figure 26. FB-1 through FB-4 average daily usage and HDD during the period.

Temperature sensors were installed in each unit of this wood frame brick-veneered building for part of the heating season (February through April 2011). Energy use data was obtained via periodic utility meter readings, as energy transducers were installed in May 2011; after the end of the heating season. The average indoor temperatures vary considerably—70°F, 65°F, 66°F and 58°F. Each of the homes in this building contains the same conditioned area, 1,080 ft<sup>2</sup>. Figure 26 charts the electricity used during each utility meter measurement period normalized to the number of HDDs in that period. The FB-4 unit appears to be an anomaly both as an exterior unit and lower slope of energy use with reference to the weather severity.

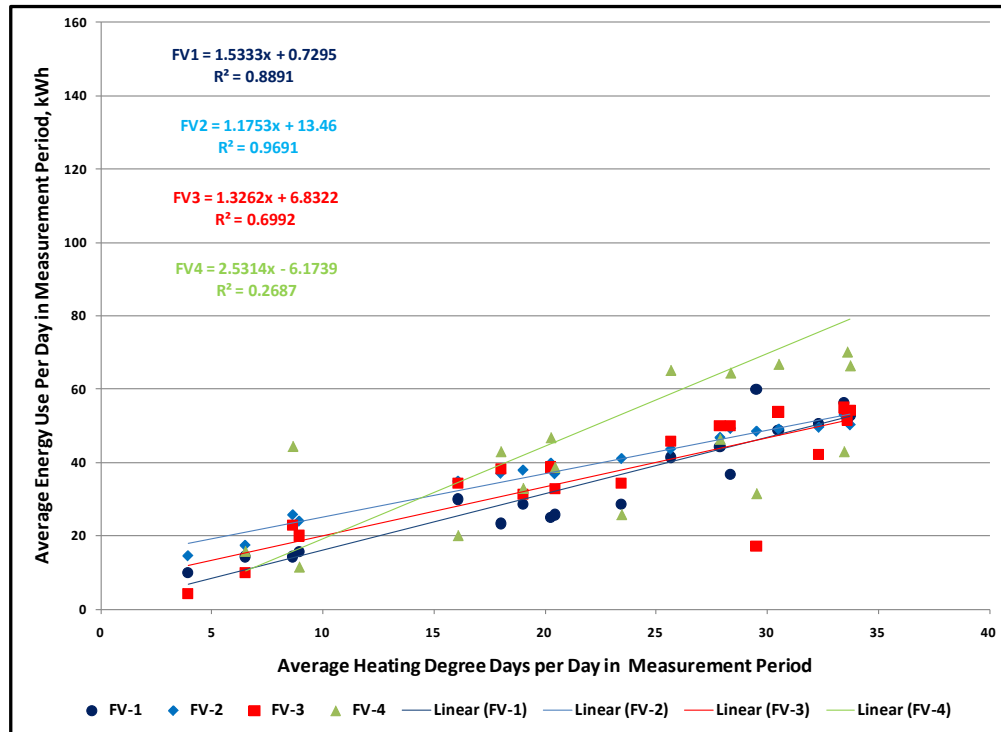
Figure 27. FV-1 through FV-4 average daily usage and HDD for the heating period.

Temperature sensors were installed in each unit of this wood frame vinyl-sided building for part of the heating season (February through April 2011). Energy use data was obtained via periodic utility meter readings, as energy transducers were not installed until May 2011 after the end of the heating season. Average indoor temperatures were 63°F, 69°F, 68°F, and 68°F. Whole house energy use is plotted against the HDDs in the period in Figure 27.

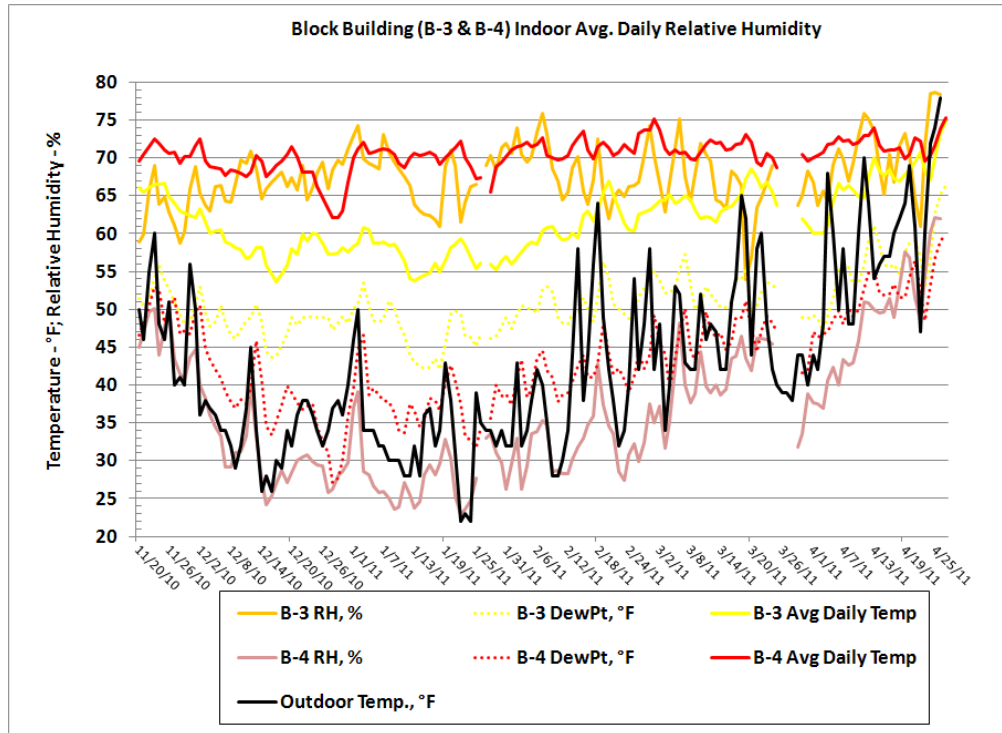
Figure 28. Indoor relative humidity B-3 and B-4.

Homes in the pilot study tended to show average indoor RH within the ASHRAE recommendation range, however, a majority of the units showed average household RH higher than the more recently recommended limit of 40%; 14 of 26 homes recorded in Table 11 showed average heat season RH above 40%. Two of the block houses had RH levels over 60% (B-3 and B-5) for some duration of the heat season. Both of these units indicate significantly cooler indoor average temperatures than the pilot group of homes—62°F and 64°F. The GHI Report 1, Phase 1<sup>11</sup> proposed exhaust fans with timers as a method of diluting the humid indoor air by exhaust ventilation. (RH sensors in units B-1 and B-2 were not available for this measurement period.) Figure 28 through Figure 38 show the available RH data for each home.

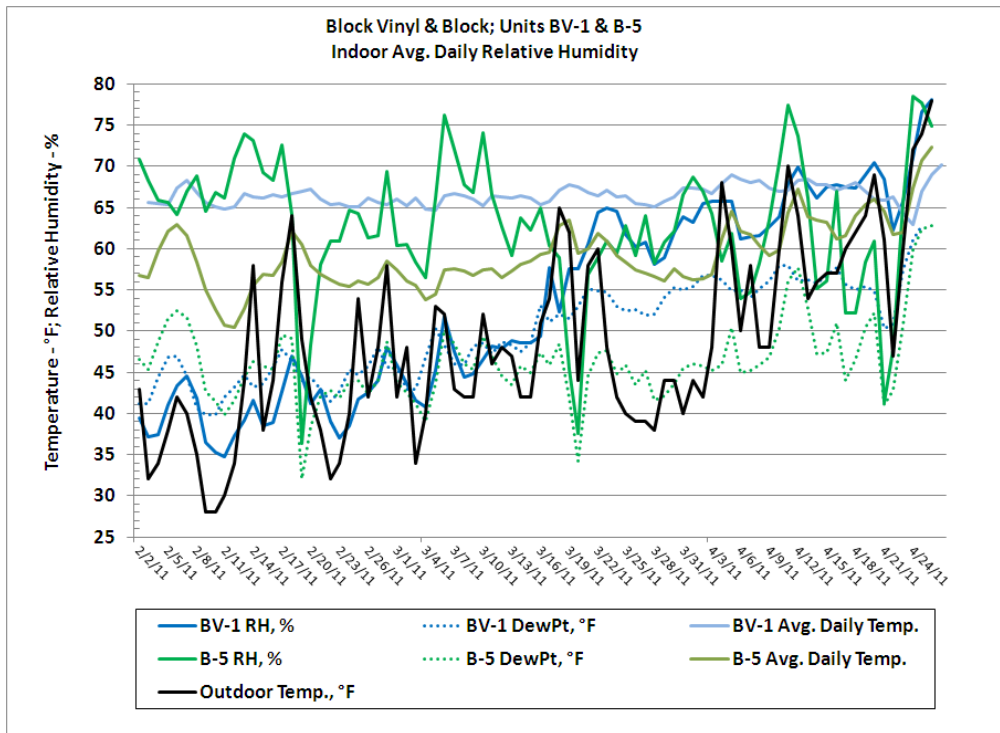
Figure 29. Indoor relative humidity BV-1 and B-5.

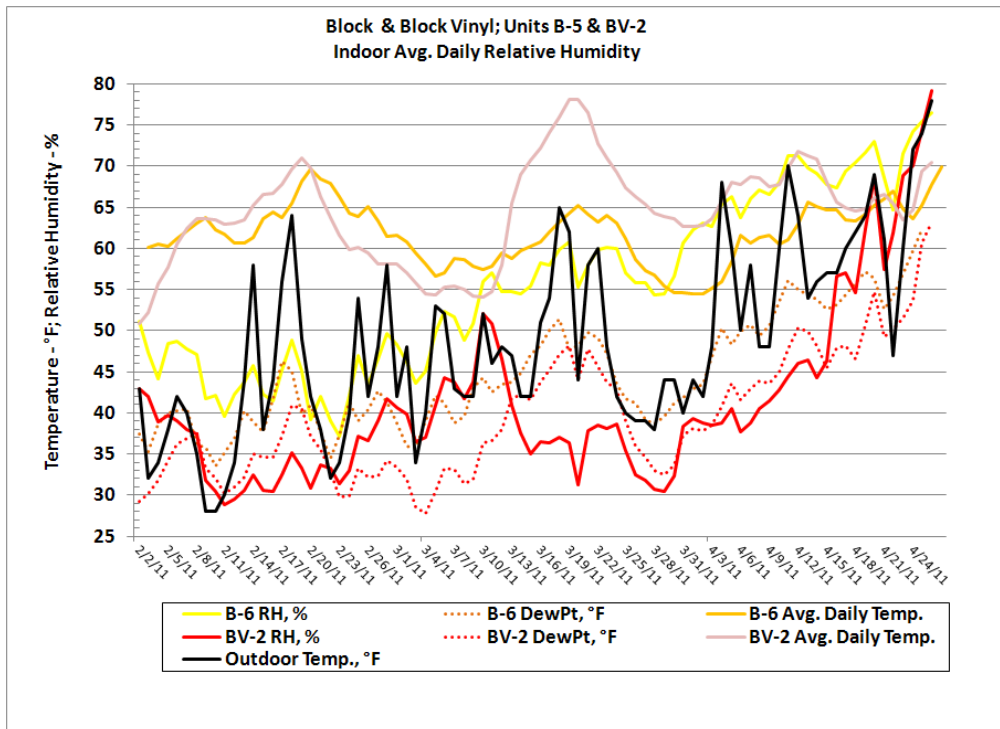
Figure 30. Indoor relative humidity B-6 and BV-2.

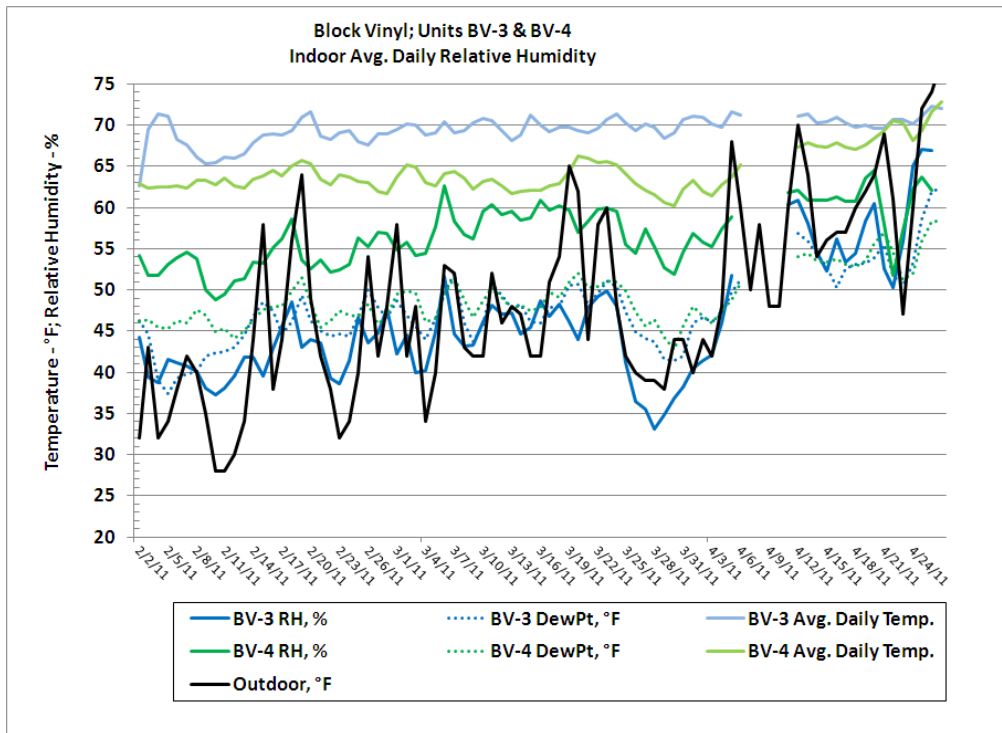
Figure 31. Indoor relative humidity BV-3 and BV-4.

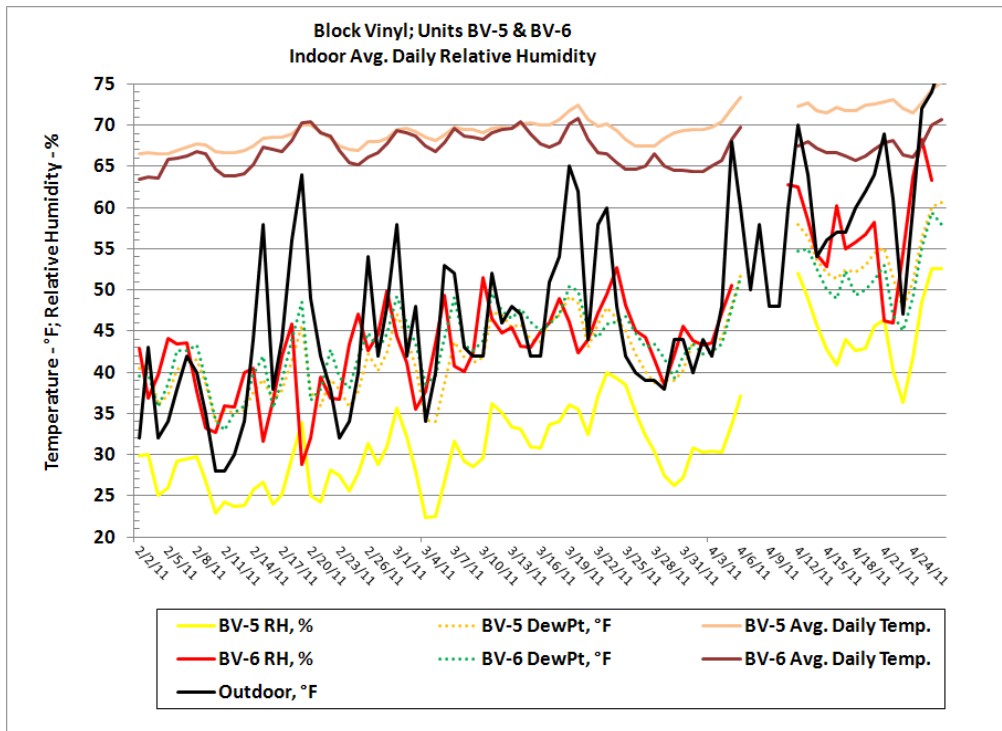
Figure 32. Indoor relative humidity BV-5 and BV-6.

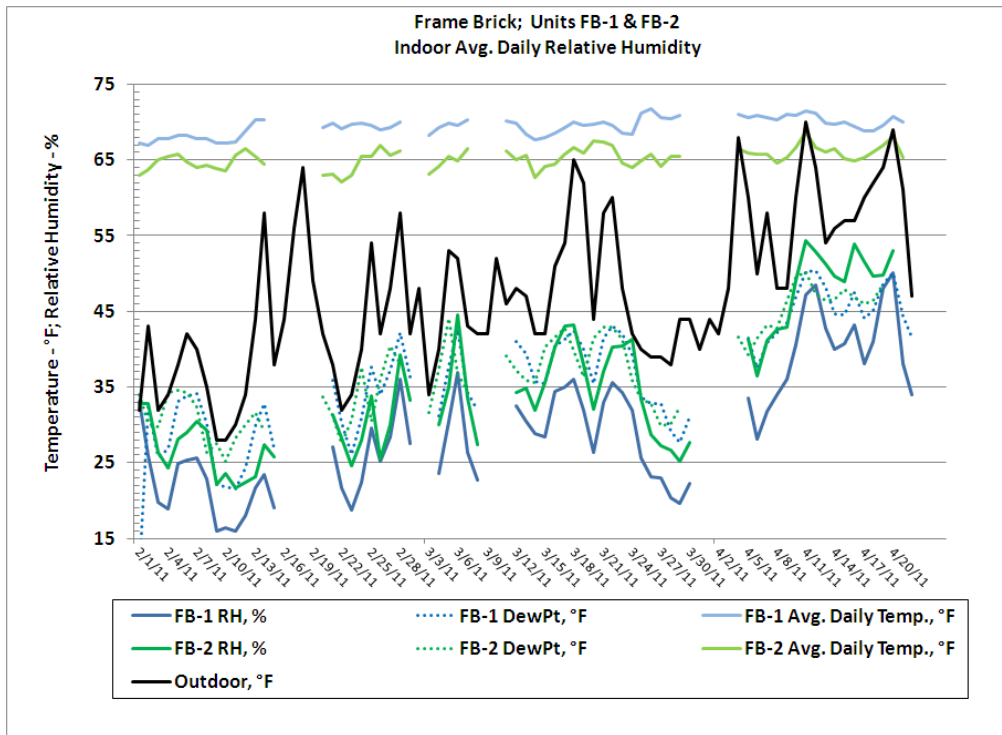
Figure 33. Indoor relative humidity FB-1 and FB-2.

The indoor RH of the wood frame brick and wood frame vinyl buildings for the heating period are detailed in Figure 33 through Figure 38.

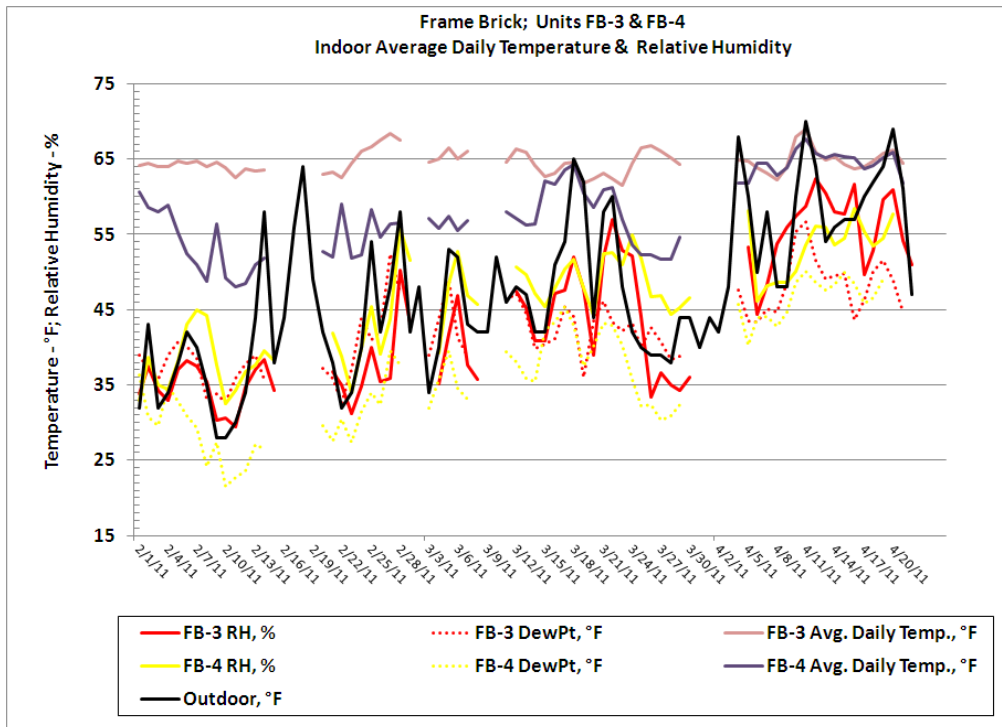
Figure 34. Indoor relative humidity FB-3 and FB-4.

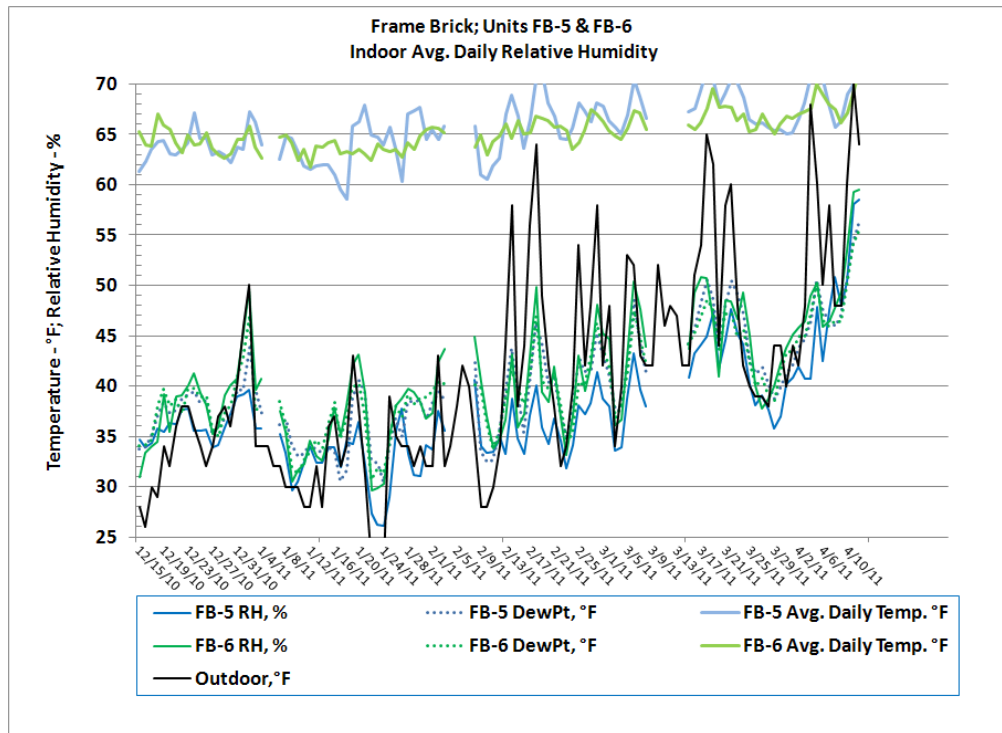
Figure 35. Indoor relative humidity FB-5 and FB-6.

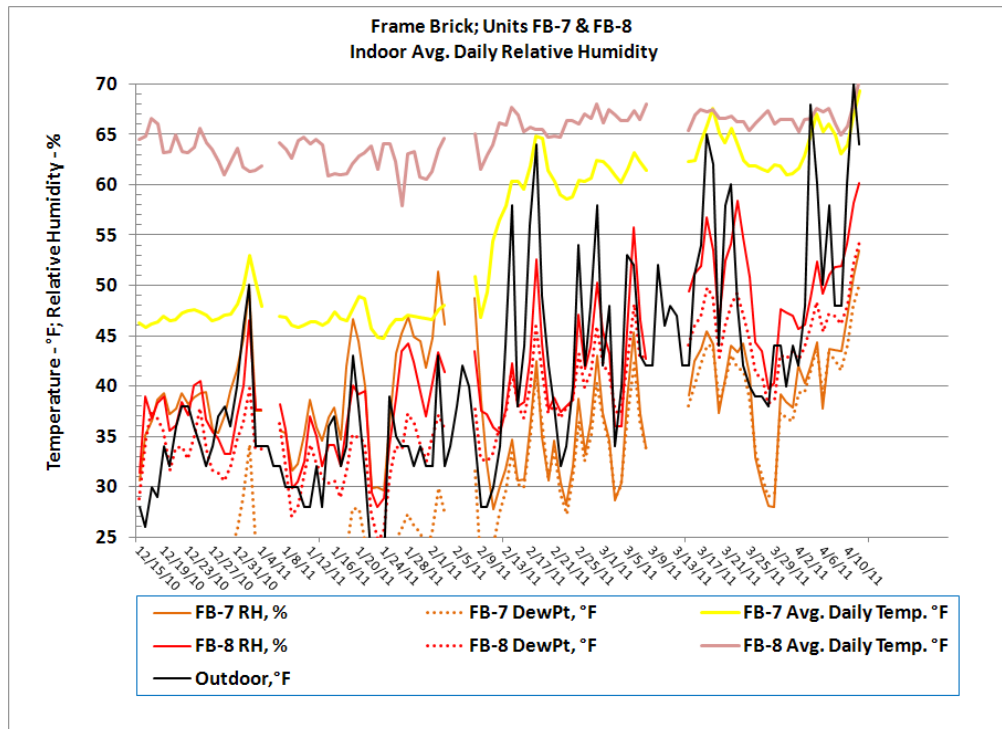
Figure 36. Indoor relative humidity FB-7 and FB-8.

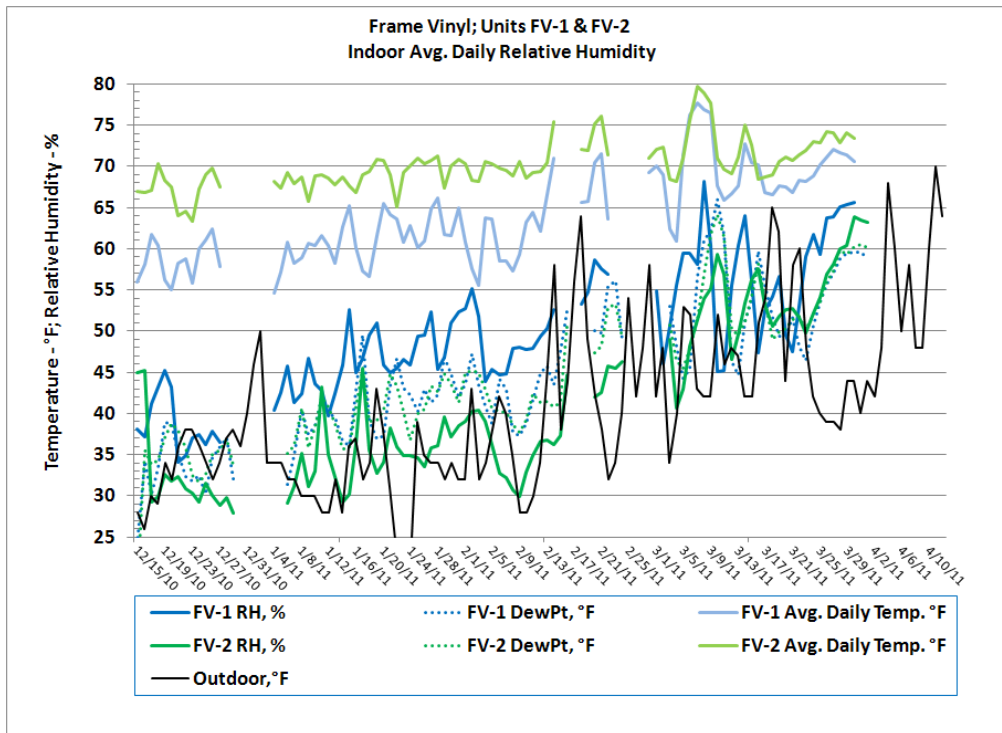
Figure 37. Indoor relative humidity FV-1 and FV-2.

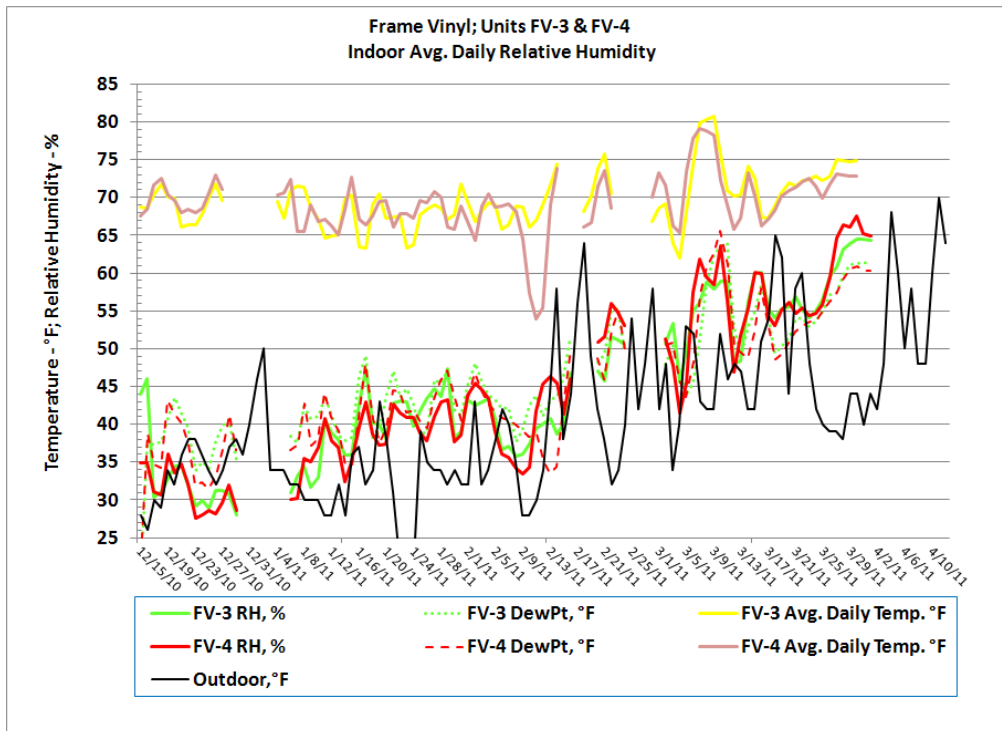
Figure 38. Indoor relative humidity FV-3 and FV-4.
