# **Greenbelt Homes Pilot Energy Efficiency Program Phase 1 Summary: Existing Conditions and Baseline Energy Use**

J. Wiehagen, M. Del Bianco, and A. Wood  
*NAHB Research Center*

February 2013

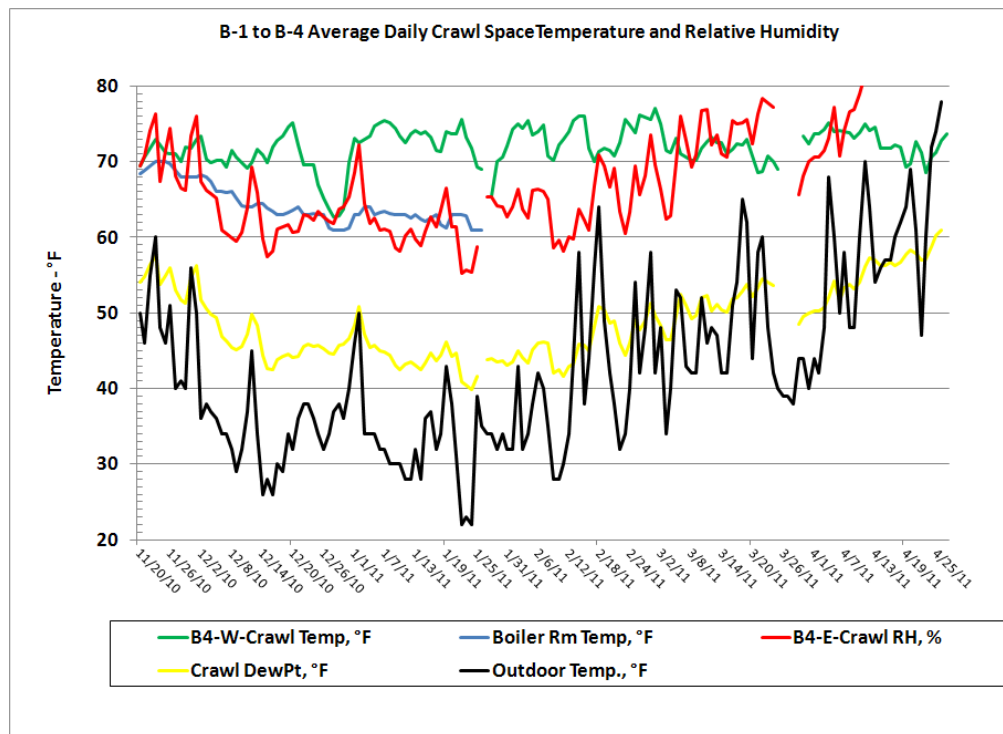
Figure 39. Crawlspace relative humidity; Units B-1 through B-4.

The data indicates that the dew point in the crawlspaces remains below the temperature in the crawlspaces, generally resulting in little condensation potential on surfaces. One group of block building, units BV-1 through BV-2, did not report the RH due to a sensor malfunction. Average daily temperatures for the crawlspace are reported.

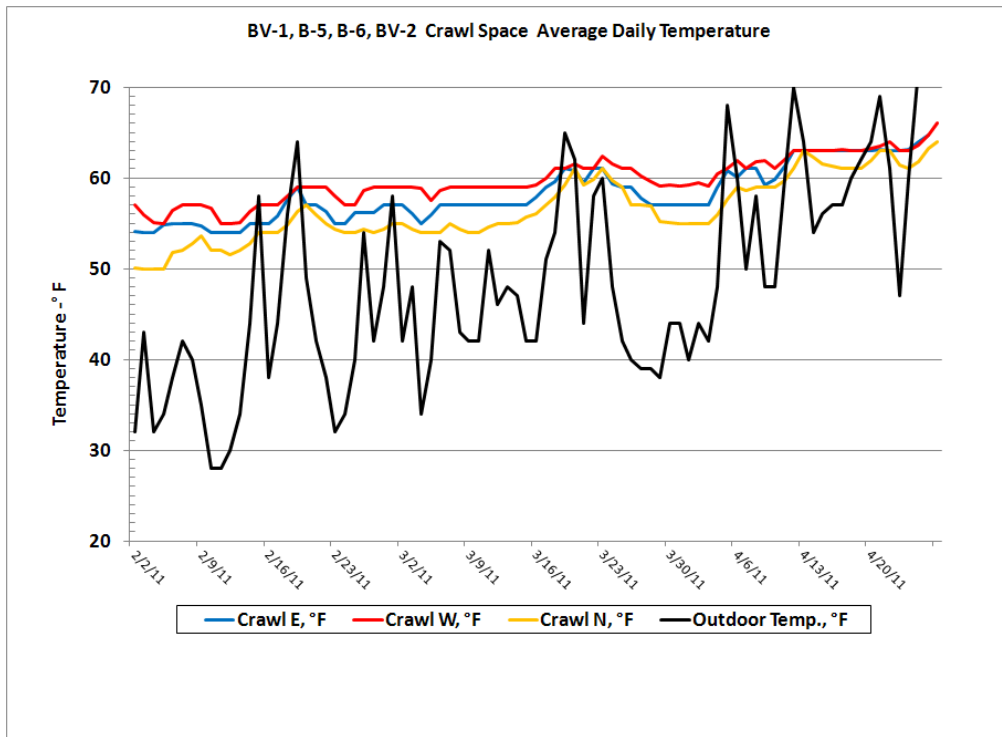
Figure 40. Crawlspace temperature; BV-1, B-5, B-6 and BV-2.

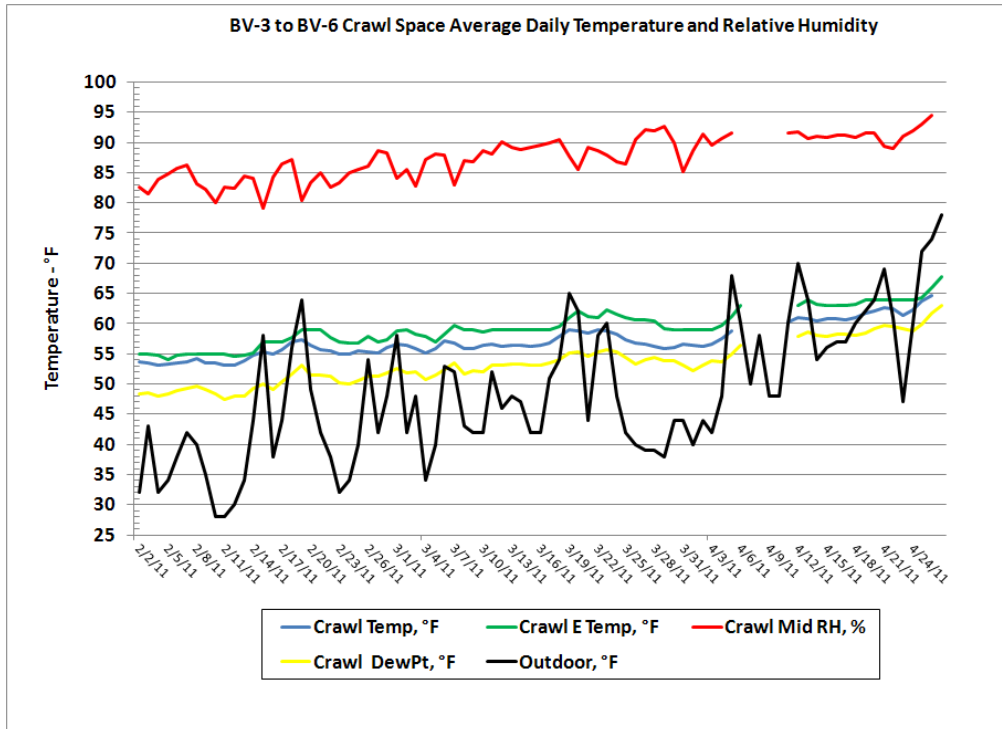
Figure 41. Crawlspace temperature and relative humidity BV-3 through BV-6s.

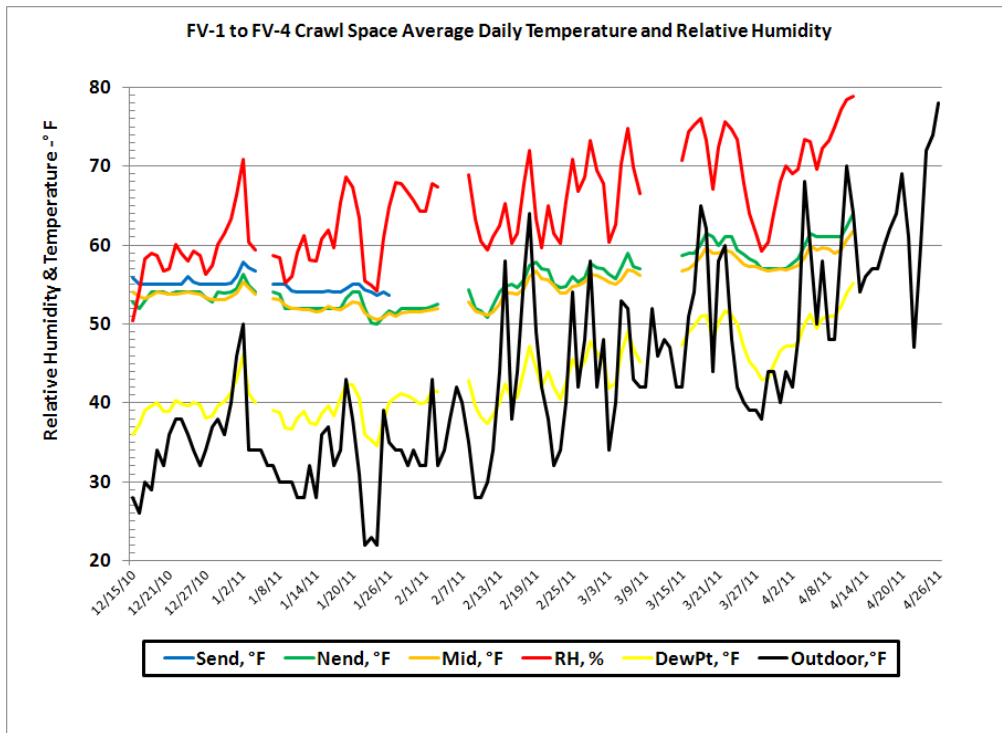
Figure 42. Crawlspace temperature and relative humidity FB-1 through FB-4.

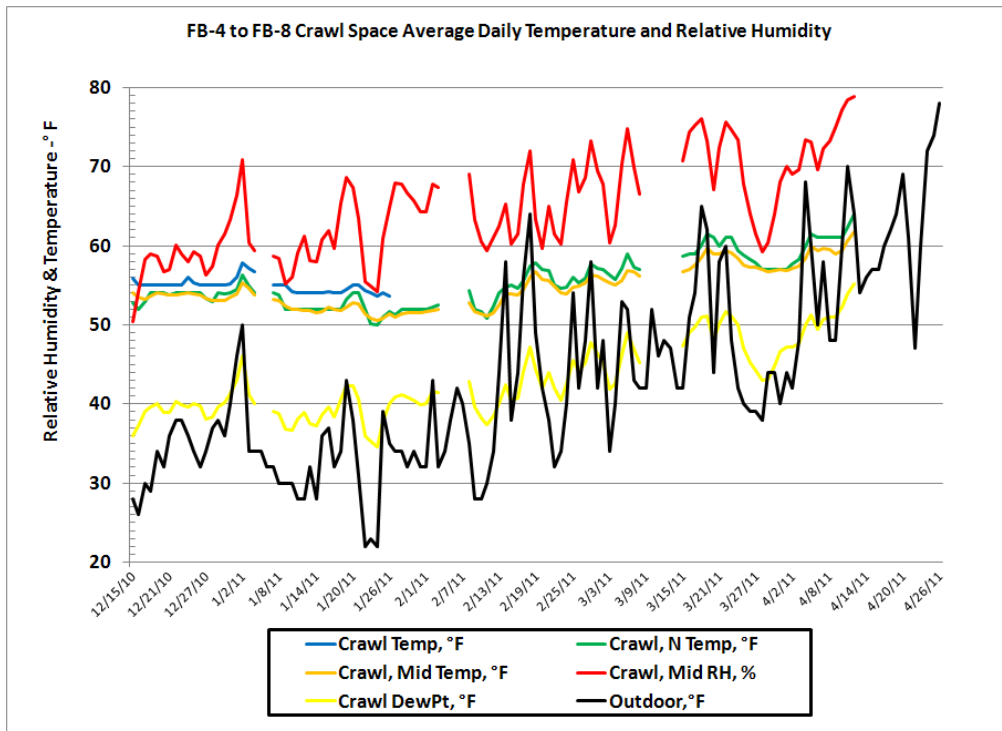
Figure 43. Crawlspace temperature and relative humidity FB-5 through FB-8.

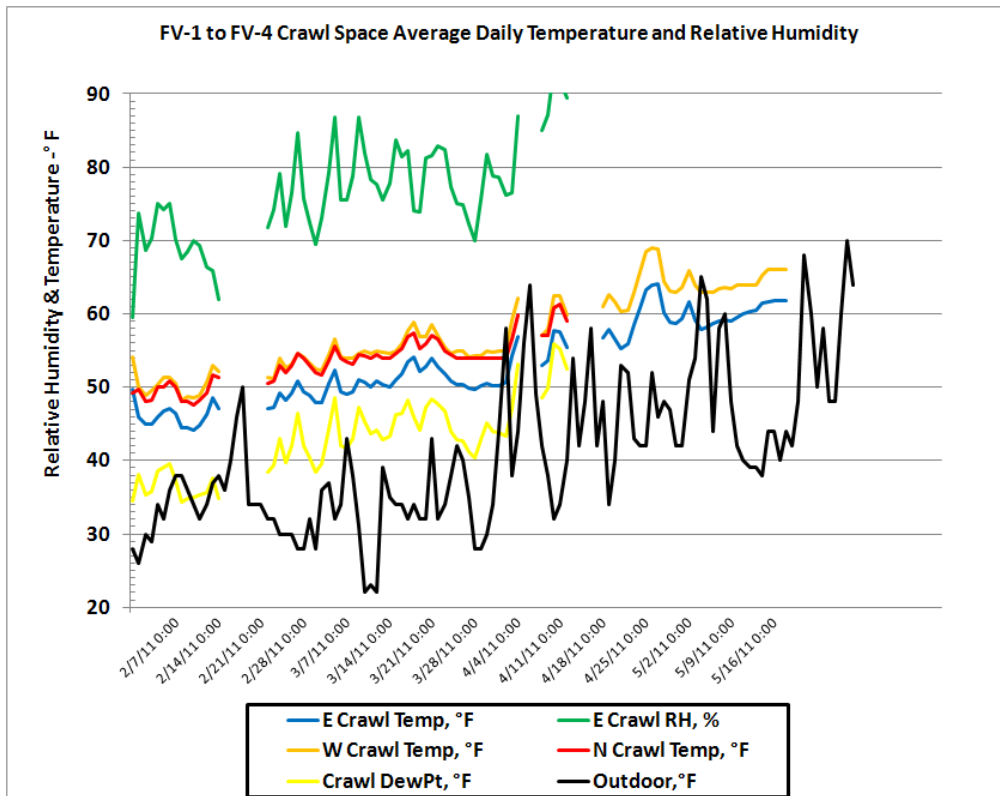
Figure 44. Crawlspace temperature and relative humidity FV-1 through FV-4.

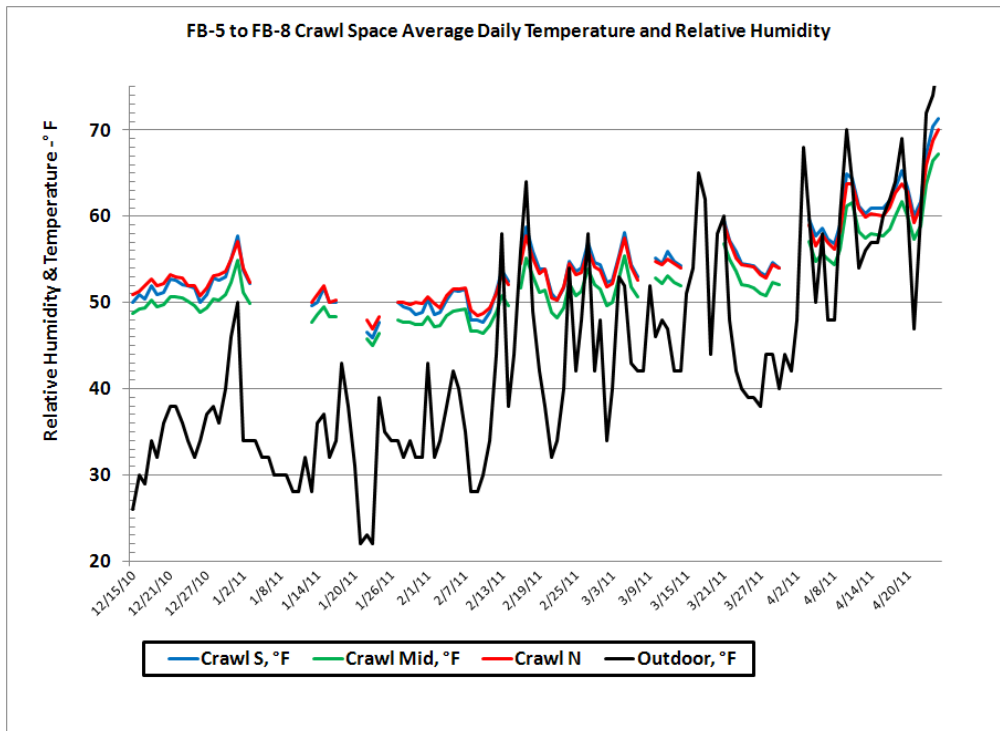
Figure 45. Crawlspace temperature and relative humidity FV-5 through FV-8.

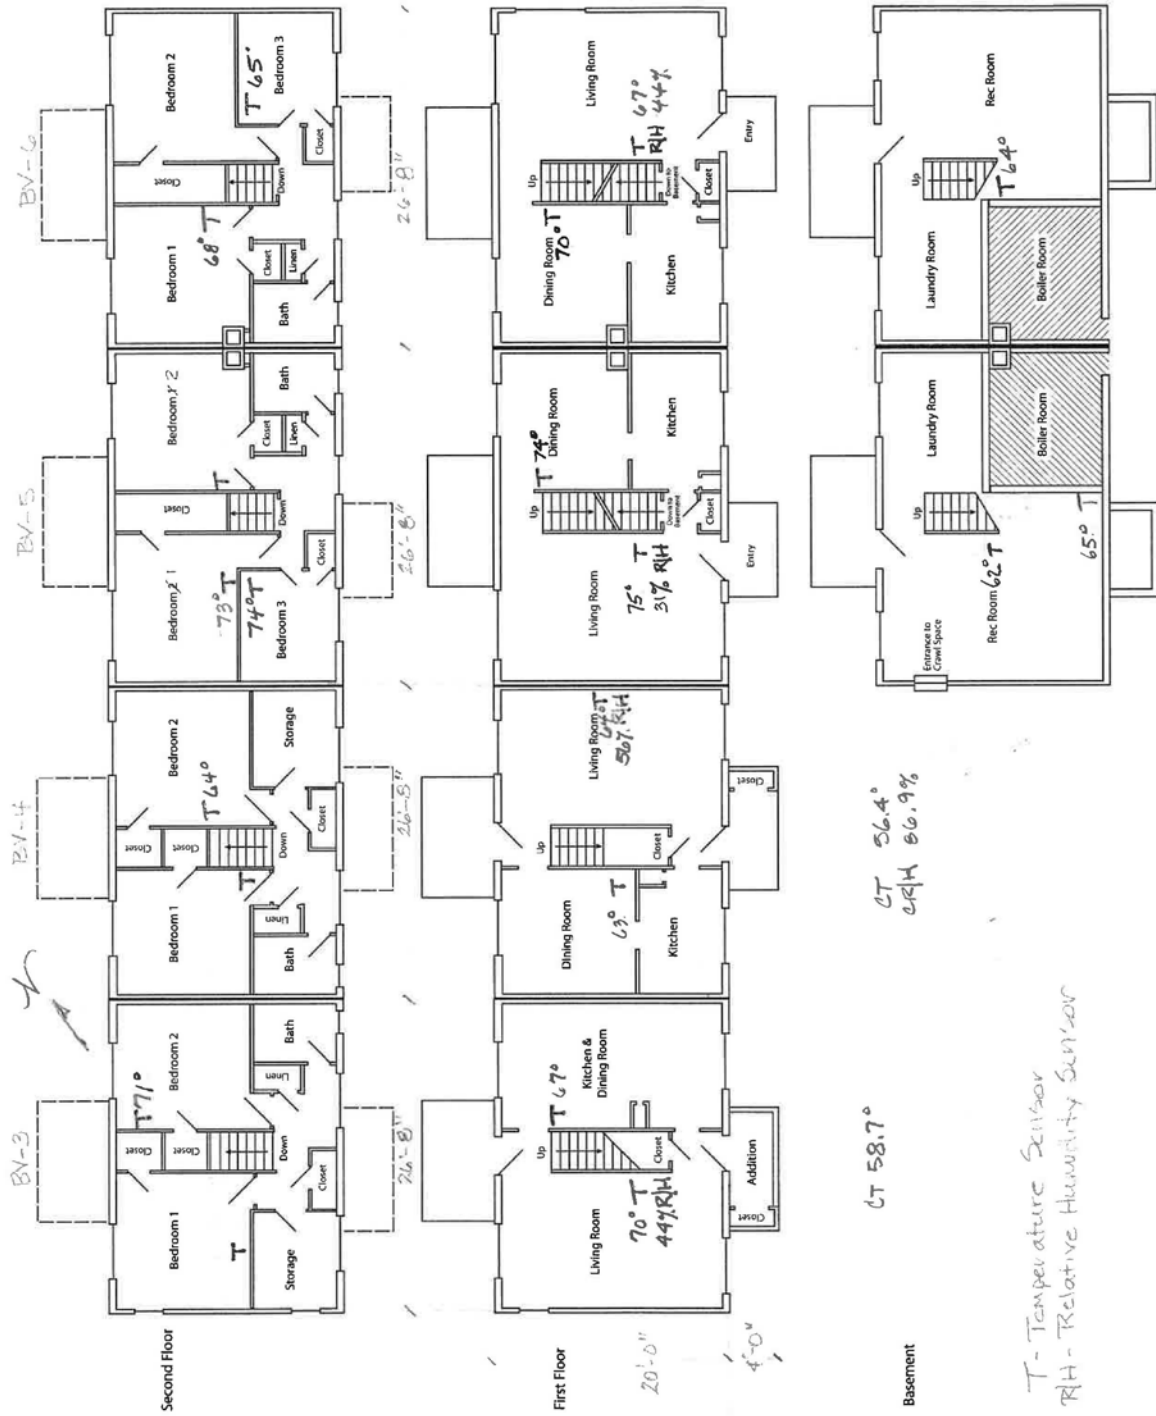
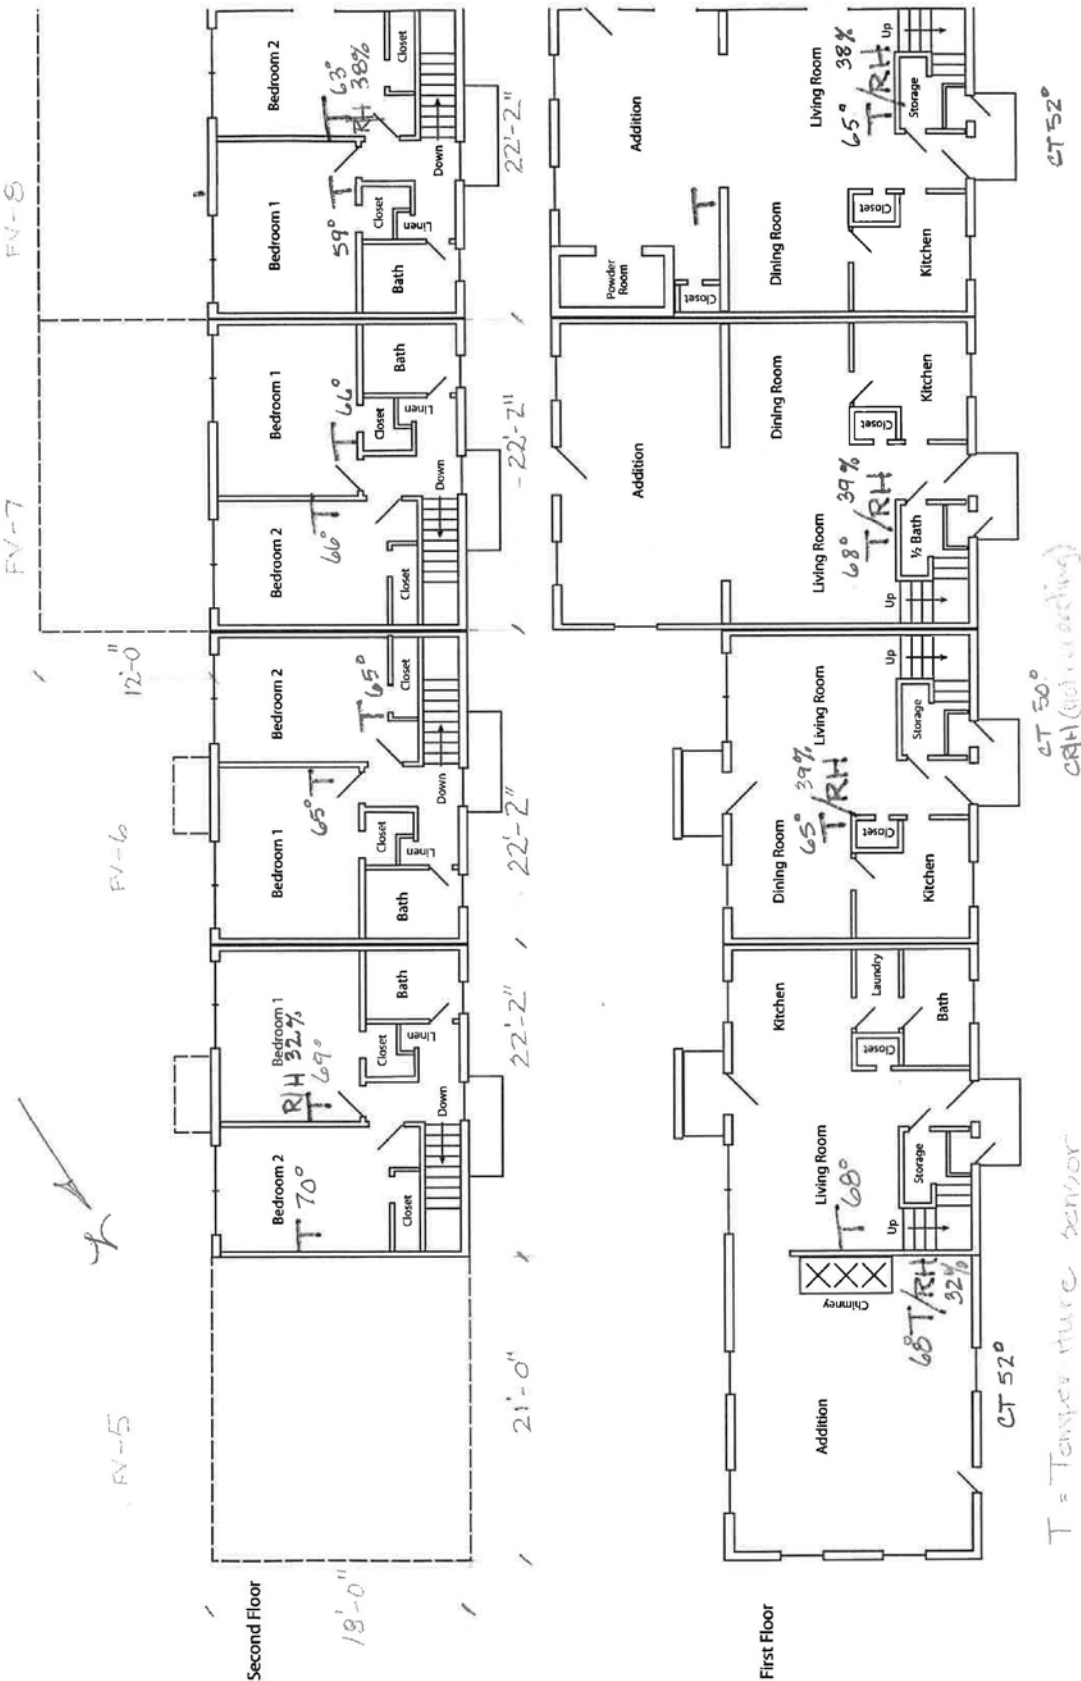
## Appendix B: Temperature and RH Sensor Locations

These drawings show example of floor plans and location of temperature/humidity sensors.

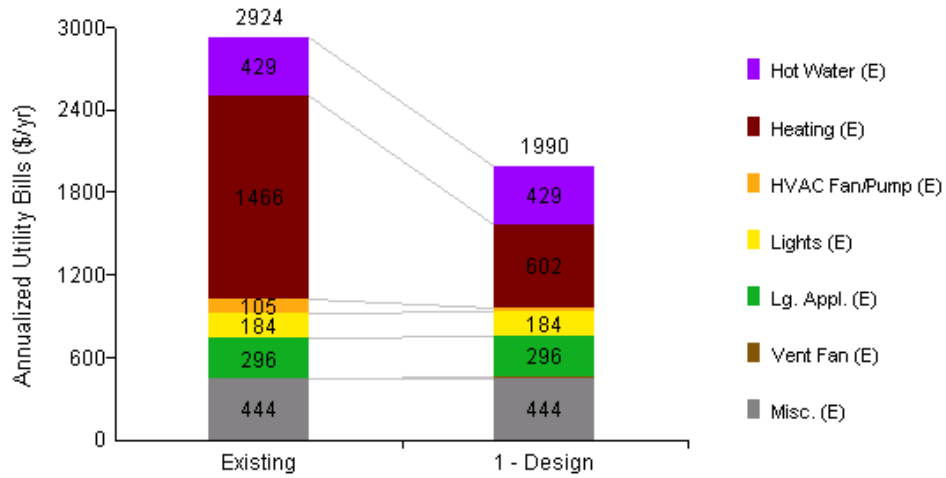
Figure 46. Modeled energy use B-1.

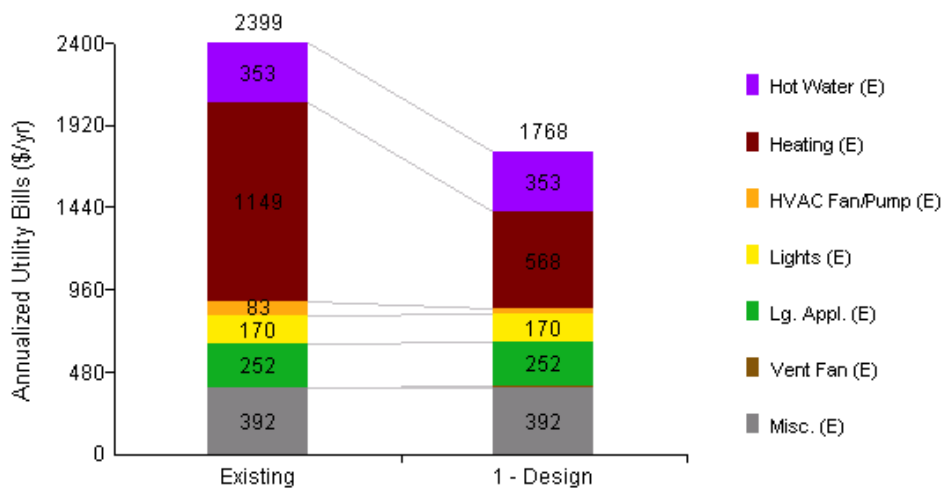
Figure 48. Modeled energy use BV-3.

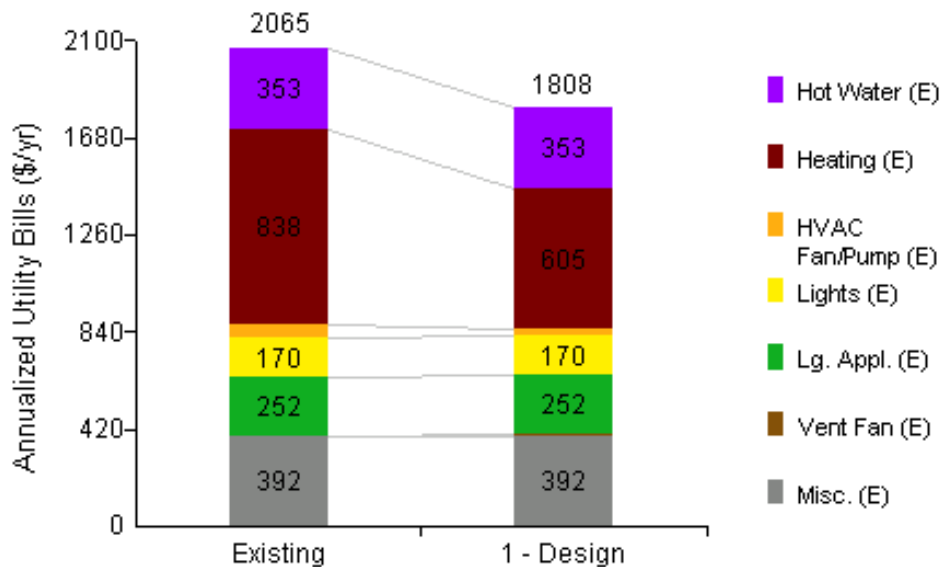
**Figure 52. Modeled energy use FB-1.**

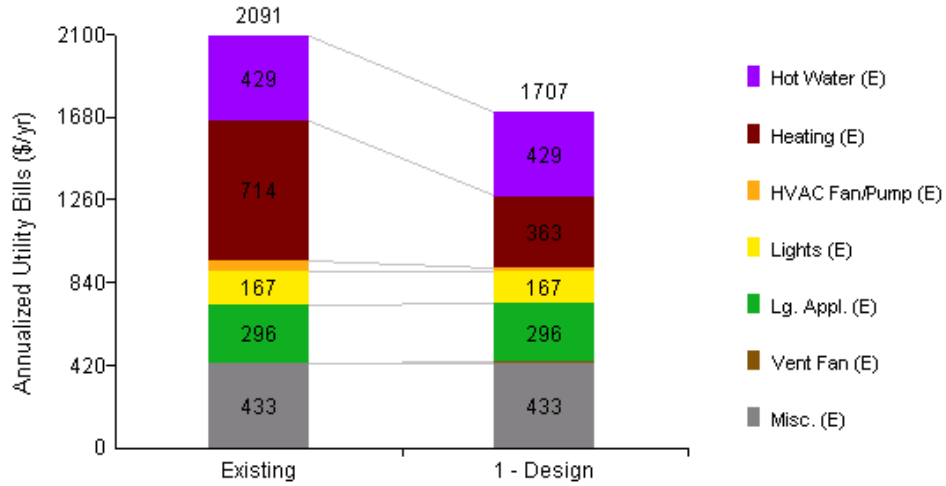
Figure 57. Modeled energy use FV-7.

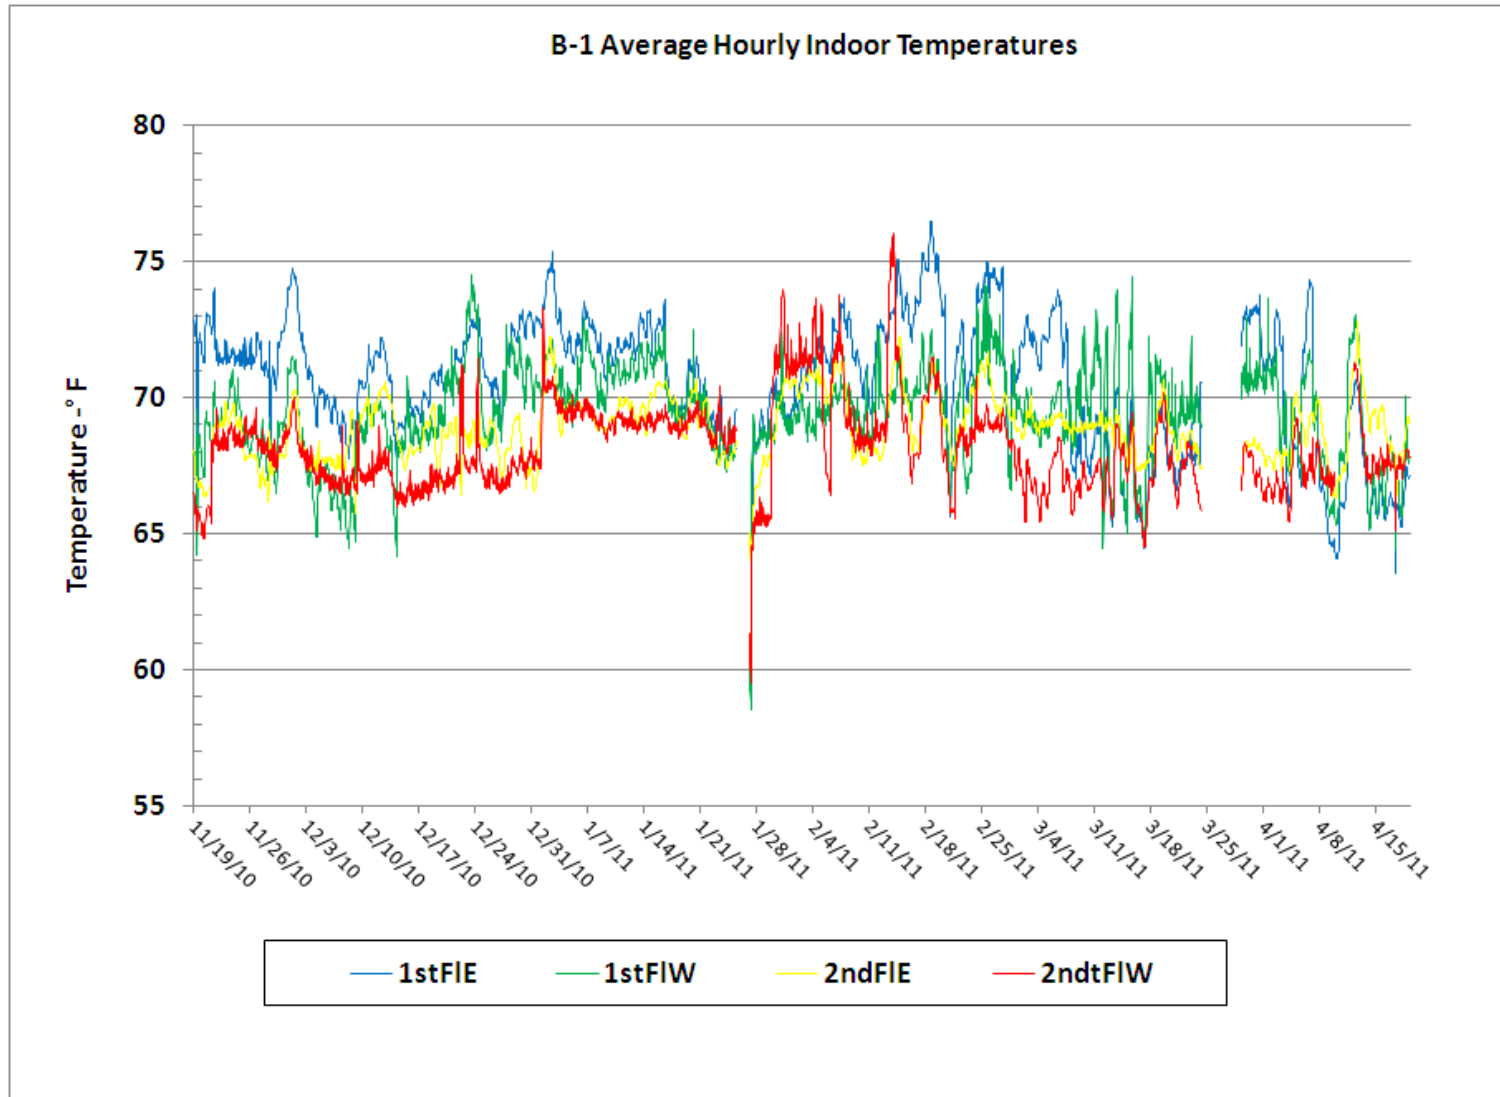
Figure 59. B-1 Average Hourly Indoor Temperature – November 2010 through April 2011.

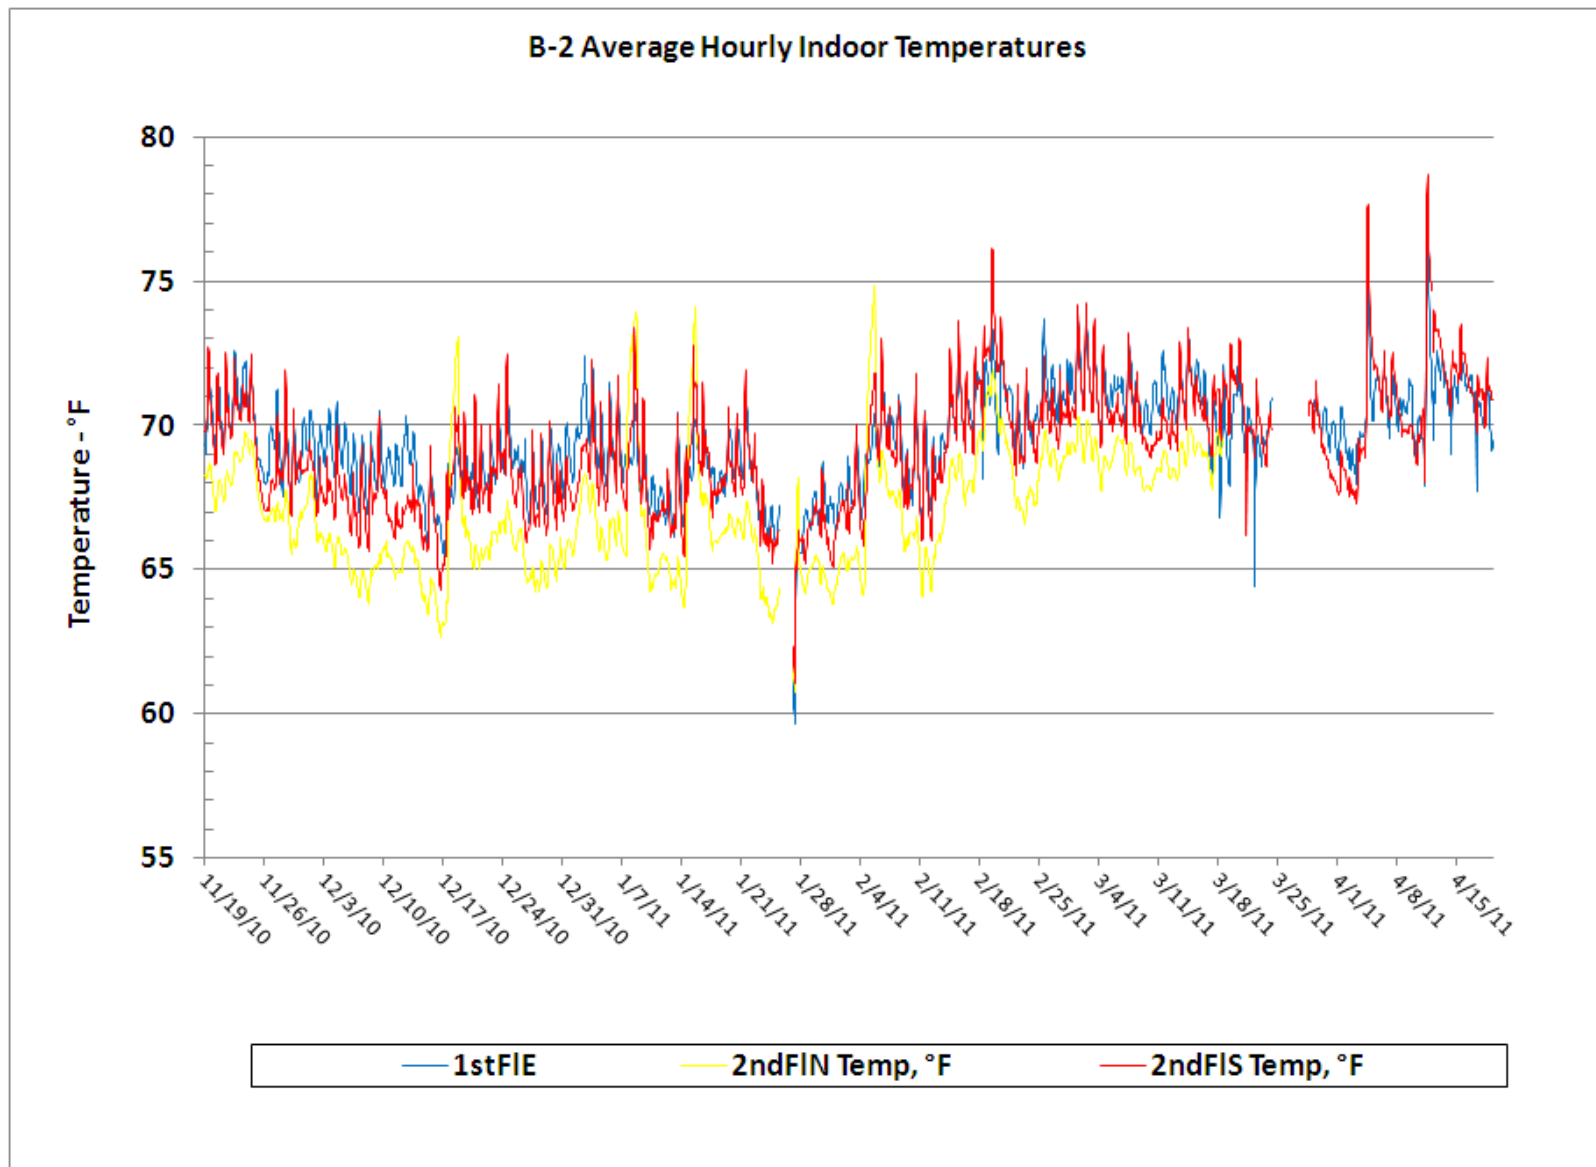
Figure 60. B-2 Average Hourly Temperature – November 2010 through April 2011.

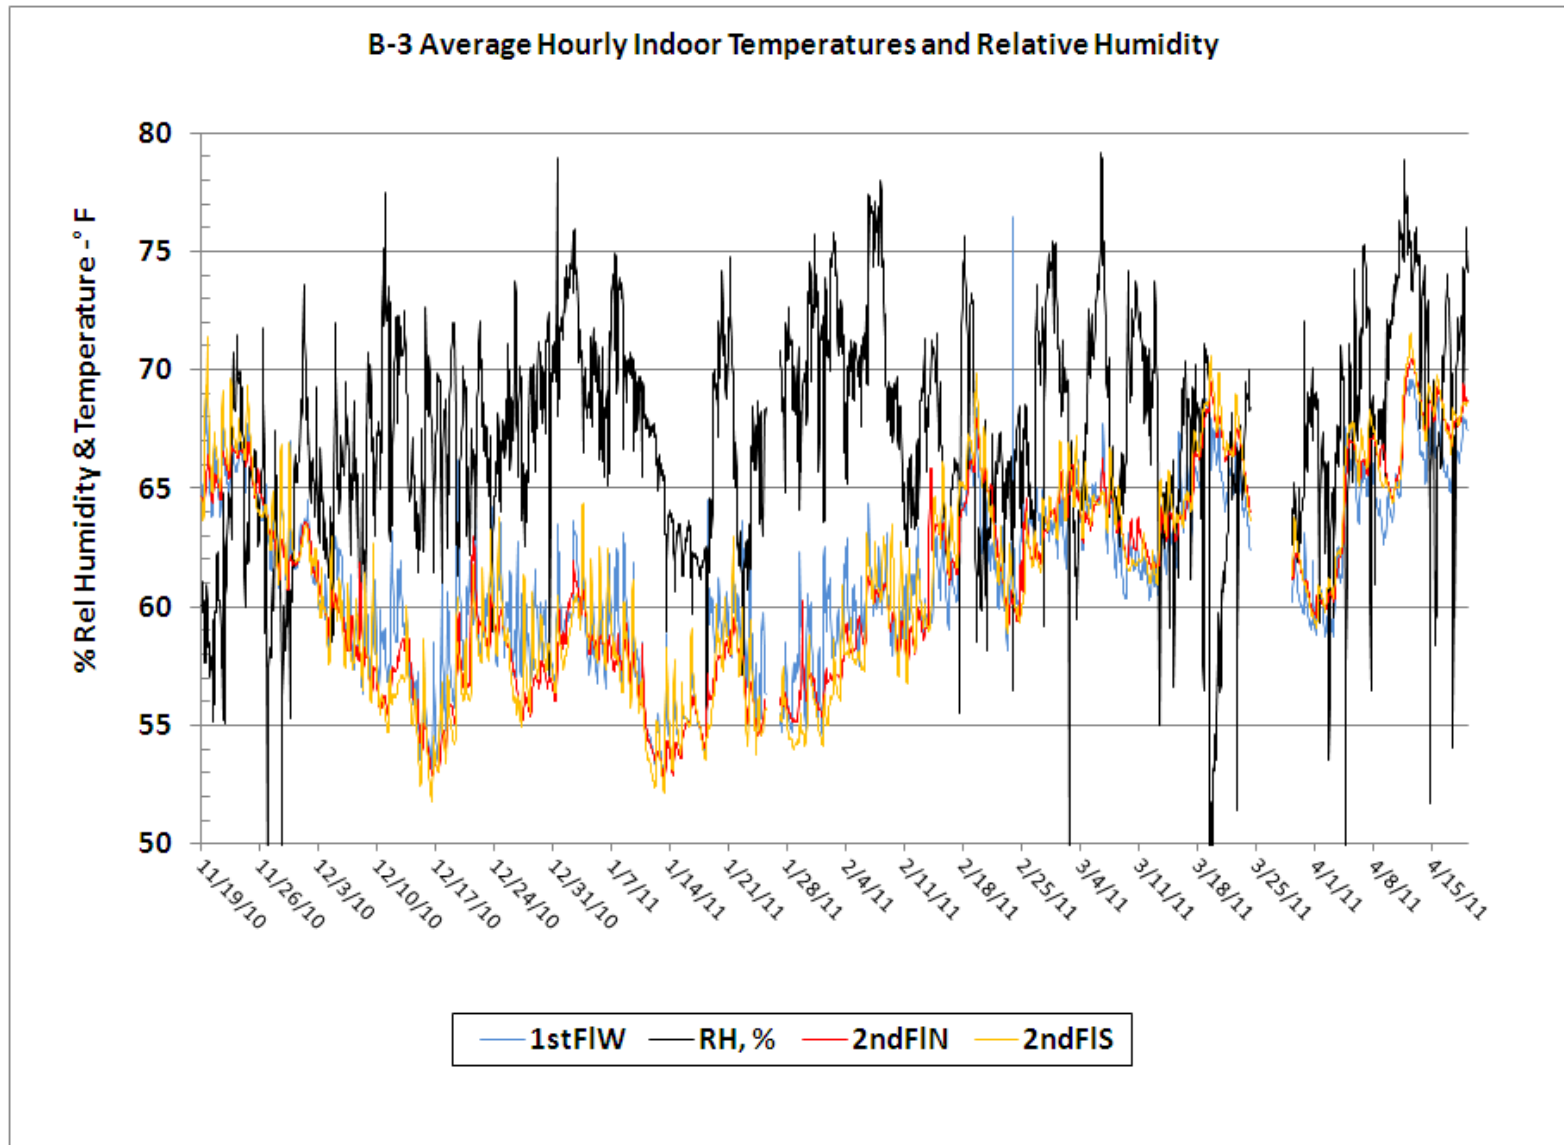
Figure 61. B-3 Average Hourly Temperature – November 2010 through April 2011.

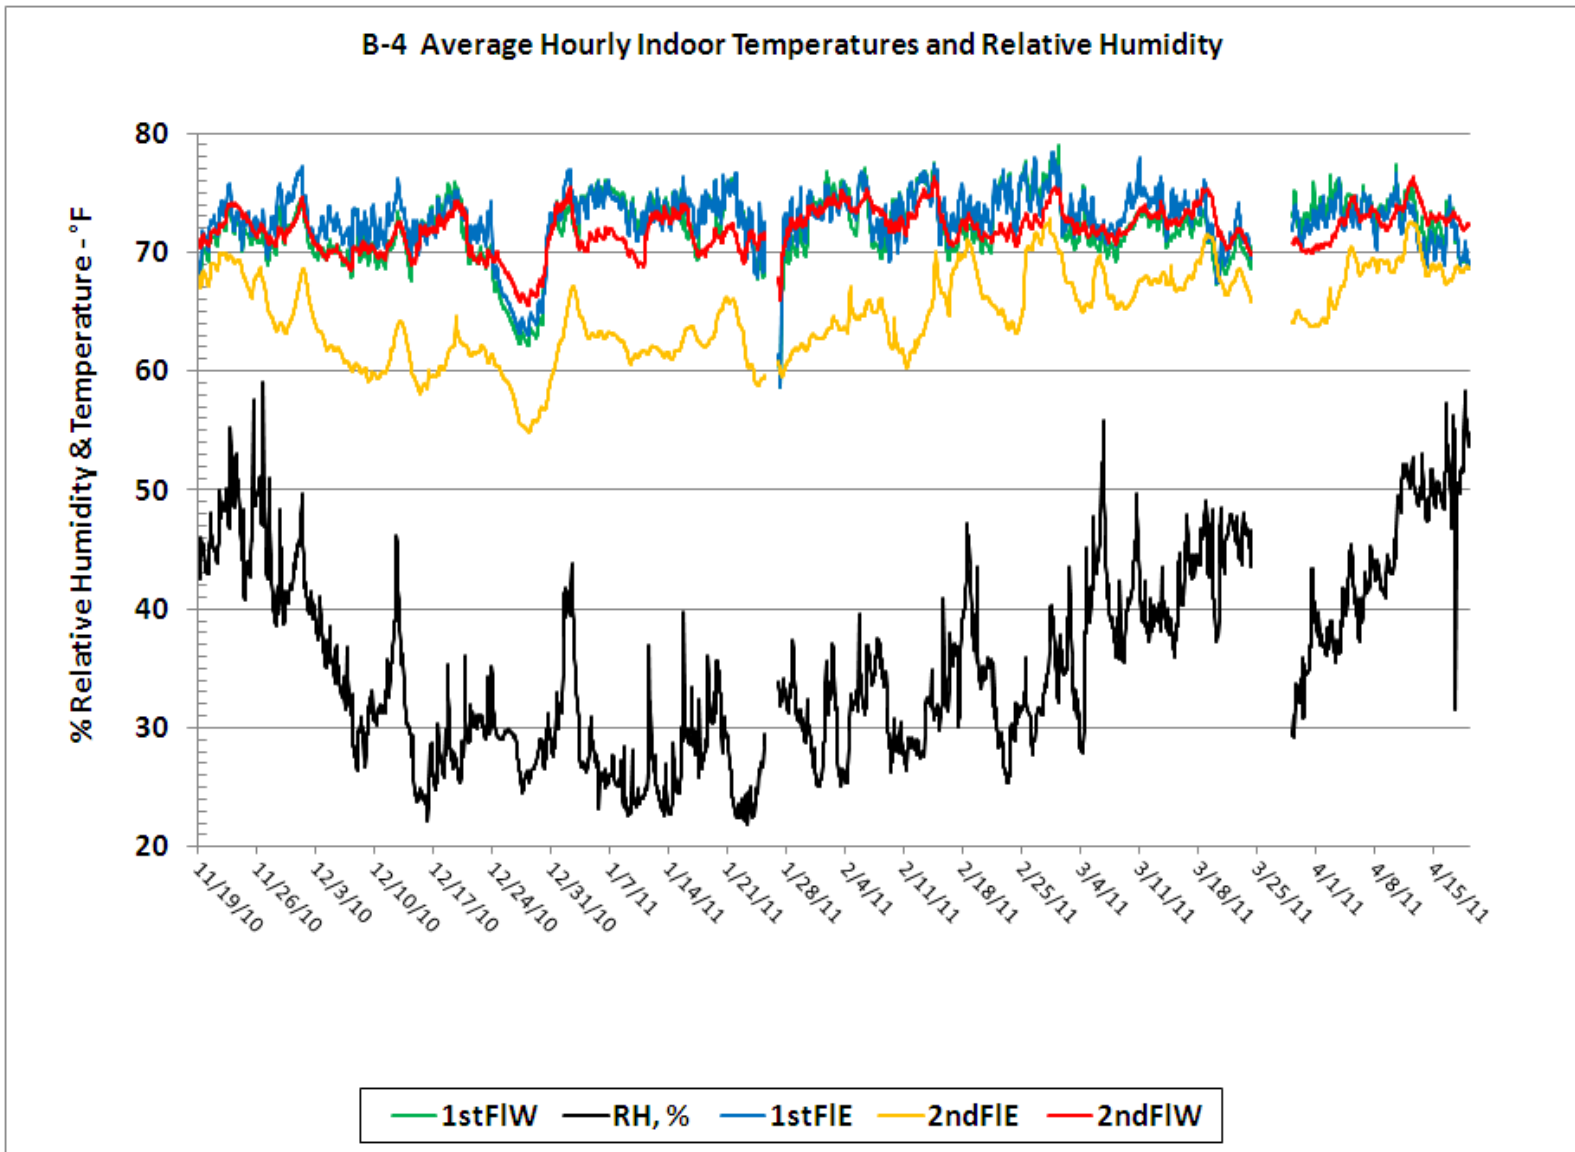
Figure 62. B-4 Average Hourly Temperature – November 2010 through April 2011.

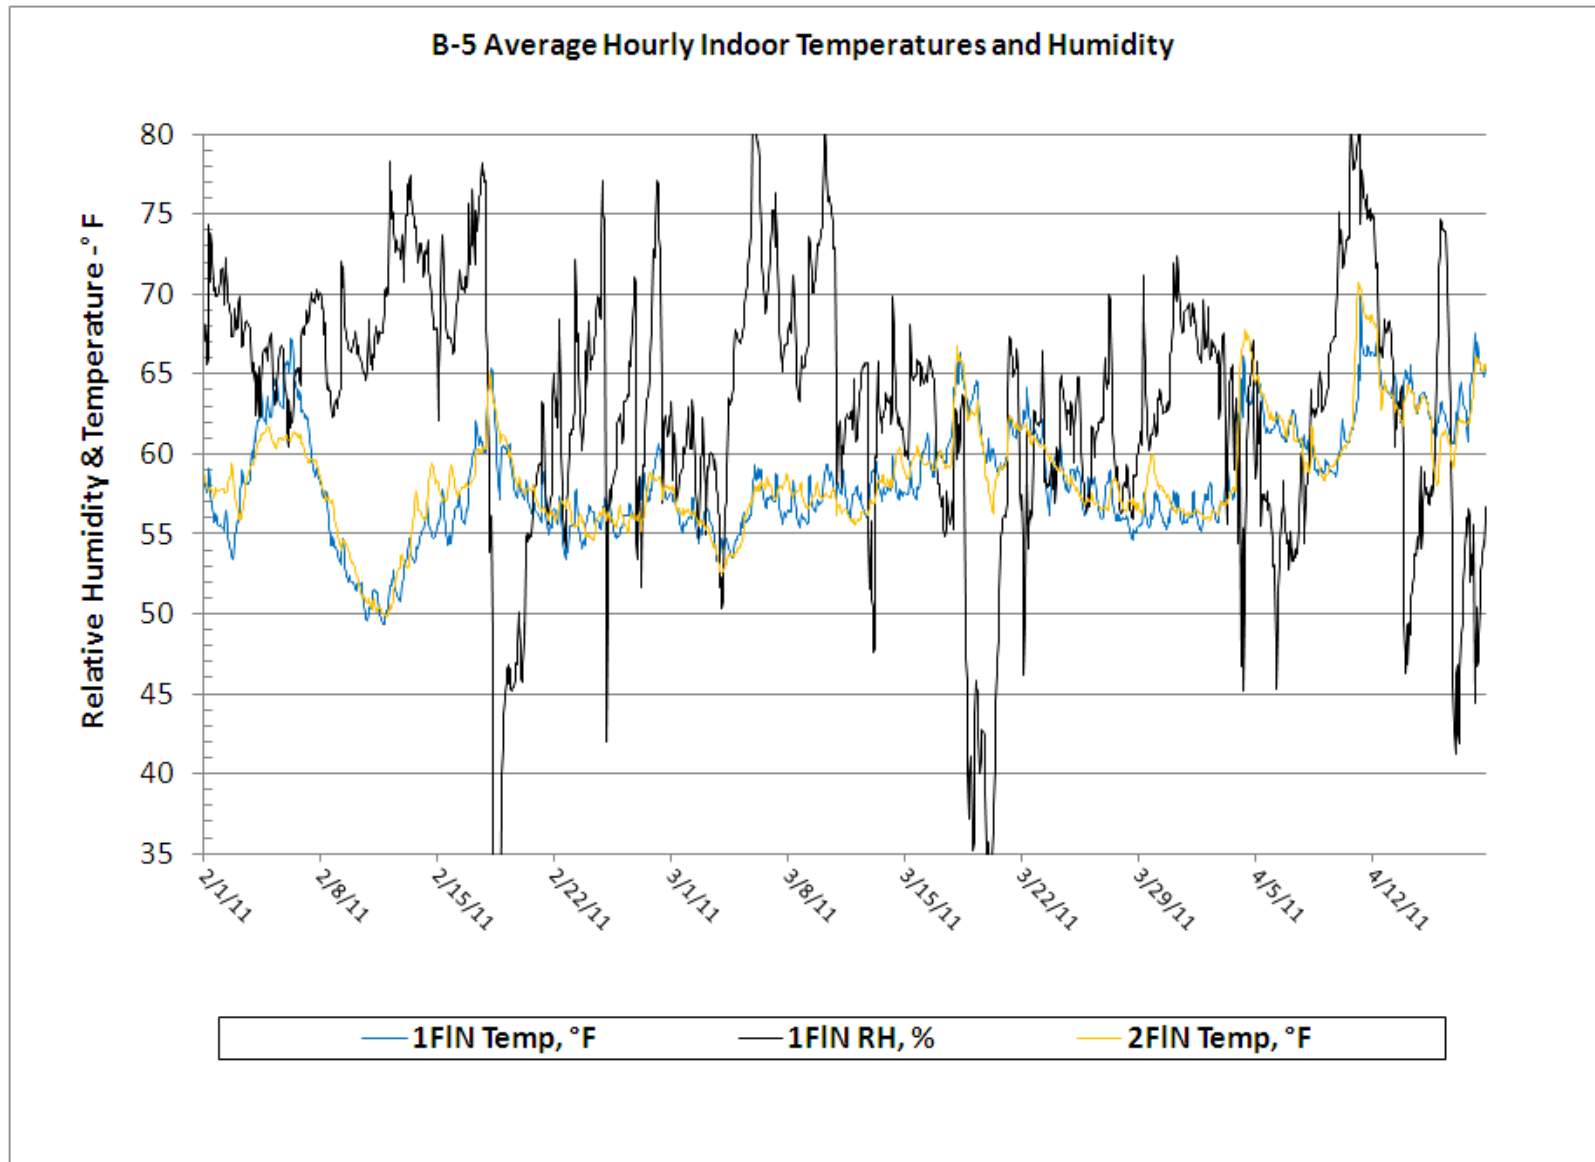
Figure 63. B-5 Average Hourly Temperature – February 2011 through April 2011.

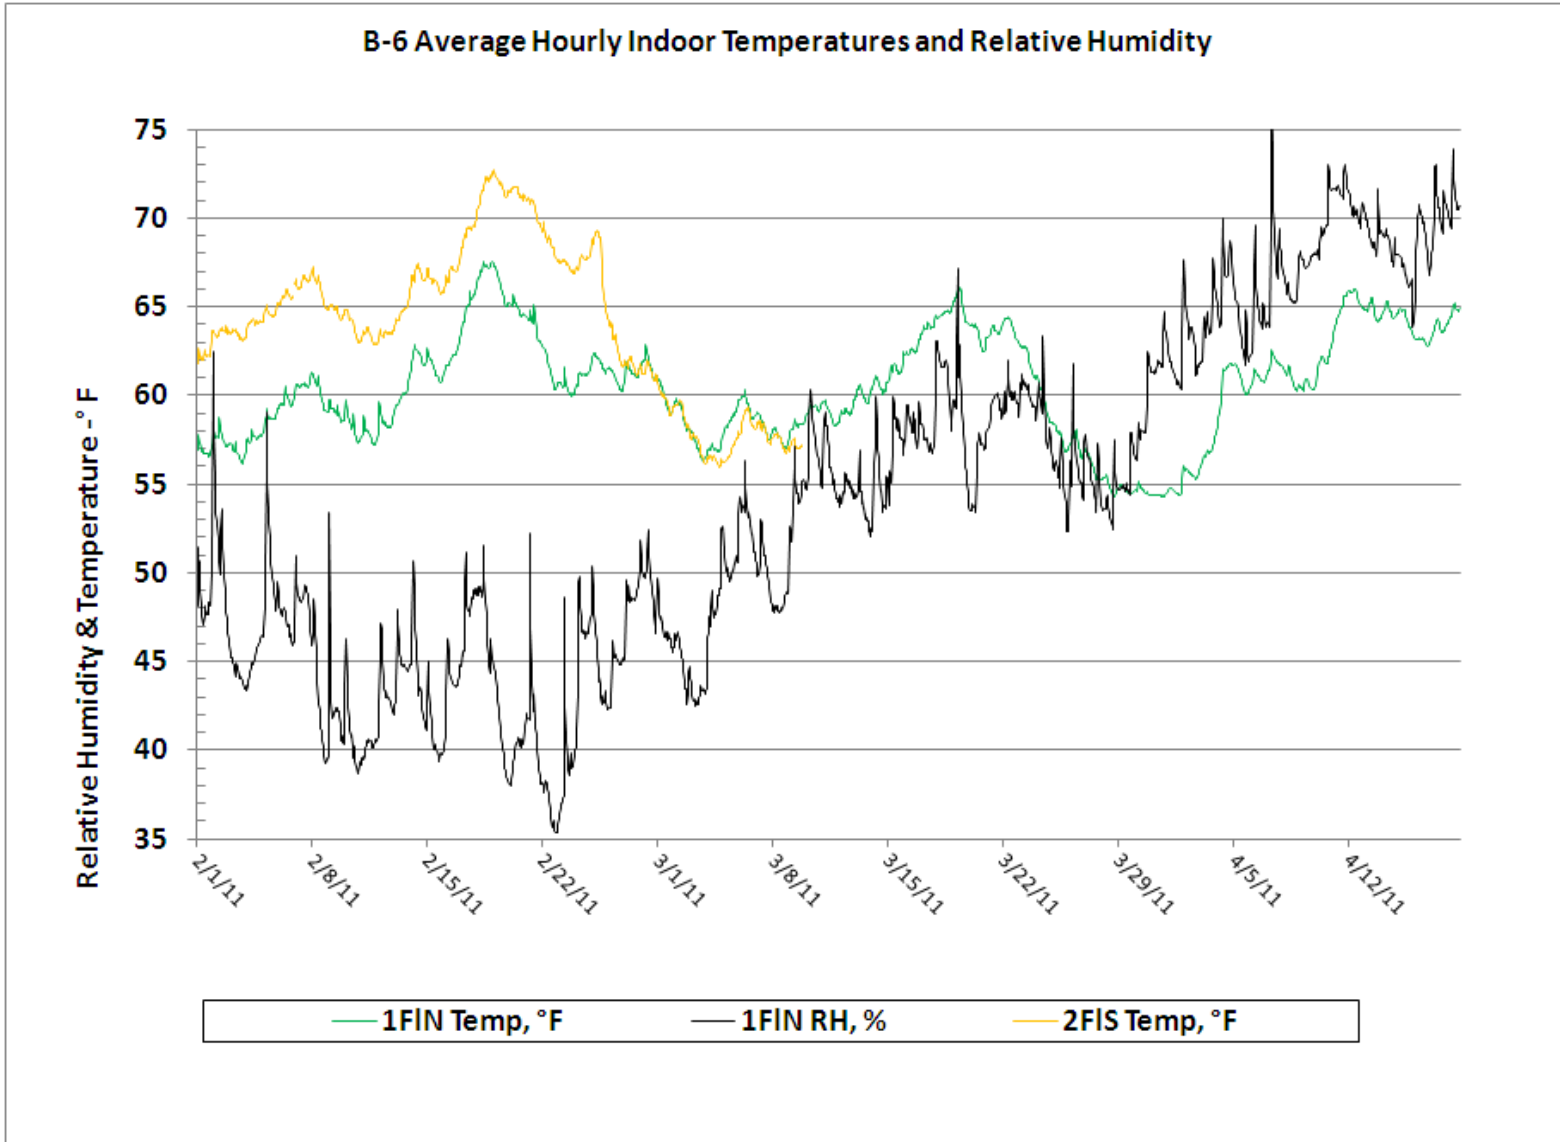
Figure 64. B-6 Average Hourly Temperature – February 2011 through April 2011.
