# **Greenbelt Homes Pilot Energy Efficiency Program Phase 1 Summary: Existing Conditions and Baseline Energy Use**

J. Wiehagen, M. Del Bianco, and A. Wood  
*NAHB Research Center*

February 2013

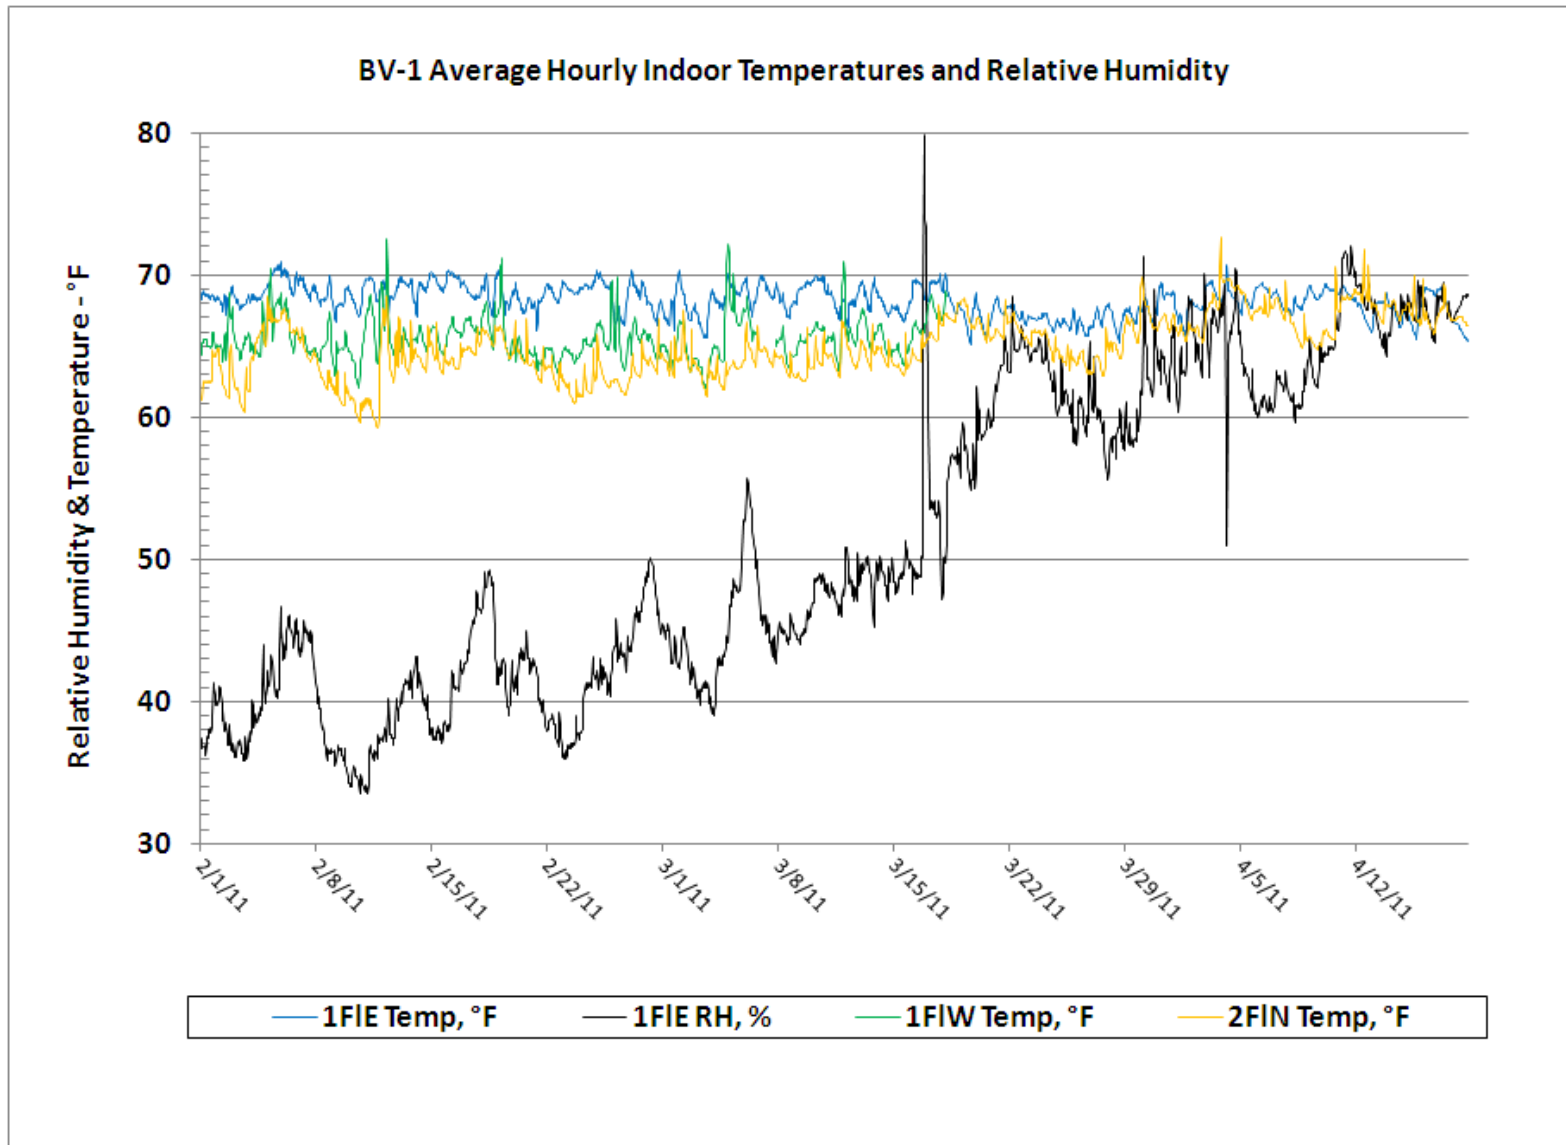
Figure 65. BV-1 Average Hourly Temperature – February 2011 through April 2011.

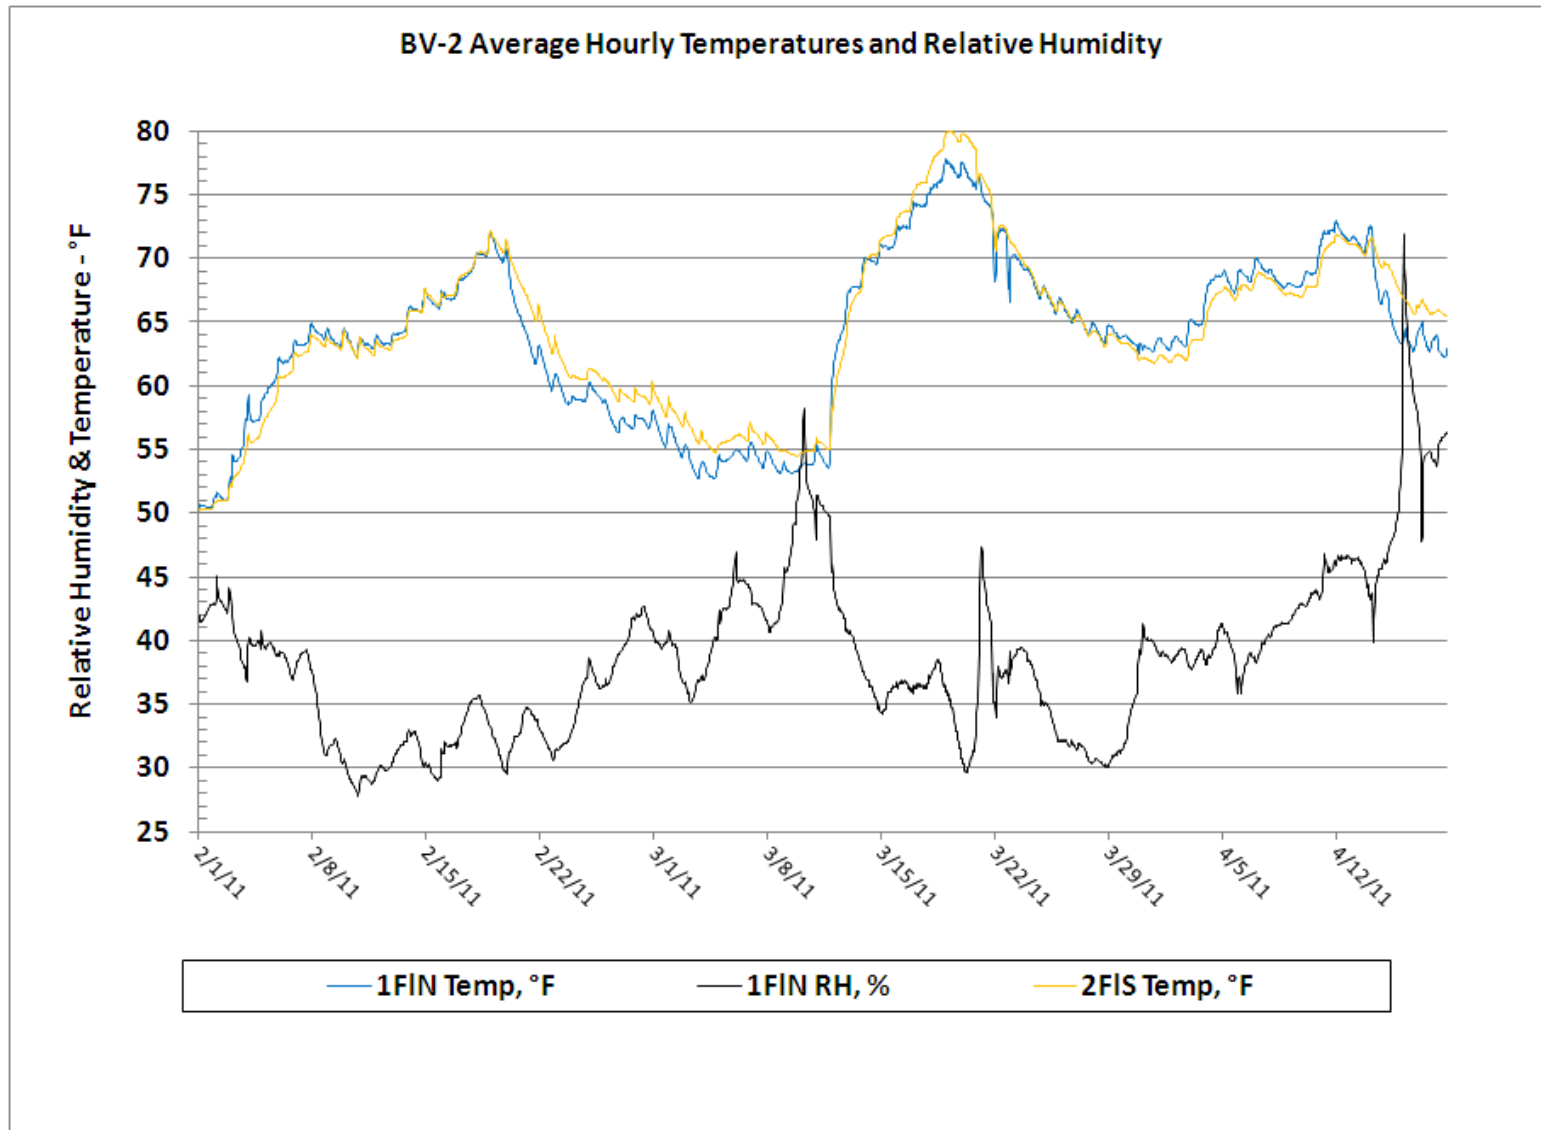
Figure 66. BV-2 Average Hourly Temperature – February 2011 through April 2011.

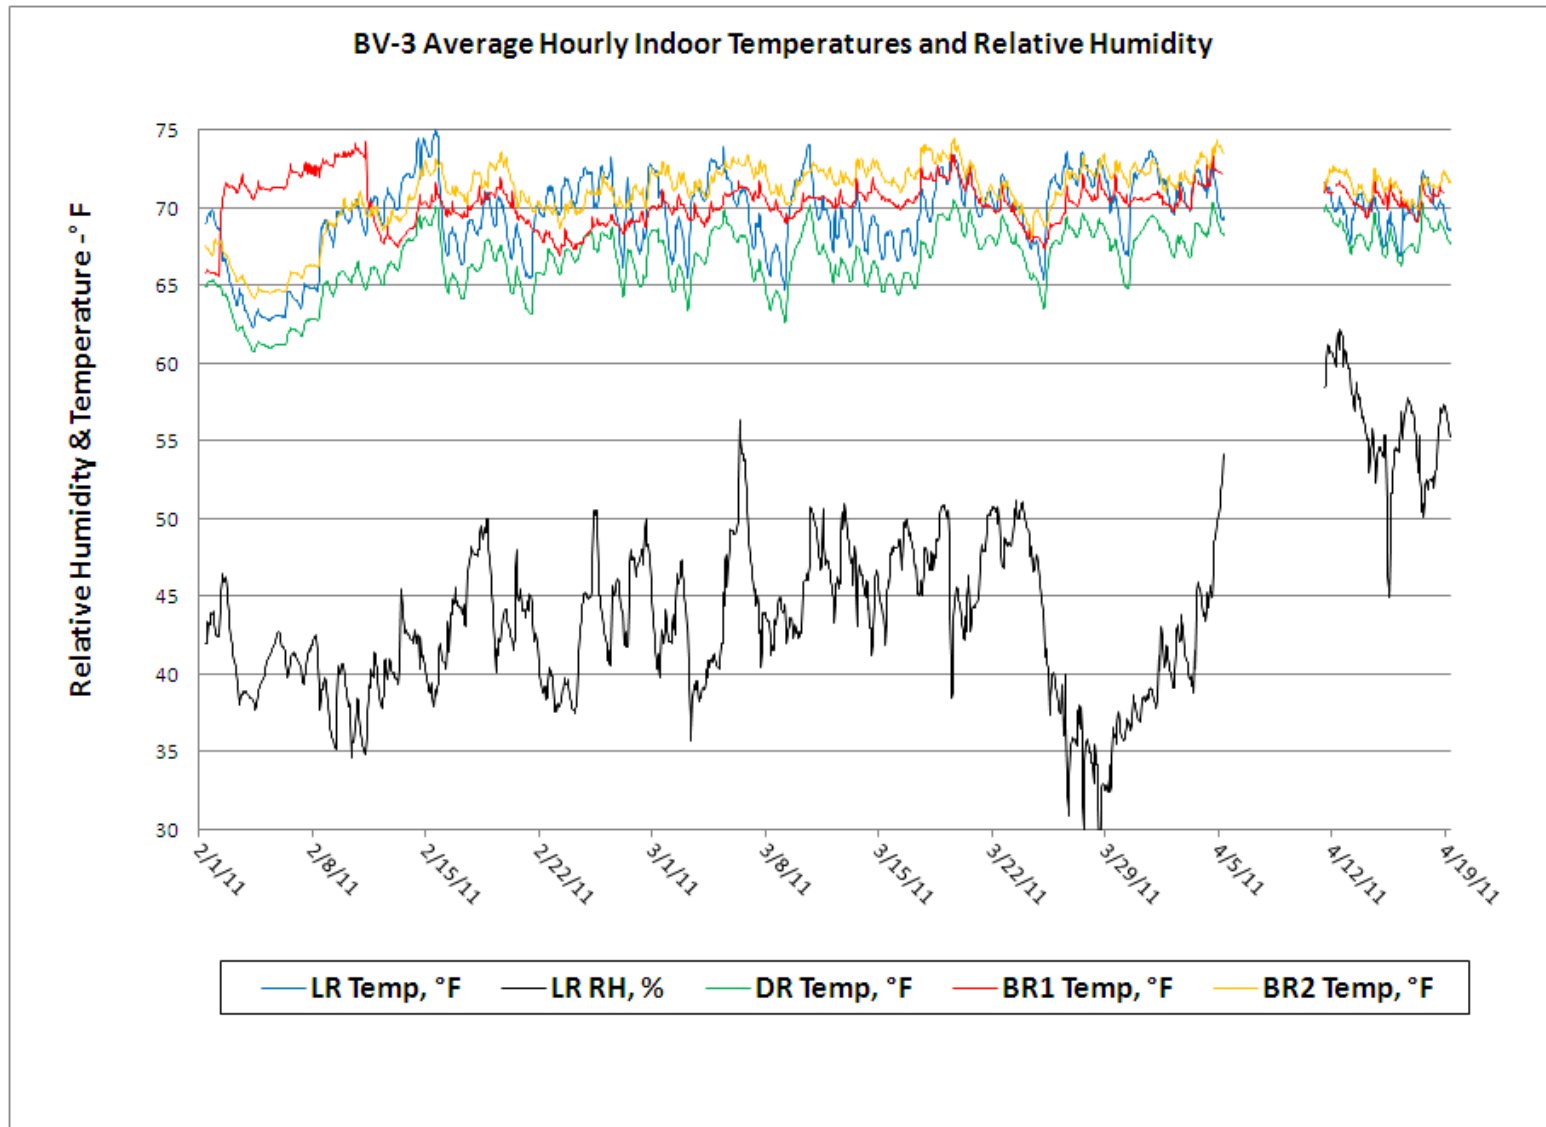
Figure 67. BV-3 Average Hourly Temperature – February 2011 through April 2011.

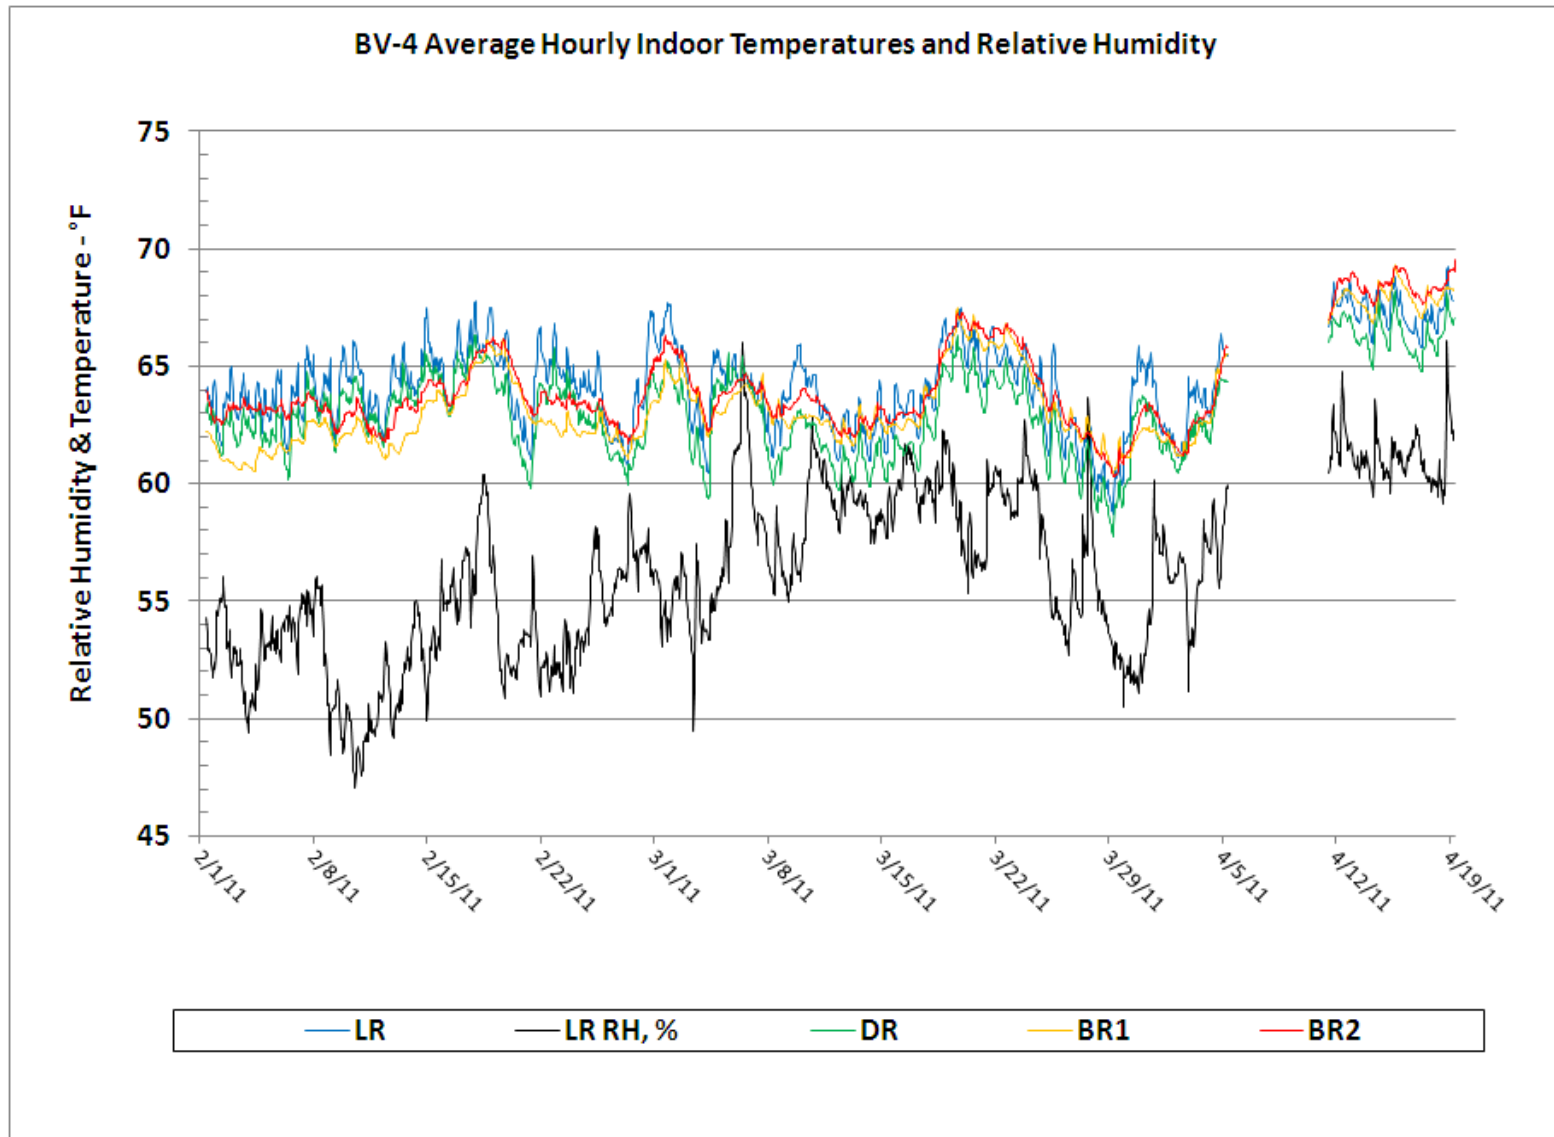
Figure 68. BV-4 Average Hourly Temperature – February 2011 through April 2011.

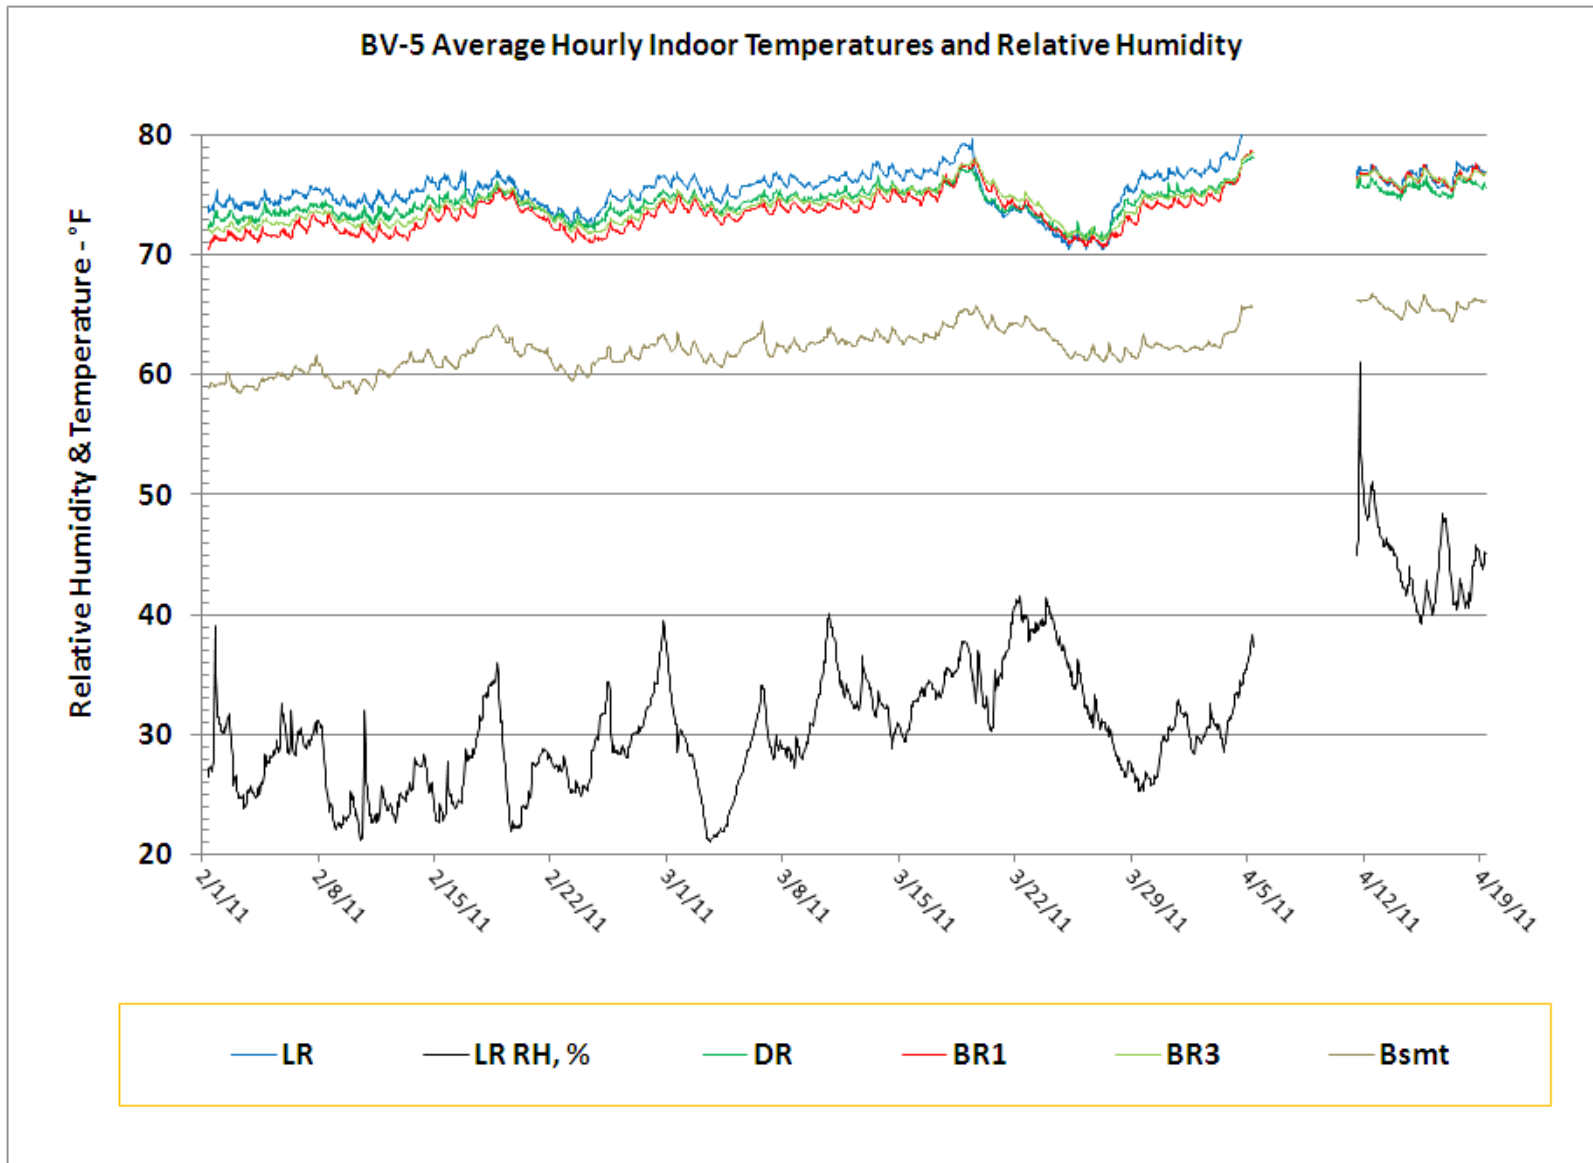
Figure 69. BV-5 Average Hourly Temperature – February 2011 to April 2011.

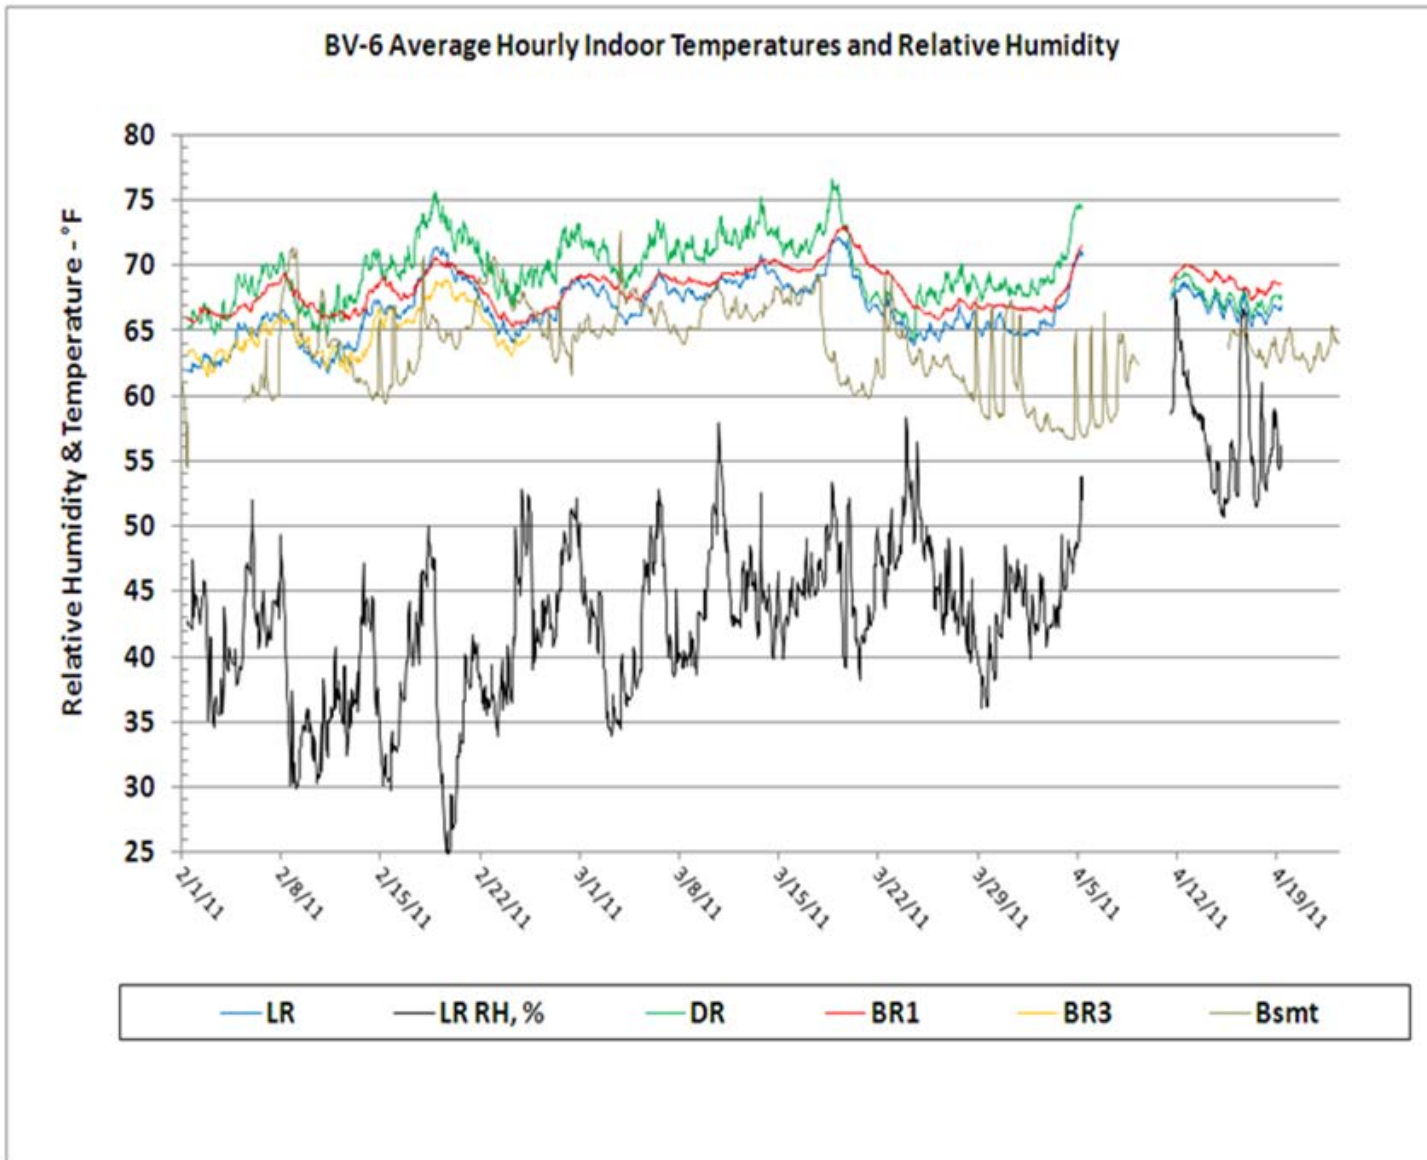
Figure 70. BV-6 Average Hourly Temperature – February 2011 to April 2011.

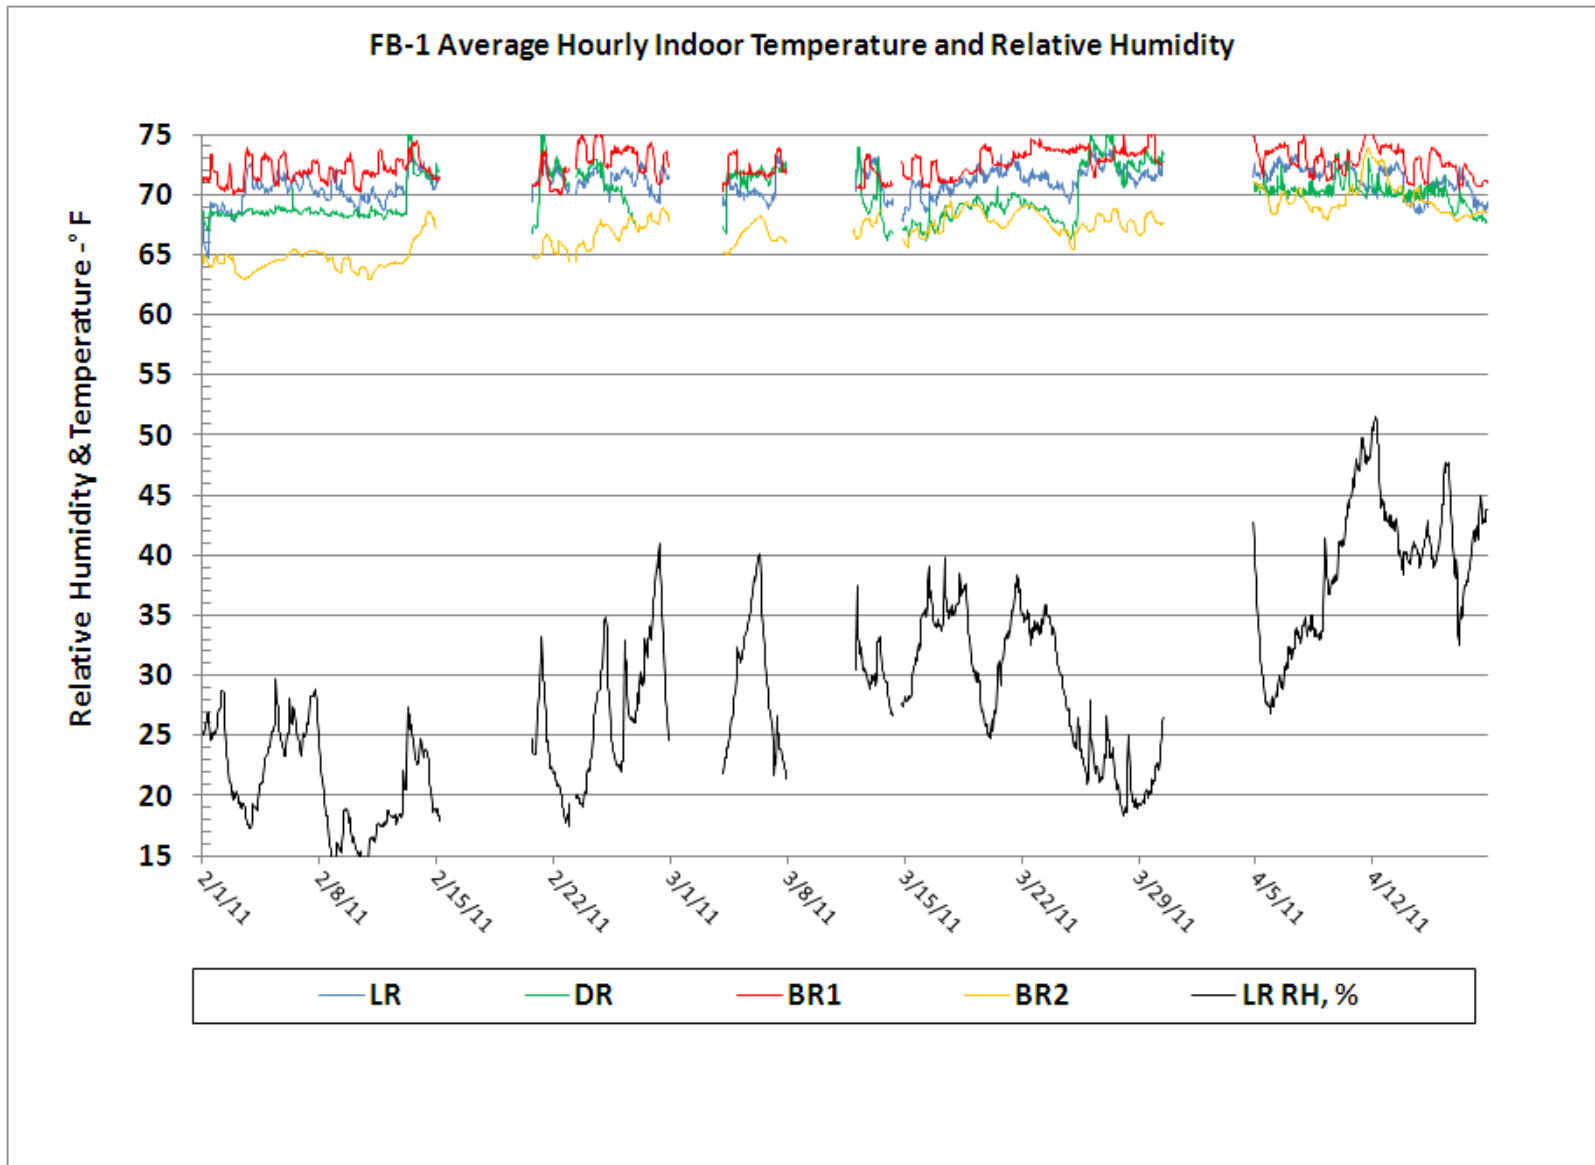
Figure 71. FB-1 Average Hourly Temperature – February 2011 to April 2011.

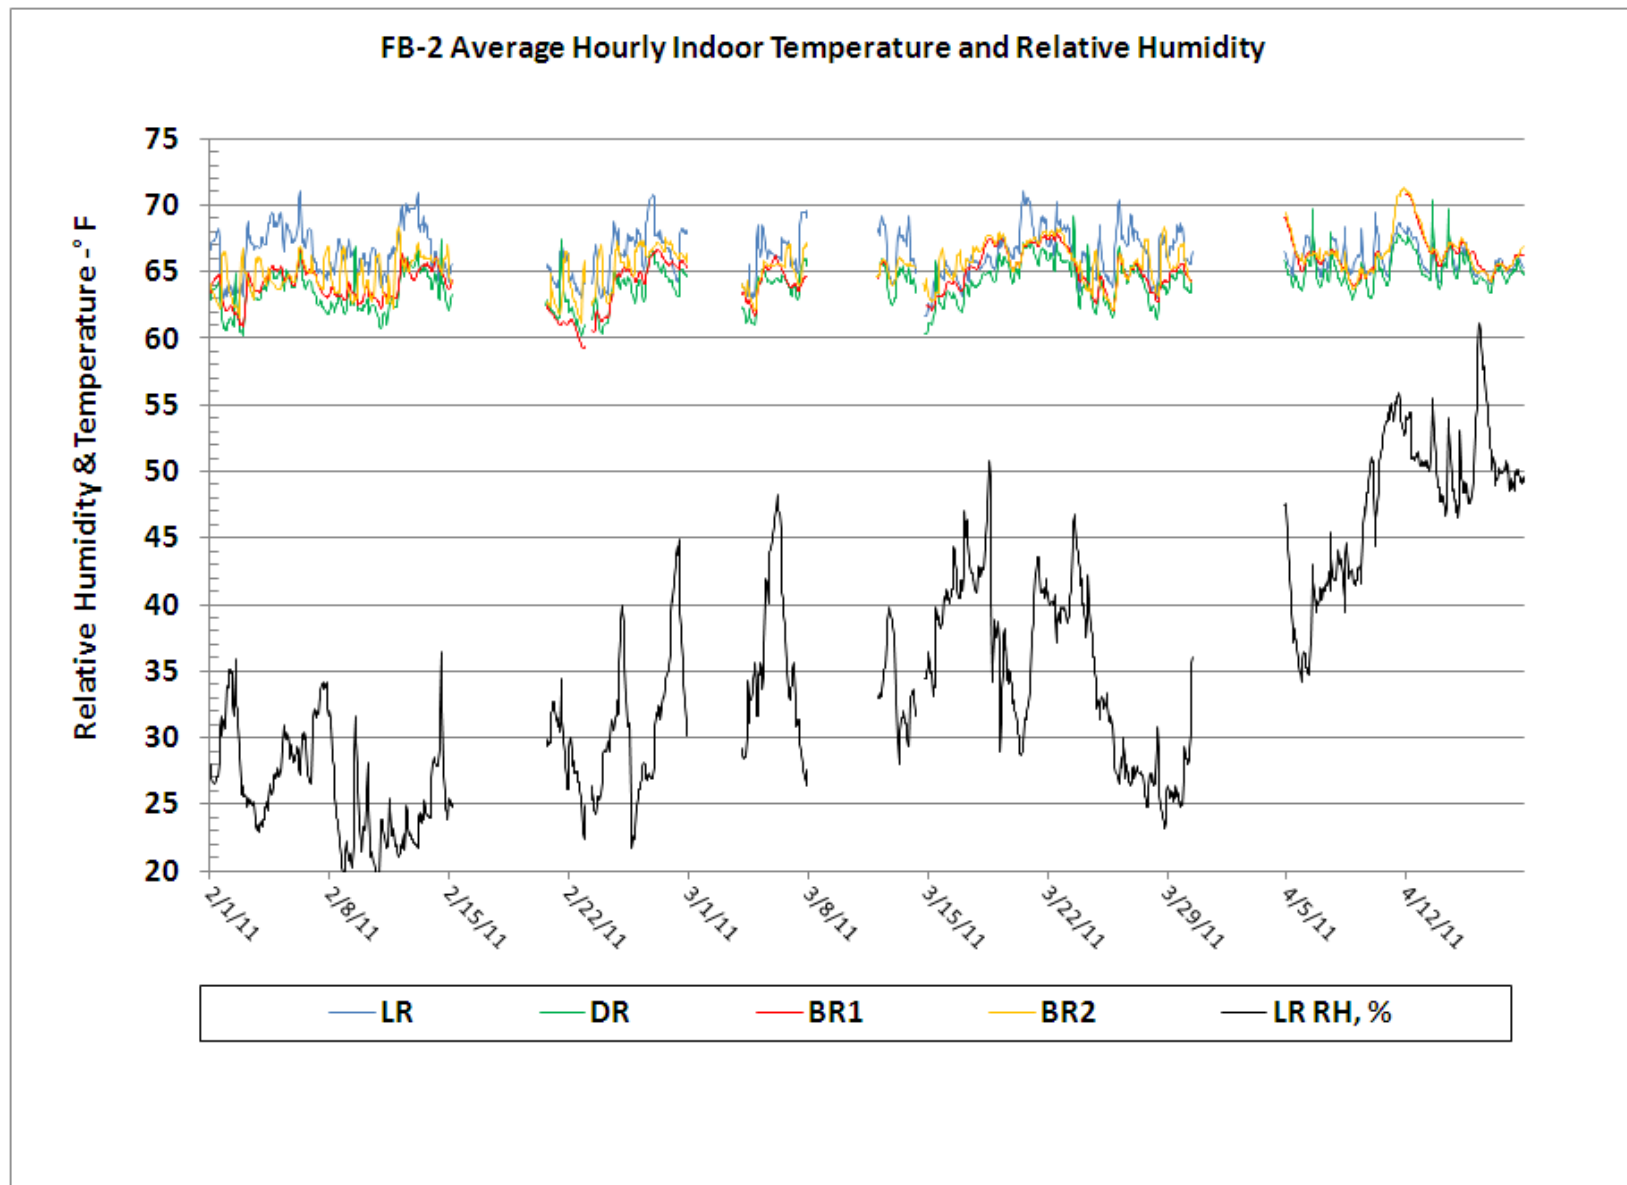
Figure 72. FB-2 Average Hourly Temperature – February 2011 to April 2011.

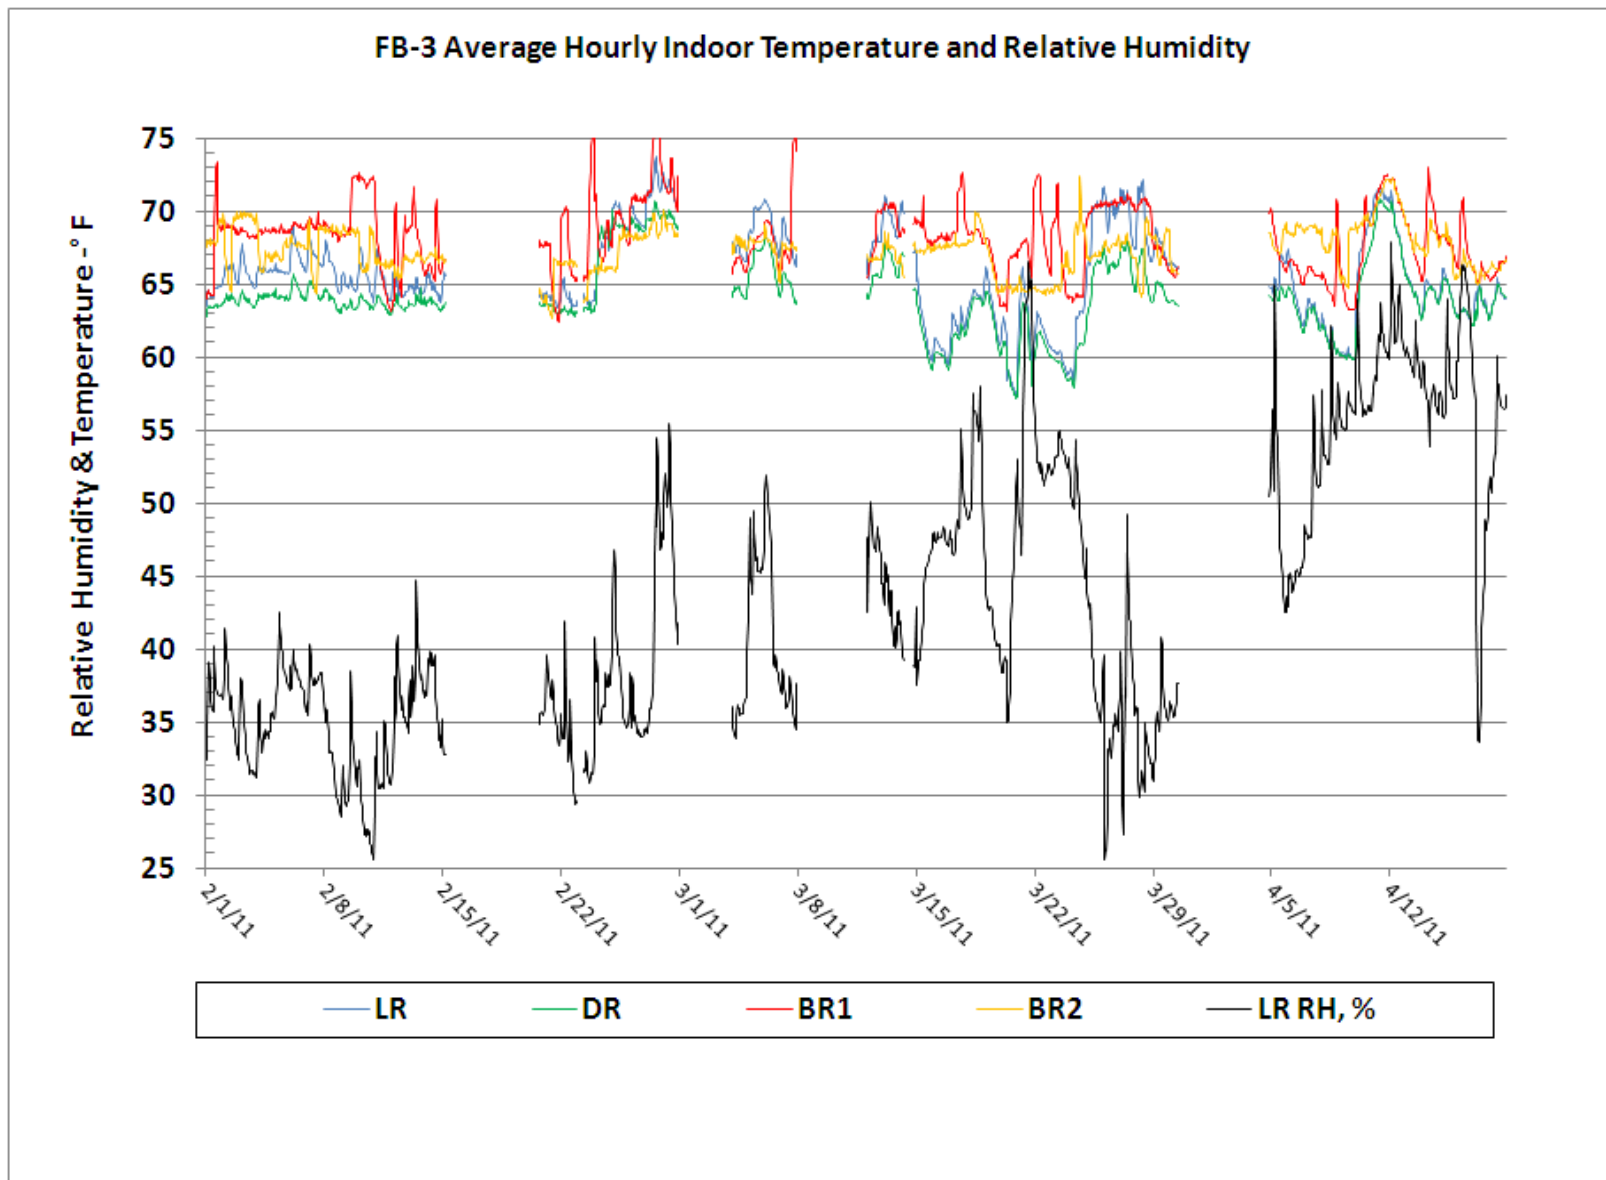
Figure 73. FB-3 Average Hourly Temperature – February 2011 to April 2011.

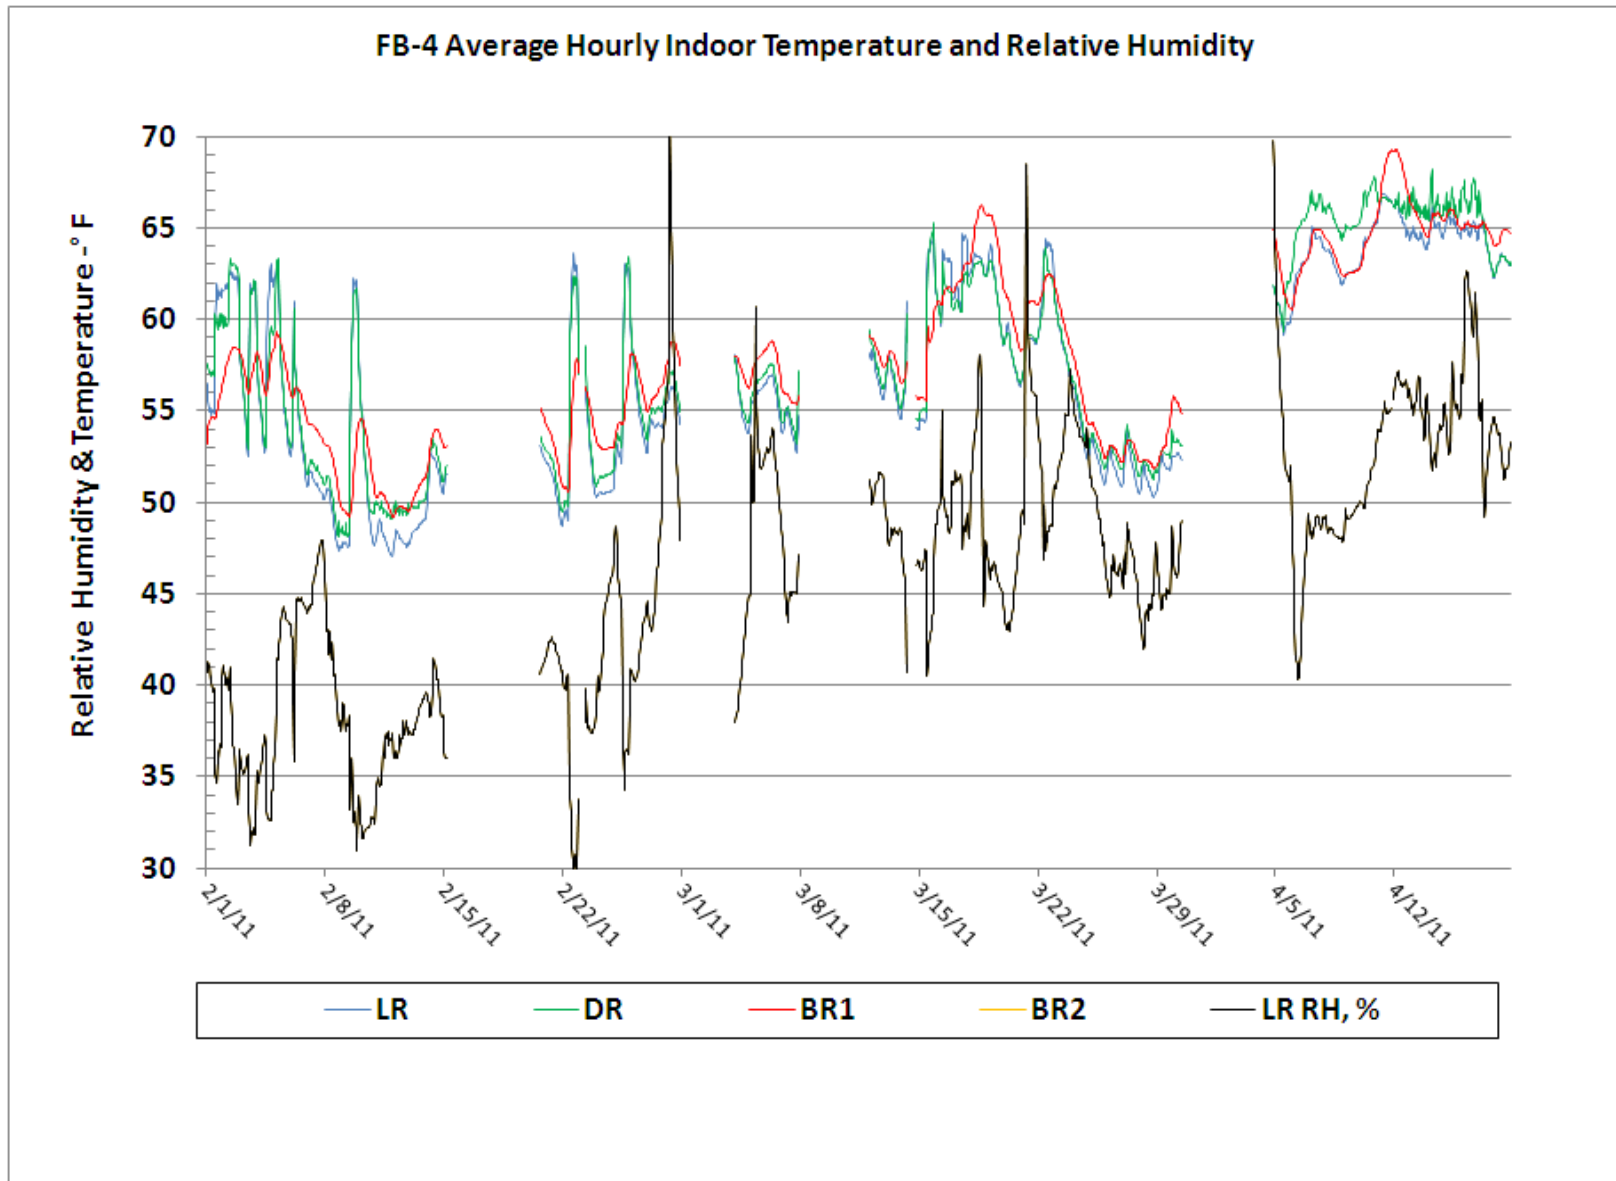
Figure 74. FB-4 Average Hourly Temperature – February 2011 to April 2011.

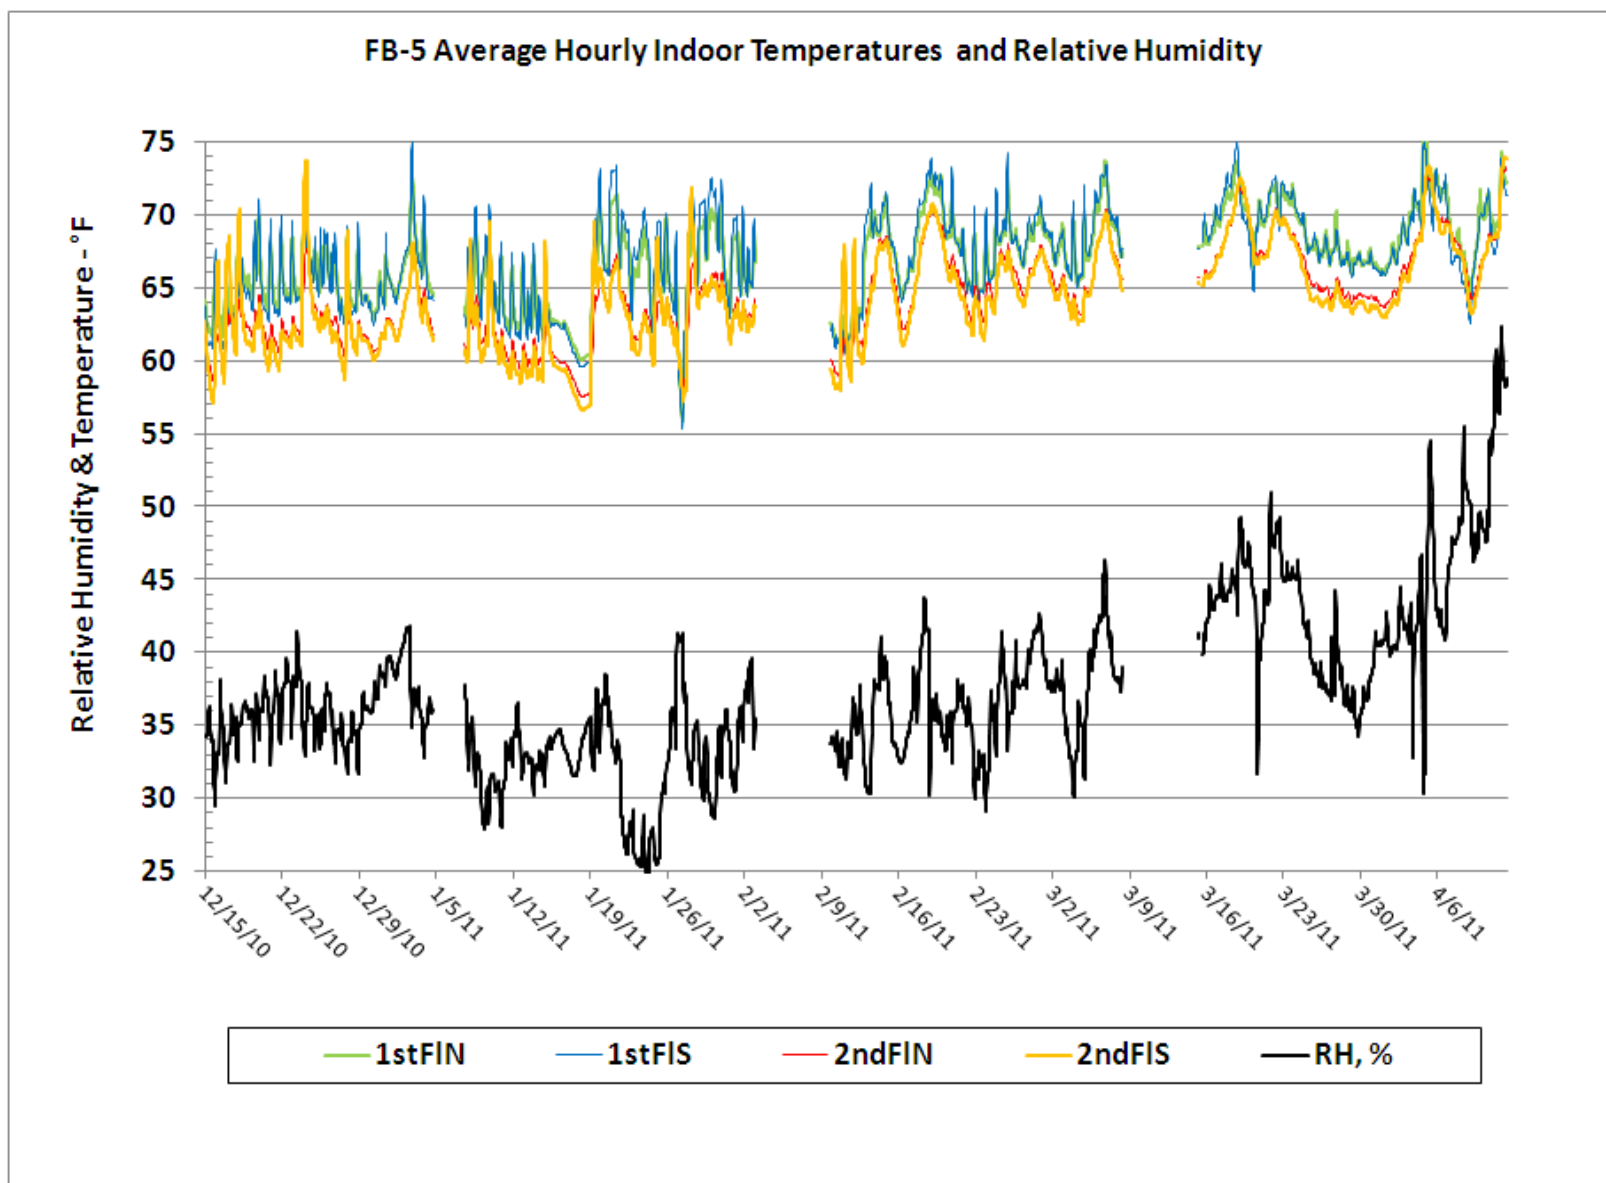
Figure 75. FB-5 Average Hourly Temperature – December 2010 to April 2011.

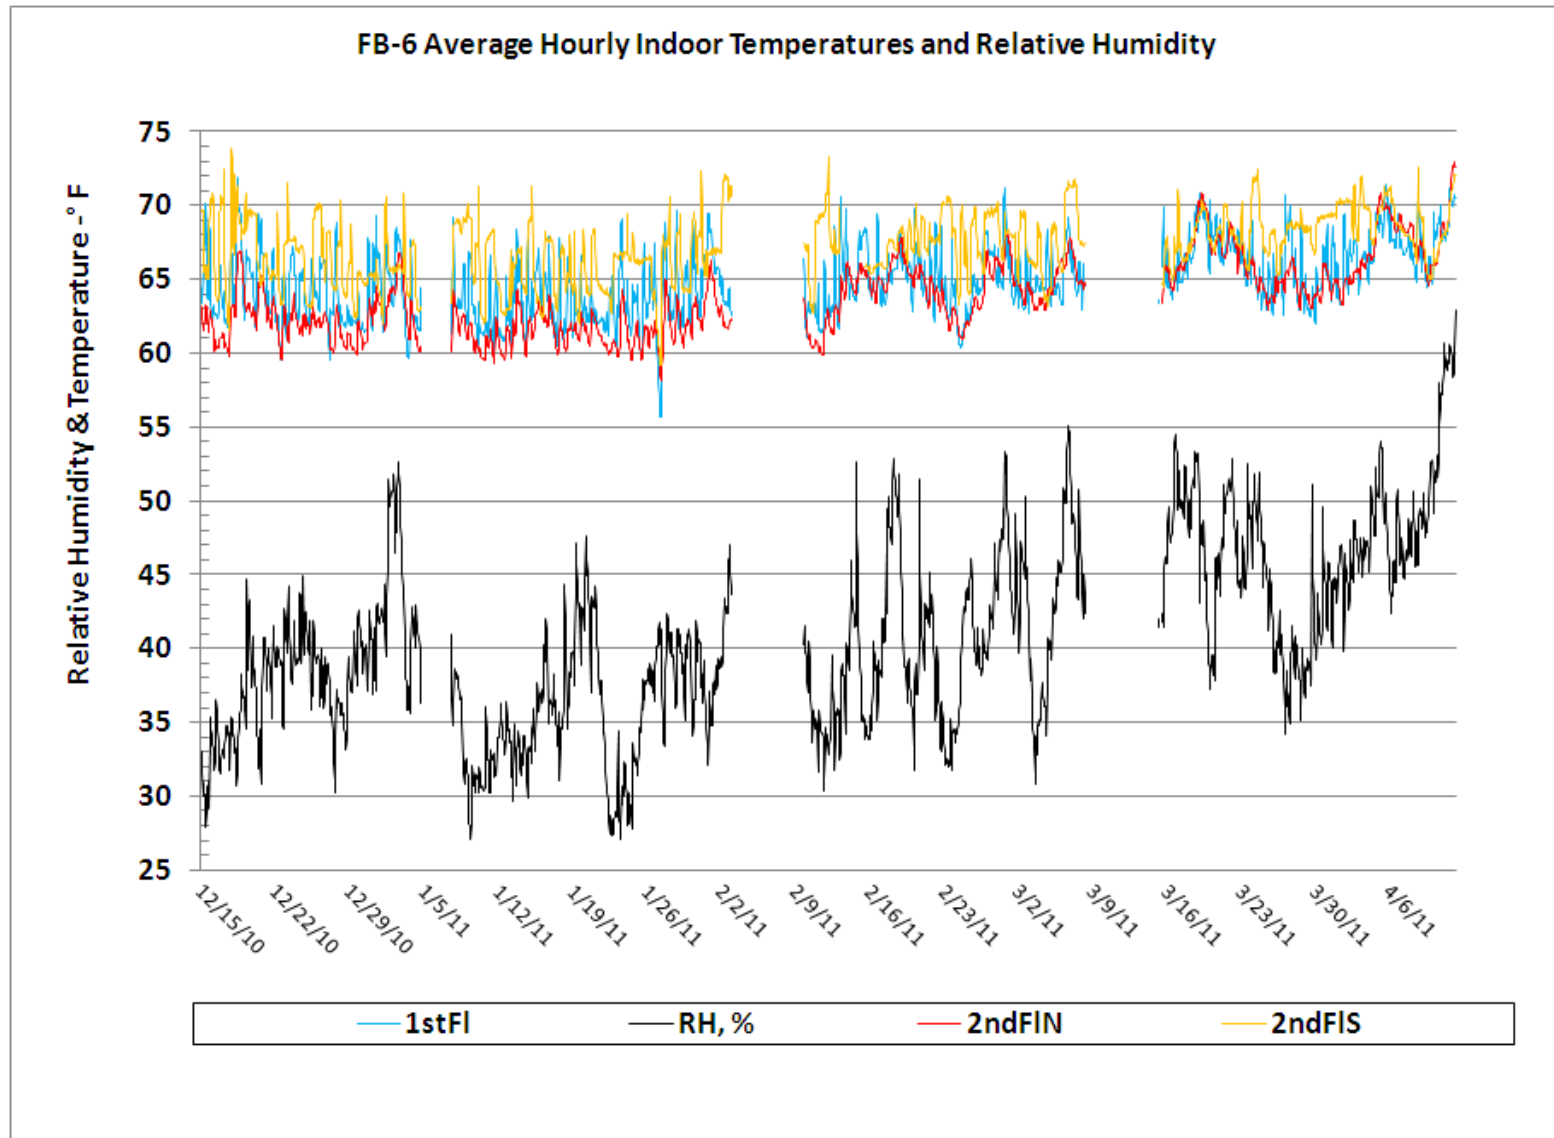
Figure 76. FB-6 Average Hourly Temperature – December 2010 to April 2011.
