# **Greenbelt Homes Pilot Energy Efficiency Program Phase 1 Summary: Existing Conditions and Baseline Energy Use**

J. Wiehagen, M. Del Bianco, and A. Wood  
*NAHB Research Center*

February 2013

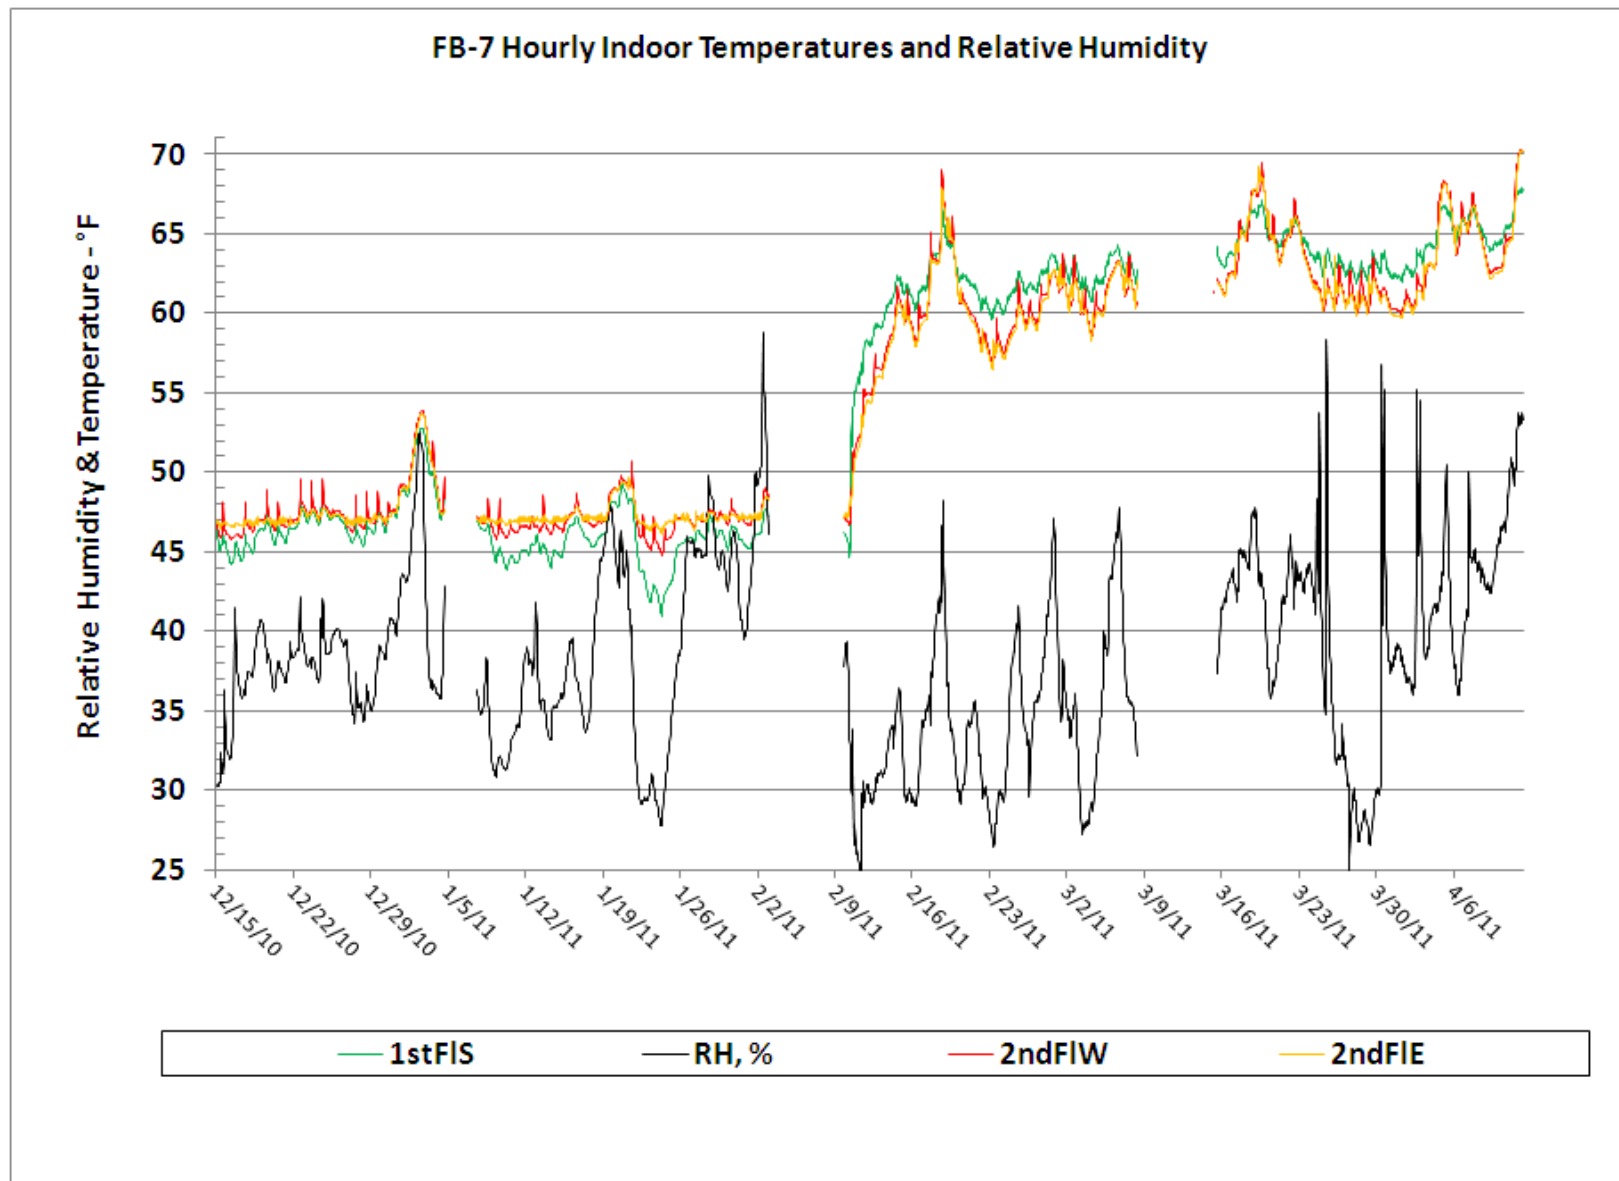
Figure 77. FB-7 Average Hourly Temperature – December 2010 to April 2011.

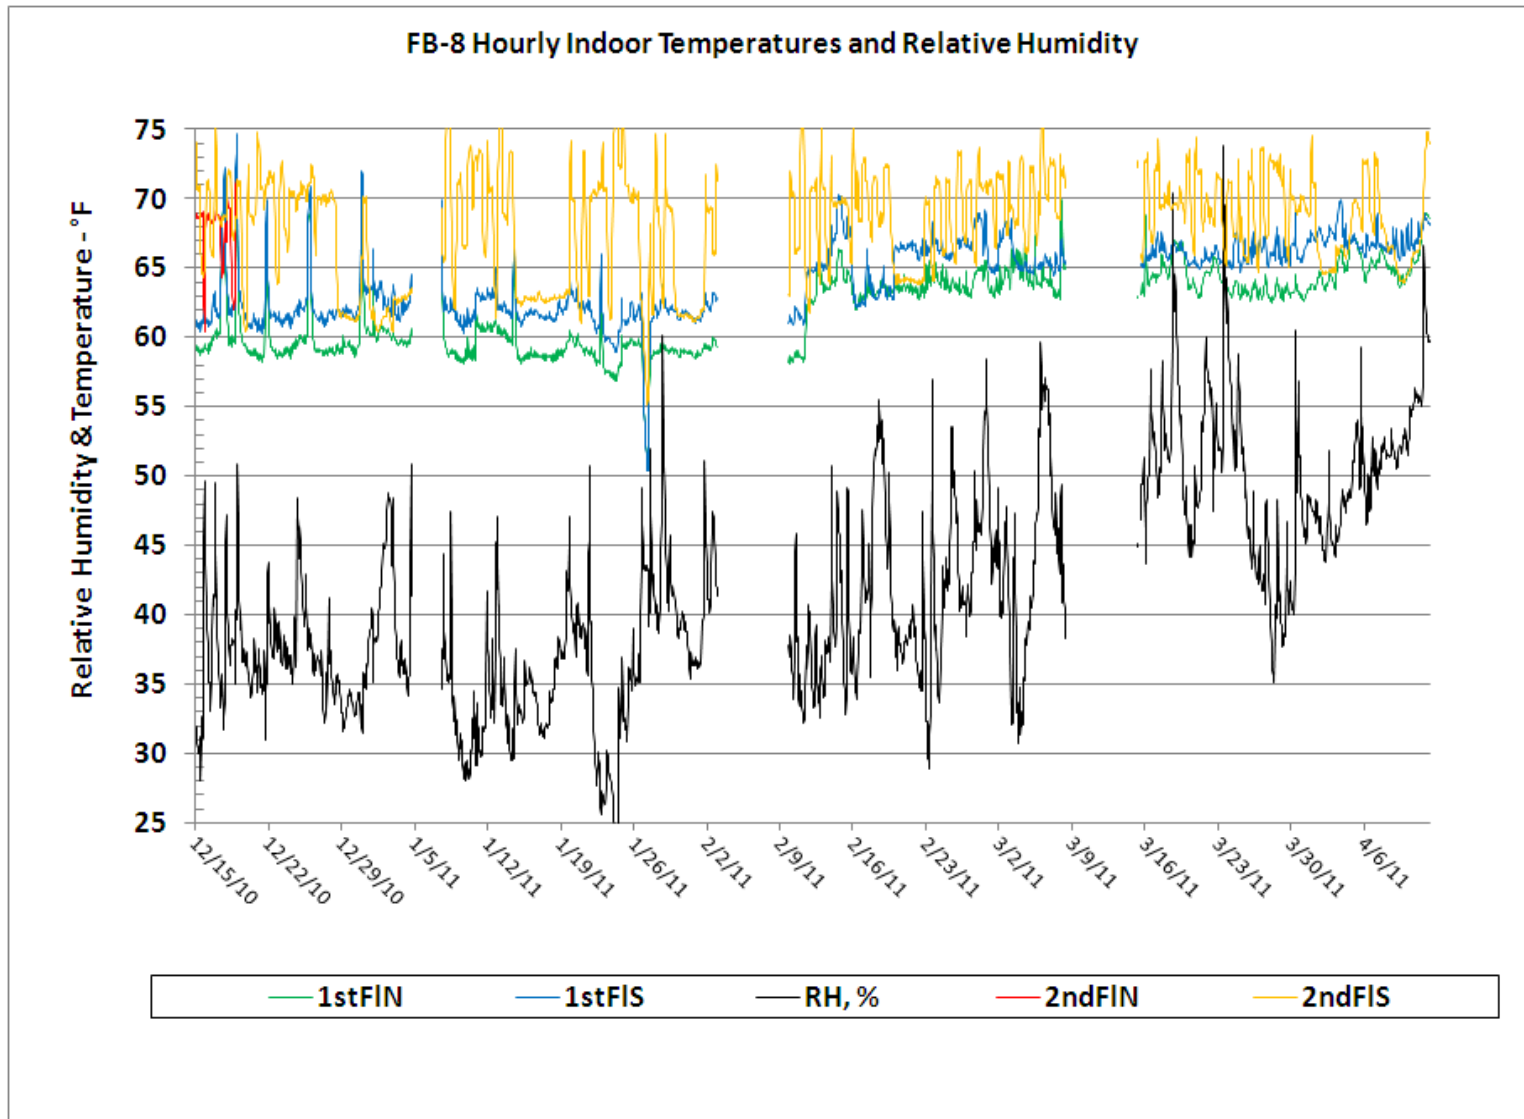
Figure 78. FB-8 Average Hourly Temperature – December 2010 to April 2011.

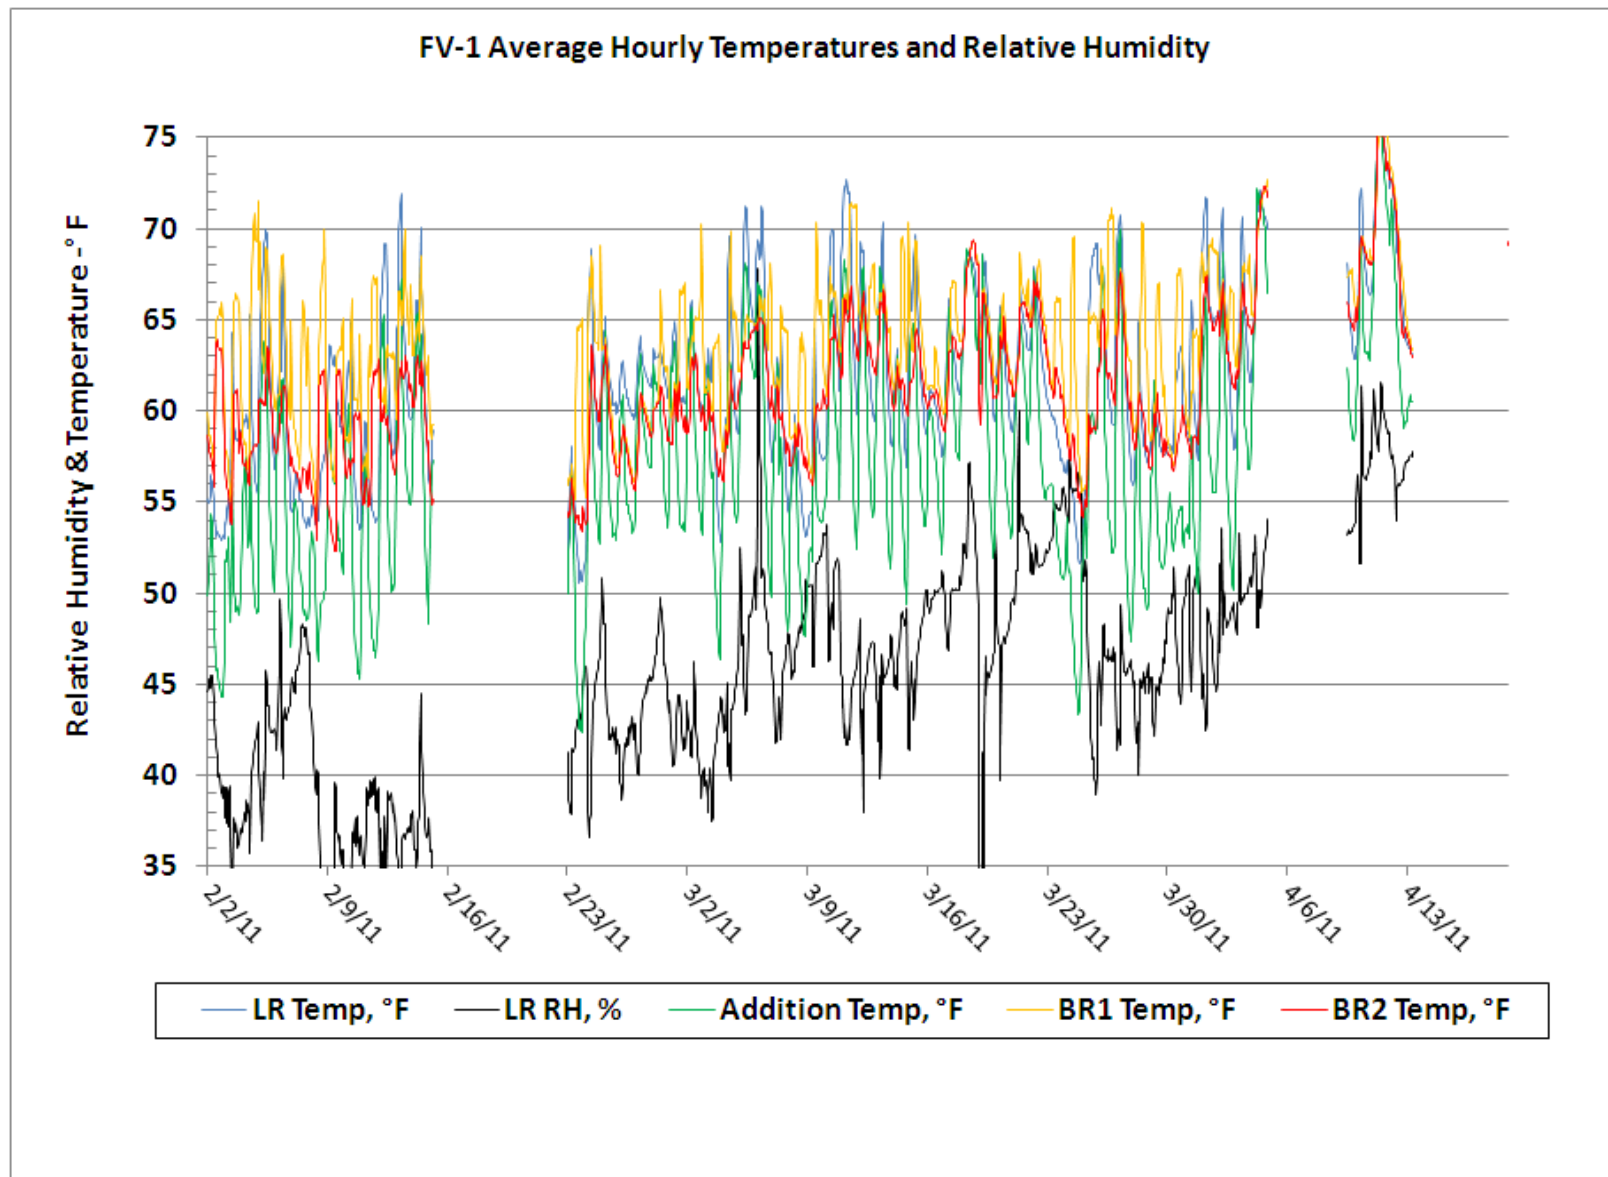
Figure 79. FV-1 Average Hourly Temperature – February 2011 to April 2011.

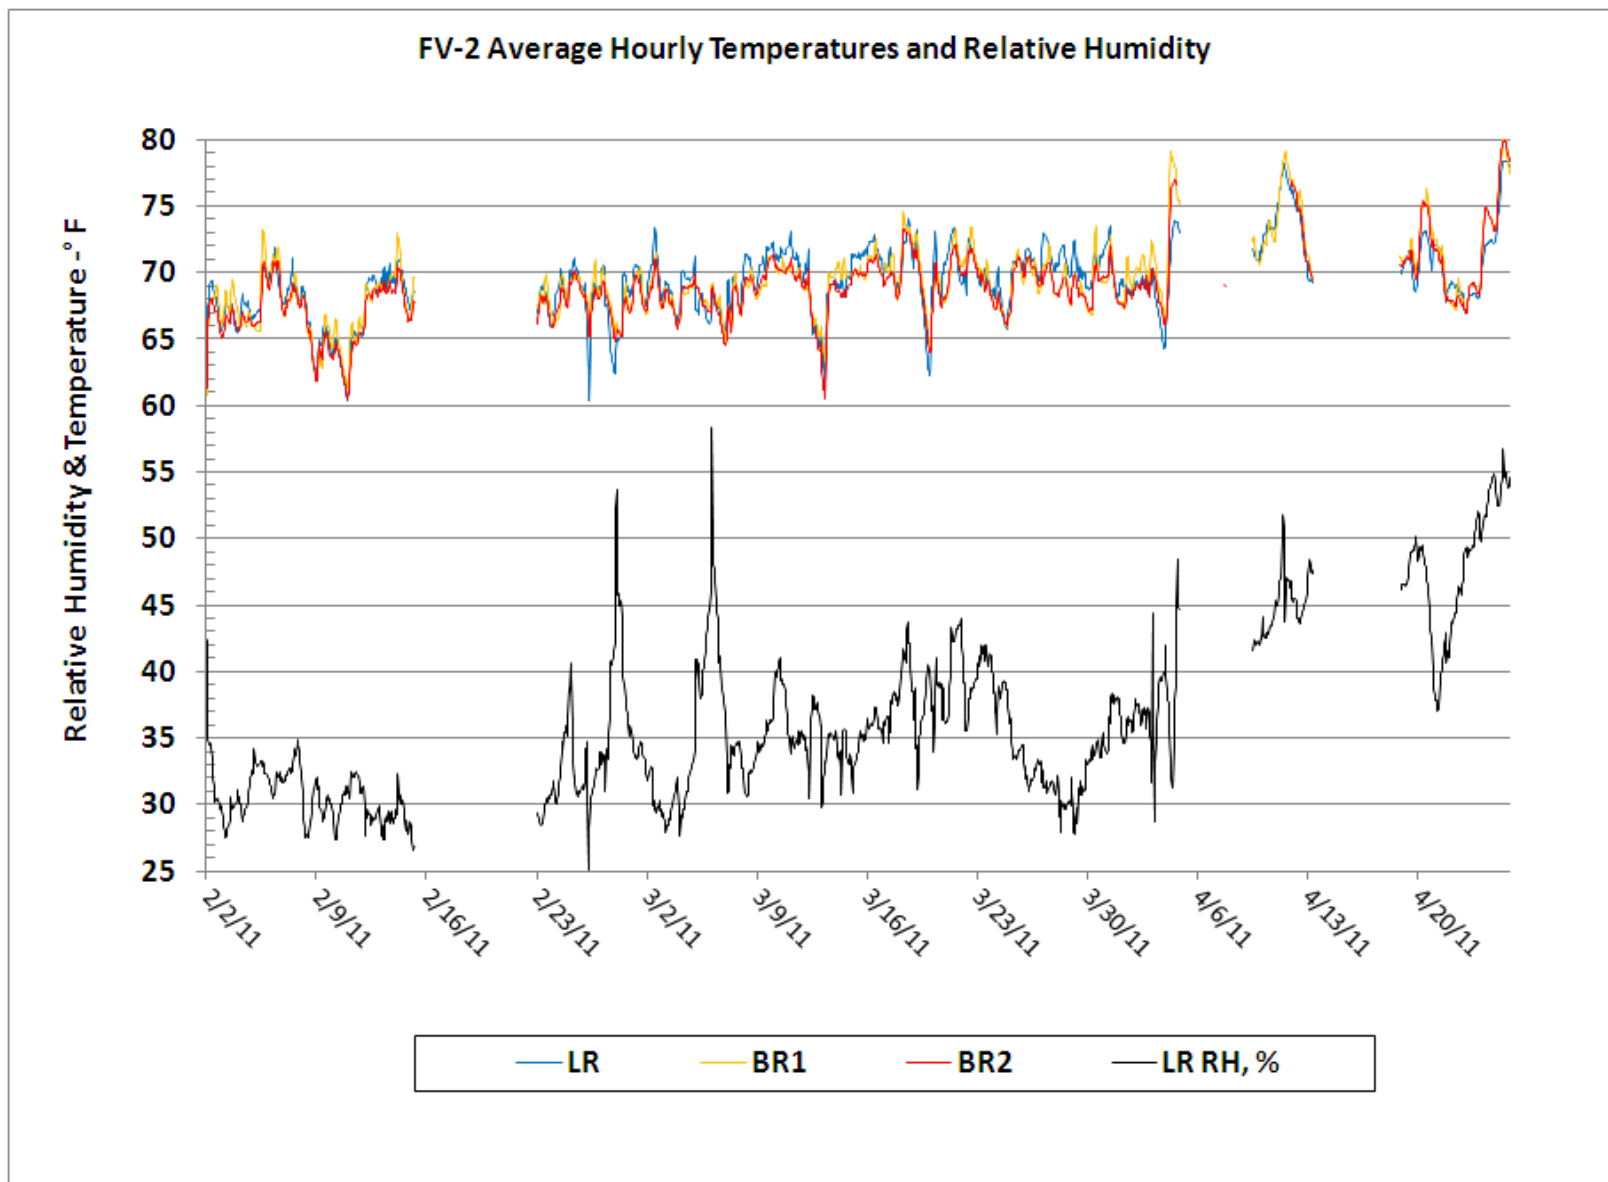
Figure 80. FV-2 Average Hourly Temperature – February 2011 to April 2011.

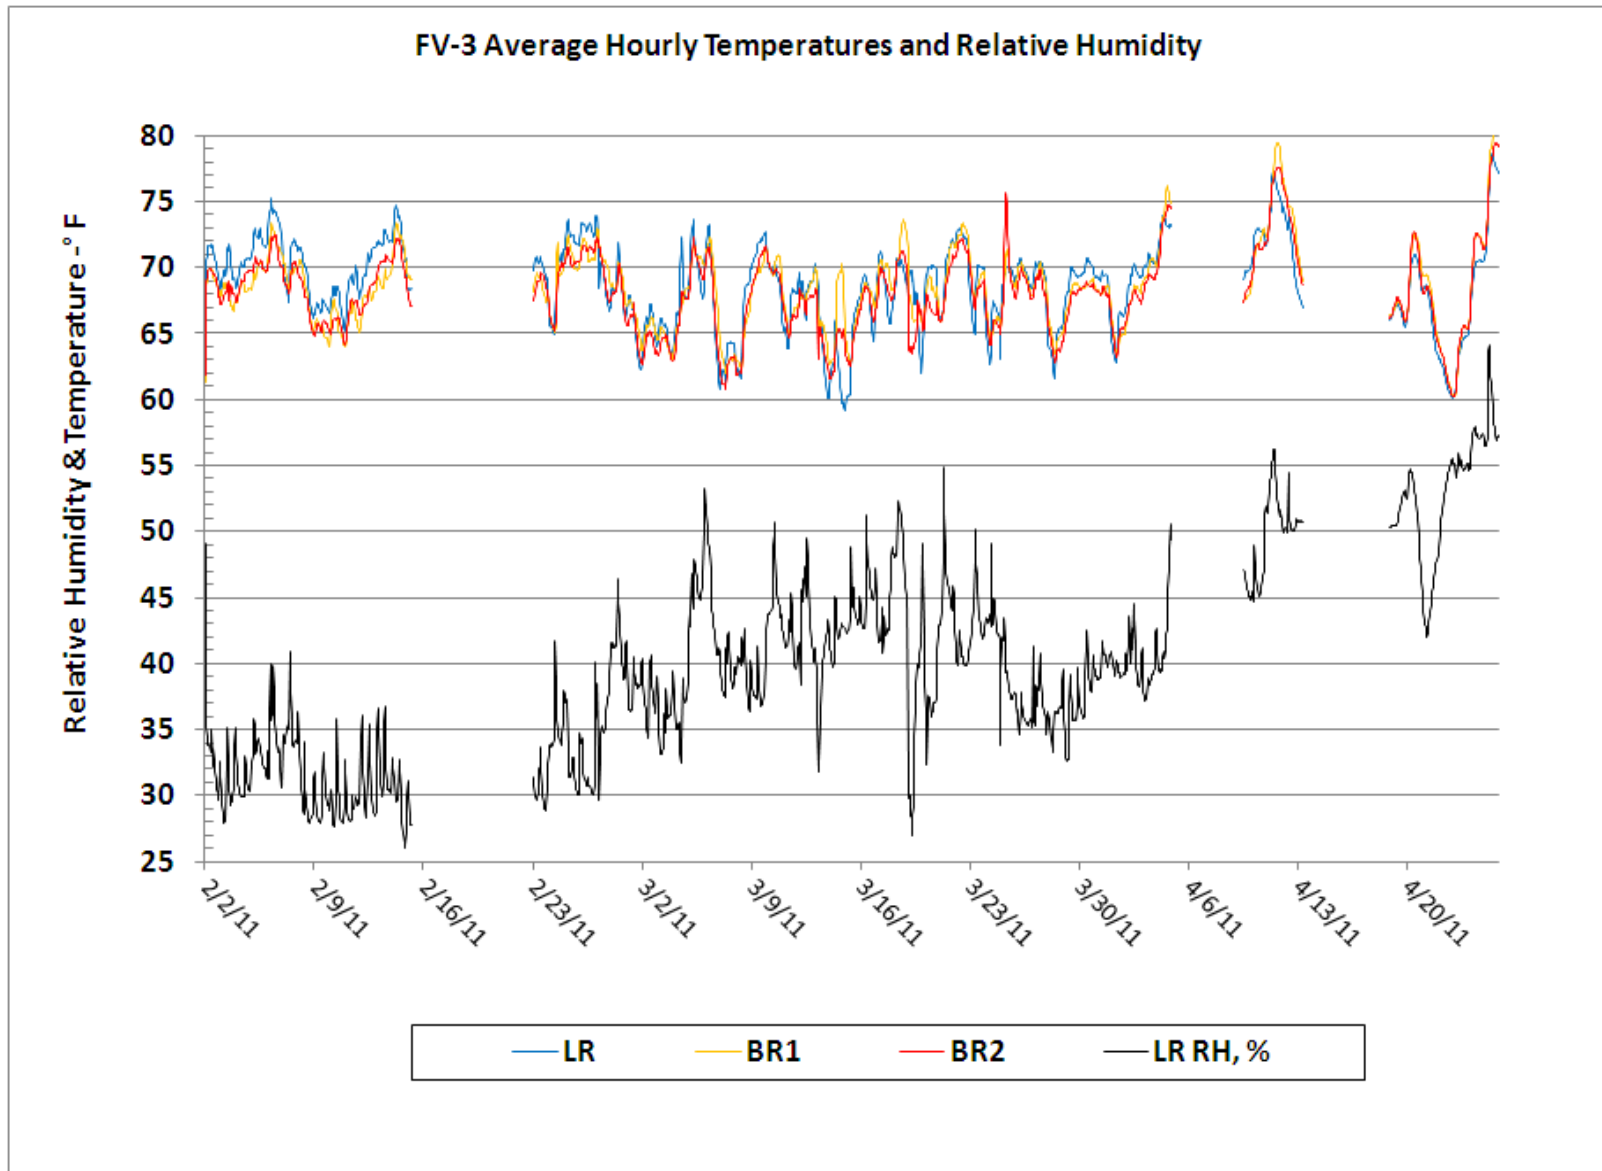
Figure 81. FV-3 Average Hourly Temperature – February 2011 to April 2011.

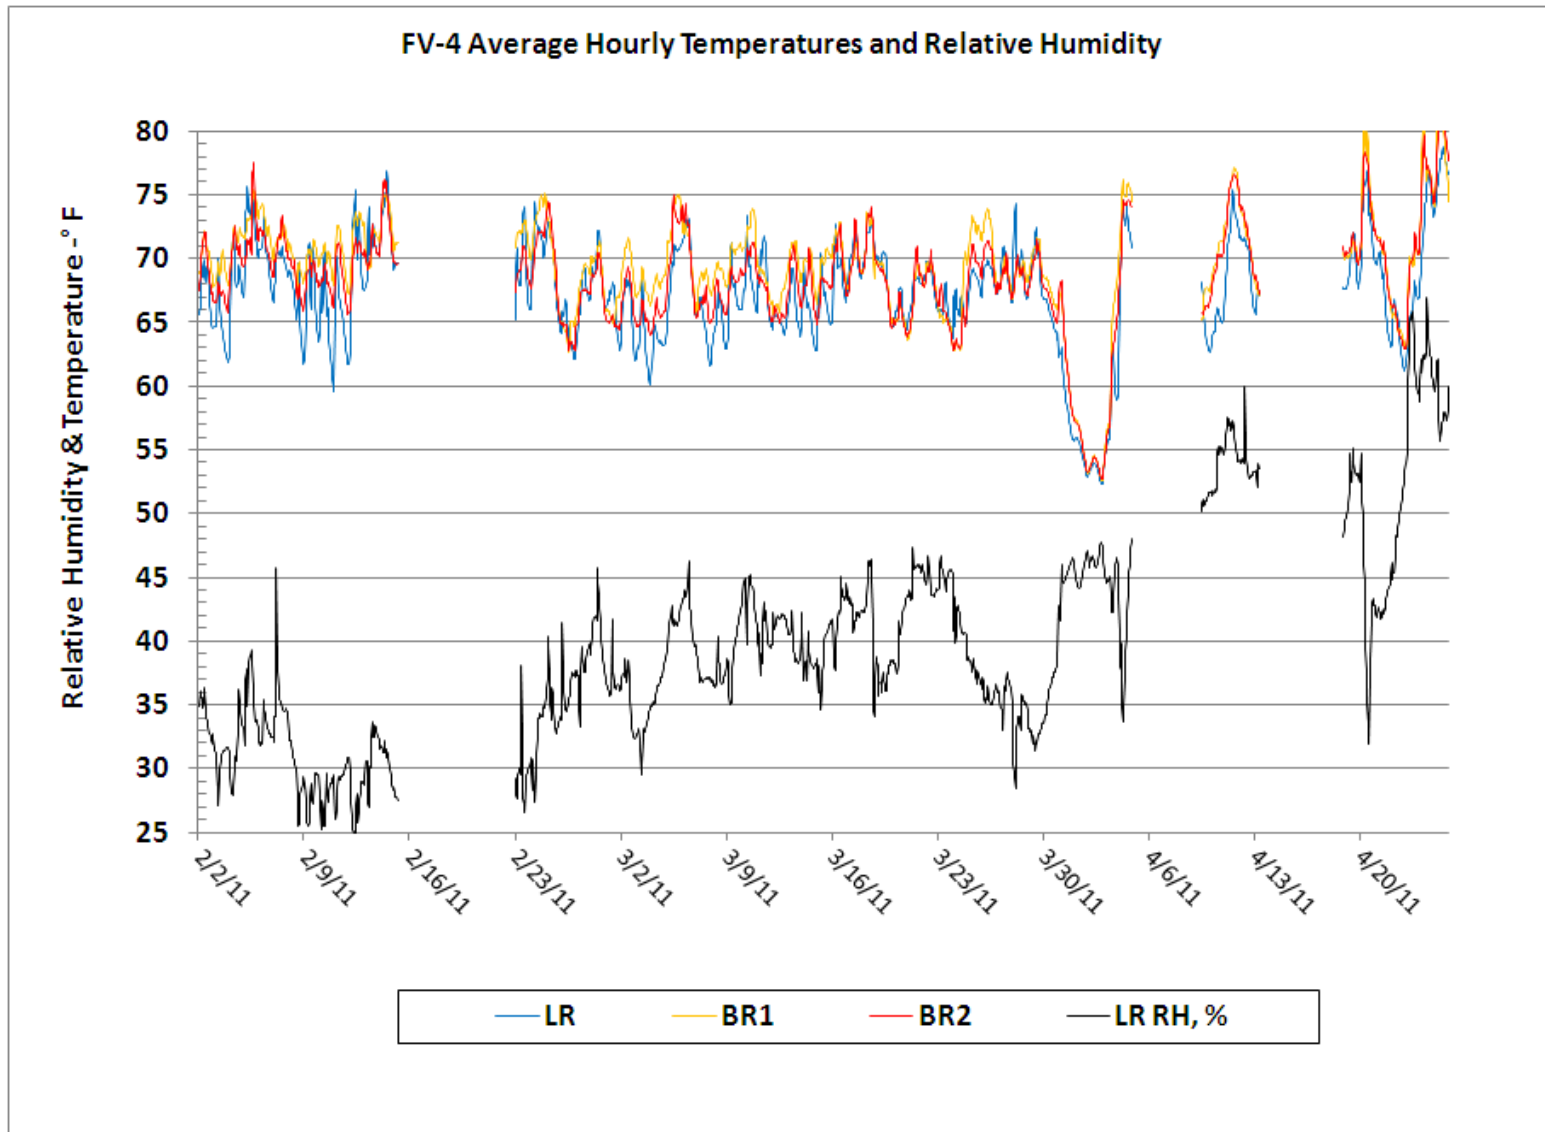
Figure 82. FV-4 Average Hourly Temperature – February 2011 to April 2011.

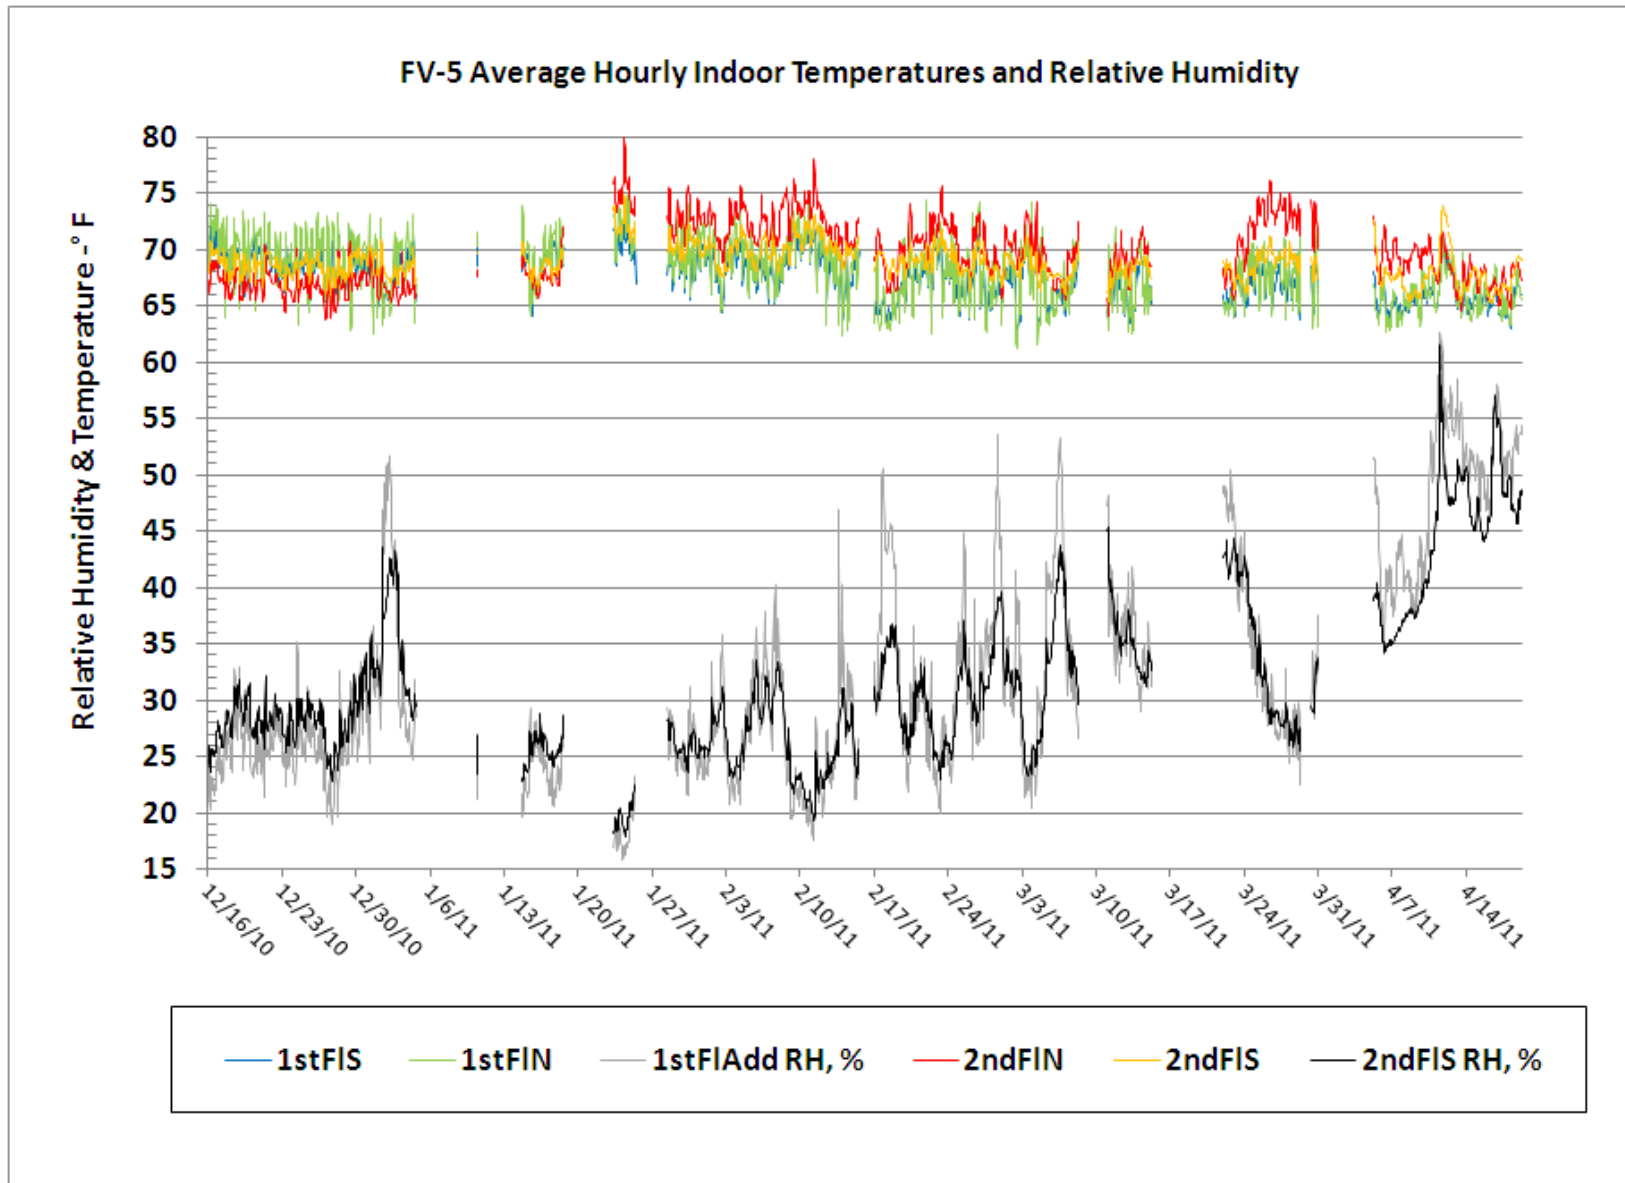
Figure 83. FV-5 Average Hourly Temperature – December 2010 to April 2011.

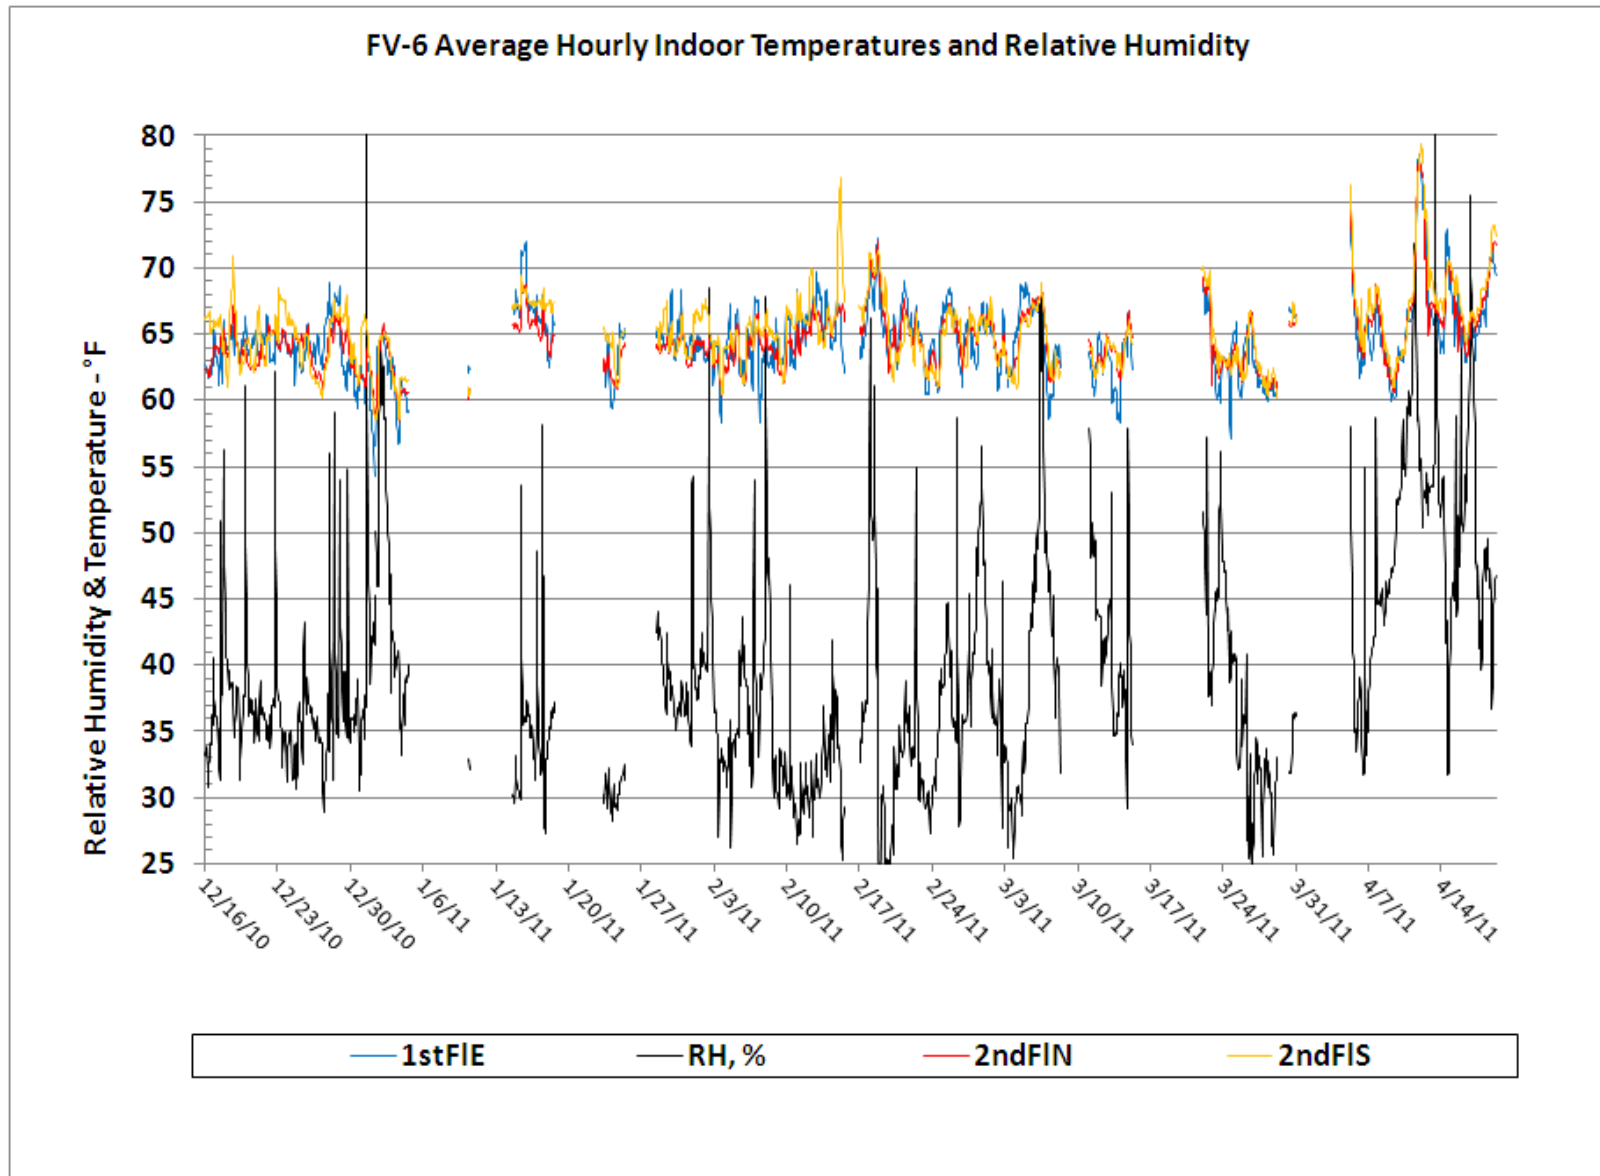
Figure 84. FV-6 Average Hourly Temperature – December 2010 to April 2011.

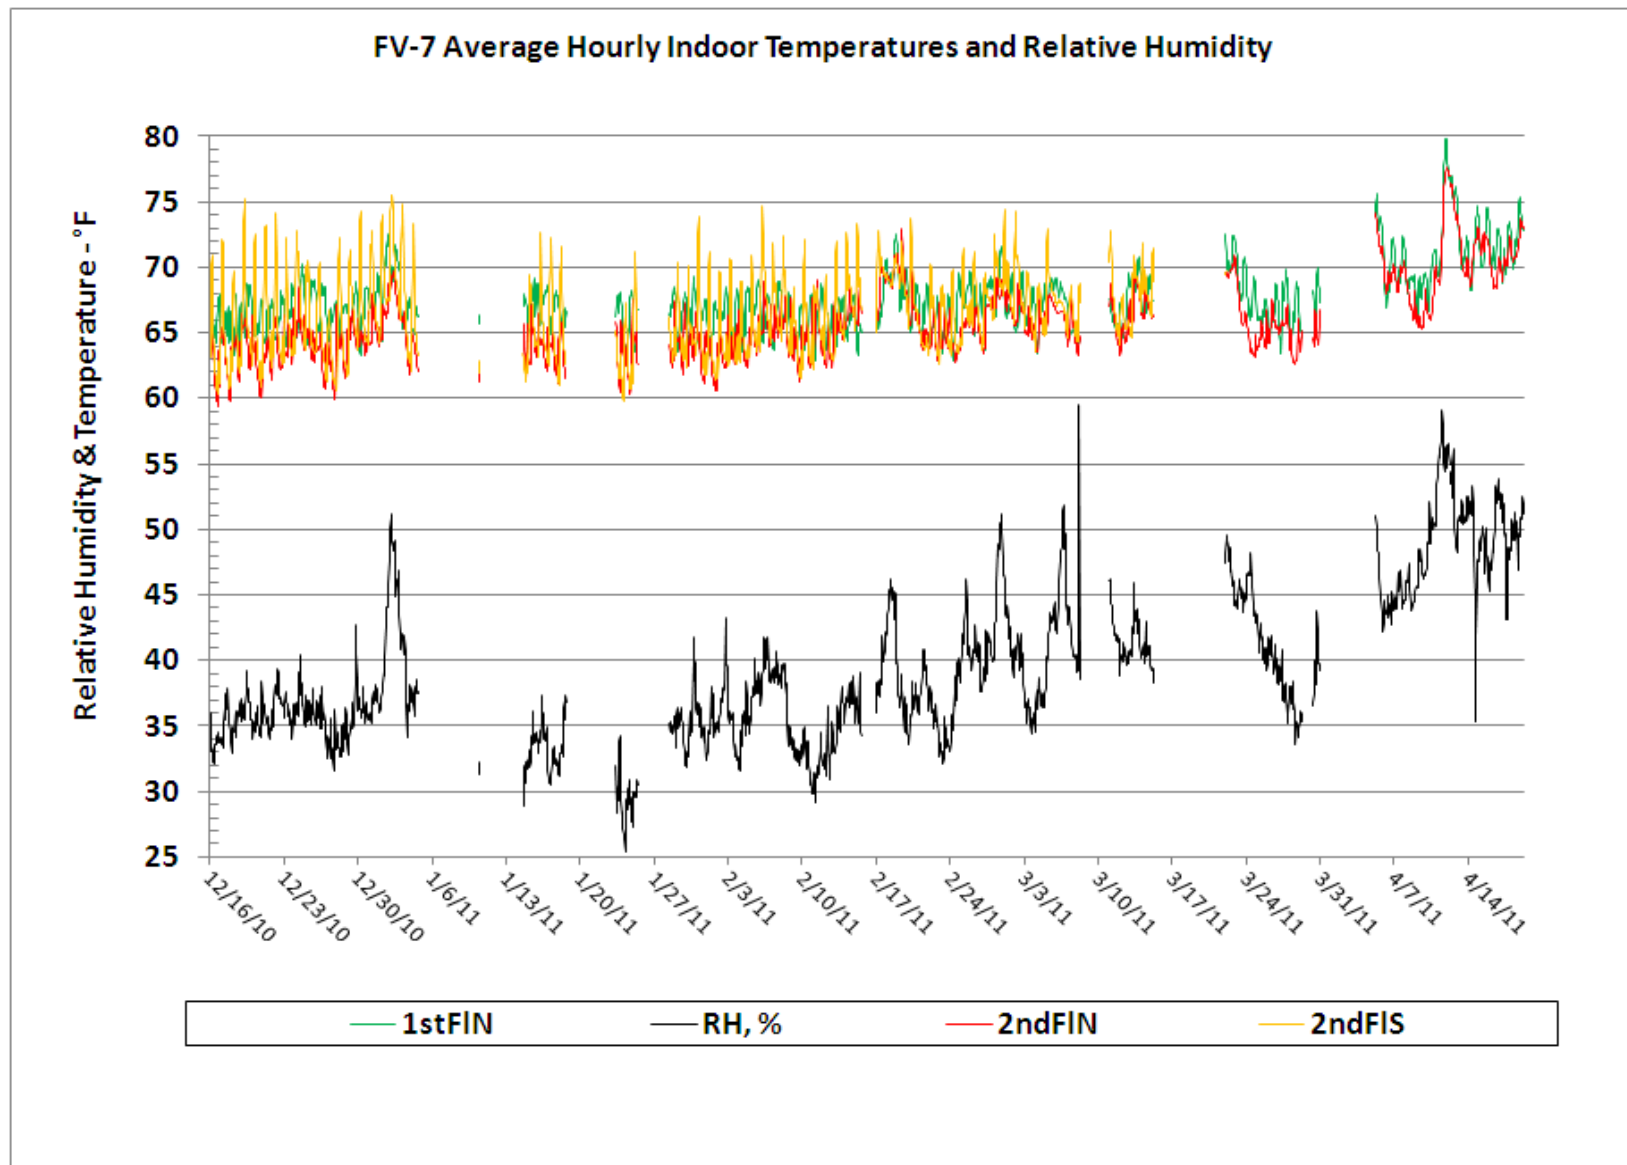
Figure 85. FV-7 Average Hourly Temperature – December 2010 to April 2011.

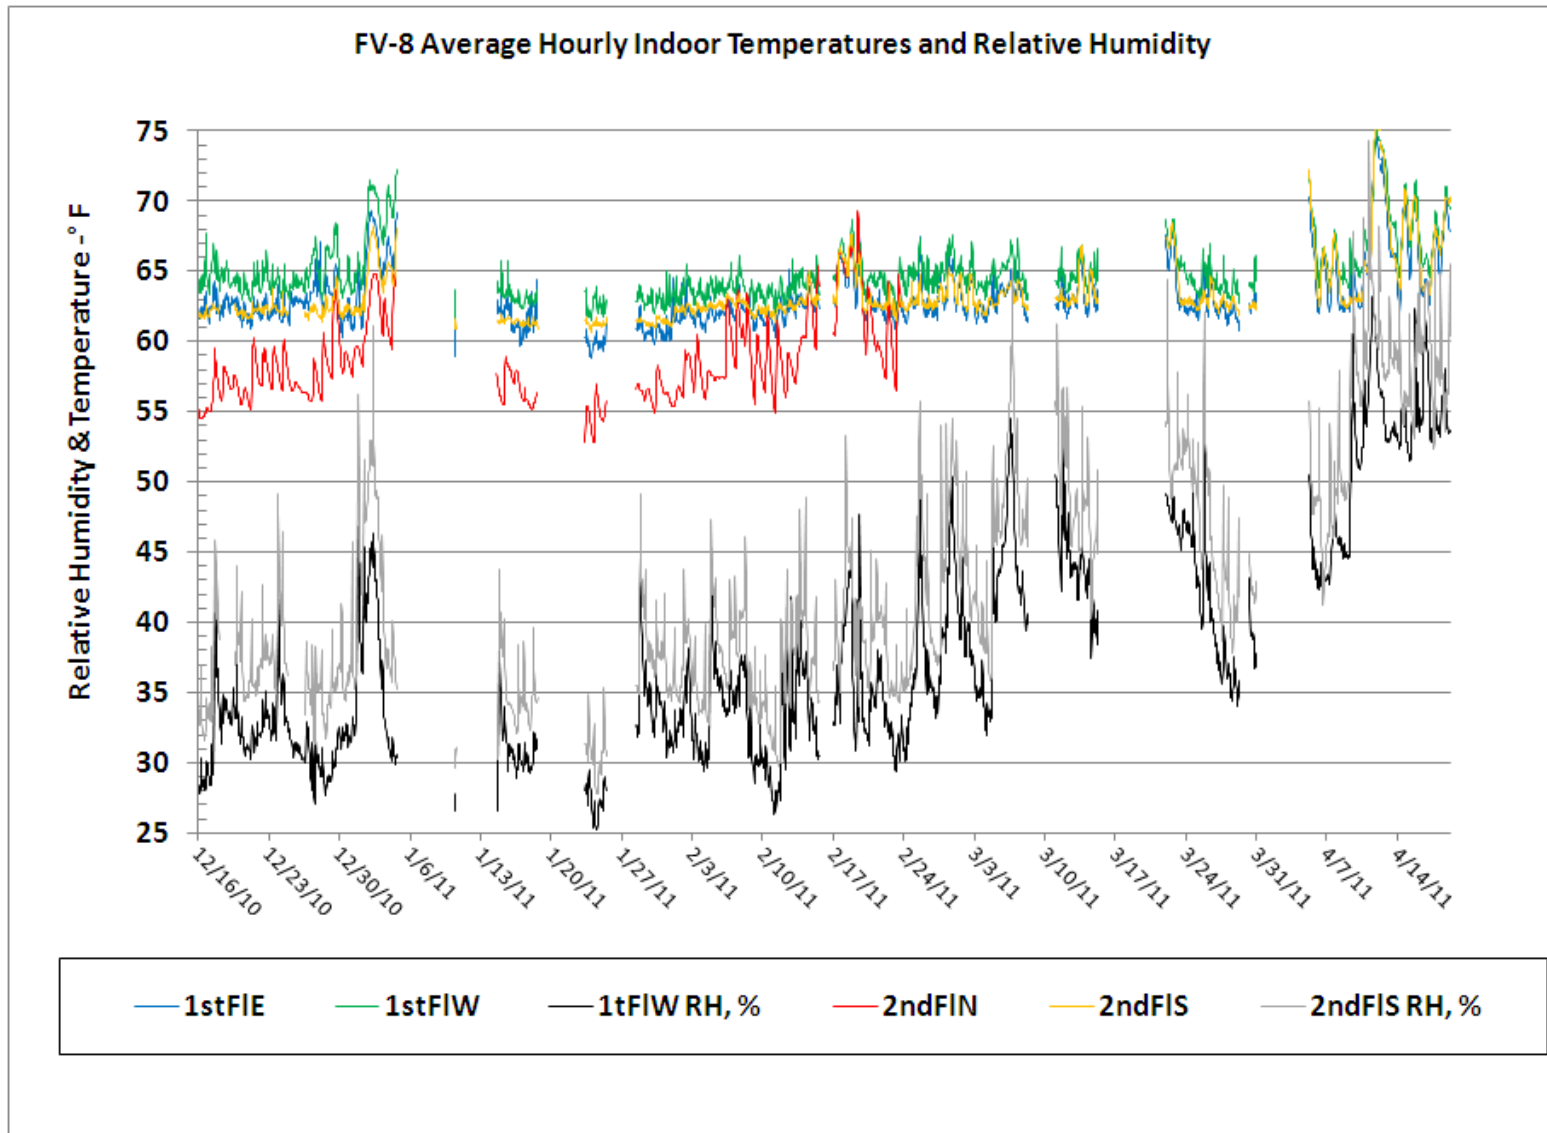
Figure 86. FV-8 Average Hourly Temperature – December 2010 to April 2011.

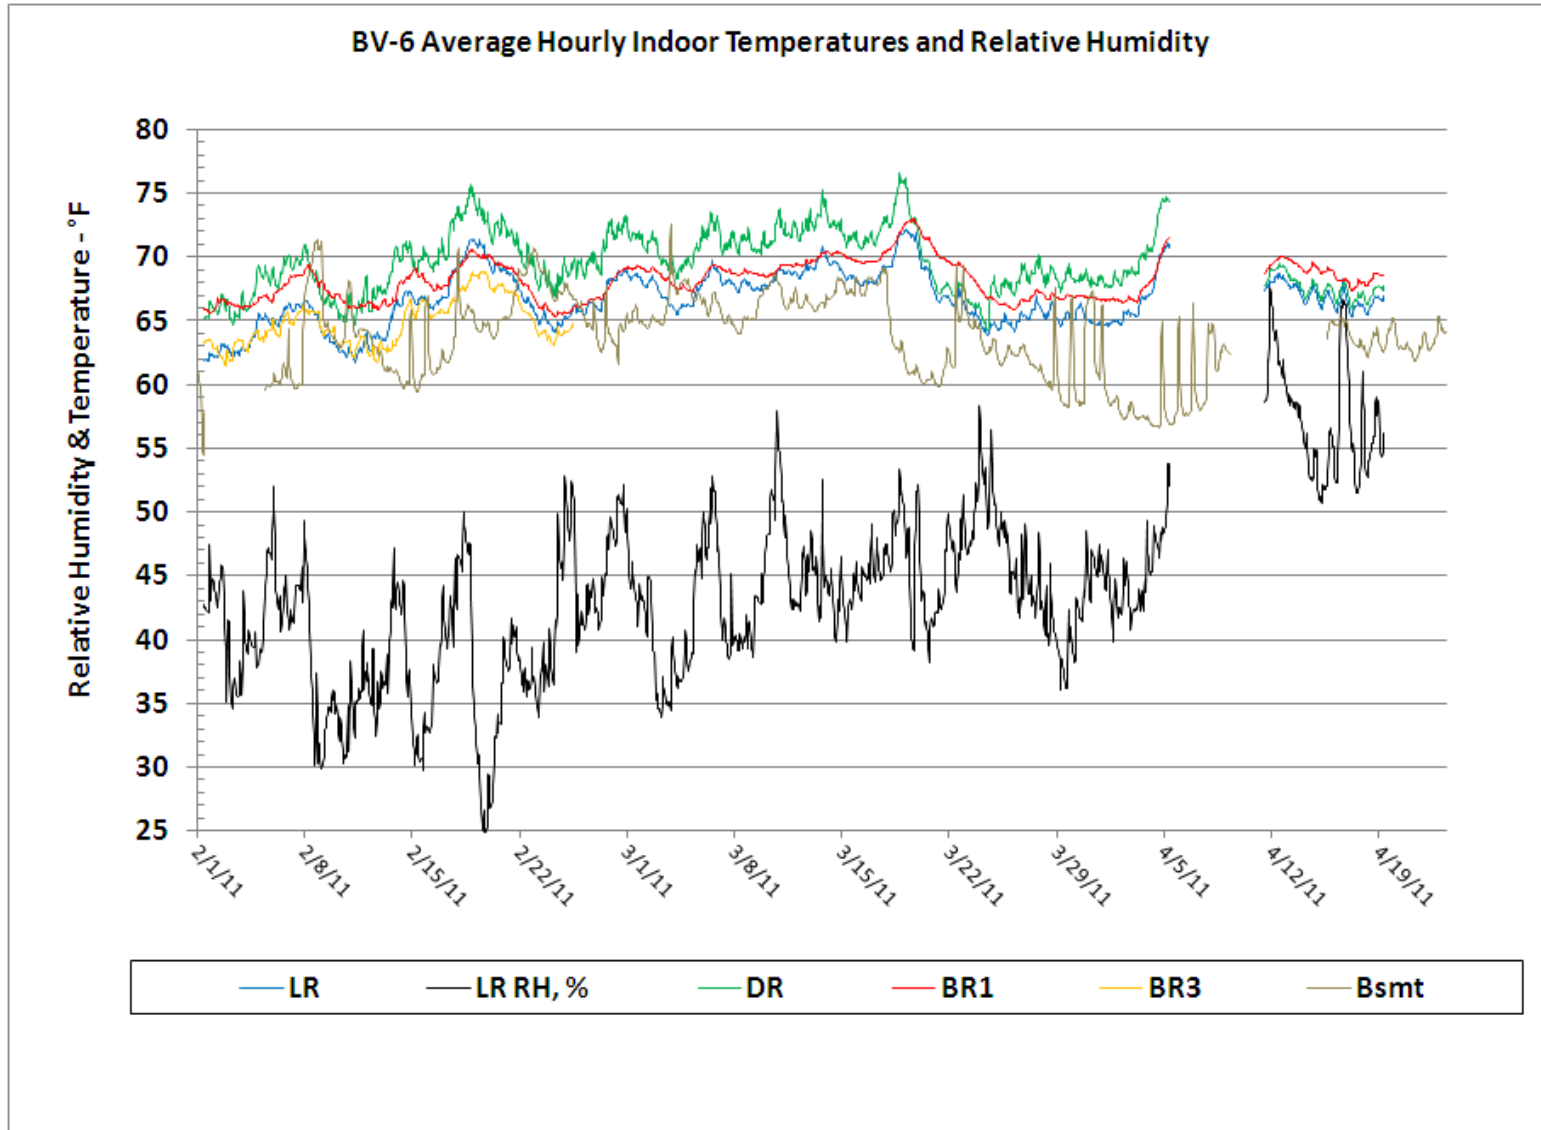
Figure 87. BV-6 Average Hourly Temperature – February 2011 to April 2011.
