# Hygric Redistribution in Insulated Assemblies: Retrofitting Residential Envelopes Without Creating Moisture Issues

J. Smegal and J. Lstiburek  
*Building Science Corporation*

January 2013

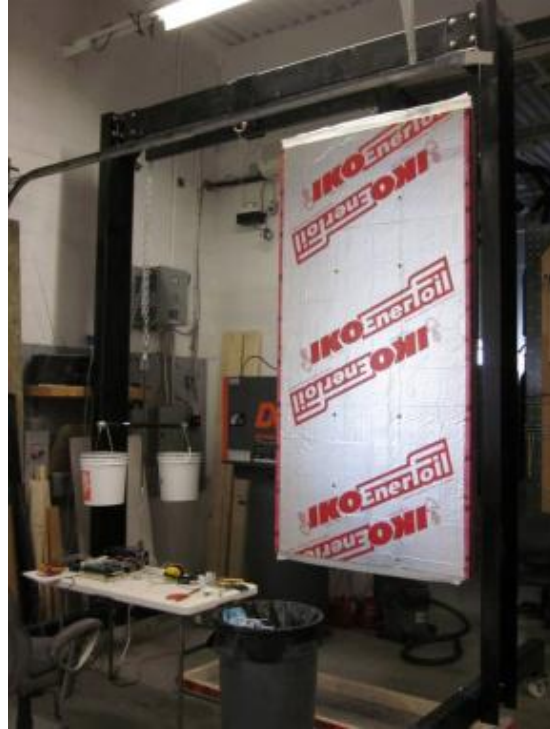
Figure 4. Drainage and drying balance

Figure 4 depicts the actual balance used in the laboratory. The test balance is a steel structure that is self contained so that it can be moved around the laboratory. It is not anchored to the floor. Test walls were outfitted with nine wood MC sensors to continuously monitor the wood MC of the sheathing. Figure 5 shows the layout of all nine sensors, and Figure 6 illustrates an individual wood MC sensor and thermistor. The sensors were continuously monitored using a Campbell Scientific CR1000 data logger and multiplexer. The MC sensors measure a resistance across the wood that correlates to an MC. As the MC increases, the electrical resistances of the wood decrease (Straube et al. 2002).

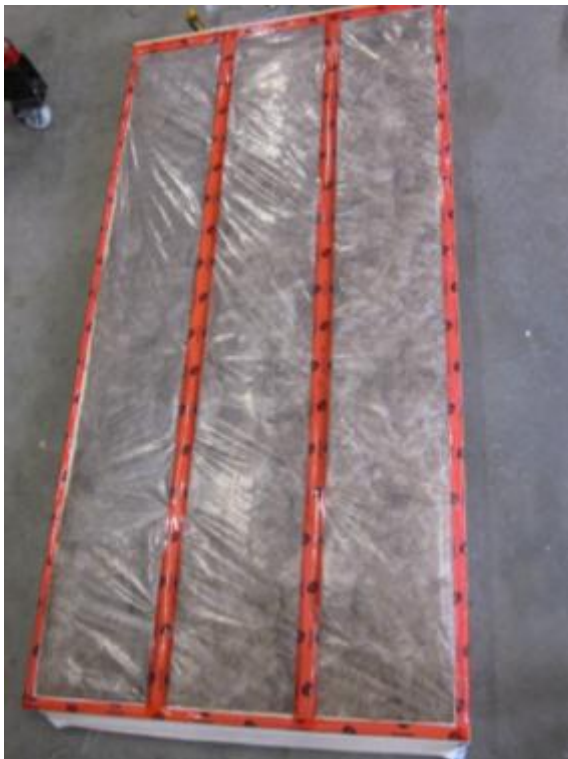
Figure 8. Interior surface of typical test wall

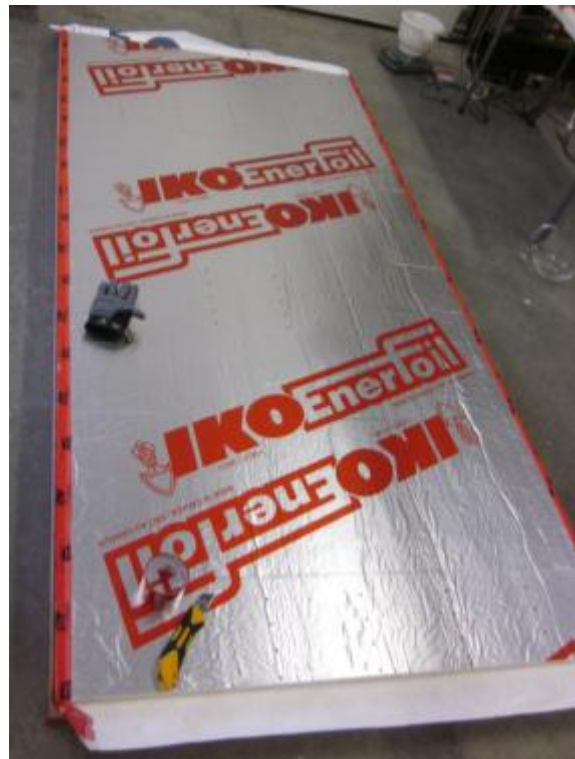
Figure 9. Exterior surface of typical test wall

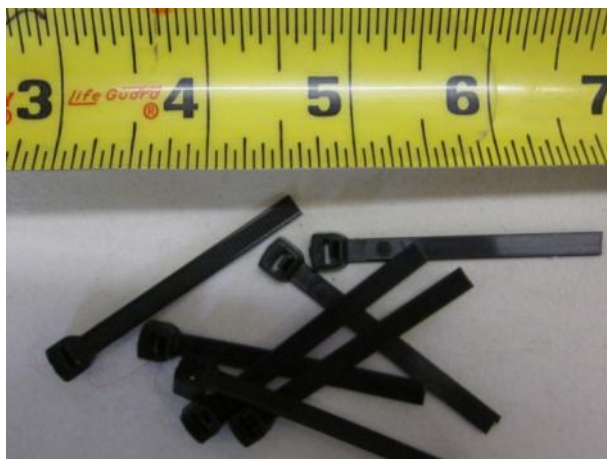
**Figure 10. Two-inch-long plastic spacers**

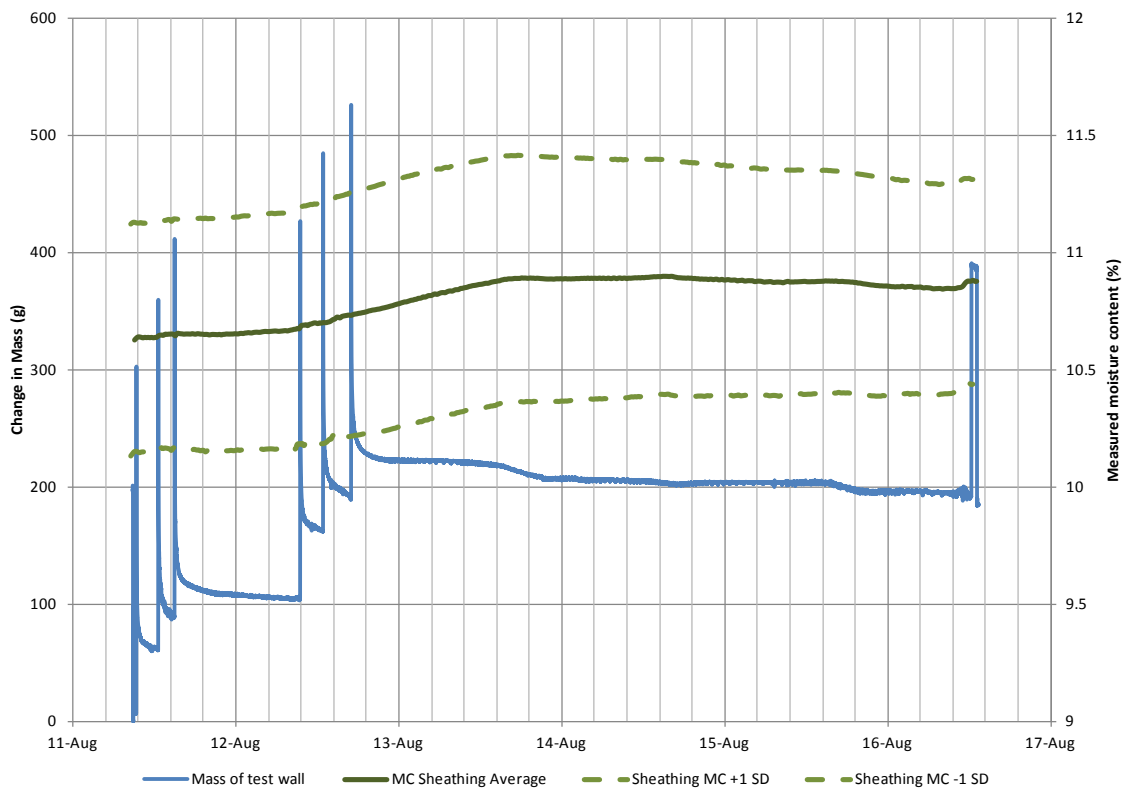
**Figure 13. Repeated drainage gap wetting analysis, smooth housewrap**

was a correlation between the sheathing MC and repeated wettings, as shown in Figure 13, but the scale of the MC is between 9% and 12% as an average for all nine MC locations. This scale is used to show the correlation, but it should be noted that moisture durability is generally not an issue until the MC is greater than 20%. The average  $\pm 1$  standard deviation of all the MC readings is also shown on the series of MC sensors.

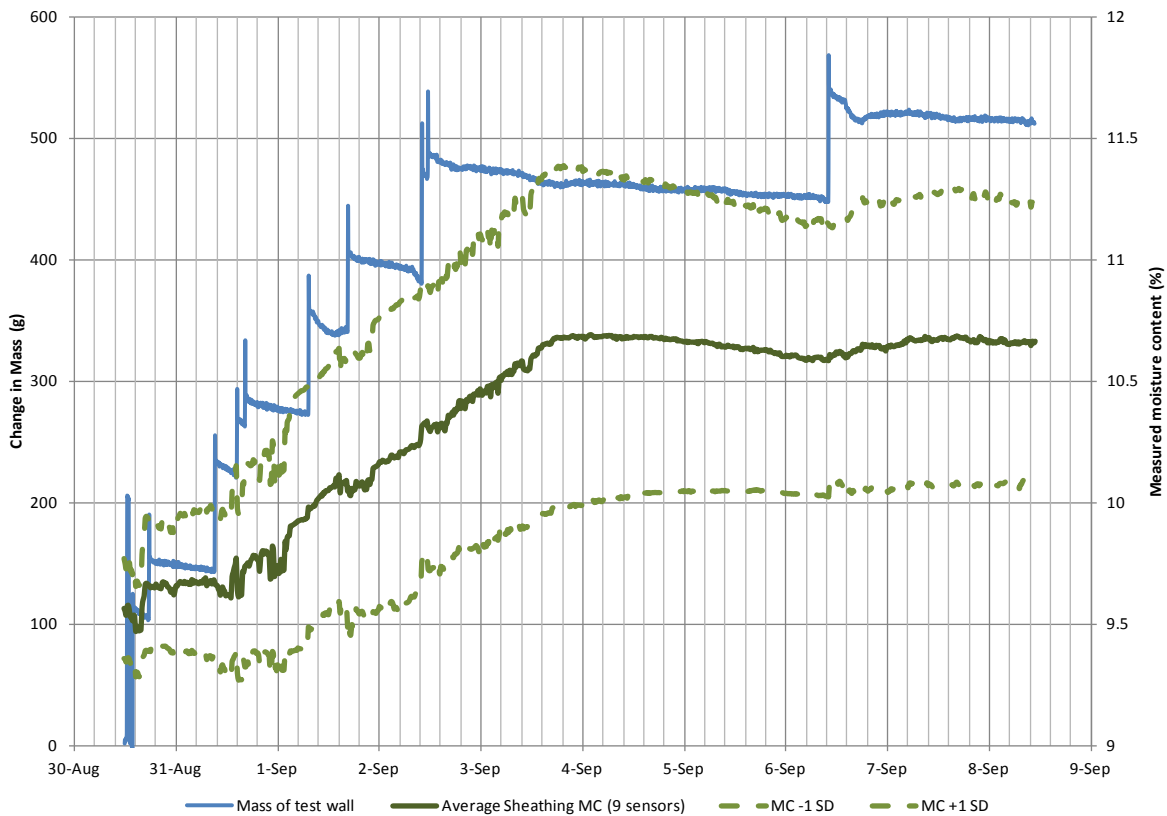
**Figure 14. Repeated drainage gap wetting analysis, corrugated housewrap**

A repeated wetting test was also conducted on the corrugated plastic housewrap wall, and the results are shown in Figure 14 (with the same scale as the previous test depicted in Figure 13). There were two extra wetting events compared to the flat plastic housewrap (Figure 13), but the entire wall system with corrugated plastic housewrap gained more than twice the mass as the smooth plastic housewrap. The drainage cavity materials are nonhygroscopic, which means that more than twice the water vapor diffused into the sheathing and stud cavity from the drainage space. This happens because more water is stored after each wetting event, and the vapor can very easily move into the plywood sheathing through the vapor permeable drainage plane. The increase in MC from repeated wettings is still less than 20%, the minimum threshold for moisture-related durability concerns.

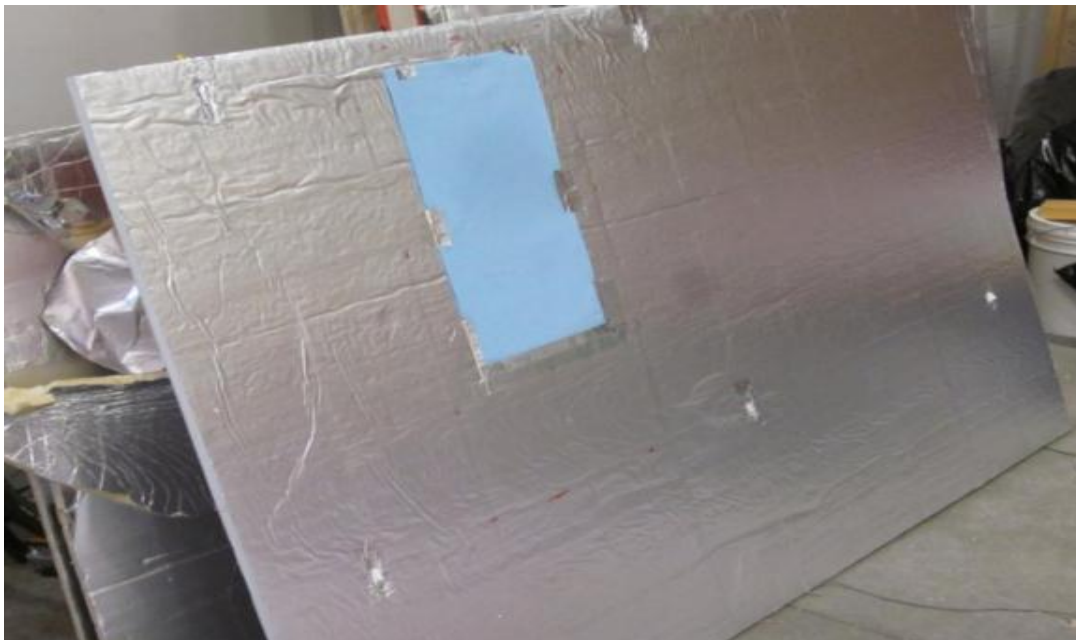
**Figure 16. Wetting system and drainage space RH sensors**

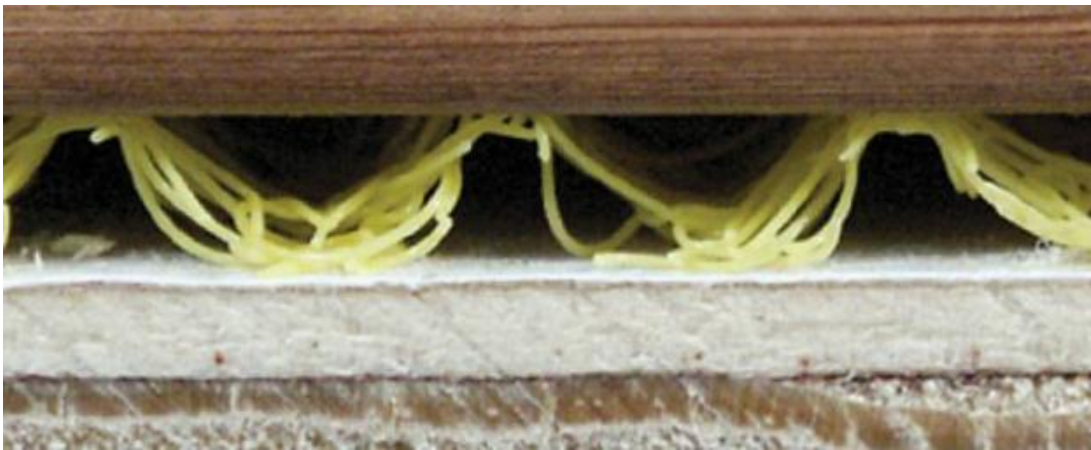
**Figure 18. Example of drainage mesh between two sheet materials**

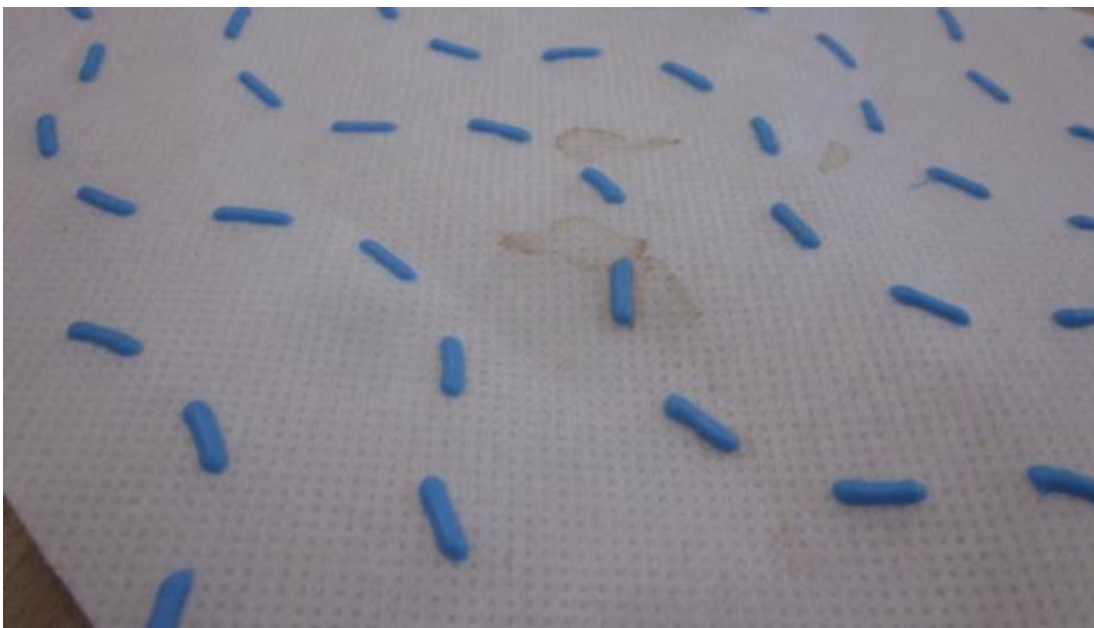
**Figure 19. Example of a bumpy housewrap**

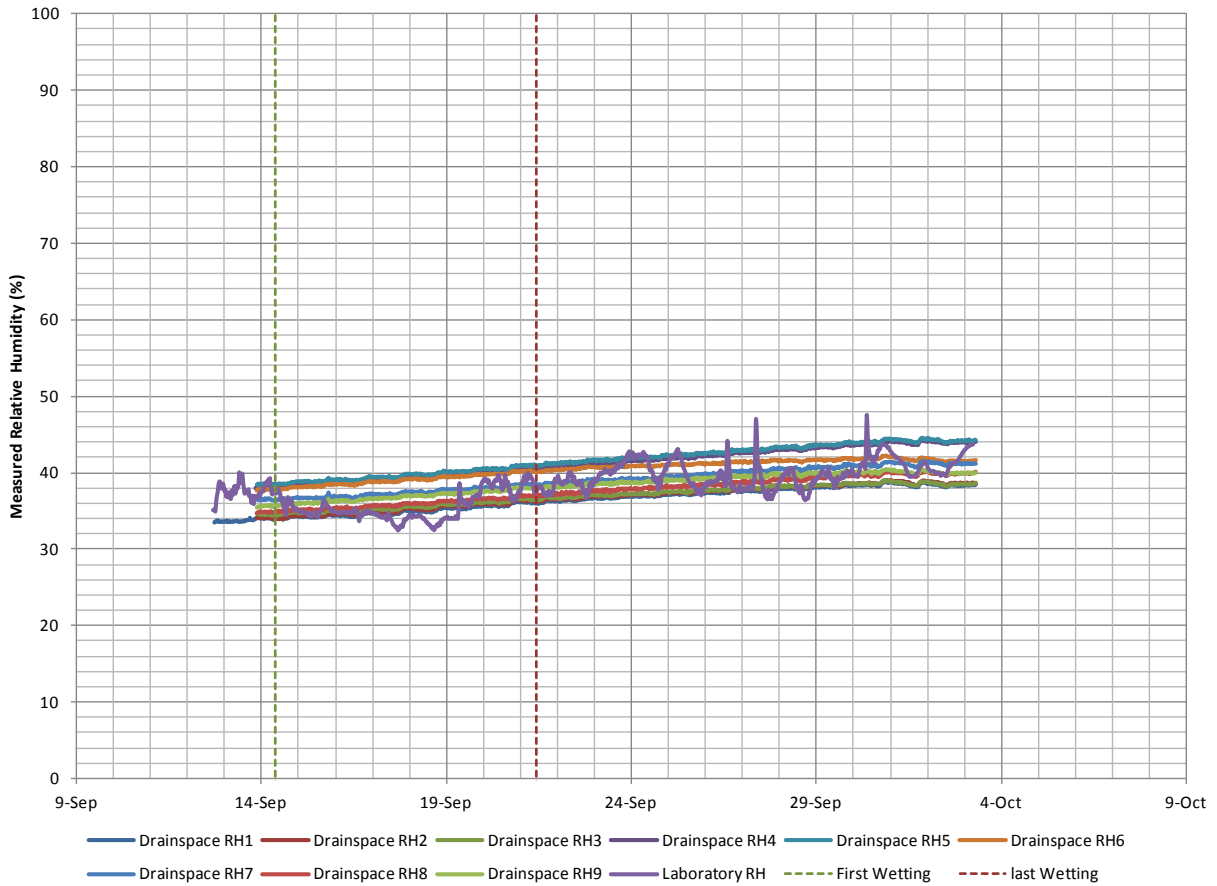
**Figure 20. Measured RH at nine locations in the drainage space**

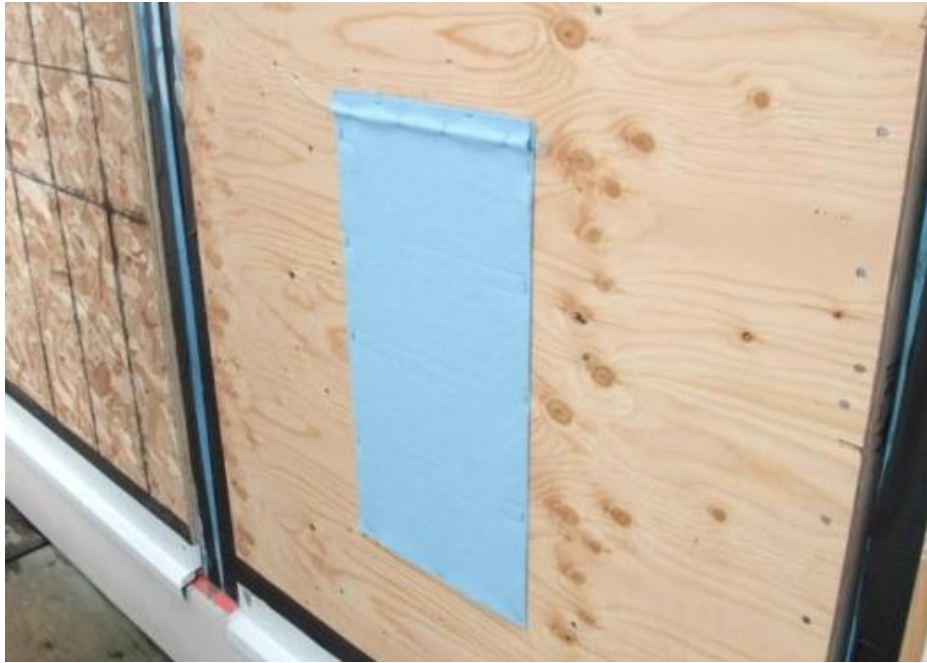
**Figure 27. Exterior wetting apparatus**

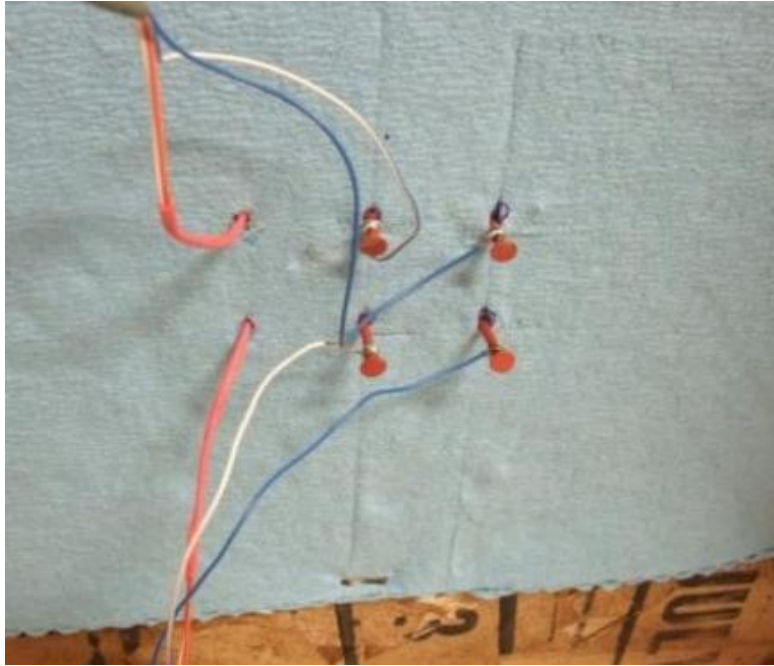
**Figure 28. MC pins installed in plywood sheathing through the wetting system**

Measurements are most commonly taken at ¼-in. (6-mm) tip depth. In this study, MC measurements were taken at two depths on the lower OSB near the wetting system so the moisture gradient could be determined. The wood MC pins were installed in combination with a temperature sensor in all locations. To correct the MC readings for temperature effects, a hole was drilled to the same depth as the MC pins and a temperature sensor was installed inside.

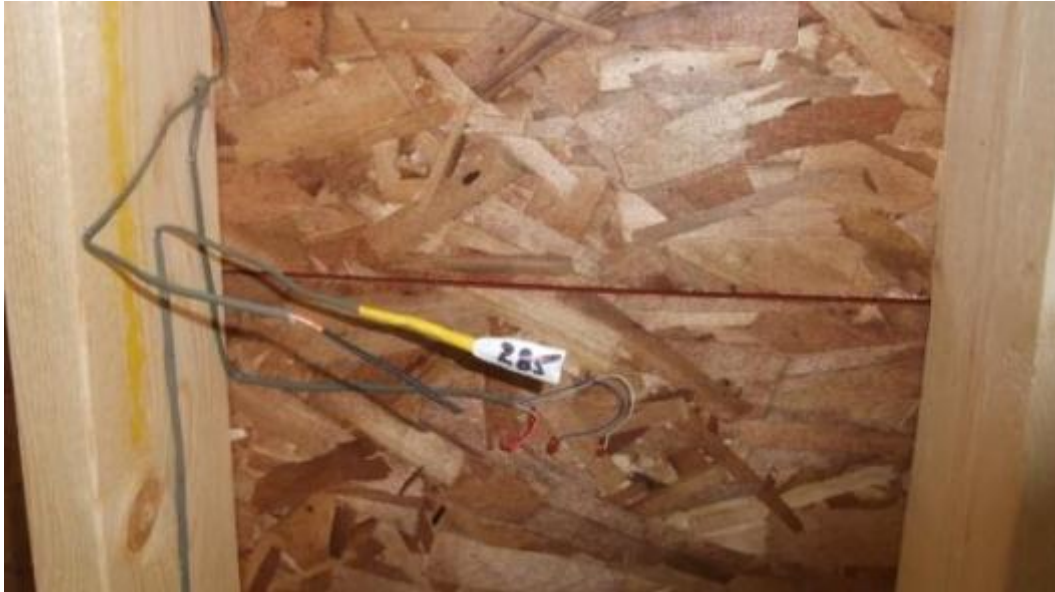
Figure 29. RH and temperature sensor installed in a stud bay (with MC pins installed below)

RH sensors were installed in the middle of each stud cavity, and in the drainage space of each wall. The RH sensor was always installed in combination with a temperature sensor, both of which are protected by a vapor permeable, water resistant cover (see Figure 29). RH and temperature sensors were installed at the midpoint of the stud space, between the drywall and the sheathing, as well as in some drainage cavities.

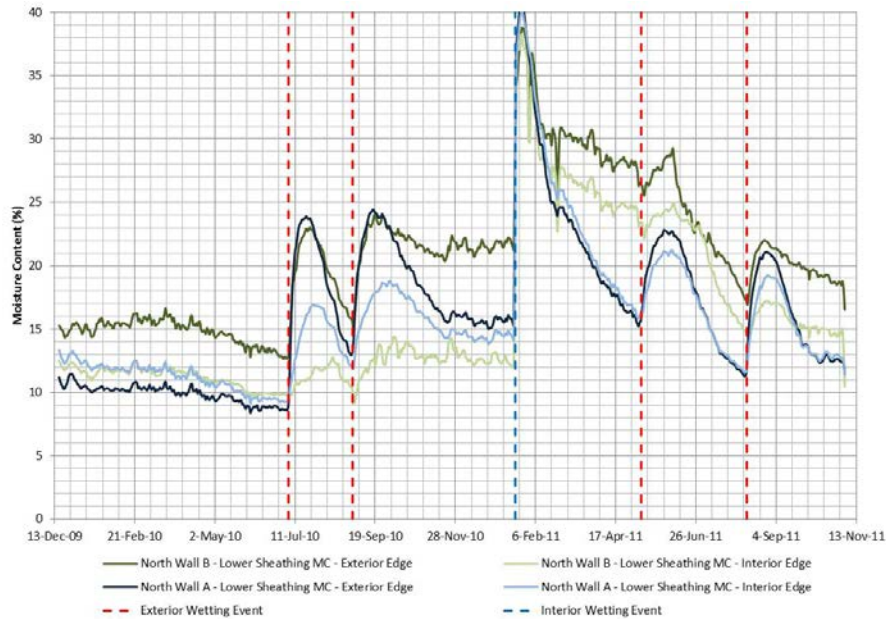
**Figure 31. Lower OSB sheathing measured MC comparison between north Wall B (direct applied stucco) and north Wall A (exterior insulation)**

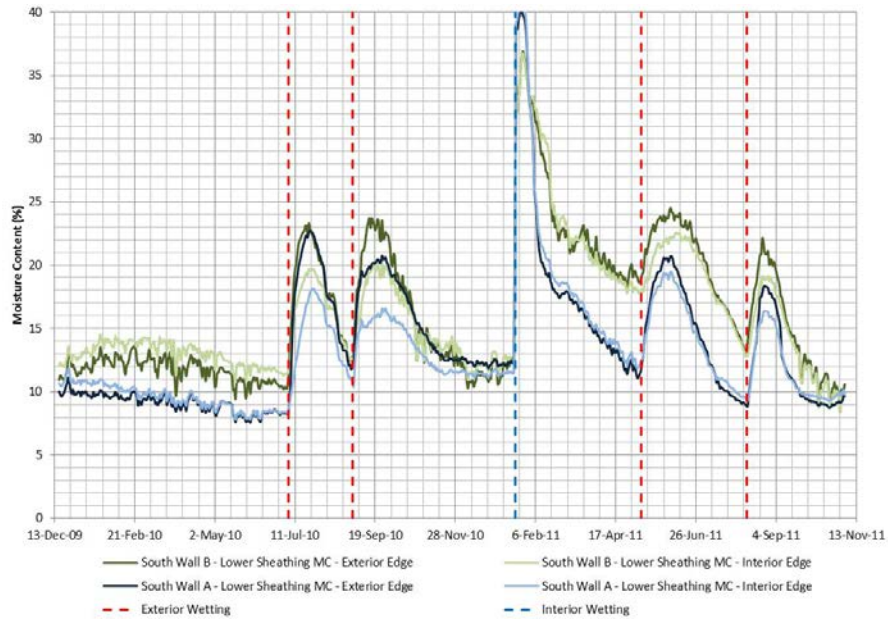
**Figure 35. South Wall B (direct applied stucco) and south Wall A (exterior insulation) lower OSB sheathing measured MC**

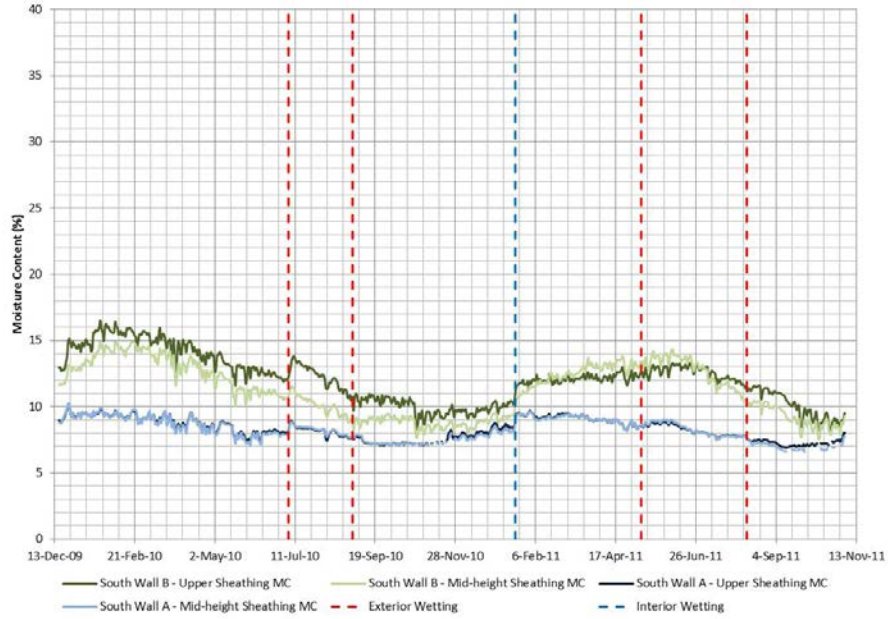
**Figure 36. South Wall B (direct applied stucco) and south Wall A (exterior insulation) middle and upper OSB sheathing measured MC**

At the midheight and upper MC measurement locations ( all four orientations on Figure 32, Figure 34, Figure 36 and Figure 38), which are largely unaffected by the intentional wetting events, the MC measurements on Wall A on all orientations does not exceed 11%, and is always less than Wall B. Wall B measurements do not exceed 17%, which is also considered a safe level of moisture in the OSB sheathing.

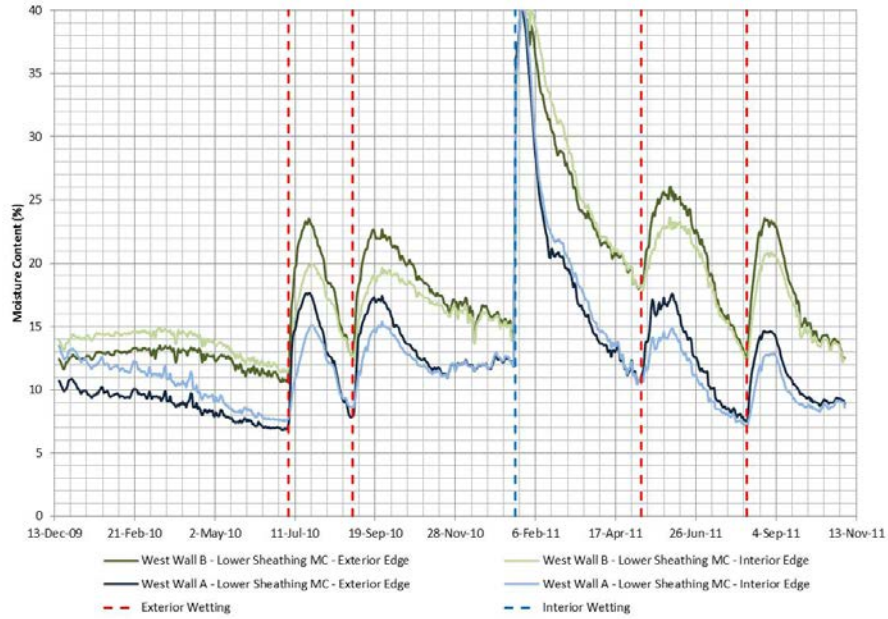
**Figure 37. West Wall B and south Wall A lower OSB sheathing measured MC comparing exterior insulation**

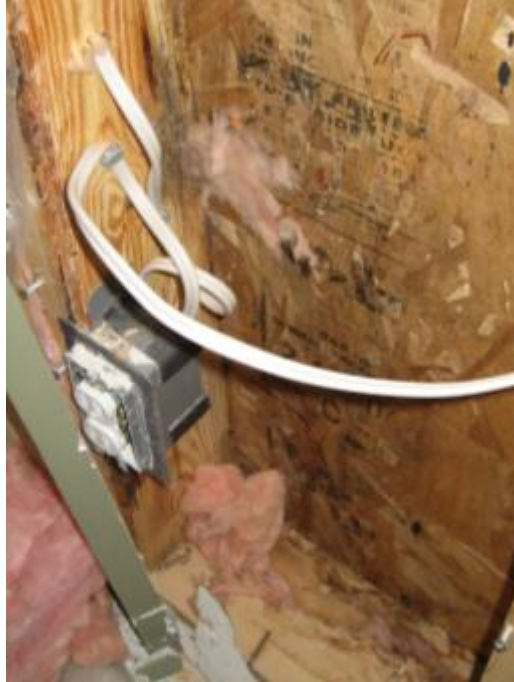
**Figure 39. Example of air leakage condensation durability issues**

Field experience with airtightness and blower door testing has demonstrated that the enclosure will always have some air leaks, and their location and size depend on the type and quality of construction. It is not uncommon to find air leakage pathways through electrical outlets, switches, and other interior finish penetrations. This means that with air permeable cavity filled insulation, which is the most commonly used, evidence of moisture condensation on the interior surface of the exterior OSB behind penetrations can be found. Figure 39 shows an example of an air leakage condensation problem behind an electrical outlet in a 6-year-old house with an interior poly vapor barrier. The OSB and framing are stained and dark with surface mold and the nails are corroding.

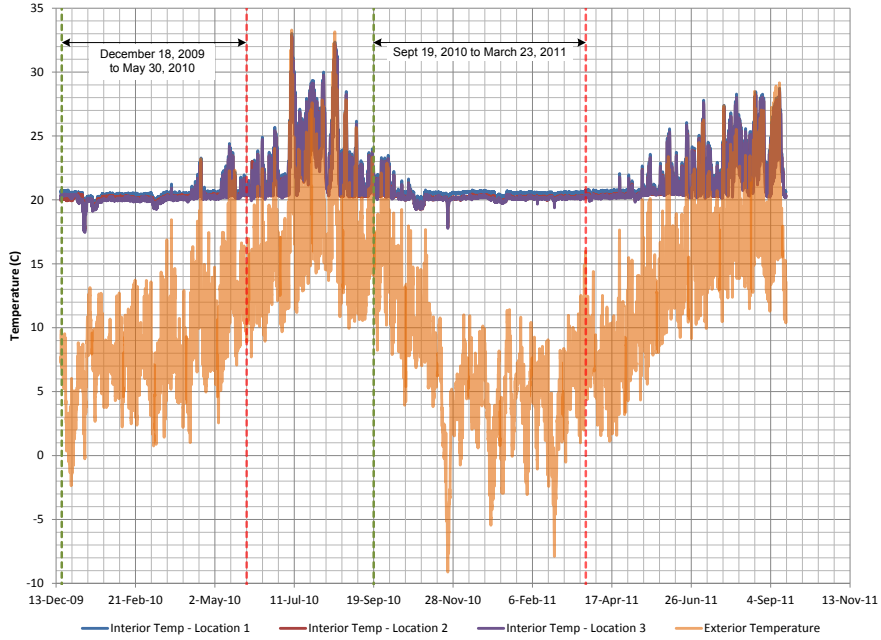
**Figure 40. Measured interior and ambient temperatures**

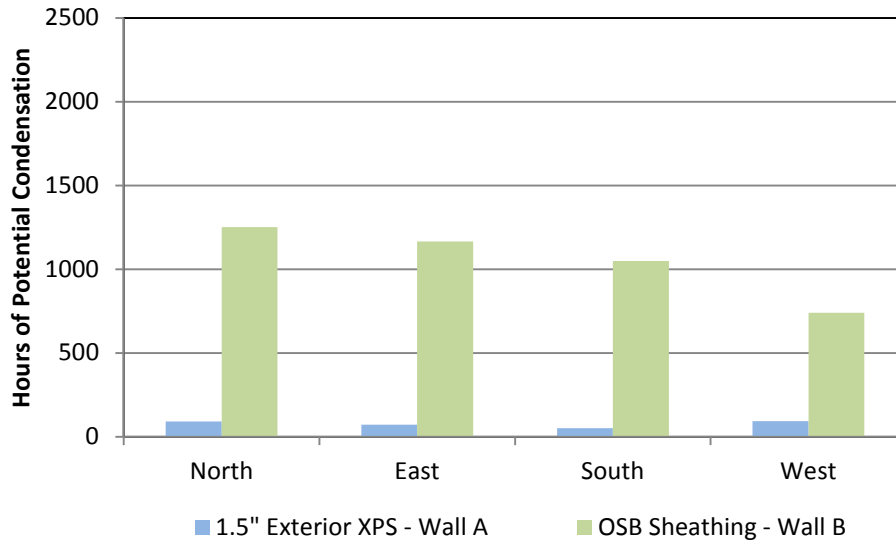
**Figure 42. Comparison of the hours of potential condensation between Wall B and Wall A from December 18, 2009, to May 30, 2010, using measured interior dew point and sheathing temperature**

The comparison results of this analysis are summarized numerically in Table 10 for both comparison time periods, and graphically in Figure 42 and Figure 43 for the individual analysis time periods. The results show a significant decrease in the number of measured potential hours of air leakage condensation when 38 mm (1½ in.) of XPS is installed as exterior insulation.

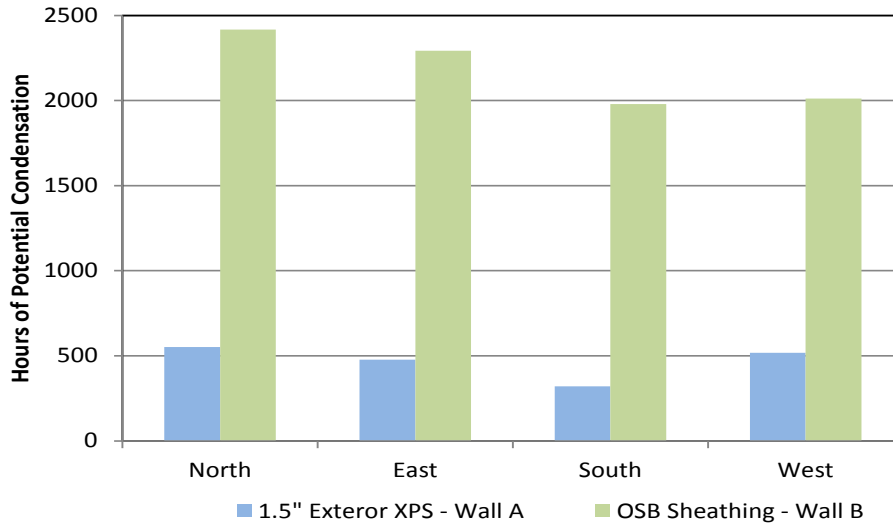
**Figure 43. Comparison of the hours of potential condensation between Wall B and Wall A from September 19, 2010, to March 23, 2011, using measured interior dew point and sheathing temperature**

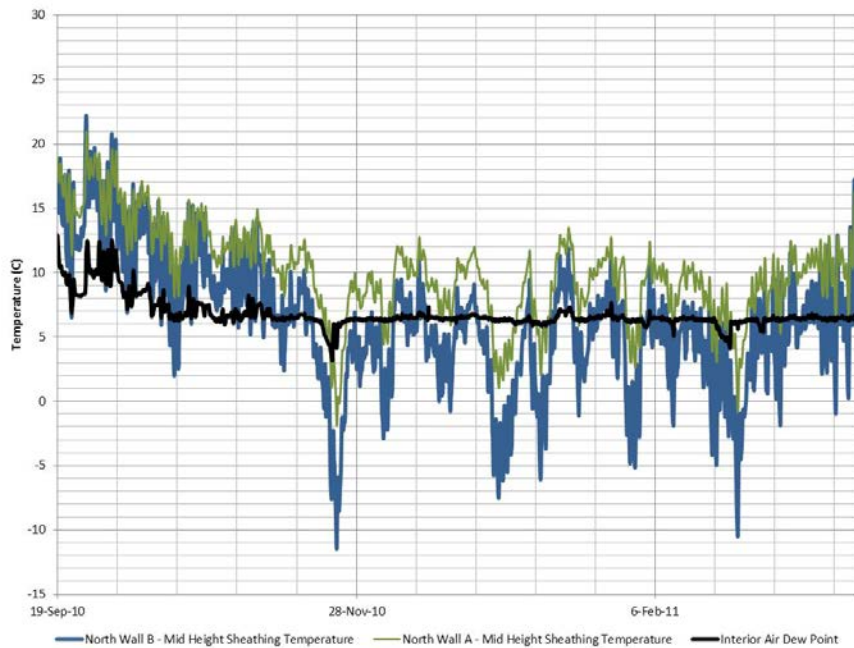
**Figure 45. Comparison of condensation potential between north walls A and B, September to March 2010**

These two figures show that the sheathing temperature for Wall B was much lower than Wall A for extended periods of time, which correlates with the numerical results of Table 10. This means that even with 1.5 in. of exterior XPS insulation, there is still a potential for a small amount of condensation, but significantly less than most building code minimum approved wall systems. If condensation does occur in Wall A, it will be able to dry much more quickly to the interior because latex paint is the only form of vapor control, compared to Wall B with a Class I polyethylene vapor barrier.

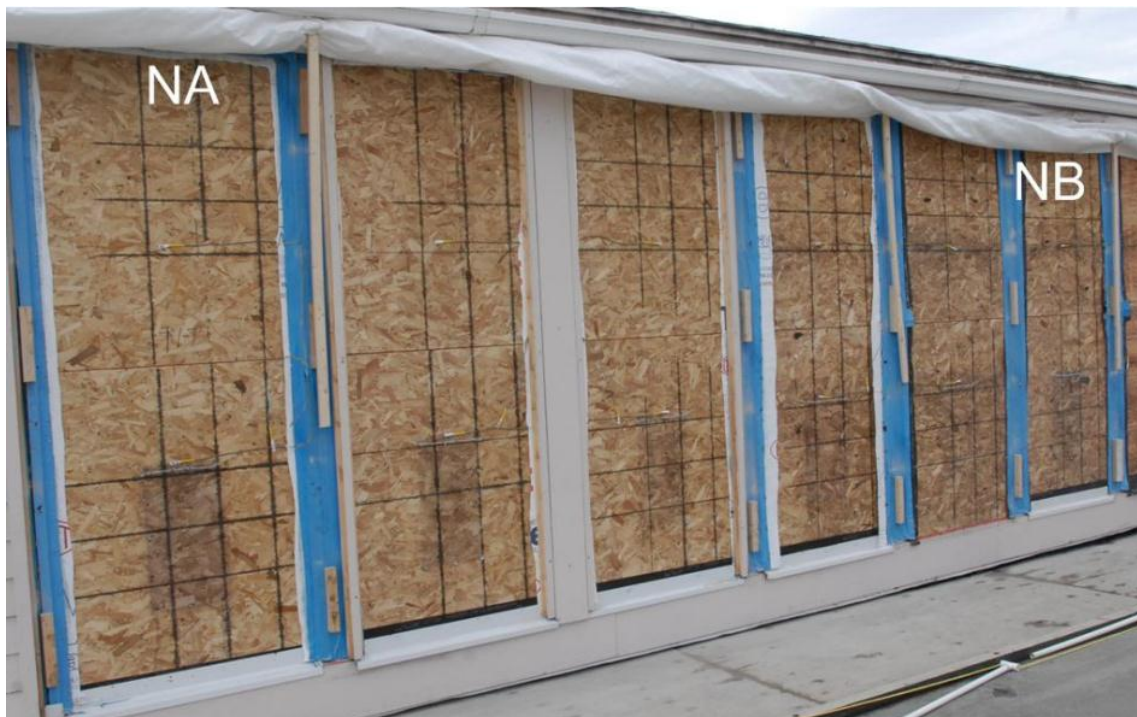
**Figure 46. Exterior OSB sheathing on the north orientation immediately following deconstruction**

Photos of the north orientation are shown in Figure 46 and Figure 47 from two different directions. Photos of the east and south orientation are shown in Figure 48 and Figure 49, respectively. Unlike the other orientations, there was no photo taken of the entire west elevation immediately following deconstruction.

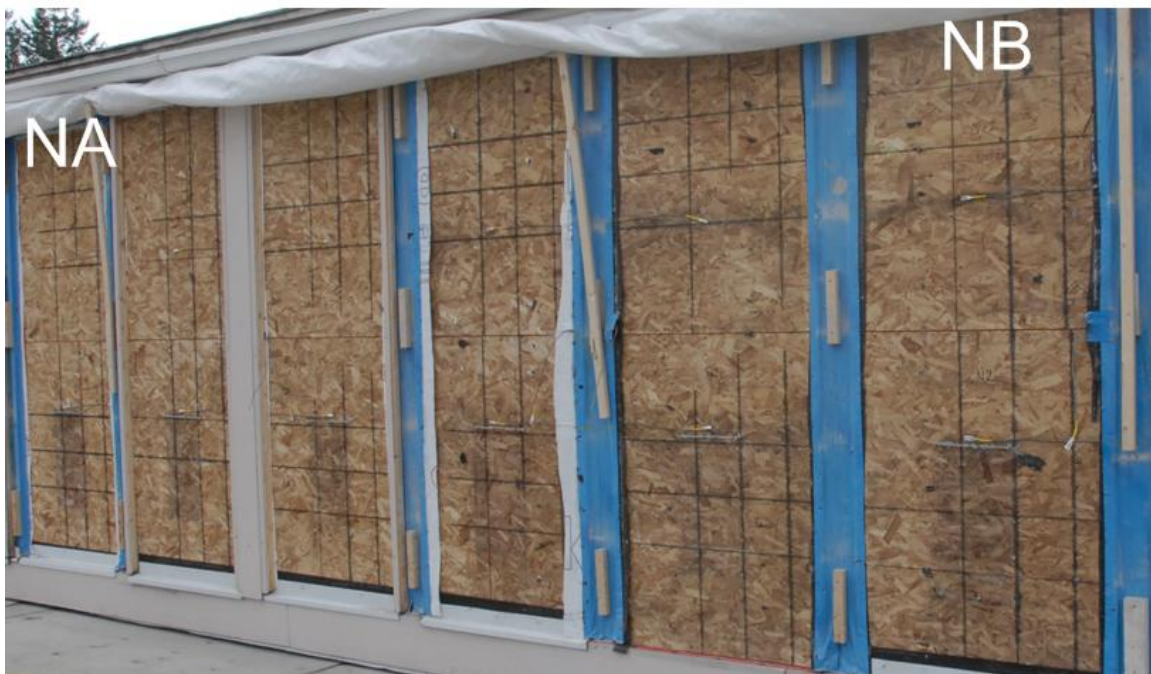
**Figure 47. Exterior OSB sheathing on the north orientation immediately following deconstruction (photo taken from the opposite direction of Figure 46)**

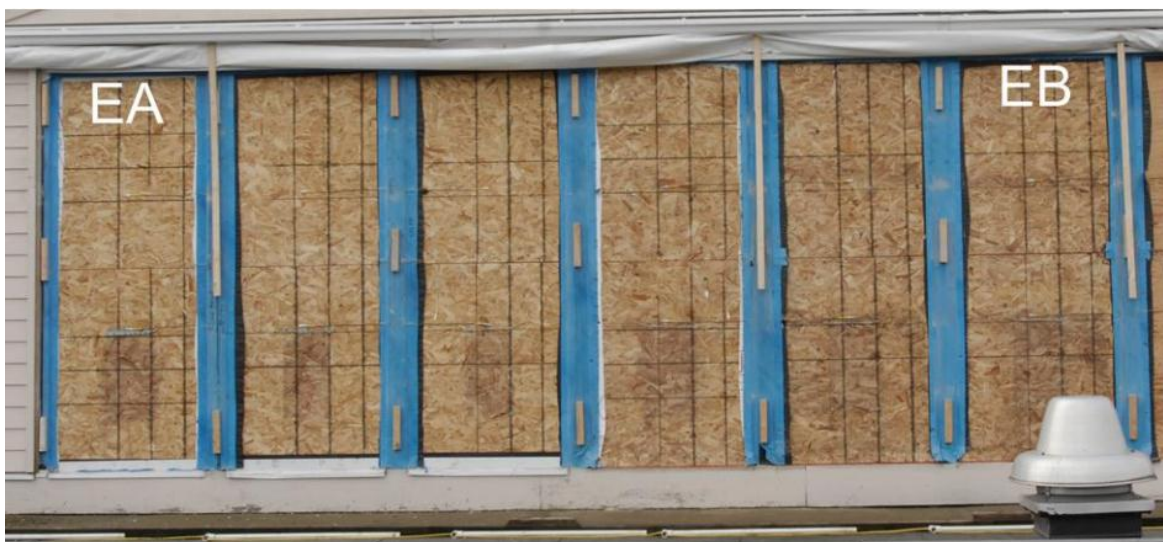
**Figure 48. Exterior OSB sheathing on the east orientation immediately following deconstruction**

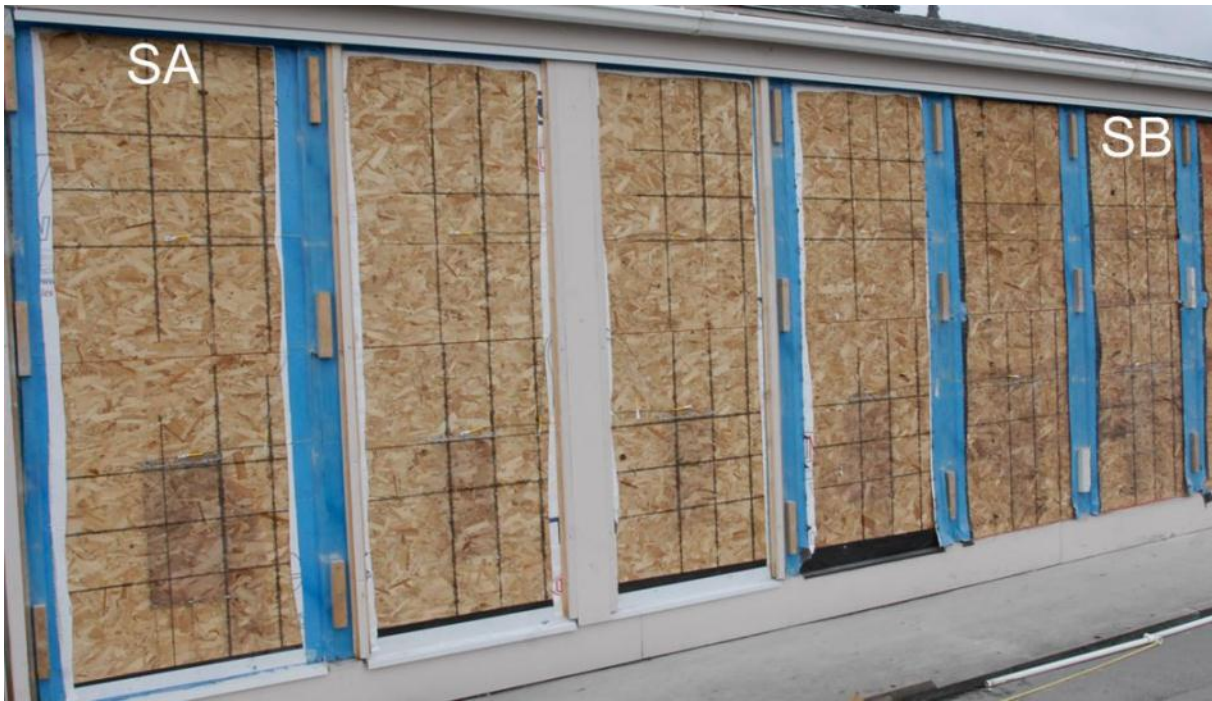
**Figure 49. Exterior OSB sheathing on the south orientation immediately following deconstruction**
