Proven Performance of Seven Cold Climate Deep Retrofit Homes

R. Osser, K. Neuhauser, and K. Ueno
Building Science Corporation

June 2012

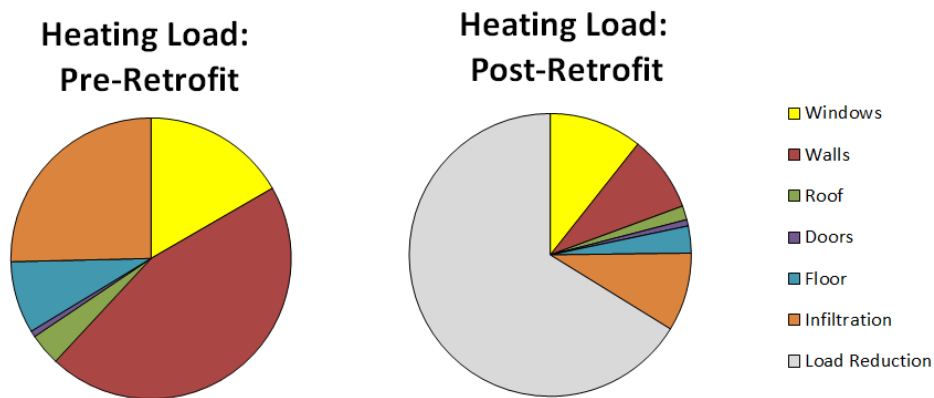
Figure 3. Sample pre- and post-DER heating load components

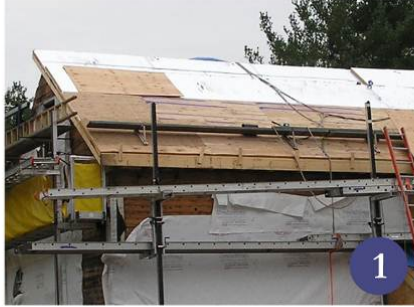
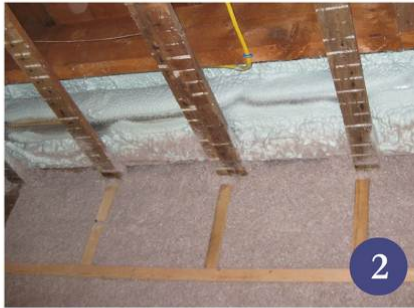
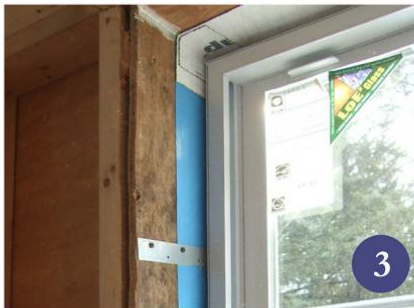
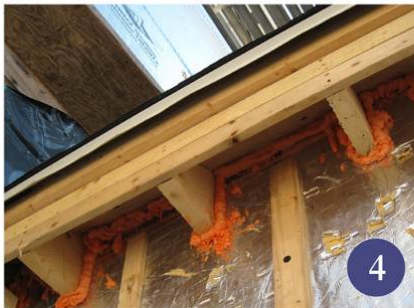
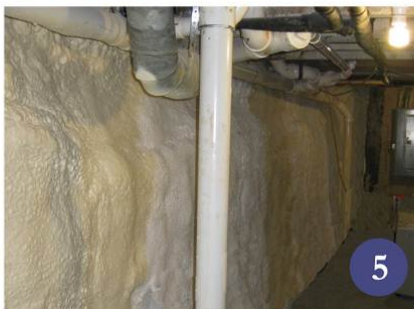
ENCLOSURE DESIGN

1 Roof Assembly: Rafter-framed unvented attic with R-56 roof insulation: unfaced fiberglass batt insulation (R-30) in rafter bay with two 2" layers of foil-faced polyisocyanurate insulating sheathing (R-26, joints staggered and taped) on top of existing/ repaired roof sheathing.

4 Air Sealing: The primary air flow control layer is the exterior face of the insulating sheathing with taped seams. Self-adhered membrane and low expansion foam sealants transition the air flow control at windows. Self-adhered ice/water membrane over the entire surface of the roof sheathing provides air flow control at the roof. Low expansion foam is used to transition the air barrier to roof framing and sheathing. Self-adhered membrane flashings transition the air control layer at the base of the above grade wall to the closed-cell foam applied to the interior of the foundation walls.

5 Foundation Assembly: Conditioned basement with 2-3" closed-cell spray foam insulation applied directly to field stone foundation walls and covered with FireFree 88® ignition barrier paint. A 12" high strip of 2" XPS as the slab perimeter thermal break also allows foundation walls to drain to the sub-slab drainage system. Trenches filled with gravel and drainage pipe connected to a sump manage bulk water below a new concrete basement floor slab, 6 mil poly, 2" XPS and continuous bed of gravel.

① **Heating:** 96% AFUE sealed-combustion gas furnace with a MERV 13 filter. Furnace installed in conditioned space.

③ **Space Conditioning Distribution:** Air handler and distribution entirely within conditioned space. Sheet metal trunks and run-outs. Ducted return from first floor with transfer grilles above bedroom doors.

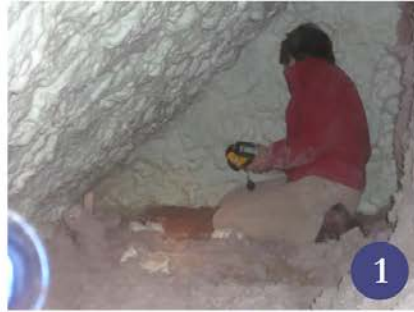
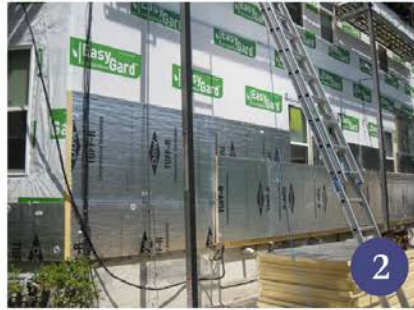
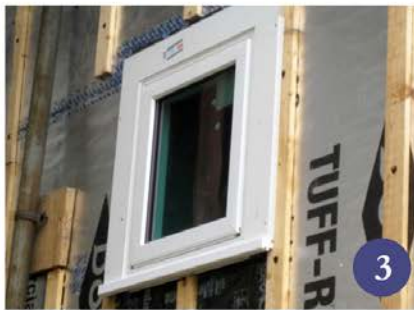
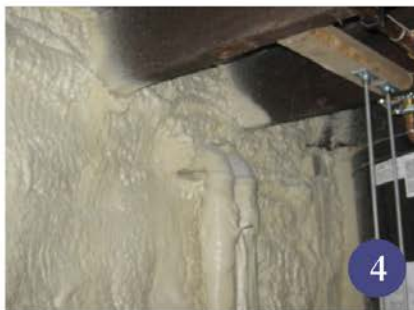
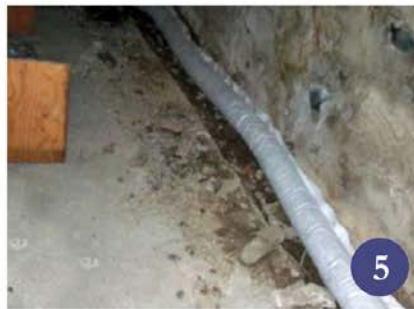
ENCLOSURE DESIGN

1 Roof Assembly: R-55 with 8" open-cell spray foam on the underside of the roof deck filling rafter bays; two layers of 2" foil-faced polyisocyanurate rigid insulation over existing roof sheathing with joints staggered and taped.

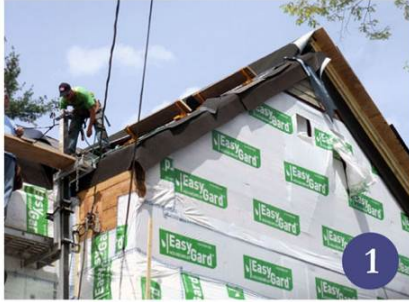
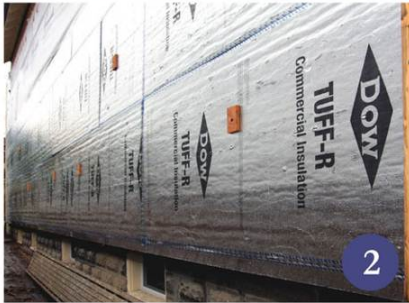
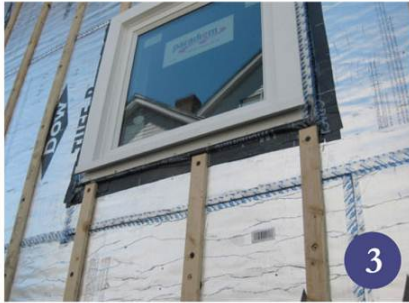
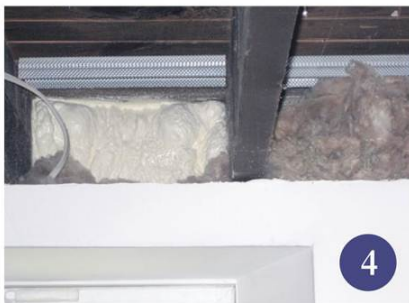
ENCLOSURE DESIGN

1 Roof Assembly: Compact (unvented) roof assembly with existing 7" deep rafter bays filled with netted cellulose insulation and with three 2" layers of foil-faced polyisocyanurate exterior insulating sheathing.

6 Site Generated Power: 4.3 kW PV system

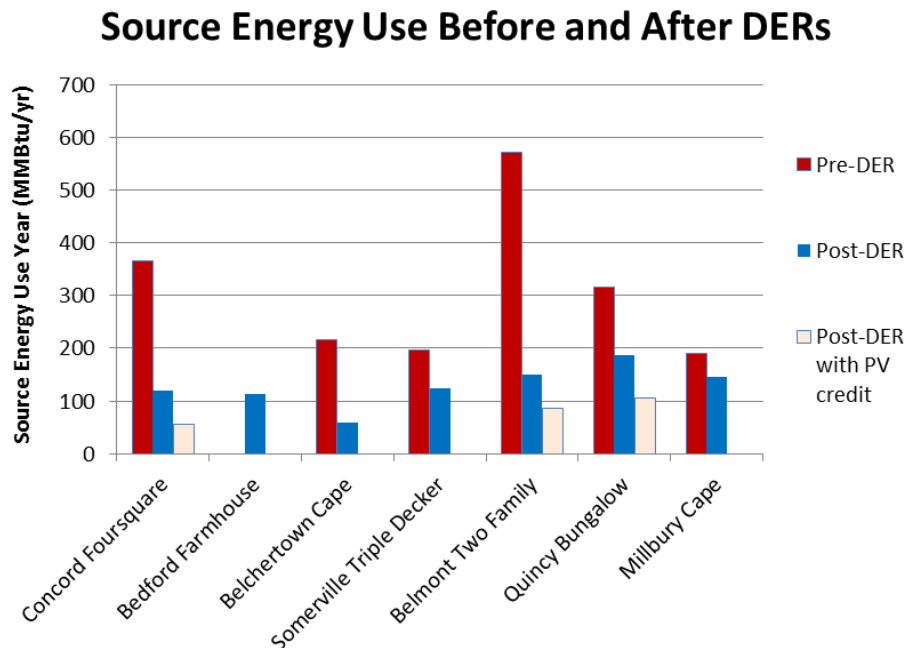
Figure 19. Source energy use before and after the retrofits for each of the 7 homes

As shown in Figure 19 and Figure 20, the Millbury Cape has the highest post-retrofit source energy use per square foot of conditioned area. The energy performance of this home compared to others is worse than anticipated; however, there are several possible factors contributing to the higher normalized energy use. One factor is that it is the smallest home in the group at only 1,868 ft², including the 768 ft² basement (Table 2). Although the Belchertown Cape is similarly sized at 1,907 ft², including the basement, it is known that the owners are extremely frugal with energy use and tolerant of more extreme interior temperatures, as described in Section 3.3.3. Smaller homes tend to have proportionally higher energy use indices because of their increased surface area to volume ratio and issues such as the fact that essentially the same appliances and miscellaneous loads are contained within a smaller space. The Millbury Cape’s source energy reduction is also confused by the fact that there was a fuel switch from oil and pellets to heat pump electricity and pellets. Wood pellets are considered to have a source to site energy ratio of 1; the factor used for electricity is 3.34 (Figure 18). Additionally, the Millbury Cape homeowners added central air conditioning in the summer. The window units they used previously may have been less frequently operated. Additional investigation and continued monitoring are needed to fully understand the long-term performance of the home.

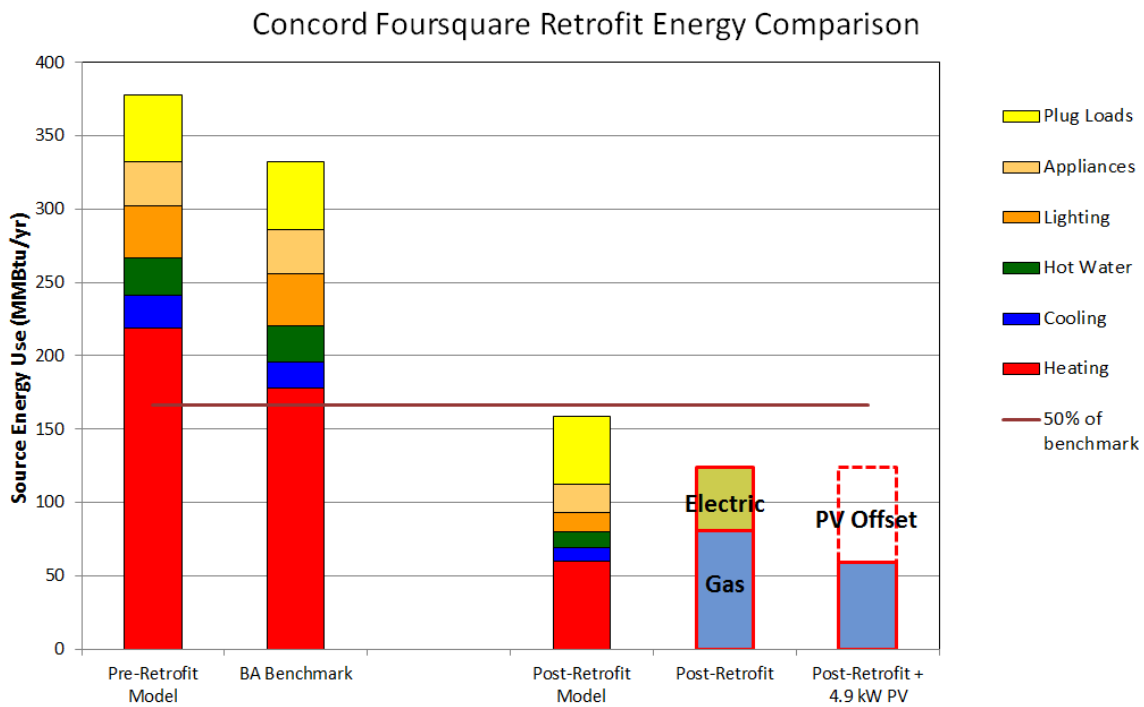
Figure 21. Concord Foursquare energy modeling comparison

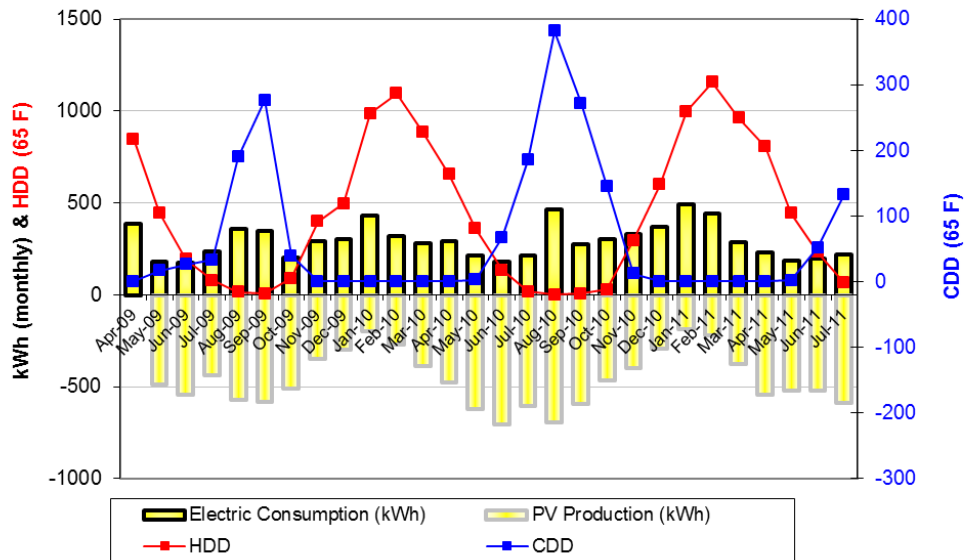
Figure 22. Monthly electricity use and generation of the Concord Foursquare

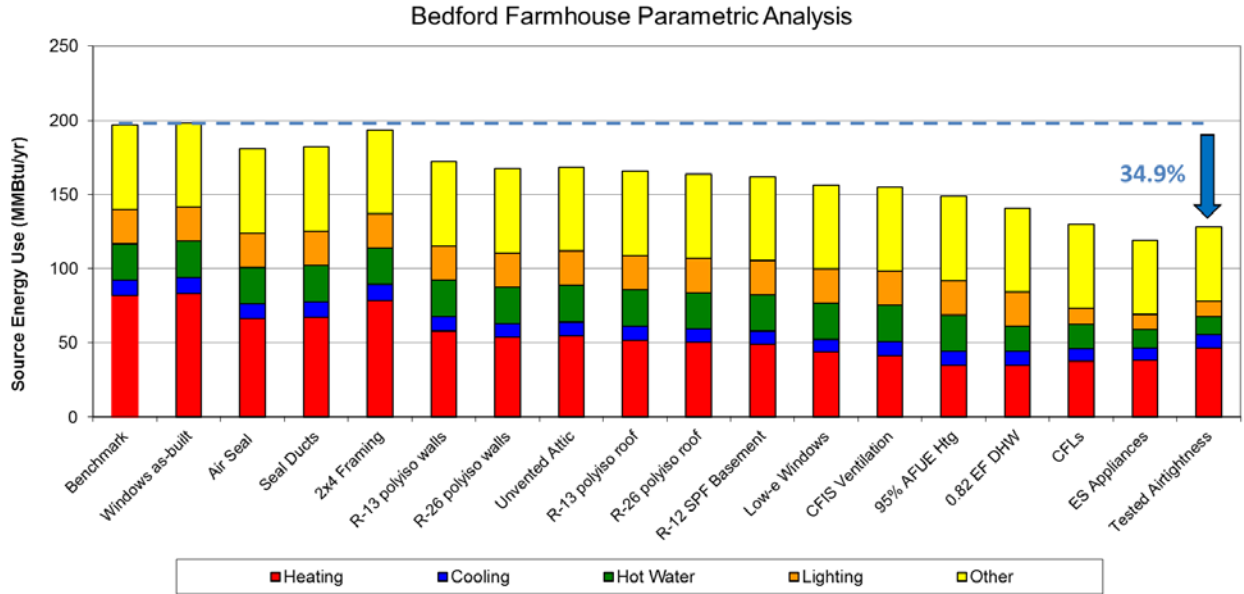
Figure 24. Parametric energy modeling of the Bedford Farmhouse

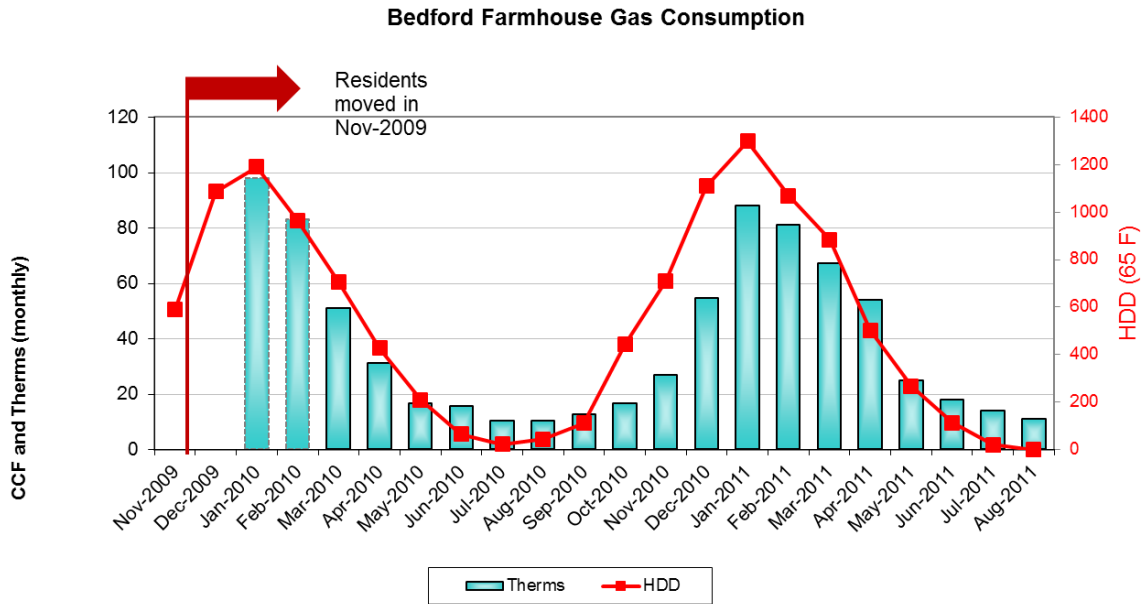
Figure 26. Gas consumption monitoring of the Bedford Farmhouse

Utility bills from the completed Bedford Farmhouse have been monitored by BSC since April 2009 (Figure 25 and Figure 26). Trending shows typical seasonal variation. More than a year of post-move-in data was available, enabling initial evaluation of post-retrofit performance.

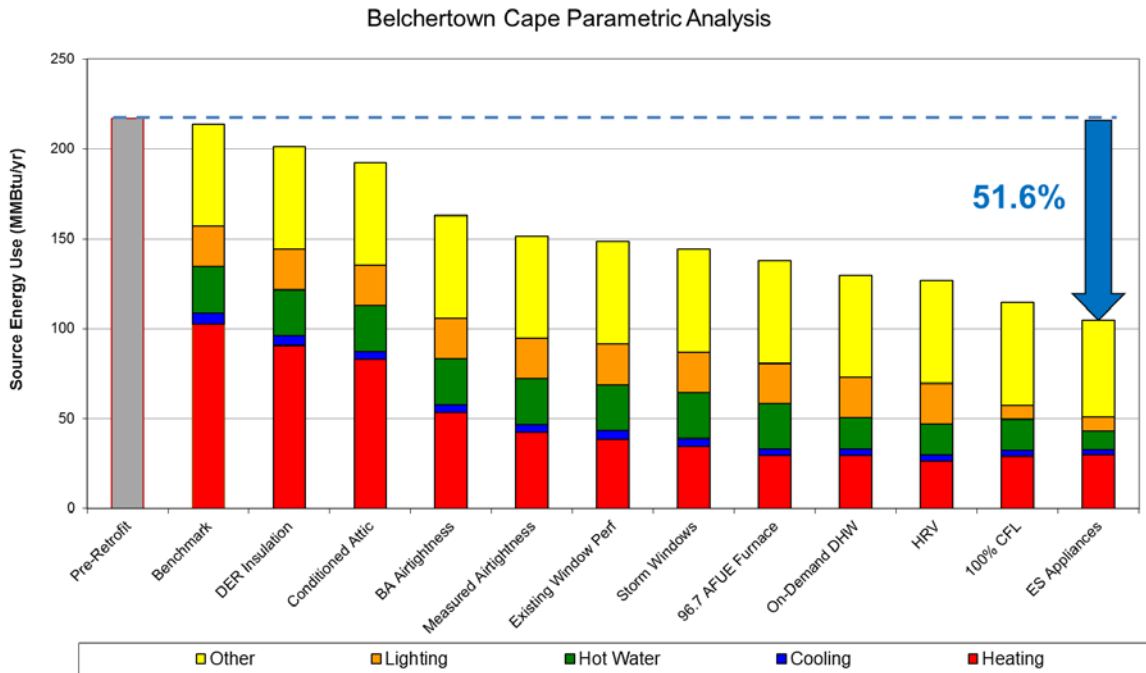
Figure 27. Parametric energy analysis of the Belchertown Cape

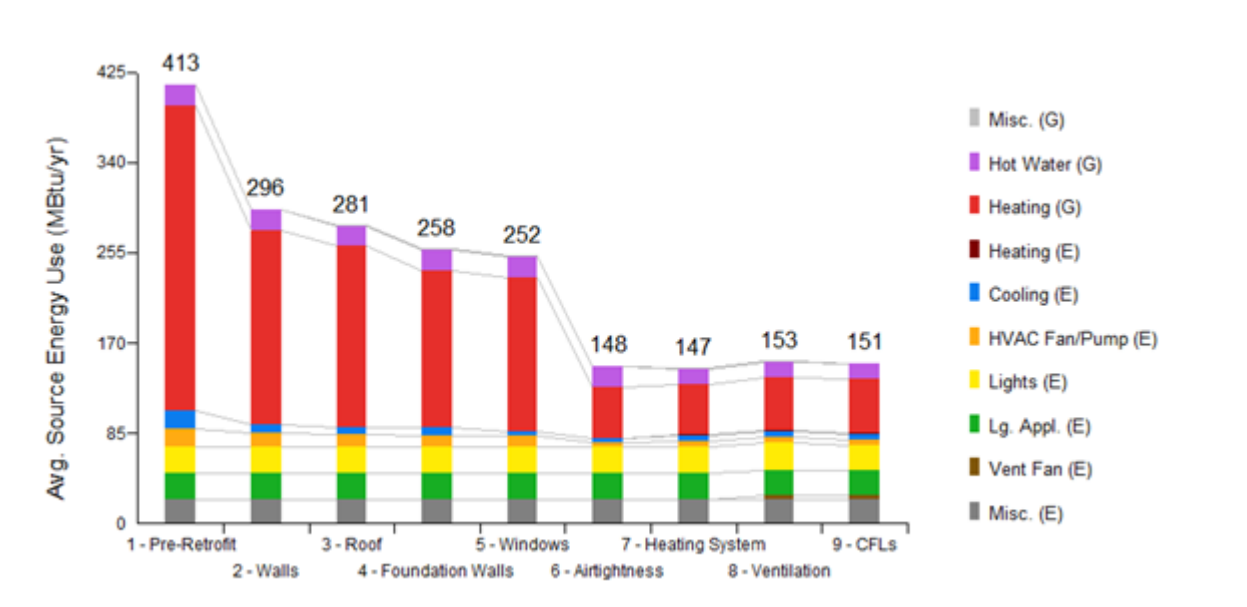
Figure 30. Parametric energy modeling of the Somerville Triple Decker

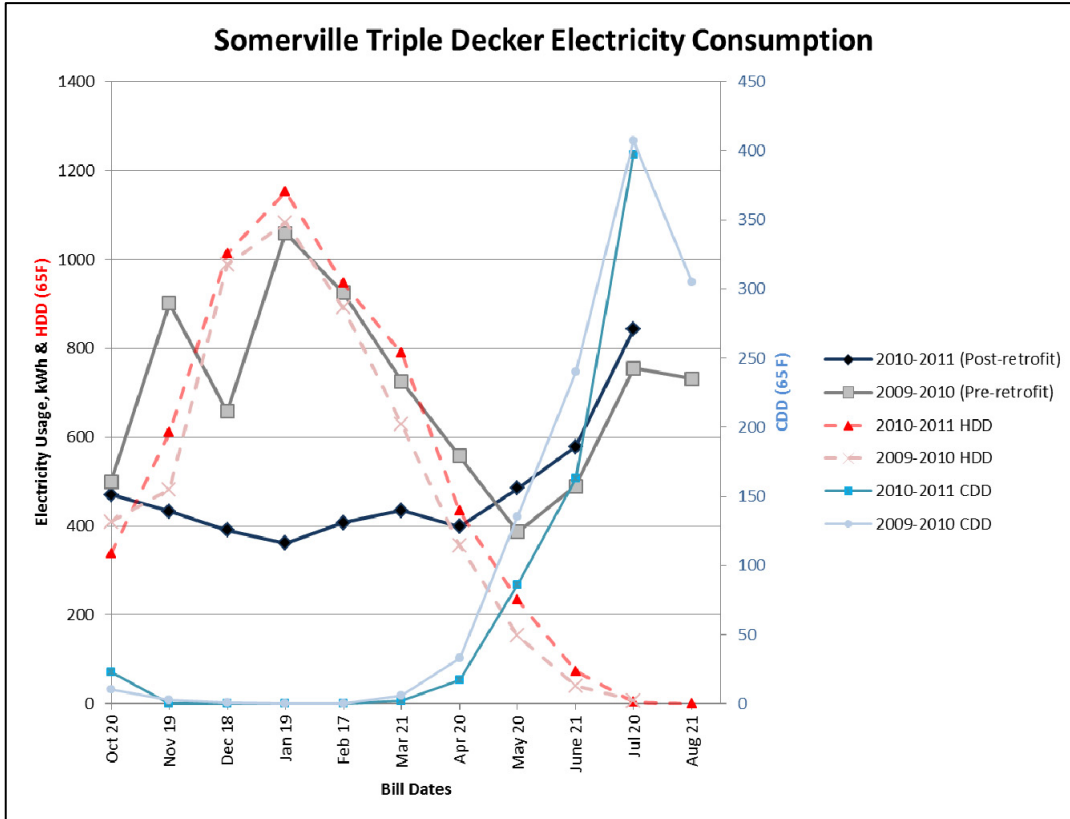
Figure 31. Somerville Triple Decker Electric consumption

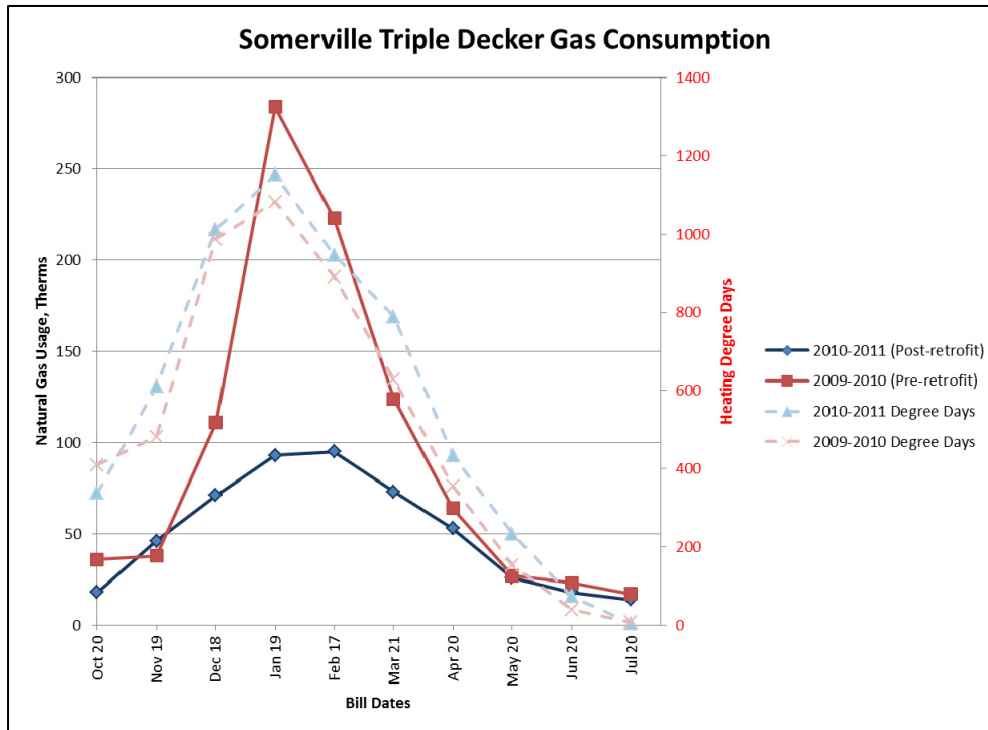
Figure 32. Somerville Triple Decker Gas consumption

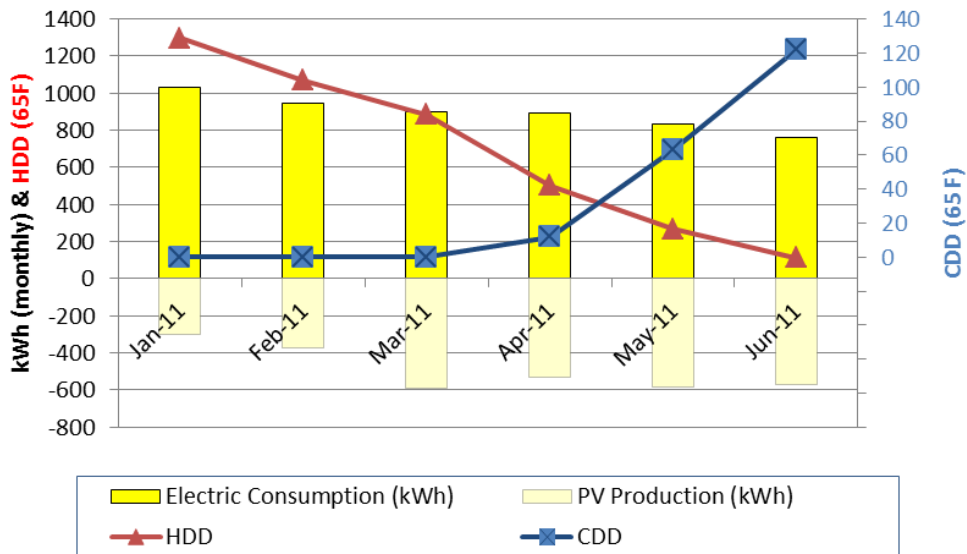
Figure 36. Belmont Two Family post-retrofit electricity use and generation

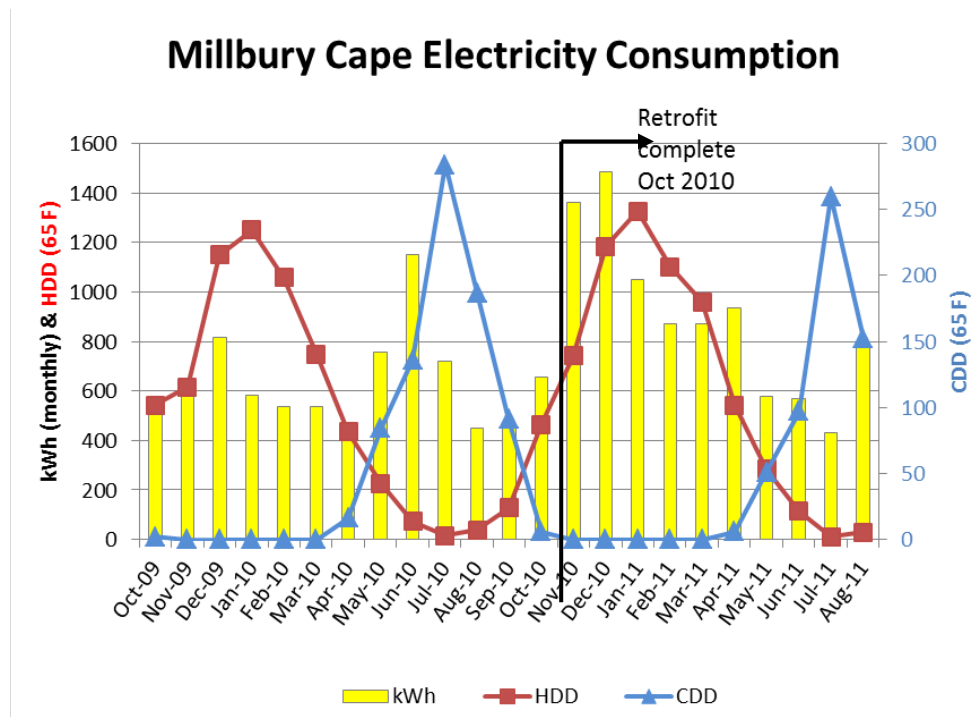
Figure 41. Pre- and post-retrofit monthly electricity use for the Millbury Cape

Available electricity use from before and after the retrofit is graphed in Figure 41. Monthly incremental use data of delivered fuels (pellets, oil, and propane) were not available; only total use data were available for the calculations in Table 5. Because of the switch from oil to air source heat pump heating, electricity use actually increased after the retrofit from 7,570 to 11,058 kWh/yr.

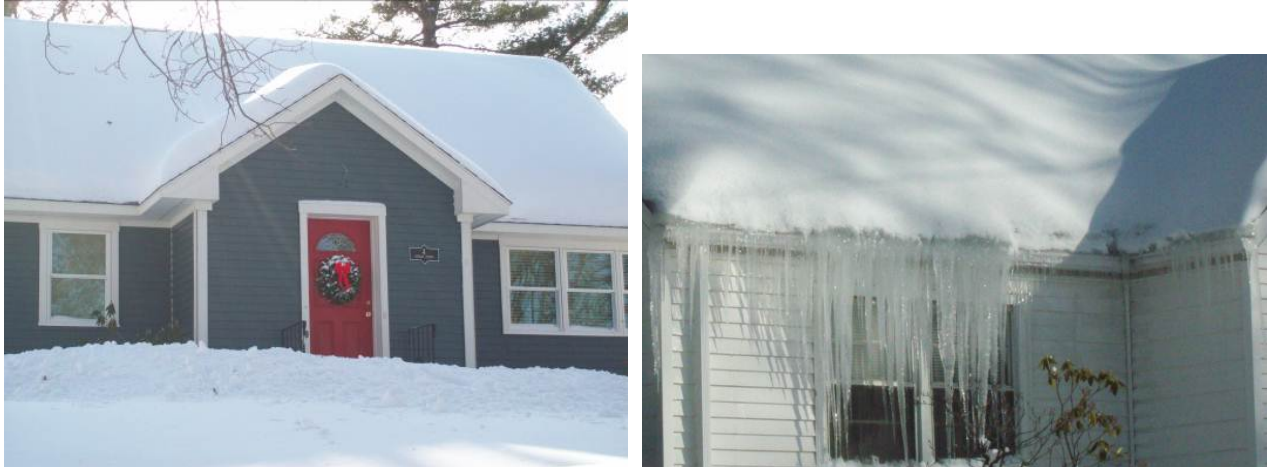
Figure 43. Left: Post-retrofit Millbury Cape; Right: Neighbor’s home with ice dams

In addition to positive comments about thermal comfort, the owners of the Millbury Cape and Somerville Triple Decker, who had both lived in their homes prior to the retrofit, noted the lack of ice dams following the roof insulation and air sealing (Figure 43). Ice dams typically occur when conductive heat or warm air escaping the roof melts snow, which then refreezes after running down to the edge of the roof (Lstiburek 2011). Ice dams often lead to water leakage into building assemblies. Worse, when an ice dam gets too heavy it can snap off, sometimes taking a piece of roof with it. Ice dams can be prevented by keeping the roof surface as cold as possible. With a vented roof, this is done by insulating and air sealing the attic floor well and ensuring outside air ventilation under the roof. For the Millbury Cape, 2 × 4s on the flat were inserted between the insulating sheathing and the outer layer of plywood, creating a vented roof capped by a ridge vent. In this case, the 2 × 4s were attached to the existing roof rafters and the plywood sheathing was attached to the 2 × 4s. This created a “vented over-roof,” successfully keeping the roof cold while still creating an attic space within the thermal enclosure.
