Retrofitting the Southeast: The Cool Energy House

W. Zoeller, C. Shapiro, G. Vijayakumar,
and S. Puttagunta

Consortium for Advanced Residential Buildings

February 2013

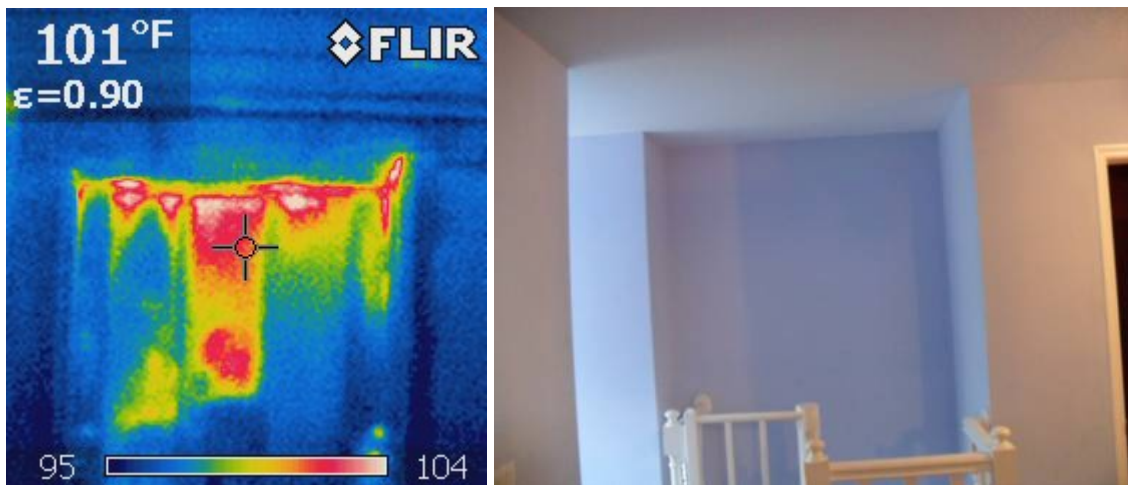
Figure 4. Thermal losses caused by poor wall insulation installation and air leakage, pre-retrofit

An energy audit of the CEH was conducted on a peak cooling-load day for Florida, August 2, 2011, and included a blower door test, a duct-blaster test, and IR photography to evaluate thermal deficiencies in the envelope. A visual inspection revealed that exterior walls had Kraft-faced fiberglass batts installed as insulation, which was evaluated as Grade III, with many gaps and voids. Although existing insulation was nominally rated as R-19 and R-13, respectively, the first floor 2×6 walls were estimated to have a de-rated R-value between 10 and 12, and the second and third floor 2×4 walls were estimated to have de-rated R-values between 7 and 9.

The attic floor had 5–8 in. of blown fiberglass insulation, resulting in an overall R-value of about 19. Air infiltration was calculated using a blower door; the infiltration rate was measured at 3,650 CFM50, or 6 ACH50 (air changes per hour at 50 Pascal). Though this rate meets current ENERGY STAR[®] Version 3 (EPA 2012). National Program requirements for homes following the prescriptive path in this climate zone, this still provides considerable room for improvement in building tightness. With the blower door test in progress, an IR camera was used to document thermal deficiencies and air leakage, as shown in Figure 4. Potential areas for envelope improvements identified in this 16-year-old house were air leakage, poorly installed insulation, and the lack of an effective air barrier separating the finished attic space from the vented attic.

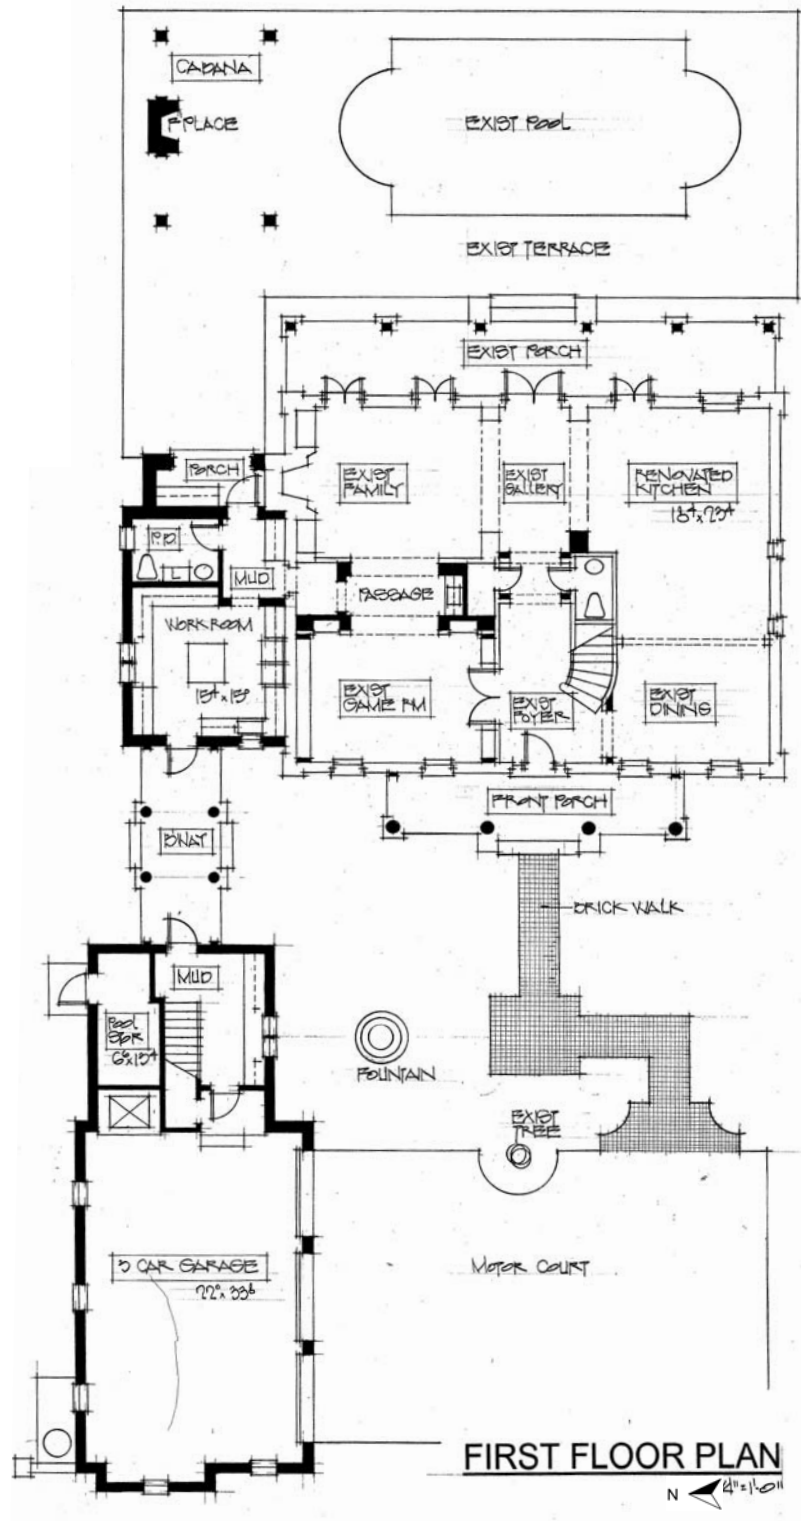
Figure 5. First floor plans, post-retrofit [Image courtesy of Winter Park Design]

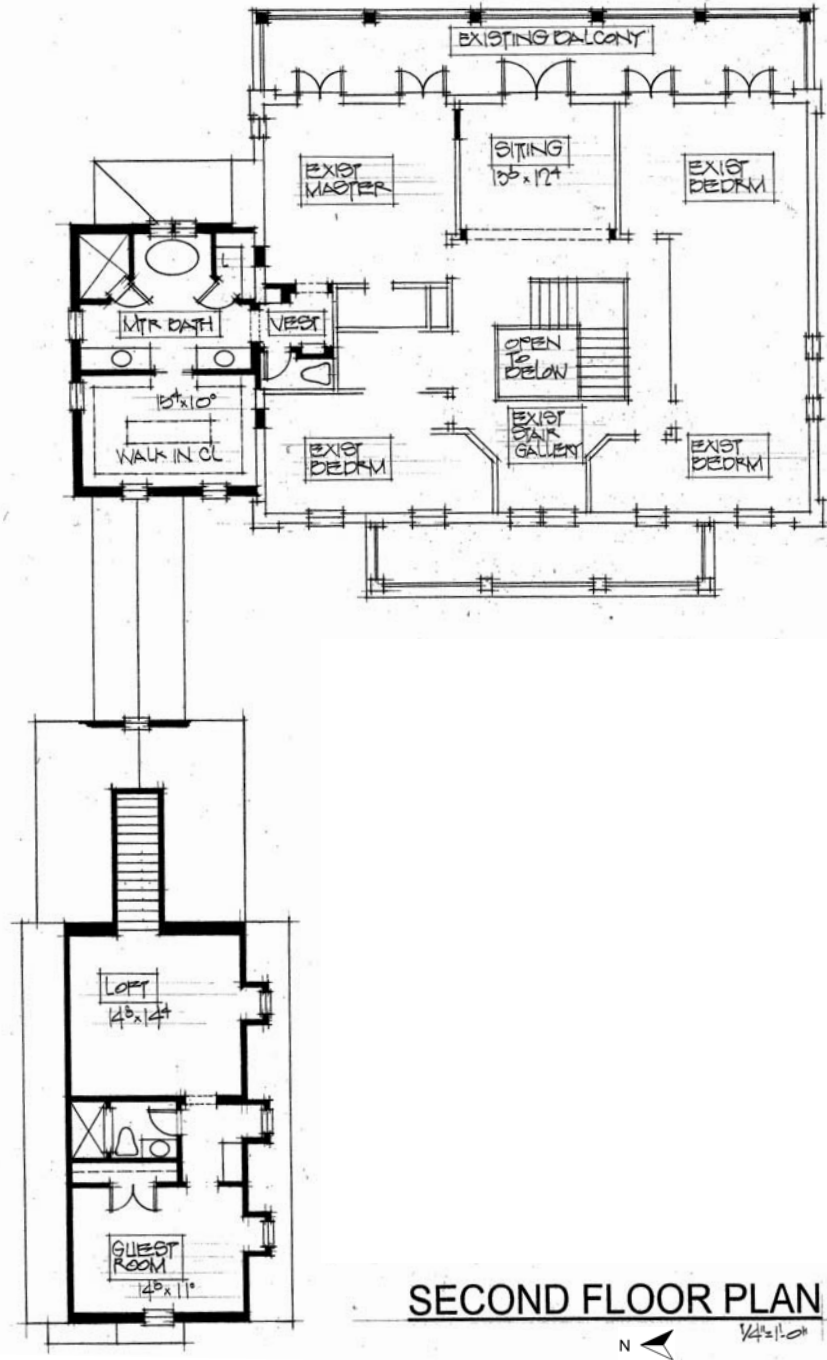
Figure 6. Second floor plans, post-retrofit [Image courtesy of Winter Park Design]

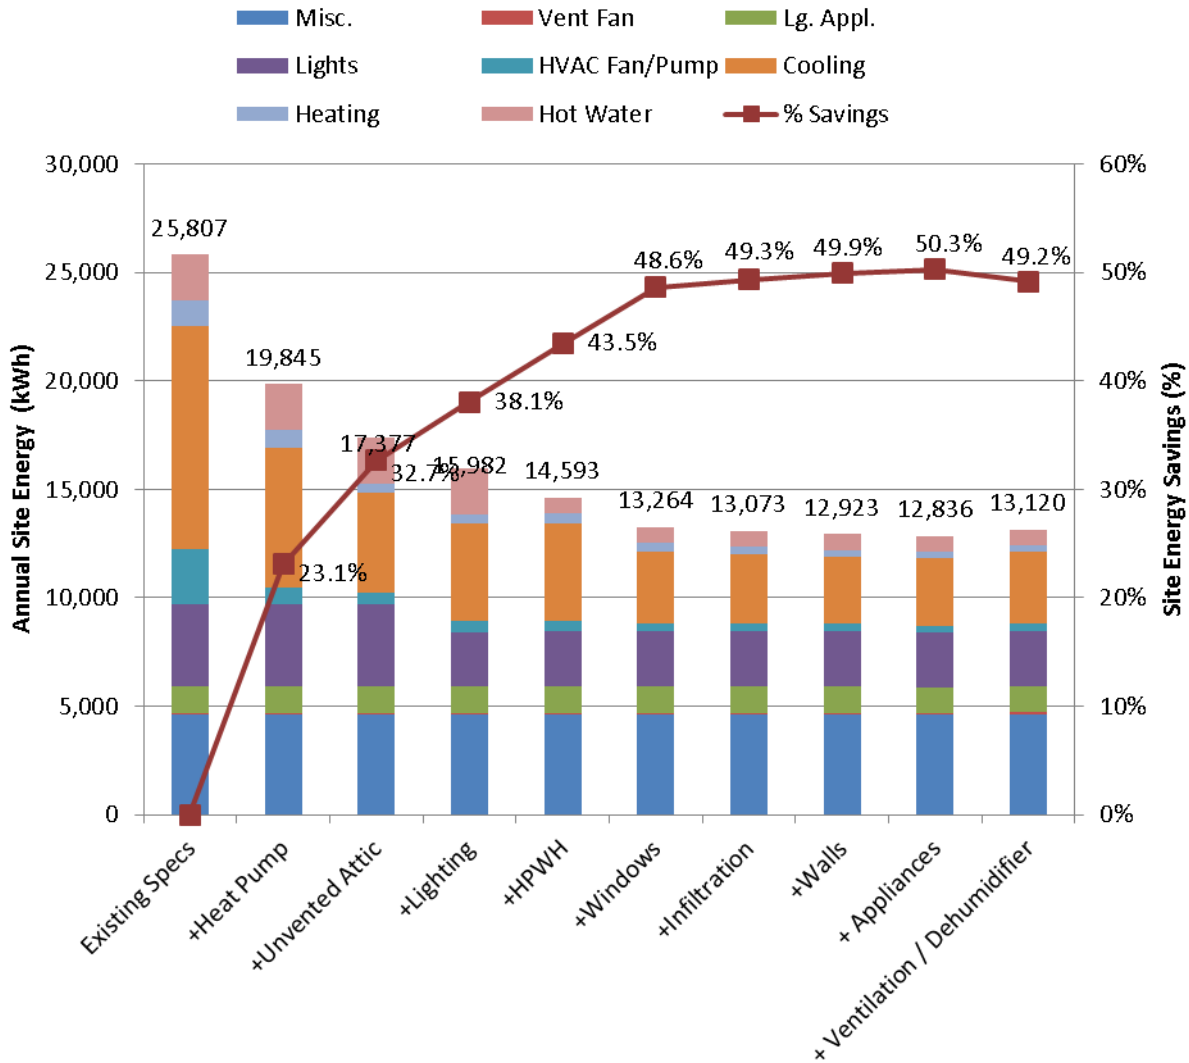
Figure 7. Cumulative contribution to total simulated energy savings, by measure and end use

Figure 7 shows the cumulative energy savings by measure and their individual impacts on the whole-house energy savings. The new air-source heat pumps contributed the most; the unvented

“conditioned” attic and HPWHs came in second and third, respectively. Improvements to lighting and windows contributed a little more than 5% each to the total 49% savings.

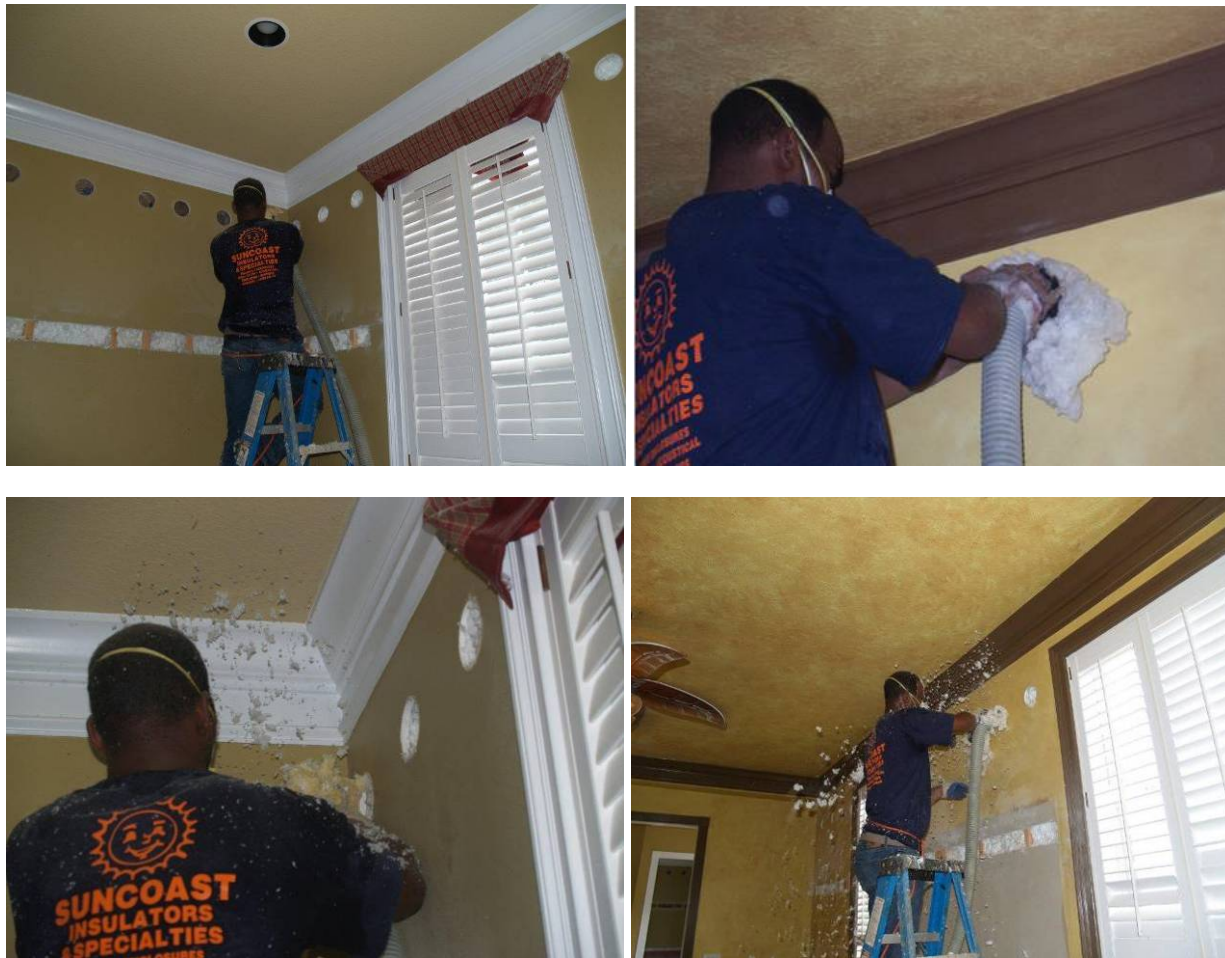
Figure 8. Process of insulating the walls [Images courtesy of BARA]

CARB took a unique approach to enhancing the home's existing insulation that aligned with the need to be as low impact as possible to interior and exterior finishes. The team cut 6-in. bands in the interior drywall at the 4-ft fire blocking level. This allowed chopped fiberglass product bearing a small amount of adhesive to be blown into the wall cavity (see Figure 8). At first, 4-in. holes were attempted to blow in fiberglass, but did not provide enough access for complete fill, so the team switched to 6-in. band cuts. After the walls were insulated, the 6-in. gaps were sealed and repainted. This new application resulted in a more complete fill of the exterior walls with the combined existing batts and added blown fiberglass. This improved the R-value of the wall assembly and likely decreased air infiltration. However, only stud bay cavities could be accessed in this manner. Three-stud corners, partition Ts, and heavily blocked areas remain inaccessible.

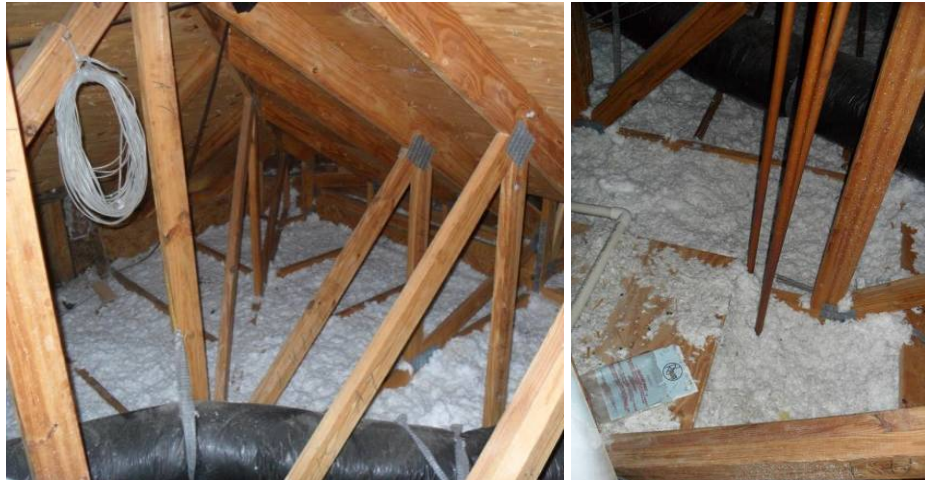
Figure 9. Attic floor insulation, pre-retrofit

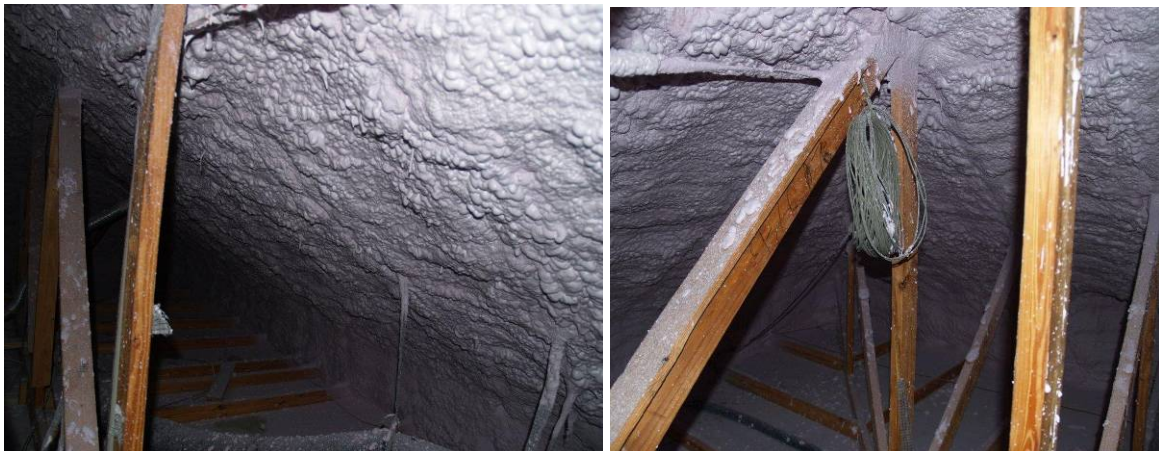
Figure 10. Attic roof deck insulation, post-retrofit [Images courtesy of BARA]

Not only did the energy audit identify air leakage from the unconditioned attic, equipment and ductwork were also located in this space, contributing to energy losses. Rather than upgrading the insulation at the attic floor (Figure 9), the roof deck was insulated by using closed-cell spray polyurethane foam at the inside surface of the roof deck (Figure 10). This increased the R-value from 19 to 30, turned a vented attic into an unvented attic and brought the equipment and ductwork into conditioned space. Added nonenergy benefits of this measure are the improvement to the roof deck’s uplift resistance and its resistance to moisture intrusion, both valuable in this hurricane-prone area.

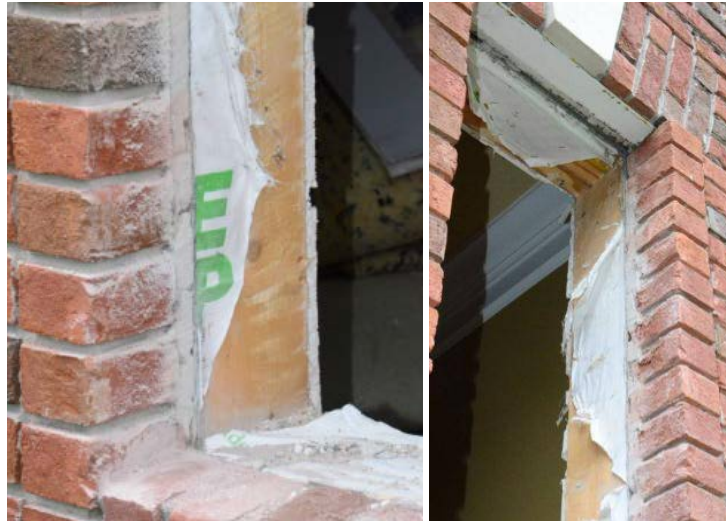
Figure 11. Rough opening after window removal [Images courtesy of BARA]

Existing windows were aluminum-framed, double-paned in most of the house, except for the single-pane wood-framed French-doors at the rear. Glazing certainly contributed to the high cooling load (40% of the home's design cooling load was due to solar heat gain). Although some of the fenestration was doubled-glazed, energy modeling indicated it was worth the effort and cost to replace the windows and French doors. However, the double-wall, brick-veneer construction presented an installation challenge. The team had to determine how to retroactively flash the window openings to prevent moisture migration into the building envelope.

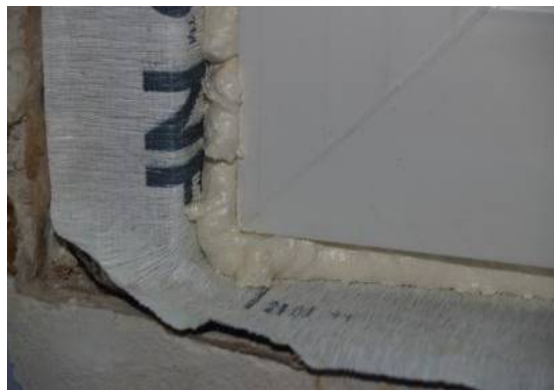
Figure 12. Foam sealant at window unit interior [Image courtesy of BARA]

The homeowner also wanted the replacement vinyl windows (U-0.28, SHGC-0.21) to look like the originals, so the builder had to flash and install them at the interface between the brick veneer and the framed wall. The solution was to wrap the entire rough opening with a treated wood buck detail that lapped over the air space between the brick veneer and the wall framing. The new head, jamb, and sill buck were wrapped with butyl flashing tape, which also formed a pan flashing at the sill. The new window frame was secured to the new wood buck (Figure 12). Snap-on exterior window trim components covered the tape, with a caulk bead added between the trim and the brick to finish the installation.

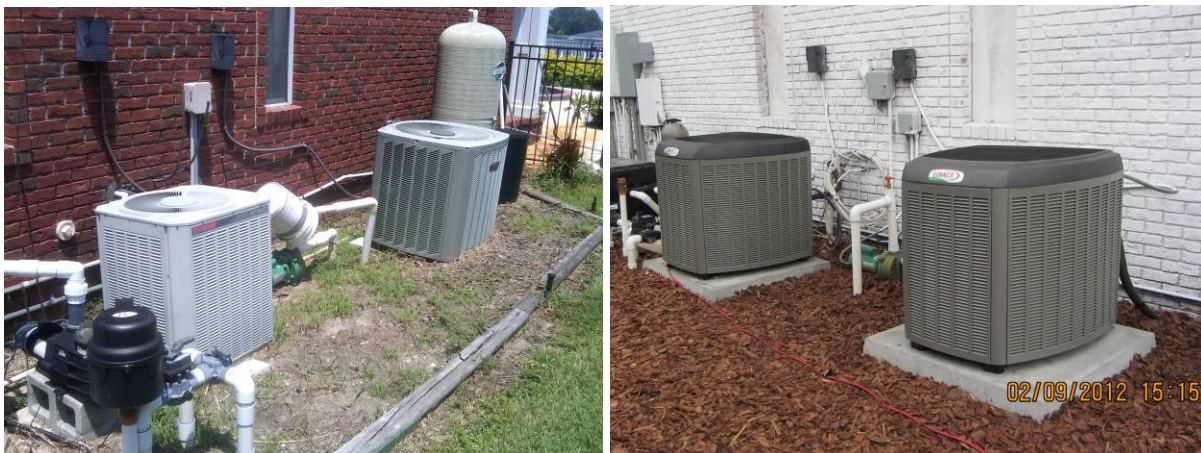
Figure 13. Heat pump compressors, pre- and post-retrofit

Existing	Post-Retrofit
Second and Third Floor Heat Pump	Trane XB13	Lennox XP17
Year Installed	2008	2012
Rated Cooling Capacity	33,400 Btu/h	25,000 Btu/h
Rated SEER	13.0	17.5
Rated Heating Capacity	31,800 Btu/h	22,200 Btu/h
Rated HSPF	7.7	9.5

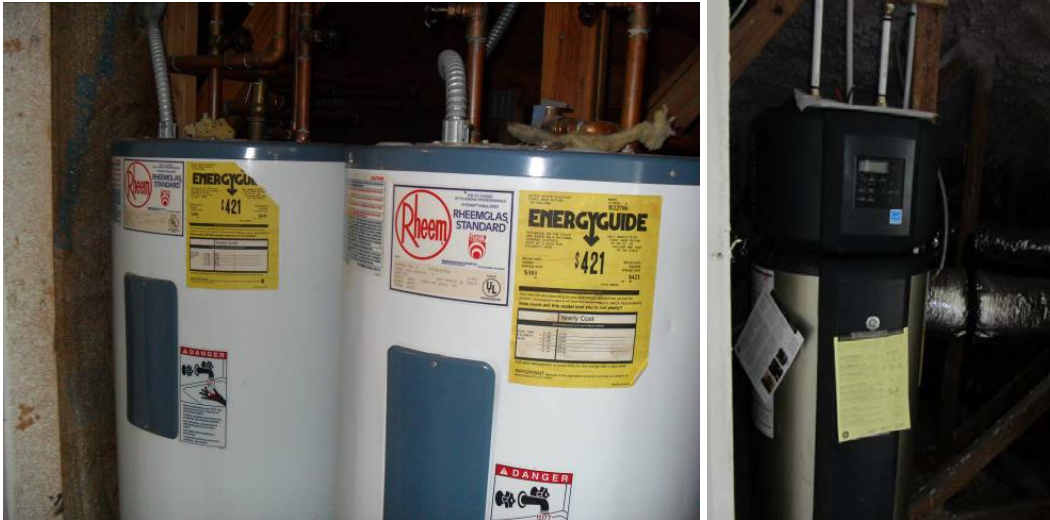
Figure 14. Electric resistance storage water heaters, pre-retrofit (left) and one of two electric HPWHs, post-retrofit (right)

The 16-year-old electric resistance storage water heaters were previously also located in the vented attic. These were removed and replaced with two new HPWHs (Figure 14), increasing the rated energy factor from 0.91 to 2.4 and reducing hot water energy use by 67%. One of the new units was placed in a first floor closet in the new addition and the other in the unvented attic.

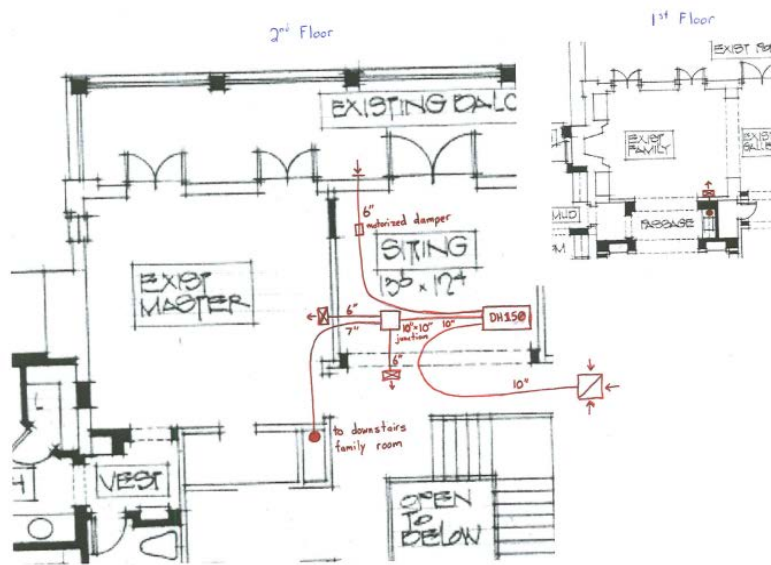
Figure 15. Designed configuration of whole-house dehumidifier

To meet ASHRAE 62.2 whole-house ventilation rate recommendations for this renovated four-bedroom, 4,700-ft² home, meant providing at least 85 CFM of fresh air. In hot-humid climates, a supply ventilation strategy is often preferred over an exhaust only strategy, so that the incoming ventilation air can be pre-conditioned. The Honeywell TrueDRY DH150 was installed to provide whole-house supply-only ventilation as well as dehumidification. A 6-in. duct brings in fresh outdoor air, mixes with air from a 10-in. return duct from the stairwell of the home, is dehumidified as needed, and supplied back to the home via a 10-in. duct. The 10-in. supply duct feeds three branches going to the master bedroom, upstairs landing, and downstairs family room.

Control of this unit was specified to be the Honeywell’s TrueIAQ digital control. This control shows indoor and outdoor temperature and relative humidity, the actual and desired humidity setting, and maintenance/service reminders. Figure 15 shows the designed inlets and outlets of the dehumidifier. Unfortunately, the system was installed with a basic humidistat so whole-house ventilation is provided only when relative humidity levels in the home exceed 60%. For modeling purposes, it was assumed that 50% of ASHRAE 62.2-2010 would be provided over the course of a year (anticipated to be near 100% run time during the summer months and 50% or less for the remainder of the year). Although this whole-house ventilation measure increased annual energy use in the energy model by nearly 300 kWh, reducing the overall savings from 50.3% to 49.2%, it does improve indoor air quality and thermal comfort. The dehumidification of the whole-house ventilation air is also expected to lead to additional savings on the cooling side, but cannot be modeled in BEopt.

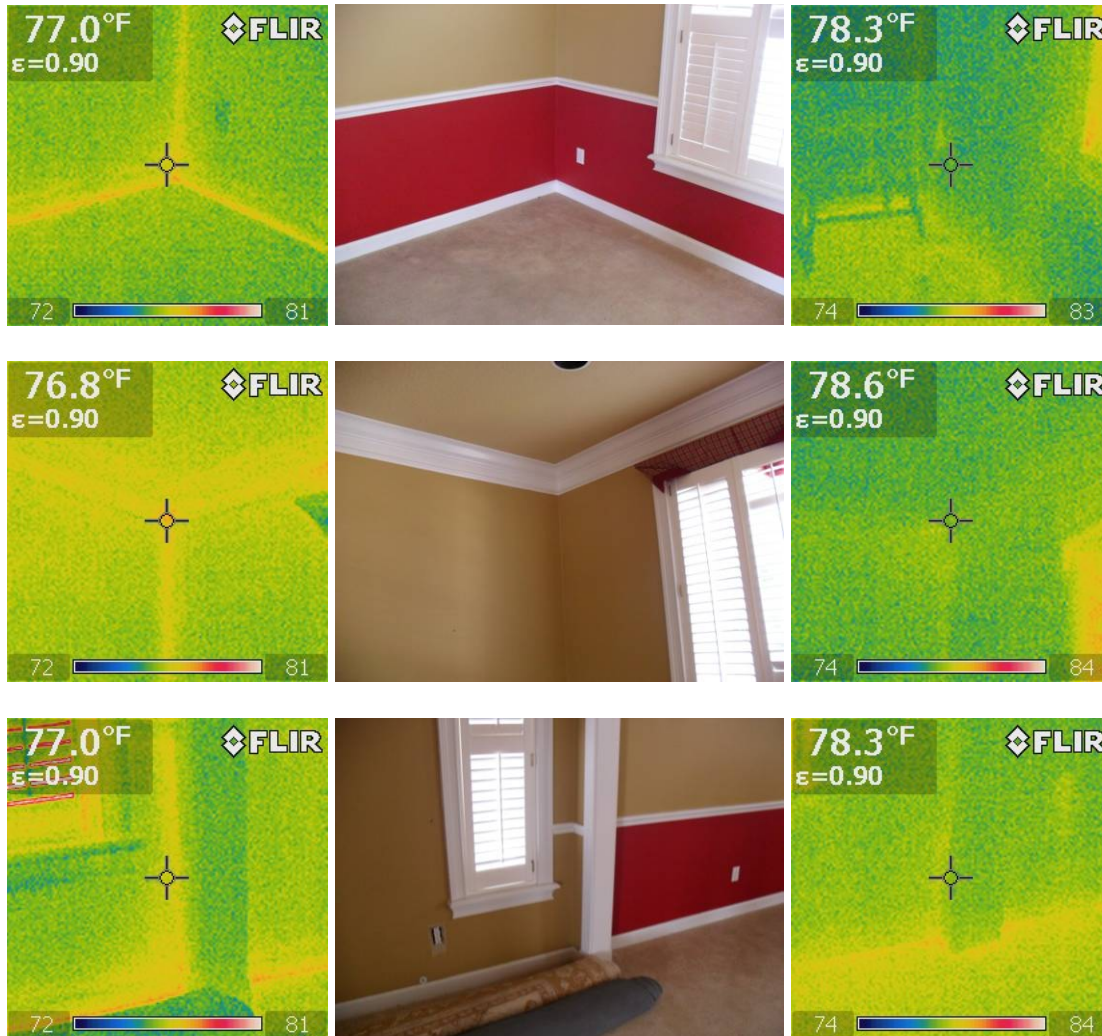
Figure 16. Thermal bridging at framing members in dining room (left: pre-retrofit IR image, center: digital picture, right: post-retrofit IR image)

By using IR thermal imaging before and after the retrofit, CARB was able to qualitatively assess the improvement in the wall cavity insulation. Heat flows in three ways: convection (transfer of heat by the actual movement of the warmed matter), conduction (transfer of energy through matter from particle to particle), and radiation (electromagnetic energy waves that directly transport energy through space). IR cameras detect radiation in the IR range (7–12 microns). The amount of radiation emitted by an object increases with temperature, so IR cameras allow the

user to see variations in surface temperature. The applicable temperature scale is noted on each image, but in general, purple/blue represents colder surfaces and red/white represents warmer surfaces. Figure 16 through Figure 19 show the improved thermal resistance of the wall assembly as evidenced by less temperature variation (typically caused by thermal bypasses or air leakage) across the building assemblies.

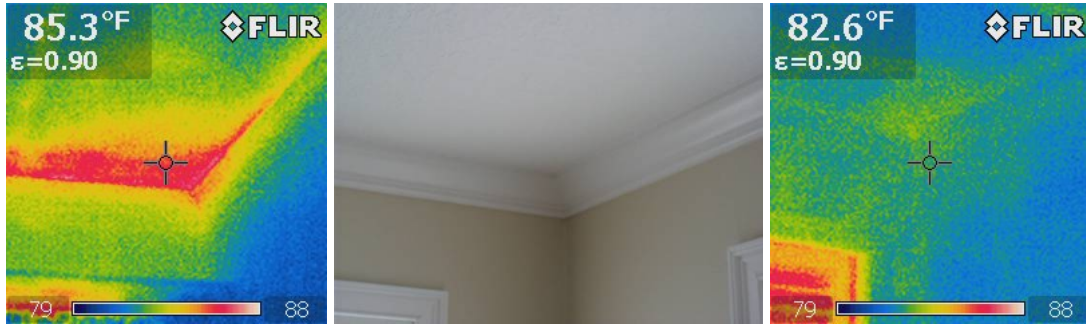
Figure 17. Wind washing of attic insulation at exterior wall corner in the master bedroom (left: pre-retrofit IR image, center: digital picture, right: post-retrofit IR image)

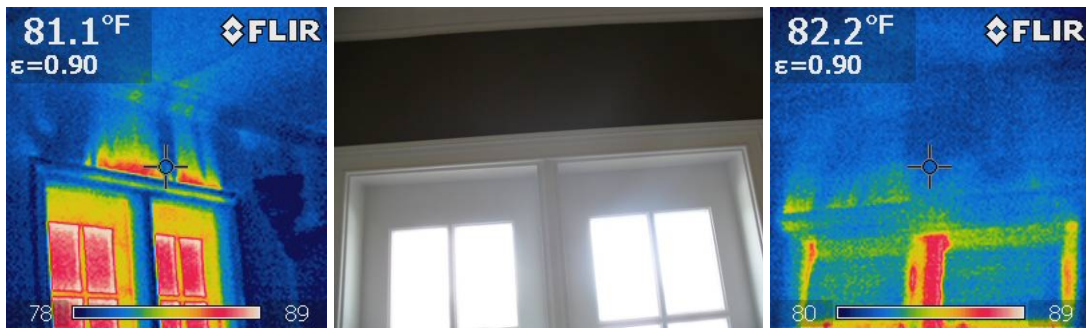
Figure 18. Air leakage at top of framing for the rear entry French doors (left: pre-retrofit IR image, center: digital picture, right: post-retrofit IR image)

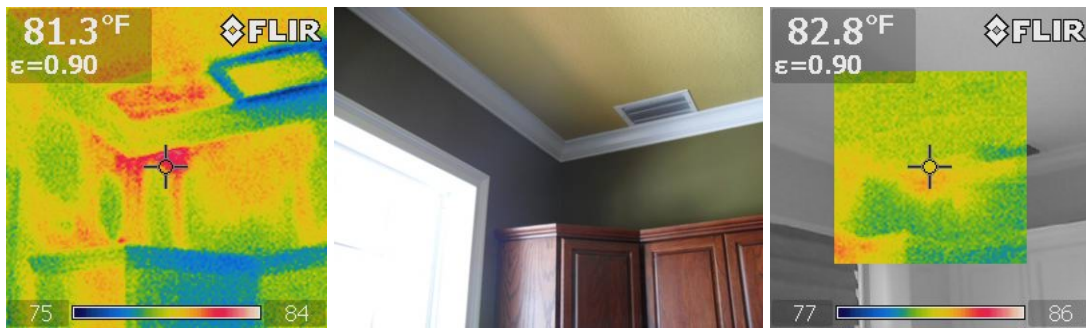
Figure 19. Air leakage in exterior wall corner in kitchen (left: pre-retrofit IR image, center: digital picture, right: post-retrofit IR image)

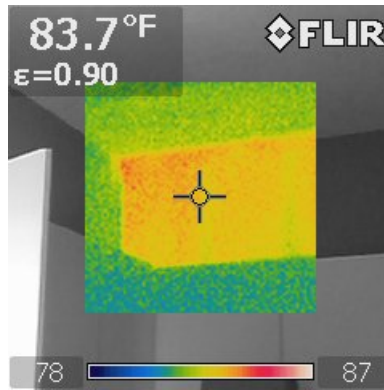
Figure 20. Air leakage in a first floor interior wall in the new addition

Still, leakage was found in a couple locations during the final performance testing. One of the interior walls in the downstairs addition between the side room and pool bath appears to be connected to the outside, as evidenced by warm air (orange/yellow) depicted in Figure 20. It is currently unclear how or why this is occurring.

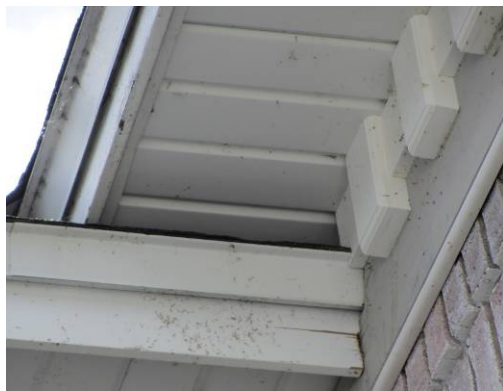
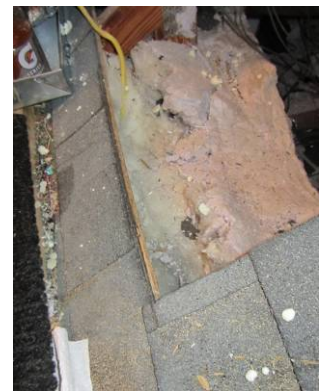
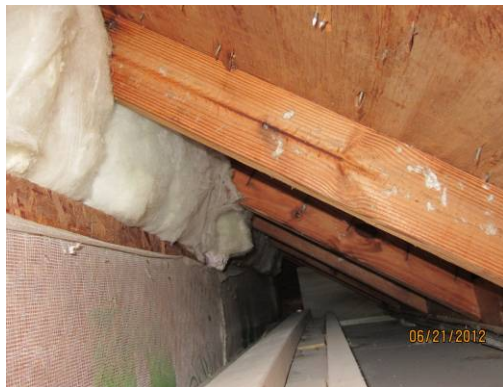
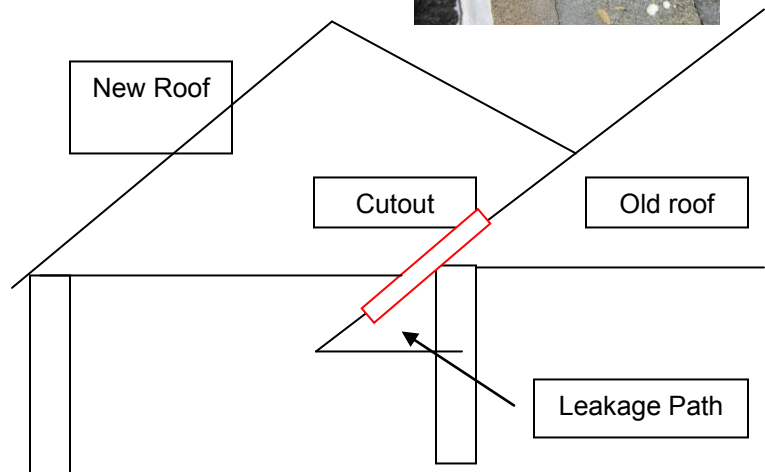
Figure 21. The old soffit is a major leakage pathway as a result of an access opening being cut out between the two attic spaces to allow for the dehumidifier ductwork to run to the existing portion of the home.

The other major source of building infiltration that was found post-retrofit was air movement between the old and new roof in the unvented attic above the master closet. The old soffit of the existing roof was not sealed and then an access cutout between the two roofs opened this soffit space to the unvented attic (Figure 21).

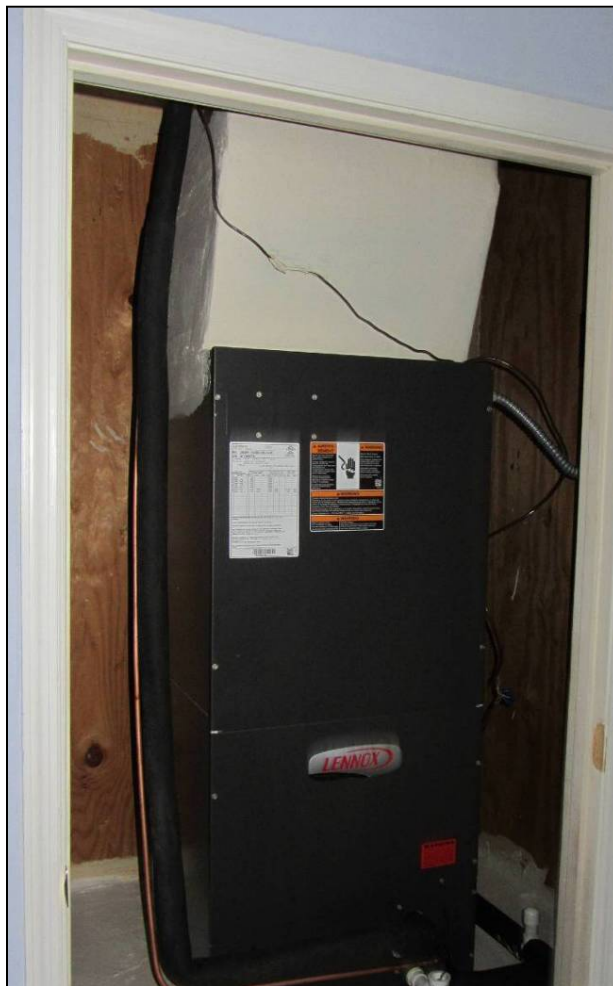
Figure 22. Air handler sealing, post-retrofit

The retrofit included duct sealing around junction boxes, boot connections, and the duct board plenums at the air handlers, and brought the ductwork into conditioned space. Post-retrofit, duct leakage to the outside was reduced to 2.5% of the total airflow. Still the total duct leakage actually increased slightly. Possibly one or more connections or joints were disturbed when the ductwork, which was mostly inaccessible in walls, was modified, which created a slightly greater internal duct leakage.

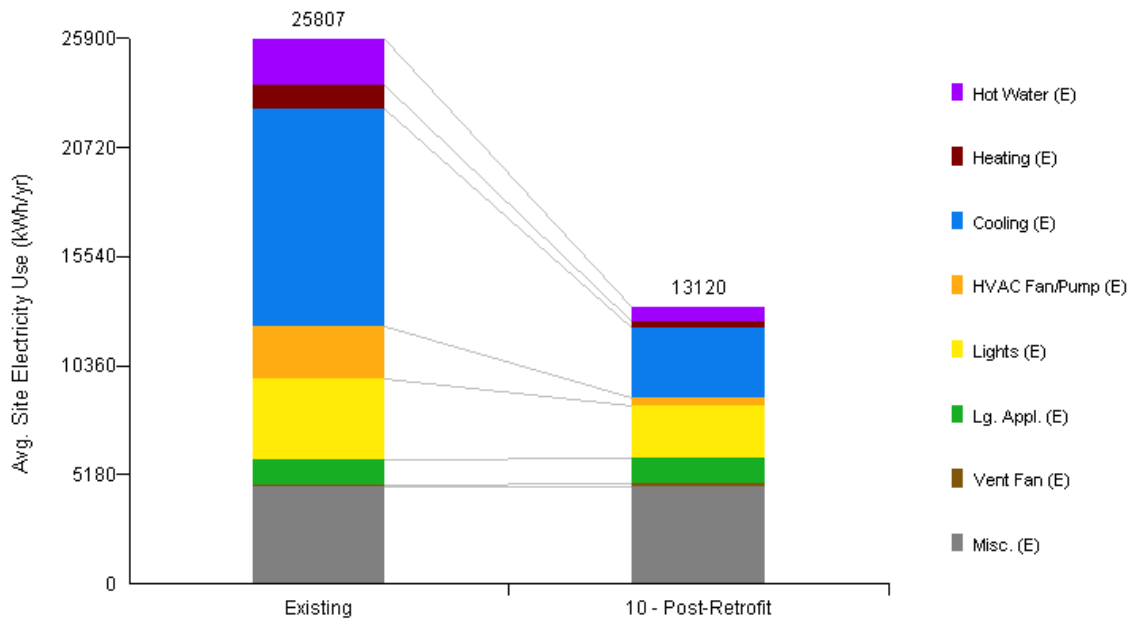
Figure 23. Comparison of simulated site electricity use by end use, pre- and post-retrofit

The simulated post-retrofit home shows significant reduction in energy consumption in all end uses except that associated with ventilation and plug loads, for annual modeled utility bill savings of about \$1,522 (assuming \$0.12/kWh per rates listed by the Orlando Utility Commission) (see Figure 24).
