Ceramographic Examinations of Irradiated AGR-1 Fuel Compacts

May 2012

**Idaho National Laboratory
Very High Temperature Reactor Project
Idaho Falls, Idaho 83415**

INL/EXT-12-25301

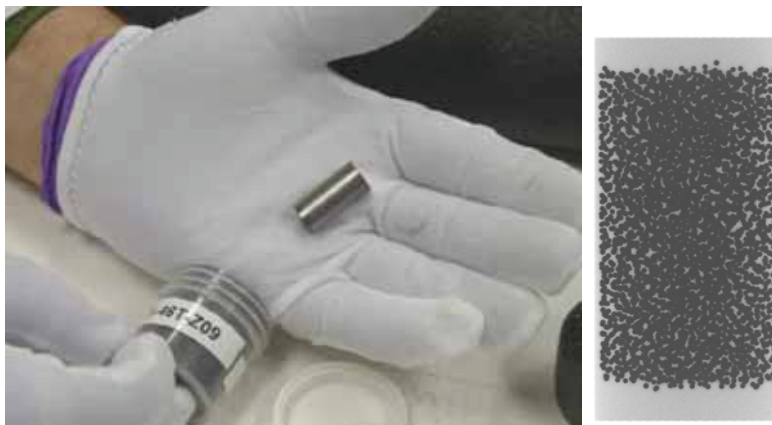
Figure 1. Photograph (left) and x-radiograph (right) of an unirradiated AGR-1 fuel compact.

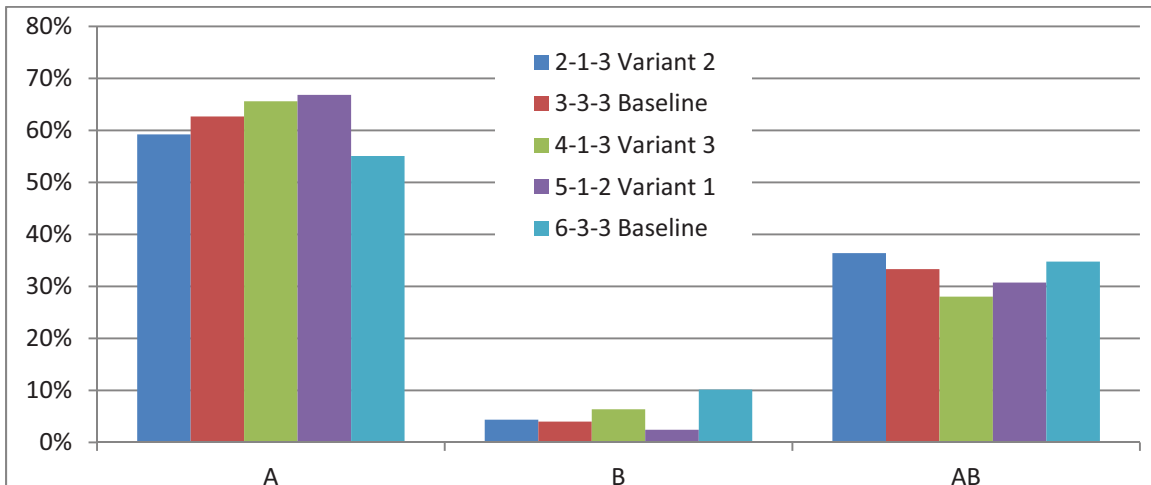
Figure 13: Percentages by AGR-1 compact within each of the three basic particle types.

Data from Table 2 were reconfigured according to the three basic particle types and then normalized into percentages for presentation in Figure 13. Buffer-IPyC debonding clearly was very common in irradiated AGR-1 particles. Fully intact buffer-IPyC bonds (Type B) were found in less than 6% of the 830 classified particles, while complete buffer-IPyC debonding (Type A) was seen in nearly 62% of the particles. Particles with partial debonding constituted approximately 33% of the population. Most images of Type ABi particles revealed that debonding occurred along much of their buffer-IPyC boundaries, so it appears that many Type ABi particles were transforming to Type Ai when the AGR-1 experiment was concluded. Figure 13 suggests that differences in neutron exposure and temperature among AGR-1 compacts (see Table 1) had only minor influence on the extent of buffer-IPyC debonding. Variations in AGR-1 TRISO coatings also had no obvious impact on how much debonding occurred along interfaces between buffer and IPyC layers.

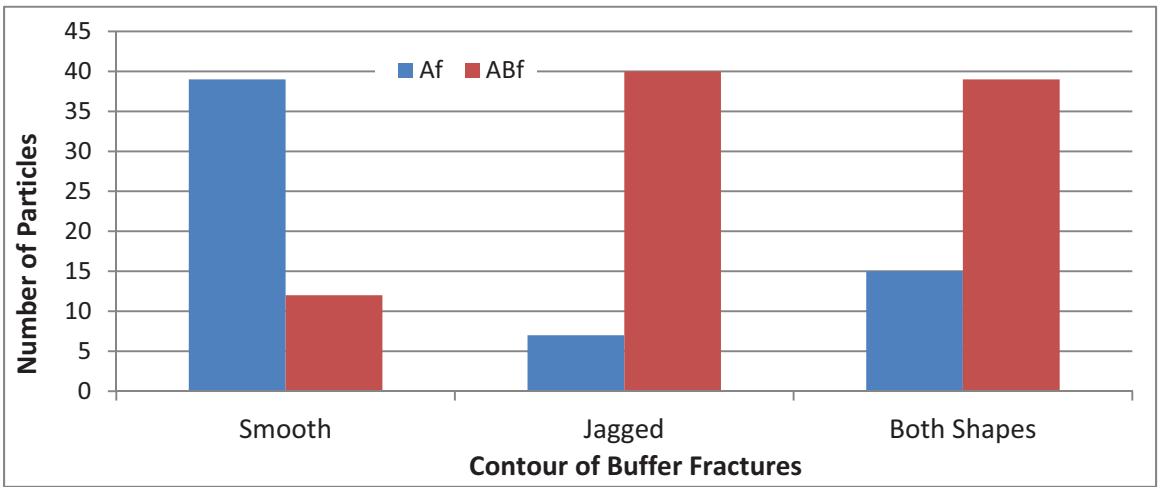
Figure 18. Different buffer fracture shapes seen in Type Af and Type ABf particles.

Figure 18 reveals that smooth radial fractures were much more common in Type Af buffers than in Type ABf buffers. Meanwhile, jagged (multidirectional) buffer fracture contours were found much more frequently in Type ABf particles than Type Af particles. Approximately one-third of the 152 particles covered in Figure 18 contained both shapes of buffer fracture, as in Figure 14(a). In addition, 16 Af particles and 17 ABf particles included in Table 2 showed too little of their buffer fractures for contours to be clearly distinguished, so they could not be included in Figure 18.

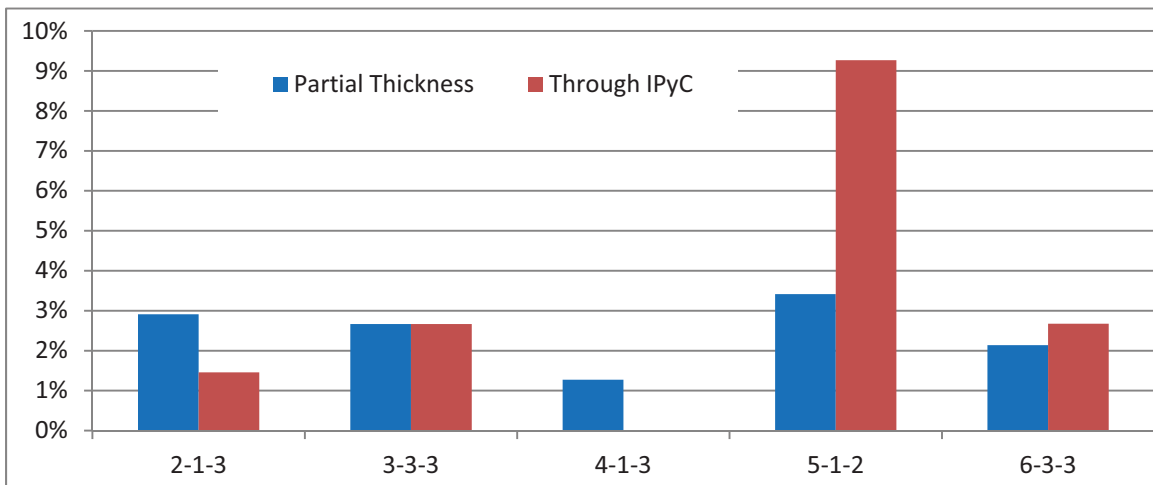
Figure 24. Percentages of particles with IPyC fractures among irradiated AGR-1 compacts.

Figure 24 presents the frequencies of IPyC fractures among the five AGR-1 compacts. Results vary substantially, particularly for fractures that penetrated the entire IPyC layer. Although values were similar for Compacts 2-1-3 (Variant 2), 3-3-3 (Baseline), and 6-3-3 (Baseline), particles in Variant 1 Compact 5-1-2 contained a much higher incidence of through-IPyC fractures (19 of 205 classified particles). The higher frequency of through-IPyC fractures in Compact 5-1-2 may be related to the lower IPyC density from the elevated IPyC deposition temperature in Variant 1 fuel [Hunn and Lowden 2006-1]. Zero through-IPyC fractures were found in Variant 3 Compact 4-1-3 (157 classified particles) despite its higher irradiation temperatures and neutron exposure (see Table 1).

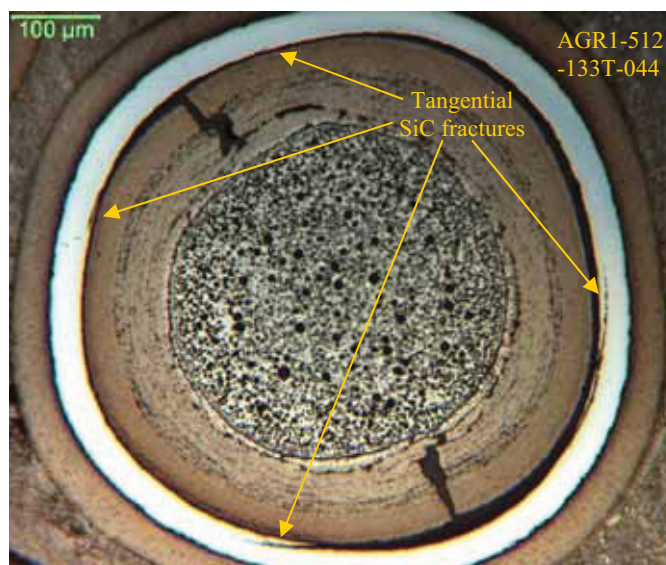
Figure 27. Pairs of SiC fractures symmetrically positioned around two buffer-IPyC fractures.

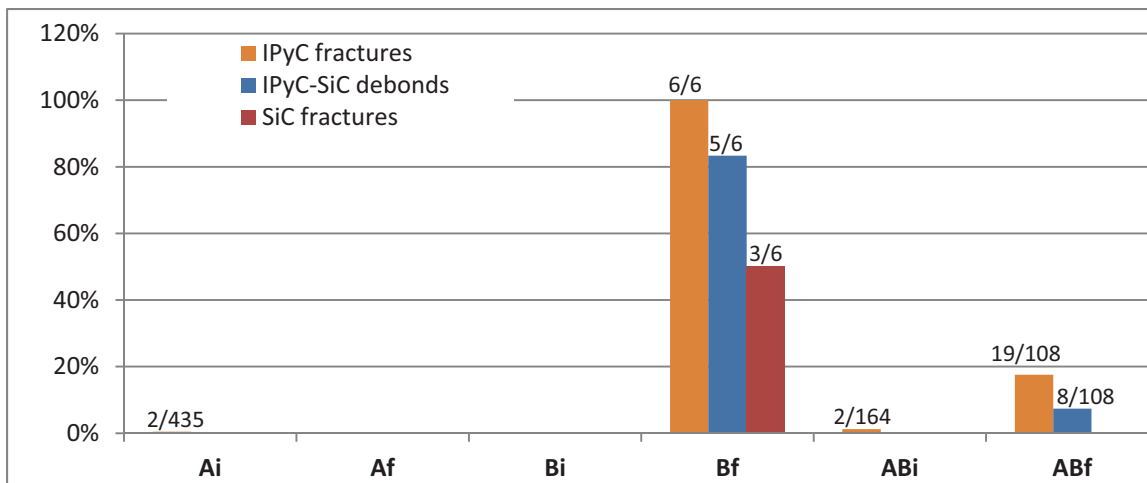
Figure 29. Frequencies of IPyC fractures, IPyC-SiC debonds, and SiC fractures by type among the 830 classified AGR-1 particles.

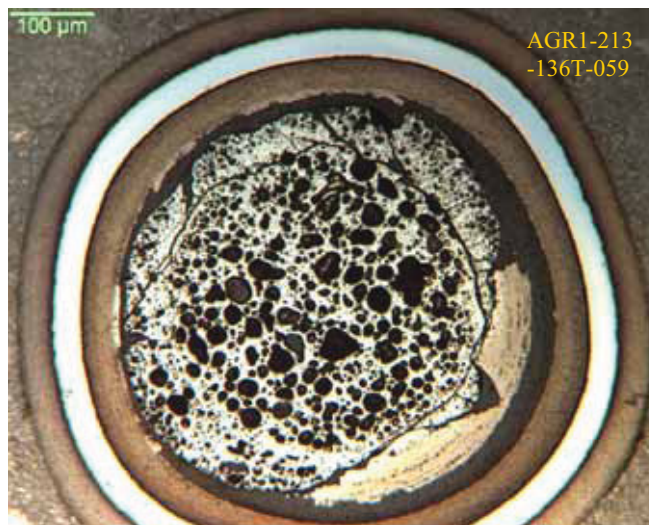
Figure 30. Extensive kernel swelling at a plane between separated pieces of buffer.

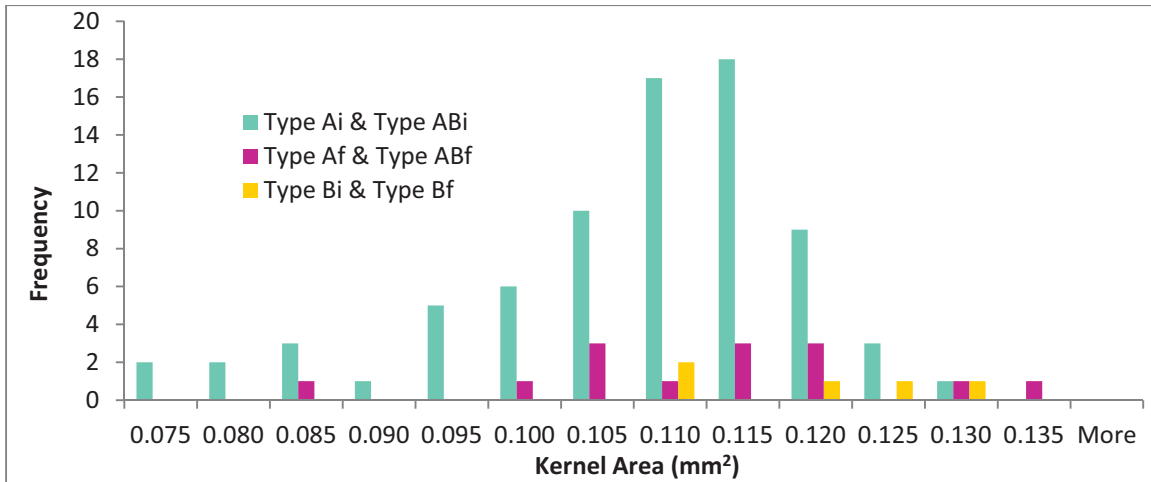
Figure 40. Kernel areas grouped according to buffer-imposed constraint on kernel growth.

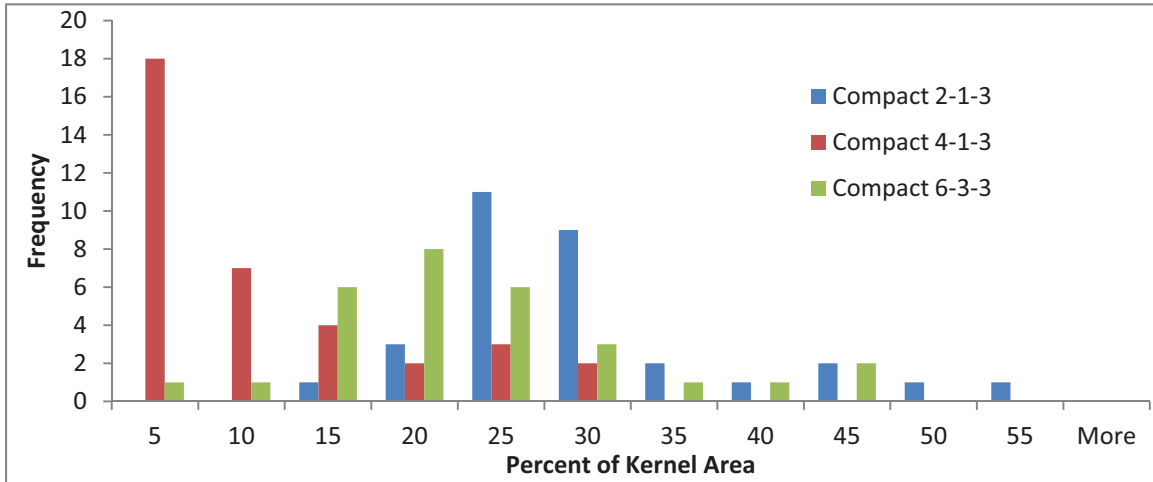
Figure 42. Kernel pore area percentages grouped by compact.

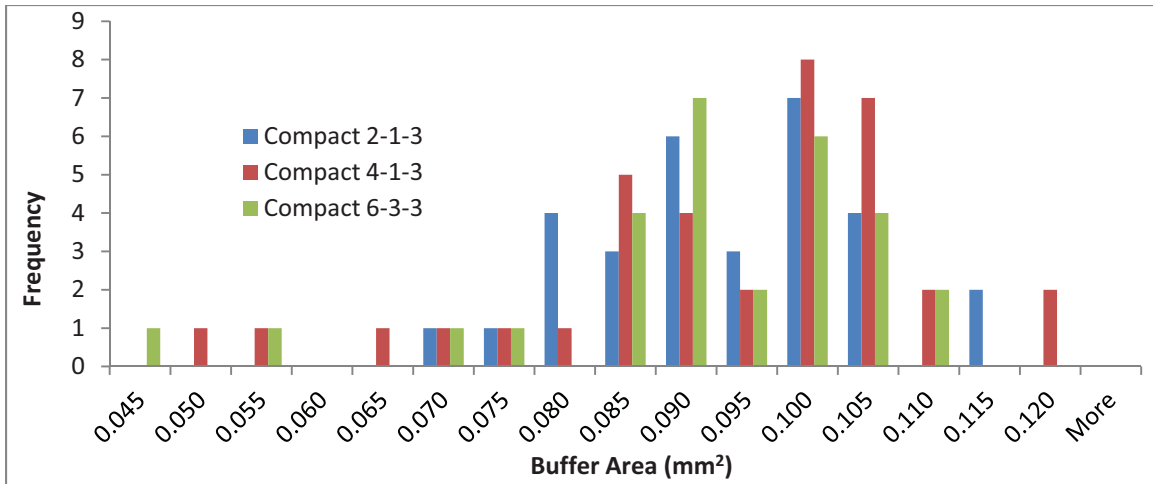
Figure 45. Buffer cross-sectional areas grouped by compact.
