# REACTIVITY INITIATED ACCIDENT TEST SERIES RIA SCOPING TEST QUICK LOOK REPORT

IDAHO OPERATIONS OFFICE UNDER CONTRACT EY-76-C-07-1570

TFBP-TR-289  
September 1978

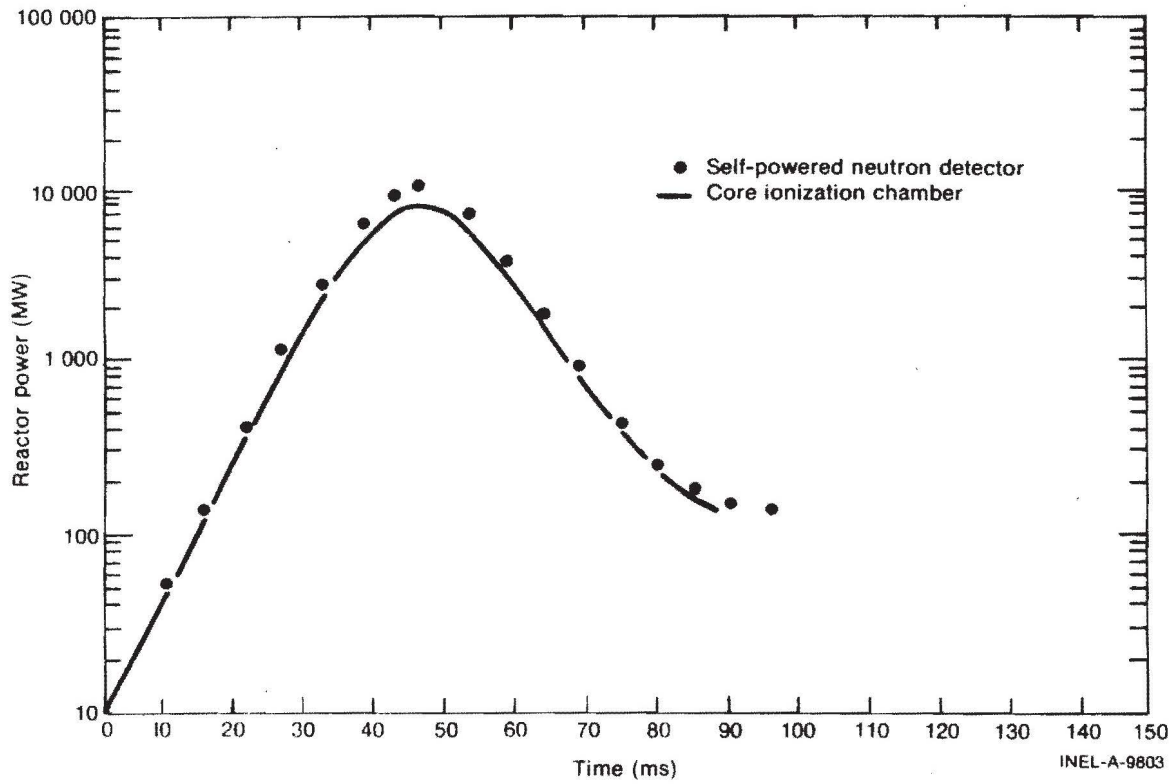
Fig. 8 Comparison of PBF core power during RIA-ST-3 as derived from 0.229 SPND and TR-1 core ionization chamber.

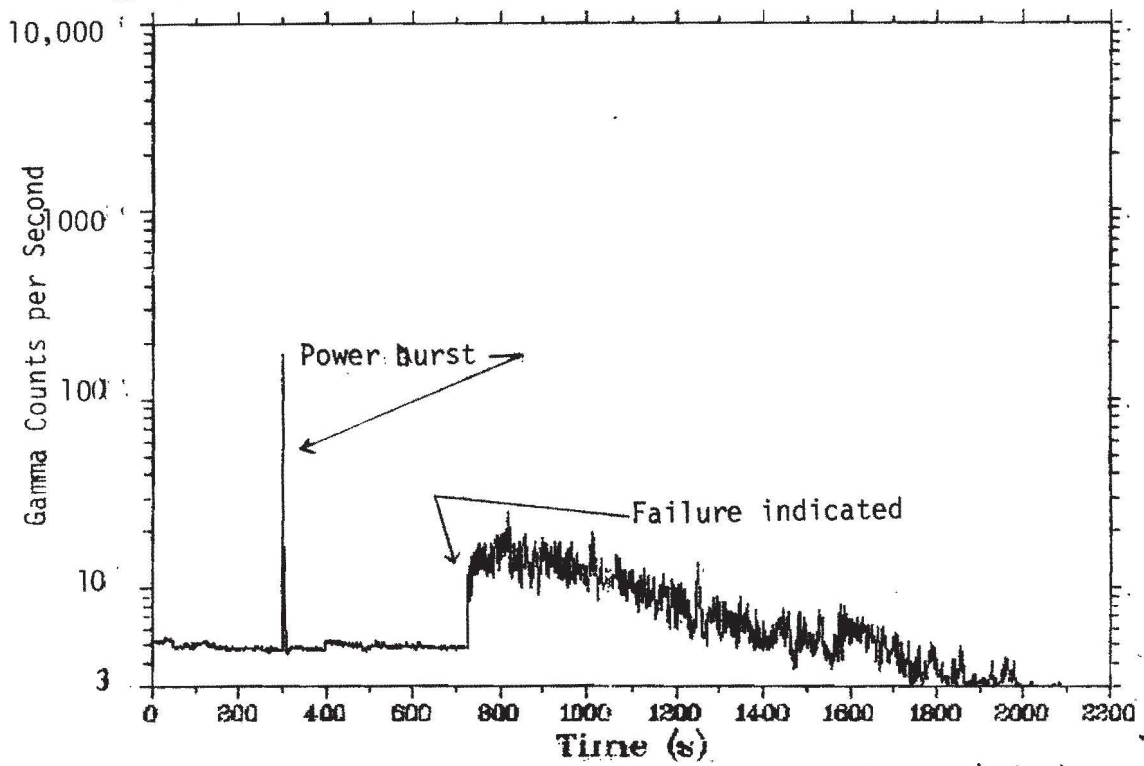
Fig.27 Gross gamma count rate (150 - 3400 keV range) during Scoping Test 1 burst 2.

Following the second power burst of RIA-ST-1, and the power bursts of RIA-ST-2 and RIA-ST-4, rod failure was indicated by an increased gamma count rate as shown in Figures 27, 28, and 30, respectively. During RIA-ST-3 an increase was not observed indicating failure had not occurred (Figure 29). There was a significant difference in the maximum count rates measured during RIA-ST-1, RIA-ST-2, and RIA-ST-4 indicating that the RIA-ST-4 rod sustained more extensive failure.

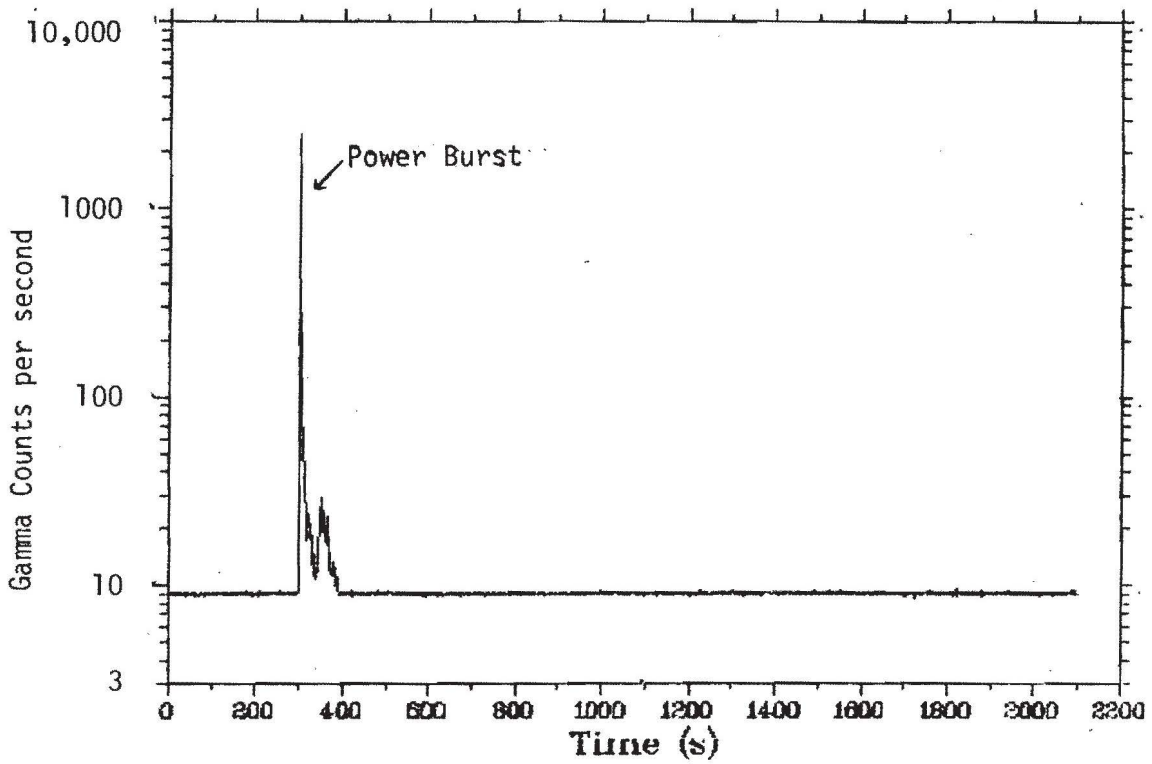
Fig. 29 Gross gamma count rate (150 - 3400 keV range) during Scoping Test 3. No failure indicated.

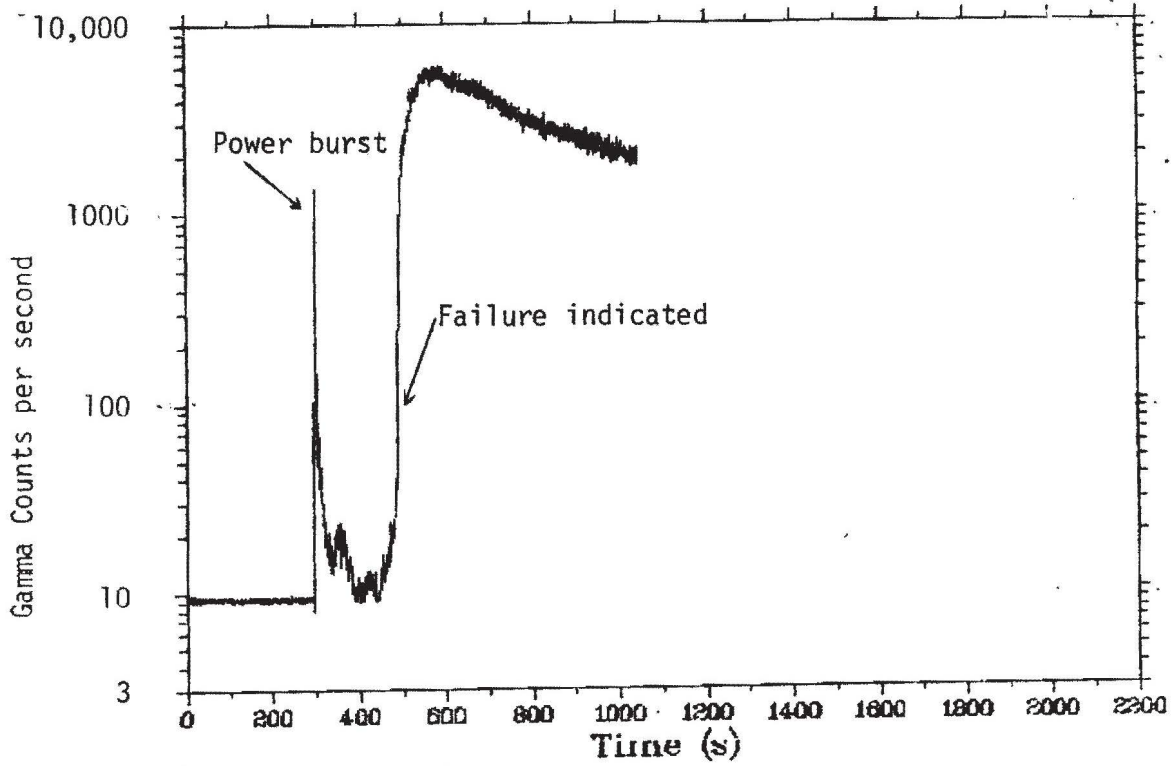
Fig. 30 Gross gamma count rate (150 - 3400 keV range) during Scoping Test 4 power burst.
