# **Baseline Fracture Toughness and CGR testing of alloys X-750 and XM-19 (EPRI Phase I)**

**Idaho National Laboratory  
ATR-NSUF  
Idaho Falls, Idaho 83415**

INL/EXT-11-24173  
Revision 2

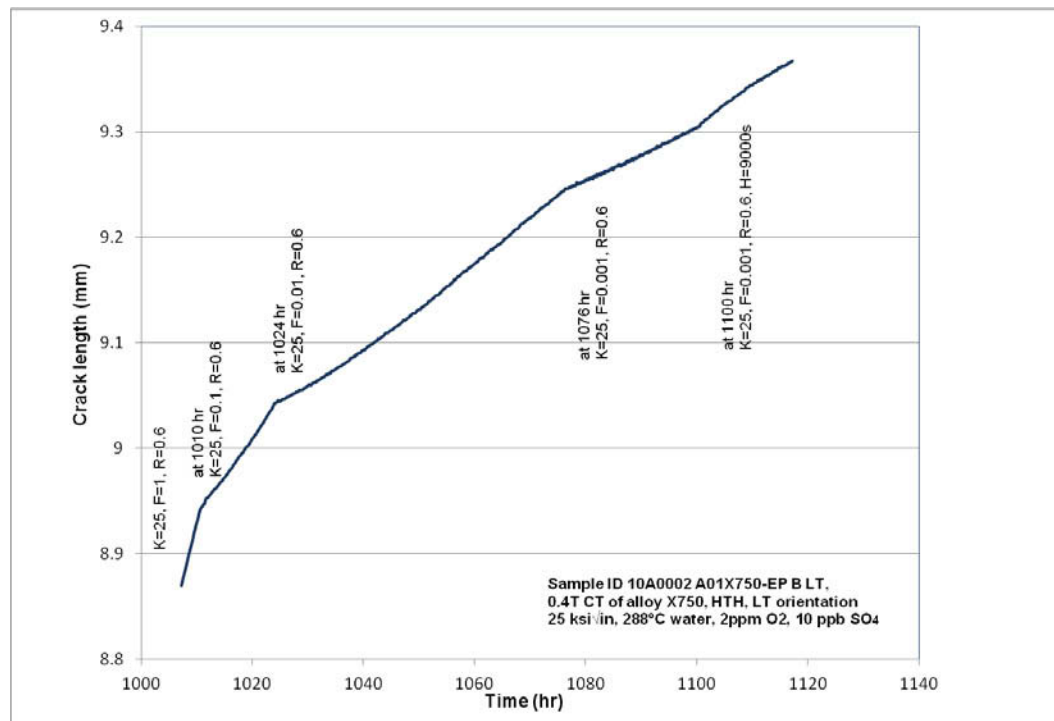
Figure 3-6: Crack length vs. time obtained with sample ID 10A0002 A01 during cycling in water.

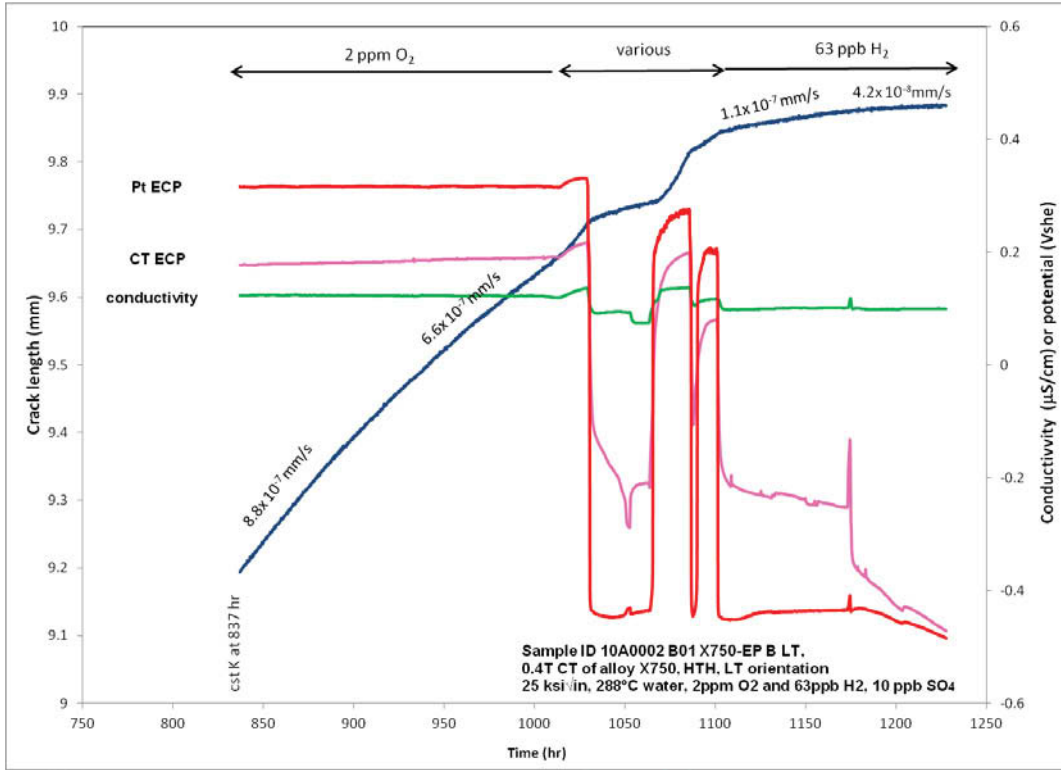
Figure 3-14: Crack length vs. time obtained with sample ID 10A0002 B01 in 288°C water with sulfate addition.

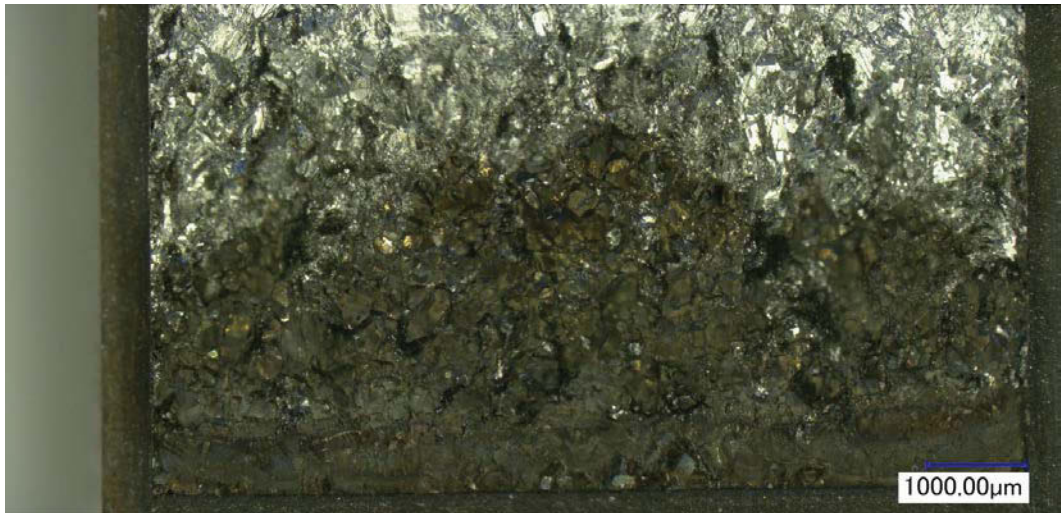
Optical fracture surface analysis of sample ID 10A002 B01 (Figure 3-17) showed a fully engaged crack but with a non uniform crack front. The minimum crack depth is 2.178 mm, the maximum is 3.668 mm and the average 2.960 mm. Ahead of the crack can be seen “dark areas” that may be oxidized areas, which may indicate that finger like cracking occurred outside the plane of the crack. The maximum crack depth given does not include those features as their connection to the main crack, although likely, is not evident on the picture.

**Figure 3-17: Digital fractograph of sample ID 10A0002 B01.**

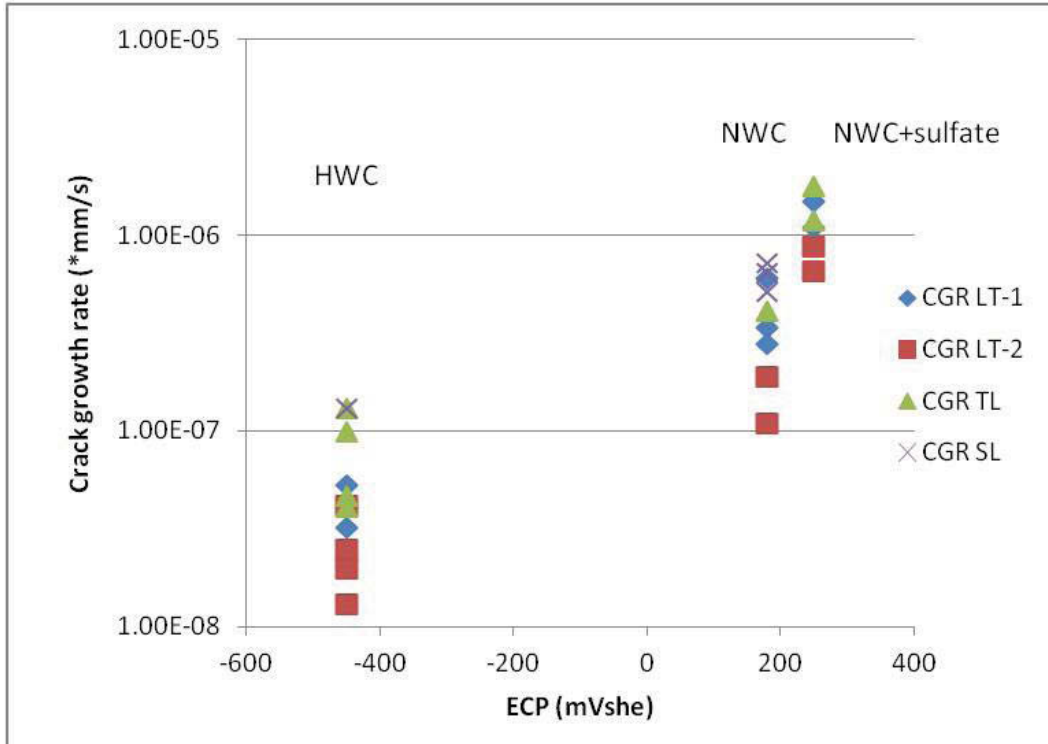
Figure 3-25: CGR for alloy X-750 as a function of ECP.

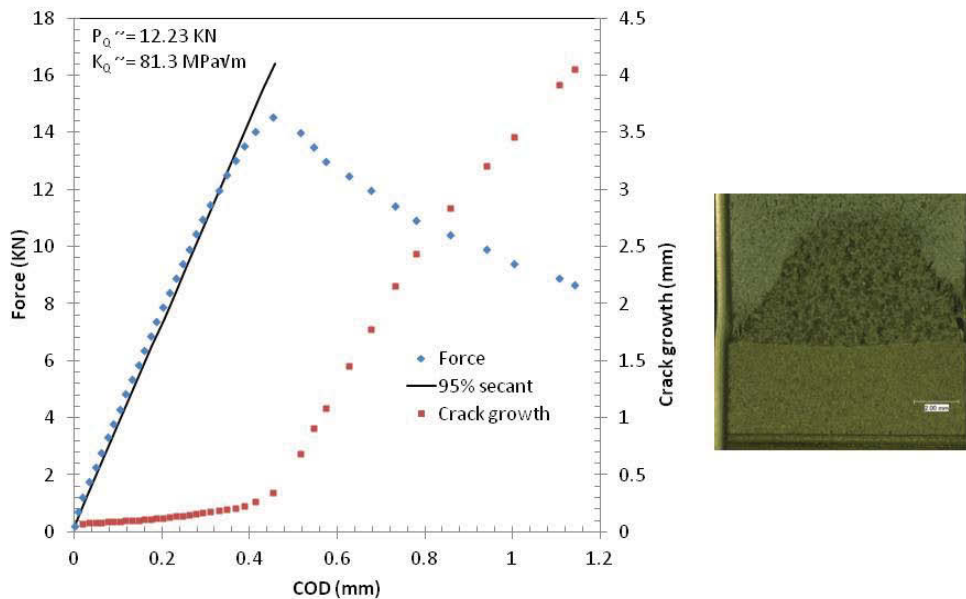
**Figure 4-2: Specimen 10A0016 A1 01 (19.3% CW XM-19) fracture test at 288°C.**

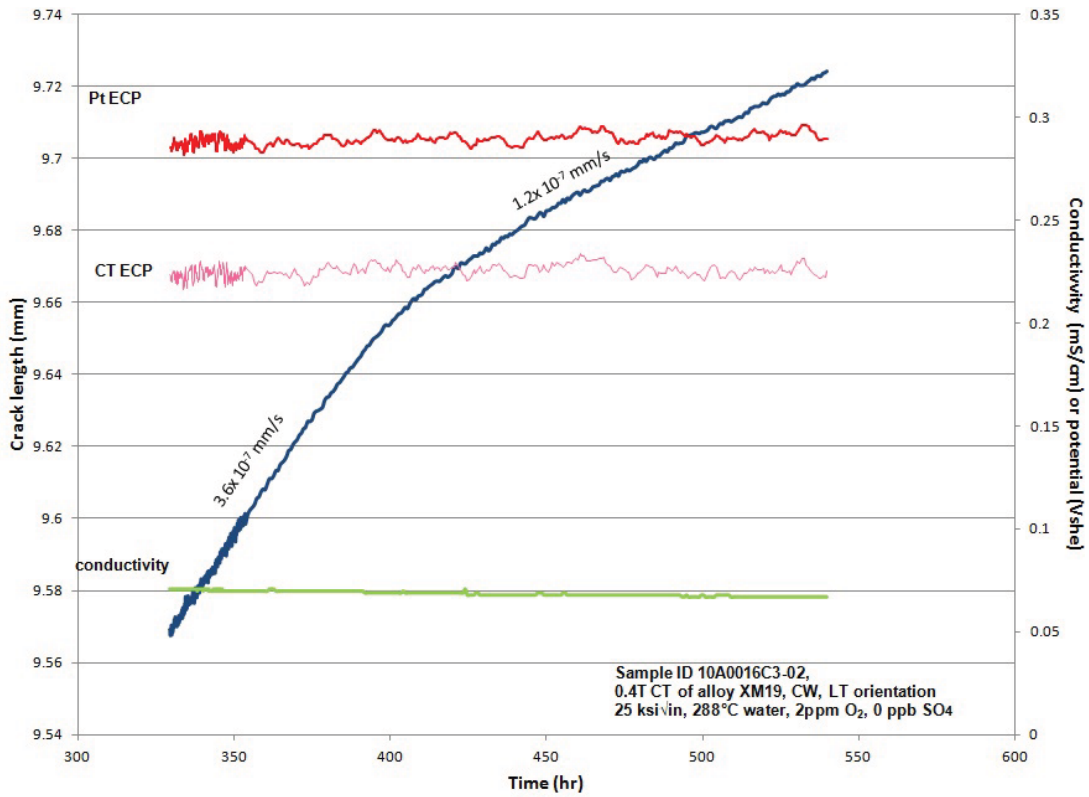
Figure 4-13: Initial crack length vs. time obtained with sample ID 10A0016 C3 02.

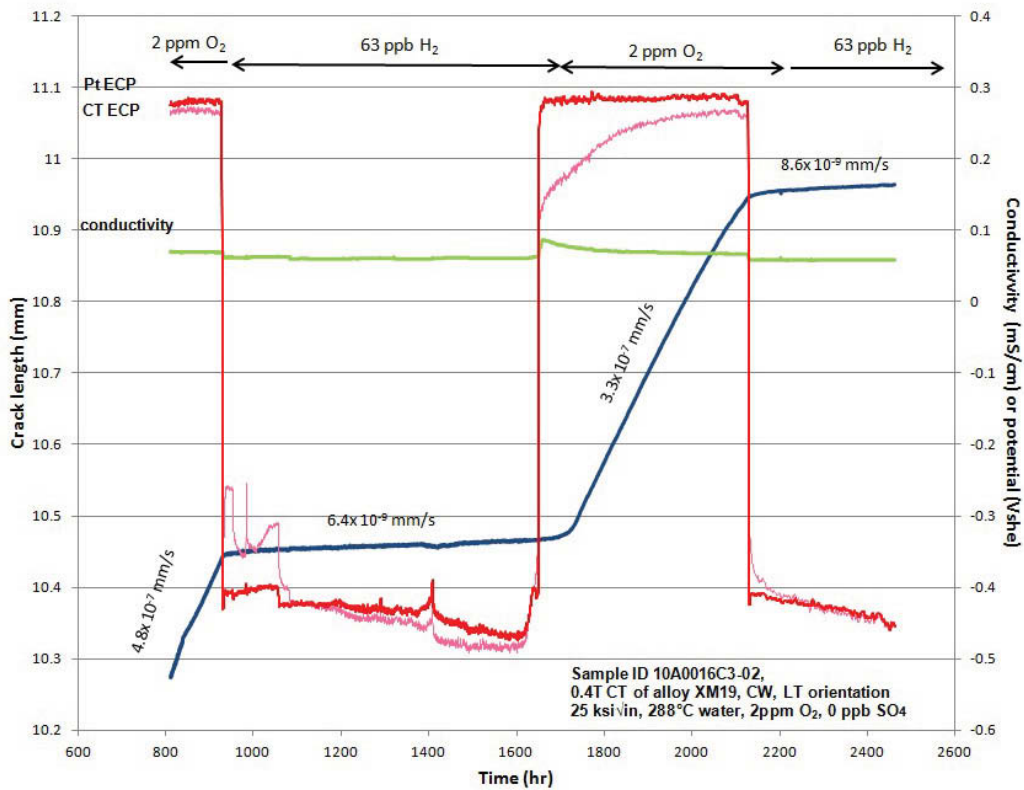
Figure 4-14: Crack length vs. time obtained with sample ID 10A0016 C3 02.

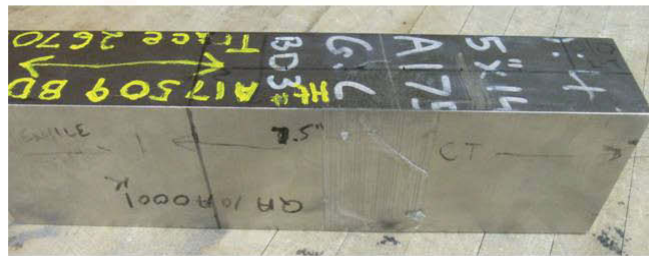
CT specimens  
Tensile blanks  
Extra material

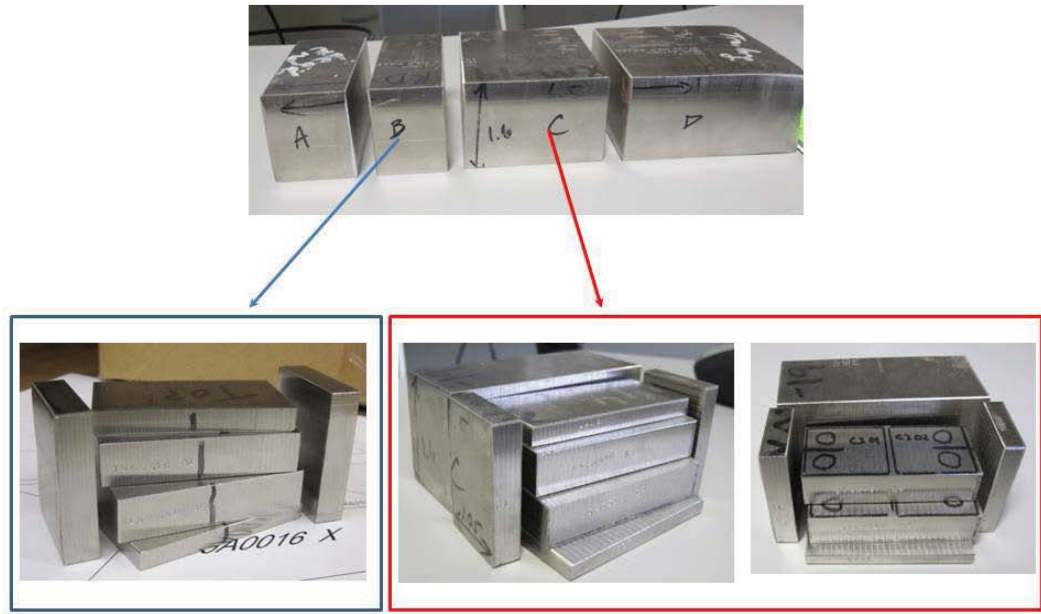
**Figure B-4: Baseline SCC specimen extraction from 19.3% cold worked alloy XM-19**

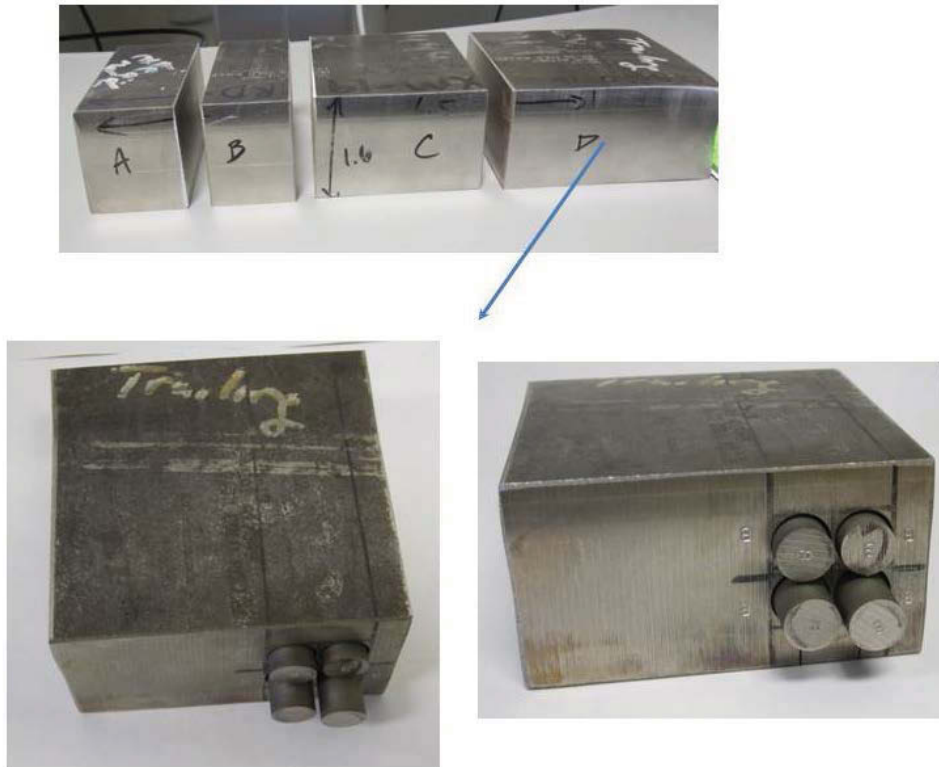
**Figure B-6: Baseline tensile specimen extraction for 19.3% cold worked alloy XM-19**
