Transport and Installation of the Dark Energy Survey CCD Imager

Greg Derylo¹, Edward Chi, H. Thomas Diehl, Juan Estrada, Brenna Flaughner, Ken Schultz

Fermi National Accelerator Laboratory, Batavia, Illinois, USA 60510

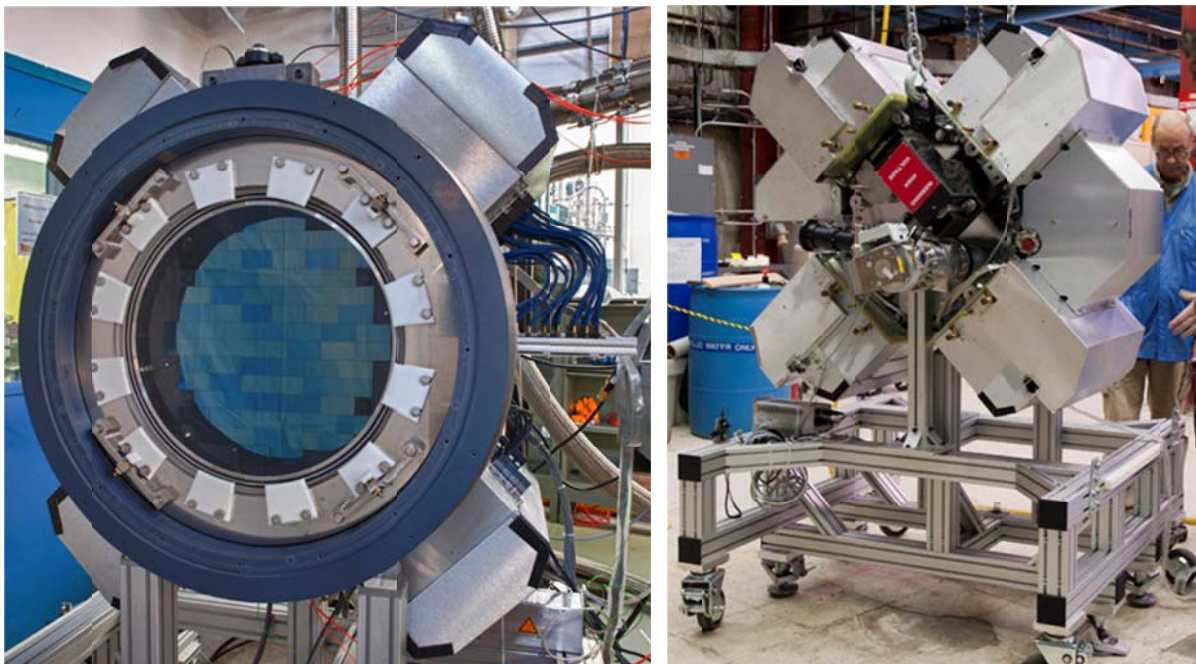
Figure 1. The DES imager front and rear views. The thick grey ring around the window is used to support bolt-on testing equipment or a protective lens cover.

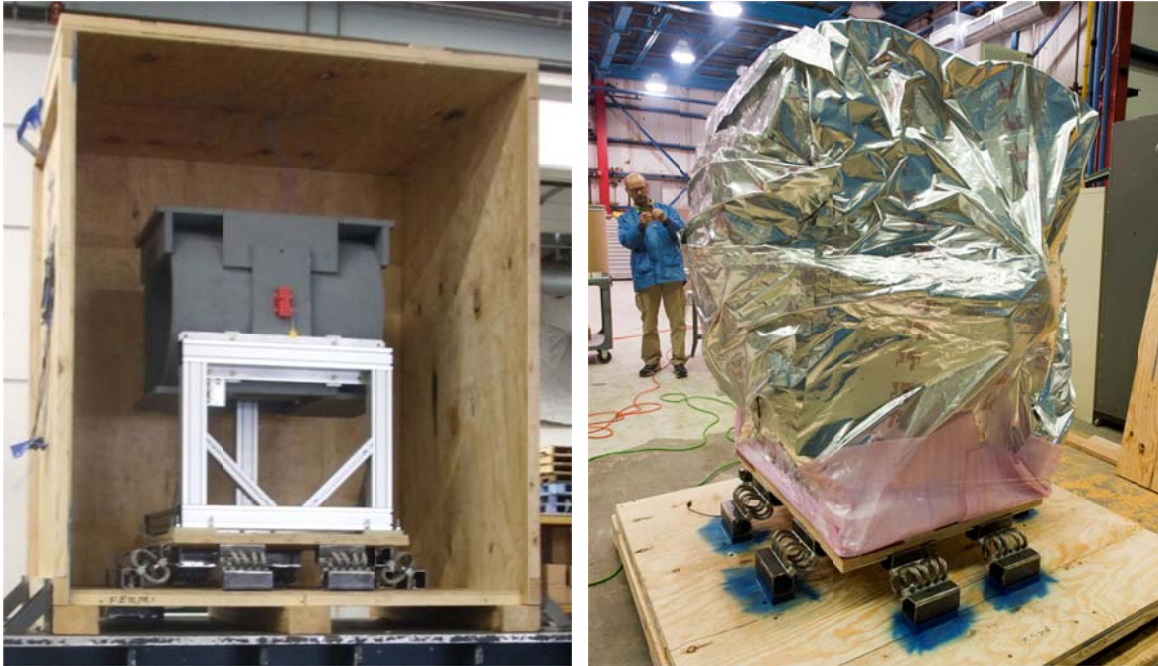
Figure 2. The shipping crate internals showing the vibration isolation coils supporting the imager payload. The photo on the left shows crate testing at an independent testing laboratory using a mockup weight. The photo on the right shows the DES imager being prepared for shipping to CTIO, where the imager is wrapped in ESD-safe foam sheeting and a vapor barrier.

shock loads by transmitting input energy more slowly, which results in larger motions spread out over longer periods but with a reduction in maximum pulse heights. The crate, with cradle and mockup weight, is shown in Figure 2.

The crate's performance was validated during a day of testing at Pira International⁸ and consisted of several batteries of tests. Horizontal shock impact testing was performed on all four sides at several speeds up to 1.2 m/s, corresponding to approximately 15 G's. Accelerometer data from the payload indicated transmitted shocks of less than 1.1 G's. Vertical shocks were applied by first lifting one edge of the crate and supporting it on a spacer block up to 10 cm thick. The spacer block was then rapidly pulled out, inputting shocks to the crate base in excess of 30 G's. For these cases, the maximum transmitted shock load was just under 3 G's. The wire rope vibration isolators therefore did an impressive job of shock isolation. However, a problem was identified with the crate design when the horizontal testing was repeated with one wall of the crate removed. The payload motion was found to be so large that if the real imager had been in place rather than the smaller mockup weight, its various protrusions could have struck the wall of the crate. Therefore, the shell of the crate was remade by Nefab to provide additional internal clearance.

At FNAL the imager vessel was transferred into its cradle in the shipping crate. Staff from the shipping crate vendor were on hand on packing day to help wrap the camera in ESD-safe foam and a heat-sealable vapor barrier (Figure 2). A sealed port had been prepared for the vapor barrier to allow pass-through of a cable for the shock logger. The two Sensr

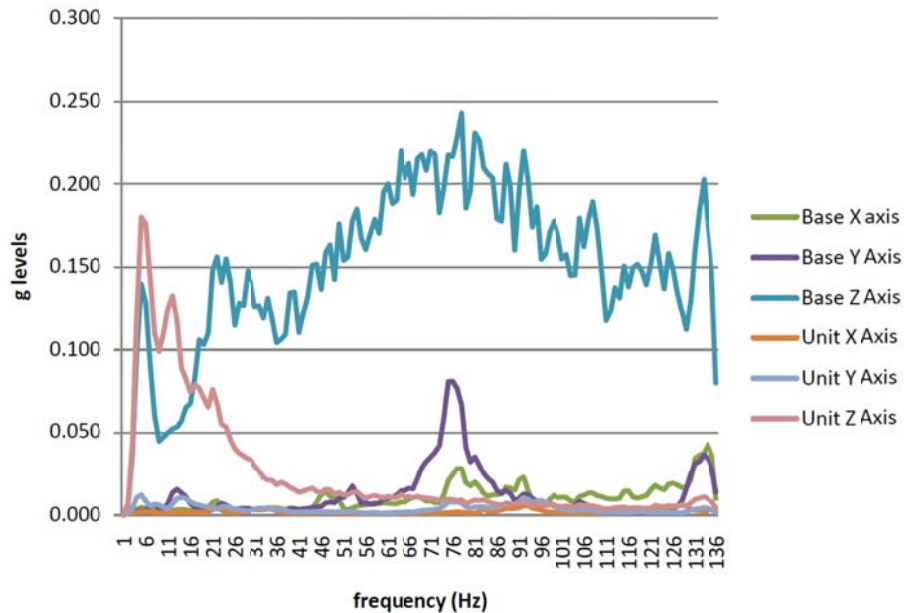
Figure 3. Vibration test spectral response of the shipping crate to a simulated air-ride-truck trip. The “Base” accelerometer is mounted to the crate floor while the “Unit” instrument is mounted to the imager mockup weight.

Further vibration table testing was then performed with air-ride-truck simulation programs of various intensity levels. Accelerometer response for the simulation of a typical ride is shown in Figure 3 and indicates that vibration energy applied near the natural frequency does indeed result in a heightened response at this region. Having a low natural frequency is a direct outcome of having good shock isolation properties, but the magnitude of the amplification factor is

limited due to the internal damping of the isolation coils resulting from internal friction between individual wire strands. Given the good shock isolation response, which was of primary importance, the relatively mild amount of amplification, and the improvement anticipated with the addition of the mounting bracket spacer plates, this frequency response behavior was considered to be acceptable.

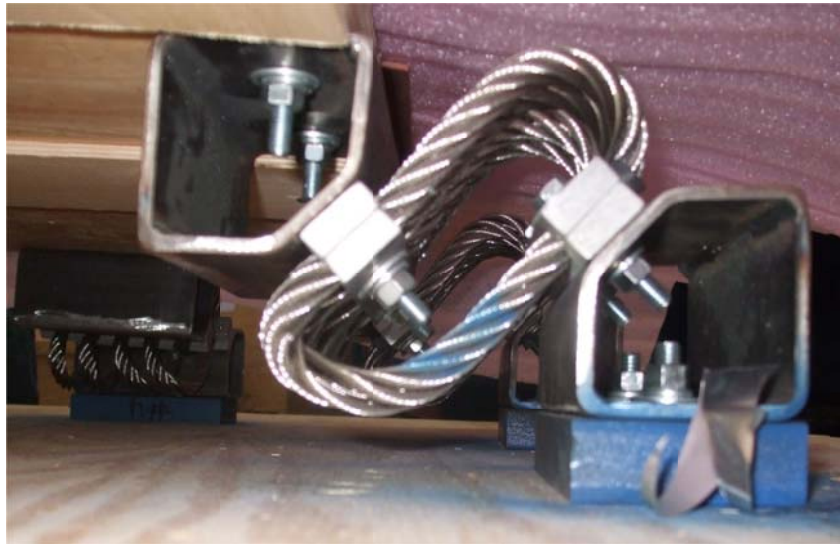
Figure 5. Isolation coils after arrival in Chile. View along listing edge of the suspension system with the imager not yet removed from crate. Crate floor shows some sign of coil contact even with the additional spacer shown under the coil mounting bracket.

After first checking the shock logger data to verify that the loads on the imager were within acceptable levels, the crate was opened and a tilt in the way the imager sat in the crate was noticed. Examination found what appears to be some loosening of the vibration isolation coil itself along one edge of the suspension system, as shown in Figure 5, and the surface of the crate floor shows some sign of coil contact here. This degradation is possibly due to extended operation near the natural frequency. Although the imager was delivered safely, in light of this observation it may have been desirable to trade some reduction in shock isolation capability for increased stiffness and therefore more separation from the expected natural frequency of the truck transportation.

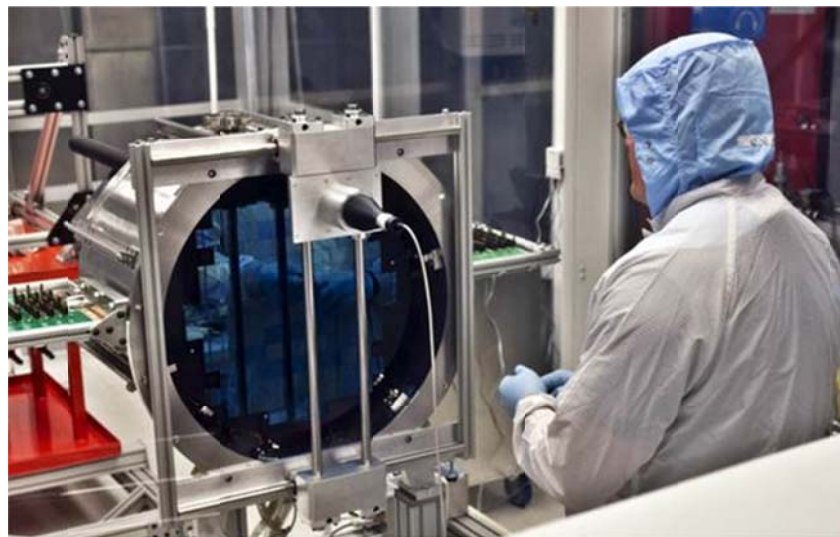
Figure 7. The Micro-Epsilon confocal chromatic displacement system being used to perform a quick scan of the CCD array after arrival at the Blanco telescope. The simple rail system was built to allow quick inspection of a CCD surface relative to its immediate neighbors. The same instrument, mounted on a precision stage system, is separately used to survey the focal plane array through the flat vessel window. Photo credit T. Abbott (CTIO).

The imager was then transferred back onto its handling cart and moved into the cleanroom facility in the Blanco dome. There it was opened and the transportation-related hardware changes described above were reversed. While the front cover of the vessel was off, a quick flatness scan of the CCD surfaces was done to ensure that the spring-mounted CCDs were still solidly seated against the focal plane support plate. The Micro-Epsilon confocal chromatic displacement sensor was mounted on a simple rail system, shown in Figure 6. This rail system was not intended to be used to do an accurate survey of the entire array, but rather just perform a quick check of a CCD relative to its immediate neighbors. The same instrument, mounted to a more accurate positioning system, is used to perform more accurate scanning of the array through the flat window under both warm and cold conditions². After reassembly, the imager was ready for electrical and plumbing connections and the beginning of post-transport validation testing.

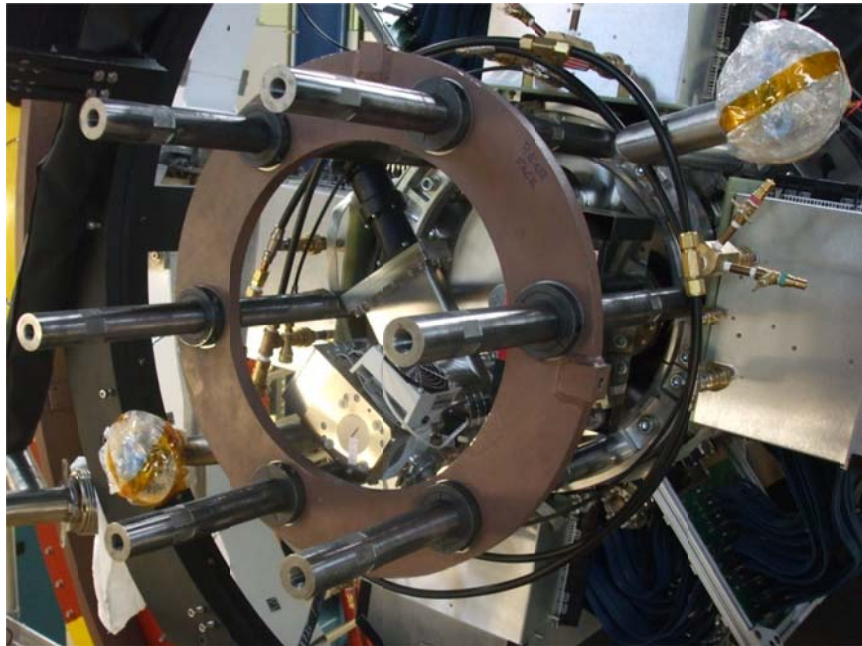
Figure 8. Set of six handling rods threaded into brackets on the rear of the imager vessel. The ring increases stiffness of the rod assembly and acts as a lifting point when moving the imager by crane. The two liquid nitrogen plumbing flanges are shown covered with plastic wrapping for handling protection.

With the perimeter of the imager vessel largely covered with readout electronics and cooling connections, only selected points on the back face of the vessel are available for supporting the weight of the imager. The supports must be long enough to reach past the services at the end of the cage, through the cage opening, and past the vacuum pumps mounted on the rear of the imager vessel and still provide enough stiffness to rigidly support the imager's 640 kg weight. This was done with a set of six rods that screwed into brackets mounted onto the back of the imager vessel, as shown in Figure 8. A ring inserted over the ends of the rods is held in place with shaft collars and serves two important functions: it stiffens the rod assembly by constraining them all together, and hoist rings added to it serve as a pickup point out past the electronics crates that surround the vessel. During rigging operations, an additional pickup point is used at the front of the vessel by use of a temporary lifting bracket added to the vacuum window flange as shown in Figure 9.

As shown in Figures 8 through 10, the installation process was tested successfully on the Telescope Simulator built at FNAL. Having completed the process beforehand significantly reduces the technical and schedule risks associated with such a critical handling step to be performed at a remote worksite. Installation of the imager on the Blanco telescope is scheduled for August of 2012.

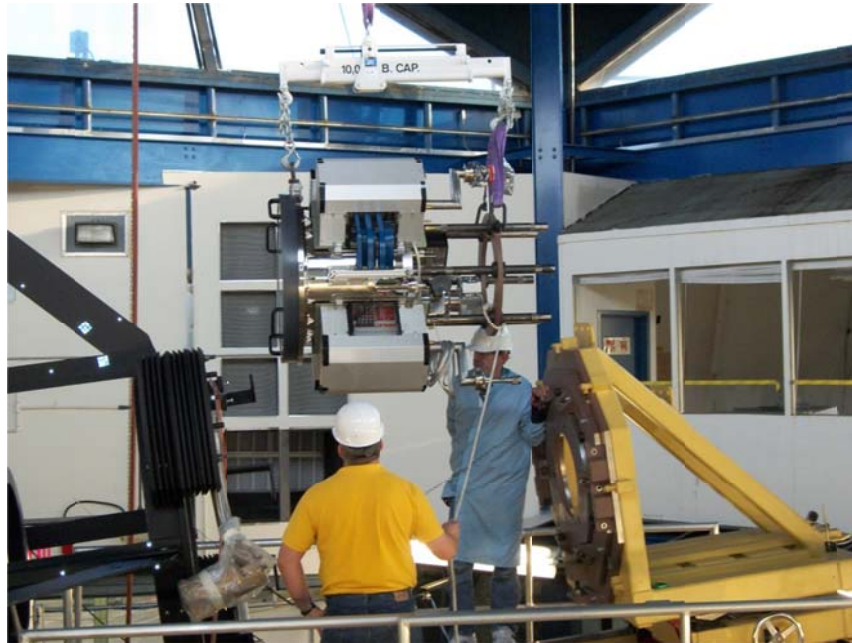
Figure 9. Imager installation testing on the Telescope Simulator. The crane is being used to transfer the imager onto its installation fixture. The fixture supports the cantilevered imager and permits adjustment of its transverse & vertical position and its pitch & roll angles as it moves axially into the prime focus cage where it mates it with the corrector.

At the Northwest platform maintenance station, the installation tooling makes use of selected existing hardware used to position equipment there. The rods extending from the rear of the imager attach to a set of plates mounted to the movable slide (Figure 9). The slide hardware allows adjustment of transverse position and tilt angle as it moves axially along its length. The set of plates attached to the front of the slide mount are designed to provide adjustment in vertical position and roll angle. All the motions are necessary to move the imager through the opening in the end of the prime focus cage, where there is approximately 19mm of radial clearance, and onto the rear of the corrector (Figure 10), where the mounting bolts and the expandable/removable locating pins¹⁰ can be installed (pins are removed after imager mounting to preserve electrical isolation between the imager and the corrector). The installation fixture motion adjustments therefore cover five out of the six motion types; what is missing is yaw angle control, so careful initial setup work will be necessary to ensure that the fixture equipment is well-aligned to the telescope for this operation. This

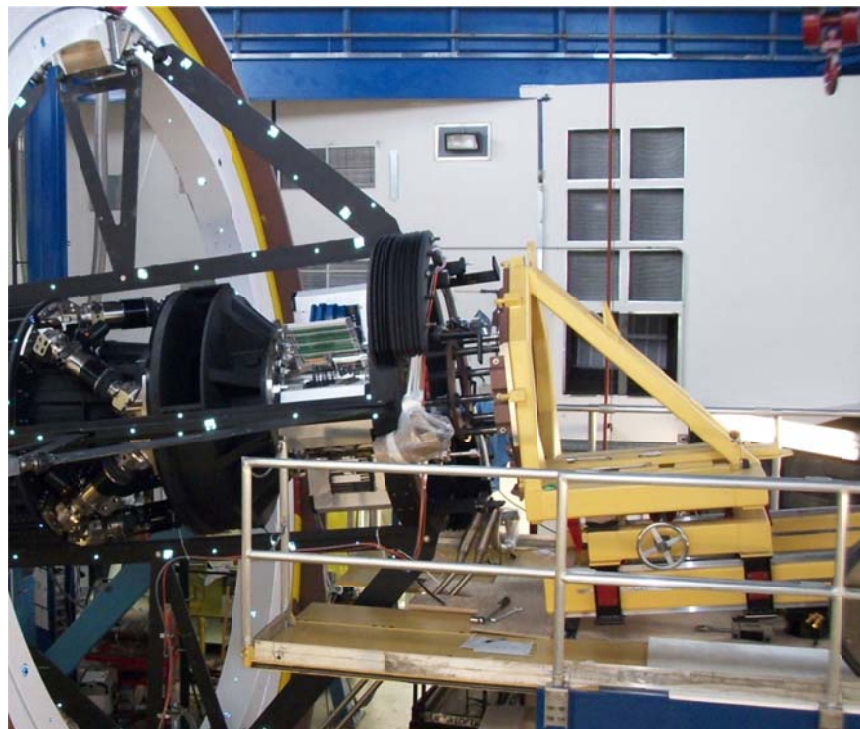
Figure 10. Imager installation testing on the Telescope Simulator. The imager has been translated forward and mated to the back of the corrector.
