AFIP-6 Breach Assessment Report

Dan Wachs
Adam Robinson
Pavel Medvedev

February 2011

**Idaho National Laboratory
Reduced Enrichment for Research and Test Reactors Program
Nuclear Fuels and Materials Division
Idaho Falls, Idaho 83415**

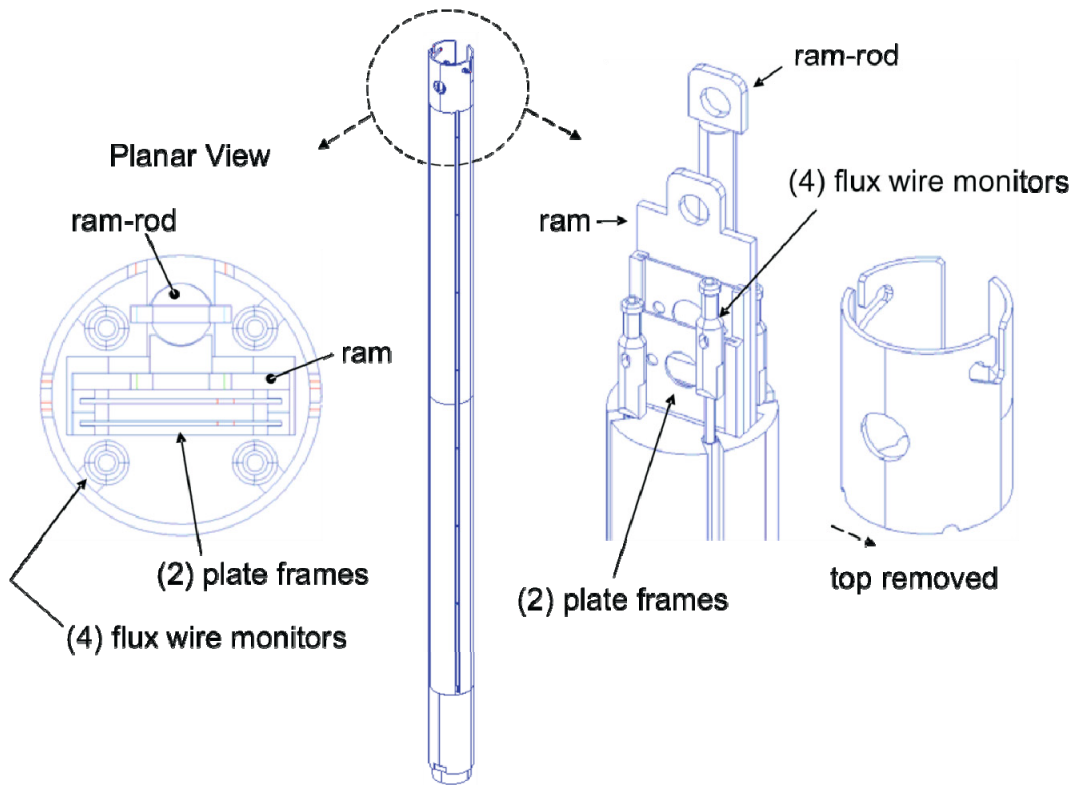
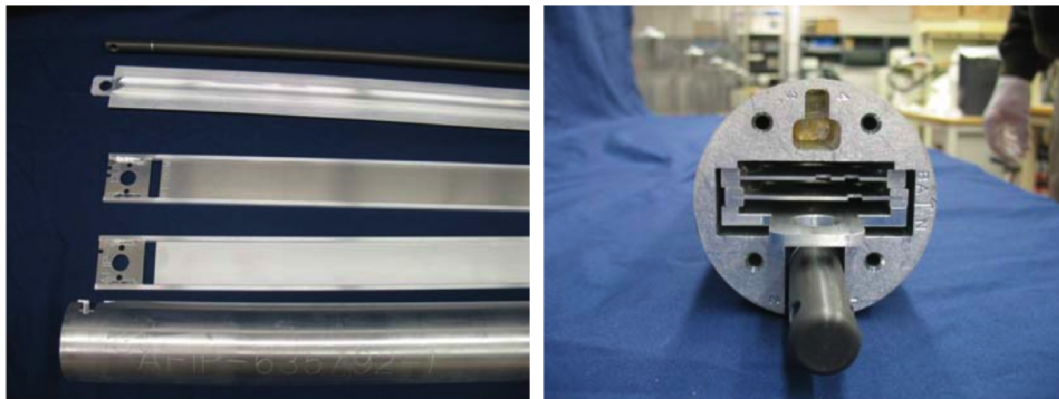
Figure 2. Schematic and photographs of the AFIP test vehicle.

The plates were irradiated using the same test vehicle used for the AFIP-1, -2, -3 and -4 experiments (shown in Figure 2). This apparatus allows for two plate assemblies of the geometry shown in Figure 1. In previous tests, the entire length of the plate was occupied by the fuel zone. However, the AFIP-6 fuel plates used 40% enriched fuel (rather than the 20% used in the previous tests) in order to achieve the desired powers. This increase in enrichment forced the fuel zone to be shortened to 22.5” so that an acceptable non-fueled backup of equivalent reactivity worth could be produced.

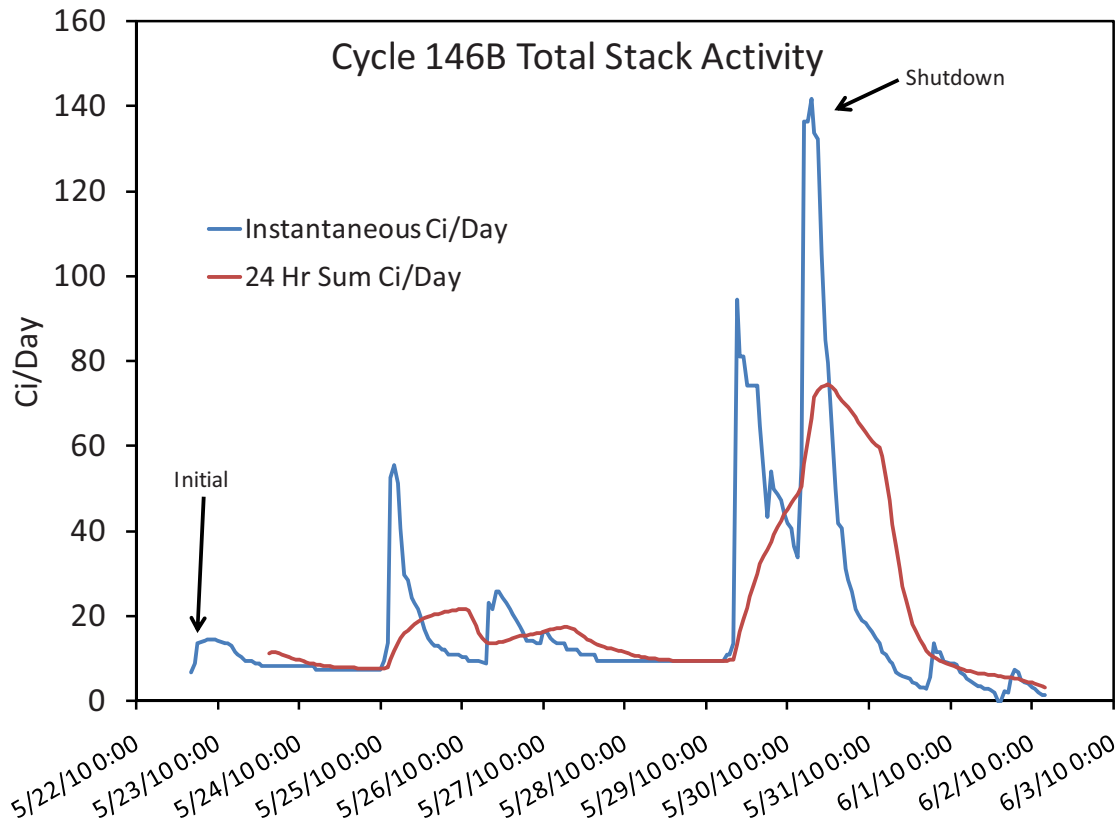
Figure 3. ATR stack gas activity measured by the Real Time Monitor during ATR cycle 146B.⁷

ATR stack gas activity monitoring indicated that approximately five discrete releases occurred over the last week of operation as shown in Figure 3. It appears that individual blisters of different sizes may have ruptured and released fission gases into the coolant. As the gas pressure inside the blister was relieved, the stack gas activity trends back to normal levels after each event. It was also observed that the primary coolant system activity was largely unaffected by the events as shown in Figure 4 (an upward trend in activity is normal during a typical ATR operating cycle).

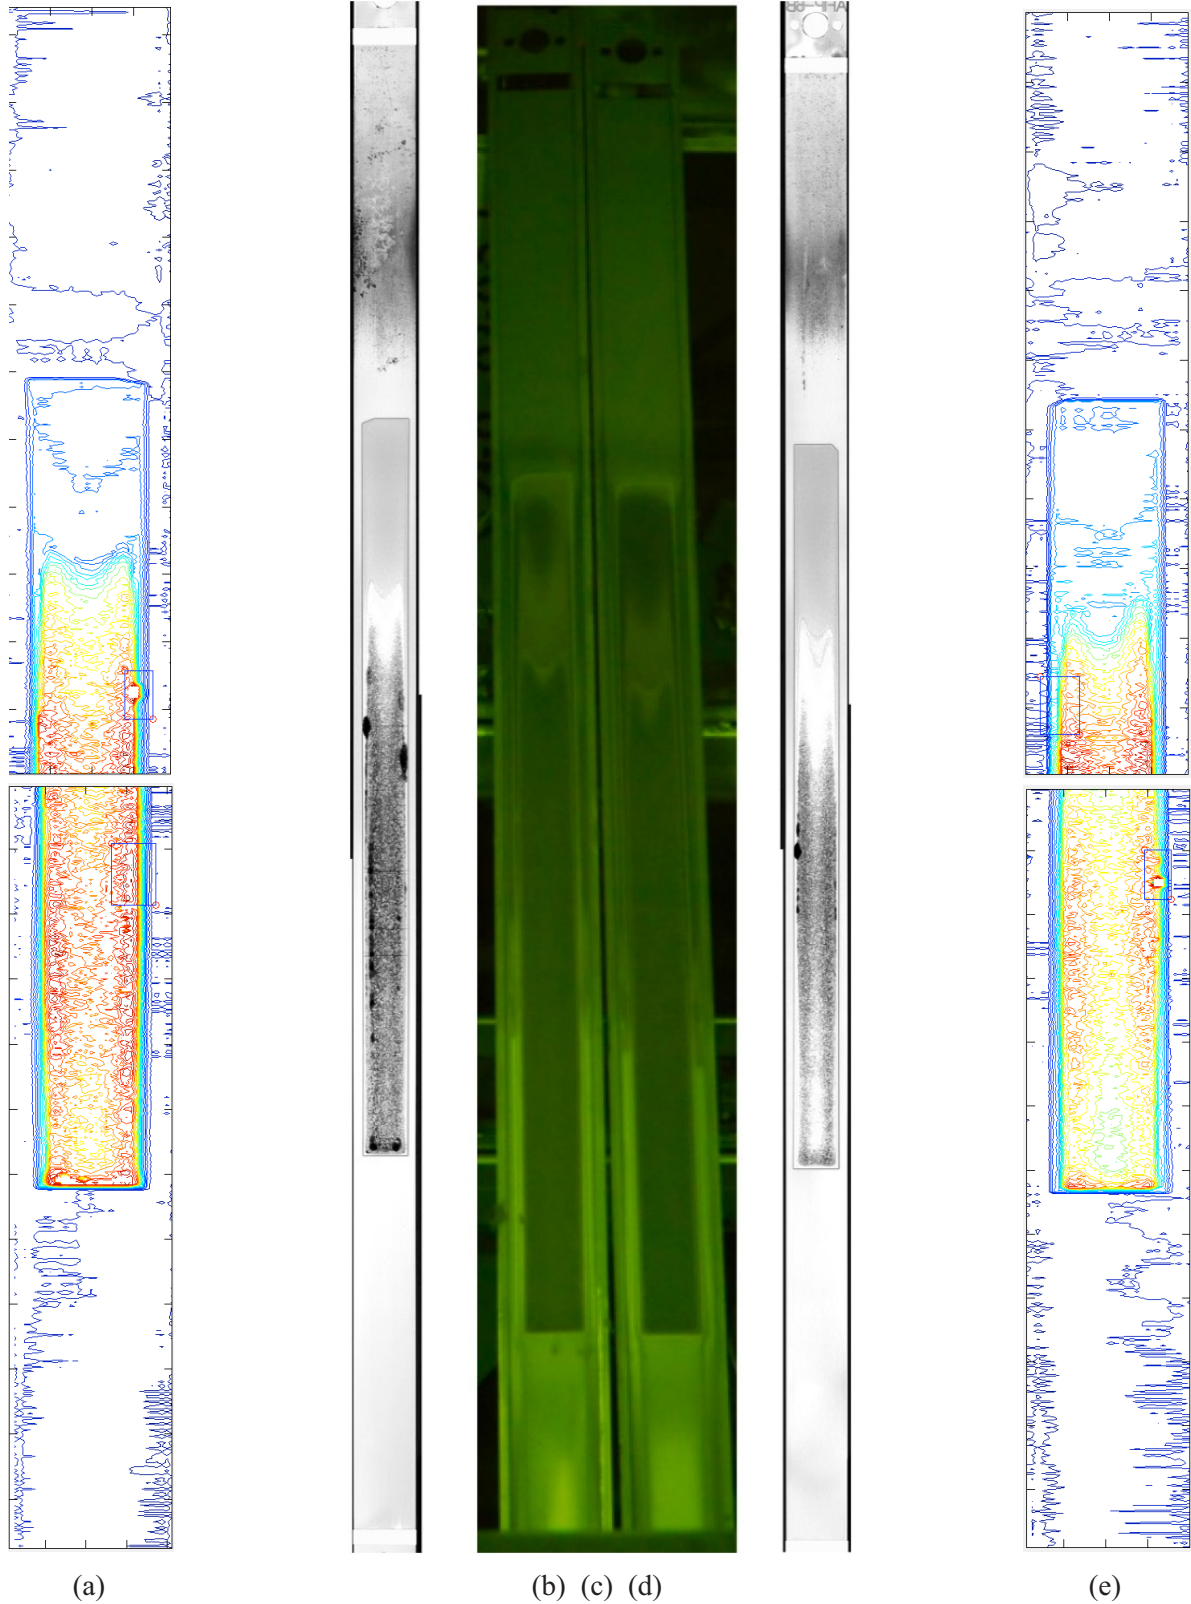
(a) (b) (c) (d) (e)

In-canal ultrasonic (UT) examination was performed to further describe the surface morphology and internal features of both fuel plates. The UT scanner uses a ‘transmission’ based transducer to identify discontinuities inside the fuel, which are typically indicators of delamination or voids. This first examination confirmed the presence of small voids under the blistered regions of the fuel plate. The black spots shown on Figures 5b and 5d are the delaminated areas. The UT scanner can also operate in a ‘reflection’ mode that uses a time-of-flight method to measure the local plate thickness. The contour maps shown in Figures 5a and 5e show the presence of raised regions in these same areas as the larger delaminations. In combination, these signals clearly indicate the presence of blisters. The rectangular fuel region is evident in all three examination modes (visual, transmission, and reflection).

Figure 5. UT scans (thickness scan and transmission) and visual examination (middle) of the AFIP-6A (left) and -6B fuel plates (right). The clipped upper corner of the foil is clear in both UT images and is used to identify common orientations of the plate.

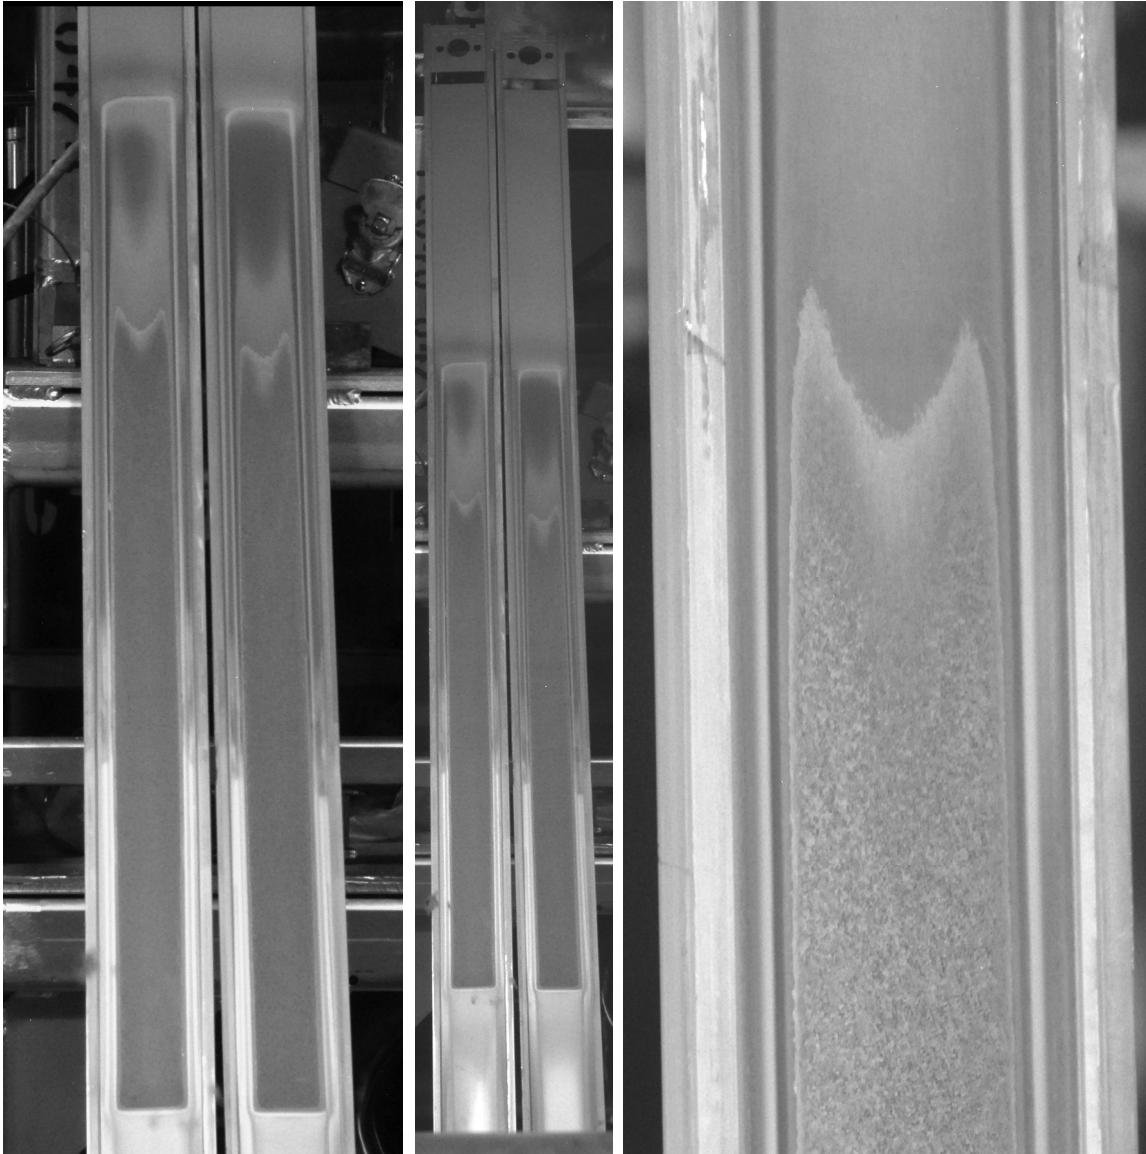
Figure 6. View of fueled region of AFIP-6A plates.

Visual examinations performed on both AFIP-6 plates in the hot cell confirm observations made during in-canal visual inspections performed at the ATR canal. Very dark oxidation was apparent starting approximately 45 cm (16 inches) from the top of the plate (~12 cm (5 inches) into the fueled region of the plate). A clear transition occurs from the typical boehmite oxide to the darker, rough surface as can be seen at the top of the plates in Figure 6. Peak power regions of the AFIP-6 plates showed additional abnormal surface behavior such as blistering and spallation of the surface oxide. Examples of these regions can be seen in Figure 7.

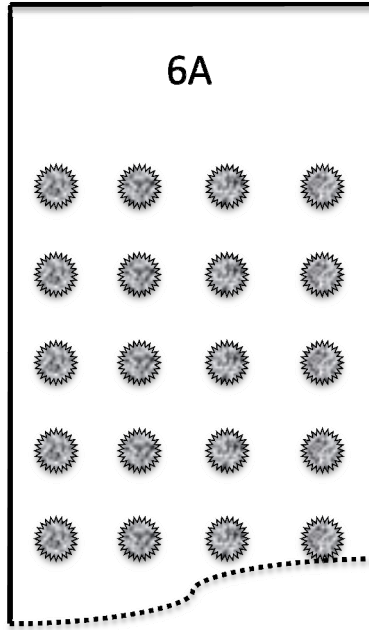
Figure 8. Location of oxide measurements (each location indicates 3 measurements).

The surface oxide thickness distribution across the plate was measured using the eddy current method. The eddy current measurements taken on the AFIP-6 plates consisted of four equi-spaced, transverse measurements across the width of the plate at axial increments of 1.25 cm (0.5 inches) (Figure 8). Each point was measured three times to ensure statistical reliability. Both sides of the fuel plate (identified as 'face' and 'back') were measured. Due to the large number of data points collected, a summary of the values is provided in Table 1. The summary provides the width averaged values at each 1.25 cm (0.5 inch) increment down the length of the plate.

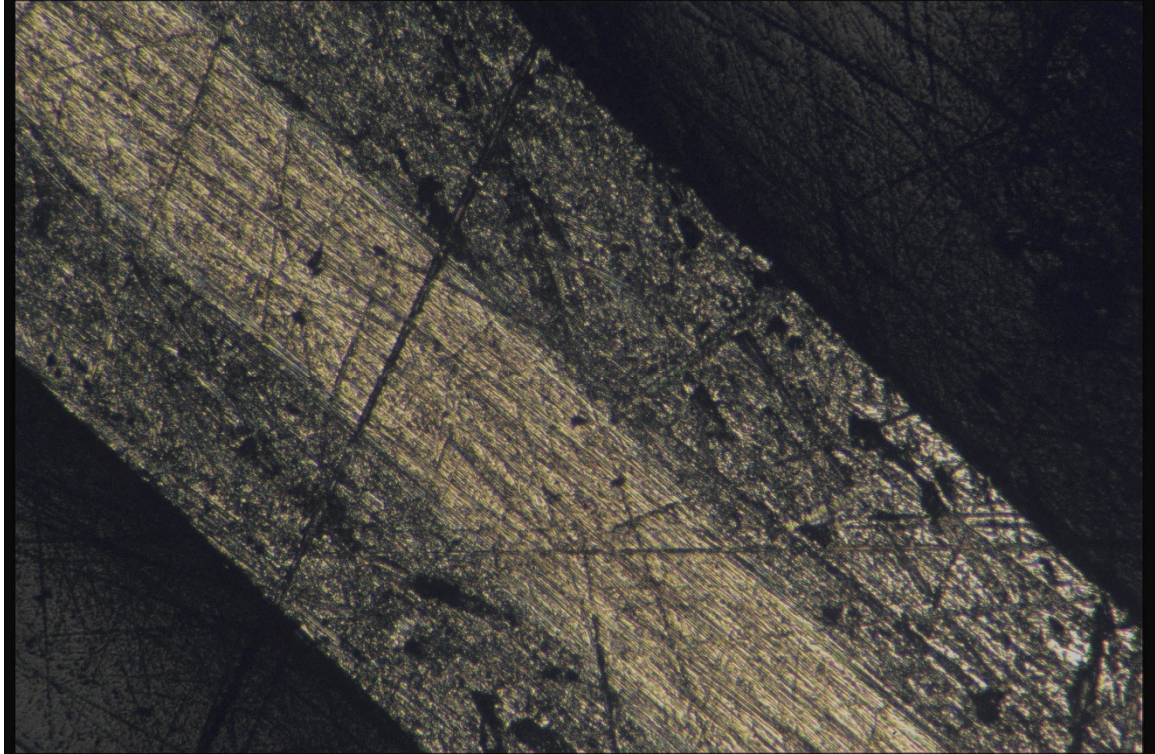
Figure 9. Cross section through the top region of the plate.

The cross section taken through the top region of the plate is shown in Figure 9. The surface of the cladding has behaved in a typical fashion with very little oxide growth. The fuel region also appears to have behaved well. Boehmite layer thickness values for RERTR mini- and full-size plates have been typically on the order of 20 μm and are similar to that seen on the upper part of the fuel plate.

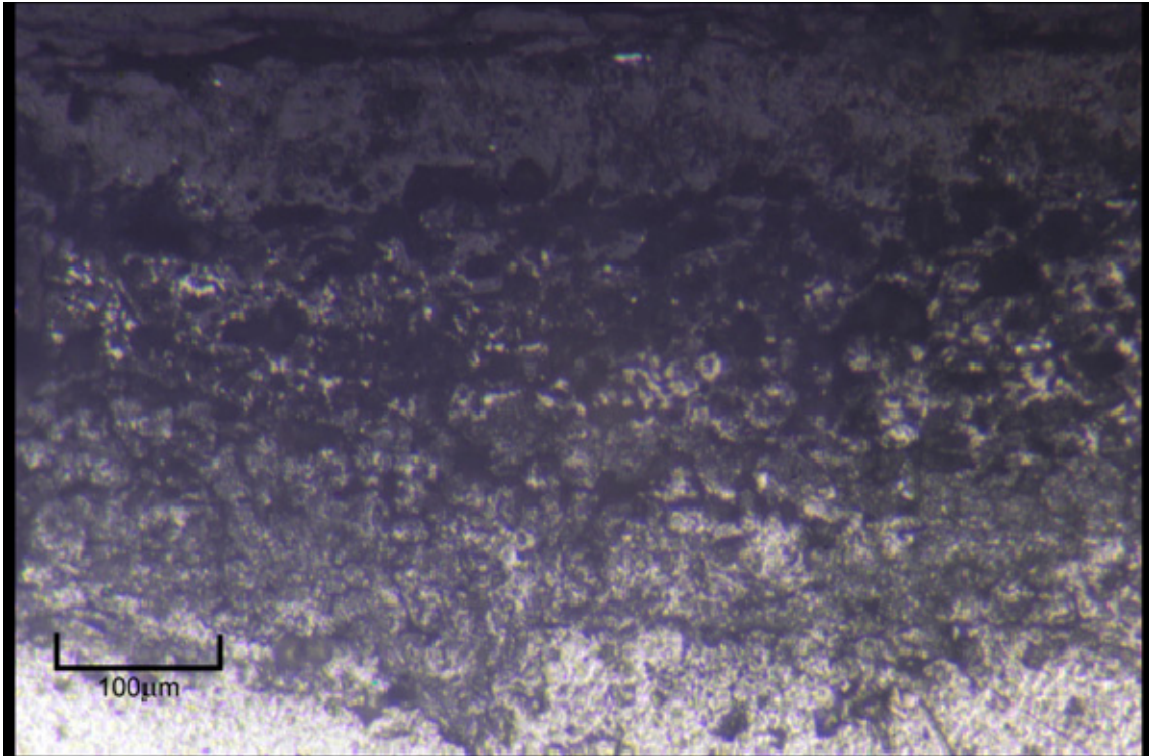
Figure 11. High magnification image of degraded aluminum zone.

The second section taken from the blistered region of the fuel plate showed much different behavior. The oxide layer in the degraded region of the AFIP-6 plates consists of two distinct regions on top of the aluminum base metal and initial metallographic images (like Figure 10 and 11) indicate that values measured using the eddy current method were slightly lower than the actual thickness of the apparent degraded aluminum zone. The upper layer of the oxide film has characteristics similar to the typical boehmite oxide layer. Underneath the boehmite is a second layer of severely degraded aluminum. This underlying degraded zone appears to consist of oxide formation on grain boundaries of the aluminum and is consistent with layers observed to form under severe conditions during historic corrosion studies and a similar event that occurred at SCK-CEN in the Belgian BR2 reactor.^{8,9} Areas where spallation of the oxide has occurred are clearly evident in several metallographic images (Figure 12). Although localized removal of the oxide in the spalled region results in a temporary reduction in local fuel meat temperature, the layer is expected to regrow quickly in response to the degraded substrate, which no longer receives any protection from the boehmite and is directly exposed to the coolant. The morphology of the overall oxide film is consistent with the assumption that a cyclic process of oxide growth, substrate degradation, spallation, and further oxide formation occurred during irradiation.

The volume fractions for the aluminum, oxide, and porosity can be estimated through examination of the micrographs shown previously in Figure 11 and microchemical analysis performed on similar layers at BR2.⁸ If the aluminum to oxide ratio is generously estimated to be 25% to 75% and the porosity is estimated at 40%, the effective thermal conductivity of the composite material is on the order of 3.5 W/m/K (assuming the thermal conductivity of Al-6061 is 160 W/m/K).

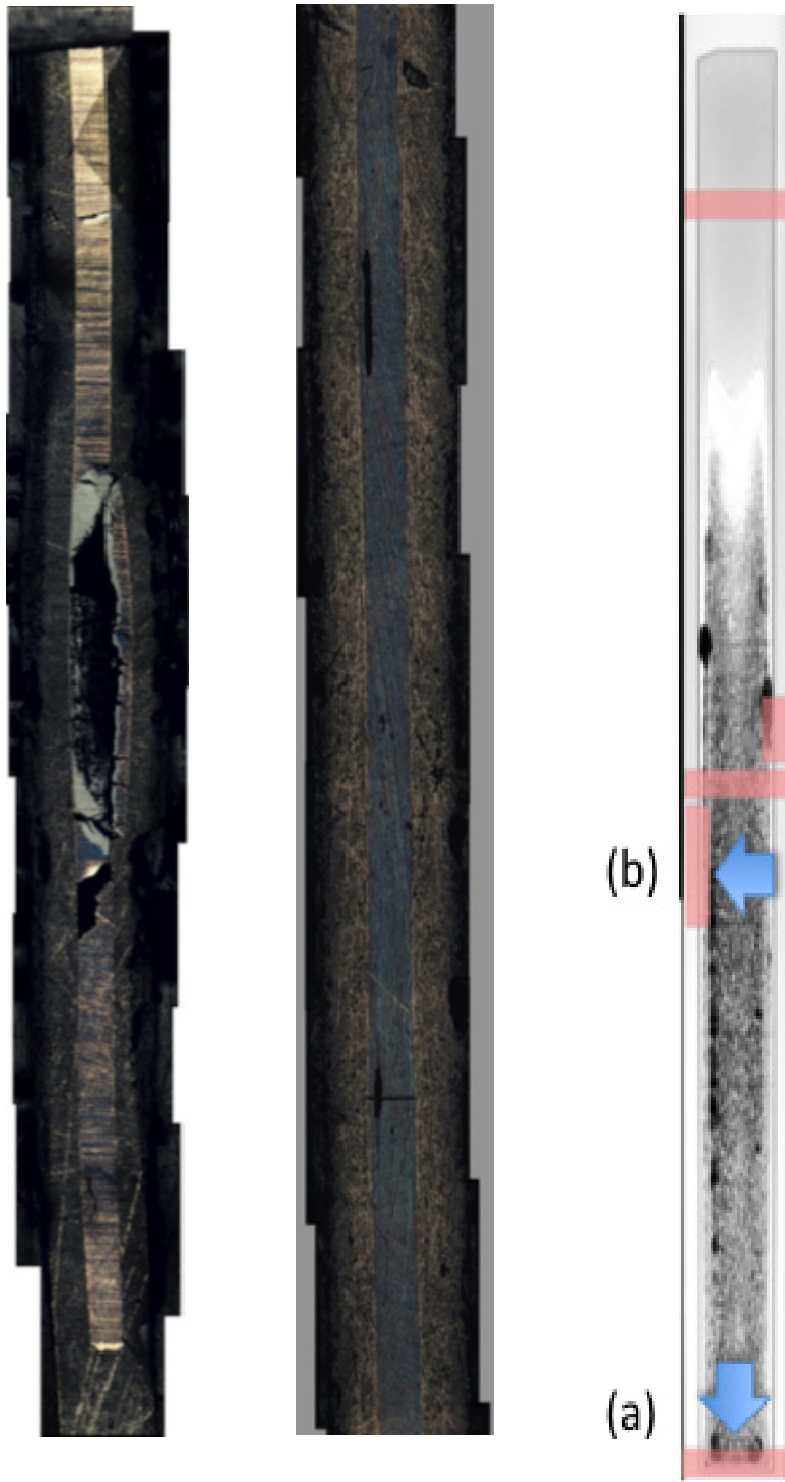
A section of the plate taken near the bottom of the fueled region is shown in Figure 13. The section was taken through a large blister and, as expected, shows significant damage to the fuel. A relatively large void has formed near the centerline of the fuel foil and cracking is evident in the fuel around the void. Fuel meat cracking has also been observed in similar events experienced by dispersion fuel types and is attributed to the thermal cycling that occurs during shutdown.⁸ The severity of this phenomenon is greatly increased by the presence of a thick oxide film. The fuel plate 'blister' is clearly visible due to the change in fuel foil and cladding thickness. It is likely that cracks in the cladding over this blister resulted in release of fission gases to the primary coolant.

Sections were also extracted from the edge of the fuel plate where UT scans indicated damage but blisters were not yet evident. Figure 13 also includes a cross section taken in the axial direction near the edge of the fuel zone. This image shows that voids have begun to form a uniform distance from the fuel/cladding interface. It is anticipated that these defects will become 'sinks' for fission gases that will ultimately become large enough to cause blisters like those observed in hotter regions of the plate (i.e., that shown in Figure 13).

(a) (b)
 Figure 13. Cross section through blister at lowest fueled region of the plate (left) and down plate length showing edge behavior (right).

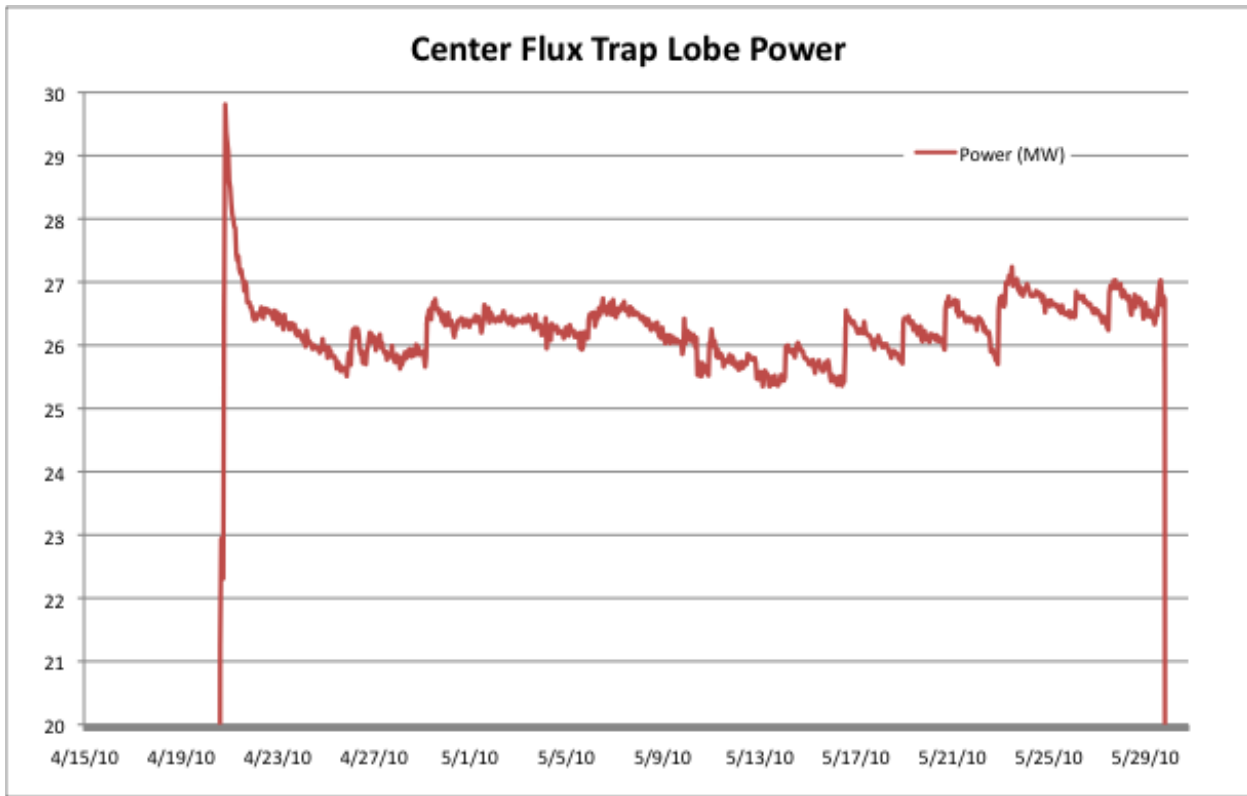
Figure 15. Center Flux Trap lobe power profile for ATR Cycle 146B.

The Center Flux Trap lobe power as a function of time is shown in Figure 15. Several salient operational features are clear from this plot. First, the CFT power spikes appreciably at the beginning of the ATR operating cycle for a short period of time as the reactor overcomes xenon poisoning after startup. Near the end of the cycle, the CFT power begins to climb due to movement of outer control drum cylinders. Small spikes in the lobe power routinely occur due to movement of control shims and the outer control drum cylinders.

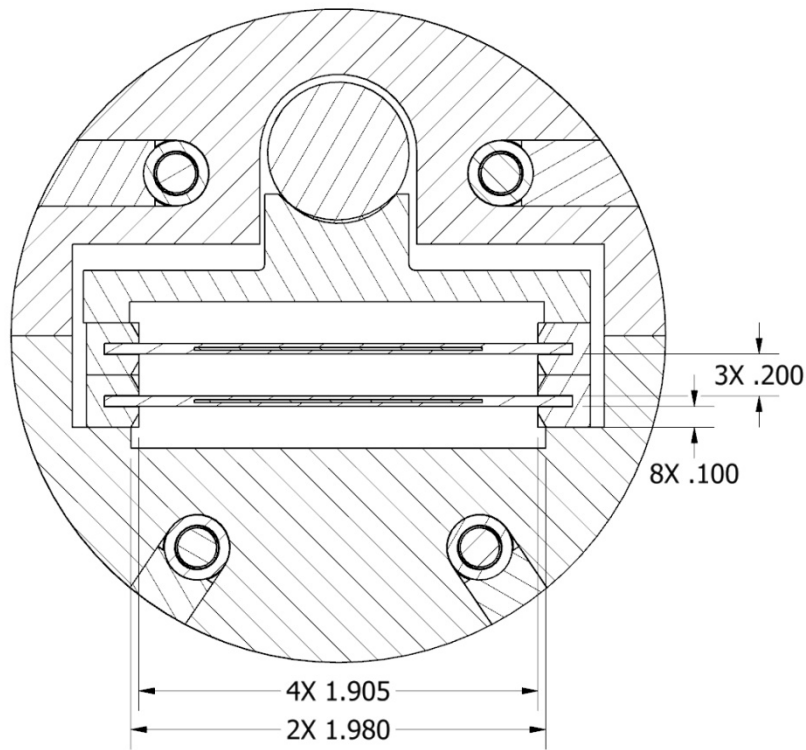
Figure 16. AFIP hardware flow channel dimensions.

The two AFIP fuel plate assemblies are configured into the experiment with coolant channels as shown in Figure 16. These coolant channels were designed to be wider than is typical in research reactor applications in order to mitigate the impact of unanticipated fuel plate pillowing or buckling and to protect the fuel plates during interim handling in the ATR canal. However, a flow restriction was incorporated to the AFIP test train to minimize coolant flow and thereby maintain the excess pressure and flow margins for the ATR primary pumps. The coolant channel hydraulic properties were measured experimentally¹⁵ and an orifice was designed based on the results.¹⁶ The orifice diameter was selected to deliver representative coolant temperature conditions in the fuel plate channels. However, new analysis described in this section has highlighted that while the orifice allows for prototypic coolant temperatures, the reduced coolant velocity also reduces the convective heat transfer coefficient between the fuel plate and coolant. This reduction in heat transfer results in a relative increase in fuel plate surface temperature for a given bulk coolant temperature.

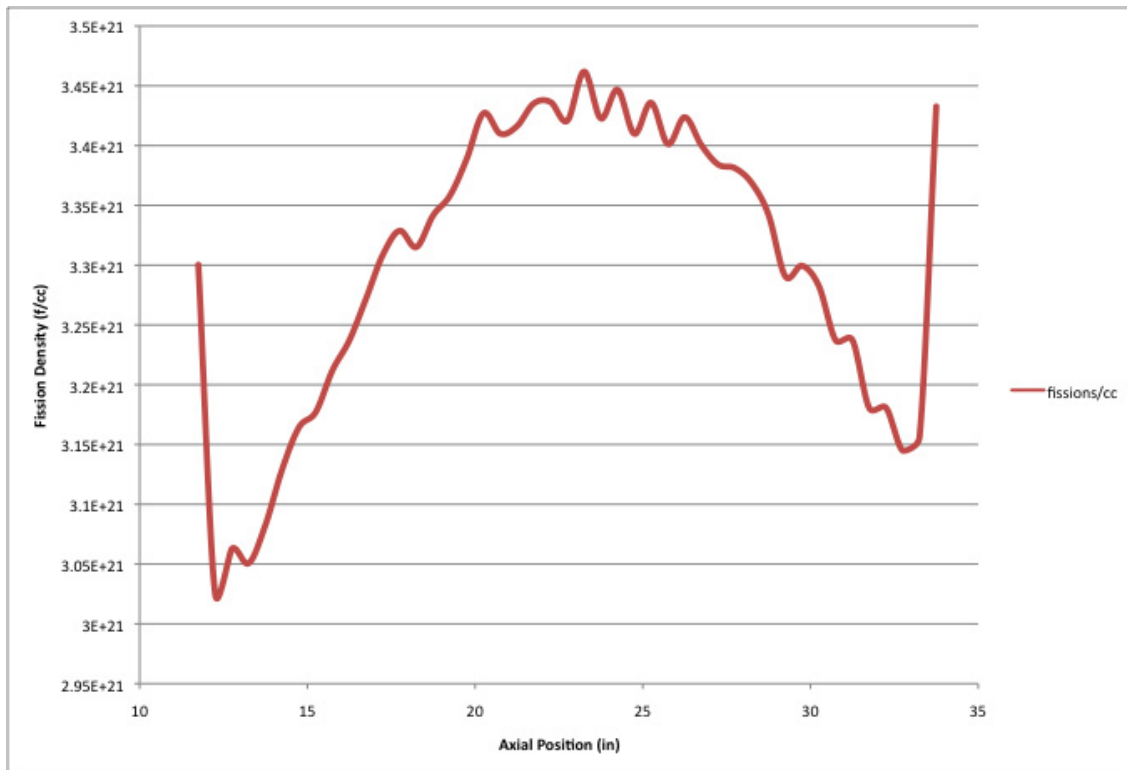
Figure 19. Calculated fission density in AFIP-6A fuel plate at the end of irradiation.

When coupled with the calculated plate power conditions and oxide thickness measurements, the AFIP-6 fuel plate thermal conditions can readily be calculated. The axial fission density (related to power distribution) for the AFIP-6A fuel plate is shown in Figure 19. The axial peaking at the leading and exiting ends and reactor core centerline are clearly evident. The end peaking is caused by extra neutron thermalization in the neighboring non-fueled region of the plates before and after the fuel zone.

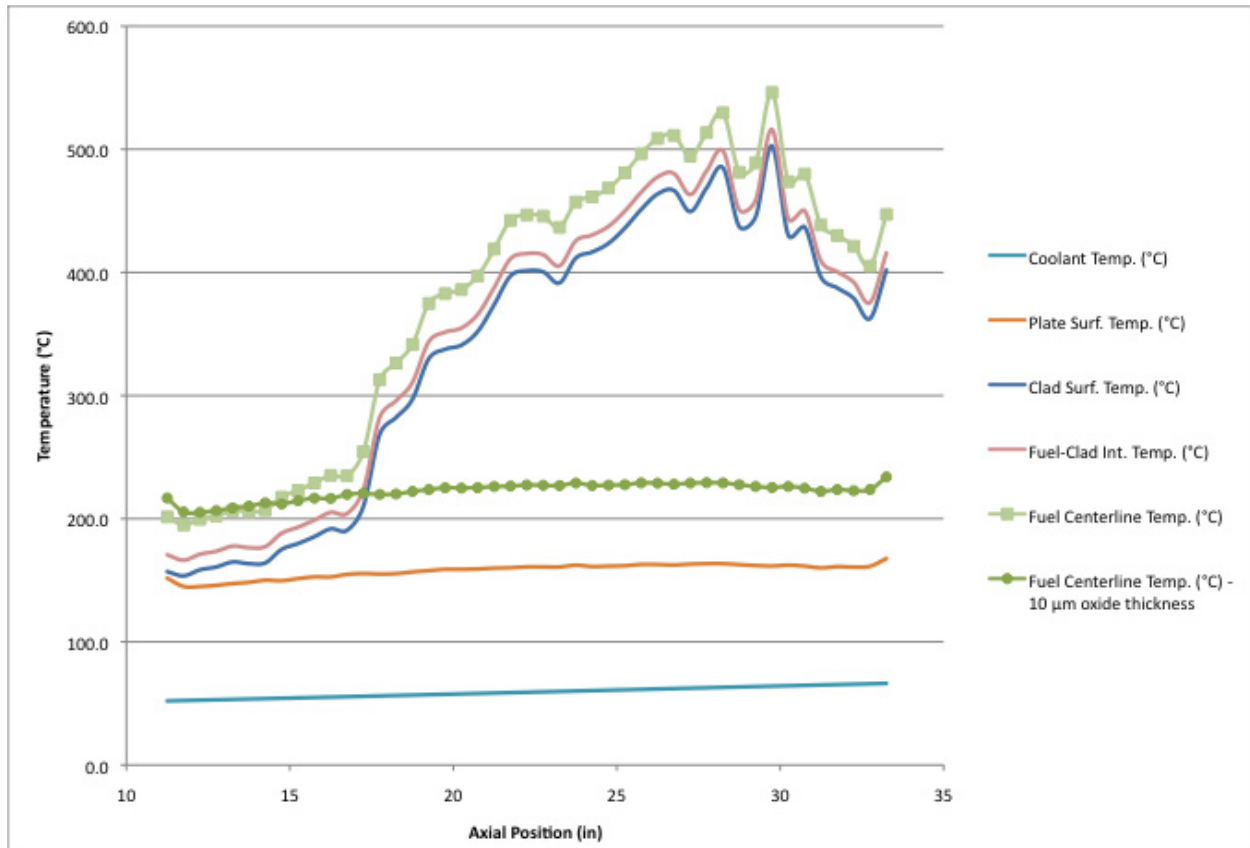
Figure 20. Estimated AFIP-6 fuel plate operating temperatures as a function of axial position on the fuel plate.

The thermal analysis results shown in Figure 20 account for variations that occur in the axial direction (including coolant temperature and fuel plate power generation) in order to predict the axially dependent temperature of the cladding and fuel meat. Two sets of curves are shown to demonstrate the affect the oxide layer has on the fuel meat temperature. One set shows the predicted temperature field based on the measured oxide thickness and the other shows the fuel meat temperature with a more typical 20 μm thick oxide layer. It is clear from the plot that the most significant (by a vast margin) temperature jump occurs across the oxide layer. Assuming a normal oxide layer of less than 10 μm covers the entire plate, the fuel meat centerline temperature would have remained well under 225°C.

As shown in Figure 20, as the oxide layer grows its extremely low thermal conductivity significantly impacts the fuel meat operating temperature. Post irradiation annealing studies have shown that common plate type fuels (including the monolithic fuel design) become sensitive to blistering when exposed to elevated temperatures and that the threshold drops as the fission density increases. A plot of the blister threshold data for representative plate type fuels is shown in Figure 21.²² At the end of irradiation the AFIP-6 fuel plates were estimated to reach fission densities greater than 3×10^{21} f/cc with peaks as high as $\sim 3.5 \times 10^{21}$ f/cc. At this fission density blistering could be anticipated to occur in regions of the fuel plate operating at temperatures as low as $\sim 400^\circ\text{C}$. As the temperature profiles shown in Figure 20 indicated that significant segments of the plate are operating above this threshold, blistering is considered possible and would be first expected to occur at peak fission density locations (i.e. near the end of the fuel plate and just below the fuel plate mid-plane along the plate edges).

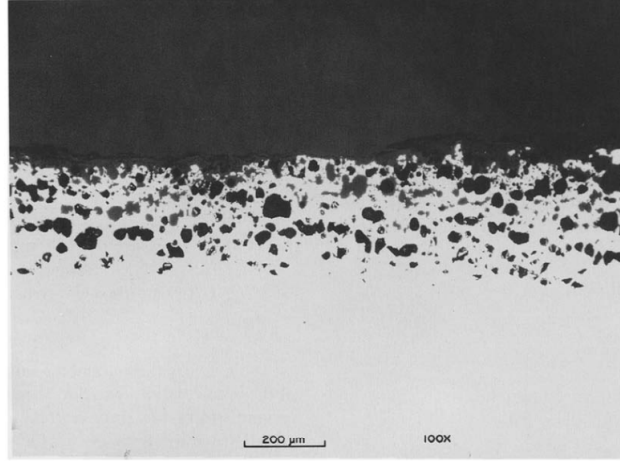
Figure 22. Specimen cross-section after spallation with subsurface attack.²⁵

- Corrosion buildup due to elevated oxide-water surface temperature and prolonged irradiation time.
- Oxide spallation occurs when temperature difference across the oxide layer reaches 119°C (driven by the oxide thickness and the local surface heat flux).
- Loss of corrosion protection normally provided by the boehmite film.
- Development of the reaction zone (Figure 22) in cladding regions affected by the spallation. The reaction zone is composed of the oxide and voids (up to 200 microns thick).
- Plate blistering in the affected regions due to impairment of heat removal. Impairment of heat removal is due to formation of the reaction zone composed of the oxide and voids.
- Cladding breach and release of fission products into the coolant.

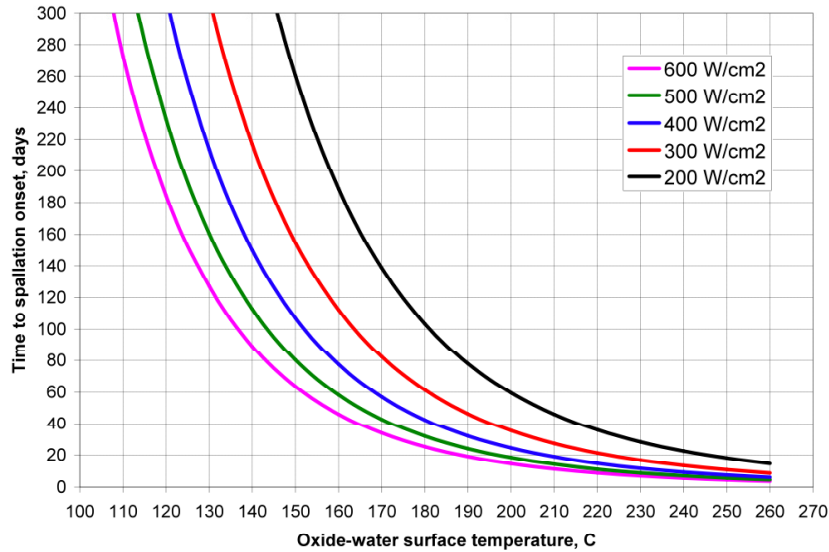
Equation (4) is plotted in Figure 23 for the given heat flux values 200-600 W/cm^2 .

Figure 23. Irradiation time to the spallation onset for a range of the heat flux values. Given expected heat flux and oxide-water surface temperature, the chart can be used to estimate irradiation time to the onset of spallation.

It is recommended that Equation (2) and Equation (3) be used during experiment design to verify that that spallation will not occur. It is important to apply this criterion to the local conditions (heat flux and oxide-water surface temperature).

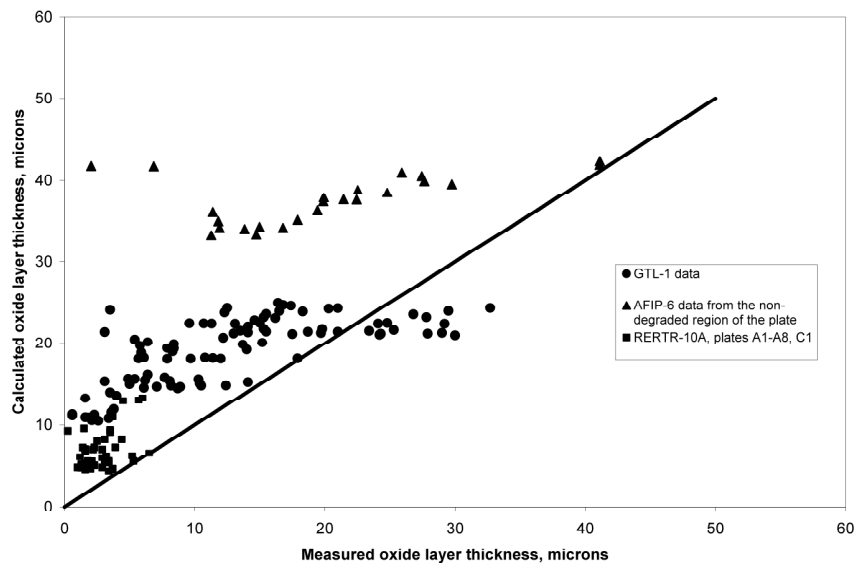
Figure 24. Oxide thickness calculated using Equation (2) versus measured oxide thickness.

As evident from Figure 24, Equation (2) provides a conservative assessment of the oxide thickness in most of the cases. Based on this result, it is established that the ATR-corrected Griess correlation is applicable to predicting pre-spallation oxide growth on aluminum clad experimental plates.
