Comparative Study of Vented vs. Unvented Crawlspace in Identical Side-by-Side Homes in the Mixed Humid Climate

**COMPARATIVE STUDY OF VENTED VS. UNVENTED CRAWLSPACES
IN IDENTICAL SIDE-BY-SIDE HOMES IN THE MIXED HUMID
CLIMATE**

Prepared by
OAK RIDGE NATIONAL LABORATORY
Oak Ridge, Tennessee 37831-6283
managed by
UT-BATTELLE, LLC
for the
U.S. DEPARTMENT OF ENERGY
under contract DE-AC05-00OR22725

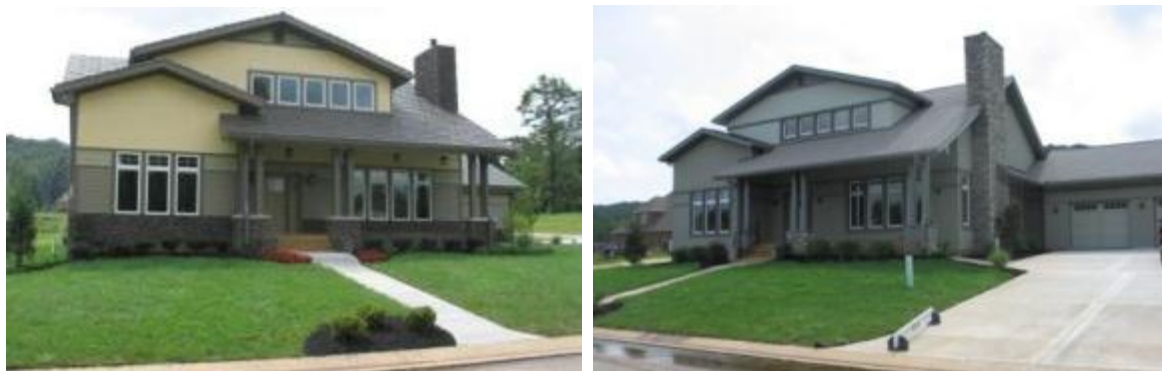
Figure 1. WC3 (left) with vented crawlspace and WC4 (right) with insulated and sealed crawlspace.

Figure 1 shows the outside front views of WC3, built with a conventional vented crawlspace, and WC4, built with a sealed crawlspace. An oriented strand board (OSB) subflooring was used in the two homes, with a tongue-and-groove joint to improve the airtightness. The subflooring is a pre-engineered panel designed and treated for low water absorption and warp characteristics. The ventilated crawlspace in WC3 has two R-16 fiberglass batts installed in the floor chase cavities above the crawl, while the crawlspace in WC4 is sealed and insulated with 1.5 inch thick foil-faced (Thermax) polyisocyanurate board insulation on the interior side of the block wall. Figure 2 shows the footer construction in WC3 and WC4. The exterior of the masonry block forming the crawlspace on both homes was waterproofed using an emulsion-based asphalt coating (Figure 3). A channel of washed crushed stone backfill was installed on both the inside and the outside of the footer and a drainage pipe was installed that sloped away from the footer and was exposed to daylight.

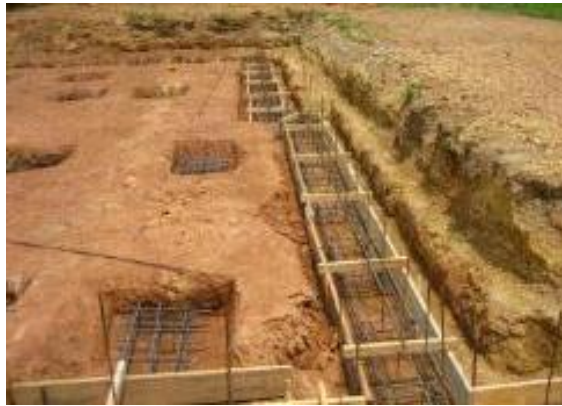
Figure 2. No. 4 rebar used in construction of footer in WC3 and WC4.

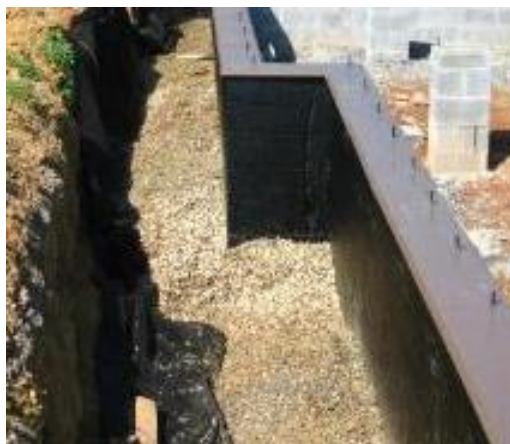
Figure 3. Tremco waterproofing on the exterior of the concrete masonry unit (CMU) crawlspace wall.

On the exterior wall of both houses, stack stones were installed up to the termite barrier of through-the-wall aluminum flashing, which was sandwiched between the 8 inch 2-hollow core concrete masonry block wall and the base plate. A 20 mil (0.02 inch) liner covers the floor of both crawlspaces and is taped to a 10 mil wall liner in WC4 only. WC3 crawlspace walls contain eleven vents, each about 15.5 inch by 7.5 inch, yielding a total vent area of 8.9 ft². The wall liner in WC4 was adhered to the masonry block using a low-VOC polyurethane caulk and stopped about 3 inches below the sill plate to allow for termite inspections. DOW's Thermax™ rigid polyisocyanurate foam insulation (R_{US} -9.8) was glued to the wall liner using a polyurethane caulk adhesive. R_{US}-10 was a code requirement for the Tennessee Valley region in October 2010. WC4's crawlspace also incorporates a dehumidifier and is semi-conditioned through an air supply duct from the supply plenum that discharges into the crawlspace. Photographs of the crawlspaces in WC3 and WC4 are shown in Figure 4. The insulation and sealing features were installed by Bennie Marshall of Your Crawlspace Inc. (www.yourcrawlspace.com/).

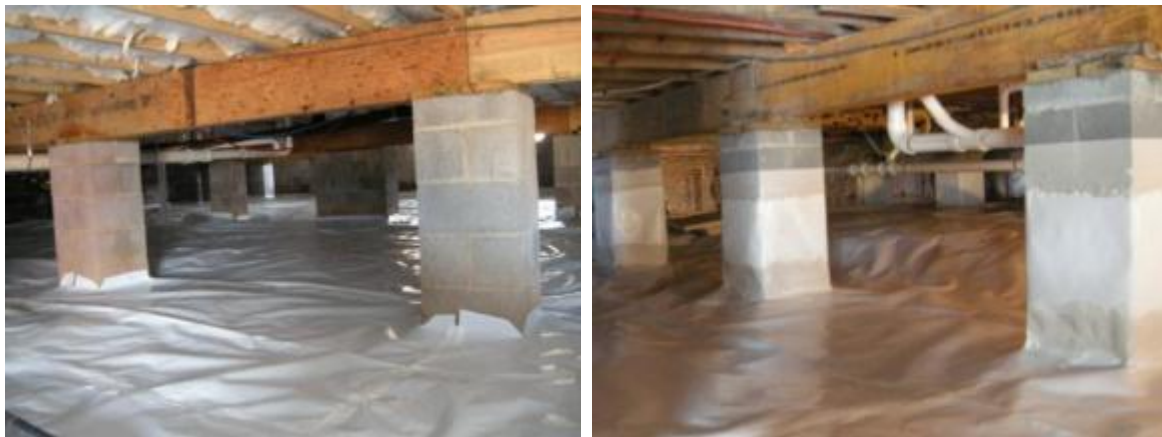
Figure 4. Vented crawlspace in WC3 (left); walls insulated and sealed in WC4 crawlspace (right). Notice that there are no ducts in either crawlspace.

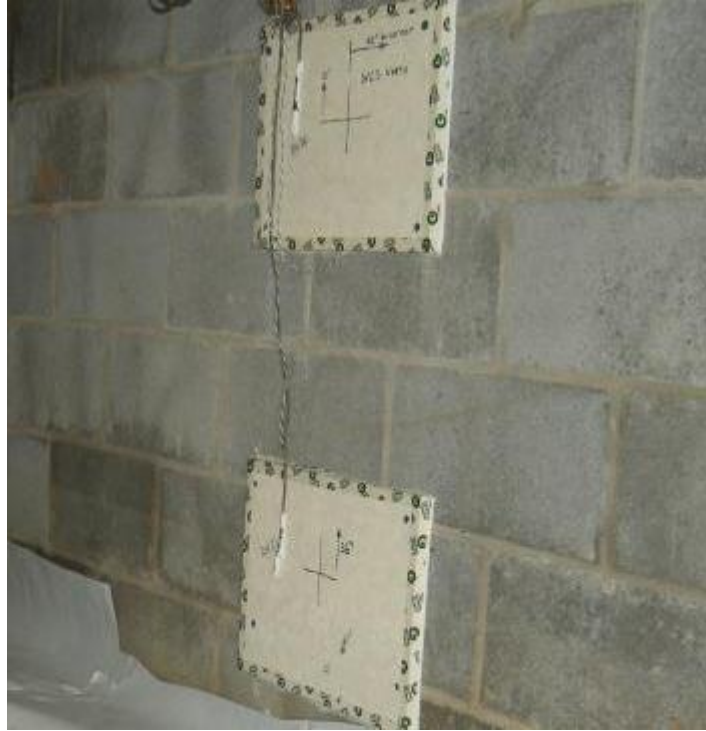
As indicated in Table 1, the east and north walls of the two crawlspaces were instrumented with thermistors and humidity sensors inside and outside the masonry walls, both above- and below-grade. In the WC4 crawlspace, thermistor and humidity probes were also installed on the foam surface facing the crawlspace interior. Heat flux transducers were installed on the interior surfaces of the masonry wall, in WC3 using ½ inch gypsum board and in WC4 between the foam sheet and the masonry wall. The ½ inch gypsum boards and the foam sheets had square slots routed on their surfaces to house the inlaid HFTs to ensure good contact with the masonry walls and prevent the formation of air pockets. Figure 9 shows the installation of HFTs in WC3, with “+” signs marking HFT locations. The T/RH combination probes (in white) can also be seen on top of the gypsum board surface.

Figure 9. Sensor installation on the WC3 crawlspace masonry wall.

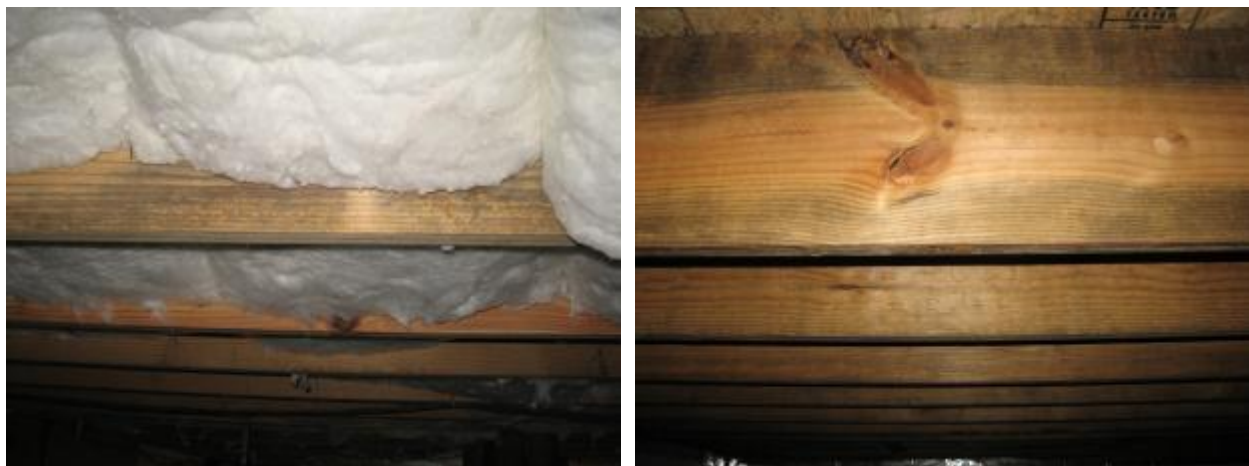
Figure 29 shows a visual comparison of the joists in the WC3 and WC4 crawlspaces after the end of the evaluation period. Some discoloration was visible on a number of joists in both crawlspaces. Overall, the joists in WC3 crawlspace did not appear to be worse than the WC4 joists. There was some powdery deposit on a few joists in the WC3 crawlspace, seen in the left panel in Figure 29, which could indicate a mold-related problem. It should be noted that, early in the construction period, mold growth was observed and mitigated in WC4 crawlspace. The two crawlspaces will continue to be monitored for another year, with a close focus on the subfloor joists for mold growth.

Figure 29. Visual comparison of WC3 (left) and WC4 (right) crawlspace joists in September 2011.
