ORNL/TM-2011/449

An Innovative Technique for Evaluating the Integrity and Durability of Wind Turbine Blade Composites - Project Final Report

October 2011

**An Innovative Technique for Evaluating the Integrity and
Durability of Wind Turbine Blade Composites
FY2011 Project Report**

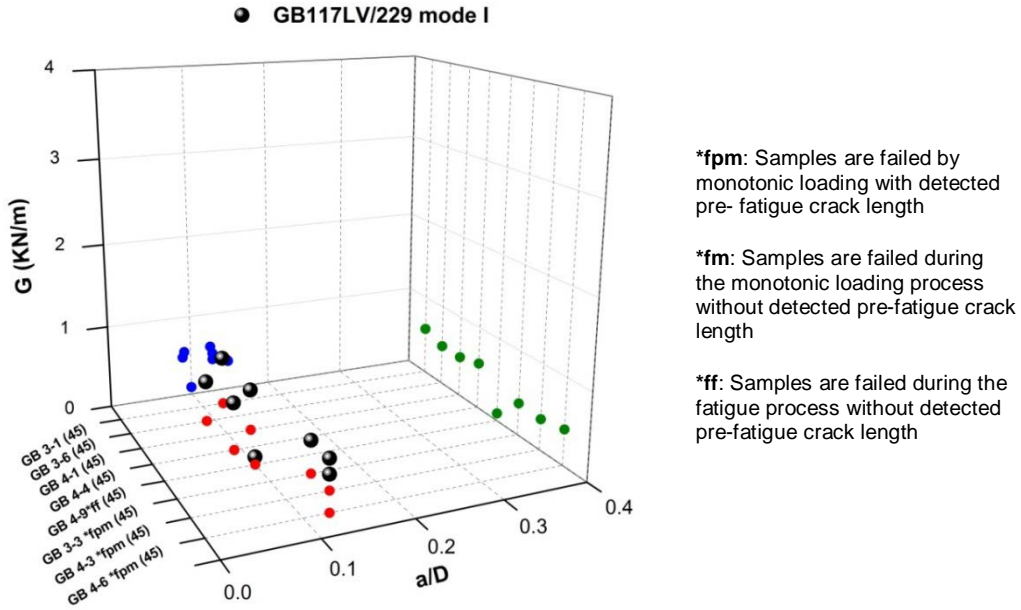
Figure 24. Energy release rates of epoxy GB117LV/229 at mode I failure

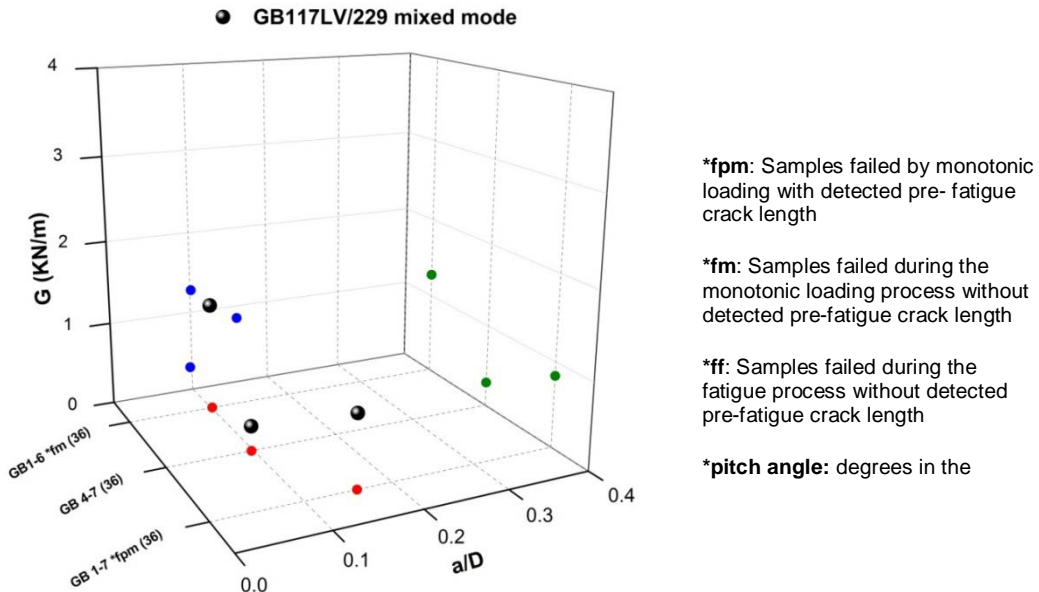
The energy release rates estimated from available mixed-mode samples appeared to have wide spectrum (Figure 25). The energy release rates of mixed mode samples seemed to be higher than that of the Mode I samples. For the mixed-mode samples, those failed along the 45° principle stress plane had much higher fracture toughness than the samples failed along the initial mixed-mode spiral crack front.

Figure 25. Energy release rates of epoxy GB117LV/229 at mixed mode failure

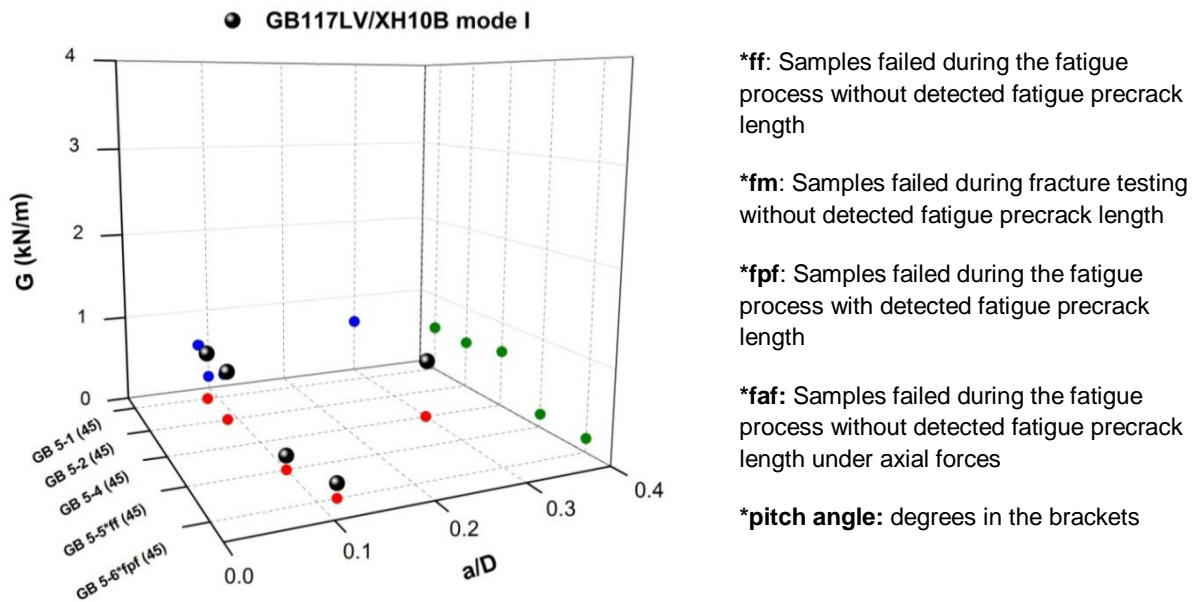
Figure 26. Energy release rates of epoxy GB117LV/XH10B at mode I failure

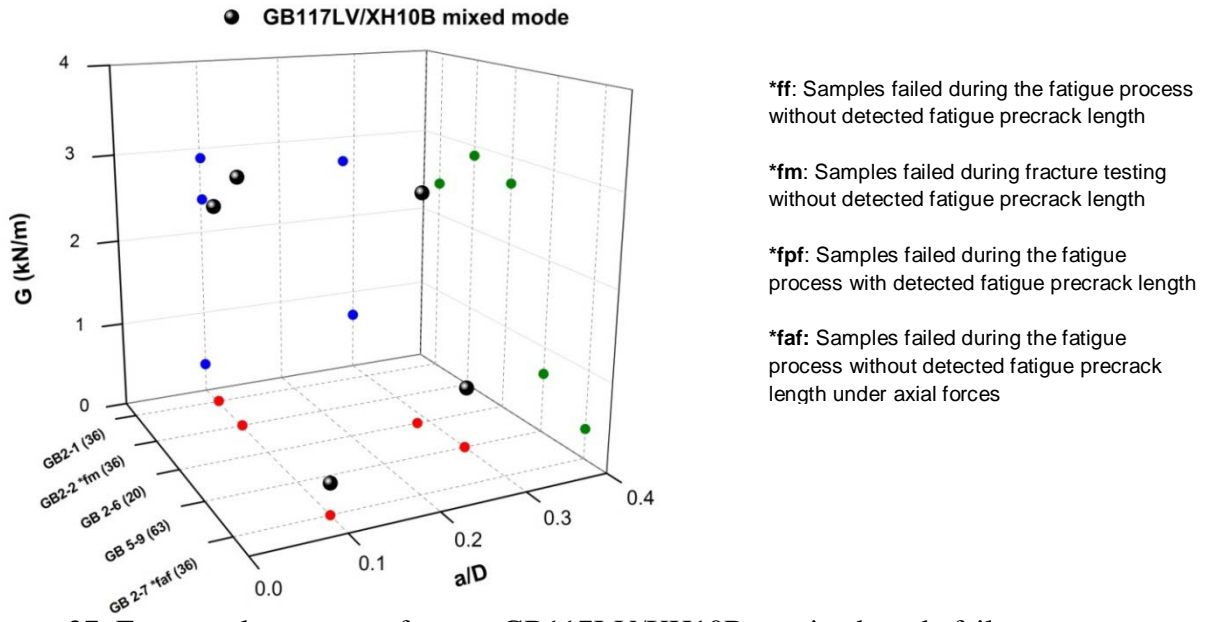
For sample GB2-7, the associated energy release rate appeared to be significantly lower than that of the other mixed-mode samples. This sample failed during SNTT testing but with notable axial loading increased to 332 lb upon fracture. The cause might be that highly localized constraint enforced by the axial loading at the crack front decreased the apparent fracture toughness.

Figure 27. Energy release rates of epoxy GB117LV/XH10B at mixed mode failure

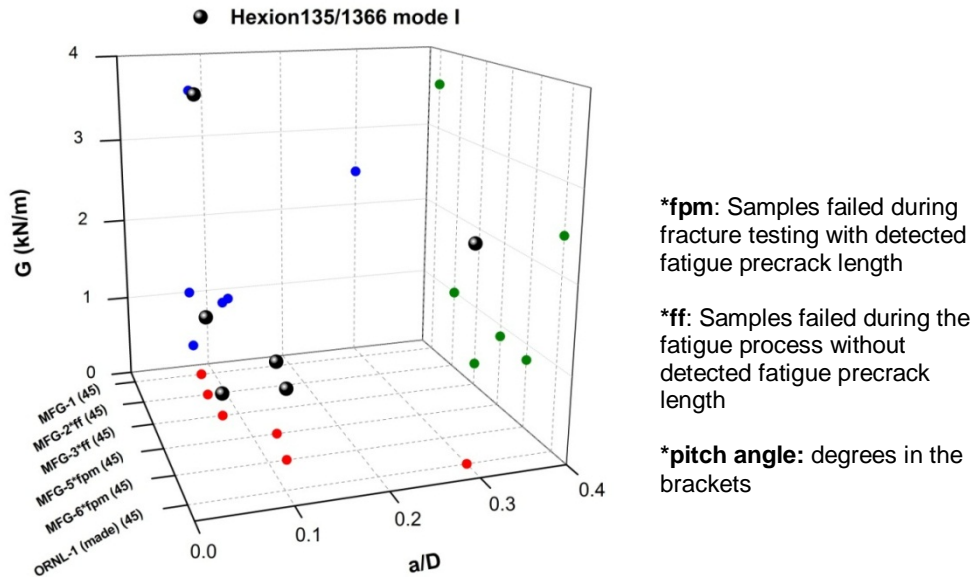
The energy release rates of epoxy Hexion 135/1366 at mode I failure were shown in Figure 28. Large variation of the energy release rates from SNTT tested samples, i.e., MFG-1 and ORNL-1, could be observed. The energy release rates of samples failed during the fatigue pre-crack process, i.e., MFG-2 and MFG-3, showed much less toughness that those of regular SNTT tested samples of similar a/D ratios. The energy release rates of samples failed under fracture loading with detachable fatigue pre-crack, i.e., MFG-5 and MFG-6, also had lower toughness, i.e., 0.84 kN/m, compared to that of samples without fatigue pre-crack.

Figure 28. Energy release rates of epoxy Hexion135/1366 at mode I failure

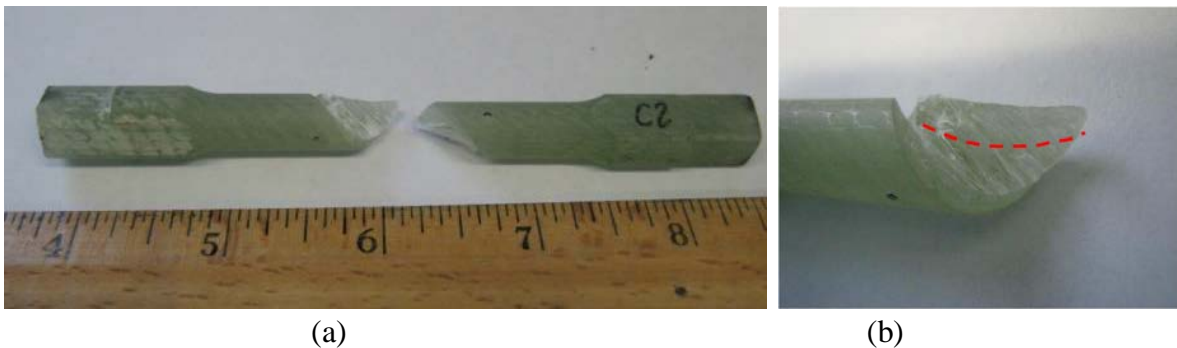
Figure 50. Pictures of a failed C-type sample (#C-2).

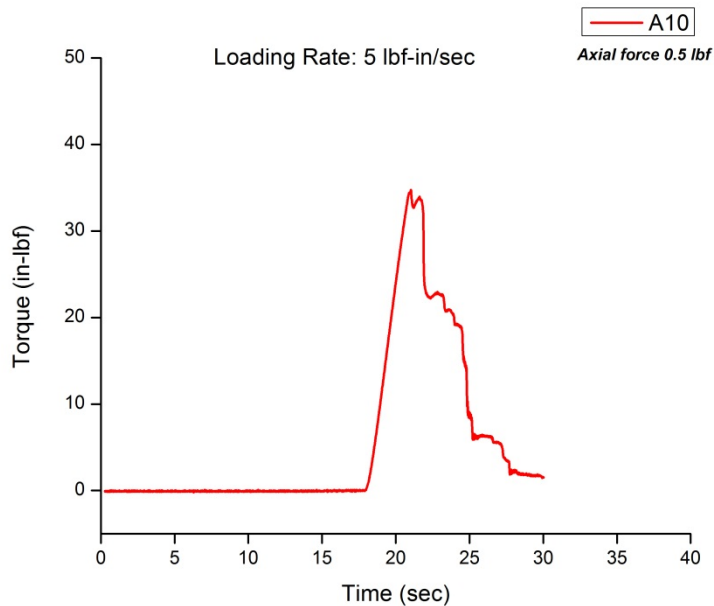
Figure 51. A representative load-displacement curve of composite SNTT sample A

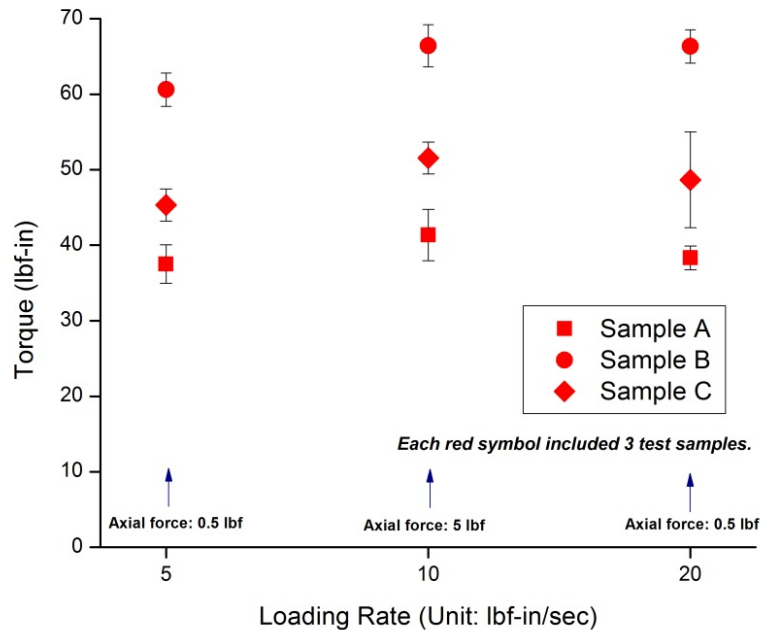
A few hints could still be obtained from the available results. For instance, for the same axial forces, the failure loads at the loading rate of 20 lbf-in per second were slightly higher than that with lower loading rate of 5 lbf-in per second. This seemed to be reasonable since higher loading rates reduced the time-dependent stress relaxation effect of the composites structure. More data were needed to further quantify this phenomenon. Furthermore, for the intermediate loading rate of 10 lbf-in per second with high compressive load of 5 lbf, it appeared to have similar failure toques level as that of higher loading rate data but with less axial compressive forces. This could be the increased localized constraint due to higher compressive stress in the intermediate loading rate data achieved the same effect of the higher loading rate data with smaller axial compressive stress.

Figure 54. Experimental results of composite SNTT samples

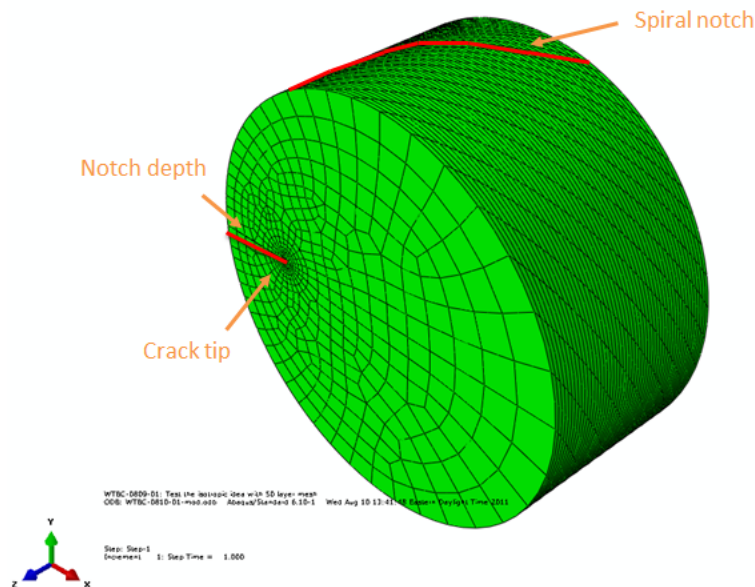
The mesh of the composite SNTT sample followed the same rule as those in epoxy samples. Different element types were assigned to various areas. In order to capture local stress concentration, the element C3D15R in ABAQUS was assigned to the crack tip area. The element C3D20R in Abaqus was assigned to web areas around the crack tip circle area and the rest of the model. The mesh of the composite SNTT model was shown in Figure 56.

Figure 56. The finite element mesh of the composite SNTT sample

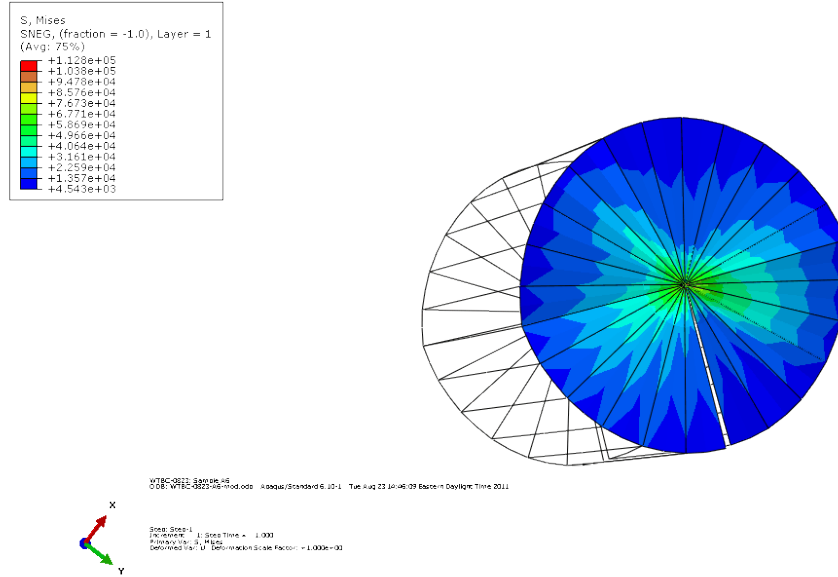
Figure 65. Mises stress distributions in the crack tip area of composite SNTT sample A

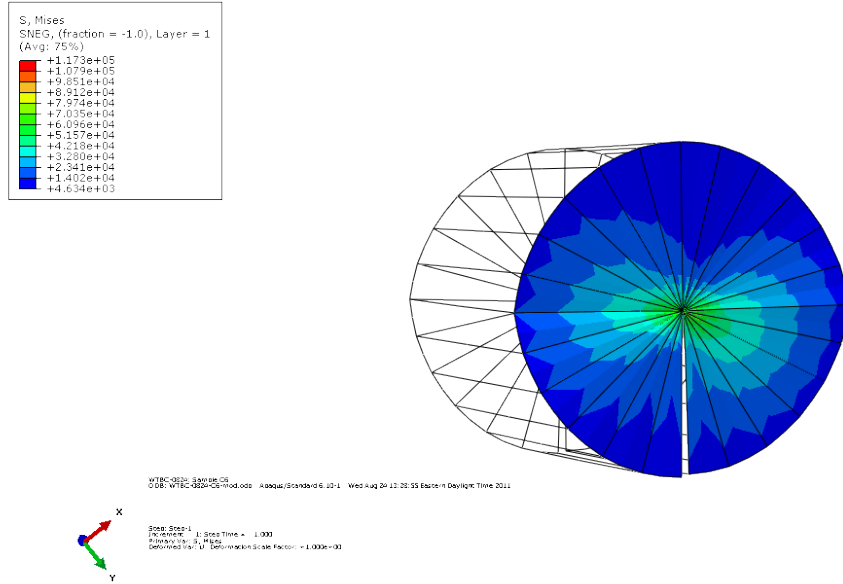
Figure 69. Mises stress distributions in the crack tip area of composite SNTT sample C

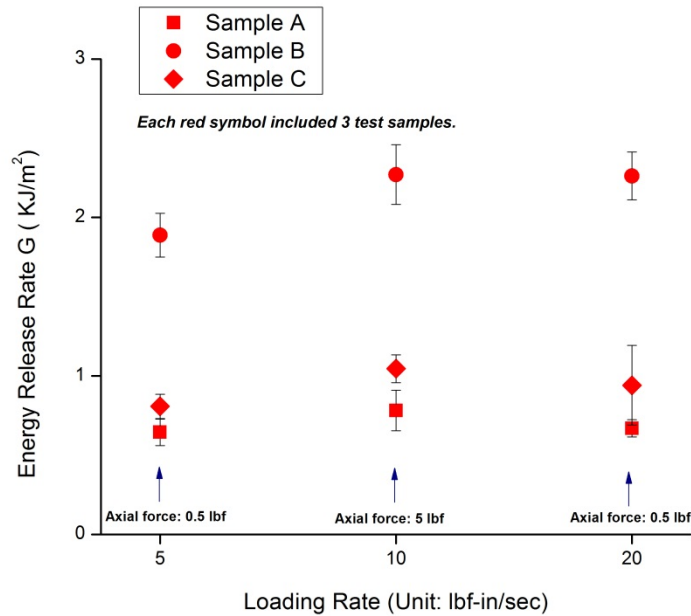
In general, the energy release rates of the same type of composite samples stayed at the same level or intensity for different loading rates. The energy release rates at the loading rate of 20 lbf-in per second appeared to be higher than that of loading rate at 5 lbf-in per second. Over the range of loading rates tested, the time-dependent effect was not significant to energy release rates of the SNTT composite samples. Nevertheless, a more thorough loading rate investigation with higher loading rate spectrum needed be considered to further quantify the loading rate effect of composite materials.

Figure 71. Energy release rates of composite SNTT samples

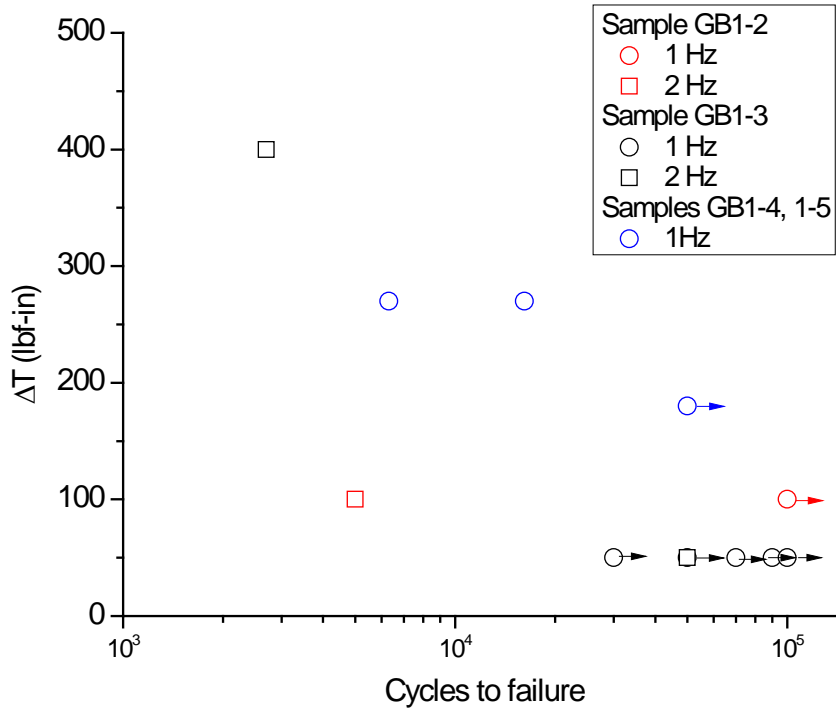
Figure 25. Fatigue S-N plots of samples from GB batch 1.
