# **3013/9975 Surveillance Program Interim Summary Report**

Publication Date: June, 2011

## **3013/9975 Surveillance Program Interim Summary Report (U)**

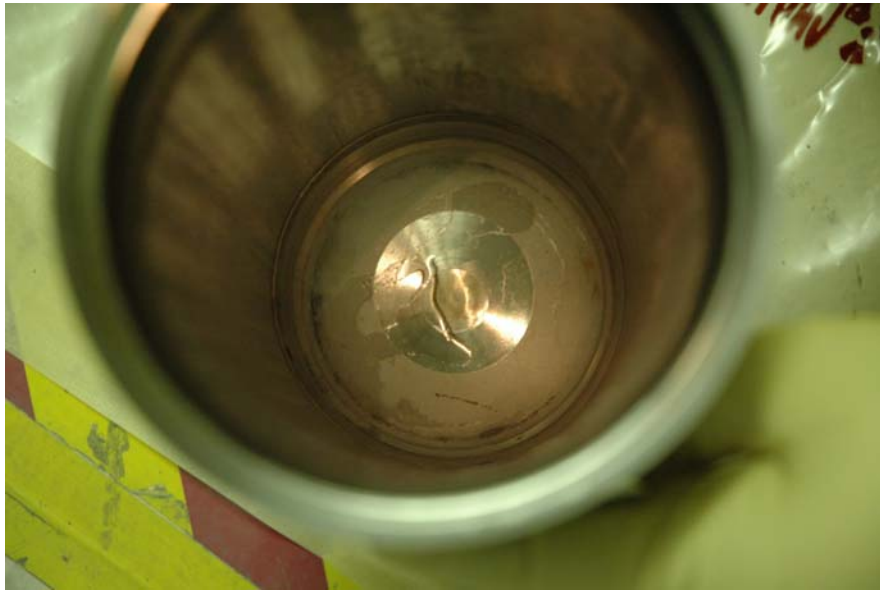
the PCV of 9975-06704 (Figure 1) and on the exterior of the 3013 (Figure 2), there was no degradation. The field observations provide evidence that there is no corrosion mechanism attacking the outside of the outer 3013 container as a result of the KAMS storage environment and outer container integrity is acceptable for continued service.

Figure 1. Moisture inside the PCV

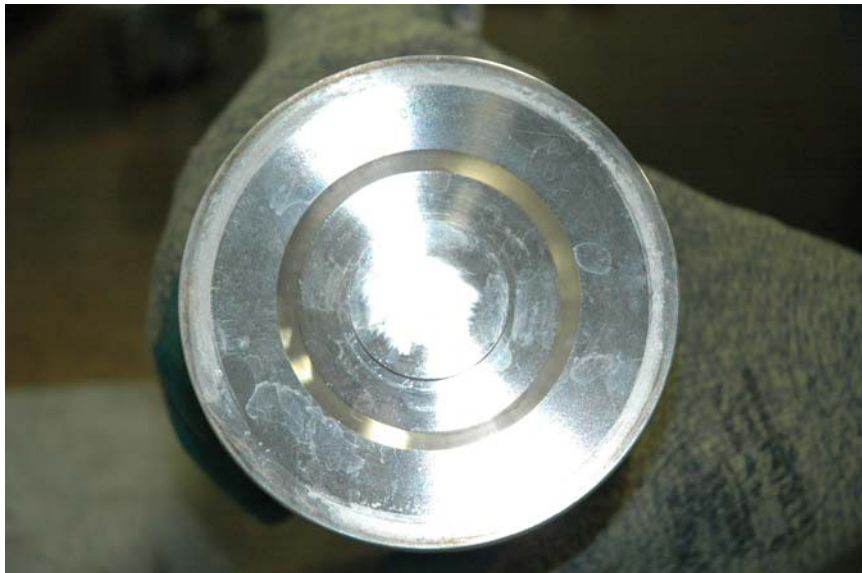
Figure 2. Evidence of moisture on the outside of the 3013

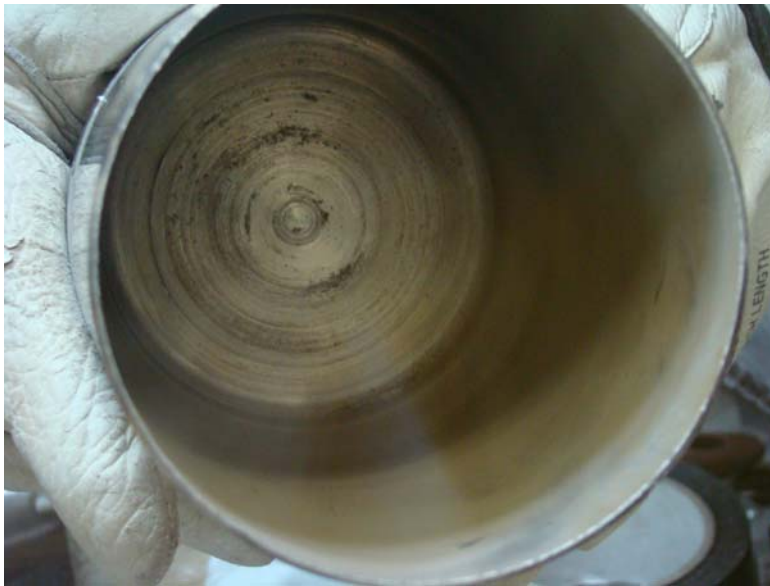
After removing the oxide, the outer and inner cans are visually inspected for any corrosion or evidence of degradation caused by the storage of Pu oxide. In the majority of the cases, the cans appeared in excellent shape. It is not uncommon for the convenience can to have a coating either in the region of the oxide or more commonly in the head space region. In FY 10, DE 3, 4, 5, 8 and 15 had some staining or residue on the inside of the inner can also (Figure 3). No visible pitting or degradation, beside the staining or coating, was identified during the FY10 field surveillances.

Figure 3. Residue on DE #3 H003710 Inner Can

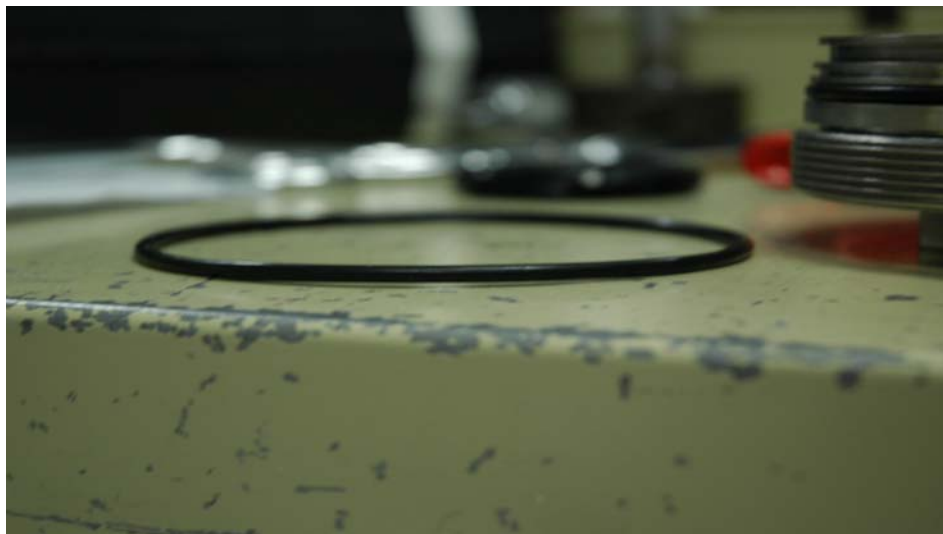
A leak check is performed on the SCV and PCV O-ring seals prior to opening the containers in the K-Area Complex to provide evidence that the seal performance has not changed since the time of packaging. The leak check is conducted using the same 9975 post load leak check procedure, used at the time of packaging, which simultaneously tests the pressure boundary on both the upper and lower O-rings. A leak check of the PCV in 9975-06742 failed the test criteria of  $\leq 1 \text{ E-3 cc/sec}$ . The inner O-ring was determined to be leaking during the follow up bubble test. The subsequent inspection of the inner O-ring determined that a twist in the seal may have cause the leak (Figures 4 and 5). The O-rings were replaced and the shipping package passed the annual leak test.

Figure 5. O-ring does not lie flat due to deformation
