PNNL-18845

200-BP-1 Prototype Hanford Barrier – 15 Years of Performance Monitoring

September 2009

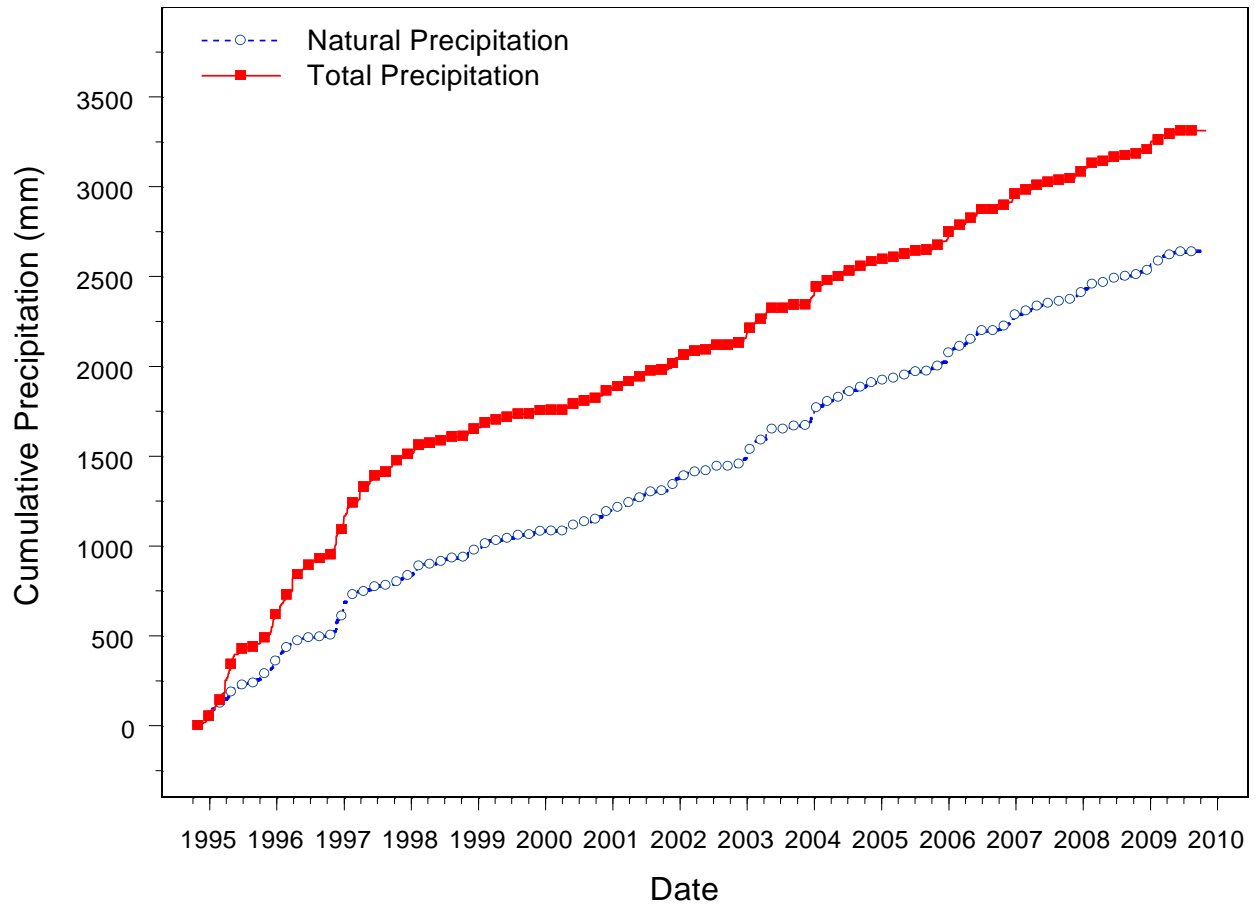
Figure 2.3. Natural and Total Precipitation (Natural plus Irrigation) at the Prototype Hanford Barrier From October 1, 1994, September 30, 2009.

Over the last 15 years, seasonal distribution of precipitation has shown significant variability. The highest winter precipitation for the monitoring period was 138.4 mm, observed in FY 1997. This amount is over four times the low of 34 mm recorded in the winter of FY 2005 and some 211% of normal. In FY 2008, winter precipitation amounted to 59.94 mm, compared to the normal 65.56 mm. Of the total FY 2009 precipitation, 69.60 mm occurred during the winter (December 2008 through February 2009). Total precipitation has shown a general decrease from 1994 through 2009. A similar trend is obvious in the winter, except for 2003 and 2004, and spring although summer precipitation has been more erratic (Table 2.2). Spring and autumn precipitations totals are less than normal in both FY 2008 and 2009.

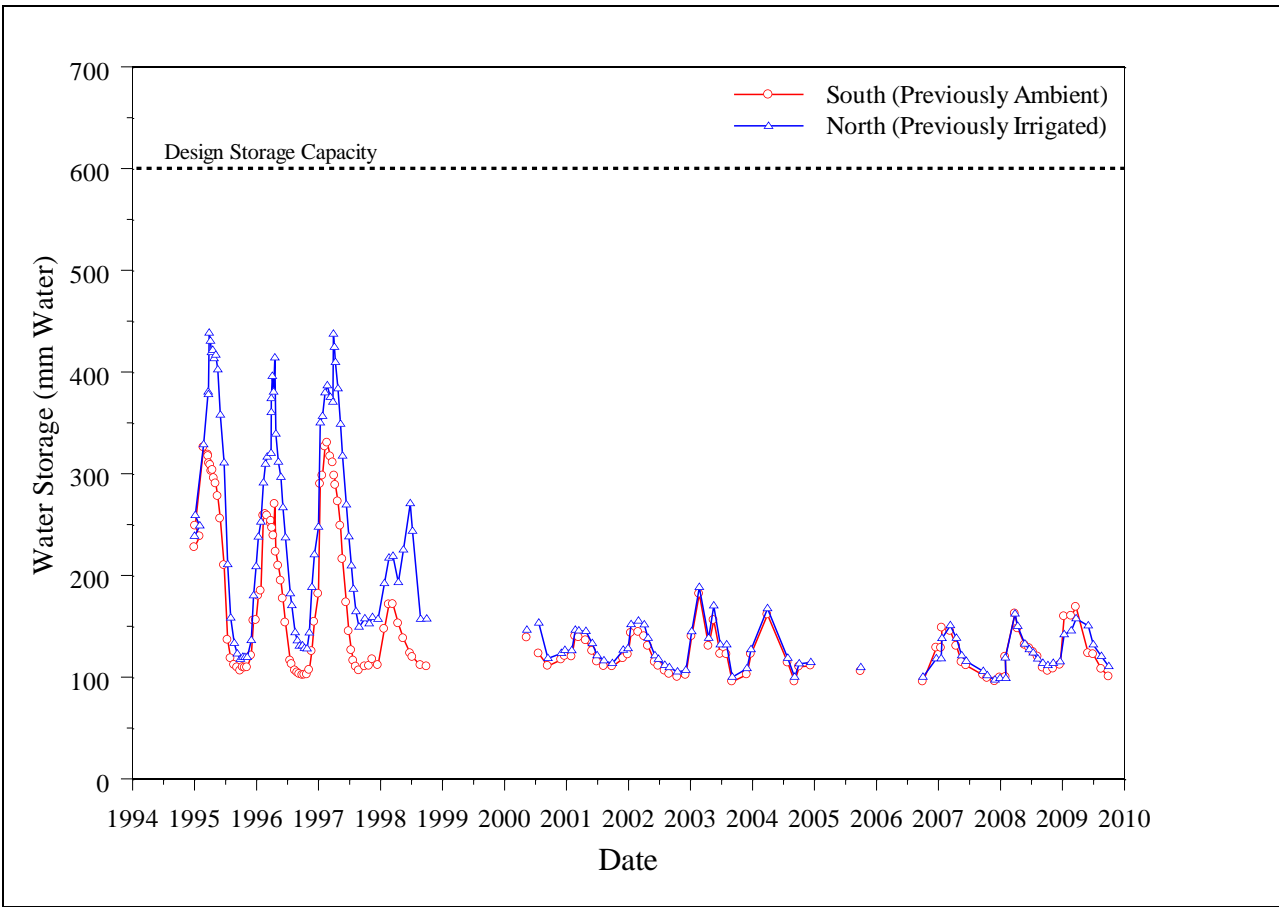
Figure 2.8. Temporal Variation in Mean Soil-Water Storage on the North and South Plots at the Prototype Hanford Barrier, October 1994 Through September 2009 (design water storage capacity is 600 mm)

Figure 2.8 compares the mean storage on the north and south sections of the barrier. The mean storage for the north was calculated as the temporal average of $W(t)$ measured at S1 through S6. The mean storage for the south was calculated as the temporal average of $W(t)$ measured at S7 through S12. Over the last 15 years, mean $W(t)$ has ranged from 97 mm to 438 mm with a standard deviation of 103 mm. Over the same period, $W(t)$ on the south section has ranged from 95 mm to 330 mm with a standard deviation of 69 mm. The storage data also show that since the completion of the treatability test, the once-prominent peaks have shown a progressive decline over time except for the last two years. In the 4 years following the treatability test, mean storage rarely exceeded 150 mm. In 2003, peak storage was closer to 200 mm, and in 2004, the peak was around 167 mm. This increase in peak storage over the last two years is a direct consequence of changes in precipitation and its seasonal distribution. The divergence in the lower limits of storage is also quite clear in the plot of mean storage. In the early stages of testing, the lower limits of storage between monitoring stations were quite similar but gradually diverged until 1999. This deviation has been attributed to interplot differences in the ability of the vegetation to recycle applied water. In FY2008, mean $W(t)$ ranged from 97 mm to 162.2 mm with a standard deviation of 21.6 mm on the north. For the same period, mean $W(t)$ ranged from 96 mm to 162.4 mm with a standard deviation of 21.5 mm on the south side. These results show that the divergence in the lower values of storage on the north and south sections, prominent during and immediately after the treatability test, has essentially disappeared. These results confirm the hypothesis that the differences in the lower limit of water withdrawal may have developed as a result of stresses caused by irrigation. The disappearance of these differences is an important observation and suggests that the native species can easily recover from relatively short-term stresses. In this case, increased stress was present for 5 years and may have been caused by elevated precipitation on the irrigated treatments over the 3-yr treatability test. Effects of this imposed stress persisted for about two years after irrigation ceased.

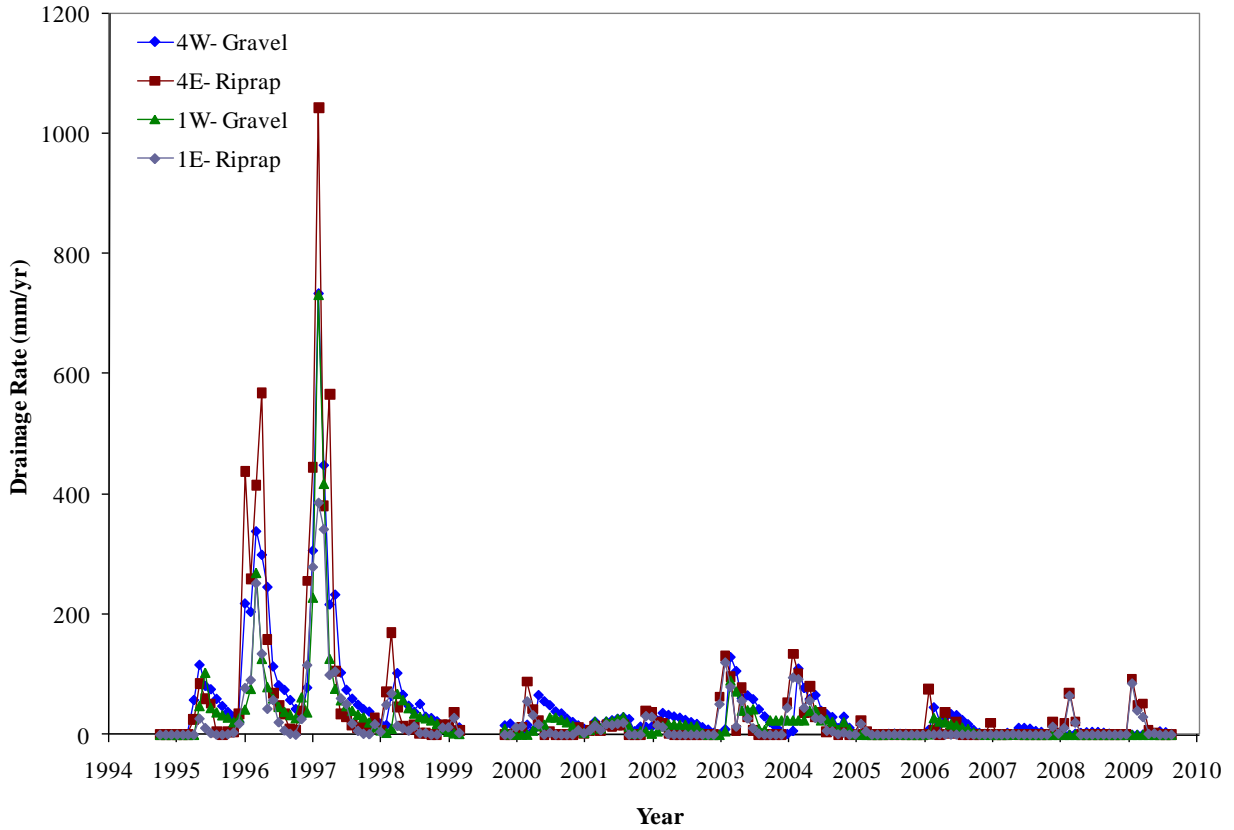
Figure 2.11. Rate of Drainage from the Side-slope Plots at the Prototype Hanford Barrier for the Period September 1994 Through August 2009.

The drainage data show significant differences between precipitation treatments as well as within treatments from year to year. Both the north riprap and gravel covered slopes show similar totals for the monitored period (Table 2.3). However, there is a significant difference in drainage between the south gravel and riprap slopes (Table 2.4). Differences in total drainage between the north and south slopes are due to the differences in precipitation amounts during the treatability test. During the 3-yr treatability test, the north plots were irrigated whereas the south plots were maintained under ambient precipitation conditions. Figure 2.11 provides a graphical summary of the rate of drainage from the side-slope plots for the monitored period. Figure 2.12 provides a similar plot for rate of drainage from the silt-loam plots.

These rates can be considered as equivalent rates as they are computed by converting the total drainage collected over a period of one month to an equivalent rate in mm/yr. Equivalent drainage rates were typically at their highest during the winter months. However, rates from the side slopes were significantly higher than from the silt-loam plots. Drainage from the side slope reached a maximum rate in excess of 1000 mm/yr in the winter of FY 1997. Drainage rates from the silt-loam plots also peaked in the winter months but the values were several orders of magnitude smaller. The highest equivalent rate from the silt loam was 0.79 mm/yr, recorded from 3W in FY 1996. These rates would have been of very short durations. However, a more complete picture of drainage performance can be derived from a comparison of cumulative drainage amounts.

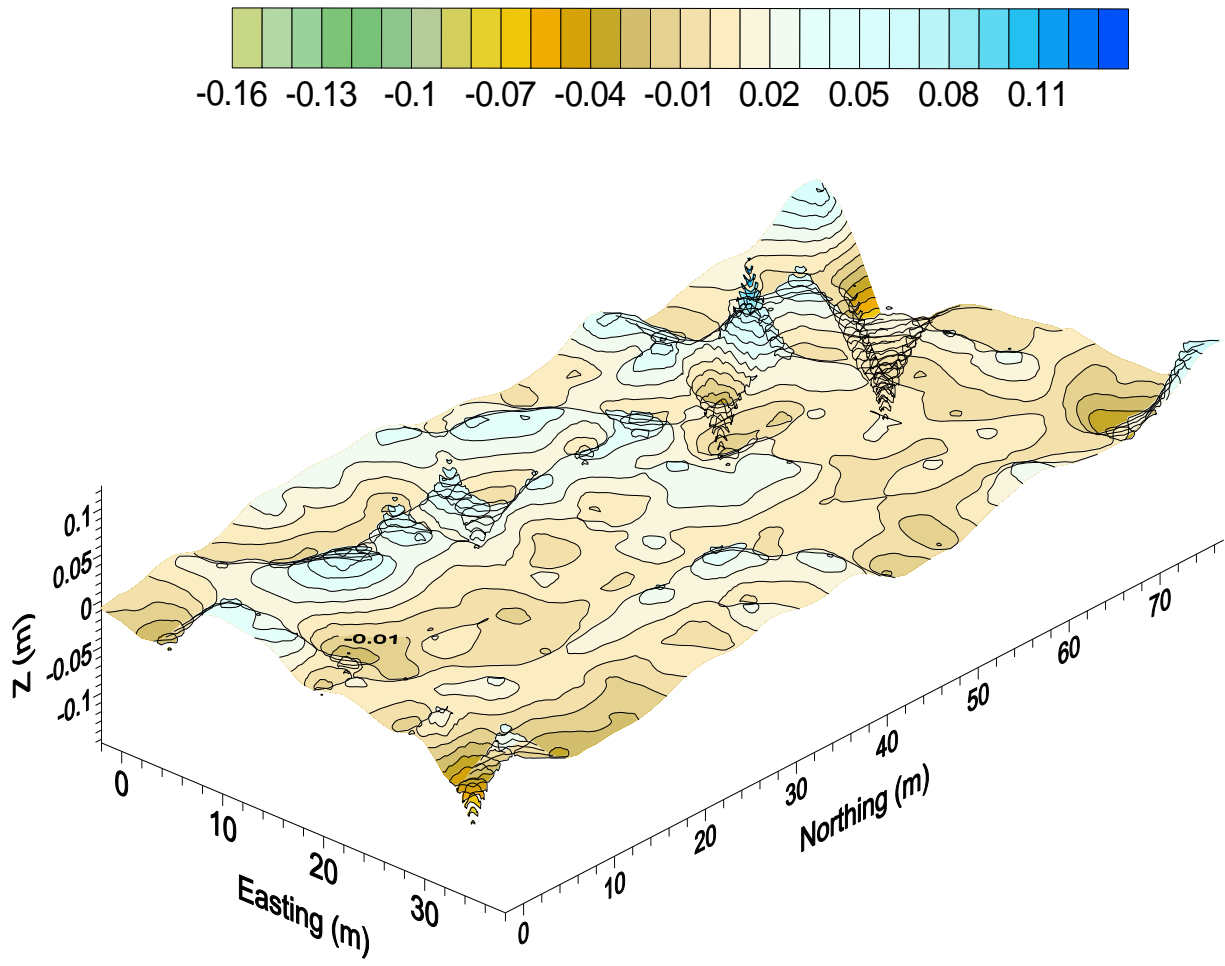
Figure 3.5. Change in Surface Elevation ($66 \times$ Vertical Exaggeration) at the Prototype Hanford Barrier as of July 29, 2009 Measured Using a Real-Time Kinematic Global Position System.

In order to quantify any changes in elevation during the monitored period, elevations from December 1994 were subtracted from those recorded in July 2009. Figure 3.5 shows a plot of the differences between 1994 and 2009. A positive number is indicative of an increase in elevation relative to 1994 whereas a negative number is indicative of a decrease. Current elevations do not show any large difference from 1994 elevations. Relative to December 1994, the surface shows only small increases and decreases (hachured shade) in elevation. Elevation changes ranged from -0.15 m to 0.08 m, but there is no consistent trend or spatial pattern. Over the 15-yr period, the largest increase in elevation was about 8 cm and occurred in the northwest corner (top left corner of Figure 3.5). The cause for this increase has never been established. The largest decrease in elevation, about 12 cm, occurred in the southeast corner. Owing to its proximity to the steep rip rap slope, additional creep gauges were installed in FY 2000 to allow closer monitoring of this area. Although no further changes have occurred, cause for the initial decrease has never been established. In addition to these two changes, several other small changes can be seen on the surface and can be attributed to both manmade excavations related to instrumentation (e.g. relocation of the runoff plot, bury cables, instrument repair) and small mammal activities such as burrowing and the formation of mounds. Small animal activities and how they may influence elevation changes are discussed in Section 5. There are also some areas where shrubs have died and collapsed leaving small depressions. Some of the earlier increases may have also been caused by increases in plant biomass in the near surface.

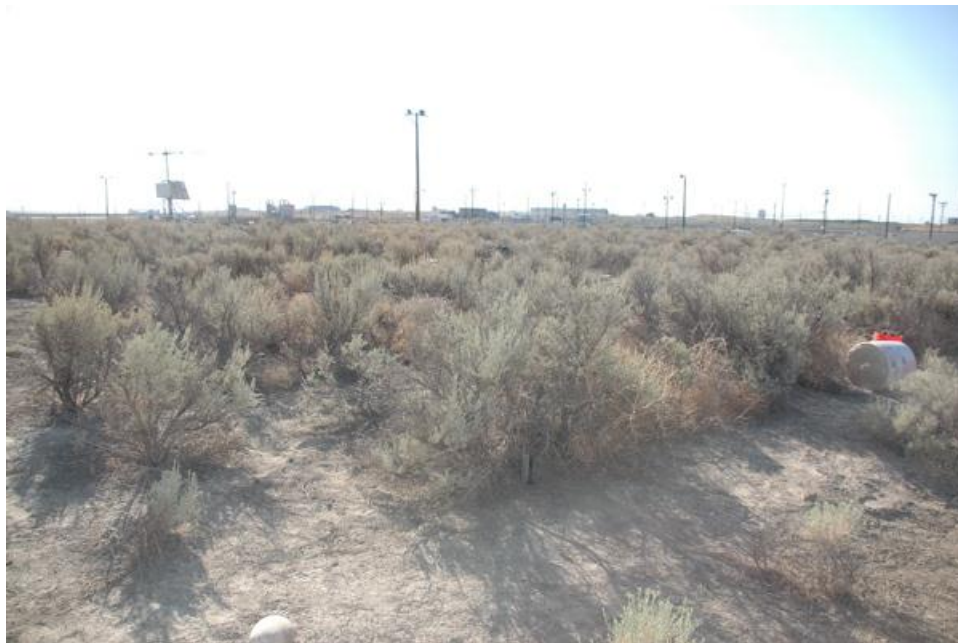
Figure 4.1. Prototype Hanford Barrier Cover Dominated by *Artemisia tridentata* in 2007, 15 Years After Establishment.

Sagebrush dominated the shrub cover of the Prototype Hanford Barrier. Figure 4.1 shows the surface in 15 years after establishment. Rabbitbrush is sparse on the barrier surface, with relatively few plants in either treatment (formerly-irrigated, and non-irrigated). These were found near the edges of the surface. In FY 2008, the vegetation was removed from the north half of the surface in a controlled burn (Ward et al. 2008; 2009).

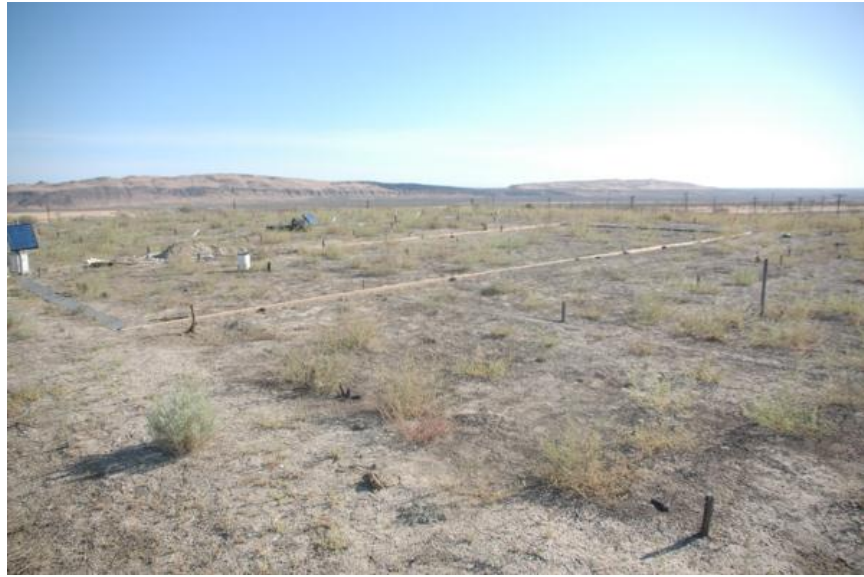
Figure 4.2. South (originally unirrigated) Section of Prototype Hanford Barrier Cover Dominated by *Artemisia tridentata* in 2009, 15 Years After Establishment.

After the fire on the formerly irrigated north half of the barrier sagebrush is no longer dominant and has been replaced by *Salsola kali* (Figure 4.2). Figure 4.3 compares the total number of annual and perennial species on the barrier surface from 1995 through 2009.

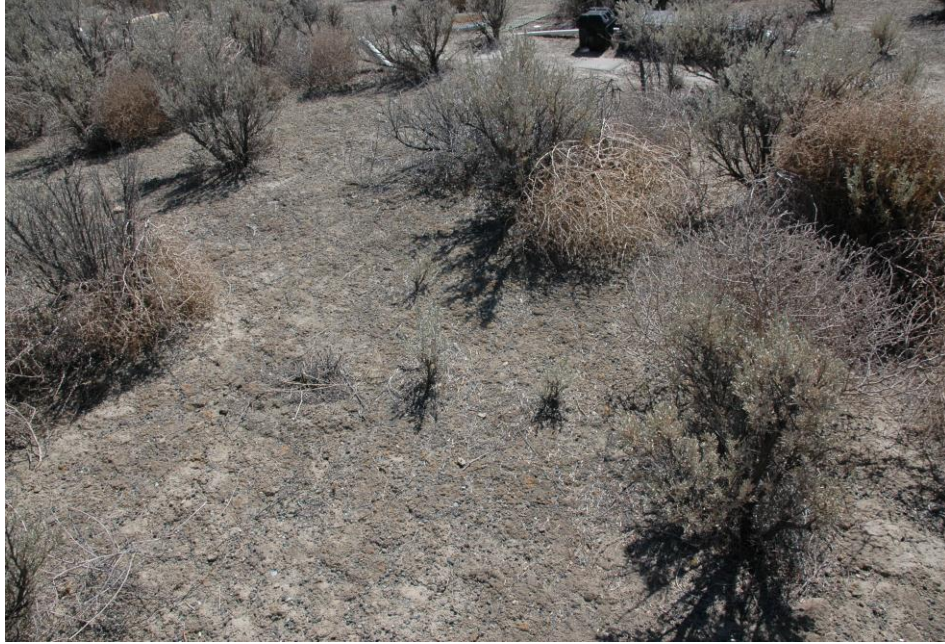
Figure 4.4. Cryptogamic Crust Covering Most of the Soil Surface. Bright Patches on the Surface are Bare Soil.

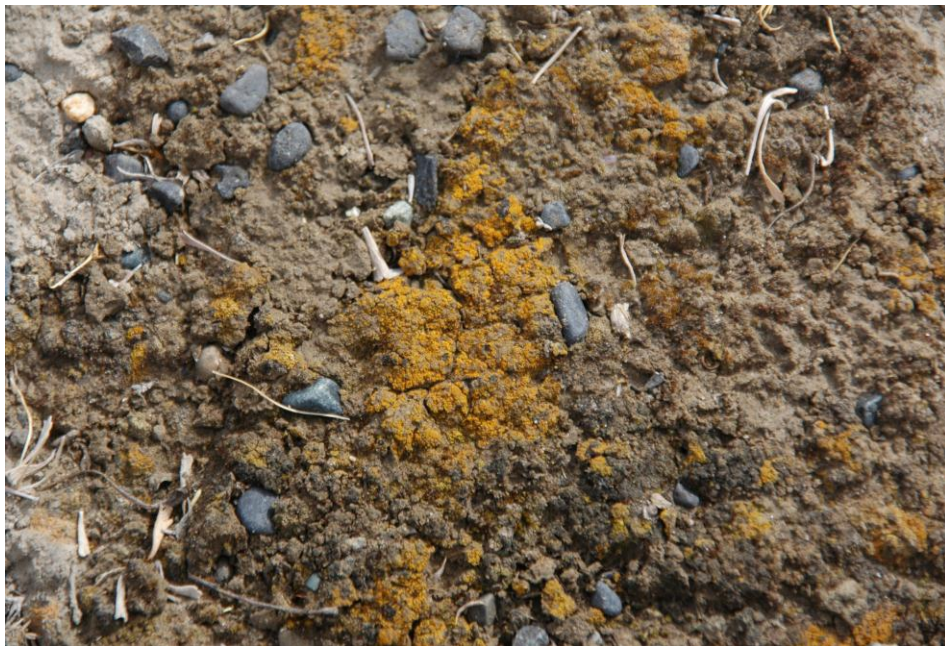
Figure 4.5. Soil cryptogams. The Orange Lichen is *Caloplaca tominii* and the Moss is *Bryum cf. caespiticium* (Link et al. 2000).

Ward et al (2009) reported surveys of cryptogram crusts at four study sites including two analog sites at the McGee Ranch and the burned (north) half of the barrier and the unburned (south) half. No soil cryptogams were observed on the burned surface of the barrier. The unburned half of the barrier surface had seven species. There was only one soil lichen found at the McGee Ranch old fire site. On the unburned half of the barrier surface cryptogamic crust is well developed with seven species (Figure 4.4), but likely to continue to change and become more diverse (Figure 4.5). Cryptogamic crust cover is now about 37.3 % in the south (unburned half). The largest colony of *thallus* of *Caloplaca tominii* was about 60 mm in diameter. Assuming it initiated in 1994, its growth rate is about 4.6 mm y⁻¹. The darker elements of the surface in Figure 4.4 are likely a combination of moss, lichens, and blue-green algae. Cryptogamic crust is also well developed at the unburned McGee Ranch site with 12 species being identified. As shown in Table 4.4, soil cryptogam composition was quite variable on the unburned half of the surface.

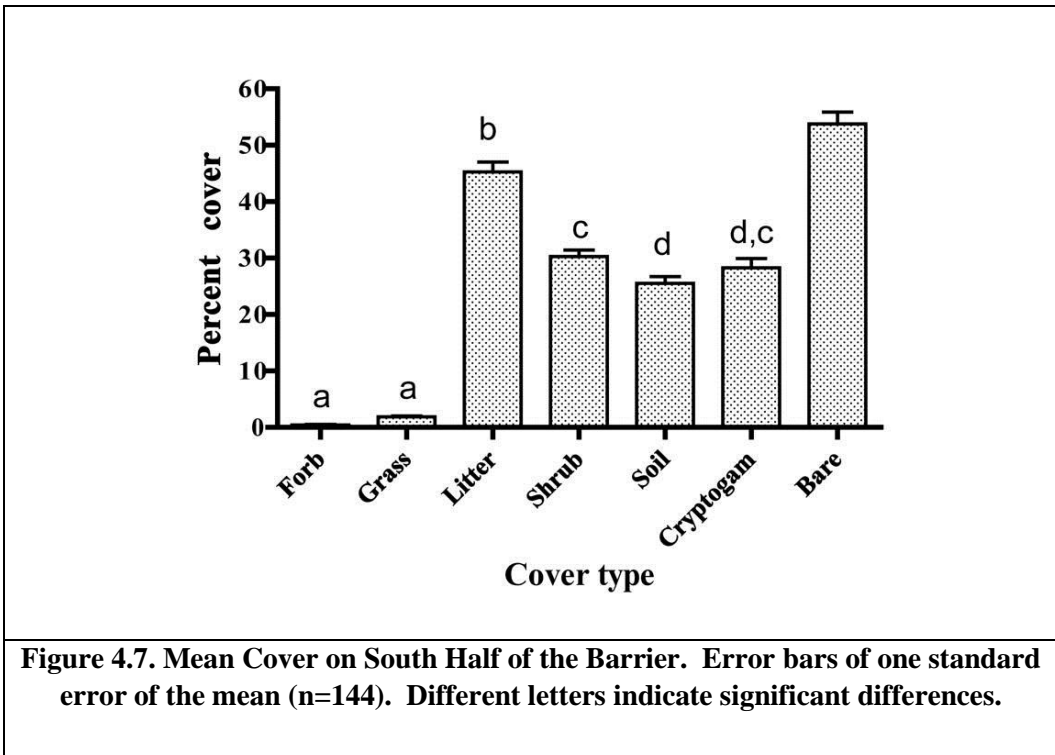
The mean cover classes for the south portion of the silt-loam plots prior to the burn is shown in Figure 4.7. Gorund cover was similar to the north before the fire. Grass cover was also significant greater than zero, and significantly less than shrub cover and other classes. Soil cryptogam cover was the same as soil cover. Percent cover was estimated for shrubs, tumbleweed, grasses, forbs, and litter. These cover estimates were summed and in some cases exceeded 100%.

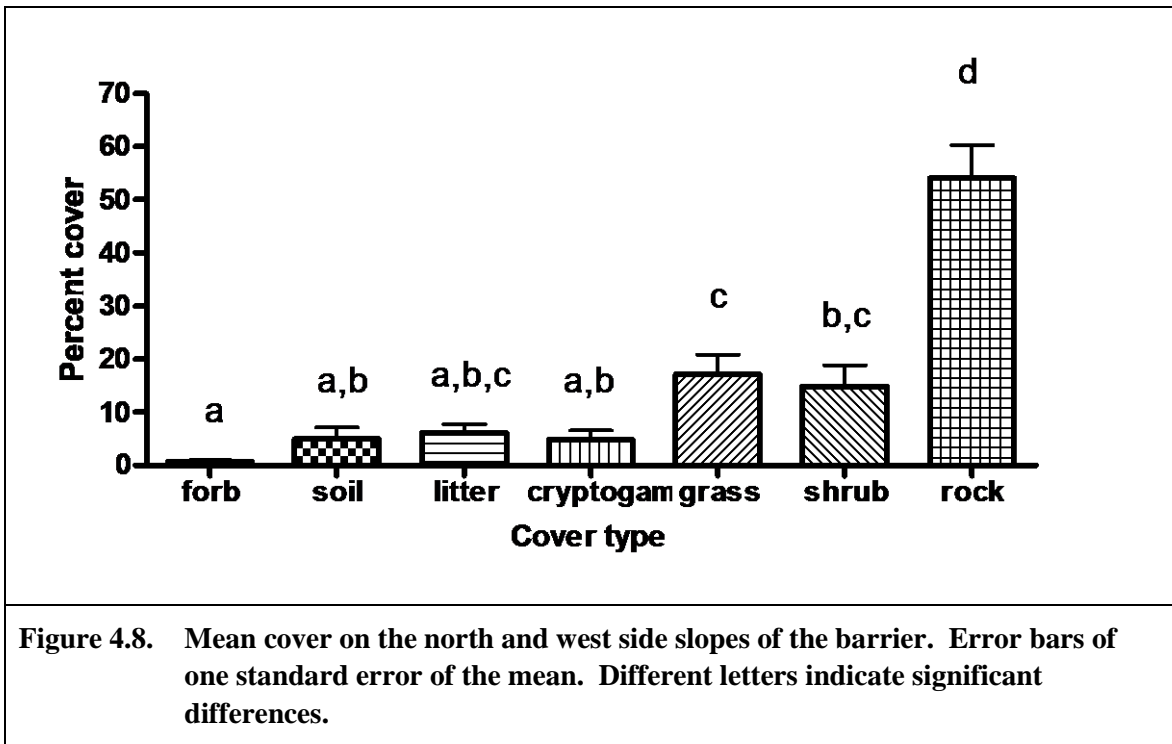
Cover on the north and west side slopes was relatively uniform, thus data were combined (Figure 4.8 **Error! Reference source not found.**). Rock cover was much greater than cover of other classes while cover of shrubs and grasses (mostly bunchgrasses) were similar.
