**Keywords:** *Inner Canister, DOE 3013, Welding, Gas Tungsten Arc Welding, GTAW, Experimental*

SRNL-STI-2012-00129

## PDC IC Weld Failure Evaluation and Resolution

March 29, 2012

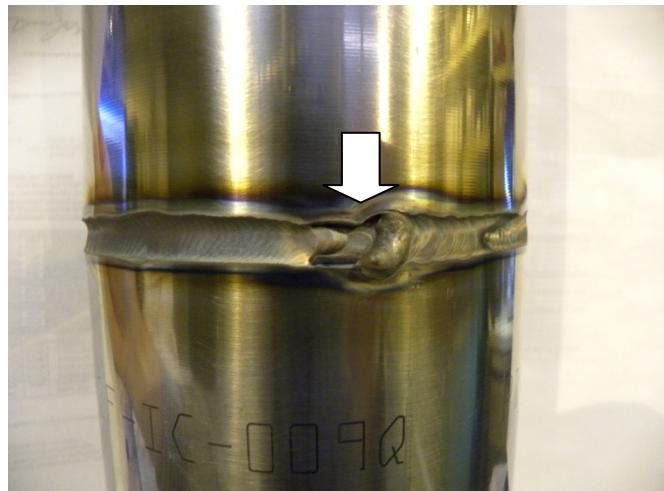
During final preparations for the PDC IC qualification effort, welding was being performed on the automated inner can welding system known as the PICN. During the first weld, a weld defect occurred, Figure 1. The weld defect had a similar appearance to the BTC weld blow-out but was not initially characterized as such. Inspection of the weld defect also identified a lack of fusion between the canister sidewall and the plug sidewall. Also, BTC blowout failures typically result in the deposit of molten metal onto the tungsten weld tip, this condition did not exist for the PDC weld defect (1).

Figure 1. Weld failure on PDCF can. Arrow indicates lack of fusion defect. Note also undercut at weld toe.

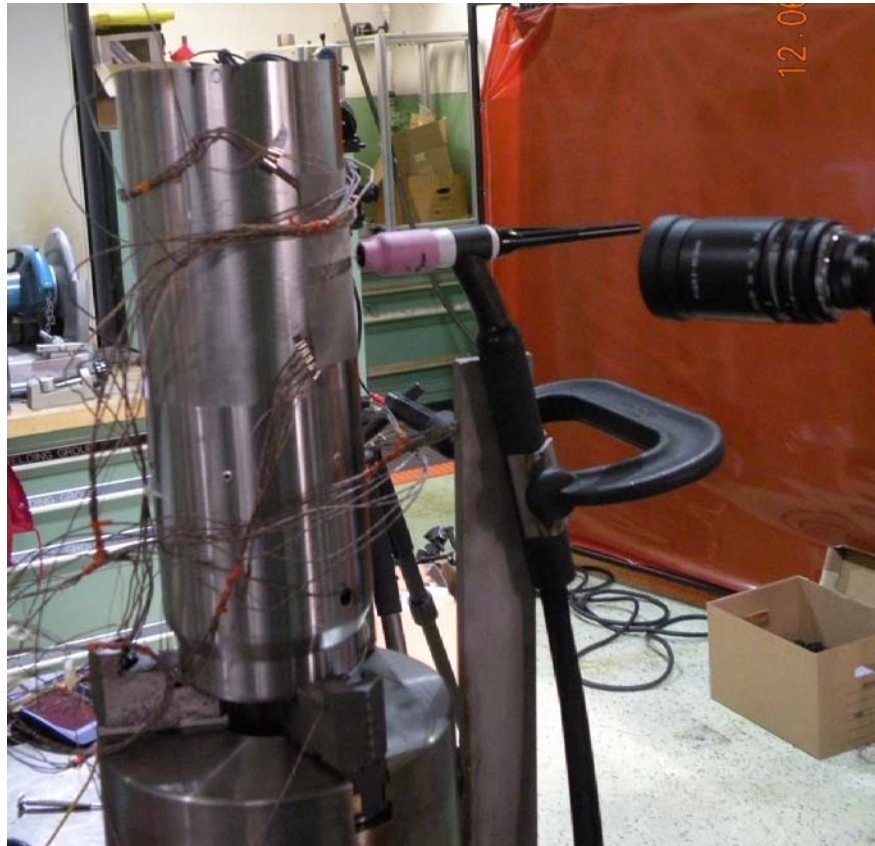
ISAA, tack welded, final welded and DR. An instrumented can and the general arrangement of cameras and the welding torch are shown in Figure 2.

Figure 2. General configuration of can, camera, thermocouples and welding torch on turntable for ISAA and gap testing.

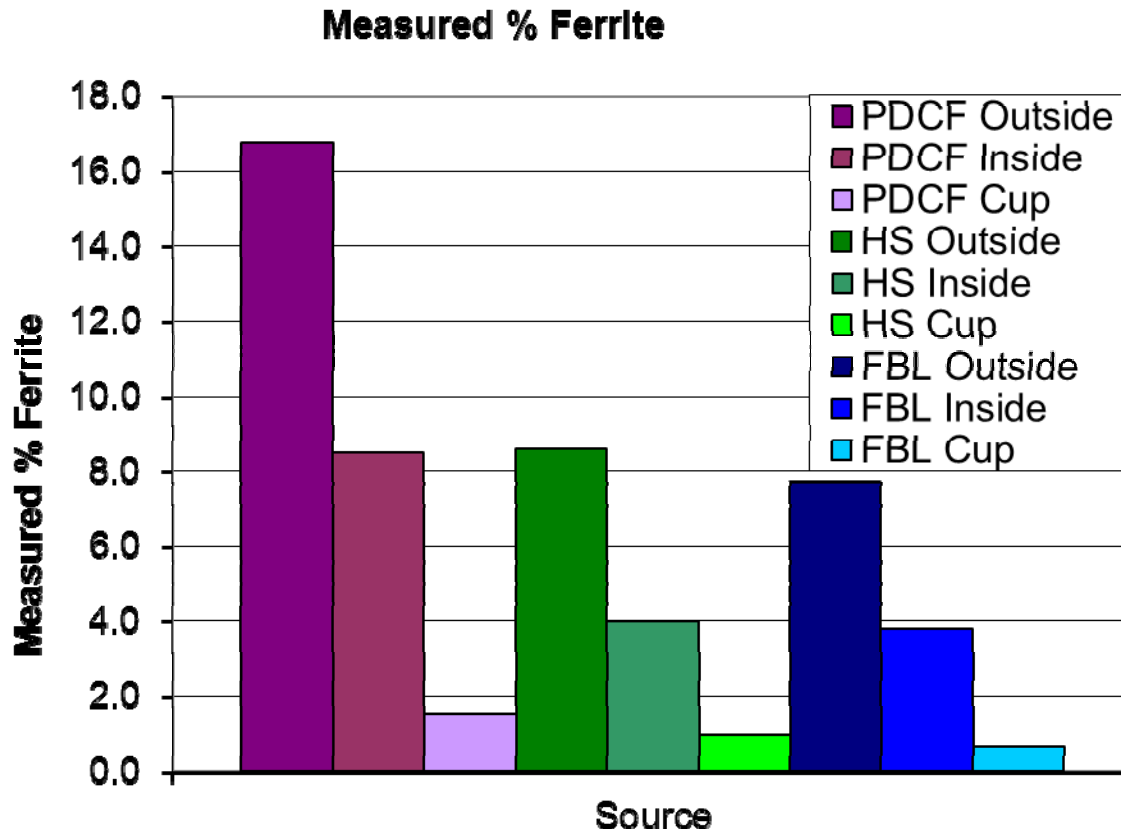
The baseline % measured ferrite, note that the flow formed cans contain the magnetic phase deformation induced martensite rather than ferrite, from the PDC, FBL and HS cans are shown in Figure 3 and Table 2. It is apparent from the data that the average values for the PDC cans are from a different population than either the FBL or HS cans. The measured % ferrite content, typically 0.7-1.5%, in the cup region is consistent for annealed 304L stainless. A more detailed discussion on the potential impacts of number on the mechanical and physical properties is presented in Ref. 1.

Figure 3. Measured % Ferrite for PDC, Hanford (HS), and FB-Line cans.

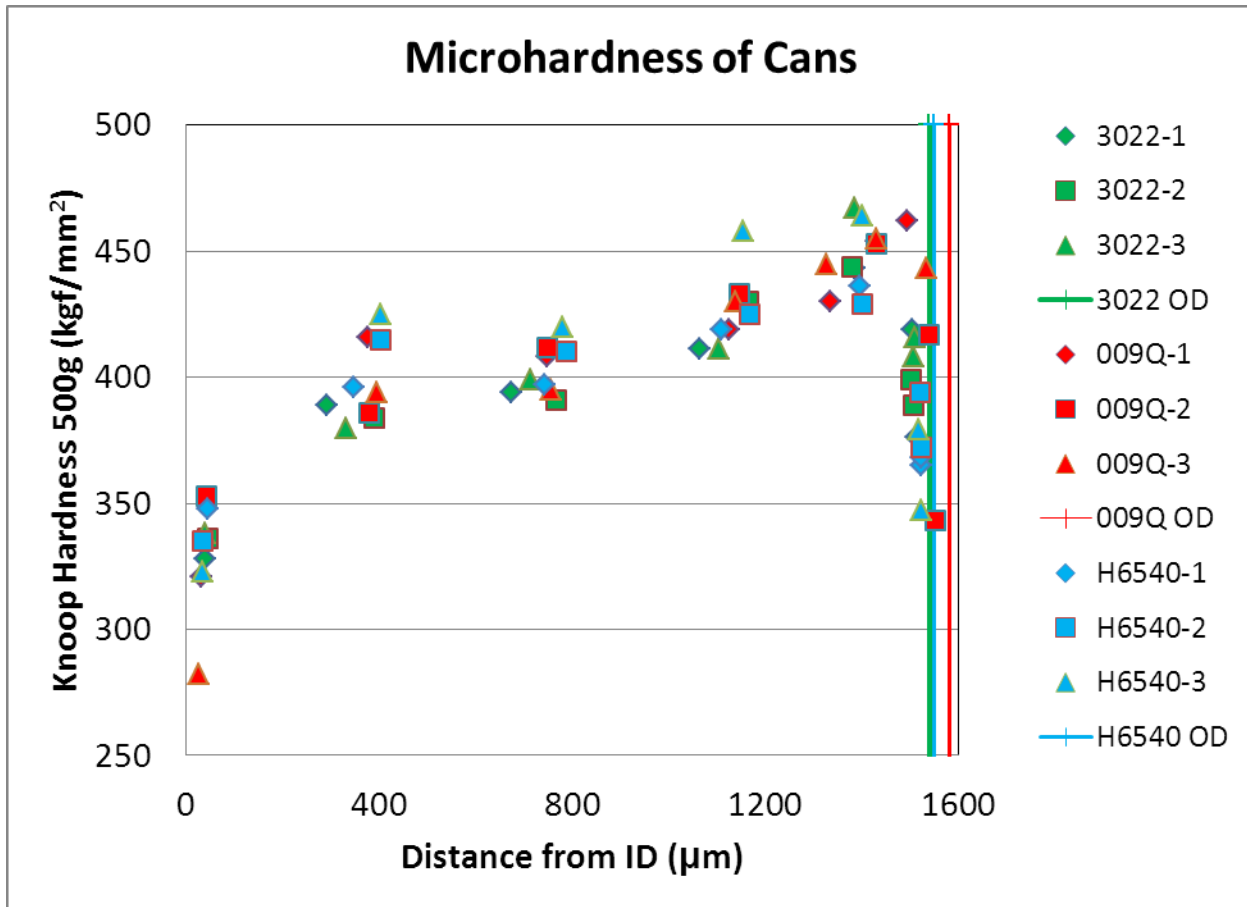
Microhardness measurements were used to characterize the profile of the PDC cans and to compare them to the FBL and HS cans. The microhardness profiles for the three cans at three locations each are shown in Figure 4. These data show that there is a hardness gradient from the inside to the outside of the can, consistent with the measured % ferrite values that show a lower value on the inside of the can compared to the outside for all three can vintages, however, unlike the % ferrite measurements there is not a significant difference in the measured microhardness values for the PDC canisters relative to the legacy canisters. Two of the three measurements for the PDC can are slightly higher than that those observed for both the FBL and HS cans, but there is a significant amount of overlap in the data so these are inconclusive with respect to property differences. Reference 8 indicates a hardness of 44-45 HRC, or similar to that measured in this study.

Figure 4. Microhardness profiles for PDC (009Q), HS (H6540), and FBL (3022) cans.

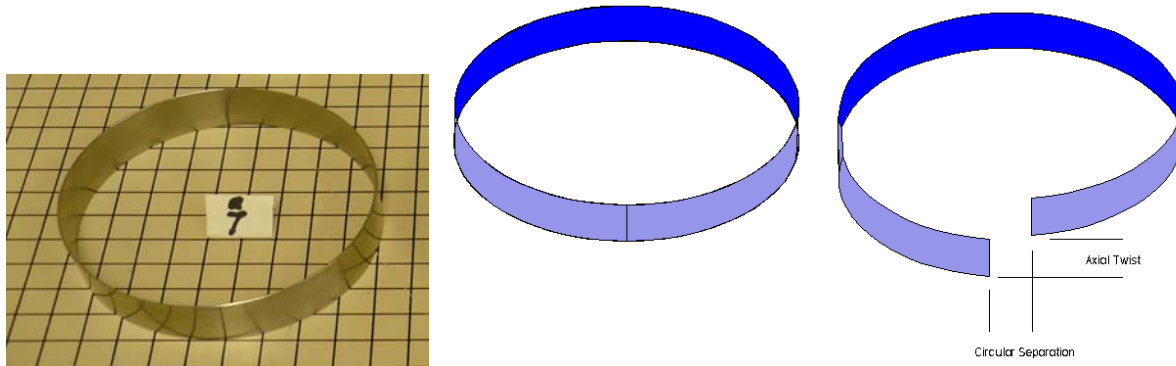
Circ Sep. is the amount of opening of the cylinder that occurred after cutting; it includes the gap due to the saw kerf. The axial twist is the distance about the measurement surface that the piece was displaced. All hardness data were converted from H30N and H30T, HRC and HRB, respectively. No macrohardness scale exists that can be used on thin samples over this entire range of hardness; estimates were made so that the data could be plotted on a single scale, but HRC values less than 20 are estimates.

**Figure 5. Photo and schematic of rings showing how distortion was measured.**

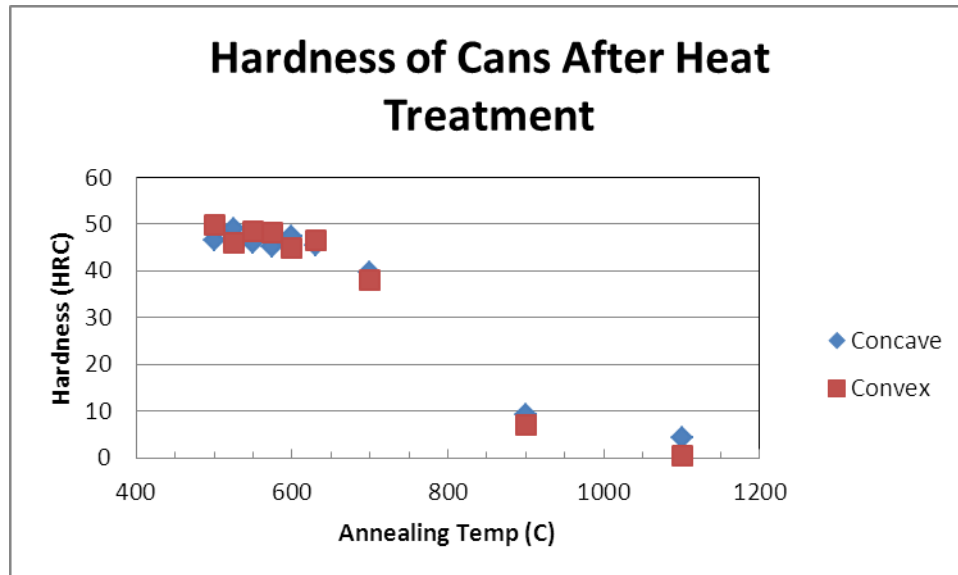
The hardness was also determined for the heat treated rings. These values are listed in Table 7 also. The thermal treatments were very effective at reducing the hardness at temperatures in excess of 630°C. This temperature is generally consistent with the rule of thumb that recrystallization occurs at temperatures in excess of  $0.5 T_{m(ABS)}$  or about 540°C. (11). It must be noted that the recrystallization temperature is dependent on time at temperature as well as the temperature itself, thus an  $\sim 100^\circ\text{C}$  difference between the rule of thumb and test temperature is reasonable for a three minute cycle.

Figure 6. Graphical representation of hardness after heat treatment. Note that the hardness for  $T > 800^{\circ}\text{C}$  is estimated since HRC scale ends at 20.

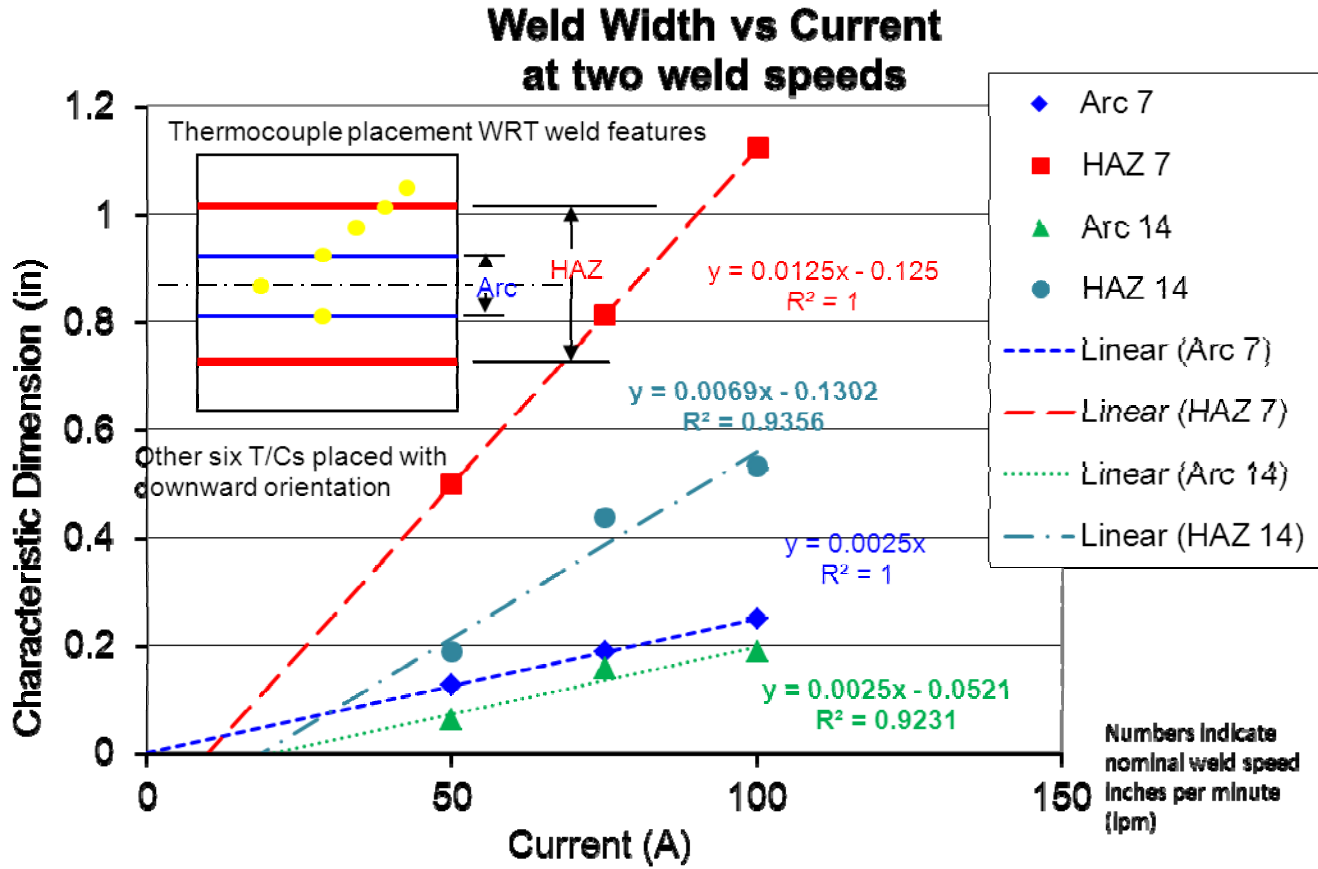
Several scoping studies were conducted on the ISAA to determine the nominal current, rotational speed, and thermally affected zone. Initially  $\sim 2.5$ " OD S/S test pipe sections were used to estimate the appropriate heating conditions. ISAA evaluations were started by using targeted currents of 50A, 75A, and 100A continuous travel at  $\sim 0.6$  rpm, no pulse. Two travel speeds were used  $\sim 7$  and 14 inches per min. These tests were used to locate the edge of the fusion zone (FZ) and heat affected zone (HAZ) based on the surface discoloration. The results of the scoping tests are shown in Figure 7.

From these scoping tests it was determined to place thermocouples at the centerline of the FZ and outboard as indicated by the inset sketch. The actual thermocouple placement for the first ISAA test is shown in Figure 8. The dimensions from the first thermocouple in the plane of the weld and the distance from the centerline were measured and used to ascertain the location at which the temperature exceeded  $550^{\circ}\text{C}$ , the temperature at which a reduction of the measured % ferrite dropped to eight. The graphical temperature output from the first test is shown in Figure 9, several data points had to be eliminated from the data set since the electromagnetic interference of the arc caused inordinate levels of noise in the data. These data indicate that the target temperature is achieved for the thermocouple positioned at 0.20 inch from the FZ centerline which provides a target zone of 0.4 inch.

Figure 7. Scoping Study to Provide Initial Estimates for FZ and HAZ Width.

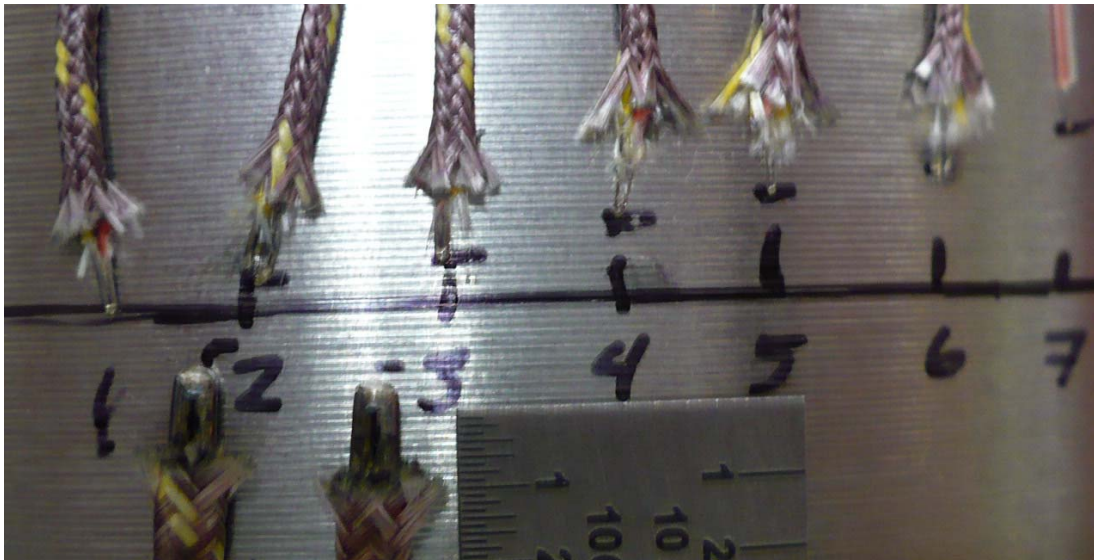
Figure 8. Photograph of ISAA01 showing thermocouple locations.

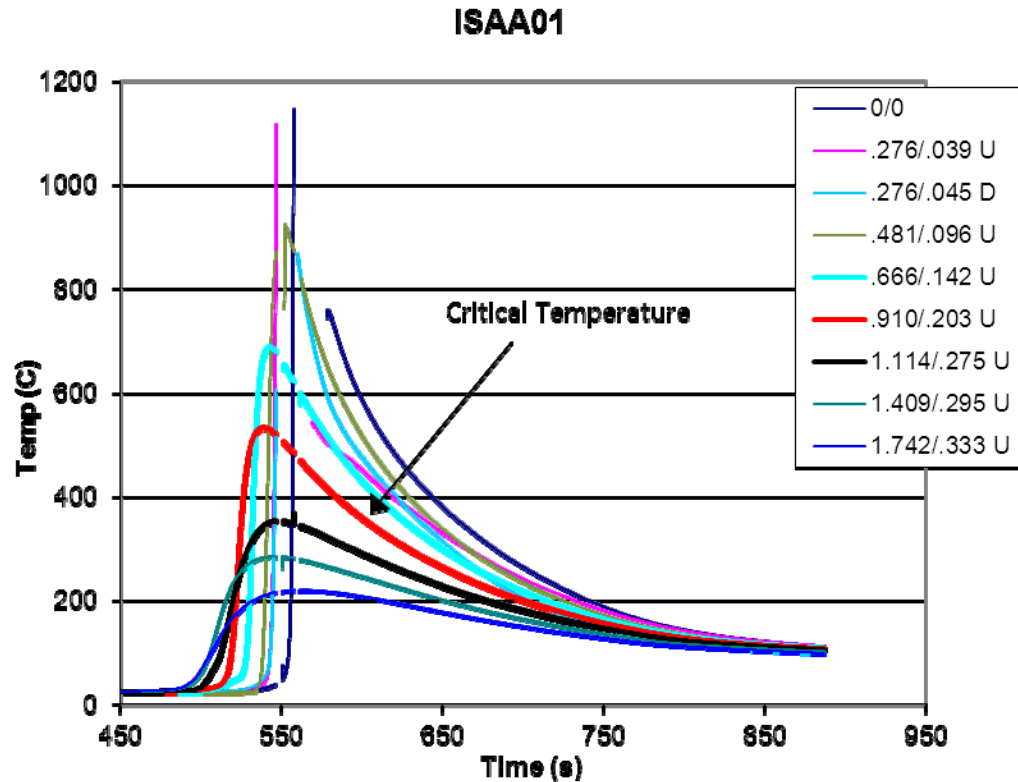
Figure 9. Temperature profile for ISAA01 showing 525°C at 0.203 inch from FZ centerline.

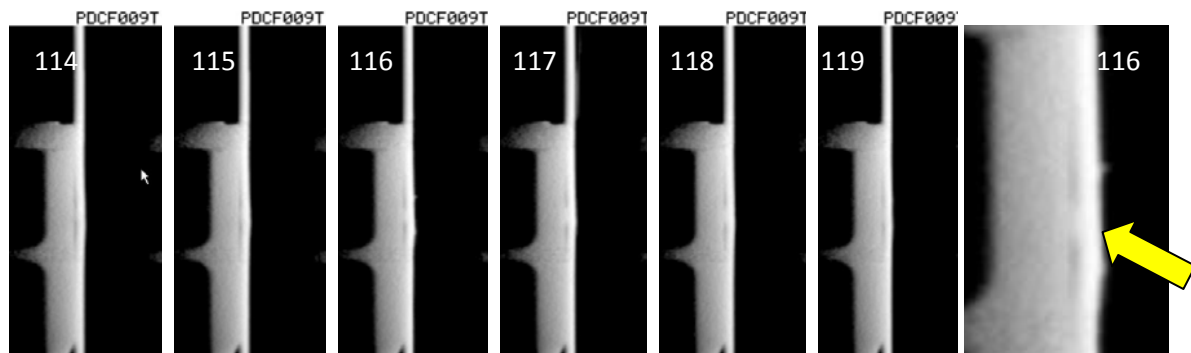
Figure 10. DR slices of ISAA01 at and near the location that can to plug bonding is suspected.

The presence of localized apparent fusion (Figure 10 -- 116-118°) between the can and plug during the arc anneal indicated that the conditions used may have been a little hotter than desired. The concern about premature fusion of the can to plug is that if it is extensive, then it could reduce the number and size of the gas paths for venting and promote the propensity for weld blow-outs. It was considered desirable to increase the width of the heat treated zone to approximately 0.5 inches which would require additional heat. To achieve both a reduction in the instantaneous heat that promotes fusion, and an increase in the residual heat that promotes annealing, it was decided that the rotational speed should be increased from 1 RPM to 1.25 RPM and the duration should be increased from 1 revolution to 2 revolutions. A second can remnant was instrumented and a similar test was conducted using 1.25 RPM, continuous 50 Amperes current, and 2 revolutions. Several changes were made to the instrumentation as well, the thermocouples were positioned outside of the FZ since the temperature of the FZ was not critical, due to the loss of data as the arc passed by the thermocouples, stainless steel screening was attached to the can over the thermocouples to act as an electromagnetic shield.

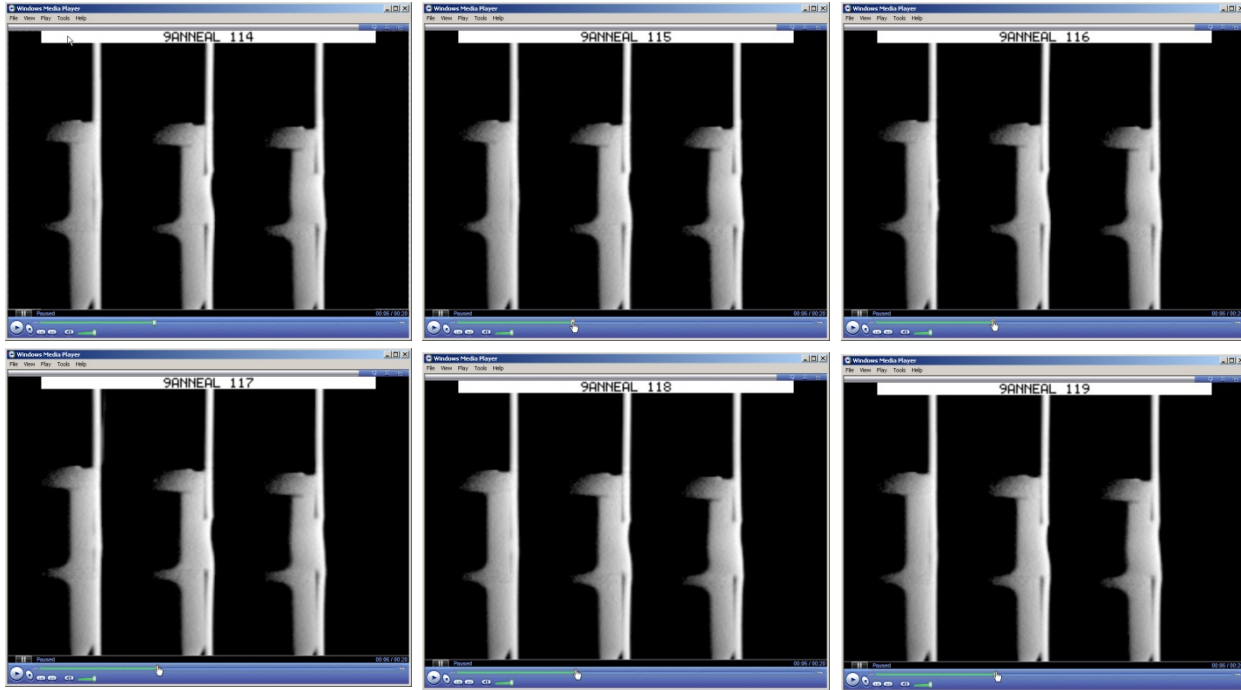
Digital radiography was used to examine the condition in the as-heat treated, tacked, and welded conditions. These three conditions were merged into one DR animation of the weld images. Review of the DR animation indicated that a minor amount of melting may have occurred over a small segment of the arc anneal, Figure 10. DR images from the animation were captured and are presented in Figure 11. The images are numbered as slices which are 1° apart. In slices 116, 117, and 118 it appears that a small amount of can to plug fusion may have occurred, as further shown in the magnified shot of slice 116 in Figure 10. Also of note is the slight increase of can to plug gap that occurs around the tacks. This result is expected and occurs to varying degree with and without the ISAA and is based on the fit up of the can to the plug, the size of the tack, tack sequence, the residual stresses in the can, etc. The overall weld DR images are shown in Figure 12. These data indicate

Figure 11. DR images of the ISAA01 test showing possible fusion during arc anneal

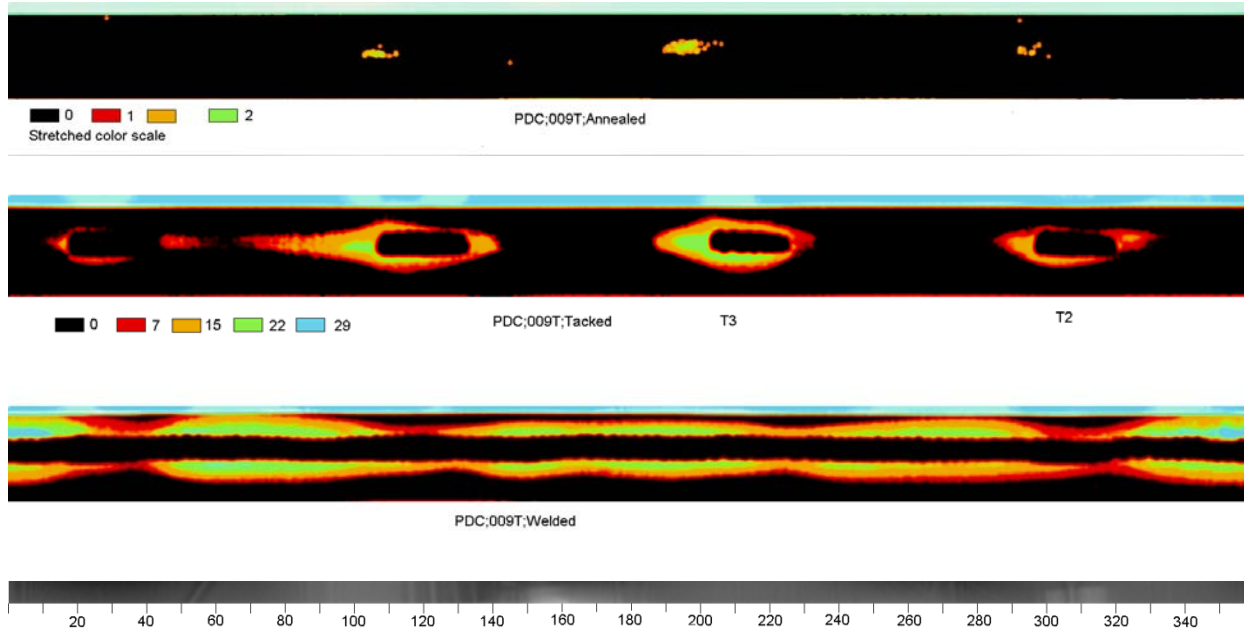
that there may be a small amount of separation between the can and plug during the ISAA at rotational positions of 100, 190 and 300°; this small amount of separation is visible in the x-ray slices in and around these locations. As indicated by the DR for the ISAA and tack welded condition, there is some localized change in the can to plug gap such that it increases around the tacks and is shown to be as high as 0.022 inch for T3.

Figure 12. Digital radiography for ISAA01 in the as annealed, as tack welded – three tacks and weld start for 15/16”, and fully welded conditions, the DR determined can to plug gap is indicated by the legend below the as-tack welded condition. The gaps are indicated in 0.001”.

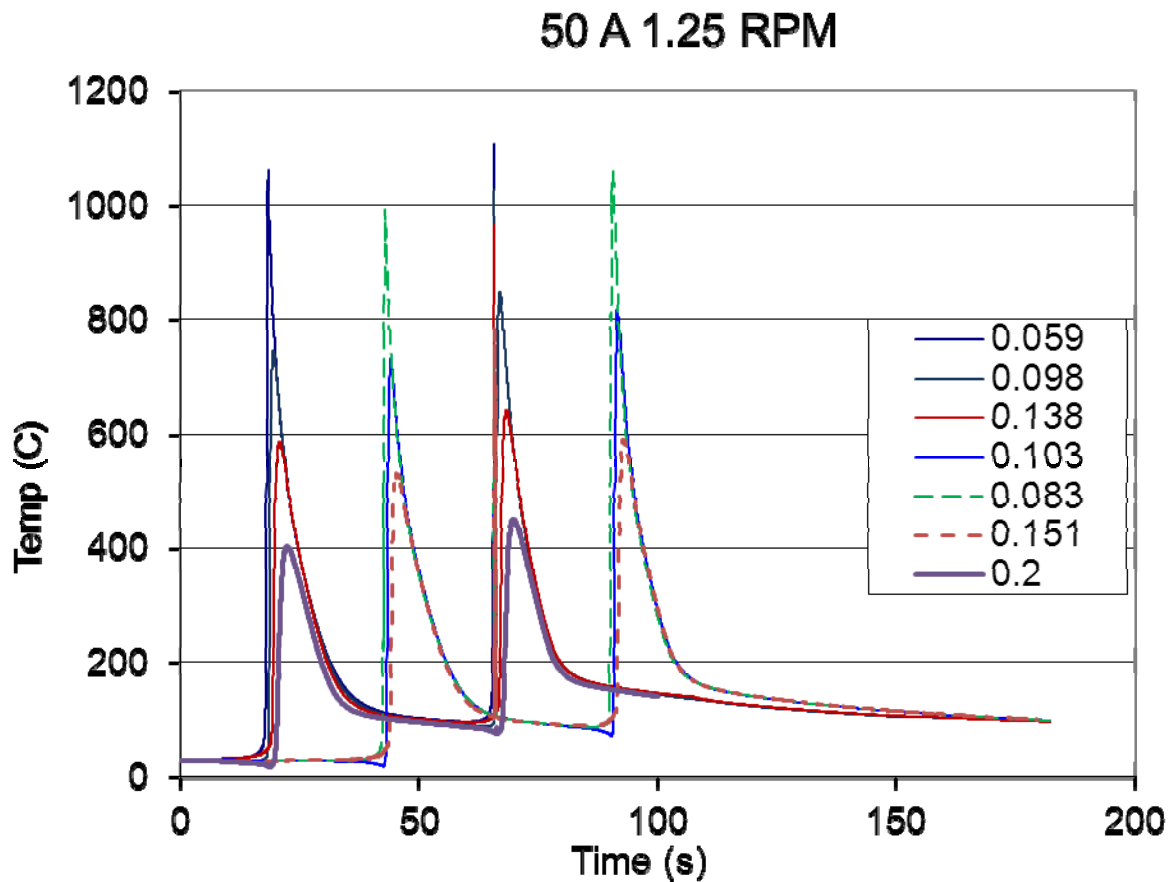
Figure 13. Thermal profile for ISAA02 showing 530°C was achieved between 0.15 and 0.2 inch.

The thermal profile for two revolutions at 1.25 RPM is shown in Figure 13. These data indicate that the target temperature was achieved for material that is between 0.15 and 0.20 inches from the FZ centerline. This value is a little lower than what was observed for the 1 RPM single revolution. The peak temperatures were slightly higher for the second pass, but the overall heat input process did not achieve the desired goals, with the exception that no fusion between the can and plug was observed. This can remnant was welded using a six tacking sequence, to be described later, that had demonstrated improvement in reducing can to plug gaps. The

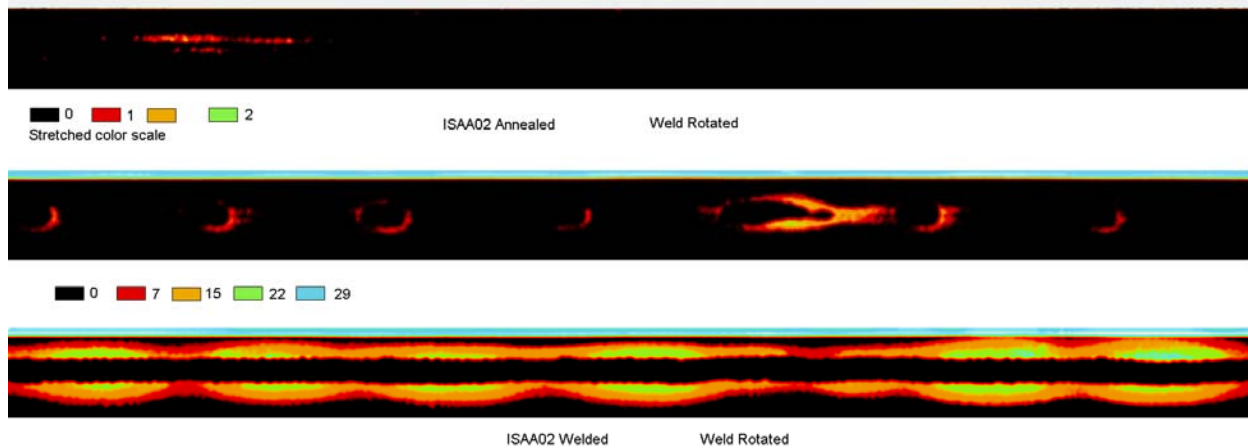
DR images are shown in Figure 14. These images show that there is less lifting in the arc annealed condition, and that six tack weld sequence has a smaller can to plug gap than the three tack sequence that was used for ISAA01. Only a small area around the fifth tack from the left shows any indication of 0.022 inch gap. Also of note is that there are virtually no areas that exhibit can to plug gaps of 0.029 inches. These qualitative results indicated that there may be a way to use DR to determine quantitatively if improvements were made for the can to plug gap.

Figure 14. DR of ISAA02 for arc anneal, six tack welds, and closure weld.

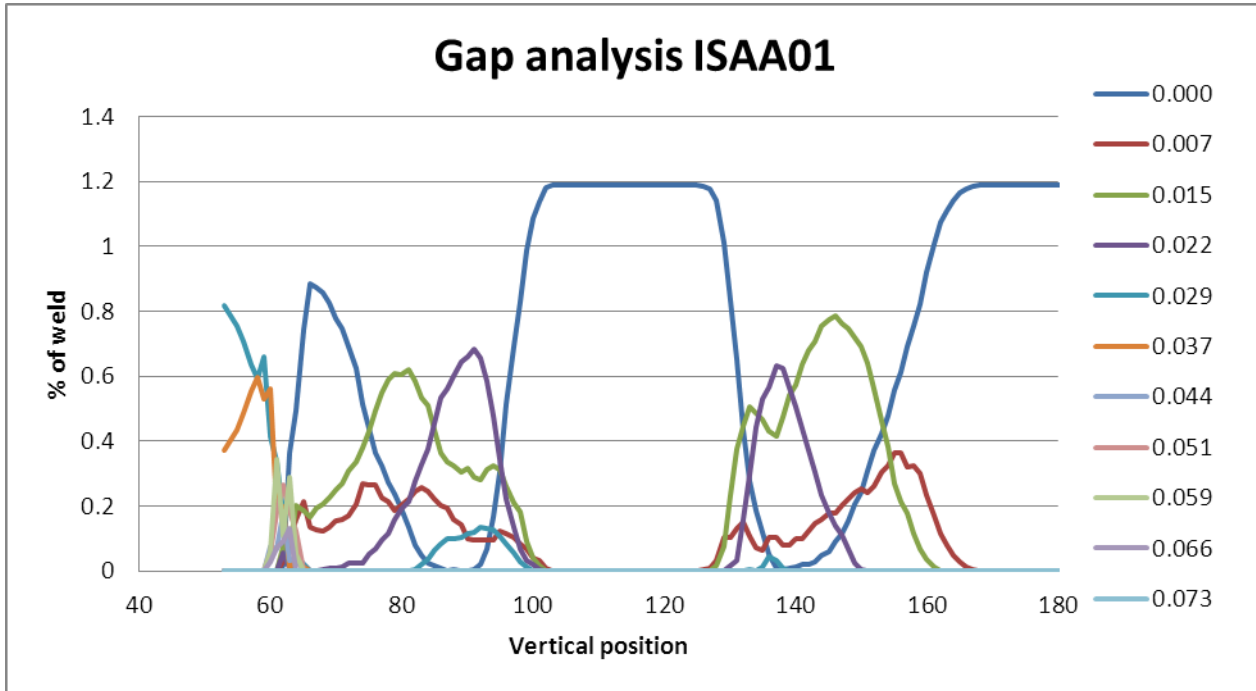
The DR data were interrogated using a simple spreadsheet that determined the number of pixels illuminated during radiography; this value is a physical limit of 0.007 inch. The technique was called Numeric Digital Radiography Data Analysis (NDRDA). The number of slices in the vertical plane from top to bottom that had integer values of 1-5 were summed, these data can be plotted to show the can to plug gap as a function of position above ( $< \sim 95$ ) and below ( $> \sim 130$ ) the weld, as indicated in Figure 15 for ISAA01. This data shows the predominance of large gaps, 0.022 inch and greater, occurs adjacent to the weld bead. It also indicates that a sizable fraction of the gap is equal to or less than 0.015 inch. The data can be further analyzed by determining the percentage of the weld that has each can to plug gap. These data are considerably more useful since they could be possibly used as weld failure predictors.

Figure 15. Percentage of DR data that exhibits the stated gap as a function of vertical position.

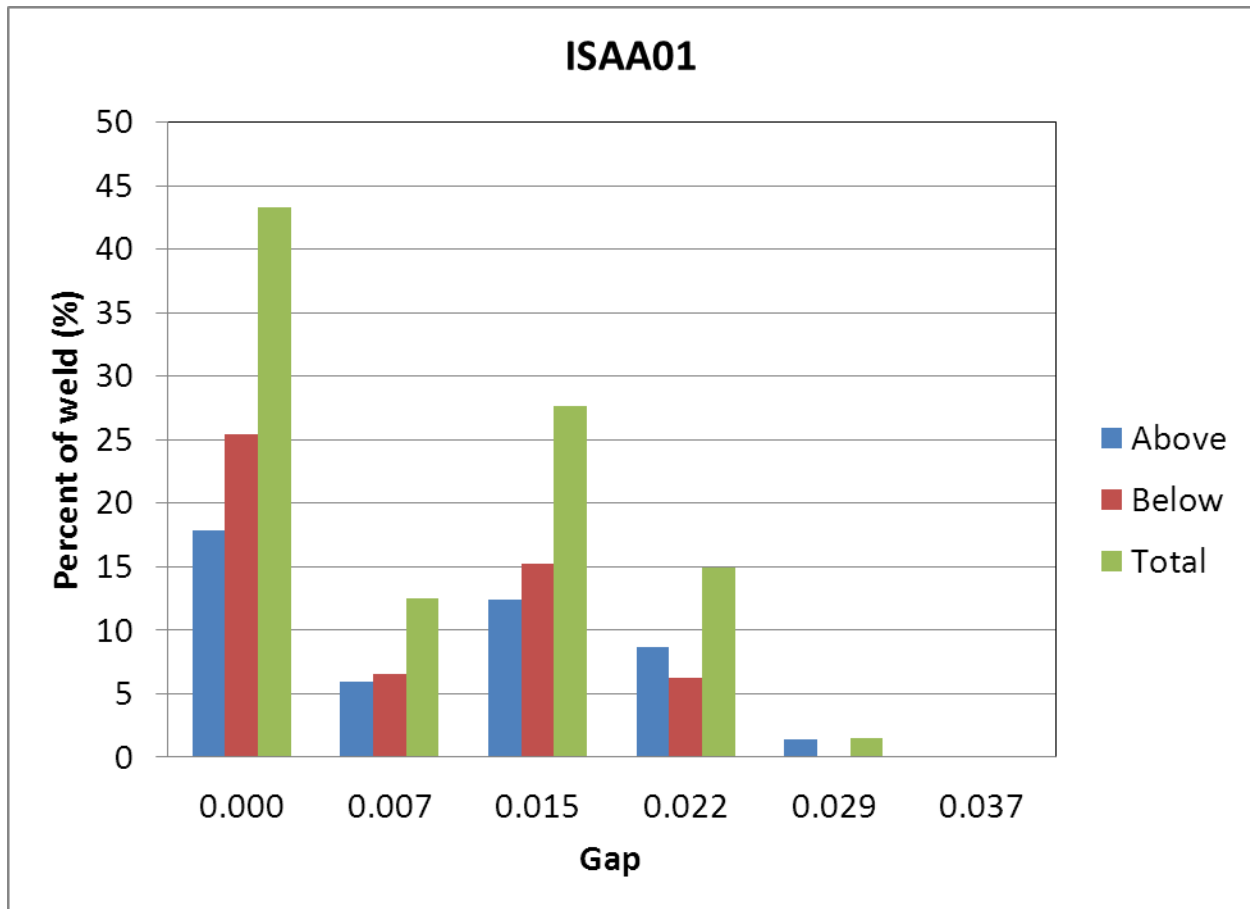
These data were further manipulated and the fractional quantity of gap distance was determined and is plotted in Figure 16. These analyses are useful for determining the effect of process changes on the resultant can to plug gap. The results for ISAA01 indicate about 17% of the weld exhibits a can to plug gap of 0.022 or more. Can to gap testing, conducted coincidentally but discussed subsequently, demonstrated that gaps in excess of 0.029 are more prone to lack of fusion defects compared to lesser gaps.

Figure 16. Percent of weld region that exhibits the DR measured gap.

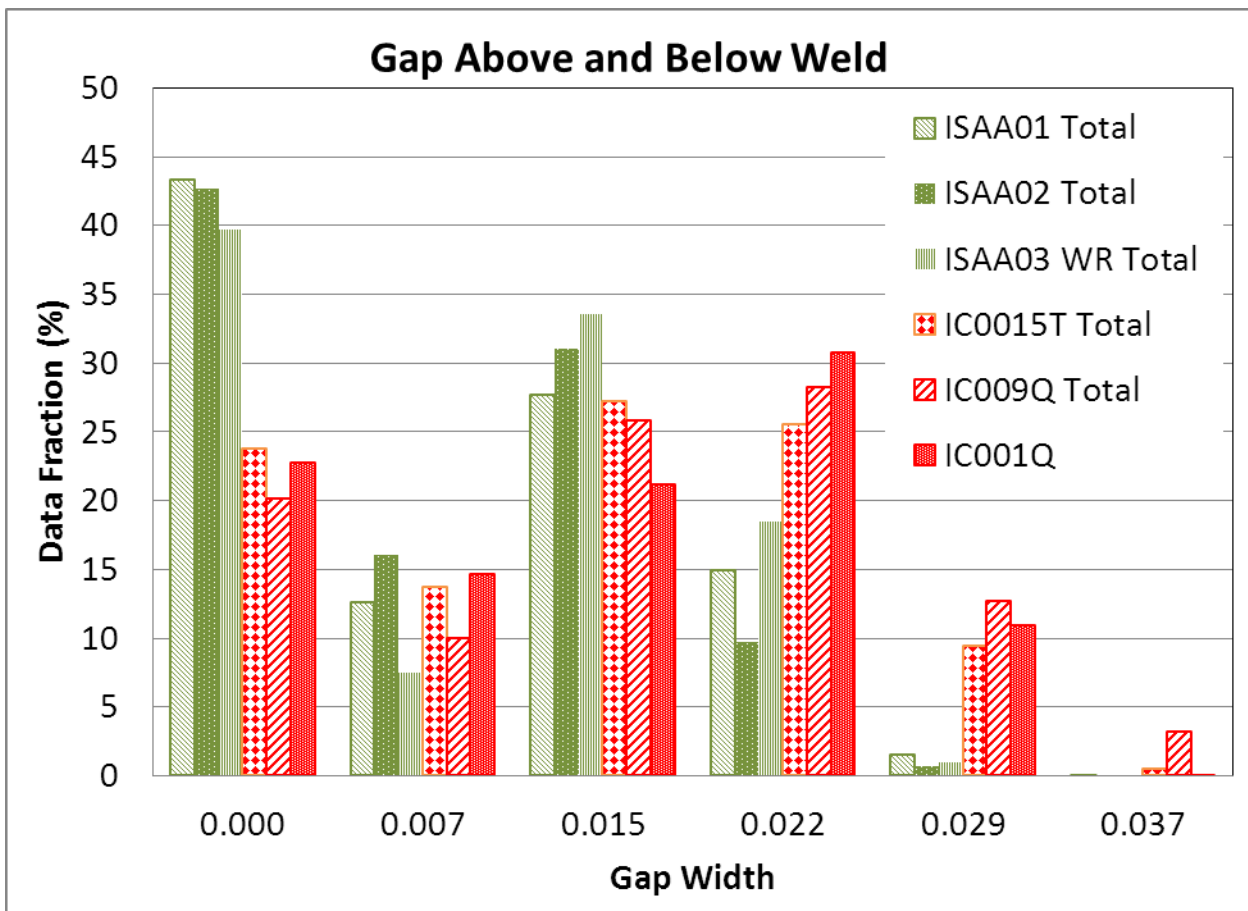
Based on the improvements in weld characteristics, can to plug gap, and weld dimension consistency a third ISAA can was welded. Since this can was fully processed in the prototype weld system, the can was not instrumented. In addition it was processed in a continuous manner so DR occurred after complete processing. The DR of the weld is shown in Figure 17. This weld exhibits slightly more gap that is 0.022 inch than ISAA02, the weld after which it was modeled. All of the ISAA test welds reduced the amount of can to plug gap that is 0.022 and greater compared to the traditional three tack weld without the ISAA, as shown in Figure 18.

Figure 18. Fraction of the weld that exhibits the given can to plug gaps for ISAA and three conventionally welded cans.

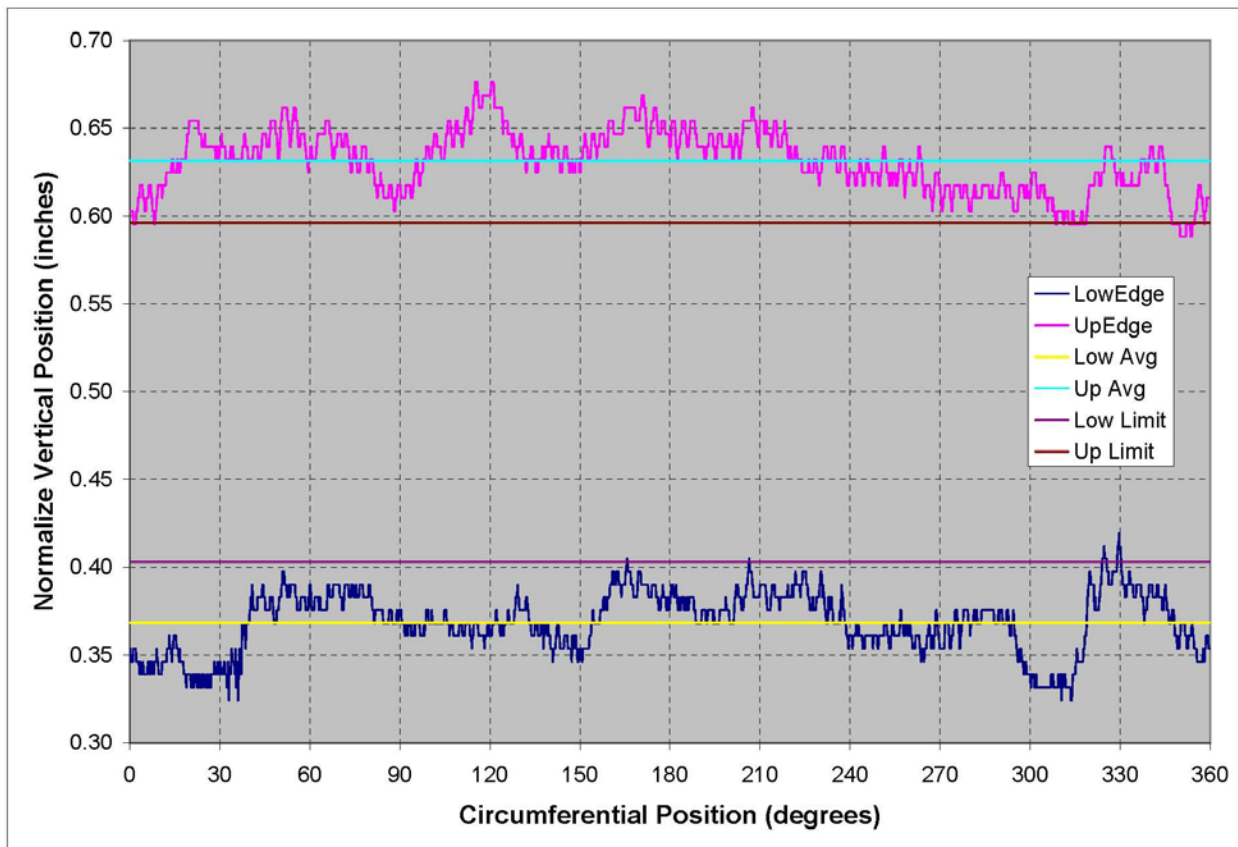
$U_{AVE}$  is the average position of the upper edge of the ligament as determined by DR,  $U_{SD}$  is the standard deviation of the upper position of the weld, and the  $L_{AVE}$  and  $L_{SD}$  are the same values for the lower position of the weld ligament, as shown in Figure 19. The weld figure of merit was used to compare weld quality in subsequent tests.

Figure 19. Normalized vertical position of the weld ligaments showing the calculation values for weld figure of merit.

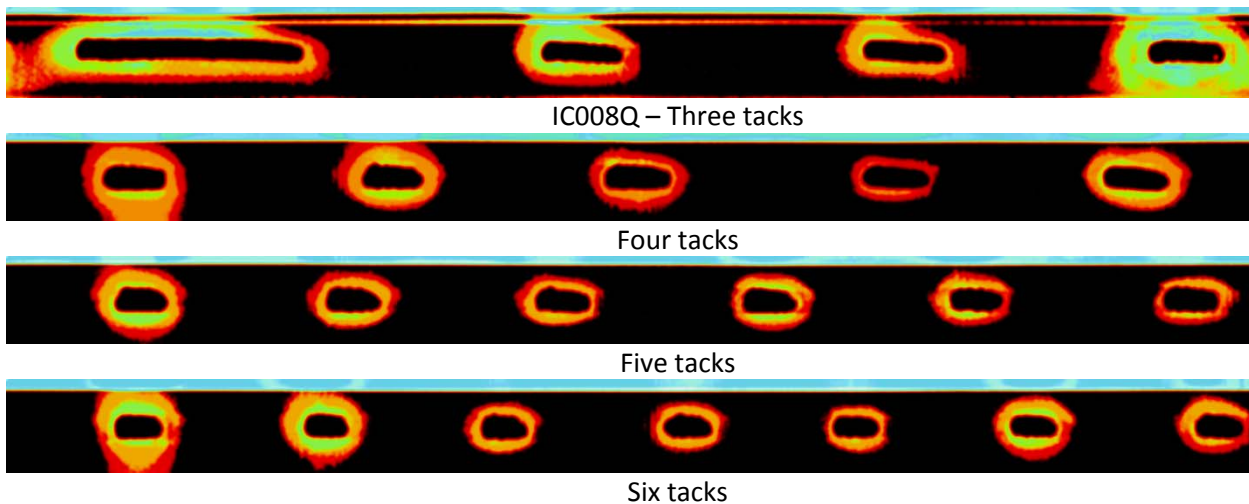
The as tacked digital radiographic results are shown in Figure 20. It is apparent from these data that size of the gap varies with the number of tacks. The traditional three tack exhibits more large gaps than the other tack sequences. These visual data were subsequently examined using the NDRDA tool. This quantitative examination of the data shows that the number of larger gaps is lower for more tack welds, and conversely the number of smaller gaps is larger for the samples with more tacks.

Figure 20. Digital radiographs of the tack welds showing traditional three tacks and extended weld start, four, five and six tacks plus nominal weld start.

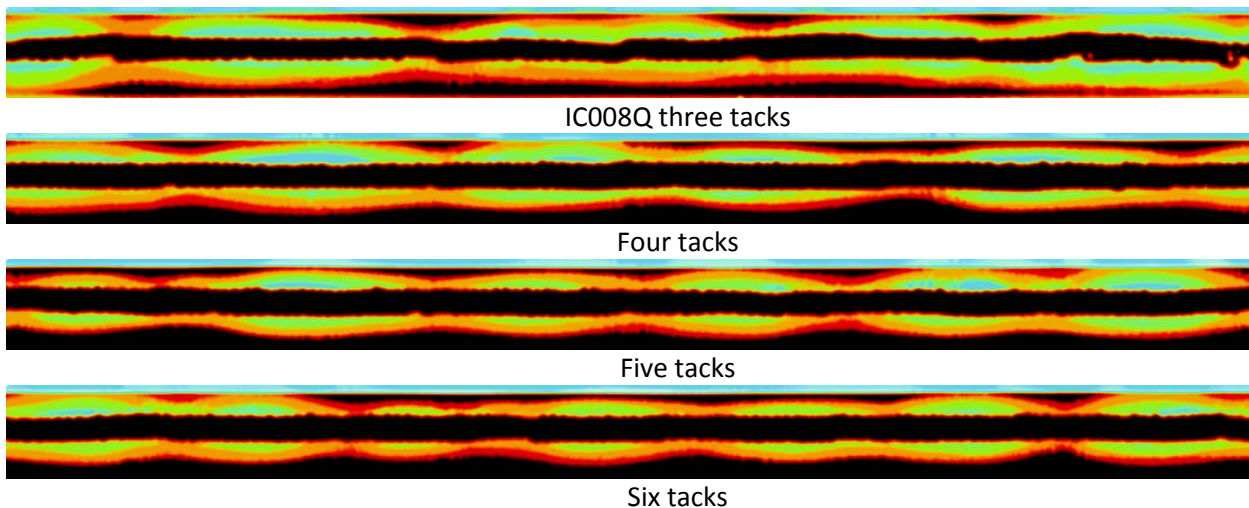
Figure 21. Effect of tacks on gap after welding

The samples were welded and analyzed using these same evaluation techniques. The weld DR images are shown in Figure 21. Qualitatively it appears that more tack welds reduce the observed gap. It is suspected that the smaller the gap, the less likely that lack of fusion defects will occur. The NDRDA tool was also used to evaluate the welded sample data. These data are shown in Figure 22 and Figure 23.

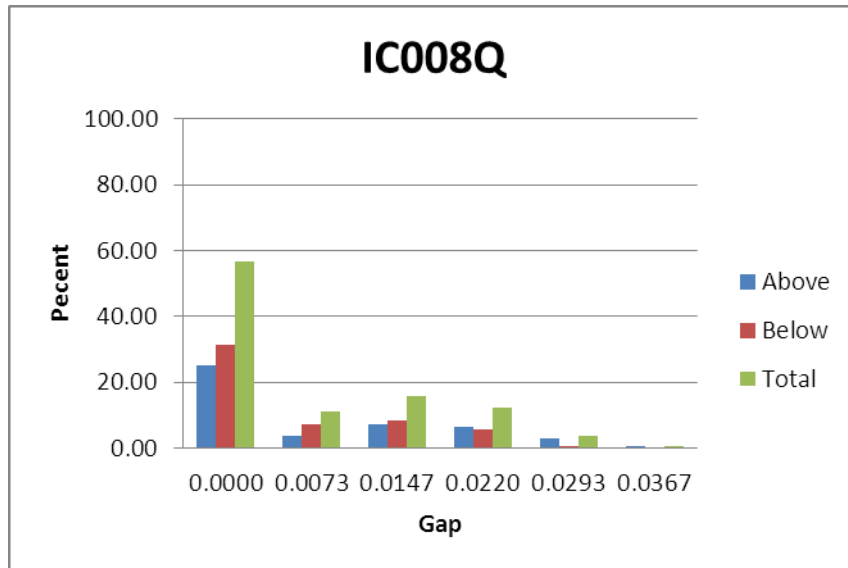
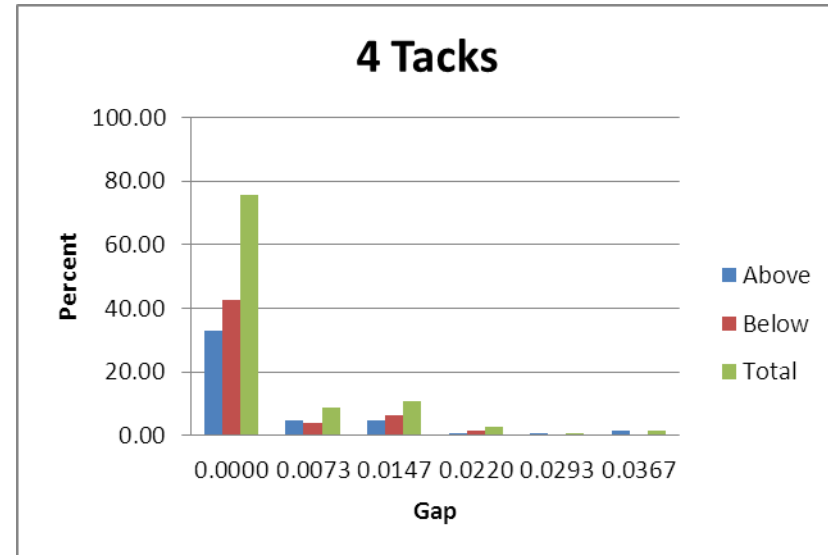
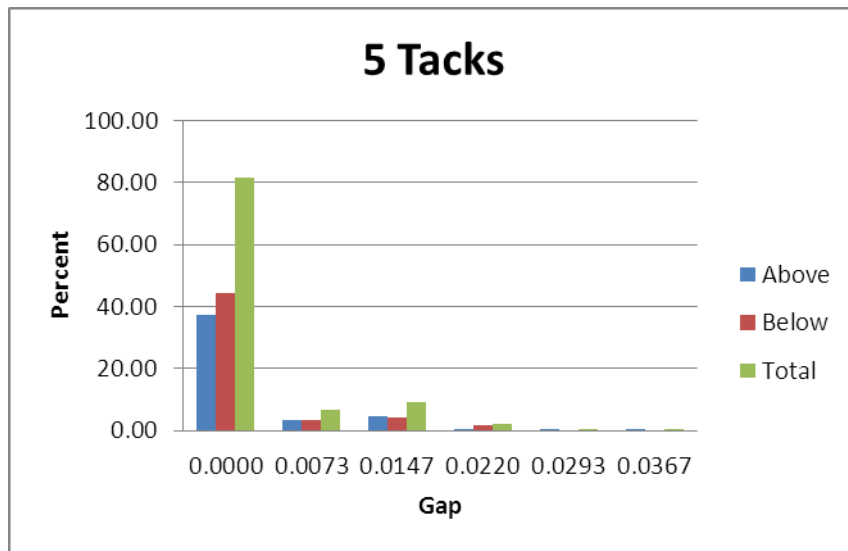
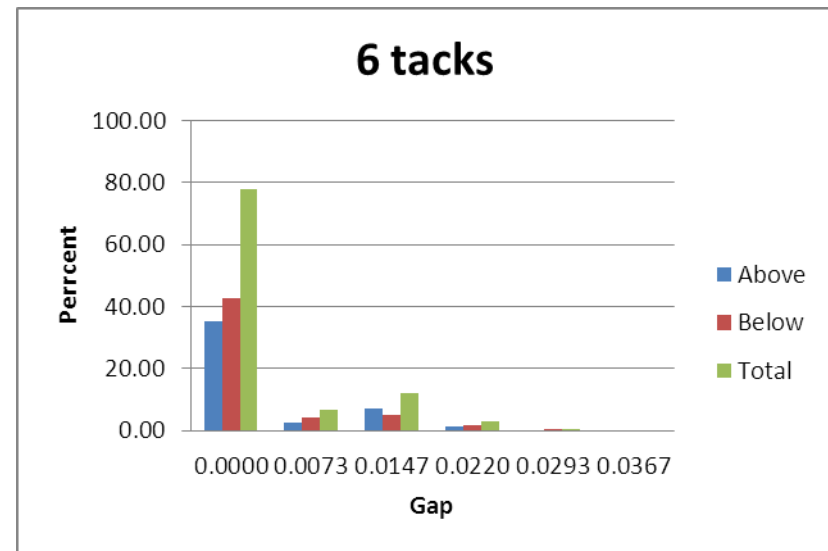
The data indicate that the gap, and consequently the expectation of lack of fusion defects should be reduced for more tack welds. Due to these results, testing using actual cans, rather than mock-up PDC can remnants and plugs was initiated.

Figure 22. NDRDA of the tack weld showing that larger gaps are reduced with more tacks.
