**Keywords:** *Inner Canister, DOE 3013, Welding, Gas Tungsten Arc Welding, GTAW, Experimental*

SRNL-STI-2012-00129

## PDC IC Weld Failure Evaluation and Resolution

March 29, 2012

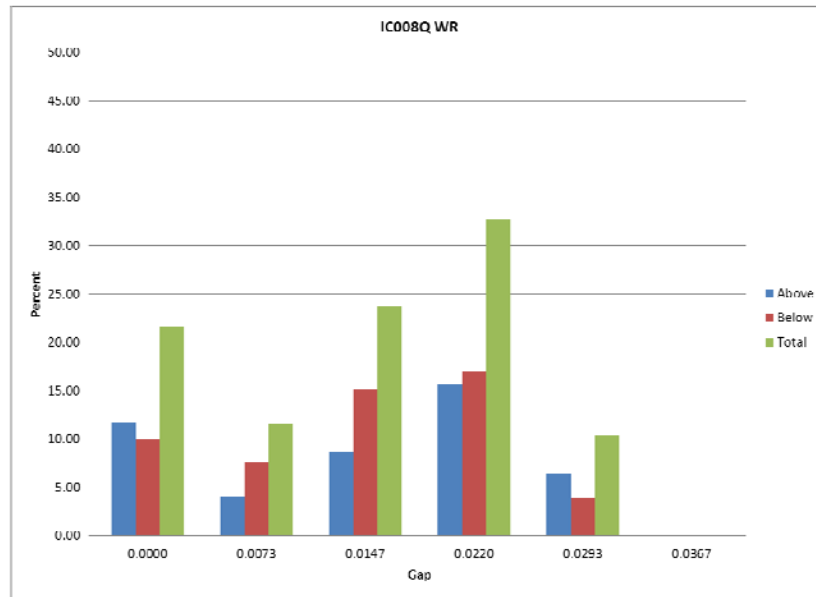
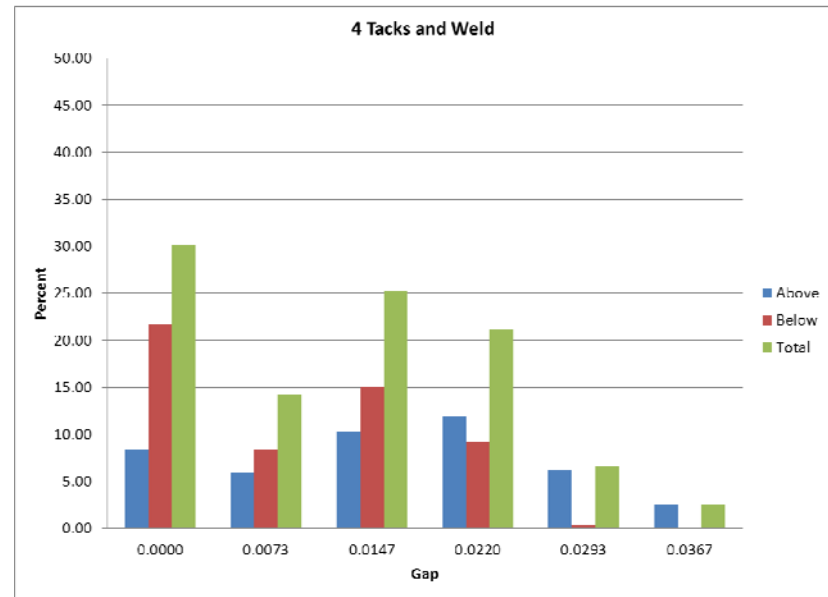
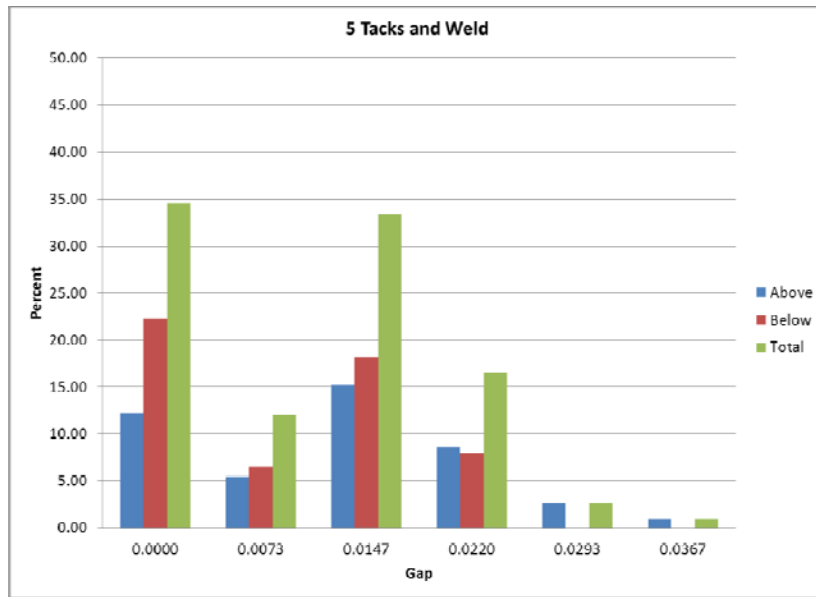
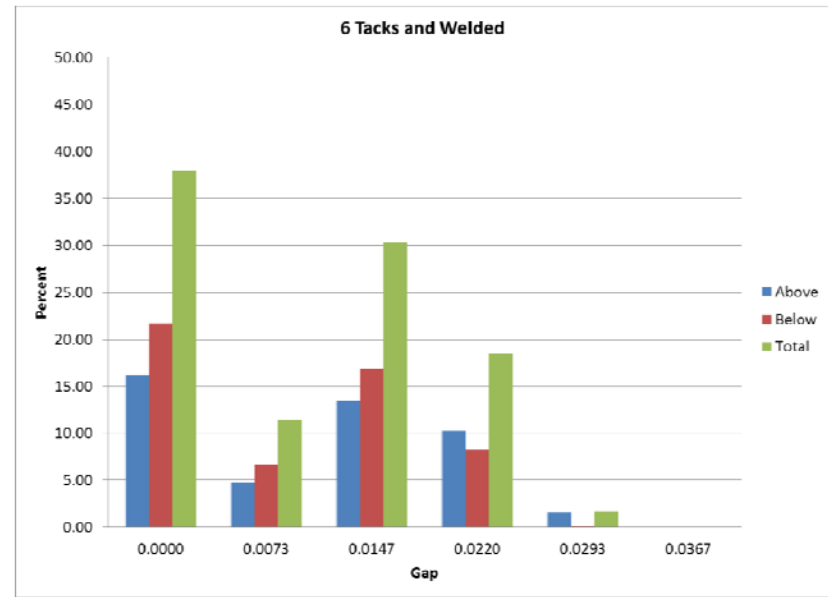
Figure 23. NDRDA of the welded samples after tacking and welding.

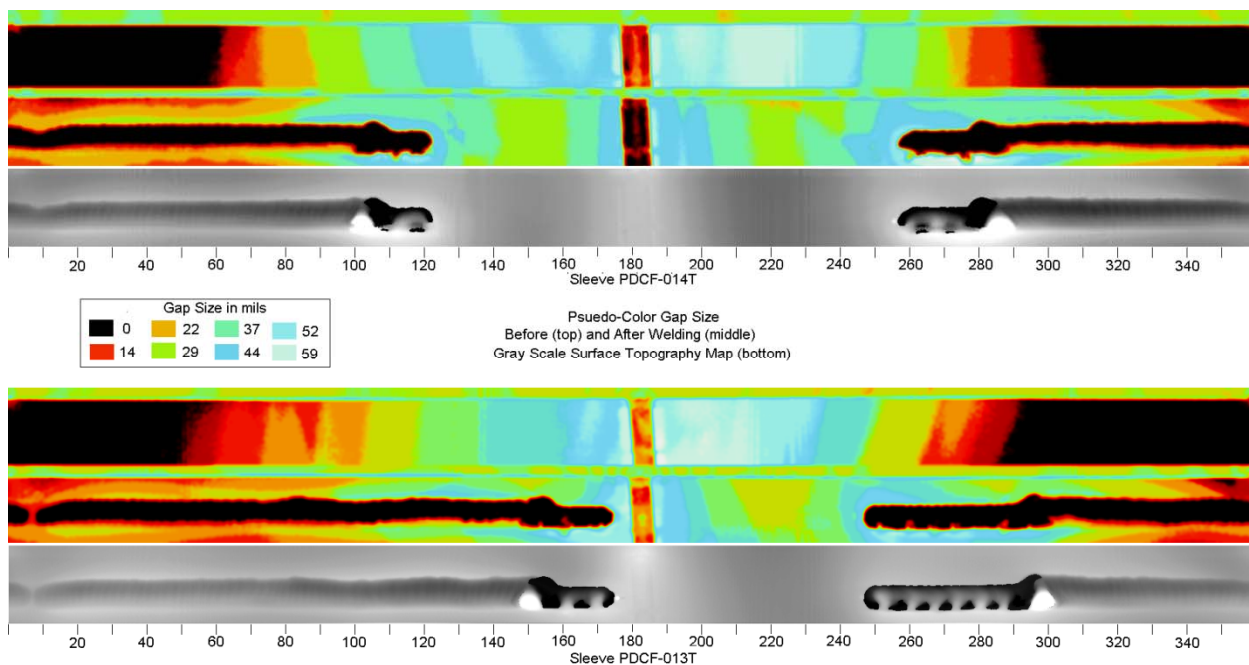
The results of the DR gap measurement are shown in Figure 24. The measurements are discrete with the increments indicated in the legend. For the welds shown on the right side of the image, the lack of fusion defect occurred at about 14 to 22 mils while the weld defect occurred at approximately 29 mils for the 014T can and 37 mils for the 013T can. These variations may be attributable to changes in the actual can to plug gap that occurred during welding of the first side. It is interesting to note that the post weld gap above and below the intact weld bead increases with increasing initial gap distance. It is also notable that the gap at the lack of fusion defect appears to increase to 44 mils. This width of gap may not represent the in-process gap since there is some mechanical stress applied by the weld on the side that is first welded in addition to possibly some relaxation when the lack of fusion defect occurs.

Figure 24. DR results in the as tack welded and as welded condition indicating the relative can to plug gap (thousandths of an inch) shown by the color coding in the legend.

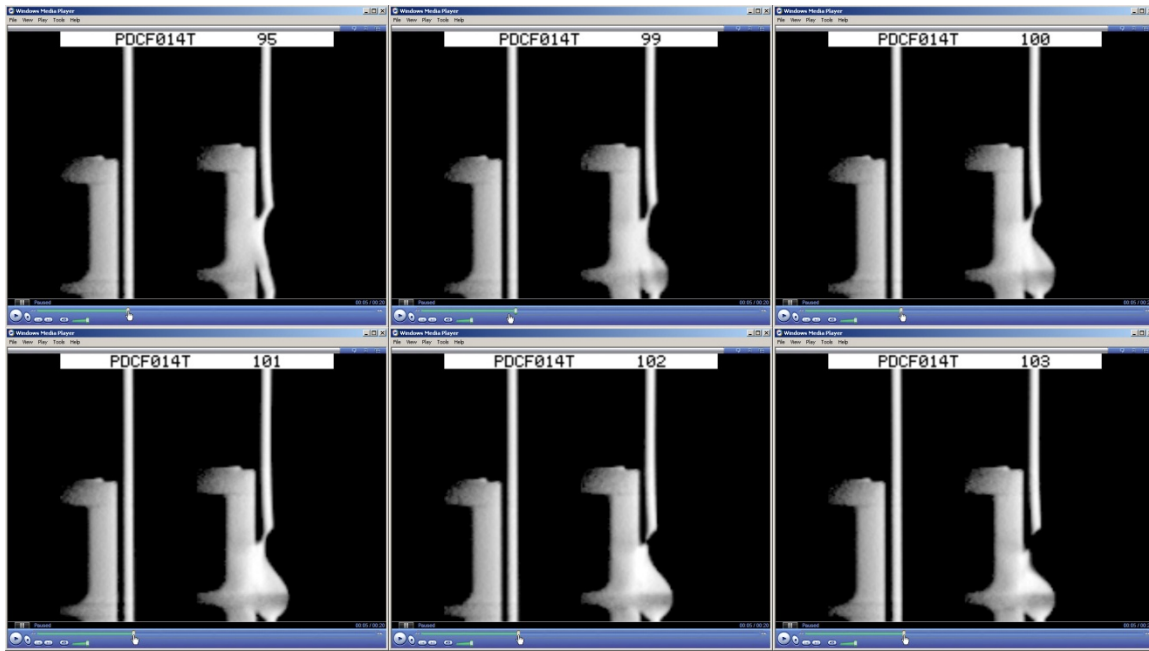
The weld was characterized using DR and the individual slices of the weld immediately before the lack of fusion defects occurred are shown in Figure 25, Figure 26, Figure 27, and Figure 28. One can see that the upper weld metal starts to thin and eventually pulls away and results in a lack of fusion defect. The weld then begins to slump. This weld failure evolution occurred for all four weld trials.

Figure 25. DR slices near lack of fusion defect for can PDCF014T.

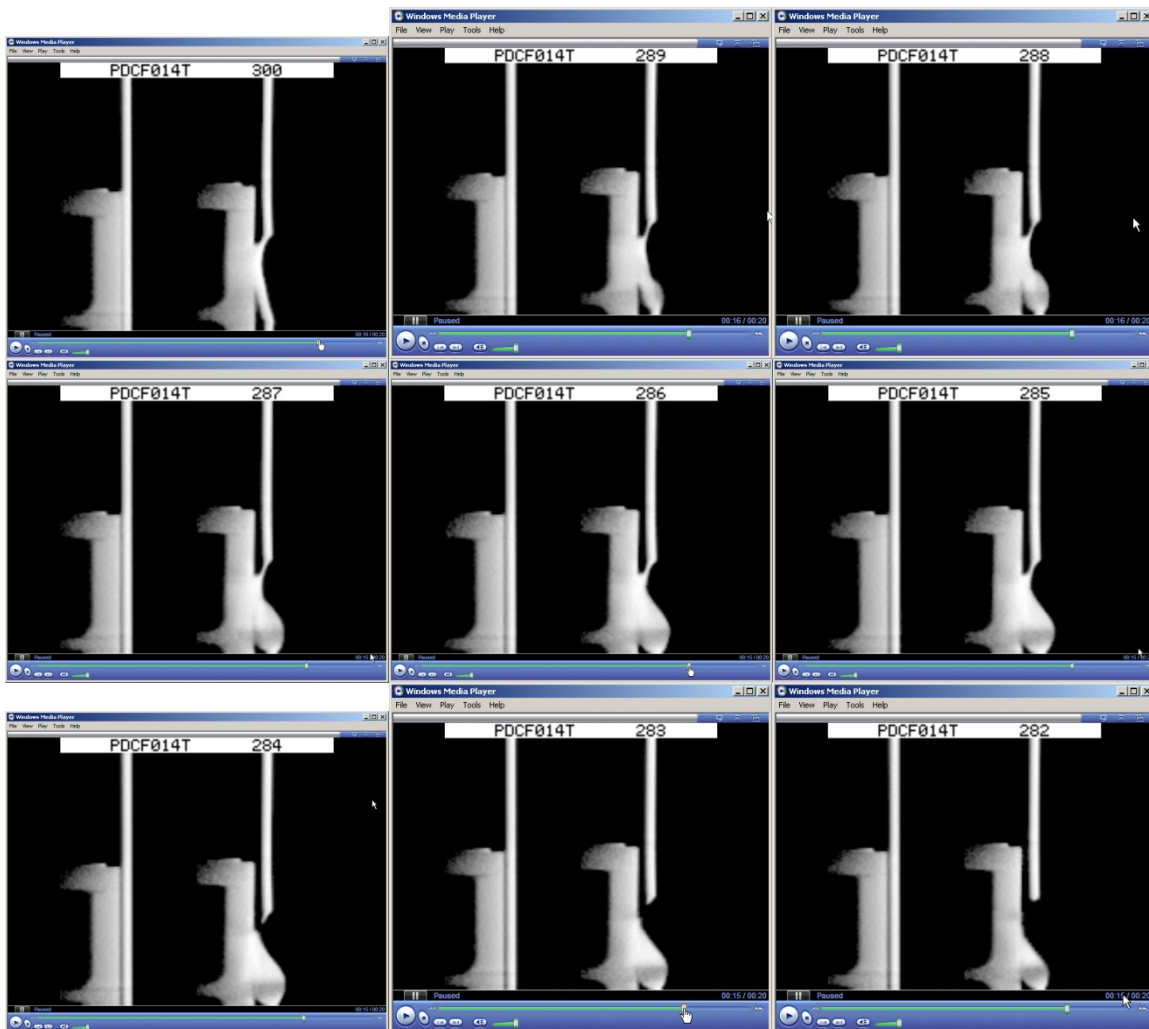
Figure 26. DR slices near lack of fusion defect for can PDCF014T.

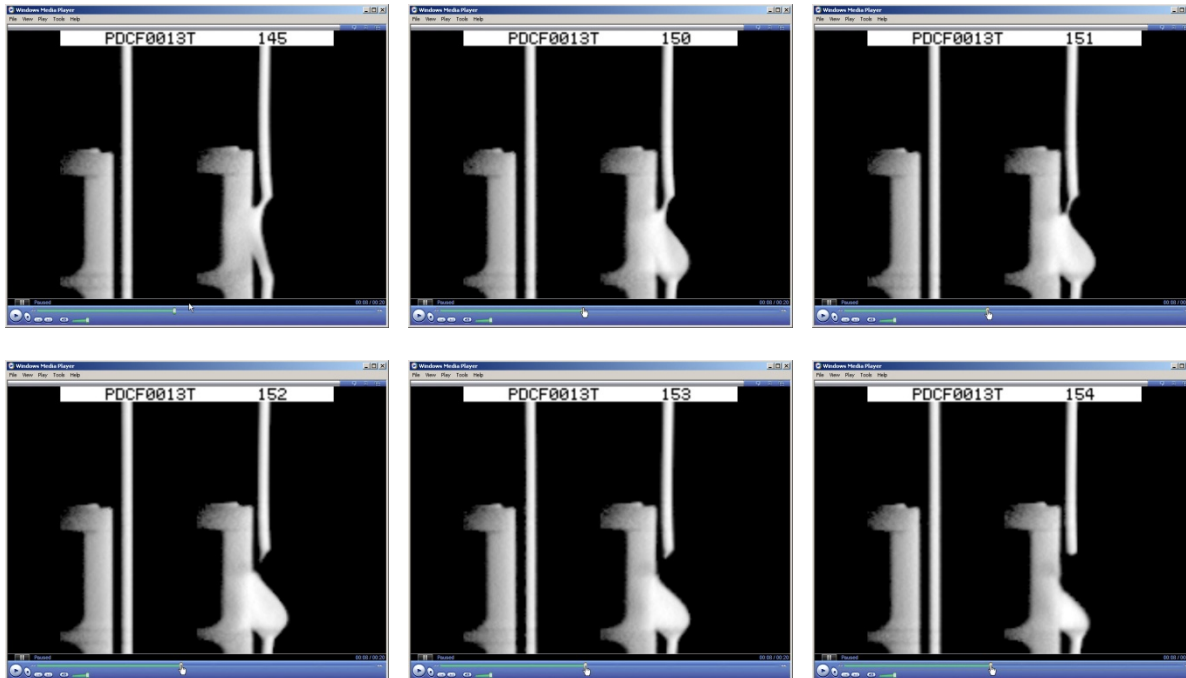
Figure 27. DR slices near lack of fusion defect for can PDCF013T.

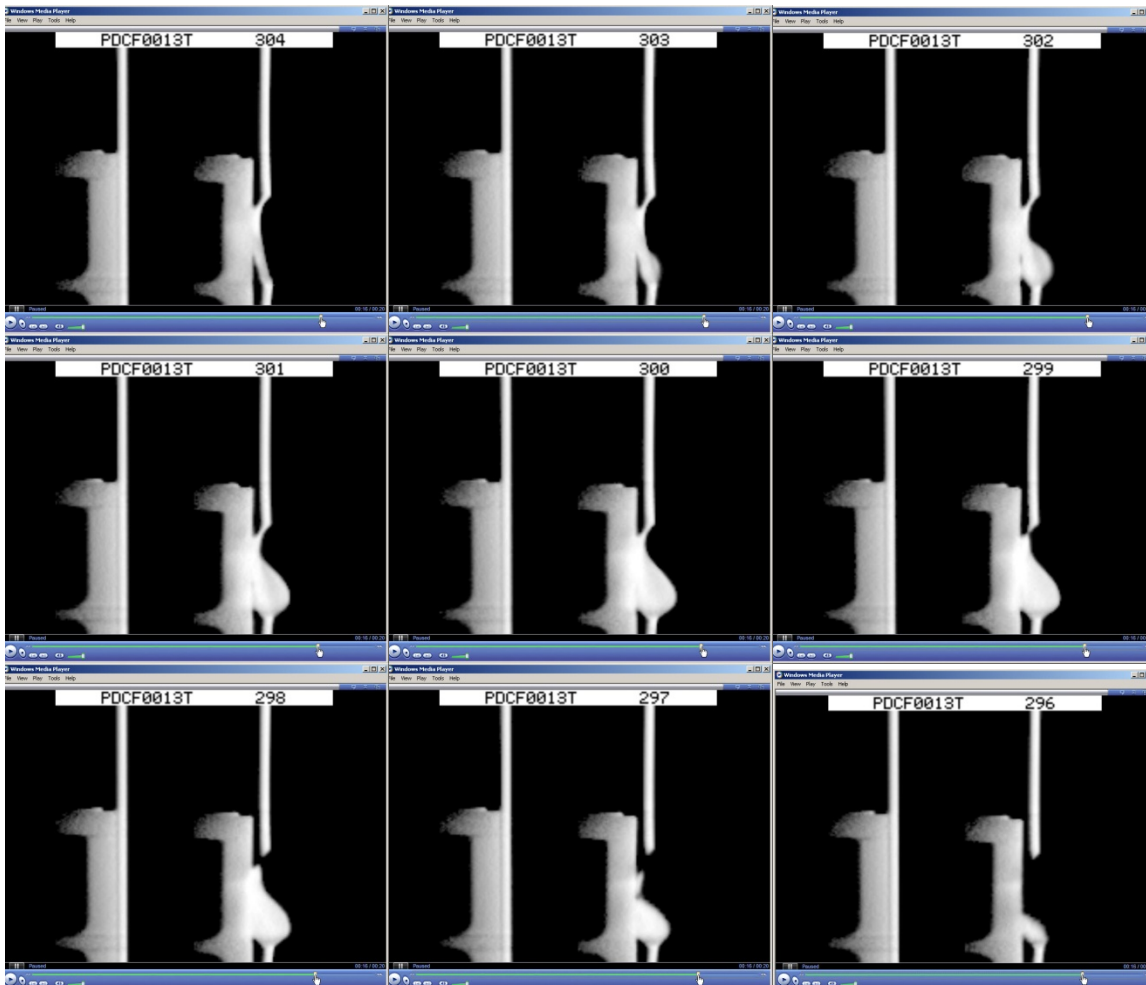
Figure 28. DR slices near lack of fusion defect for can PDCF013T.

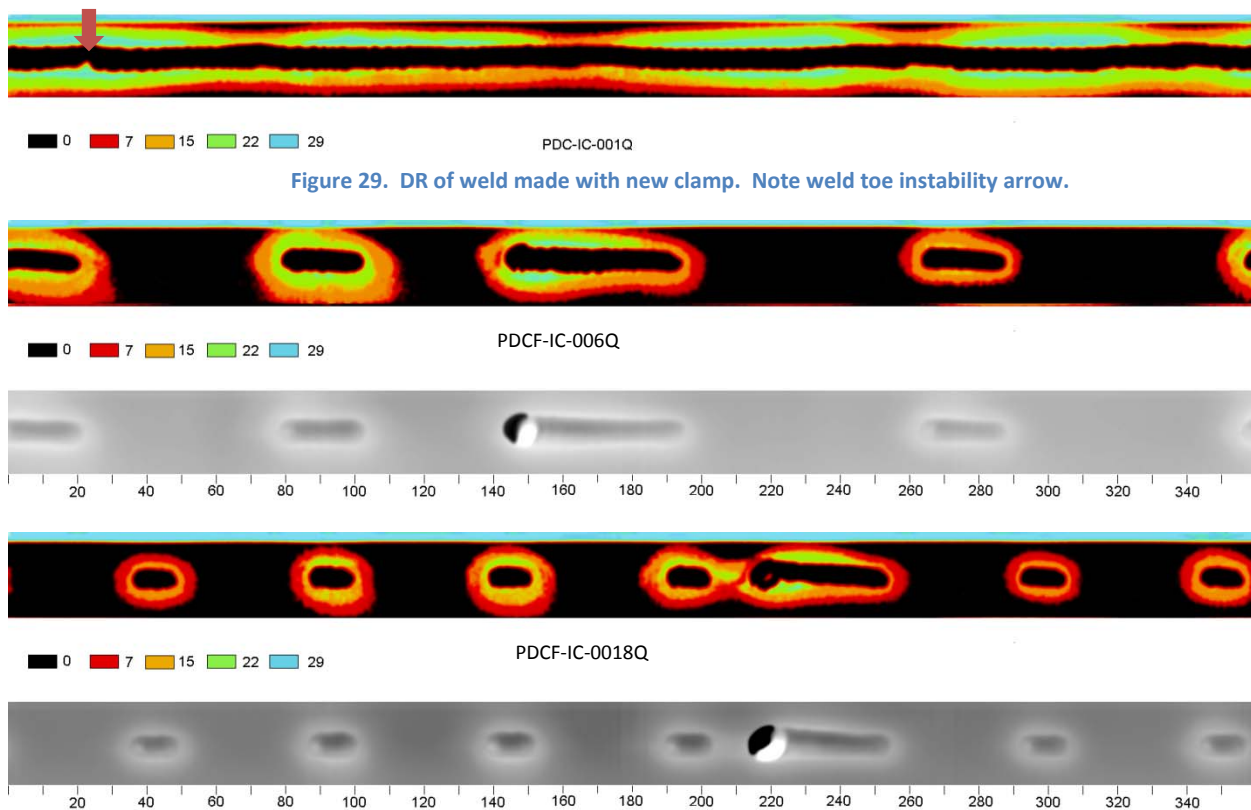
As part of the trouble shooting of the process, it was ascertained that the weld head used a different clamping mechanism. The new clamp promoted an ovalizing of the can. It was suspected that this change may have increased the local can to plug gap and promoted lack of fusion defects. Consequently, a replacement clamp was ordered that increased the number of contact points to make it more like the ones used for FBL and Hanford. The initial weld (PDCF-IC-001Q) made using the new clamp and the traditional three tacks and weld was successful, but it exhibited a weld instability after about 10-15 seconds into the weld. The DR for this weld is shown in Figure 29. The next two welds experienced failures, one weld (PDCF-IC-006Q) was a traditional three tack weld and one weld (PDCF-IC-018Q) was a six tack weld. Both of these welds experienced the lack of fusion failures at about the same time/location, i.e., 10-15 seconds into the weld and are visible at approximately 150° in the radiograph of PDCF-IC-006Q and at 220° in the radiograph of PDCF-IC-018Q, Figure 30.

Figure 30. DR of traditional (PDCF-IC-006Q) and six tack weld (PDCF-IC-018Q) that failed 10-15 seconds into the weld.

This persistent weld defect was analyzed and was determined to be caused by two separate steps that were initiated for the automated welding. These included a helium gas release--“puff”-- that was used to ensure that the suction cup was released from the plug and a coincident raising of the mast that is used to seat the plug. Upon further investigation it was discovered that the “puff” was being maintained by the controller system for an extended period of time (~13 seconds), a momentary puff was used during earlier machine development. This extended discharge time resulted in the bell jar being pressurized slightly but sufficiently to blow out the weld puddle. The “puff” was therefore eliminated, the suction cup is now simply vented prior to being decoupled from the plug. The timing of the mast movement was changed so that it would not occur during welding (tacks or continuous main weld), rather the movement is completed during the low current arc drag between the tack and weld start.

For moving forward with the IC qualification testing, it is recommended to use the three sequential tack weld process followed by a pulse weld at the same current and travel speed as was used for the legacy processes. In addition, the weld clamps to be used shall be consistent with those used in legacy operations, the He puff associated with plug operations shall be eliminated, the timing of the mast movement shall be changed to occur during weld head travel between the tacks, and the plug shall be raised .020" above the plug seat position.

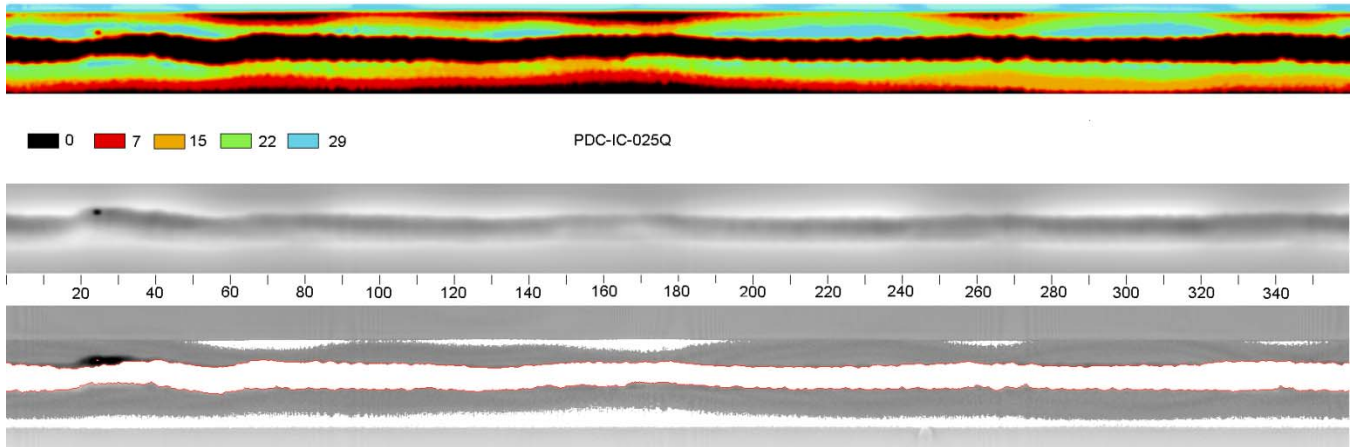
The effect of just the mast movement during welding can be seen in the DR results from can PDC-IC-025Q in Figure 31. The weld exhibits some variation in the lower edge of the weld in addition to a significant offset in the weld plane that is observed at about 20°. There is also a fair amount of can to plug gap that is over 0.029 inch. Examination of this weld led to the knowledge that the mast movement during the weld resulted in a weld disturbance and consequently led to the change in weld process alluded to above.

Figure 31. DR results of PDCF-IC-025Q showing effect of mast movement during welding.

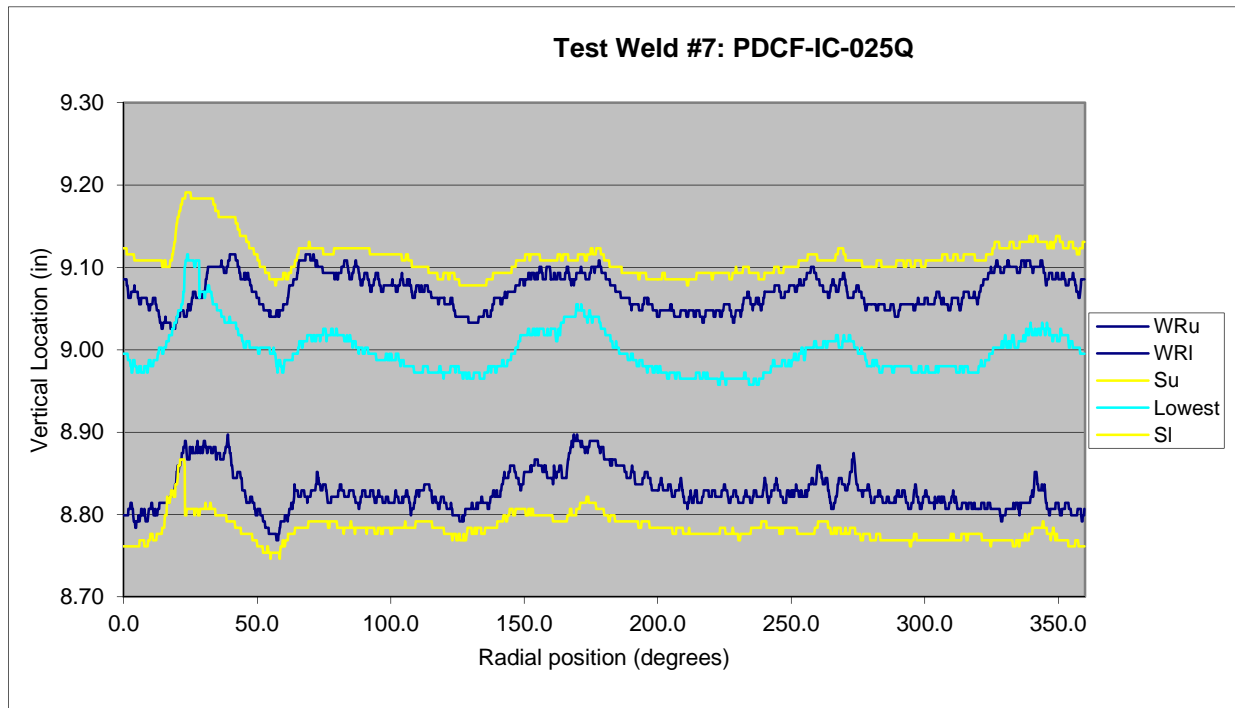
The surface and ligament traces from the DR data are shown in Figure 32. These data provide an indication of the upper, lower, and nadir of the weld on the surface and also indicate the location of the upper and lower weld ligament. Notice the relative roughness of the weld surface and ligament. In addition, note that there is a potentially thinnest ligament ( $WR_{u(min)} - WR_{l(max)}$ ) of about 0.126 inch. This weld ligament will be cut and must result in weld length of at least 0.045 inch on the can and a hermetic seal on the remnant.

Figure 32. DR trace data for PDCF-IC-025Q.

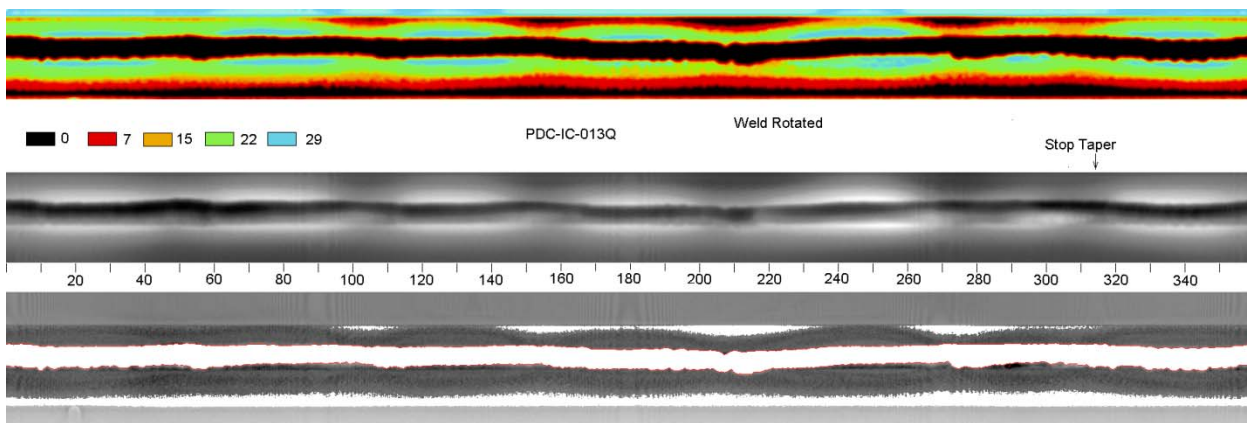
Two cans were successfully welded using the double pass 50 A, 1.25 RPM, thermal cycle that was used for the ISAA03 and either six or three tacks, PDCF-IC-013Q and PDCF-IC-004Q, respectively. These welds exhibit more variability and a shorter ligament than ISAA02. The DR results for PDCF-IC-013Q that was welded with the ISAA followed by six tacks are shown in Figure 33. The weld appears to wander along the lower edge while the upper edge of the weld and ligament is more consistent. This weld exhibits a weld merit value of 11.8; recall that the weld merit is a measurement of the average weld width, so a high standard deviation will result in a lower weld merit.

Figure 33. DR of PDCF-IC-013Q ISAA + six tacks.

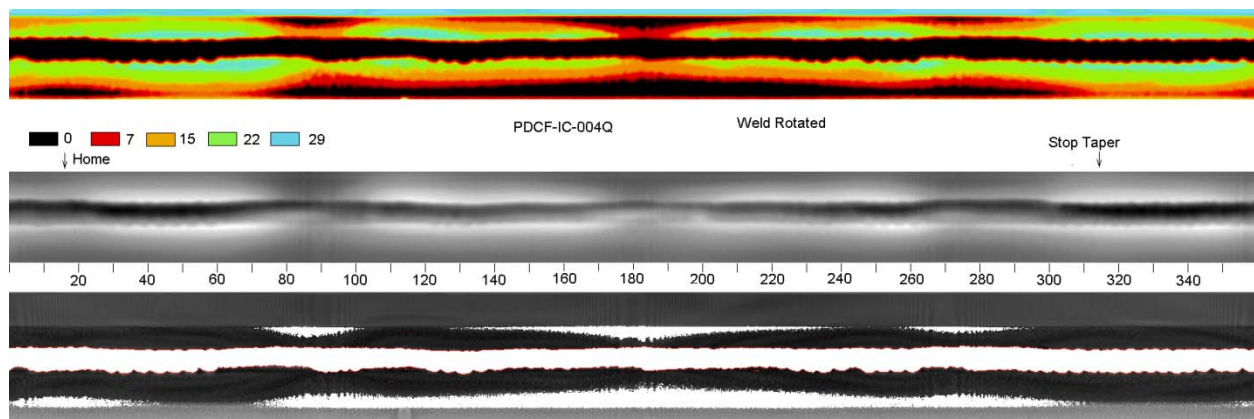
A second can was welded with the ISAA as was used on PDCF-IC-004Q except only three tacks were used, similar to ISAA01. The DR for this can is shown in Figure 34. This weld is also rough along the lower edge but exhibits a slightly improved weld merit of 16.3. The gaps were analyzed for both of these welds and the results are compared to the two prototypic welds in Figure 35. This graph shows that the number of areas that exhibit gaps larger than 0.022 for the actual cans is greater than what was observed for the developmental welds, i.e., the ISAA series.

Figure 34. DR of PDCF-IC-004Q ISAA + 3 tacks.

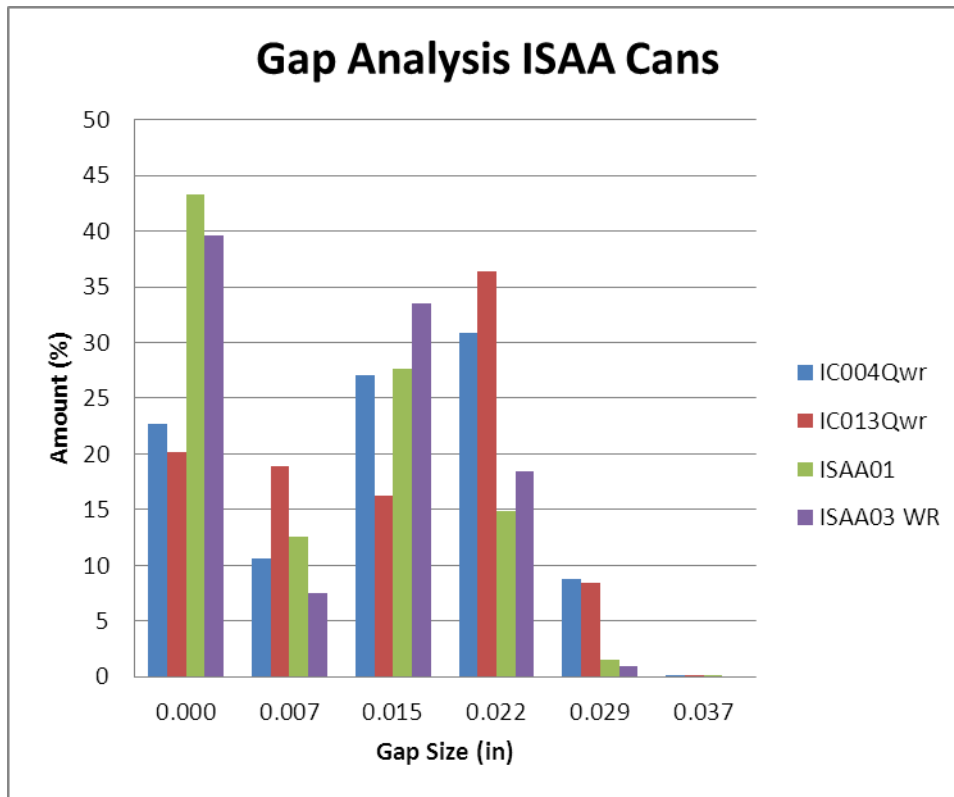
Figure 35. Gap analysis for PDCF-IC-013Q (6 tack welds) and PDCF-IC-004Q (3 tack welds) and the experimental welds (ISAA#).

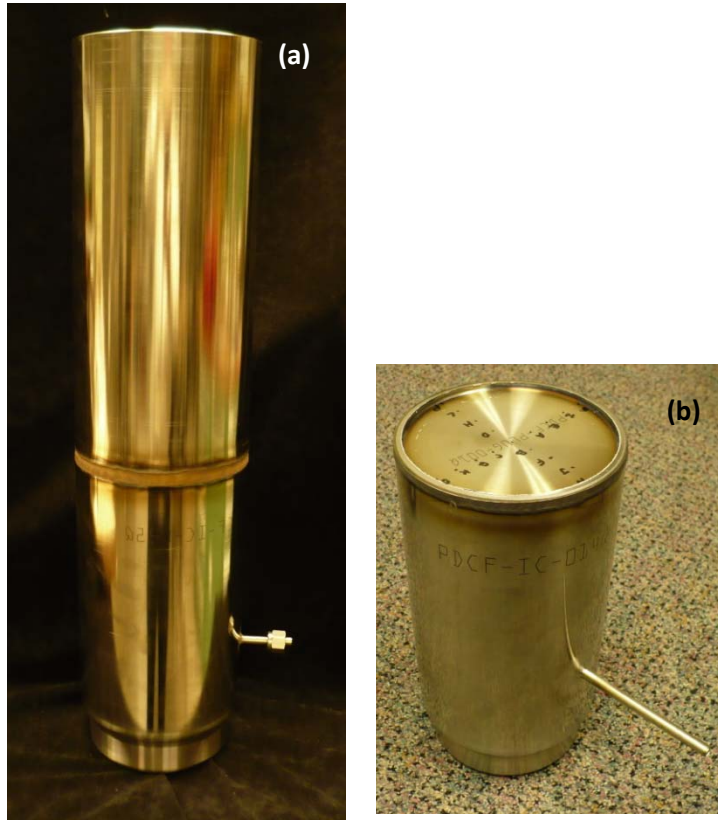
As the weld development on cans proceeded, a question regarding potential pressure increase was investigated. To address this question, several cans were prepared with a pressure tap that was located away from the weld head in the lower portion of the can. The placement of the tap relative to the weld is shown in Figure 36. It is apparent that the weld and plug are away from the pressure measurement zone. The pressure data shows a consistent increase in pressure followed by a spike, drop, and subsequent increase, Figure 37. This result suggests that the pressure measurement methodology is adequate for gross pressure rise. In the second can, the pressure was fairly constant until weld closure had occurred. The pressure – time data for two of the cans are shown in Figure 37. Unlike the outer can weld system that exhibited increases in pressure and sudden releases Figure 38 when tack welds were crossed, the PDC-IC exhibits very little pressure response during the weld until the can is nearly closed and then there is a slight increase in pressure after the weld closure is made; the pressure continues to rise for a short period of time after the weld is complete. Note that the entire pressure scale is only 0.4 psi.

Figure 36. Photograph of a can that has been pressure tapped prior to welding in the as welded and cut condition; note these photos are not of the same can. IC025Q is depicted on the left (a) and IC014Q on the right (b).

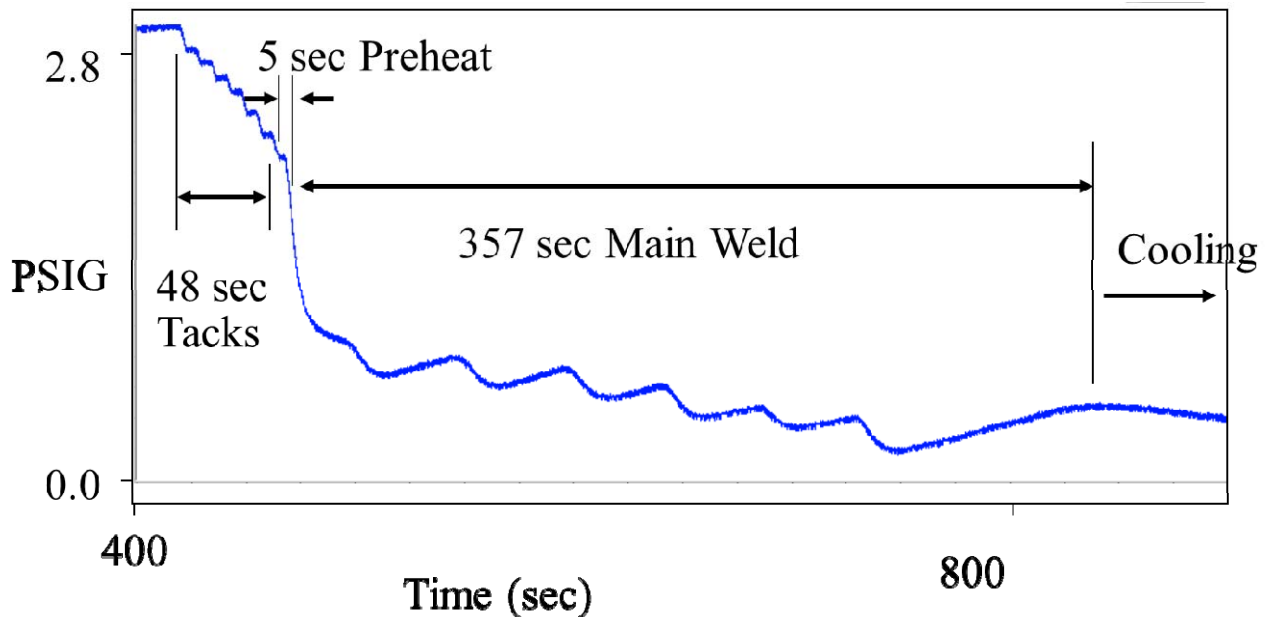
Figure 38. Pressure response from an OCW weld with a pressure tap. Notice the oscillations in pressure. These are consistent with the tack weld locations.

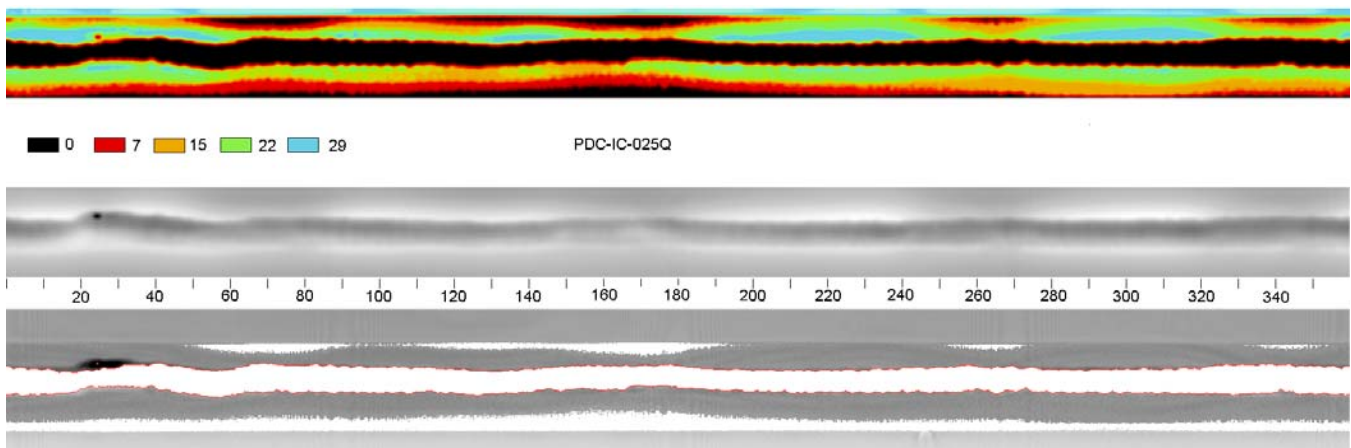
Figure 39. DR results for PDCF-IC-025Q that had a mast movement during welding shown at approximately 20°.

A test to evaluate the effect of just the mast movement was conducted. It was determined that mast movement had an adverse effect on the weld location, surface appearance, ligament, etc. but did not cause lack of fusion defects. For instance, the PDCF-IC-025Q was welded with the mast movement but not the helium gas release and a weld anomaly was detected, but it did not result in a weld failure, as shown in Figure 39 at about 20°. This finding is consistent with the fact that several cans had been had been welded without lack of fusion defects but with gross weld instability irregularities.

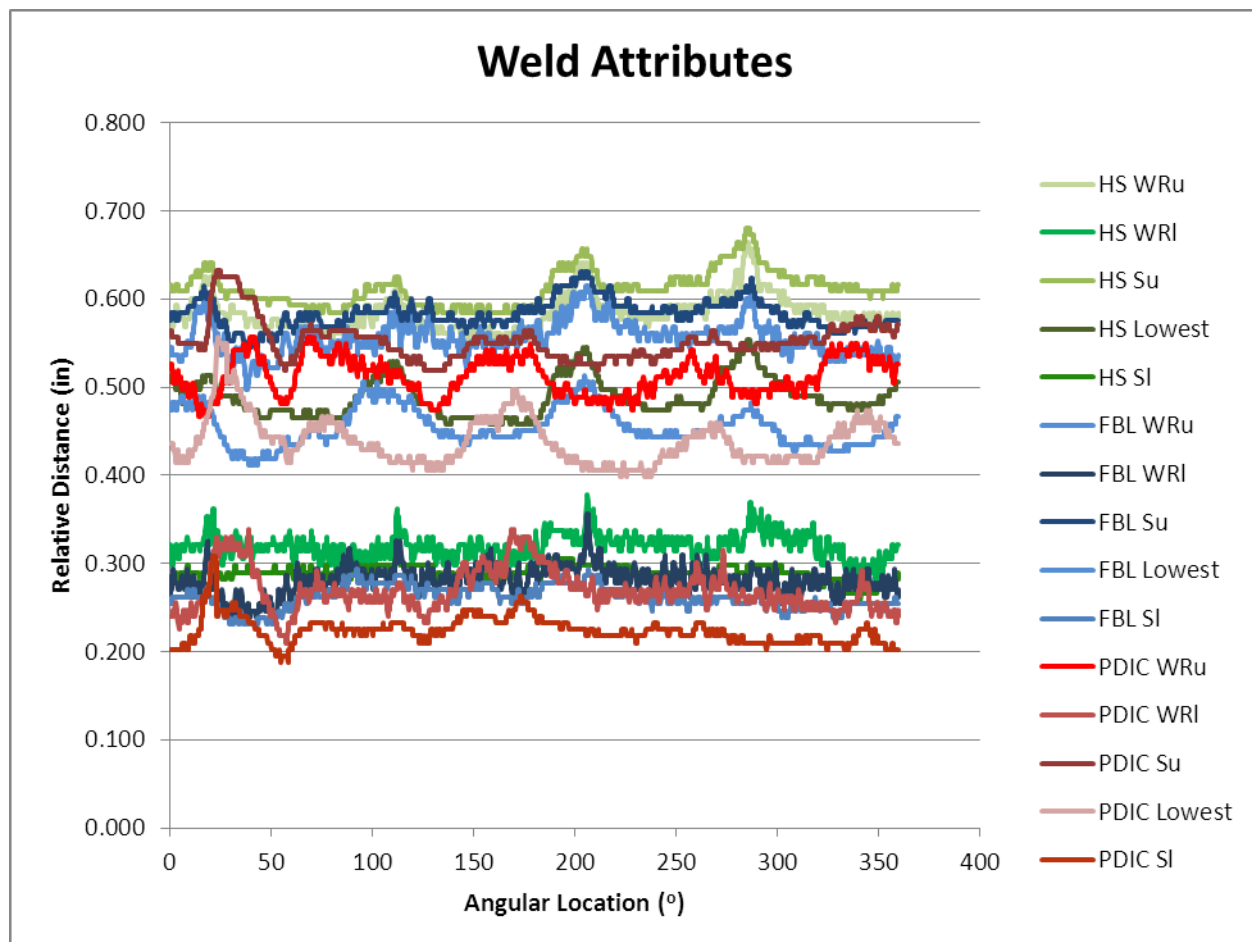
there was no observable improvement in the weld consistency of prototypic cans when ISAA or a modified tacking sequence was tested using single test articles. A benefit for using this approach was that a weld specification procedure (WPS) already existed and would not require additional testing, evaluation, and documentation to be implemented. In summary, a weld instability remains for the PDC-IC closure welding process that causes the apparent difference between the final PDC welds and the earlier FBL and HS welds. It is suspected that it was linked with 1) venting restrictions introduced by the “hard” seating of the plug that was done for nearly all of the developmental testing but was eliminated just prior to starting the validation testing, 2) a PDC plug design with a long skirt that may introduce vent gas flow restrictions or induce stresses near the weld zone, 3) the magnetic differences between the PDC can and the FBL and HS cans that may introduce arc response differences.

Figure 40. Weld attribute location for cans welded for PDC, FBL, and HS.
