PNNL-17698

Technical Letter Report

Assessment of Ultrasonic Phased Array Testing for Cast Austenitic Stainless Steel Pressurizer Surge Line Piping Welds and Thick Section Primary System Cast Piping Welds

JCN N6398, Task 2A

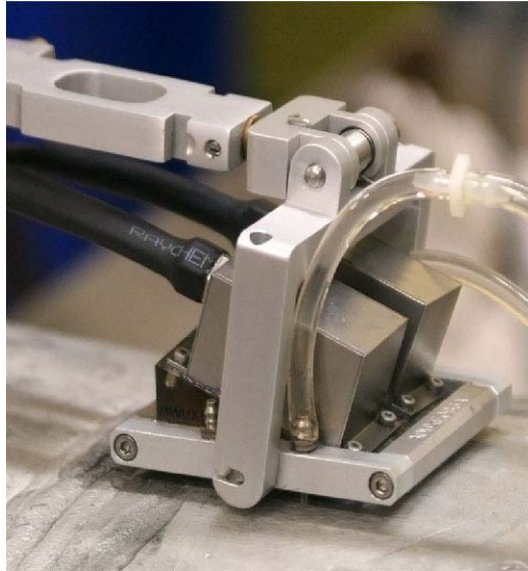
Figure 5.2. 1.5-MHz TRL Probe Originally Designed for Wrought Stainless Steel Welds

Specific focal laws were generated for the surge line based on the thickness of the piping and the width of the weld in the surge line pipe-to-elbow weld. After the focal laws were developed, the ultrasonic field that would be produced by these laws was simulated to demonstrate that the probe and the focal laws are able to insonify the region of interest. The simulations indicated that the 1.5-MHz probe would be able to produce a well-focused beam at distances from directly below the probe to approximately 45 mm (1.8 inch) in front of the wedge. The probe produces a sound field that works best for detecting and sizing flaws on the near side of the weld, but it is also capable of detecting flaws from the far side of most welds in thinner materials, assuming that the microstructure allows the waves to form and propagate properly. Multiple focal laws were used in the examinations to obtain optimal results. Example simulations of the 1.5-MHz probe steered to 30°, 45°, and 60°, focused at a depth of 36 mm

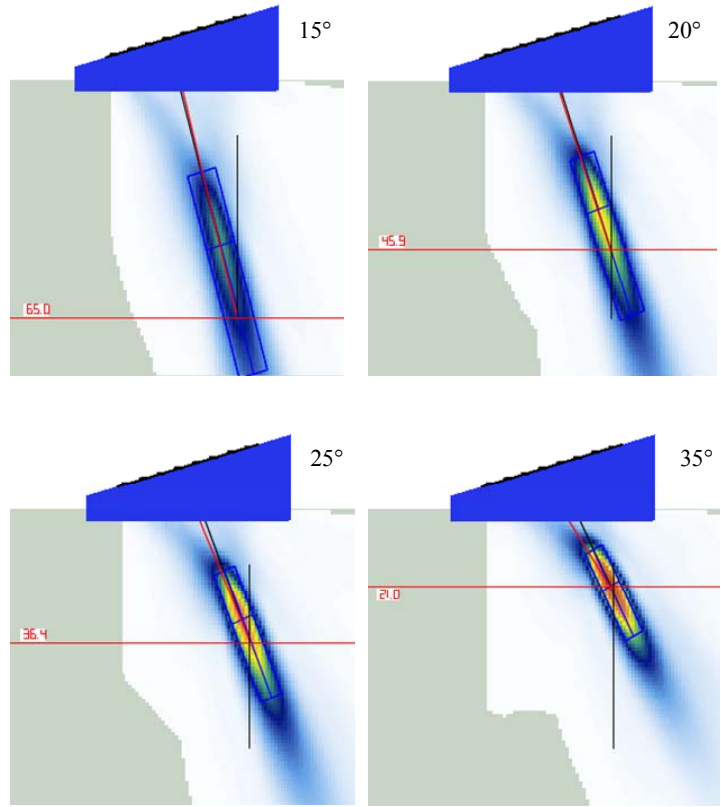
Figure 5.8. Simulated Sound Fields for the Receiver Focused 0.5 Inches under the Front of the Wedge

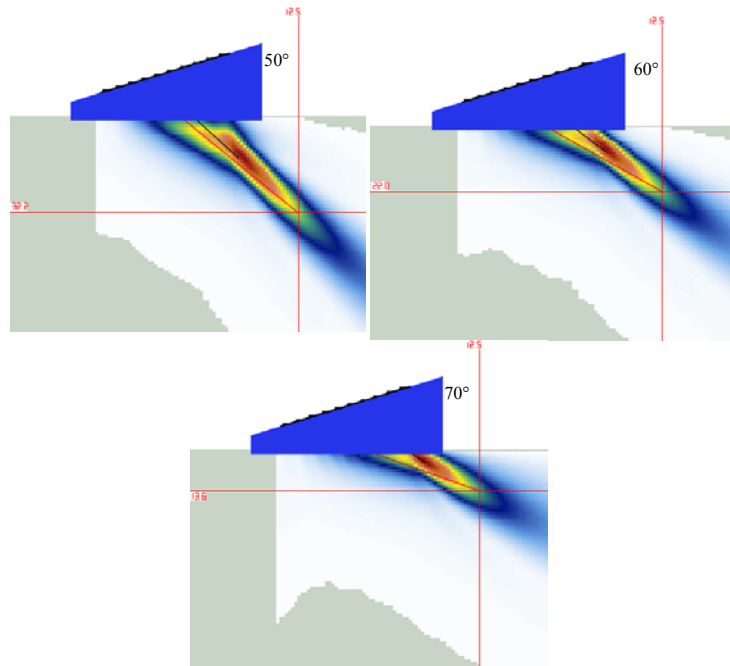
Figure 5.9. Simulated Sound Fields for the Transmitter Focused 0.5 Inch in Front of the Wedge

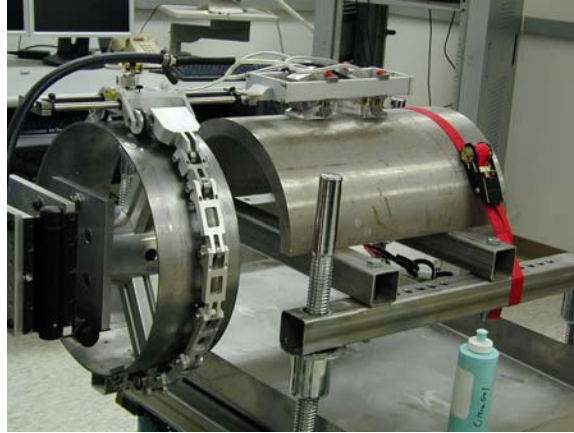
Figure 6.3. Photograph of Delta-Technique Configuration Just Prior to Scanning

The delta technique setup includes configuring two 800-kHz phased array probes in an arrangement similar to that of a TOFD method, where transmit and receive transducers are oriented opposite and facing each other, with some separation distance. This system required the use of one of the previously used 800-kHz transducers (with 5×10 elements) to serve as the transmit transducer and the new 800-kHz probe (with 8×8 elements) that acted as the receive transducer. Both transducers were machined to conform to the surge line diameter, and mounted into a custom designed chassis shown earlier in Figure 5.5 and in Figure 6.3 on the notched specimen.

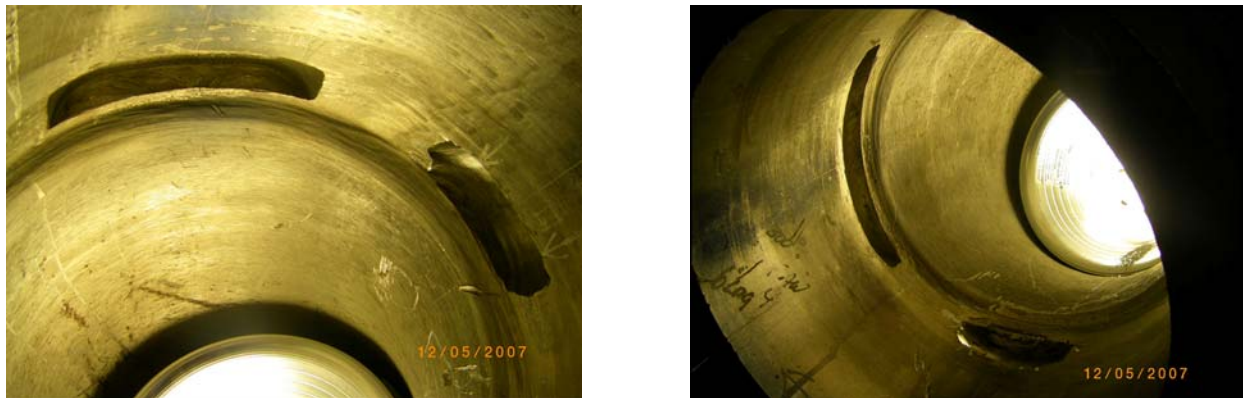
Figure 7.1. Photographs of the Inside Surface of the CASS PZR Surge-Line After Excavation and Preparation of the Areas Targeted for Flaw Implantation (courtesy of FlawTech[®], Inc.)

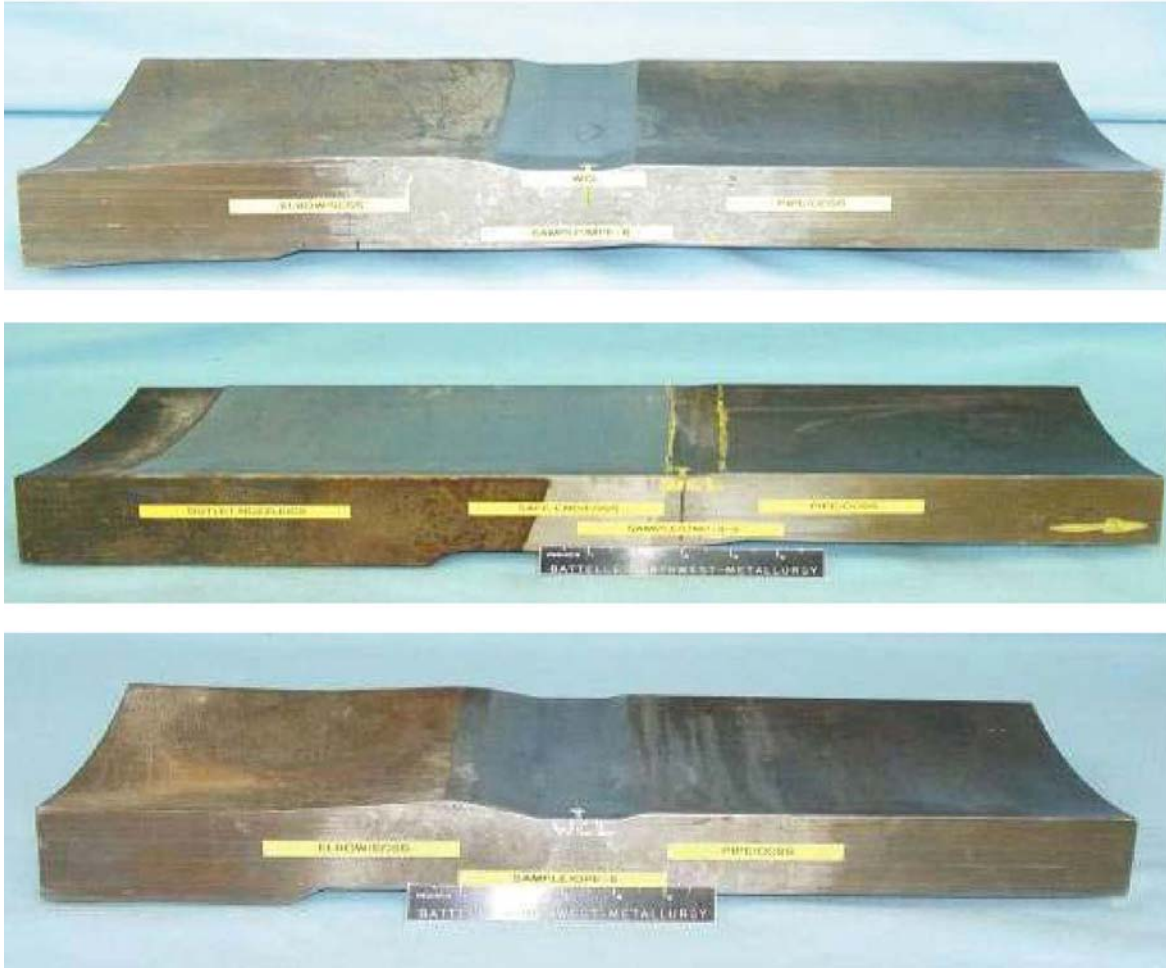
Figure 7.2. Photographs of the Three WOG Specimens Examined – (top): WOG specimen MPE-6; (center): WOG specimen ONP-3-5; (bottom): WOG specimen OPE-5

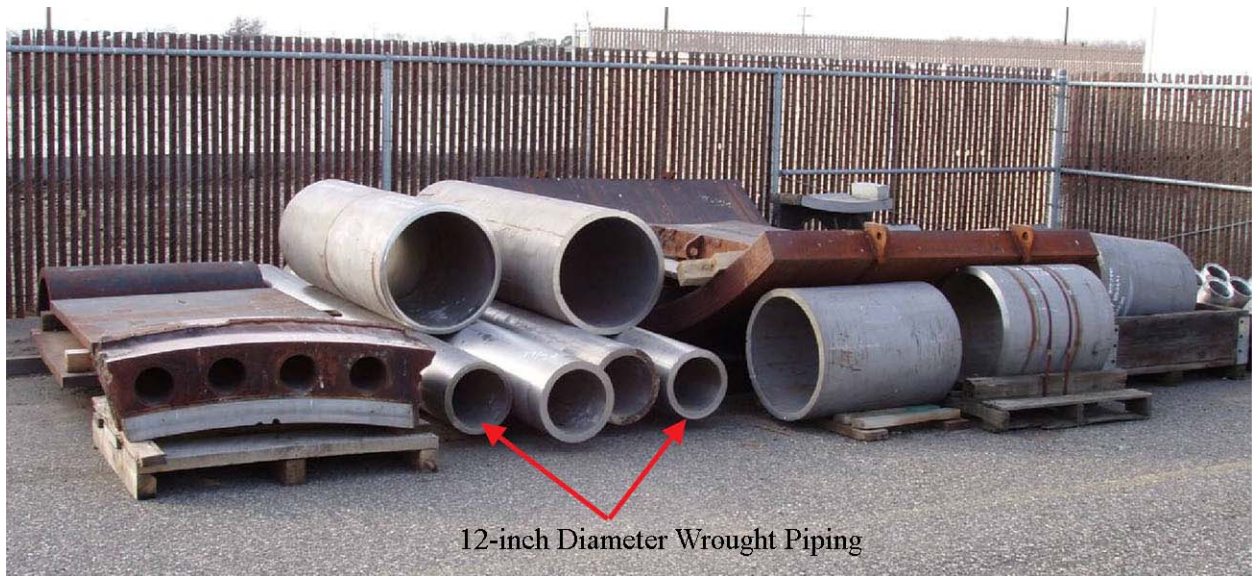
Figure 7.3. Photographs of the WSS Parent Material from which the Two Calibration Coupons (with EDM notches) were Extracted

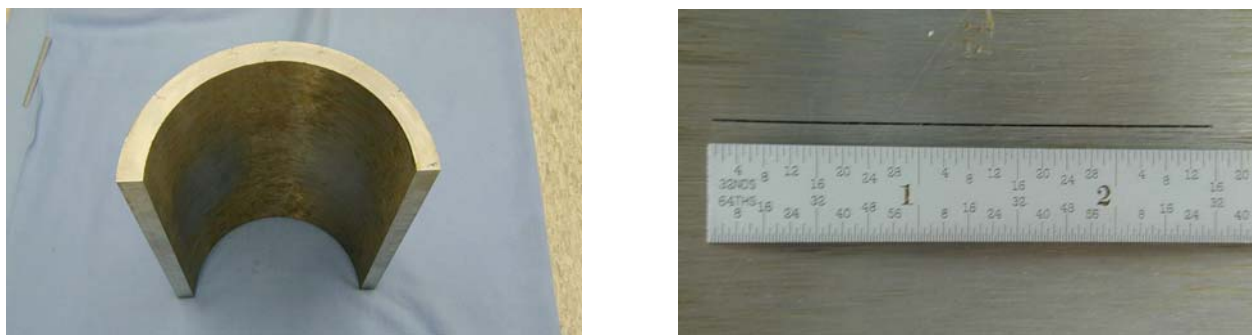
Figure 7.4. Photographs of the End View and ID Surface View for One of the WSS Coupons with EDM Notches, Used for Evaluation and Baseline Measurements of the PA Delta-Technique

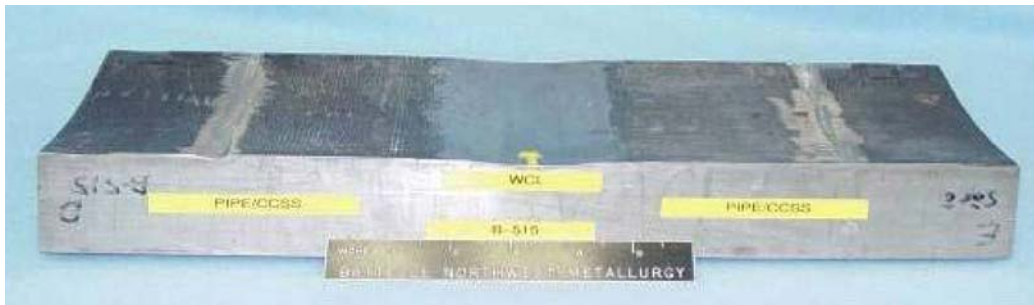
Figure 7.5. Photograph of PNNL CASS Specimen B-515

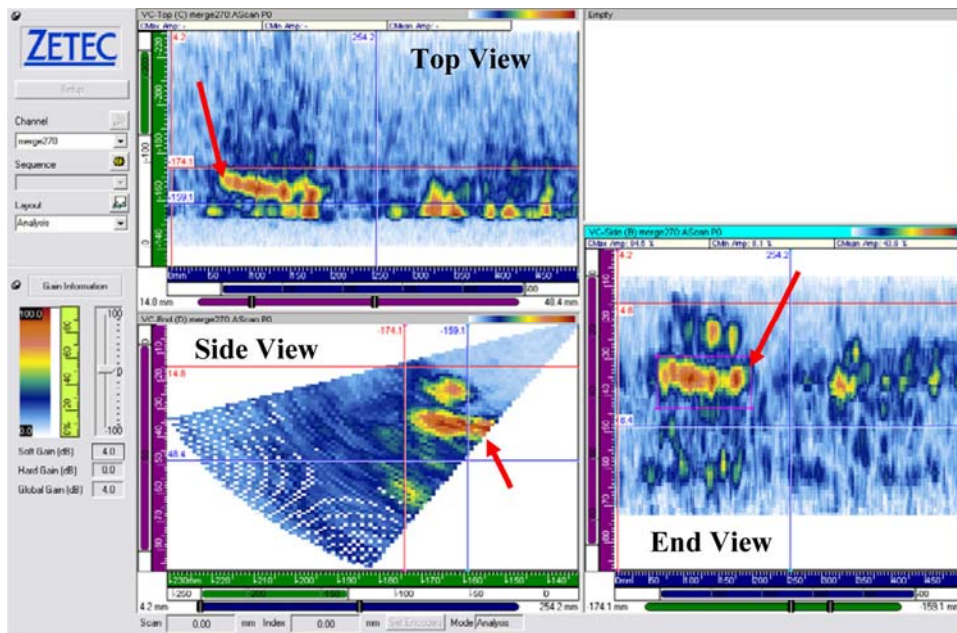
Figure 8.1. PZR Surge Line Flaw 1 from the CCSS Pipe Side at an Axial Position of -130 mm and at 800 kHz. The corner signal is identified with arrows.

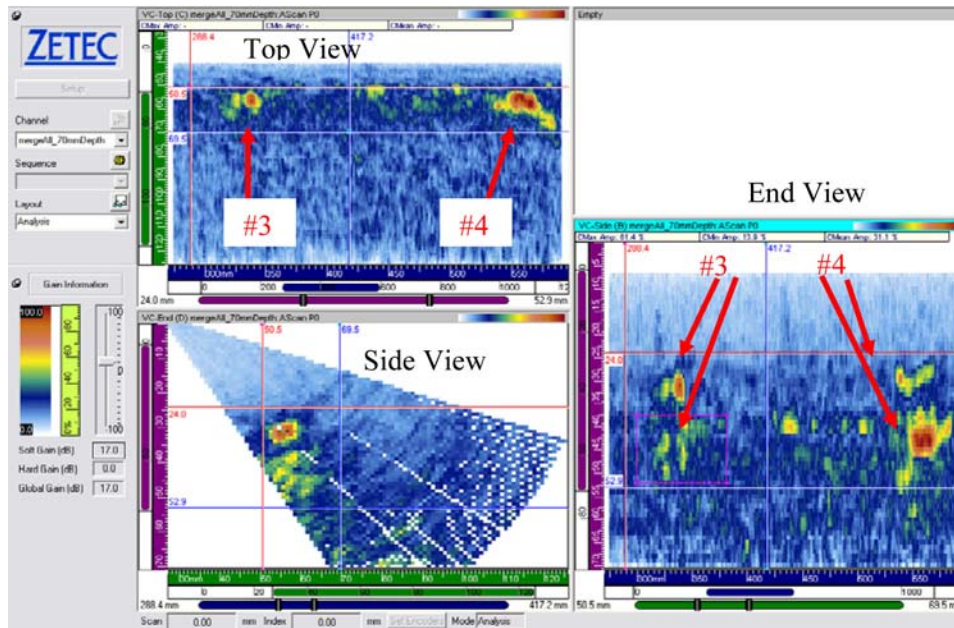
Figure 8.3. A Strong Corner Response from Flaw 4 is Shown in the Data and is More Typical of Flaw Responses. Flaw 3 has a strong top of flaw signal and exhibits a weaker corner signal.

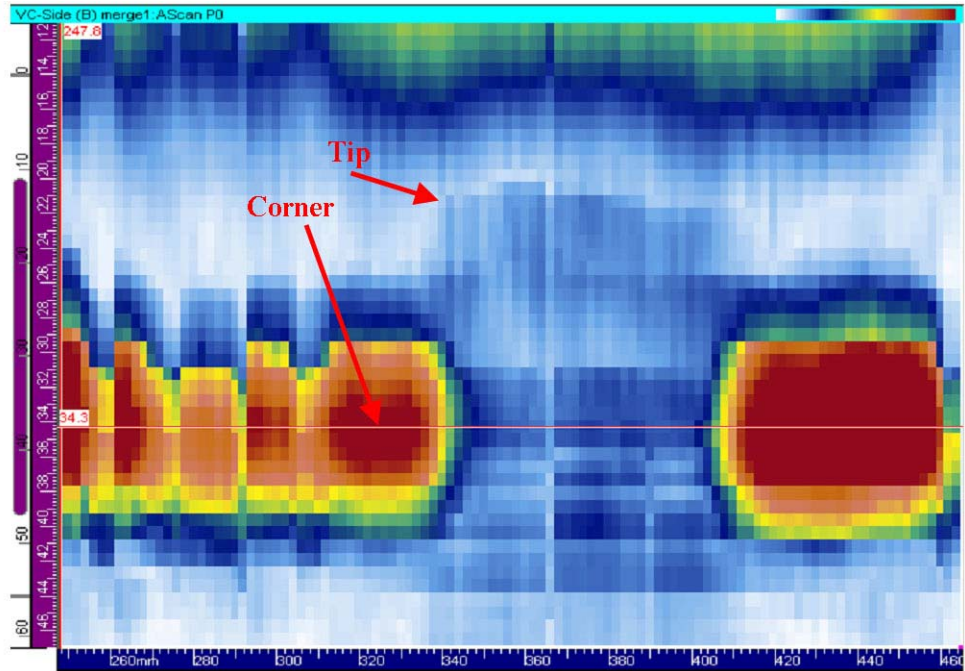
Figure 10.4. End-view from the Wrought Stainless Steel 40% EDM Notch Scan. The tip diffracted and backwall signals are marked. Notice the lack of backwall signal in the flaw area.

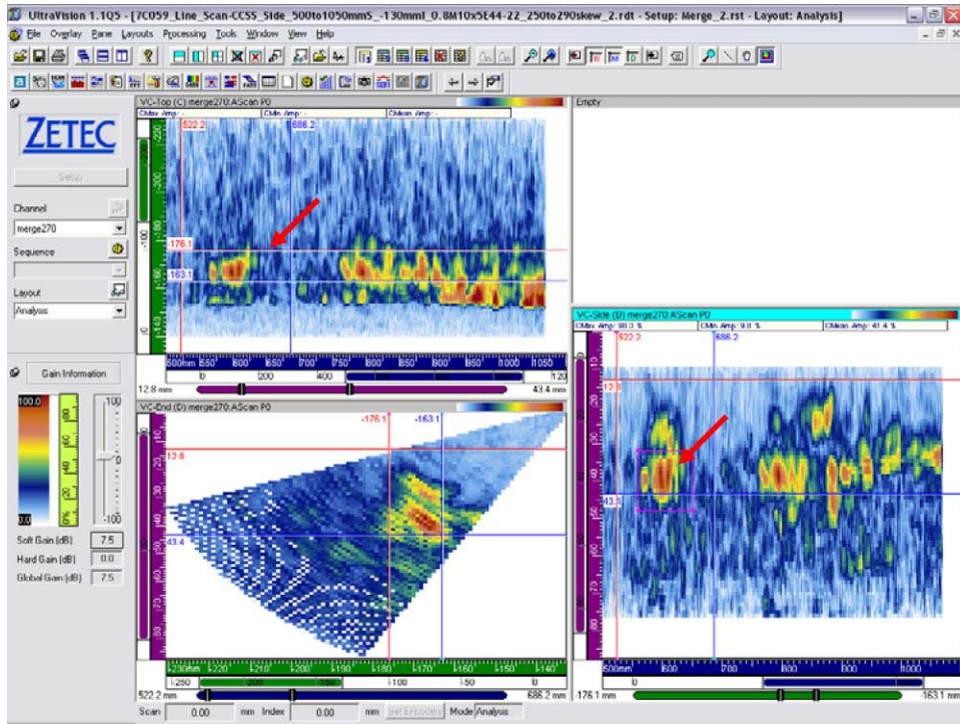
Figure A.5. Surge Line Flow 3 from the CCSS Pipe Side at 800 kHz and an Axial Position of -130 mm

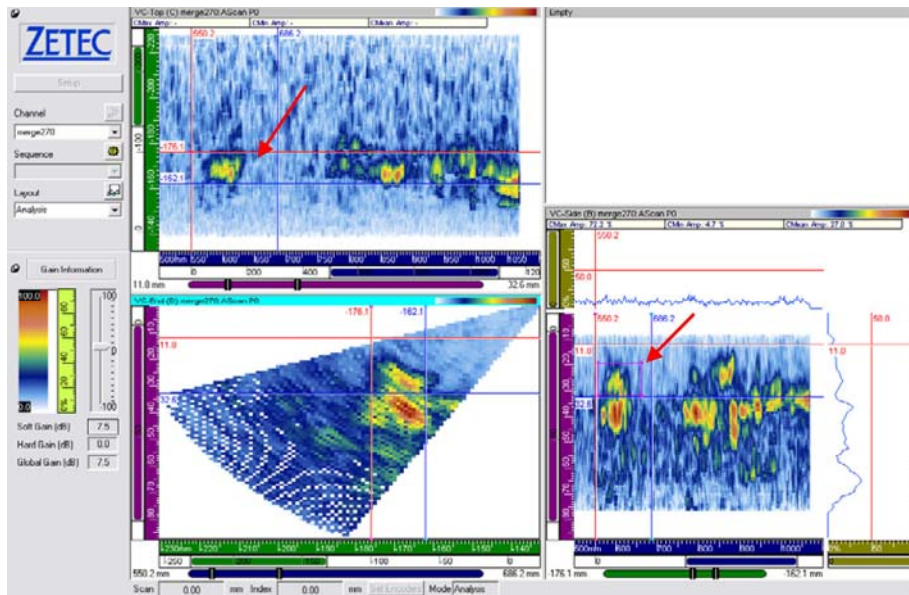
Figure A.6. Surge Line Flow 3 from the CCSS Pipe Side at 800 kHz and an Axial Position of -130 mm. The upper portion of the flaw is boxed and isolated in the C-scan, top view.

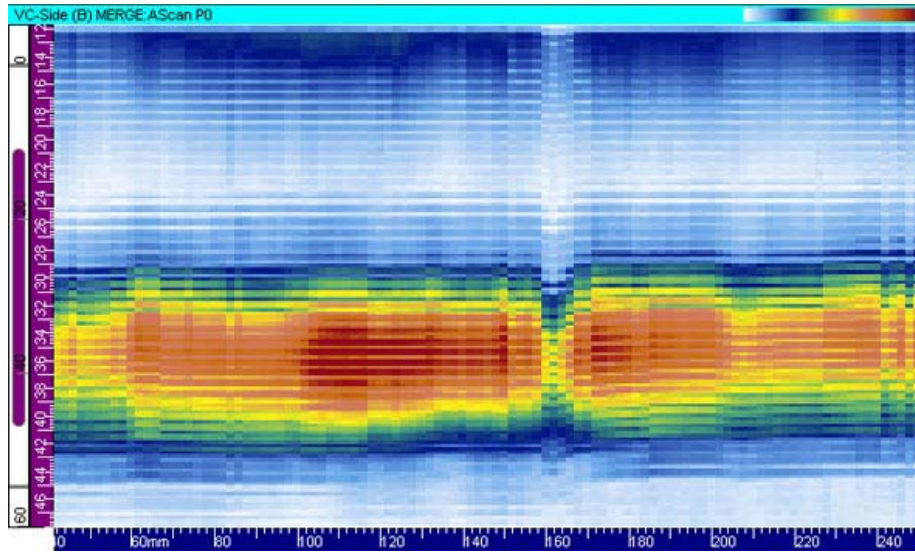
Figure D.3. Wrought Stainless, 10% Through-Wall EDM Notch (not detected)

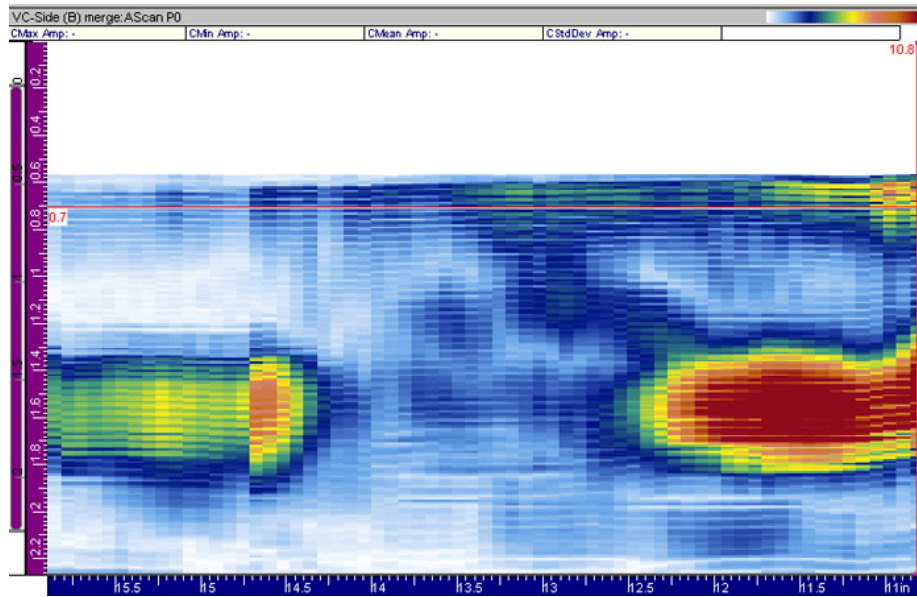
Figure D.5. Pressurizer Surge Line, Flaw 2
