# Reaching for Peak Performance in Existing Homes – A Cold Climate Study With Synergy Construction

C. Gates and R. Osser  
*Building Science Corporation*

December 2011

## Reaching for Peak Performance in Existing Homes – A Cold Climate Study With Synergy Construction

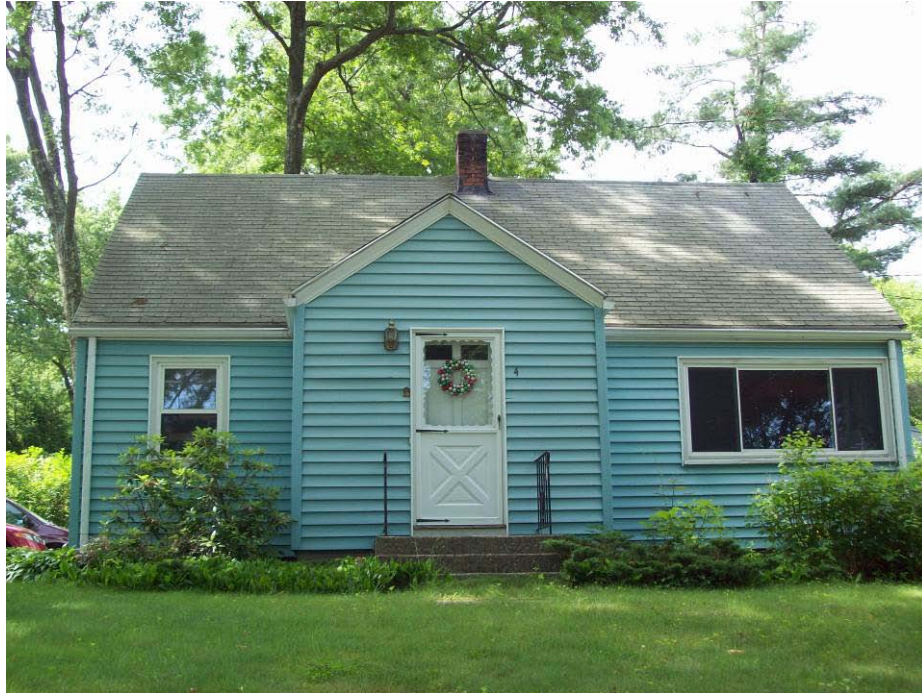
**Figure 1. Pre-retrofit Millbury Cape located in Millbury, Massachusetts**

Test Home 8.1a ("Millbury Cape") is a small, sturdily built Cape Cod-style house built in the 1950s in a neighborhood of many similar houses. There are many such neighborhoods in the New England area as well as in other parts of the United States. The occupants of these houses are often young families, or older couples whose children have left home ("empty nesters"). Particularly in the latter case, these families do not want to leave the neighborhood, but are concerned about being able to afford the increasing costs of energy.

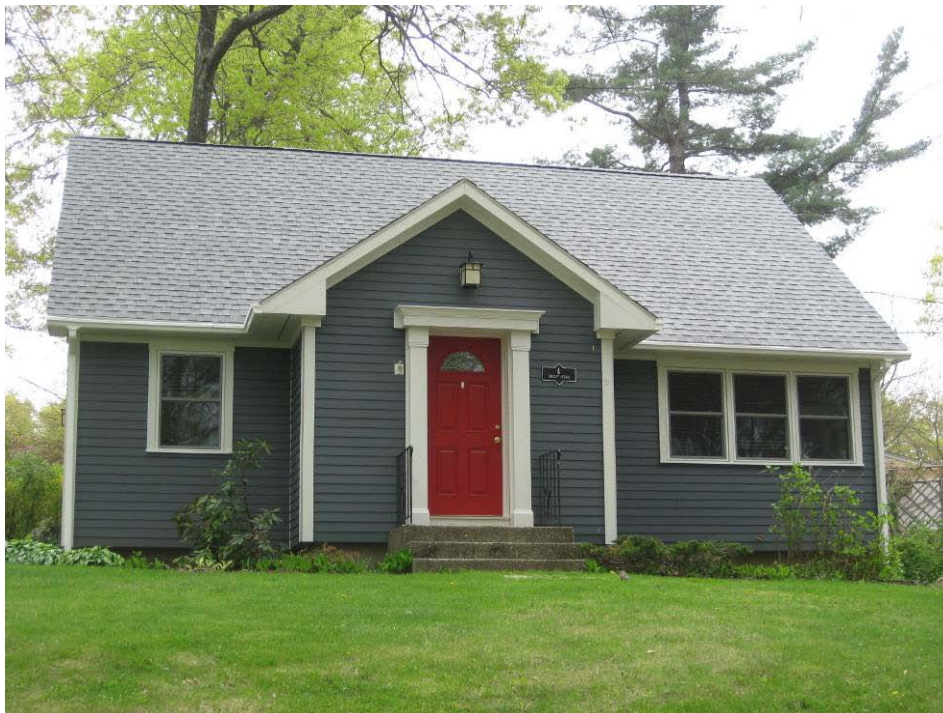
**Figure 2. Post-retrofit Millbury Cape**

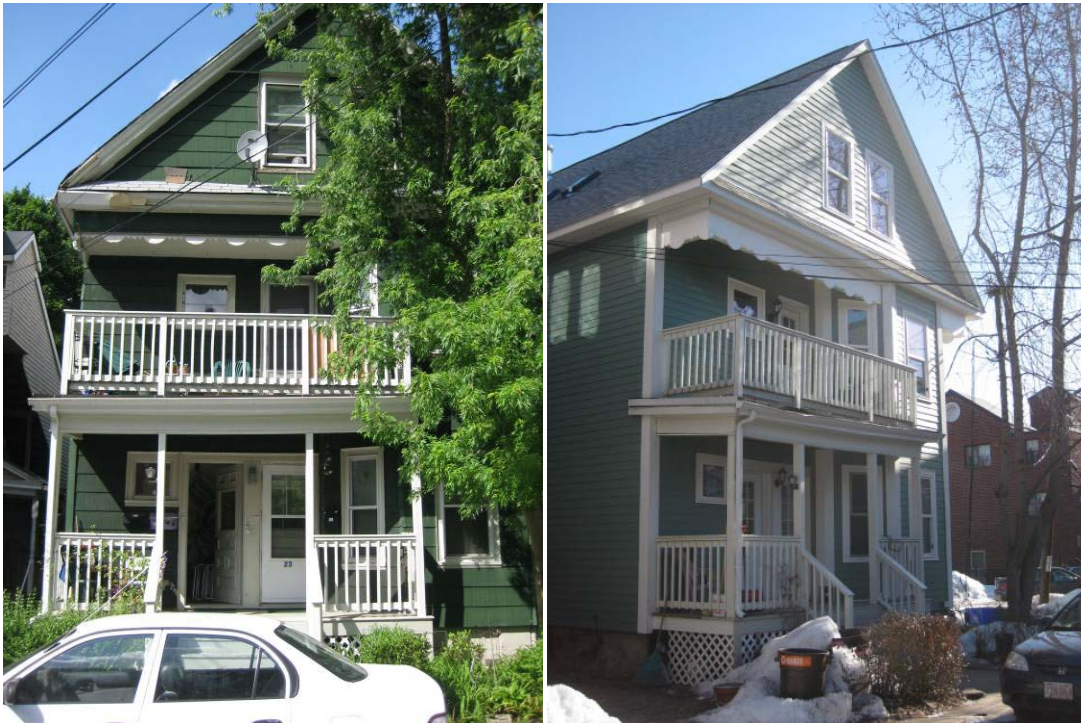
**Figure 3. Pre- (left) and post- (right) retrofit Triple Decker located in Somerville, Massachusetts**

The 8.1b Test Home (“Somerville Triple Decker”) is a triple decker multifamily wood-framed building typical of New England, circa 1920. Thousands of these homes were built to house new immigrants and other workers in the early 1900s, efficiently sharing the cost of land, roofing, and foundation among the occupants (Irving 2011). These homes are frequently owned by one occupant and rented to others, sometimes to extended family. These aging original New England triple deckers will continue to need renovations for which this Somerville test home may serve as an example.

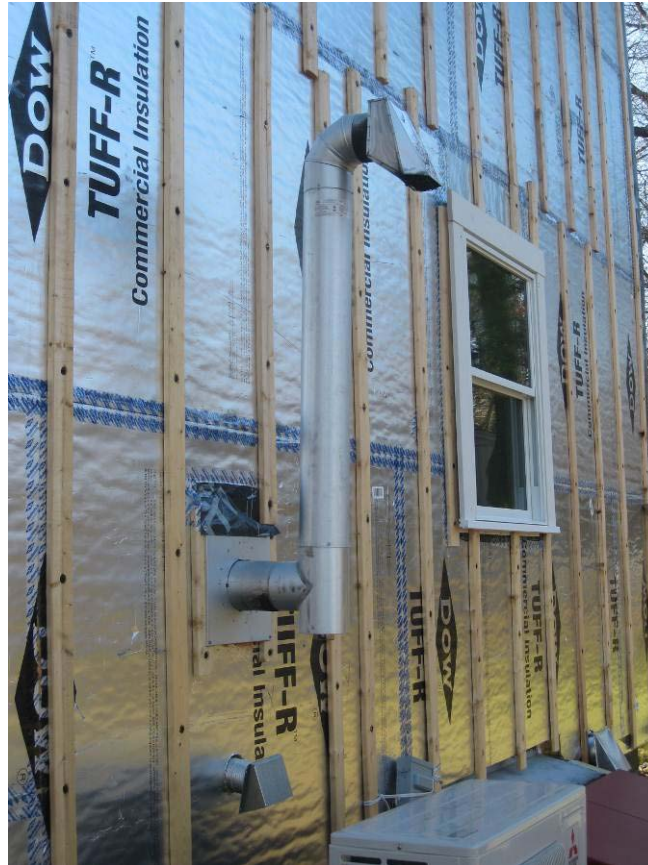
**Figure 6. Insulating sheathing on the Millbury Cape**

- Vertical wood strapping was applied over the insulating sheathing and attached to the wall studs using long screws (Figure 6).
- Fiber cement lap siding was attached to the wood strapping.
- Wall cavity insulation was added as needed.

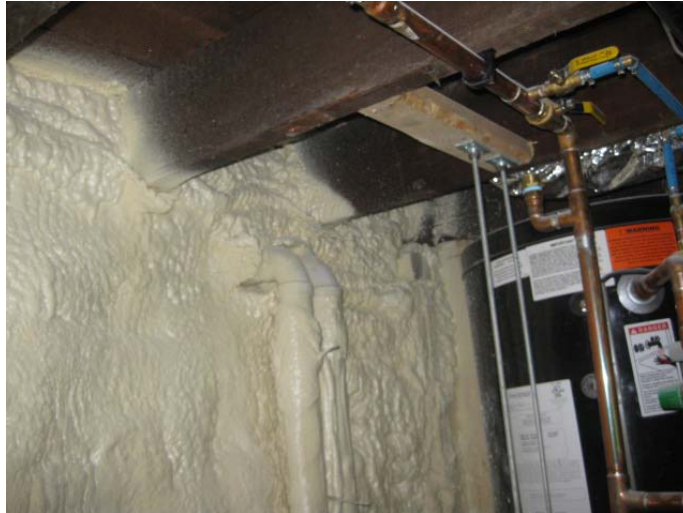
**Figure 8. Somerville Triple Decker basement wall insulation before application of ignition barrier**

- 3 in. of polyisocyanurate insulation board was applied to the interior side of the foundation wall.
- Closed cell spray foam was applied along the top of the foundation wall covering the rim joist.
- For the Millbury Cape, the spray foam was used to establish the continuity of the thermal layer and of the air barrier between the above-grade walls and the foundation walls (BSC 2009e).
- The Somerville Triple Decker has a parged rubble stone foundation wall with brick at the top. The foundation wall treatment was as follows (from exterior to interior):
  - A drainage mesh was applied over the interior side of the foundation wall;
  - 3 in. of closed cell spray foam was applied over this and extended up to the bottom of the subfloor above (Figure 8);
  - An ignition barrier paint was applied over the spray foam.

The drainage mesh applied to the foundation wall for the Somerville Triple Decker is part of the water management system. Its purpose is to direct any water that passes through the foundation wall down below the floor. Because water does not pass through the closed cell spray foam, it would have sufficed to apply the drainage mesh just at the bottom of the wall. If the drainage mesh is extended up the wall, as in this case, it should not cover any wood framing.

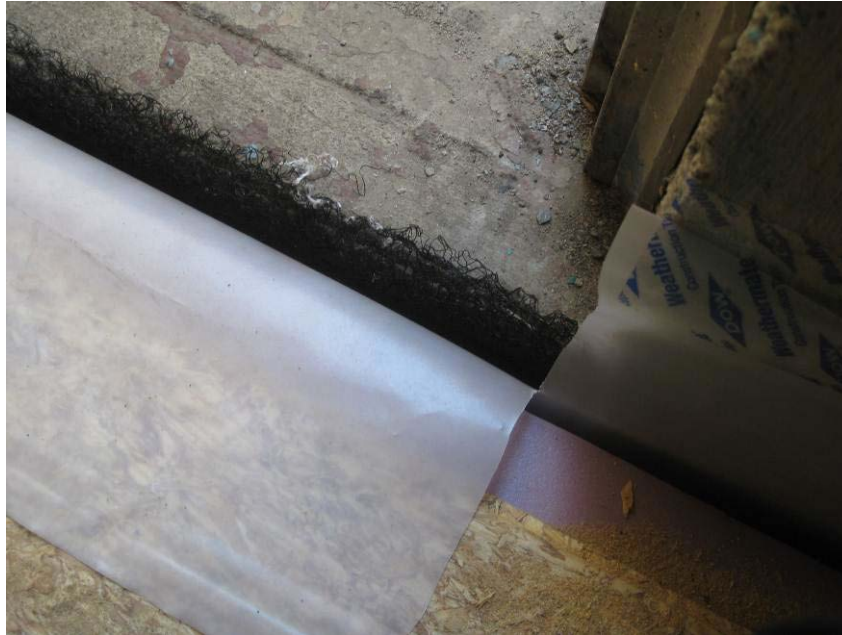
**Figure 9. Millbury Cape basement floor construction**

- Existing concrete slab
- Drainage mesh
- 2-in. layer of extruded polystyrene (XPS) with seams taped to create an air barrier
- Vapor barrier of polyethylene
- Floating oriented strand board subfloor.
- The drainage mesh in this assembly for the Millbury Cape provides some storage capacity for any water that does get through the foundation walls (Figure 9).

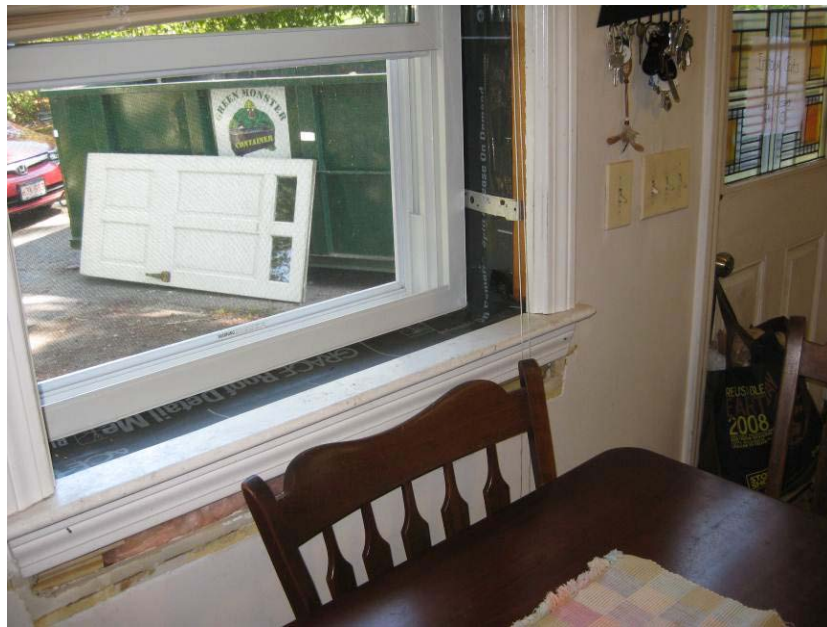
**Figure 11. Millbury Cape “outie” windows**

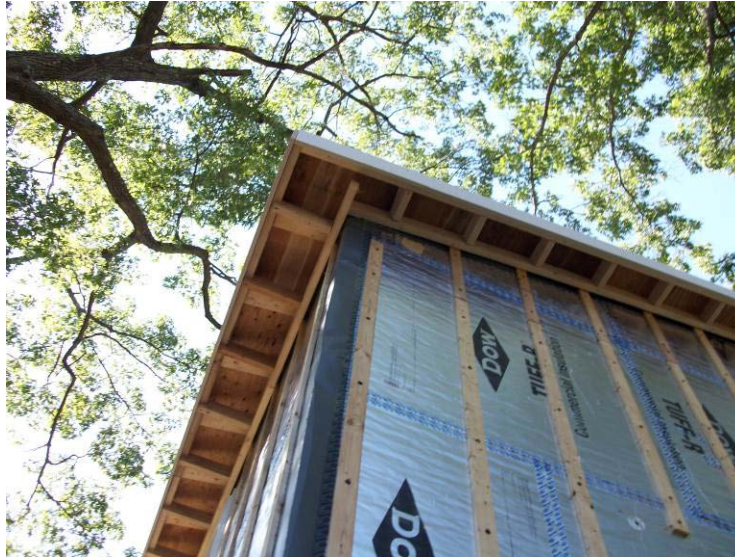
**Figure 12. The Millbury Cape eave and rake overhang**

For the roof assemblies of both houses, the ice and water shield underlayment over the plywood sheathing provides water management and the eave overhangs extend the system beyond the roof/wall intersection. The Millbury Cape did not originally have sufficient overhangs to protect the walls, and existing water damage was discovered during the construction. As part of the retrofit, new overhangs and rakes were attached to the house after the exterior insulation layers had been applied to the roof and walls (Figure 12). For the Somerville Triple Decker, the existing overhangs were generally deep enough to cover the thicker walls, though a rafter extension was applied in certain portions of the eaves where more depth was desired.

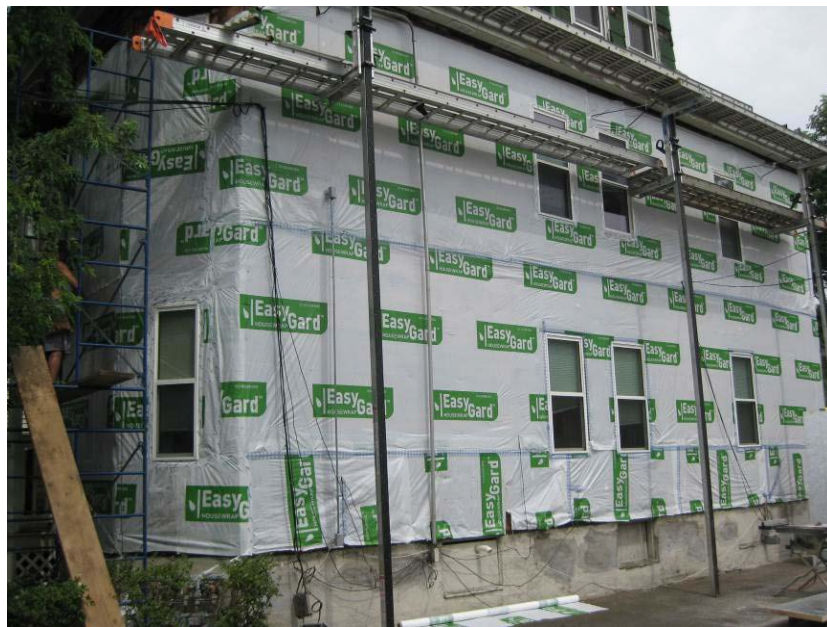
**Figure 13. Somerville Triple Decker exterior wall air barrier**

The transition between the roof and exterior wall was sealed by extending the roofing membrane down and sealing it onto the wall house wrap—this was possible as there were no overhangs or eaves. The transition between the above-grade wall house wrap and the interior insulation on the foundation wall was accomplished by applying closed cell spray foam on the interior of the rim joist and sill plate and by sealing the bottom of the wall sheathing to the outside of the foundation wall. An application of sealant in the seam between the foundation wall and the basement floor transitions the air barrier between the foundation wall and basement floor. Sealant applied around the outer frame of the windows and doors established a connection between the doors and windows and the wall air barrier.

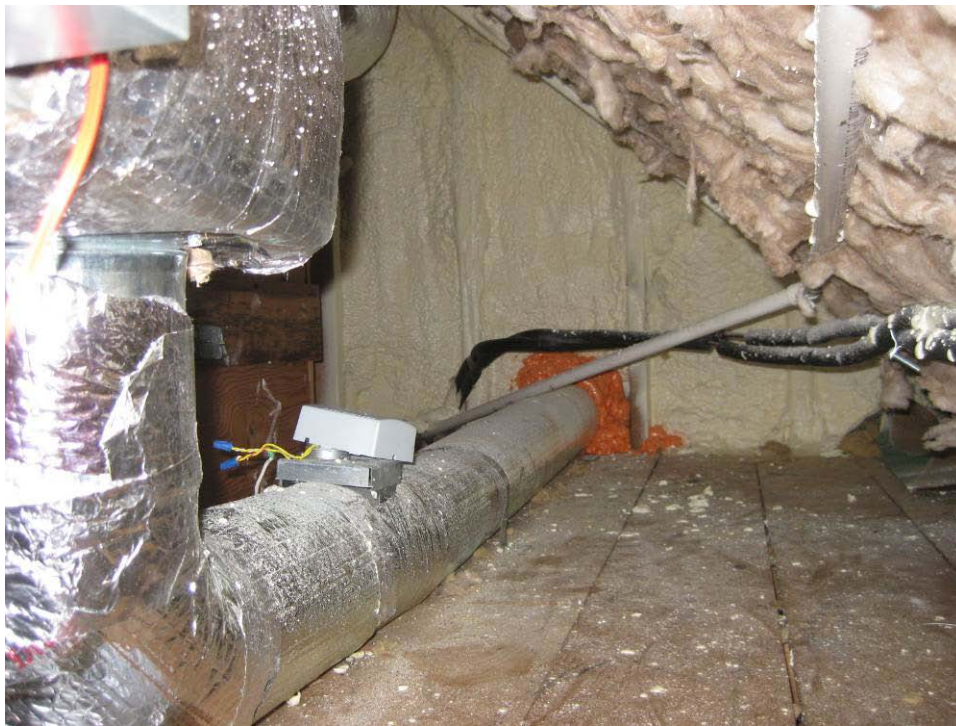
**Figure 14. Millbury Cape ventilation system in kneewall**

Ventilation is integrated with each air handler using a 6-in. outdoor air supply duct connected to the return side of the air handler with a motorized damper, connected to a fan cycling control (Figure 14). The fan cycling control ensures that the fan runs a programmed minimum amount of time to provide sufficient supply ventilation air, which is in turn distributed to the indoor spaces using the air handler's duct system. The motorized damper in the outdoor air supply duct is controlled by the fan cycling control to prevent over ventilation during times of significant space conditioning demands (BSC 2009g).

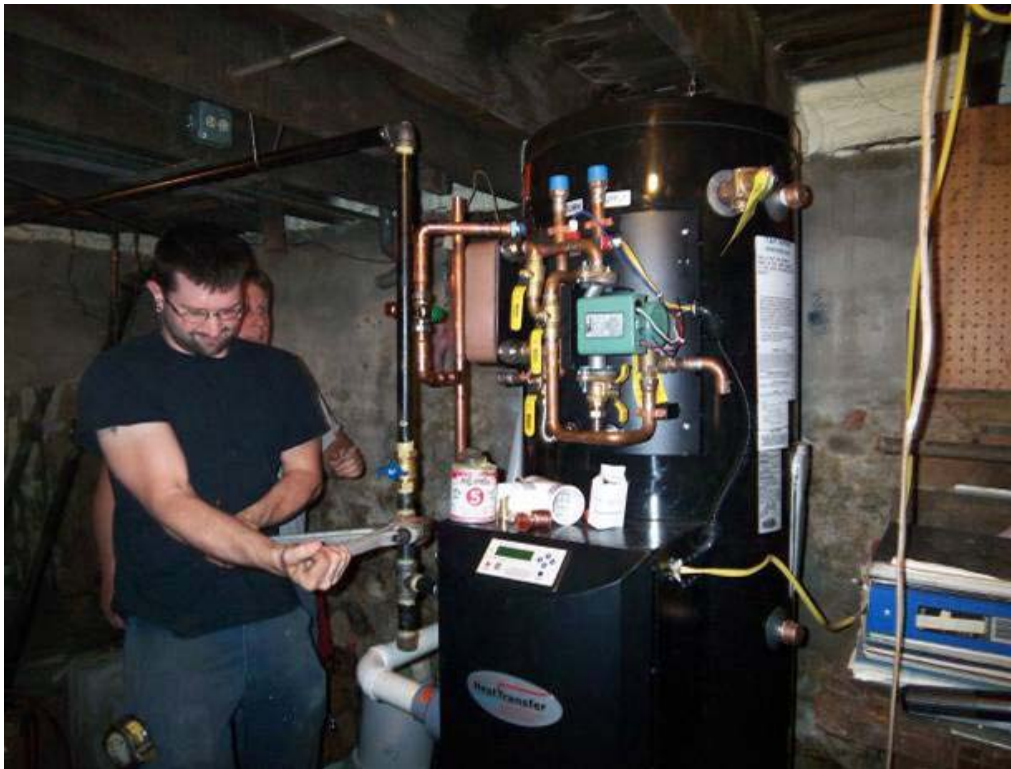
**Figure 15. Somerville Triple Decker Phoenix Versa Hydro installation. Photo used with permission from homeowner.**

For the final design, the project team elected to consolidate the space and DHW by replacing the furnaces, boiler, and water heaters with a single 80 gallon Phoenix Versa Hydro unit (Figure 15). The Versa Hydro is a modulating and condensing system that can also be integrated with solar DHW (a future project planned by the homeowner). From the experience of BSC, it may be difficult to achieve high efficiencies (as advertised) due to flue gas condensation limits. The temperature of water in the storage tank needs to be low enough for exhaust gas condensation to occur, which means that lower DHW and heating loop temperatures are required. BSC is interested in observing the long-term performance of the system in this home.

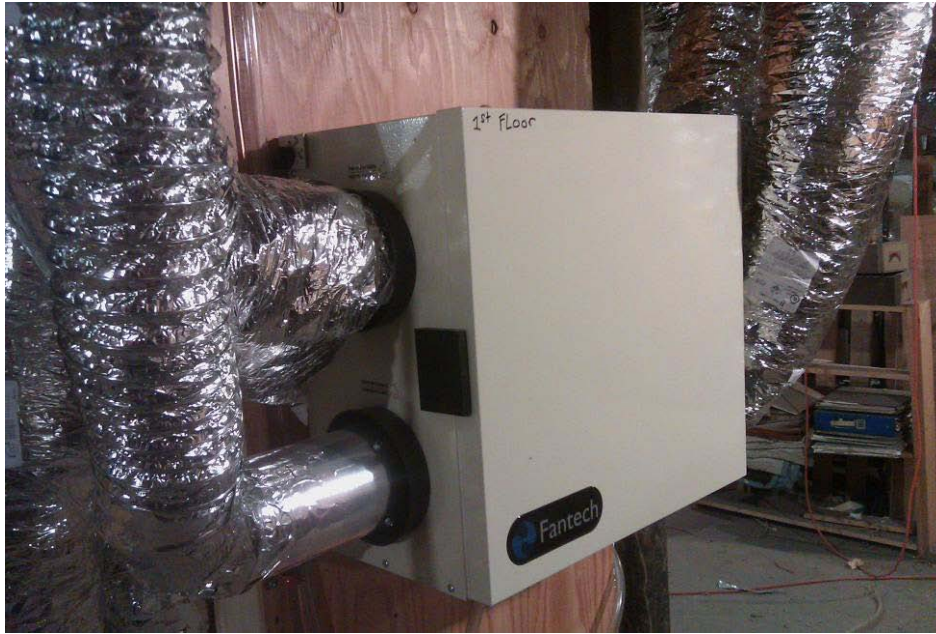
**Figure 16. Somerville Triple Decker Fantech HRV. Photo used with permission from homeowner.**

Mechanical ventilation is provided by a Fantech VH704 HRV for each apartment (Figure 16). Each is capable of supplying 67 CFM and has a rated recovery efficiency of 53%. In addition to the outside air supplied by the HRV, makeup air is supplied over the gas stove hoods in each apartment. Both the stove exhaust and the makeup air supply ducts are run through the new chase, made from the shaft formerly occupied by the chimney.

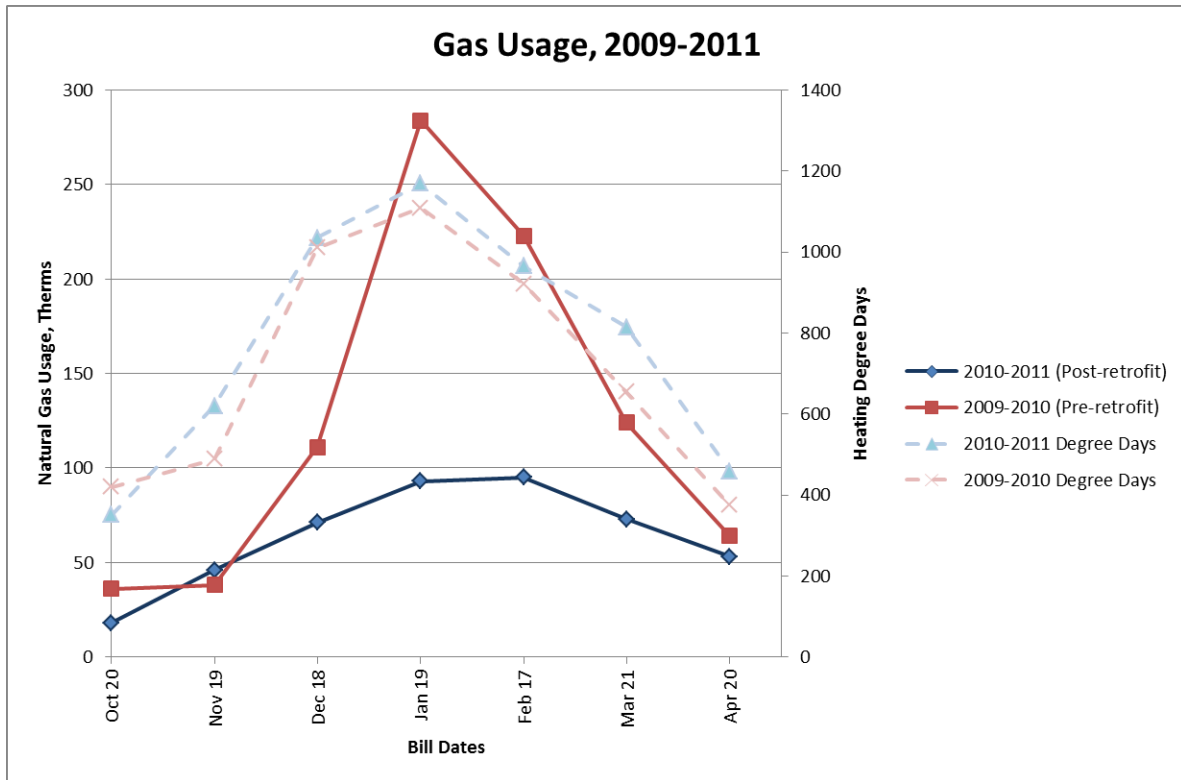
**Figure 19. Somerville Triple Decker from October to April before and after the retrofit**

Monthly utility bill data were available for the Somerville Triple Decker, allowing energy usage from before and after the retrofit to be graphed by month. As the Somerville Triple Decker is a three-family home, bills were collected from each of the three apartments and combined to plot monthly energy usage for the whole building. Heating degree days were added to the graphs to show the relationship to energy use during the two cold weather periods.

Gas usage during the two periods shows a significant decrease after the retrofit, especially considering the fact that the post-retrofit winter was colder than pre-retrofit. It is interesting to note that the difference between pre- and post-retrofit gas usage is much more extreme during colder than warmer or shoulder months.

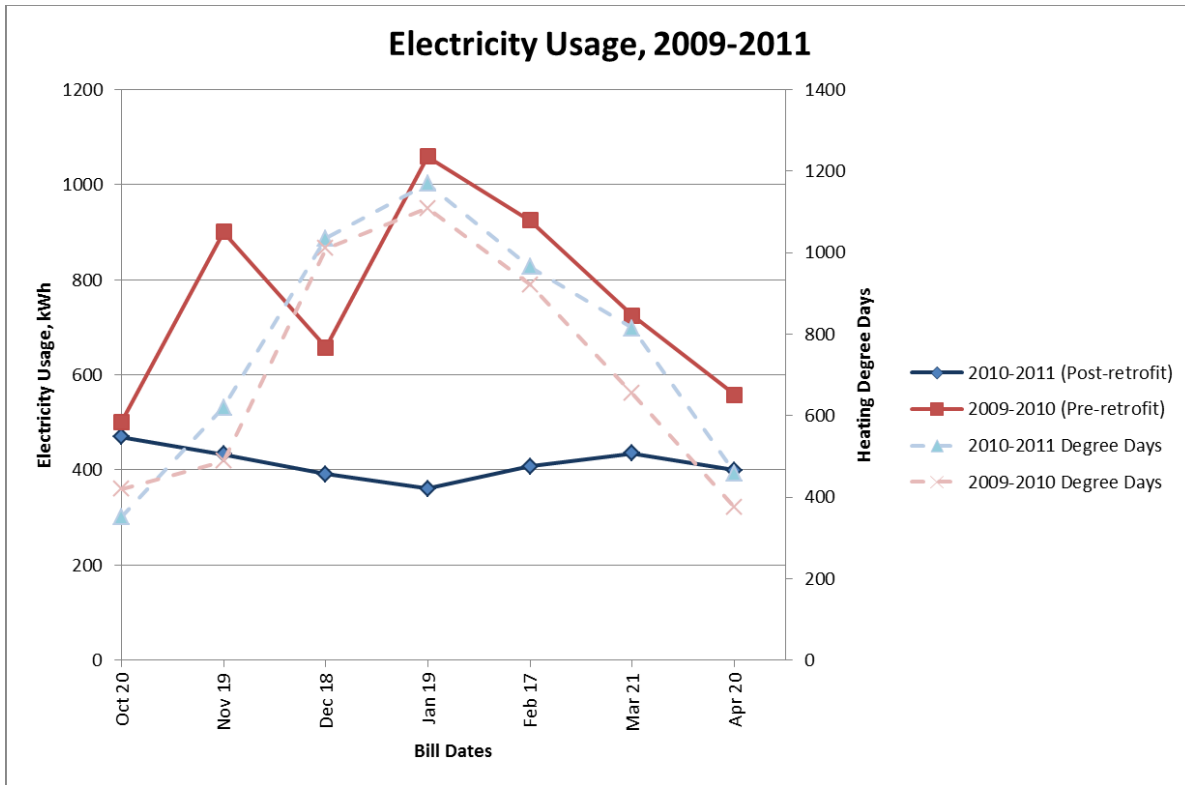
**Figure 20. Somerville Triple Decker electricity usage from October to April before and after the retrofit**

Electricity in the Somerville Triple Decker has more end uses than gas, making it more difficult to make conclusions about space conditioning savings from the retrofit. End uses such as lighting, appliances, and mechanical ventilation tend to make up a significant portion of electricity usage. When a year of post-retrofit data becomes available, the electricity usage during swing seasons (when little heating or cooling is needed) will allow base load to be determined. The base load can then be subtracted during heating and cooling seasons to determine space conditioning electricity usage. However, it should be noted that the fan energy formerly associated with the ducted hot air heating systems switched to pump energy for the post-retrofit hydronic system. In addition to the reduction of heating energy required due to the improved enclosure, this switch from fan to pump energy is a likely contributor to savings.

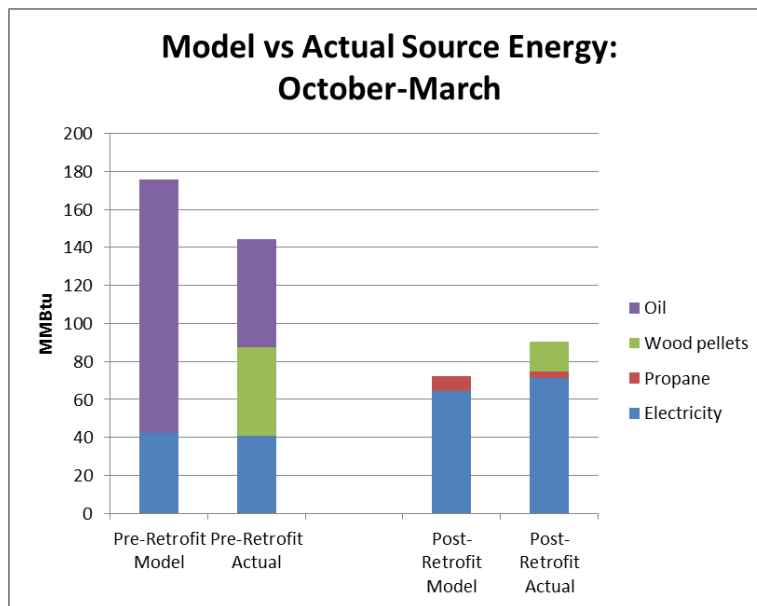
**Figure 22. Millbury Cape source energy use pre- and post-retrofit**

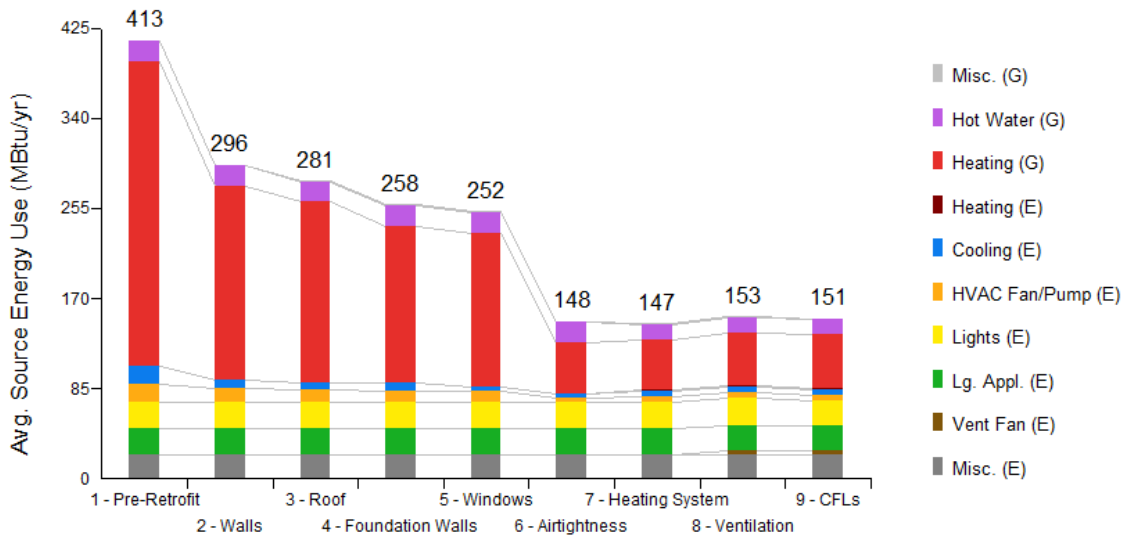
**Figure 23. BEopt incremental modeling results for the Somerville Triple Decker**

however, the resultant improvement in indoor air quality is an important benefit to the homeowner. Incremental source energy reductions with each retrofit step are shown in Figure 23.

BEopt modeling results predict a yearly source energy reduction of 63% due to the retrofit. These results are compared to yearly energy use reported by utility bills in Section 3.2. For the Somerville Triple Decker, a decision was made to compare complete years of data since a year of pre-retrofit bills was available. Additionally, the seven months of available post-retrofit bills cover the heating season in which the most effect from retrofit upgrades should be observed. This is due to the lack of an air-conditioning system upgrade and the fact that occupants report using air conditioning and the HRV extremely sparingly. The pre-retrofit utility bill summation spans the period from May 2009 to April 2010 while the post-retrofit utility bill summation spans the period from May 2010 to April 2011. During this second period of time, the retrofit measures were in place from October 2010 to April 2011. The source energy reduction reported by utility bills during these two full years is calculated at 37%.

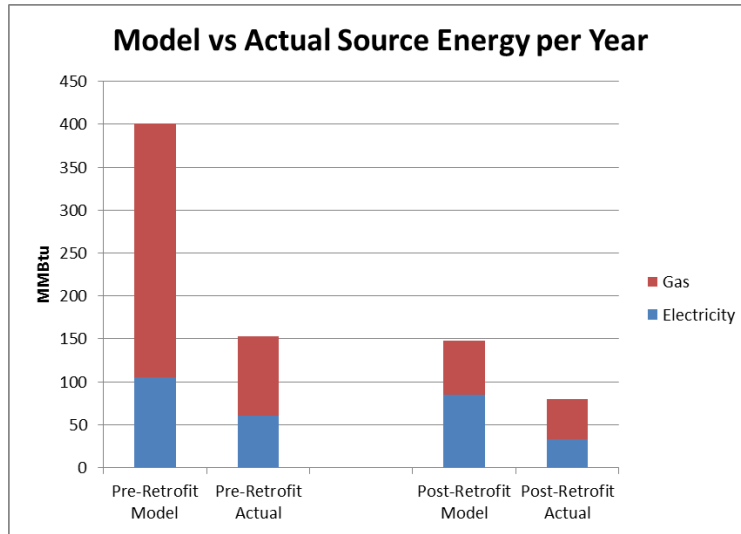
**Figure 24. Somerville Triple Decker pre- and post-retrofit source energy breakdown**

As observed in Table 15 and Figure 24, the model in all cases overpredicts energy usage compared to the values reported in occupant utility bills. In the post-retrofit case, the model overpredicts electricity usage by 20%, gas usage by 9%, and total source energy by 15%. In the pre-retrofit case, the model overpredicts electricity usage by 12%, gas usage by 65%, and total source energy by 51%. BSC and other practitioners have frequently observed such drastic modeling overpredictions of gas usage in pre-retrofit homes. The possible reasons for this observed discrepancy are an area of ongoing interest for BSC. In this case, heating was reported to have been used very sparingly before the retrofit, so average heating set point temperatures may have been significantly lower than modeled.

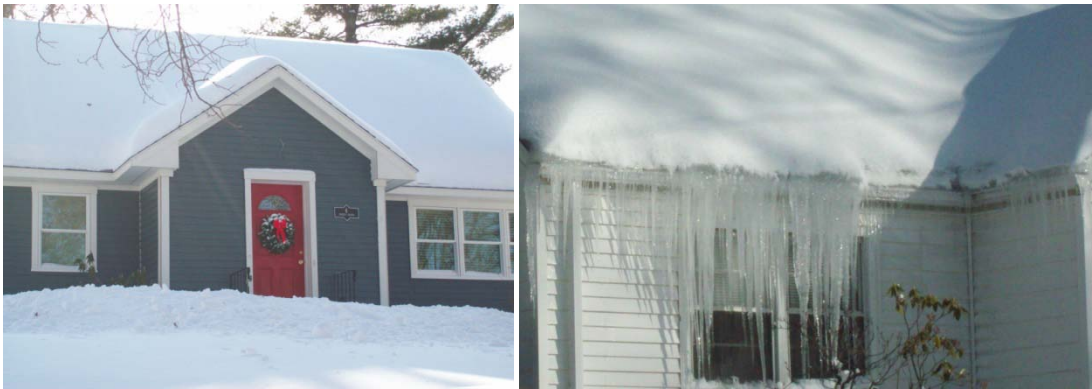
**Figure 25. Left: Post-retrofit Millbury Cape; Right: Neighbor’s home with ice dams**

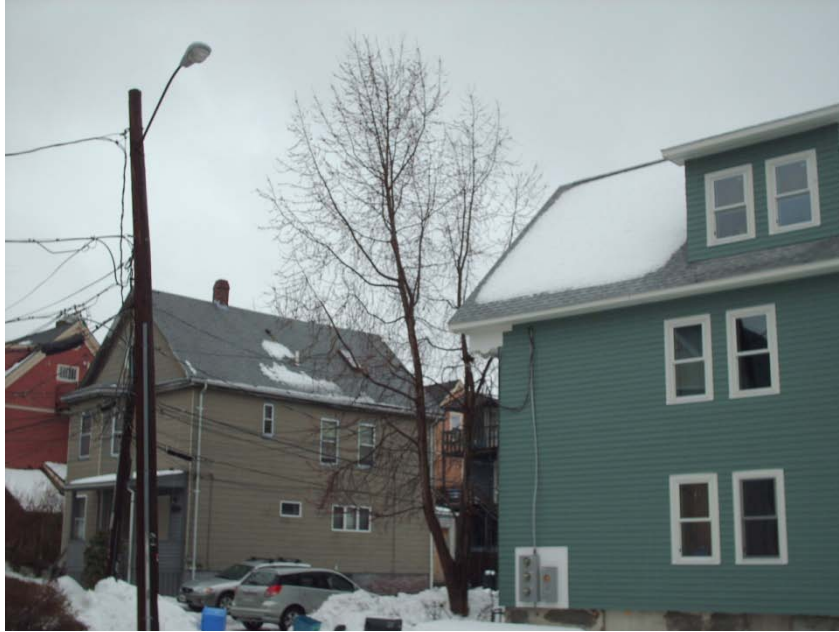
**Figure 26. Post-retrofit Somerville Triple Decker, slow snow melting and no ice dams**

In addition to interior comfort observations, the owner shared photos of the roof in winter following the retrofit and reported that few or no ice dams formed. The snow also took longer to melt than on neighboring roofs (Figure 26).

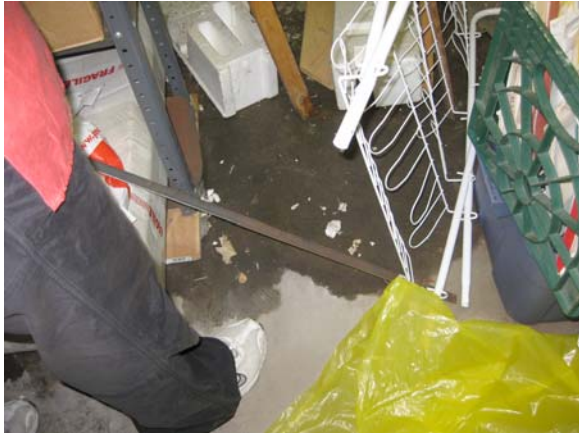
Evidence of water as well as damp surfaces were observed on both of two visits to the building.

Figure 1: Damp floor in basement storage area

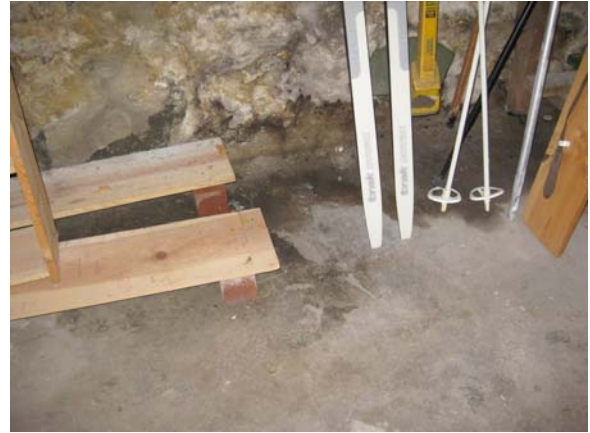
Figure 2: Damp floor and wall in basement

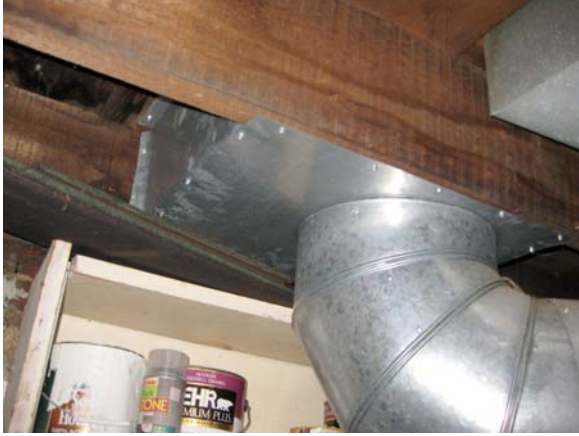
The return for this system is a panned return located at the first floor landing of the back stairs. Some of the ductwork is rusty.

Figure 3: Panned return for 2<sup>nd</sup> floor heating system

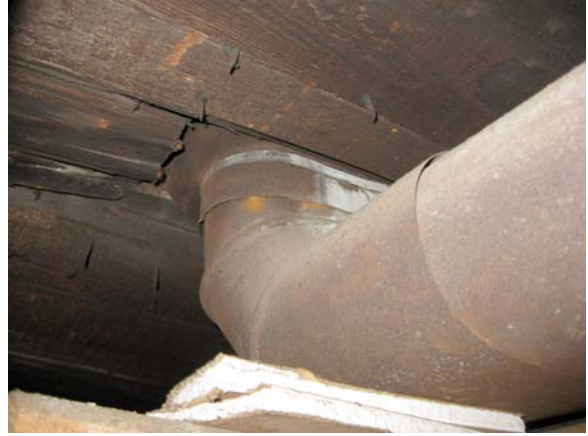
Figure 4: Supply ductwork serving 2<sup>nd</sup> floor

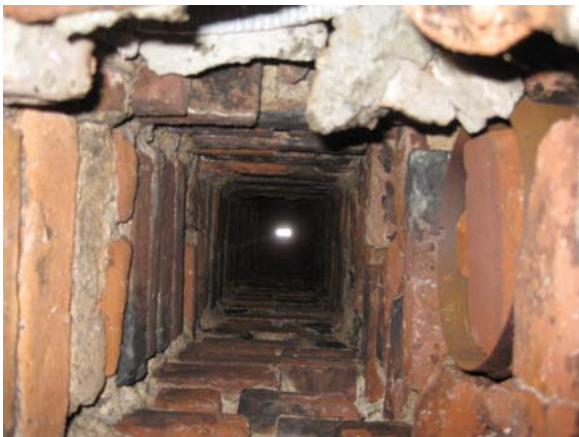
The boiler, one of the furnaces and all three of the water heaters are vented through an unlined brick chimney. Each flue in this chimney is approximately 8" square.

Figure 5: East chimney flue

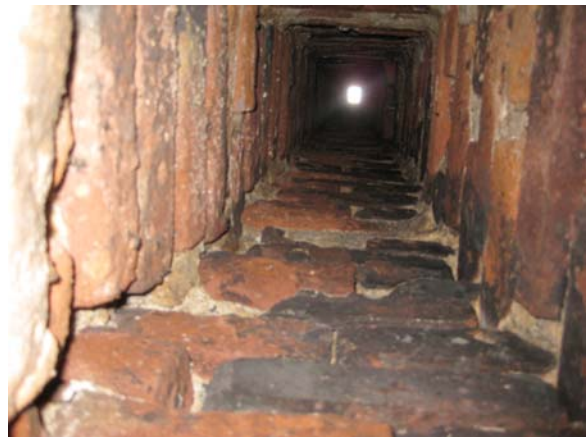
Figure 6: West chimney flue
