FINAL TEST REPORT  
MECHANICAL IRRADIATION TEST  
3/L003  
TURBOPUMP BEARING SET

Report 1. 9. 5-6E

23 April 1964

AEROJET-GENERAL CORPORATION

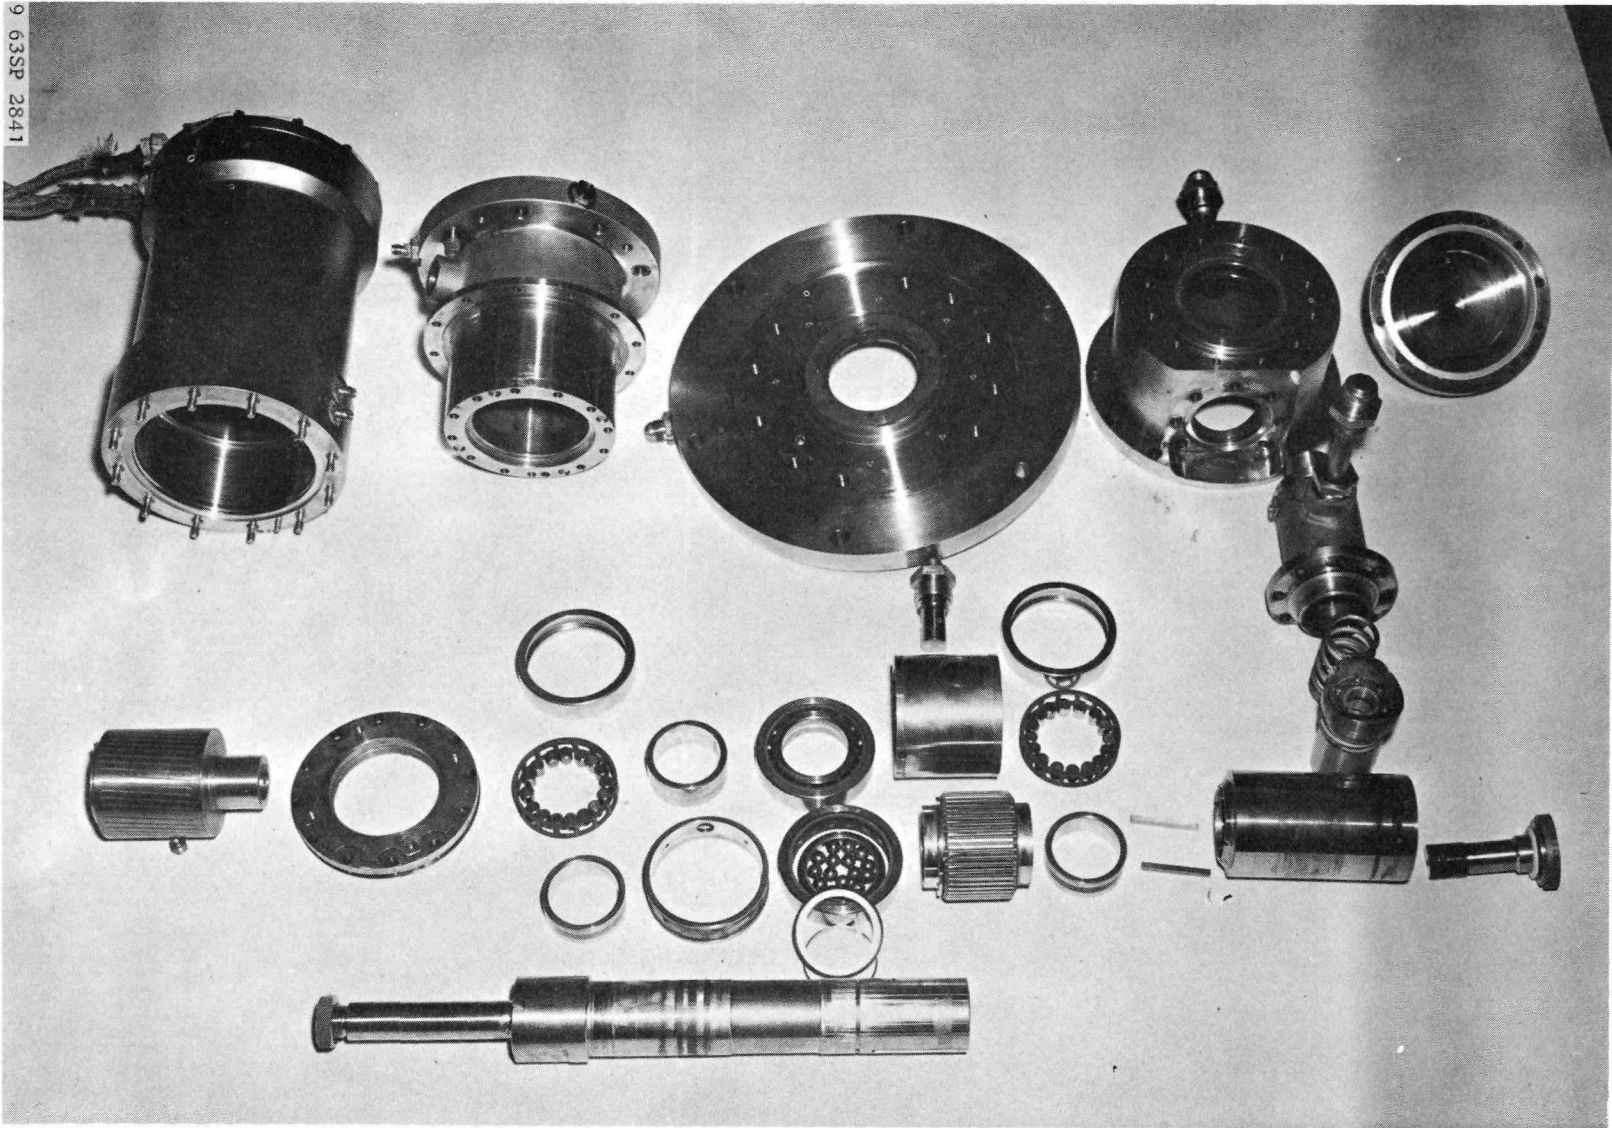
Figure A-11

Bearing Tester PN 263500-69, SN 0000004 Disassembled after Irradiation Test  
(Motor to the Left; Loading Devices to the Right)

After the bearing tester was removed from the test pallet and returned to the Aerojet-General Sacramento Plant, it was disassembled and inspected. Figure A-10 shows the tester after disassembly. Visual examination revealed that the bearings were in excellent condition (Ref 4).

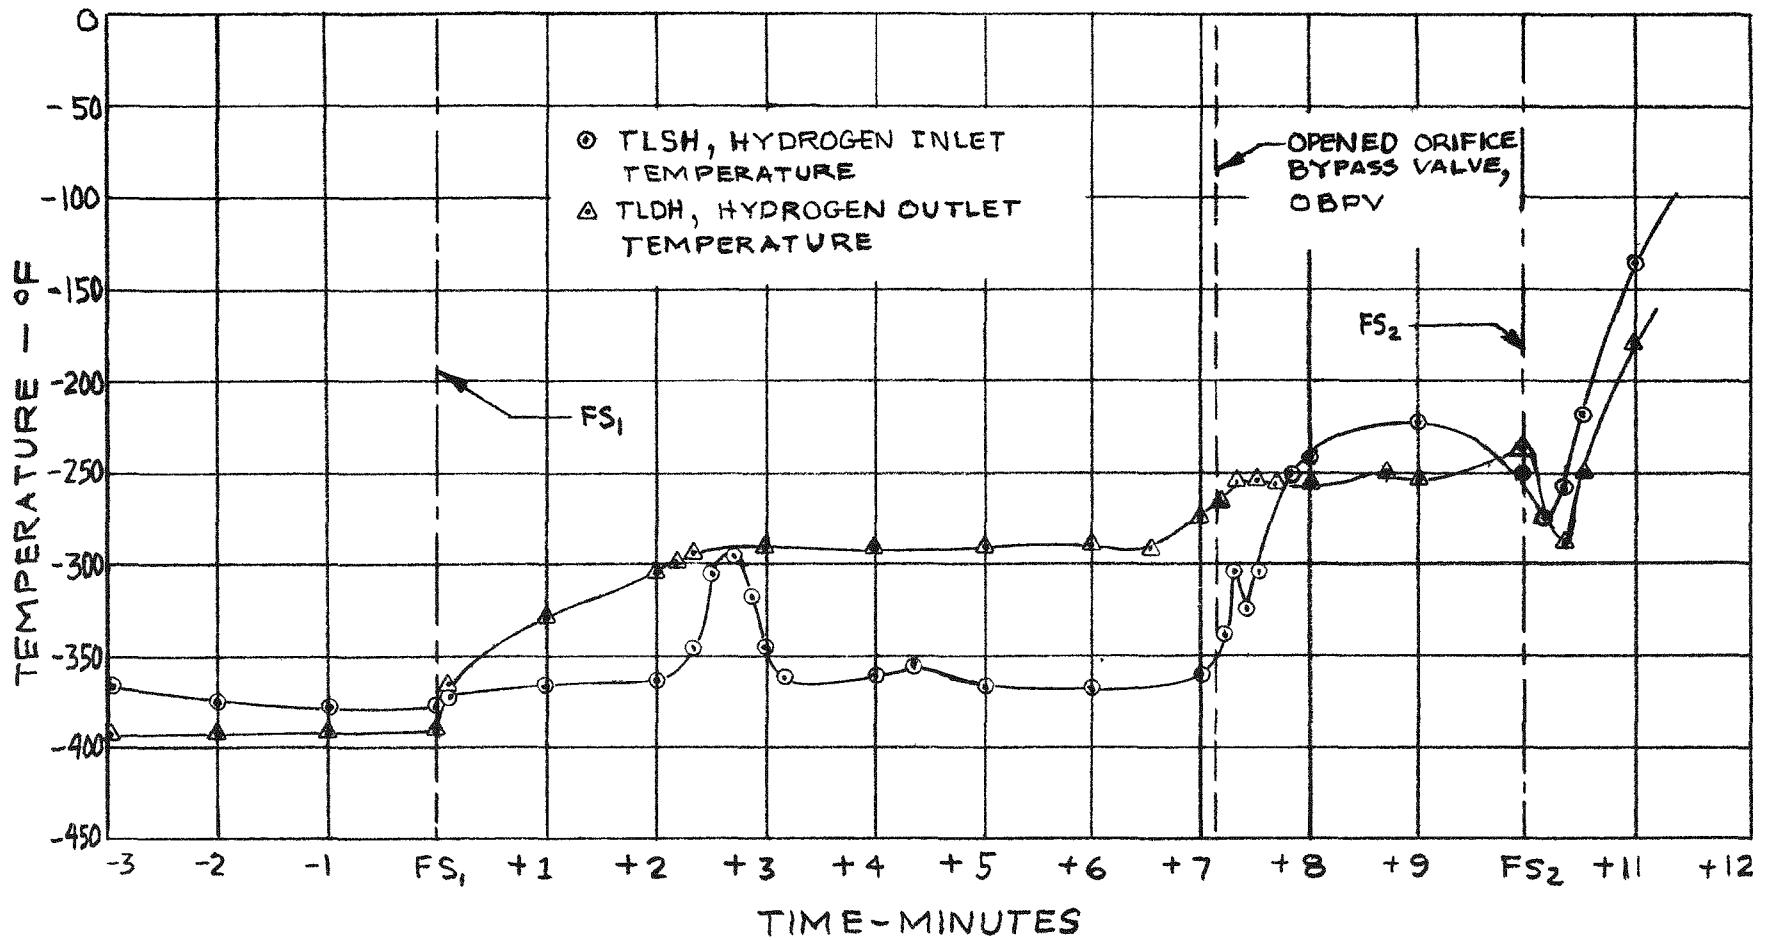
Figure D-5

Irradiation Run--Hydrogen Inlet and Outlet Temperatures vs Time

Plots of the inlet and outlet temperatures of the hydrogen coolant flowing through the bearing tester are shown in Figure D-5. Resistance temperature transducers (RTT's) measured the coolant inlet and outlet temperatures of the bearing tester. The fact TL<sub>SH</sub>, the upstream measurement point, at times indicated a higher temperature than at TL<sub>DH</sub>, the downstream measurement location, is not fully understood.

One possible explanation for the apparent temperature reversal between  $FS_1+8$  and  $FS_1+10$  min is that after the orifice bypass valve (OPBV) was opened, the flow rate decreased through the orifice leg of the parallel flow system and a resulting increase in temperature at the TLSH location occurred. The temperature reversal before  $FS_1$  has no apparent explanation.
